August 6, 2021

PROPERTY INSPECTION REPORT

Concerning: 7898 Weeping Willow Ct., Houston, TX 77057
(Address or Other Identification of Inspected Property)

By: Matthew Brading, Lic #22654 08/06/2021
(Name and License Number of Inspector) (Date)

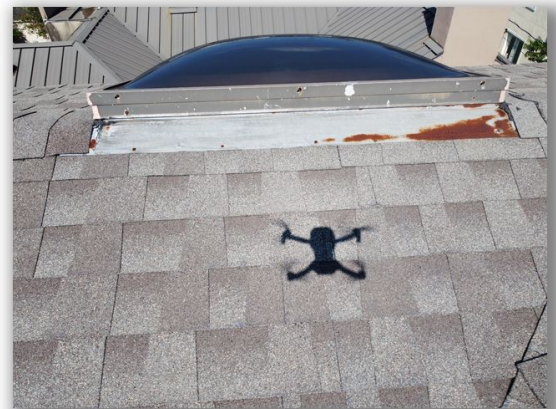
Skylight(s)

- Some of the metal flashing details were observed to be rusted and should be corrected as necessary.

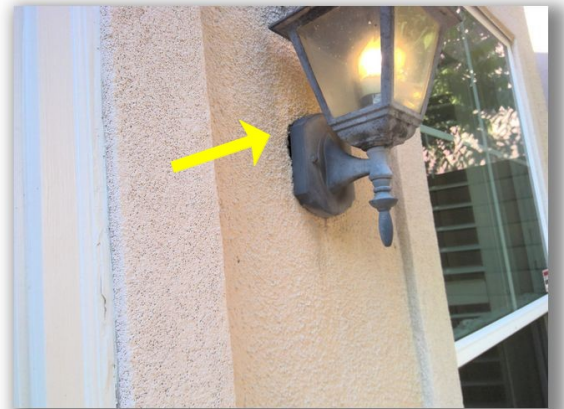
- Failing or missing sealant was observed at and around the stucco type veneer/cladding and the wall opening interfaces (windows, doors, electrical outlets, plumbing outlets, etc.) This condition should be improved to help prevent water intrusion at these locations.

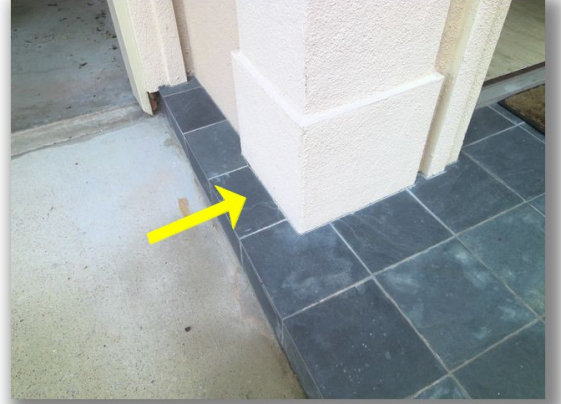
- The exterior stucco type veneer/cladding has inadequate clearance from the concrete flatwork. Most manufacturers require a minimum of 2-inches of clearance from all concrete flatwork.

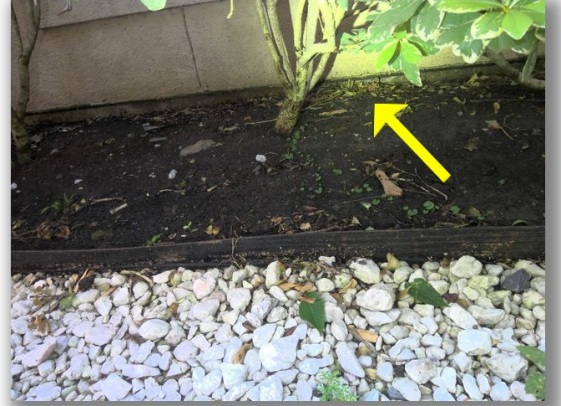
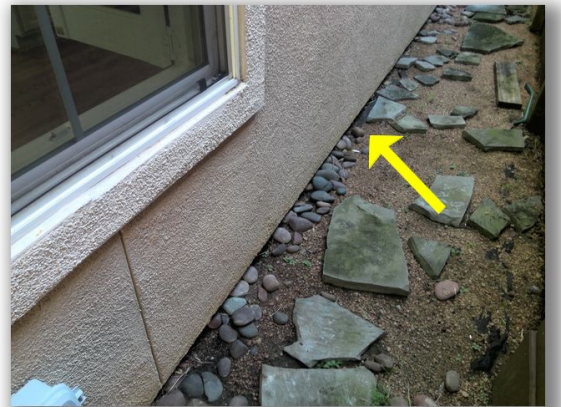
- The exterior stucco type veneer/cladding has inadequate clearance from the finished grade (ground). Most manufacturers require a minimum of 4- to 6-inches of clearance from the finished grade (ground).

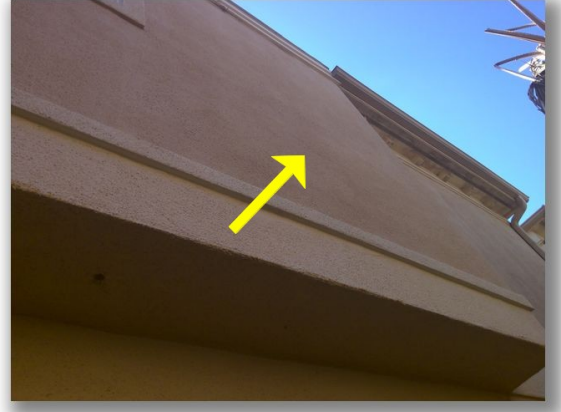
- Cracking of the stucco type veneer/cladding was observed on the west side of the structure. This condition should be further evaluated and corrected as necessary.

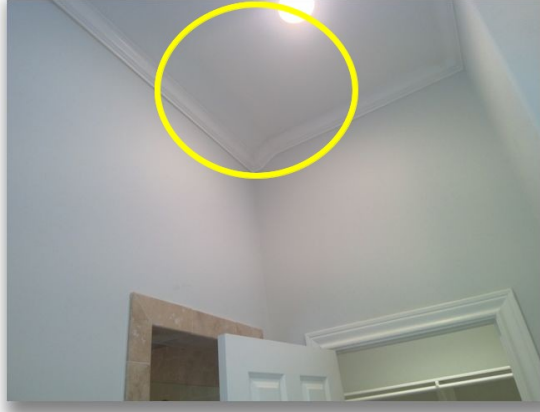
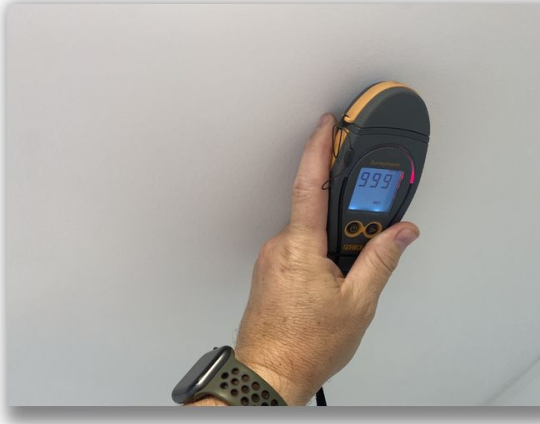
- Elevated moisture levels were detected in the ceiling finished surfaces in the master bathroom. The cause and remedy should be further evaluated and corrected as necessary.

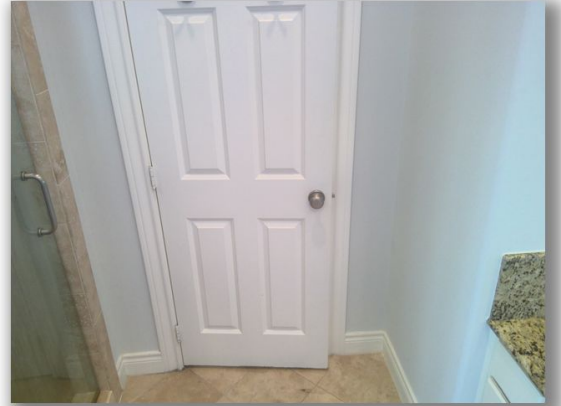
- The door is sticking to the gameroom bathroom
- The door is not latching properly to the master bedroom closet.

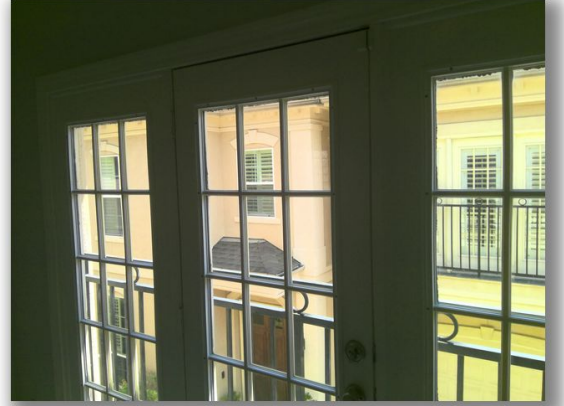
- The door frame has some damage to the balcony.
- The door is loose at the hinges to the balcony.
- The door is sticking to the balcony.

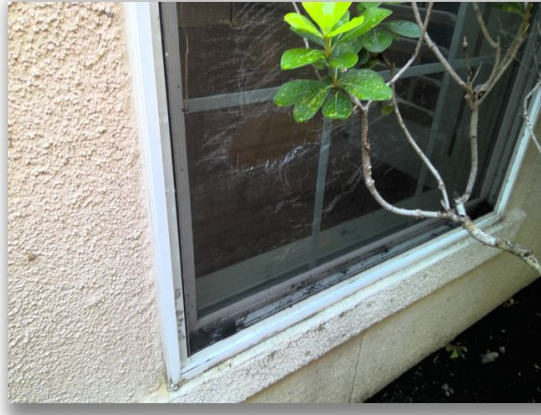
- One or more of the window screens were observed to be damaged.

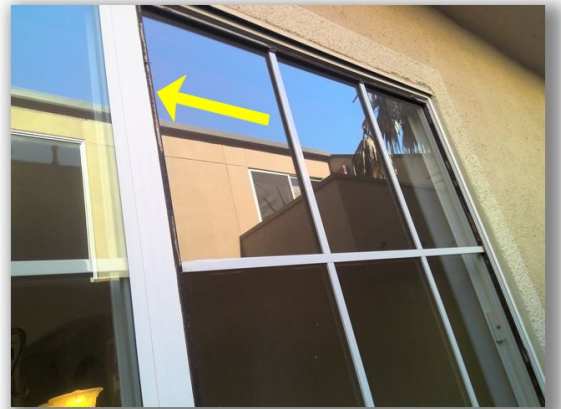
Windows

- Missing exterior vinyl glazing bead observed on one or more windows.

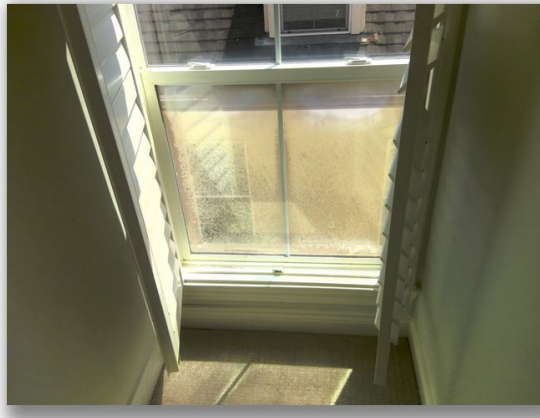
- One or more of the thermal pane windows were observed to have lost their seals. This has resulted in condensation or a fog like film to develop between the panes of glass. The thermal pane windows no longer function as designed when they loose their seal and replacement may be necessary. The windows that have noticeably lost their seals are listed but may not be limited to the following:
gameroom.

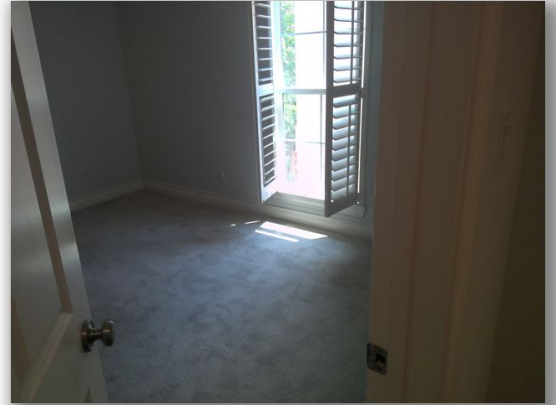
- Glass in individual fixed or operable panels within 18-inches of the floor.

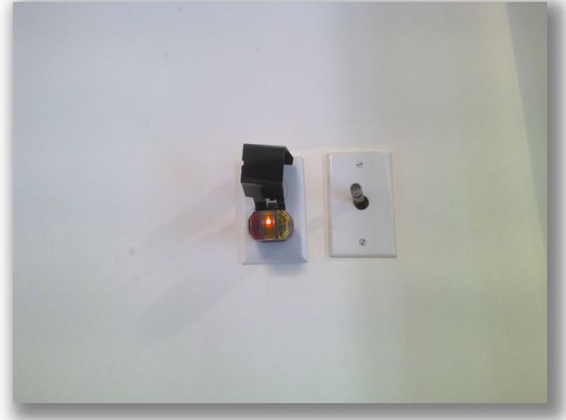
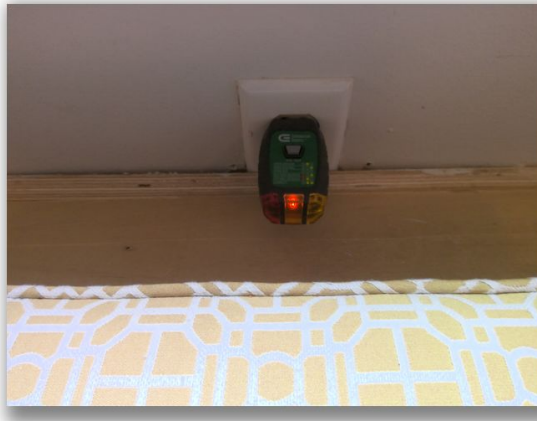
- One or more of the receptacles were observed to have an open ground connection in the living room.

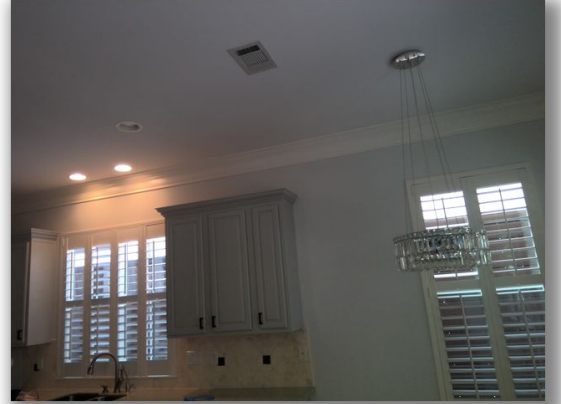
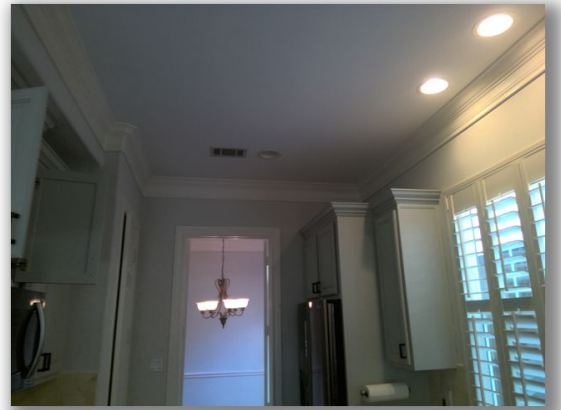
- One or more of the light fixtures appear to be inoperative in various locations throughout the house. This may be due to a bad bulb or some other unknown condition. This condition should be further evaluated and corrected as necessary.

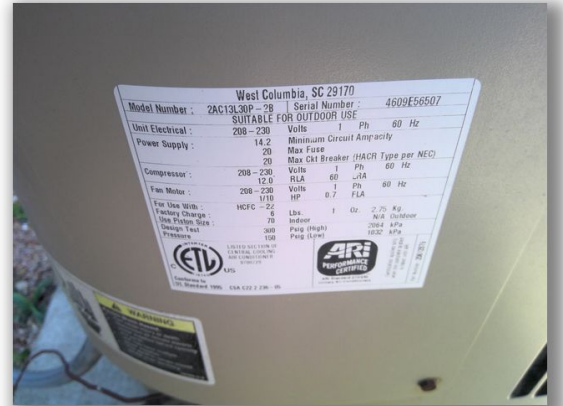
- The temperature drop measured across the evaporative coils of the air conditioning system is lower than considered typical. The unit is not cooling properly and servicing is needed.

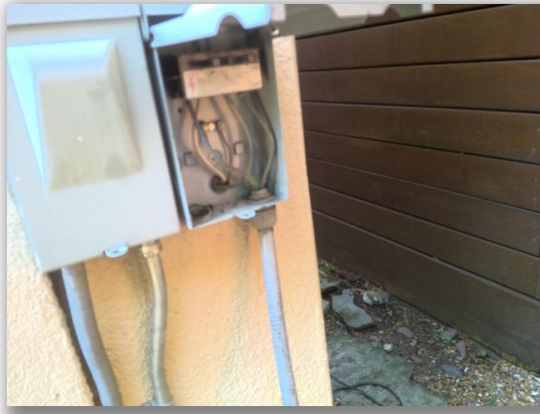
- The service disconnect interior cover plate (dead front) is missing. This should be corrected for reasons of safety.

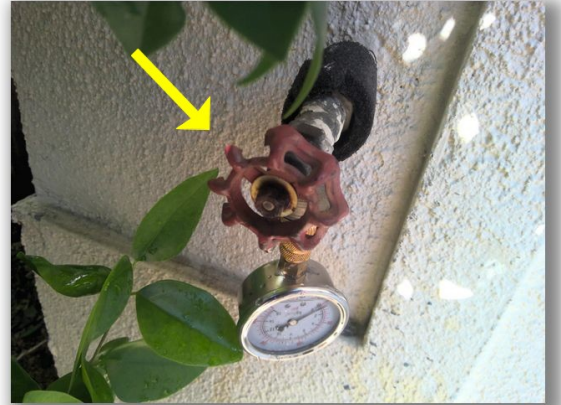
- Water was observed to be leaking back through the vacuum breaker on the east side of the structure. The vacuum breaker is not working as designed.
- The exterior water hose bibb (faucet) handle is damaged and/or missing on the east side of the structure.

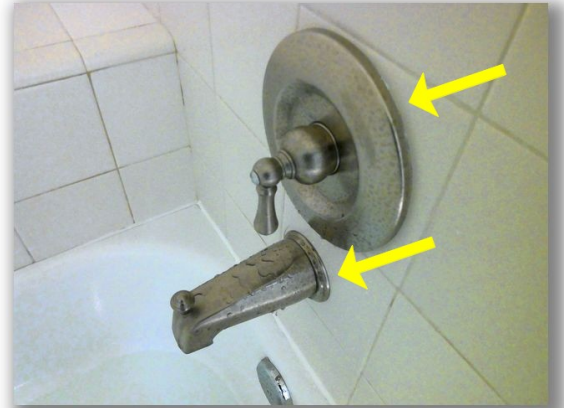
- Cracked, deteriorated and/or missing bathtub enclosure grout and/or caulking should be repaired or replaced as necessary.
- The tub spout is not sealed at the wall. This condition has the potential to allow water to leak back into the wall cavity.
- The faucet assembly is not sealed at the wall. This condition has the potential to allow water to leak back into the wall cavity.

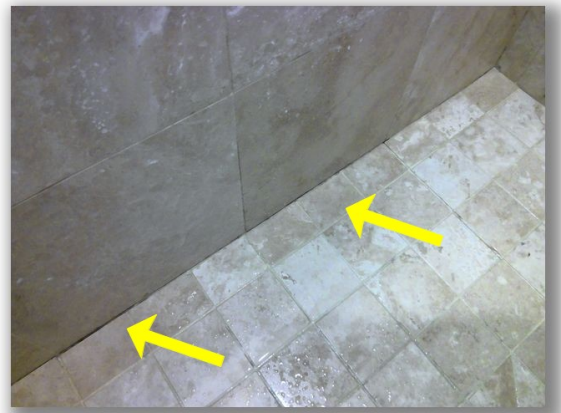
- The faucet assembly is not sealed at the wall. This condition has the potential to allow water to leak back into the wall cavity.
- Cracked, deteriorated and/or missing shower stall grout and/or caulking should be repaired or replaced as necessary.

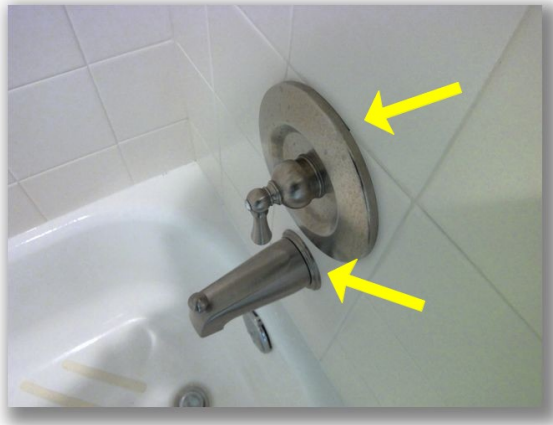
- The tub spout is not sealed at the wall. This condition has the potential to allow water to leak back into the wall cavity.
- The faucet assembly is not sealed at the wall. This condition has the potential to allow water to leak back into the wall cavity.

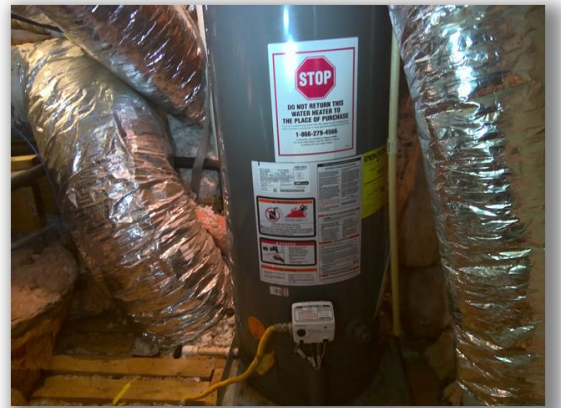
- The water heater flue (vent pipe) has inadequate clearance from combustibles. Double walled vent pipes should have at least 1-inch of clearance and single walled vent pipes should have at least 6-inches of clearance from combustibles.
- The roof level flue storm collar needs to be properly sealed to help prevent water intrusion into the structure.

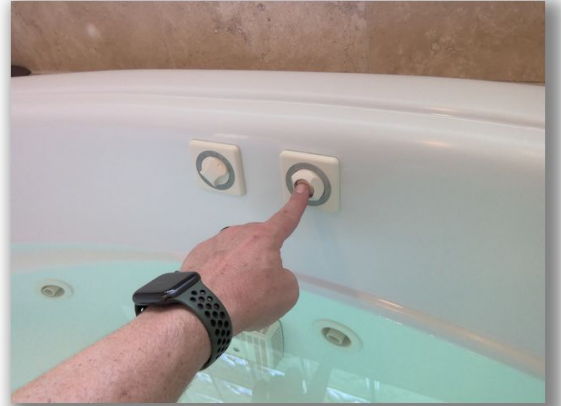
- The hydro-massage therapy equipment appears to be inoperative at the time of this inspection. This condition should be further evaluated and corrected as necessary.

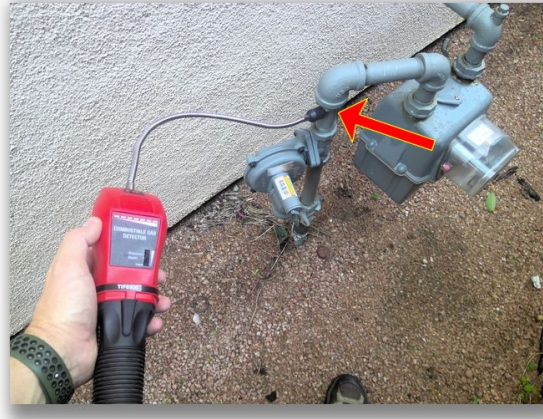
- There was a gas leak detected at the outside gas meter. The inspector used a TUFF 8900 gas leak detector to locate the leak. This condition needs to be corrected for reason of safety.

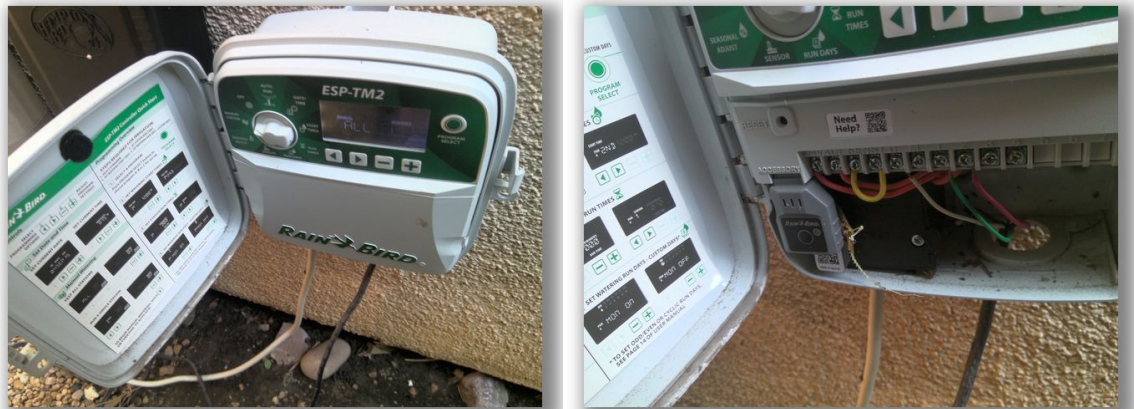
General Pictures of Sprinkler System Back-flow Preventer, Control Box, & Rain Sensor

- I was unable to locate a moisture (rain / freeze) sensor device for the sprinkler system. This is an **“as-built” condition**, but Per TREC standards of practice we are required to report this condition as a deficiency.
- I was unable to locate an anti-siphon device or back-flow prevention device for the sprinkler water supply. An anti-siphon or back-flow prevention device is needed to help protect the systems water source from contamination. The homeowner should be consulted on the location of this device. If there is no anti-siphon or back-flow prevention device in place, one should be installed.
