## PROPERTY INSPECTION REPORT

Prepared For: William Williams  
(Name of Client)

Concerning: , Spring, TX 77373  
(Address or Other Identification of Inspected Property)

By: Matthew Brading, Lic #TREC # 22654 09/22/2021  
(Name and License Number of Inspector) (Date)

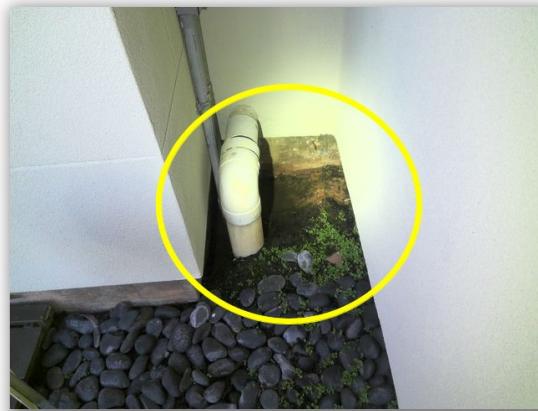
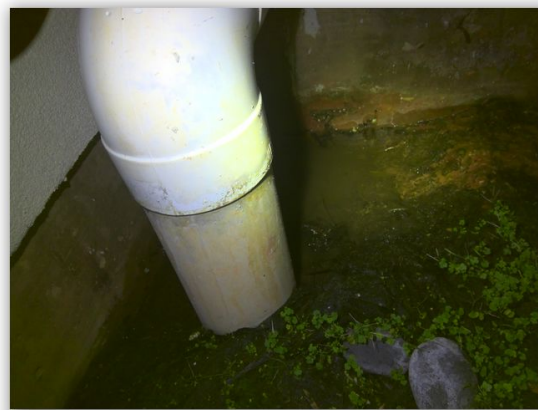
**Grading & Drainage**

- Fill dirt is needed on the front side of the structure. The low spots in the finished grade (ground) adjacent to the foundation perimeter wall need to be filled in to help prevent water from standing and/or ponding next to the foundation area.
- Ponding water was observed a the front of the structure just outside the front door and near a plumbing drain pipe. The root of this condition is unknown. Further evaluation and correction is recommended.

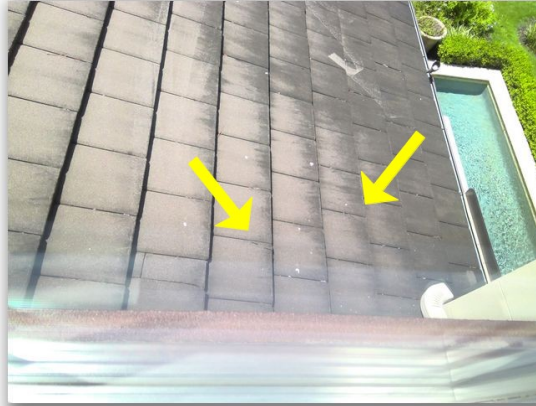
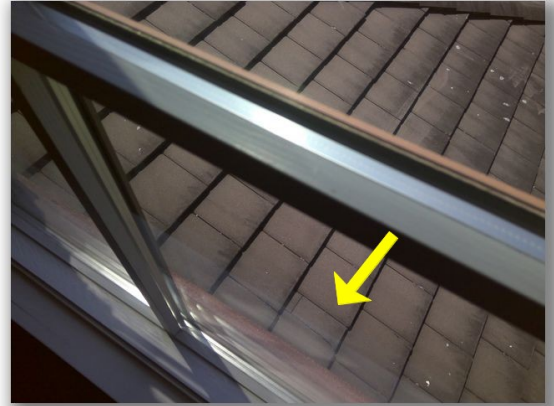
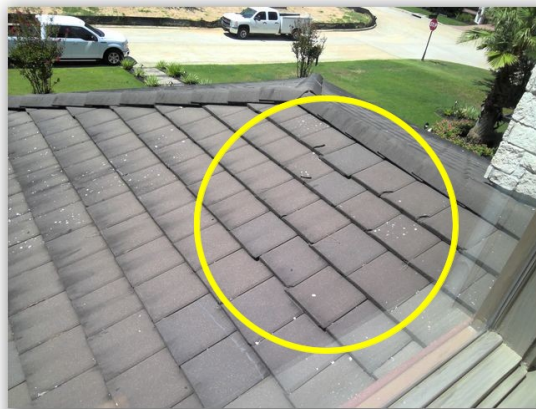
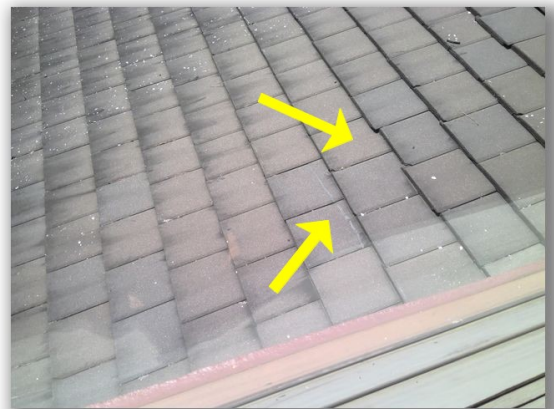
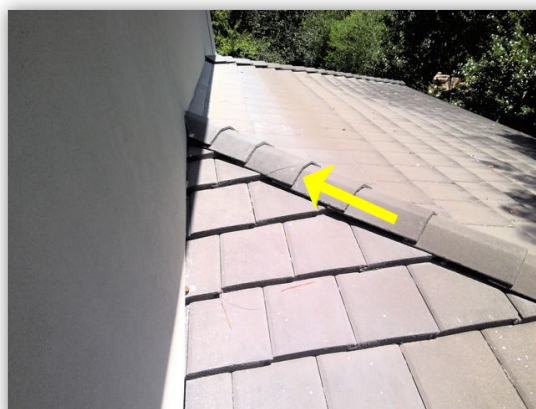
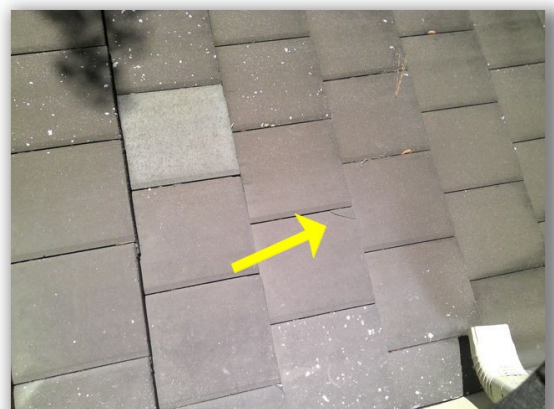
**Roof Covering**

- Damaged shingles were observed on various locations of the roof structure.

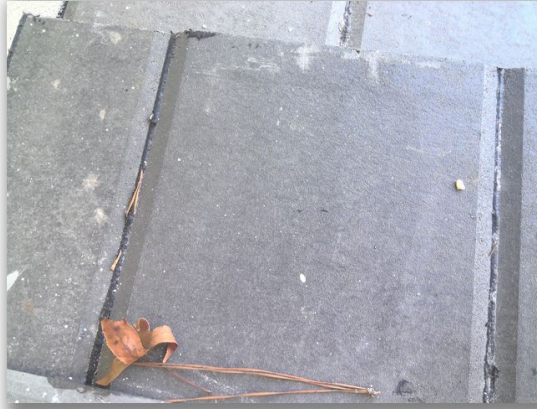
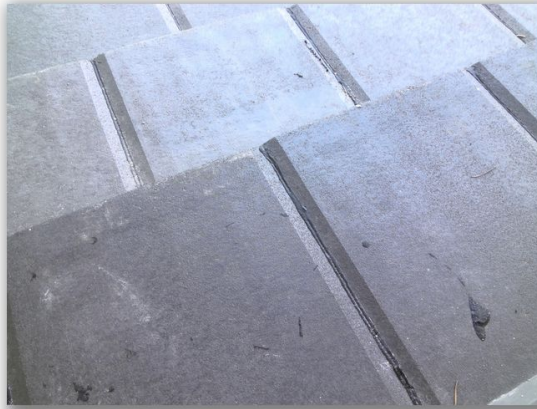
- **Note:** Prior repairs to the roofing material and/or flashing were observed in one or more locations.
- **Note:** It appears that tar has been used to perform previous roof repairs in one or more locations on the roof. This type of repair is temporary in nature and is not considered to be a long term solution to an existing roofing problem.

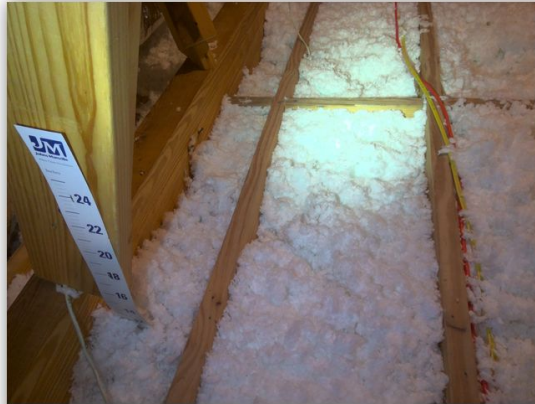
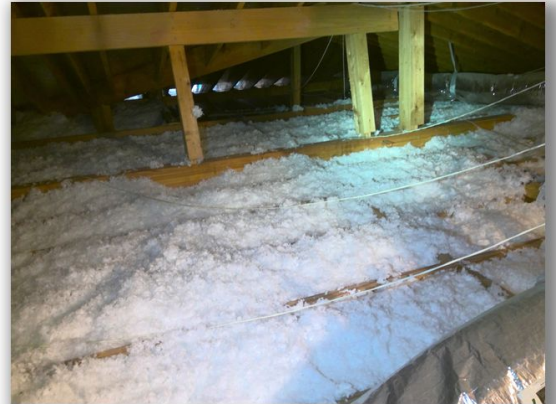
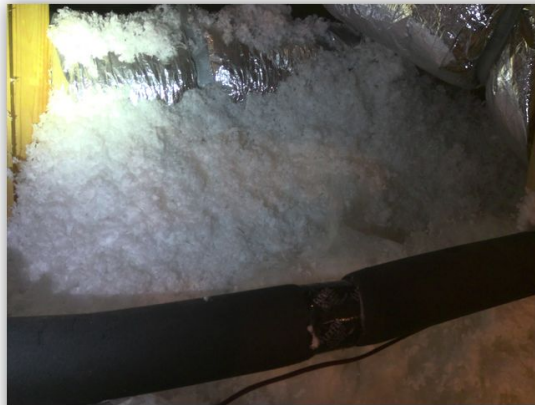
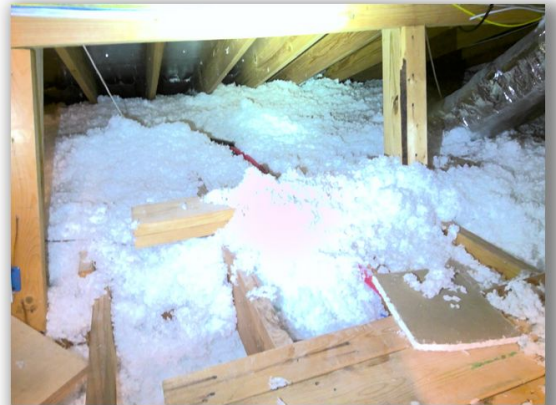
**Attic Insulation**

All components were found to be performing and in satisfactory condition on the day of the inspection.

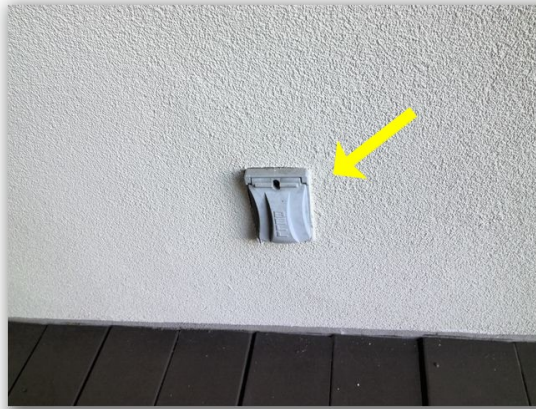
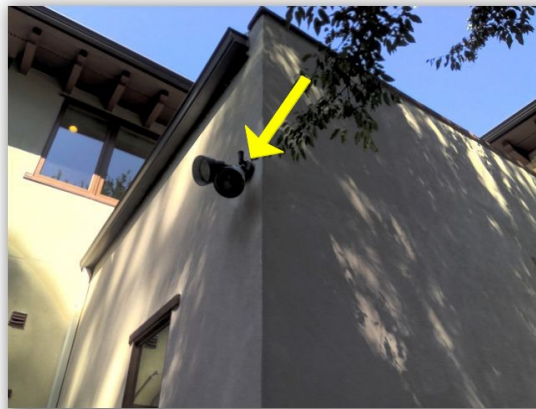
- Failing or missing sealant was observed at and around the stucco type veneer/cladding and the wall opening interfaces (windows, doors, electrical outlets, plumbing outlets, etc.) This condition should be improved to help prevent water intrusion at these locations.

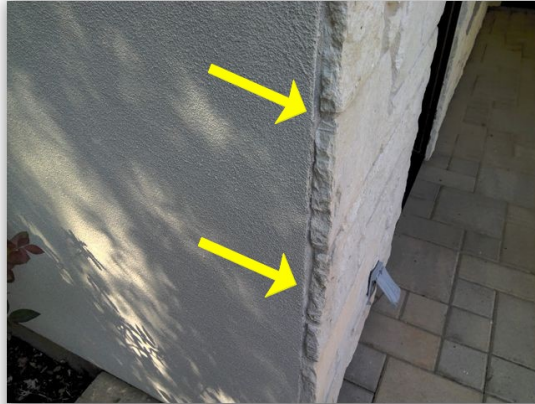
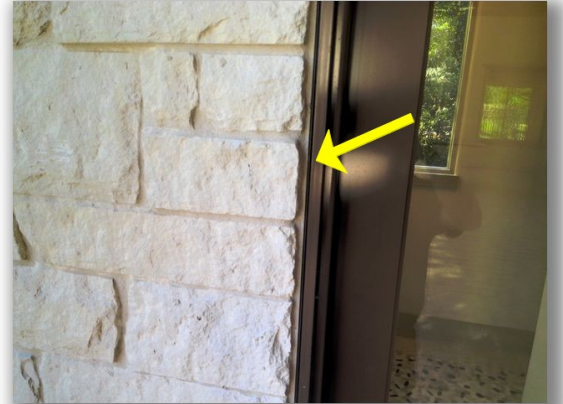
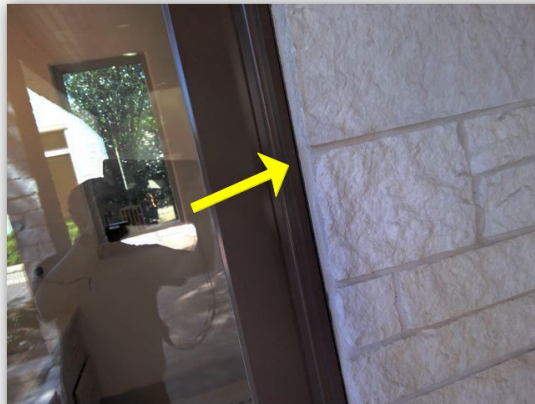
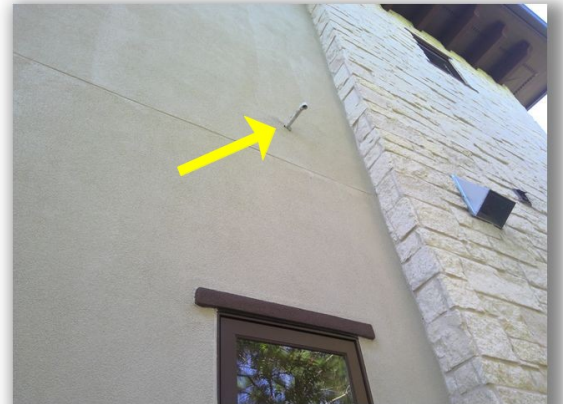
- Cracking of the stucco type veneer/cladding was observed on the back side of the structure. This condition should be further evaluated and corrected as necessary.

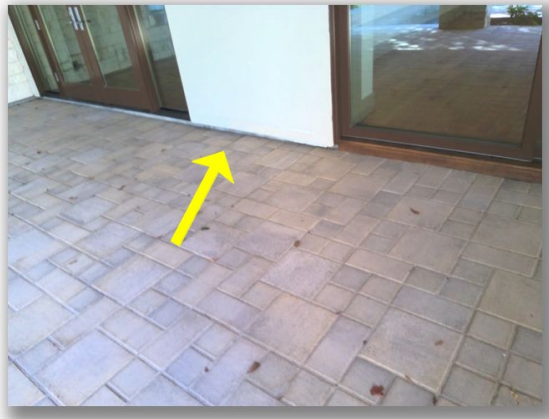
- There was no weep screed observed at the bottom edge of the stucco veneer on the back side of the structure.

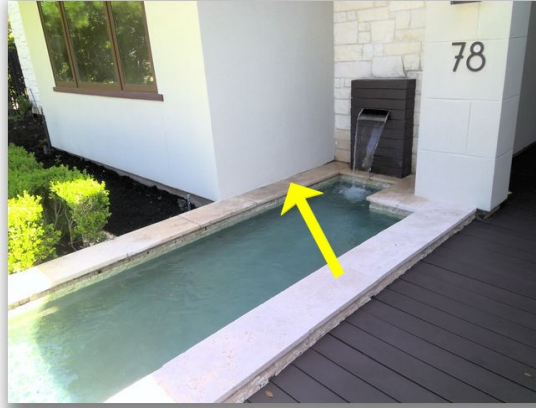
- The exterior stucco type veneer/cladding has inadequate clearance from the concrete flatwork. Most manufacturers require a minimum of 2-inches of clearance from all concrete flatwork.

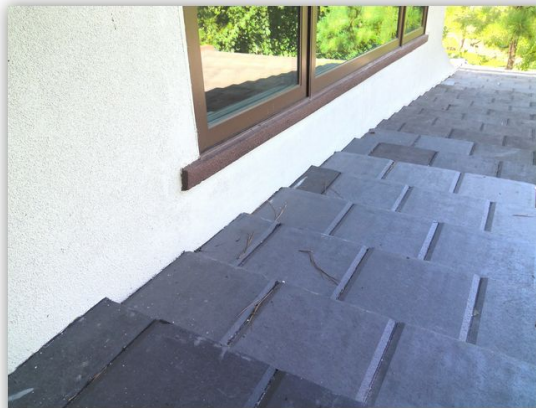
- The exterior stucco type veneer/cladding has inadequate clearance from the roofing material and/or roof structure. Most manufacturers require a minimum of 2-inches of clearance above the roof line.

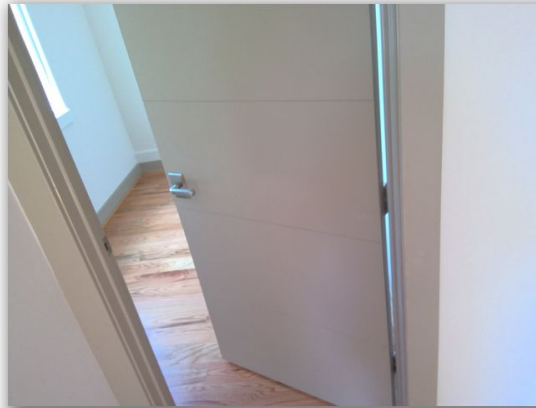
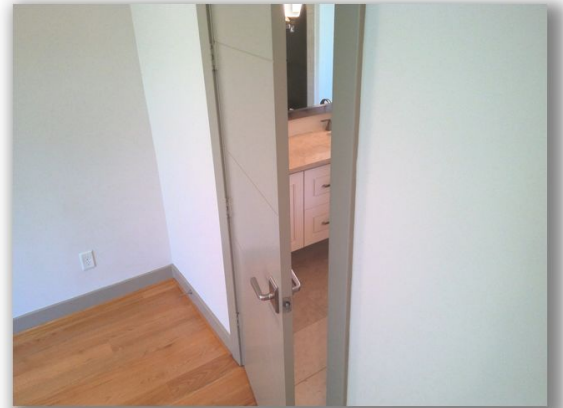
- The door is not latching properly to the upstairs front corner bedroom.
- The door is not latching properly to the upstairs resr corner bedroom bathroom.

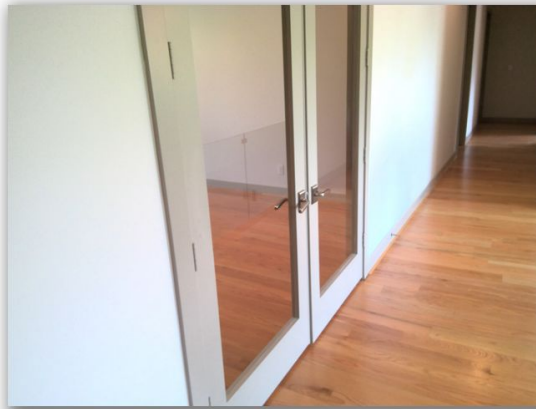
- The door is not latching properly to the gameroom.
- The door is not latching properly to the laundry room.

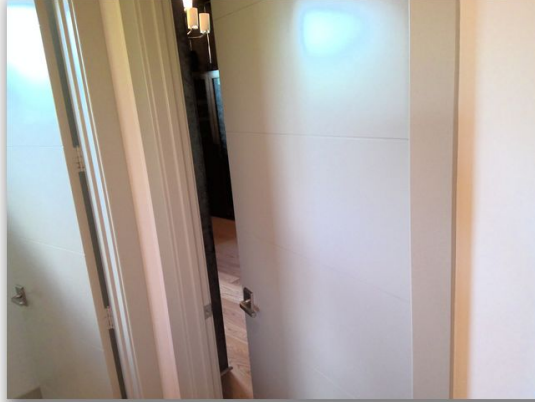
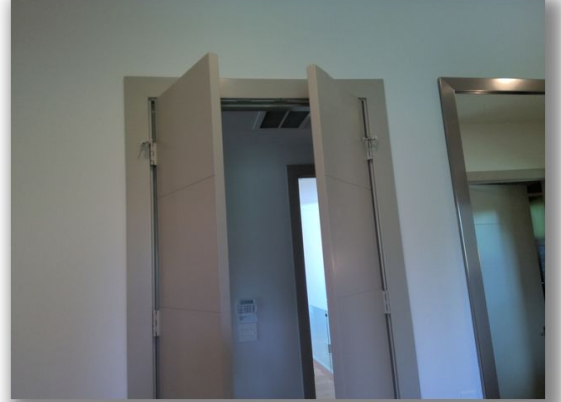
- The door is not latching properly to the master bedroom closet.
- The door spring latch(es) are damaged and/or missing to the master bathroom.

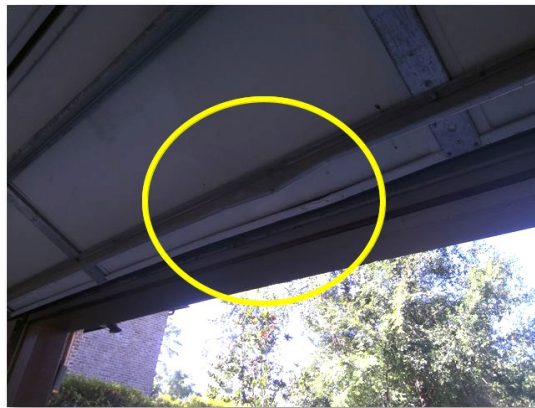
**Right Overhead Garage Door**

- The overhead garage door strut has some deterioration and/or damage.

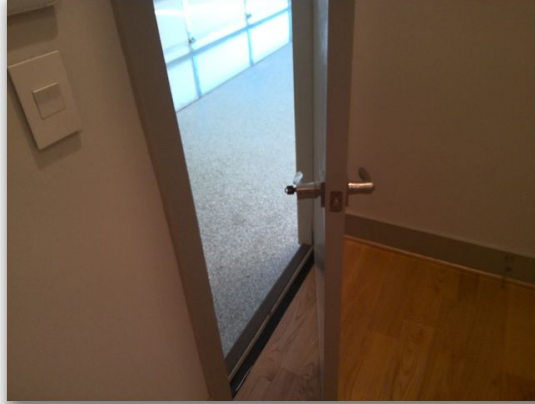
**Garage Entry Door**

- The garage entry door is not equipped with a self-closing device.
- The door hardware is loose to the garage entry door.

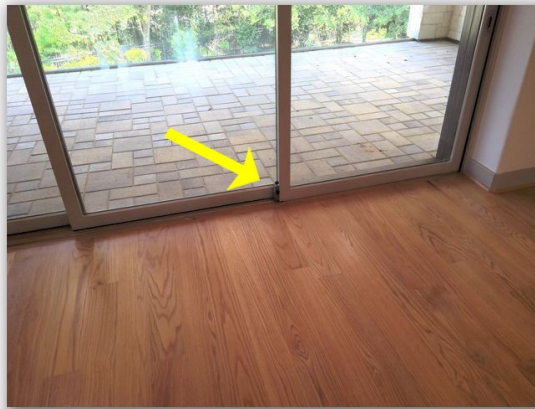
**Sliding Glass Door**

- The gameroom sliding glass door lock does not appear to be functioning properly.

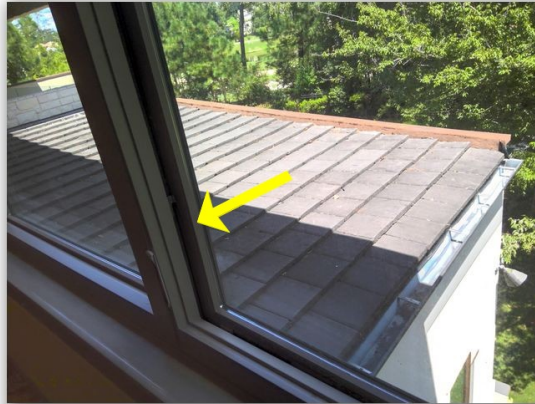
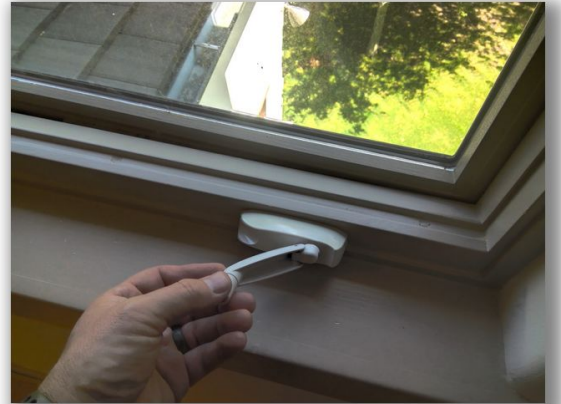
**Windows**

- The window latches do not appear to be functioning properly in the upstairs rear corner bedroom.

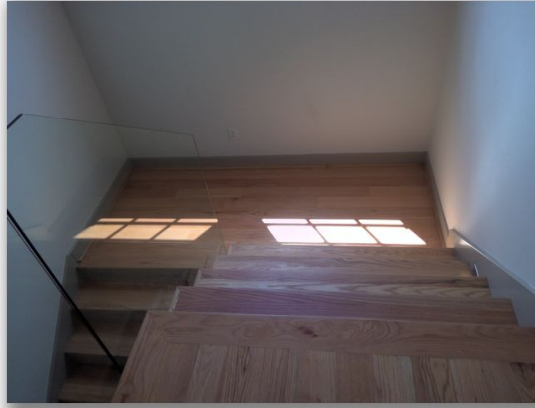
- The handrail grip size does not meet current building standards. This may be an **“as-built” condition** but *Per TREC standards of practice we are required to report this condition as a deficiency. You may consider corrective measures for improved safety.*

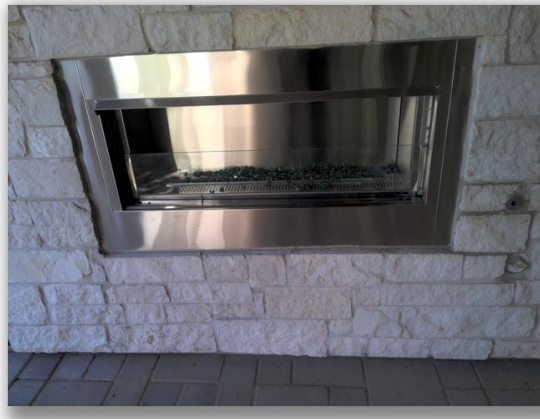
**Patio Fireplace / Chimney**

- The gas log assembly appears to be inoperative at the time of this inspection. I was unable to get the gas logs to respond to the pilot assembly / controls. This condition needs to be further evaluated and corrected as necessary.

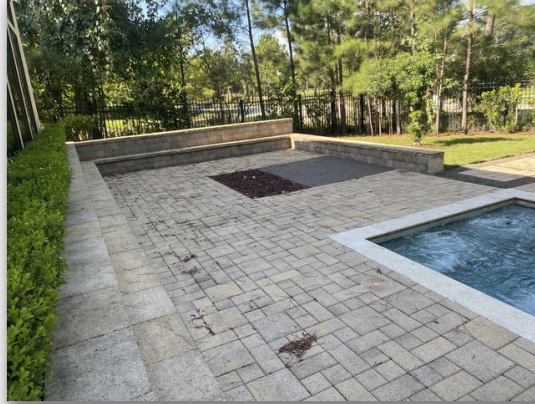
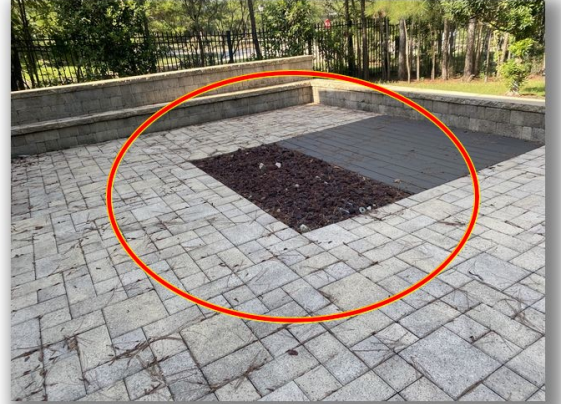
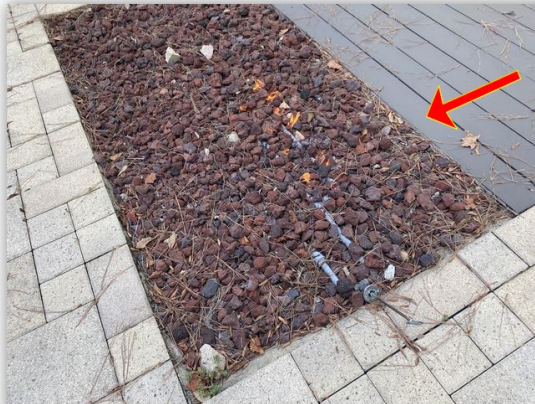
**Backyard Fire-Pit**

- The "fire-pit" observed in the backyard area is hazardous and further evaluation/correction is needed.
- There is no barrier around the fire area.
- The "fire-pit" has poor clearance to combustibile material.

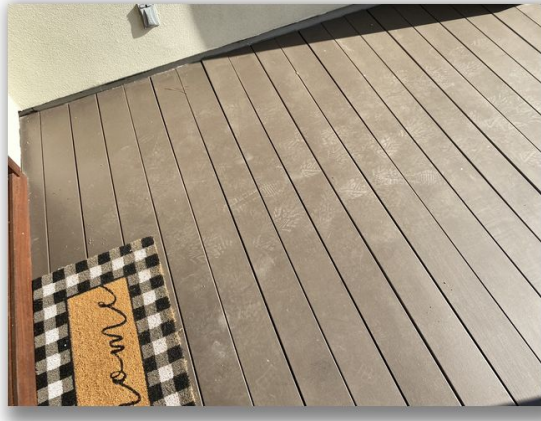
- One or more of the deck boards in the front entrance areas were observed to be loose at the time of inspection.

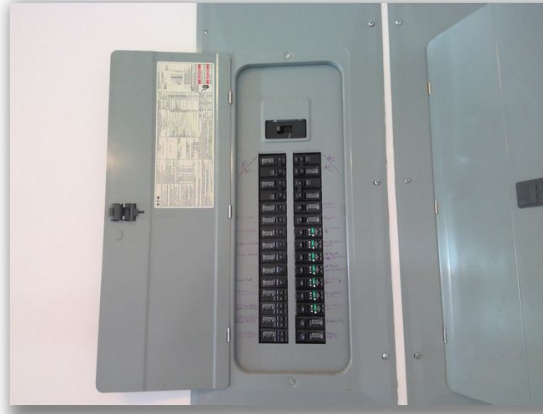
- The breakers (overcurrent devices) in the electrical panel are not properly labeled.
- One or more of the cabinet cover plate screws are missing and need to be replaced.

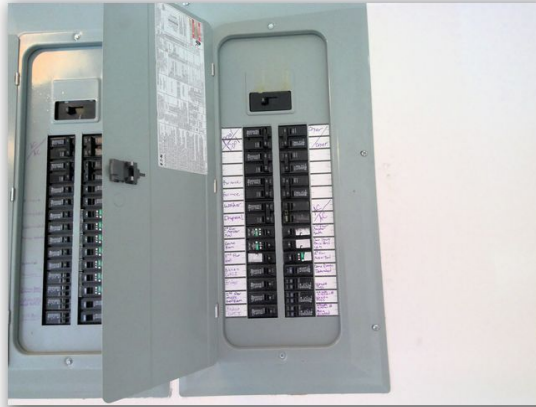
- The breakers (overcurrent devices) in the electrical panel are not properly labeled.

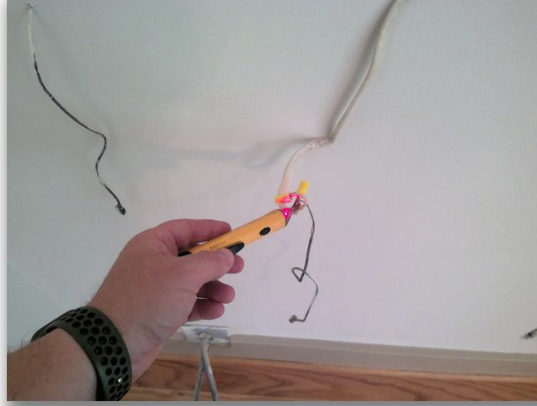
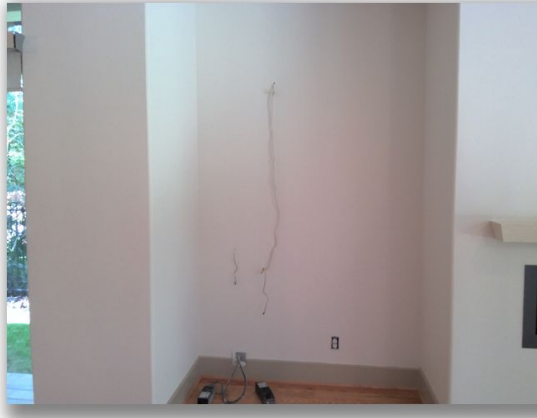
**Distribution Wiring**

- Open end wires were observed in the living room area.

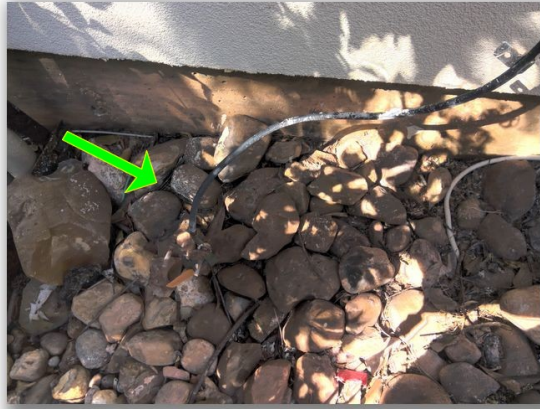
- Improper clamp was observed for exterior grounding electrode. A properly installed acorn clamp is required.

**Note:** Inspector was unable to locate a supplemental source of grounding.

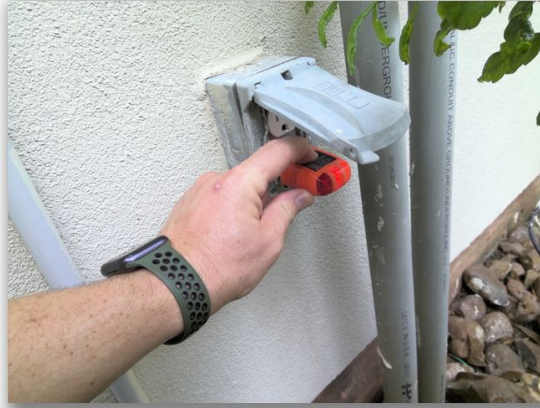
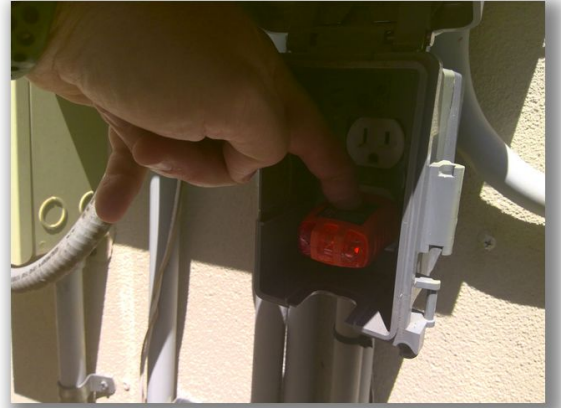
- Not all of the exterior receptacles appear to be connected to a ground fault circuit interrupter (GFCI) device. Under current electrical standards, all of the exterior receptacles should have GFCI protection.

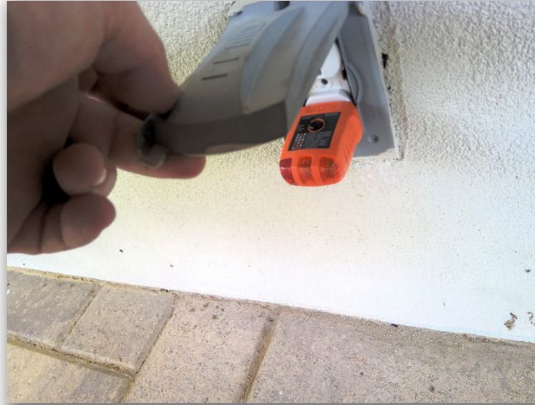
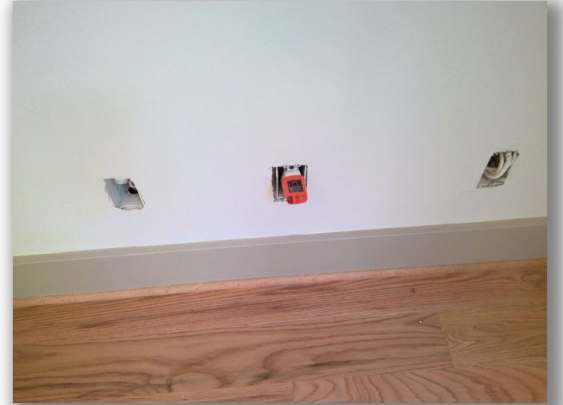
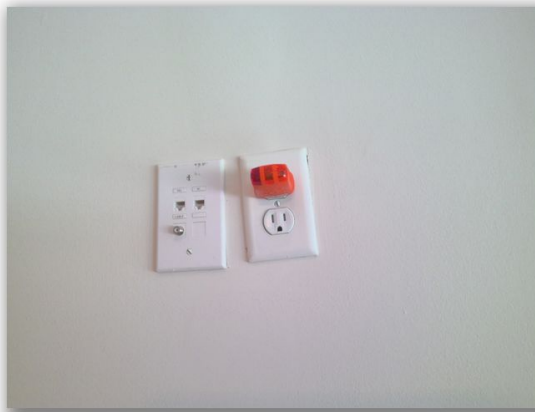
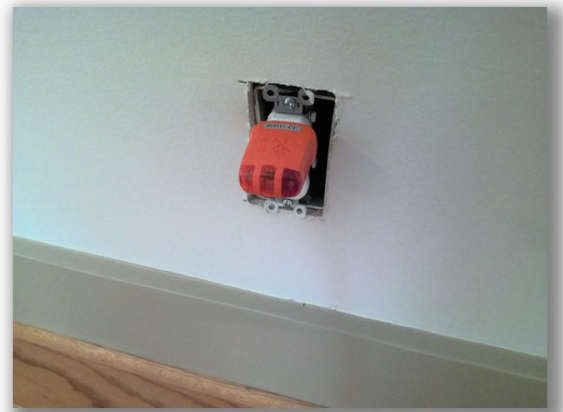
- One or more of the receptacles appears to be inoperative. This receptacle(s) and circuit should be investigated and corrected as necessary. Receptacle(s) were located in the back porch area.
- One or more of the receptacles appears to be inoperative. This receptacle(s) and circuit should be investigated and corrected as necessary. Receptacle(s) were located in the living room.

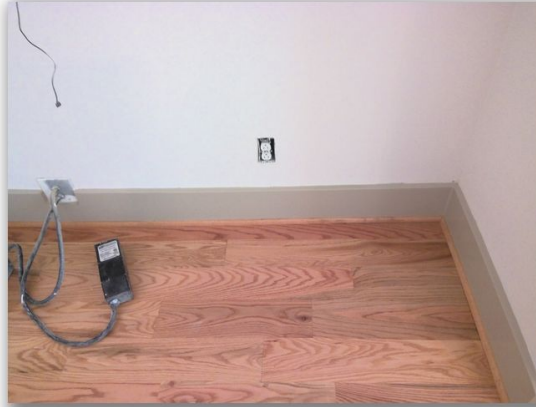
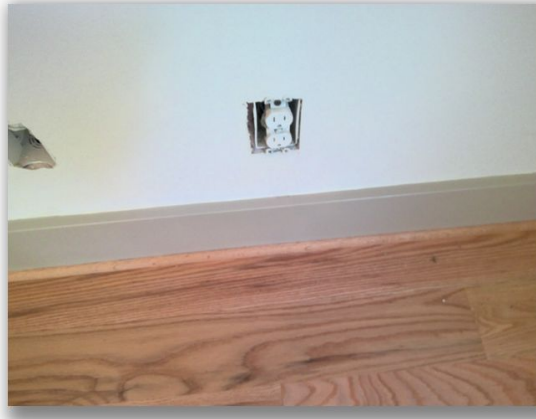
- One or more of the receptacles is missing its cover plate in the living room.

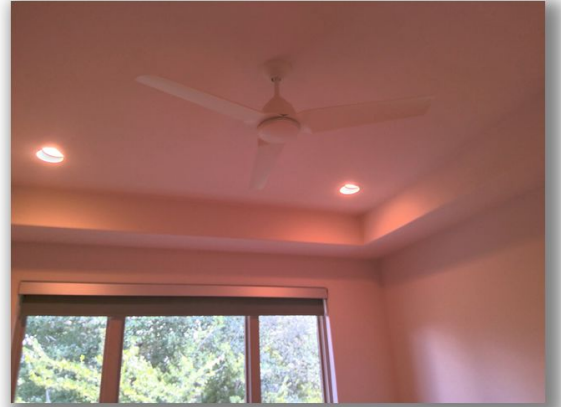
- The ceiling fan appears to be inoperative in the back porch area.
- The ceiling fan appears to be inoperative in the upstairs rear corner bedroom.

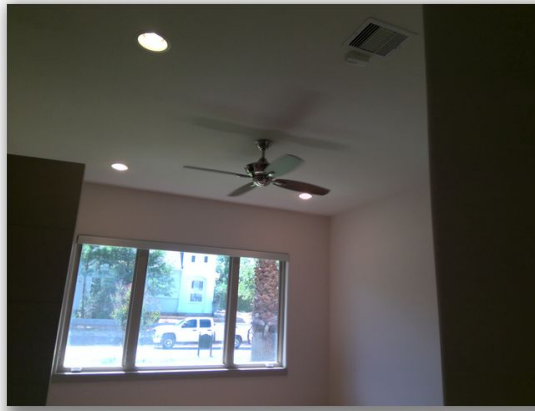
- The ceiling fan was observed to be noisy when operated in the downstairs guest bedroom.

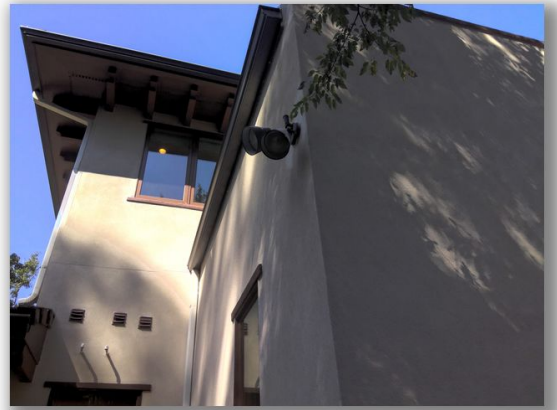
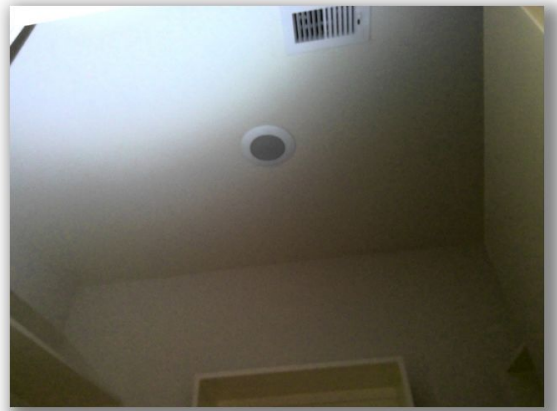
- One or more of the light fixtures appear to be inoperative in various locations throughout the house. This may be due to a bad bulb or some other unknown condition. This condition should be further evaluated and corrected as necessary.

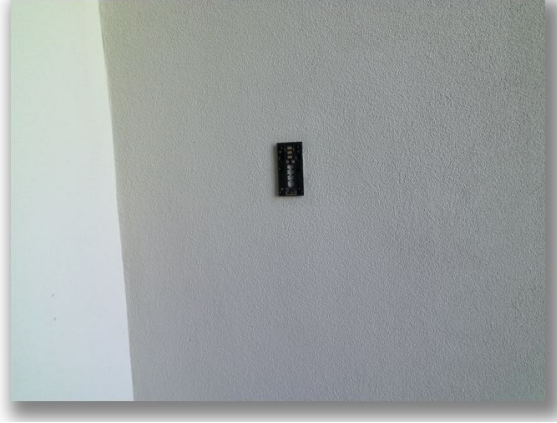
- The doorbell button is missing.

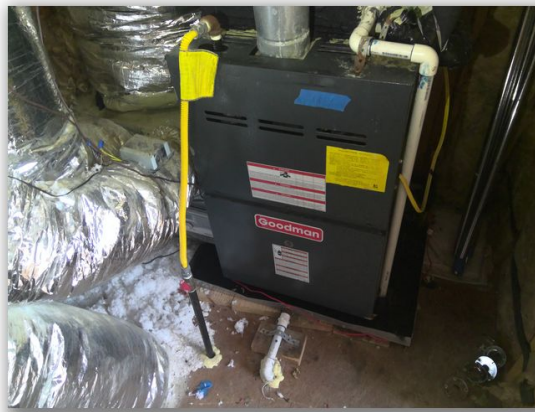
- **Note:** The inspector was unable to operate the upstairs furnace. With the AC System not functioning properly, the temperature in the upstairs area was in the high 80s and could not be cooled enough to get proper heating temperatures.

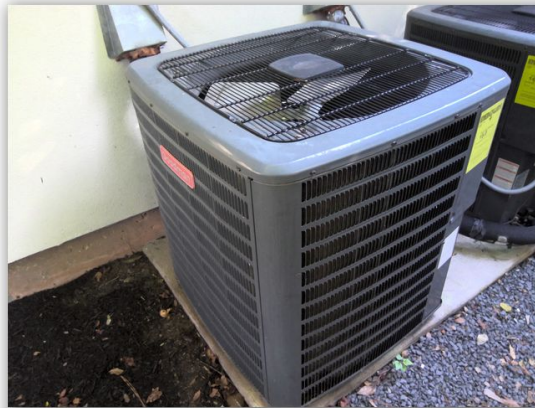
- **The air conditioning system was inoperative at the time of the inspection.**
- The electrical service disconnect is installed behind the outside condenser/coil. This does not meet the clearance requirements of the National Electrical Code or the International Residential Code and should be corrected as necessary.
- **Note:** The breaker for the AC unit was observed to be in the off position. It was changed to on for testing purposes and set back to off.

The HVAC system and equipment needs to be checked and serviced by a Qualified / Licensed HVAC Technician. The observations made to support the rendering of this opinion are listed but may not be limited to the following:

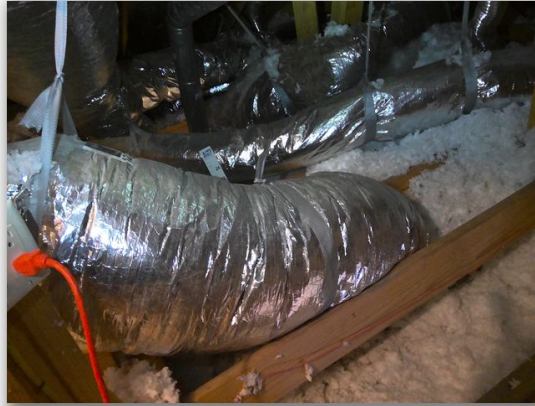
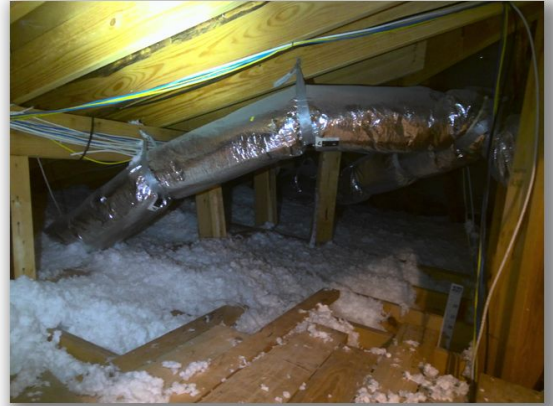
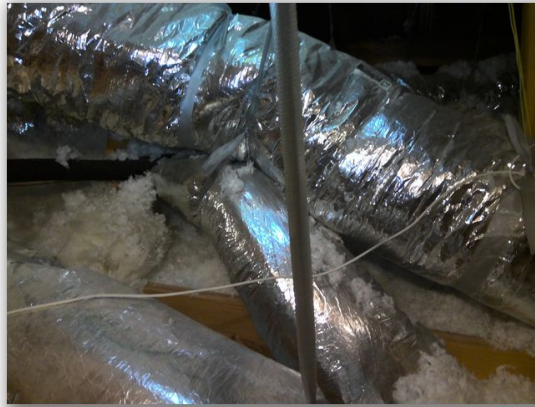
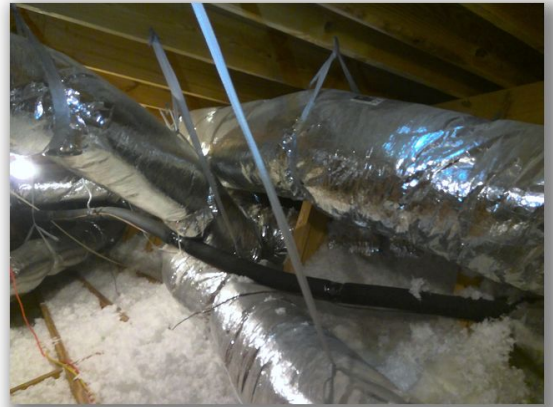
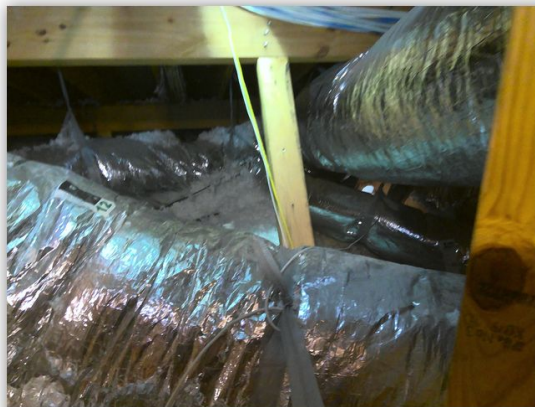
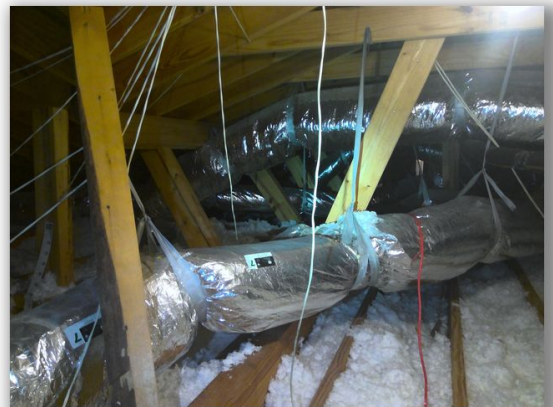
**General Photo(s) of duct work**

- Ducts that are touching should be separated by insulation to help prevent condensation.

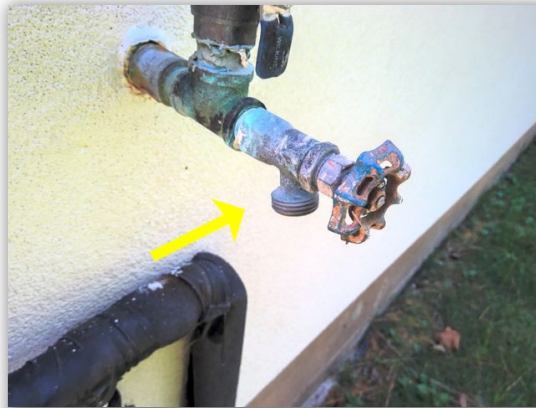
##### Exterior Faucets/Fixtures

- One or more of the exterior water hose bibbs (faucet) do not have a back-flow or anti-siphon device (Vacuum Breakers) in place.
- The exterior water hose bibb (faucet) leaks when turned off on the left side of the structure.

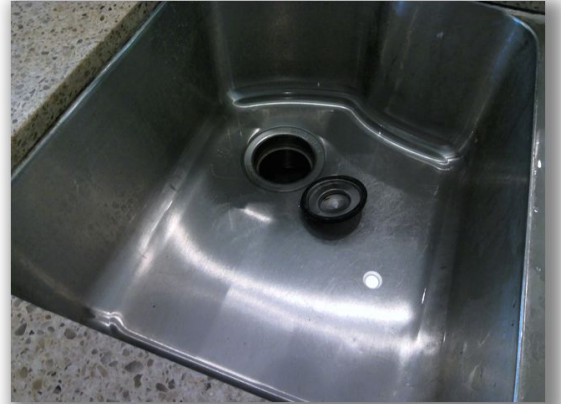
**Kitchen Sink**

- The left drain leaks water into the cabinet when drained under pressure with a large volume of water.
- The Right side sink was observed to drain slowly, suggesting that an obstruction may exist.

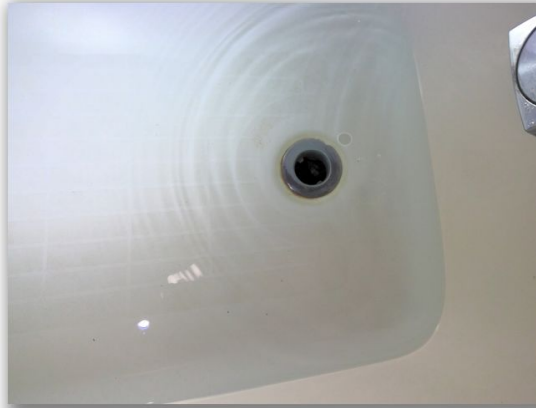
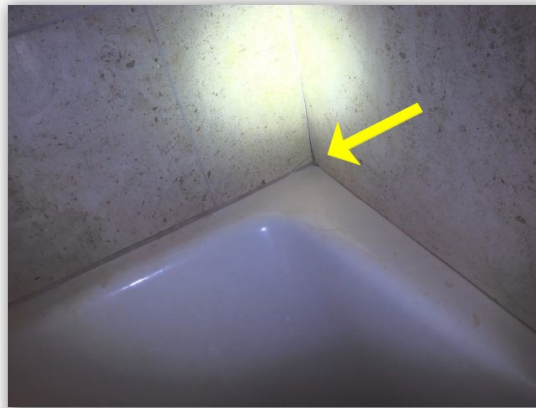
*Bathtub*

- The stopper is missing.
- Cracked, deteriorated and/or missing bathtub enclosure grout and/or caulking should be repaired or replaced as necessary.
- Some of the tub enclosure tiles were observed to be cracked.

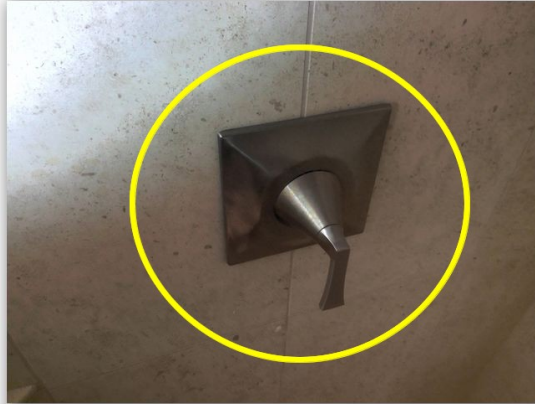
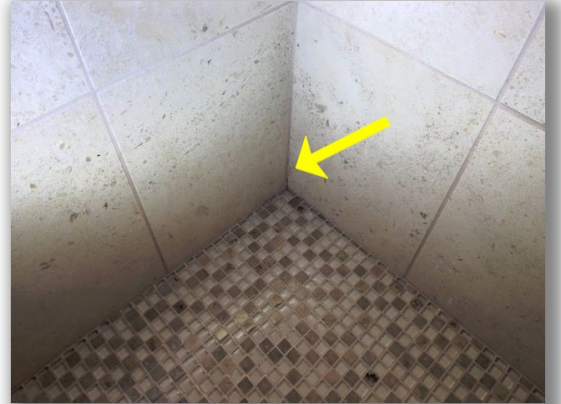
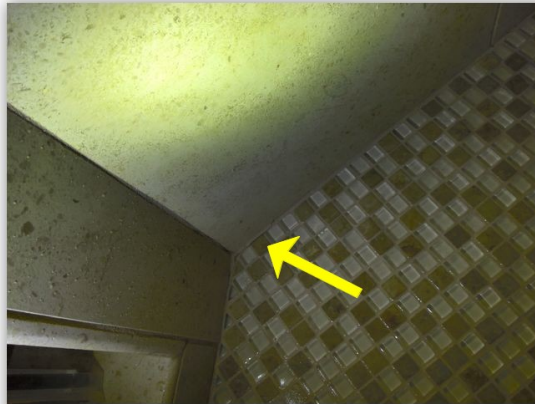
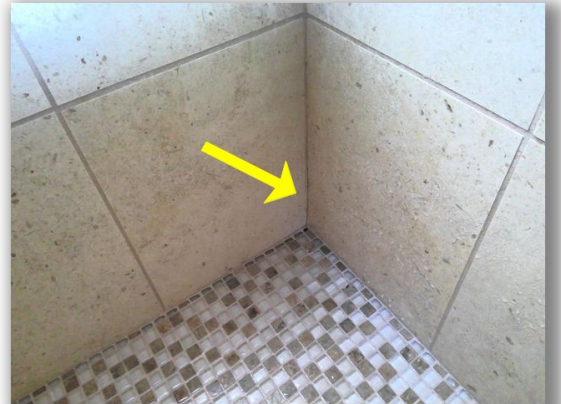
*Shower*

- The faucet assembly is loose.
- Cracked, deteriorated and/or missing shower stall grout and/or caulking should be repaired or replaced as necessary.

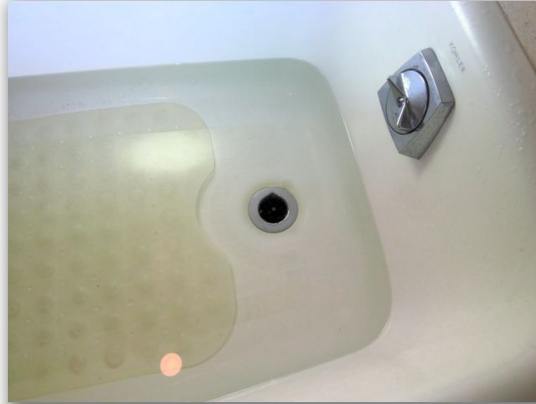
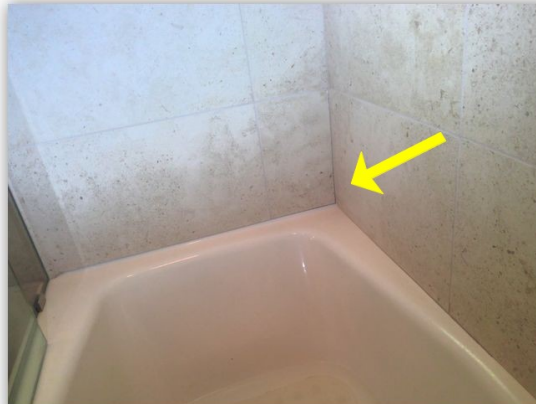
*Bathtub*

- The stopper is missing.
- Cracked, deteriorated and/or missing bathtub enclosure grout and/or caulking should be repaired or replaced as necessary.
- The bathtub was observed to drain slowly, suggesting that an obstruction may exist.

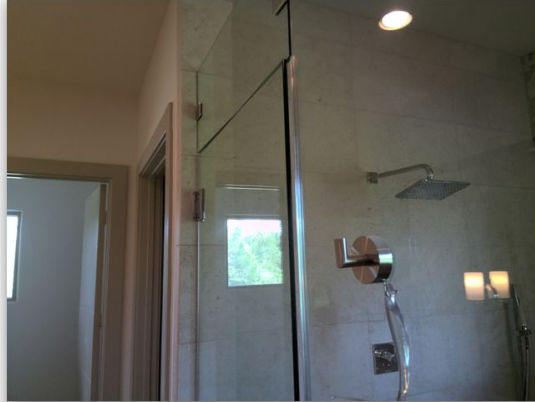
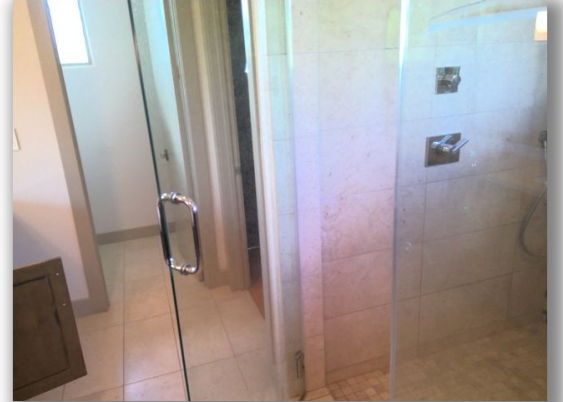
- The shower enclosure door does not function properly.

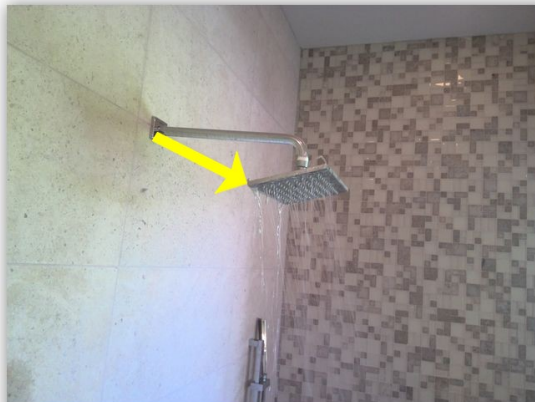
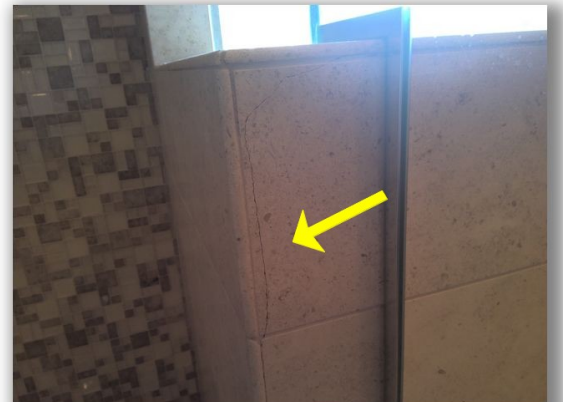
- The shower spout is leaking at the neck connection.
- Some of the shower enclosure tiles were observed to be cracked.

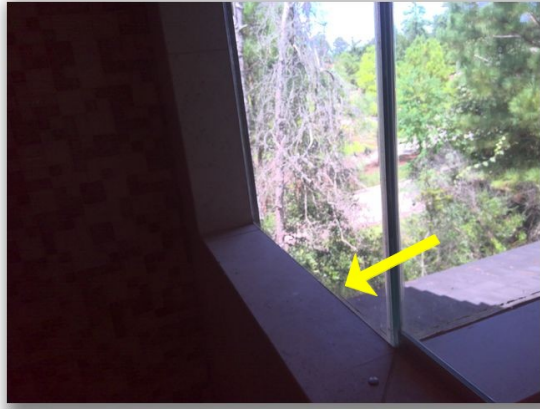
- Recommend sealant around the master bathroom shower window area.

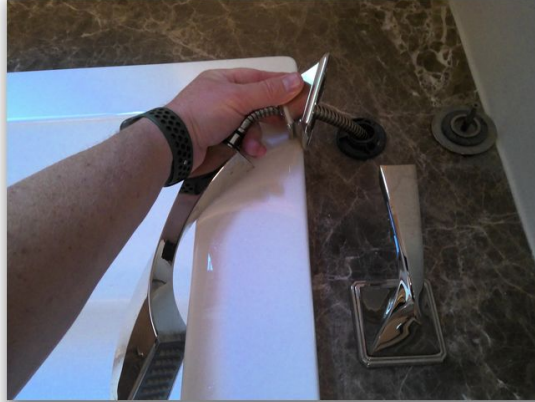
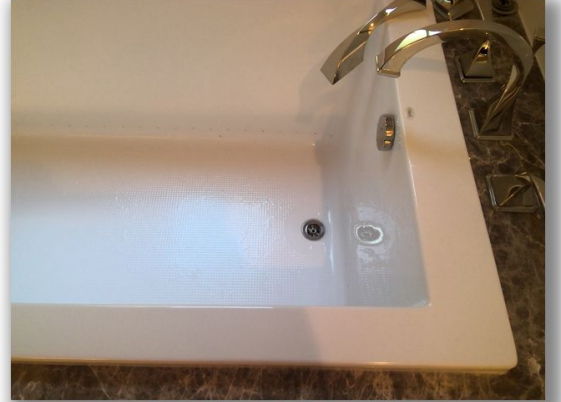
*Bathtub*

- The sink sprayer head is damaged.
- The stopper is missing.

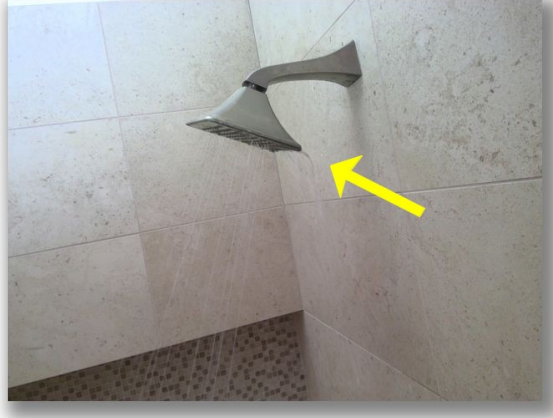
- The shower spout is leaking at the neck connection.

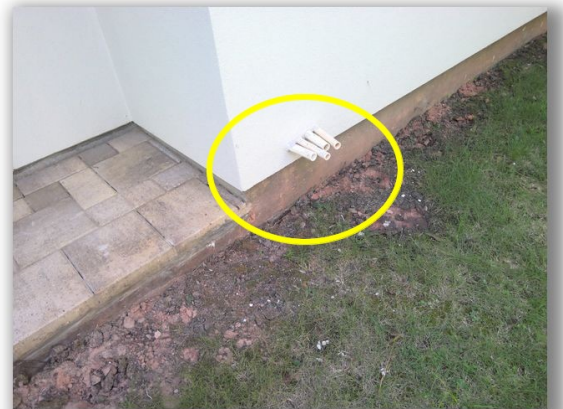
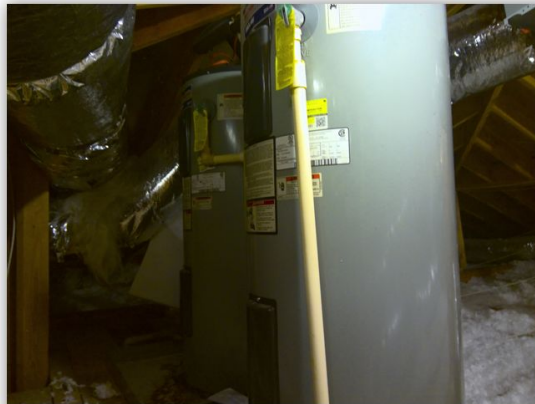
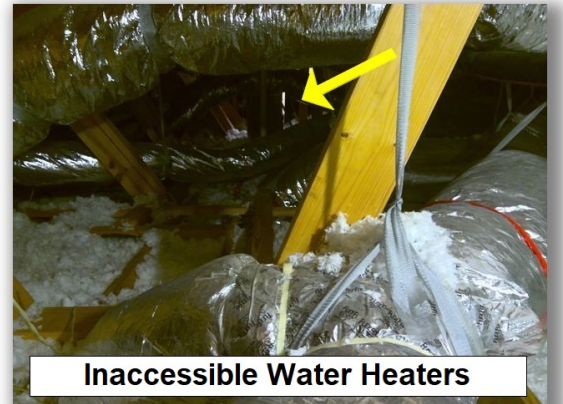
- There were two water heaters in the attic area on the left side of the structure that were inaccessible at the time of inspection.
- The exterior termination point of the temperature and pressure relief (TPR) valve discharge pipe is missing its 90-degree elbow. The TPR discharge pipe should turn 90-degrees downward and terminate within 6-inches of the ground.

- There is no decked service passage to the attic installed equipment. Under current mechanical installation standards, all appliances (i.e. HVAC Equipment and/or Water Heaters) mounted in an attic space should be accessible with a passageway of continuous solid flooring not less than 24-inches wide. A level service space at least 30-inches deep and 30-inches wide should be present along the side of the appliance where access is required.

- The attic mounted water heater is installed to far from the attic access. Under current mechanical installation standards, all appliances (i.e. HVAC Equipment and/or Water Heaters) installed in an attic space should have an attic access within 20-feet of the appliance.

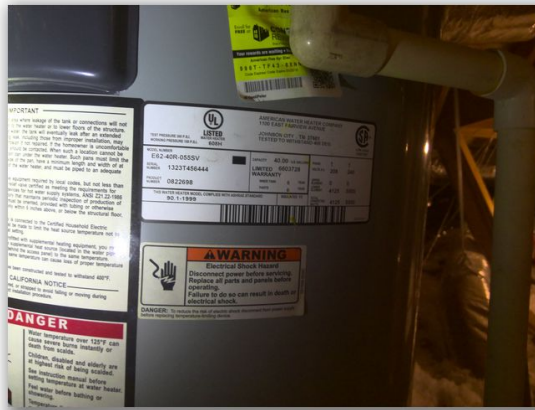
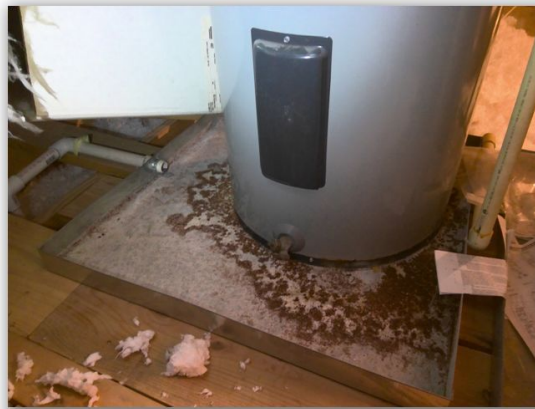
- **Note:** The auxiliary/secondary drain pan under the water heater has some water staining and/or a rust build-up. This would indicate that the pan has held water in the past and should be closely monitored.

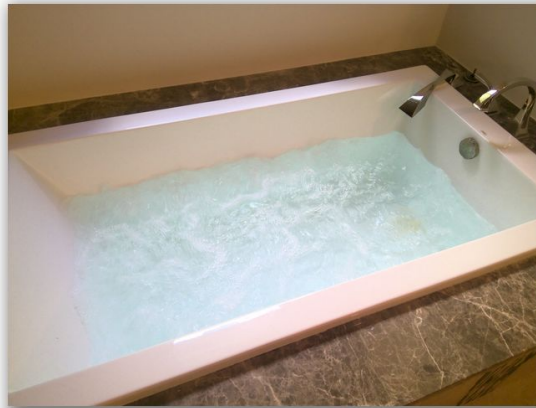
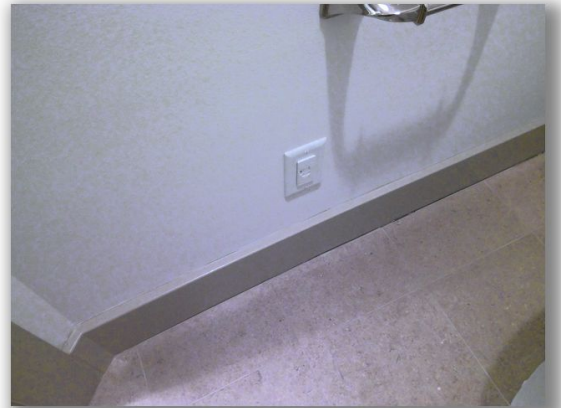
*Location of GFCI: In master bathroom area.*

This component appears to be performing adequately at the time of this inspection. It is achieving an operation, function, or configuration consistent with accepted industry practices for its age.

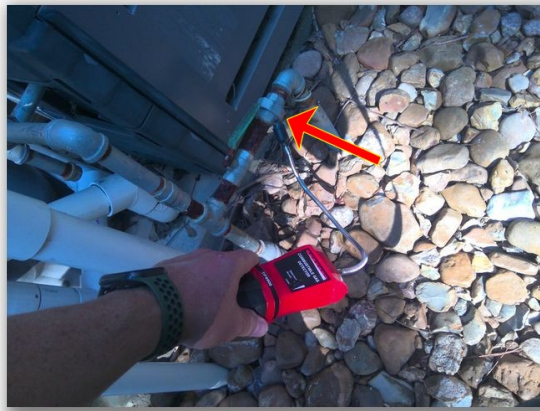
Movement was detected in the gas gauge at the time of the gas check. This indicates a gas leak is present and needs to be investigated and repaired as necessary by a Qualified Licensed Plumber. The observation made to support the rendering of this opinion are listed but not limited to the following:

- There was a gas leak detected at the pool heater. The inspector used a TUFF 8900 gas leak detector to locate the leak. This condition needs to be corrected for reason of safety.
