## PROPERTY INSPECTION REPORT

Prepared For: William Williams  
(Name of Client)

Concerning: , Spring, TX 77373  
(Address or Other Identification of Inspected Property)

By: Matthew Brading, Lic #TREC # 22654 09/22/2021  
(Name and License Number of Inspector) (Date)

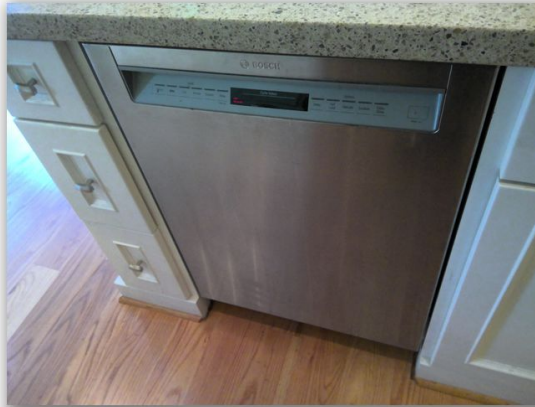
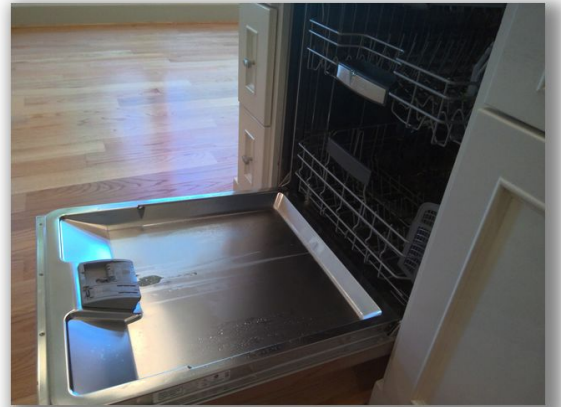
**Brand Name:** Bosch

- The dishwasher was inoperative at the time of this inspection.

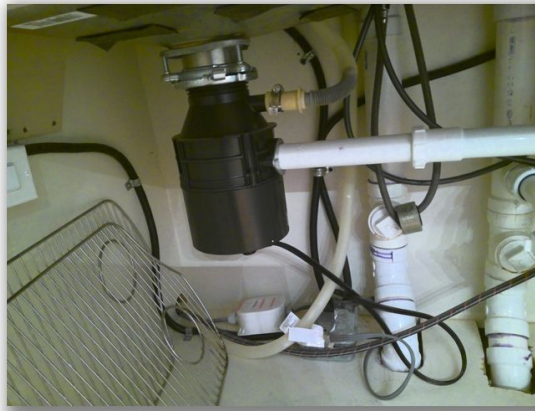
### B. Food Waste Disposers

- The food waste disposer is inoperative.

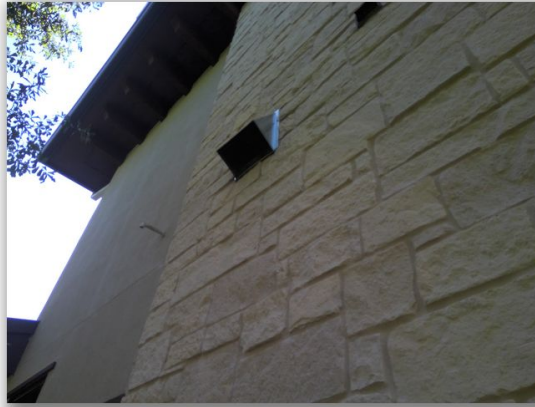
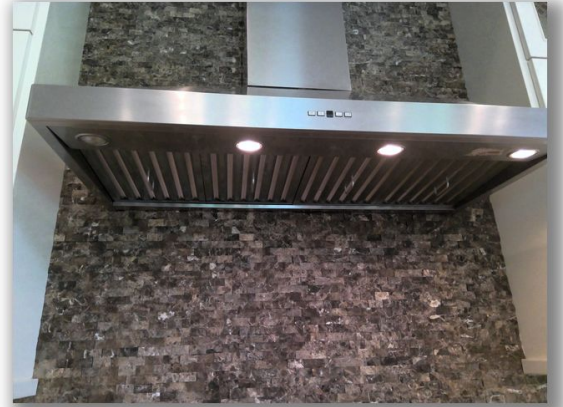
**Range Exhaust Systems**

- One of the lights at the range hood is inoperative.

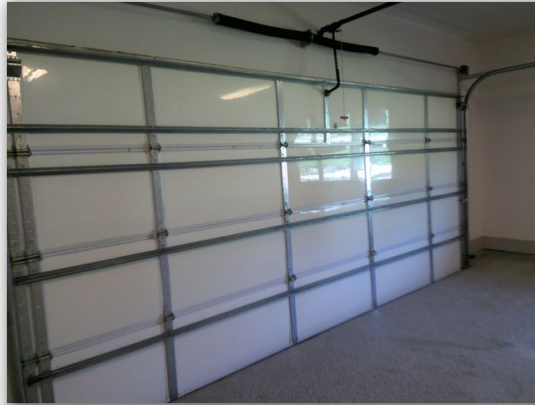
- The left garage door opener is inoperative. The cause and remedy should be further evaluated and corrected as necessary.

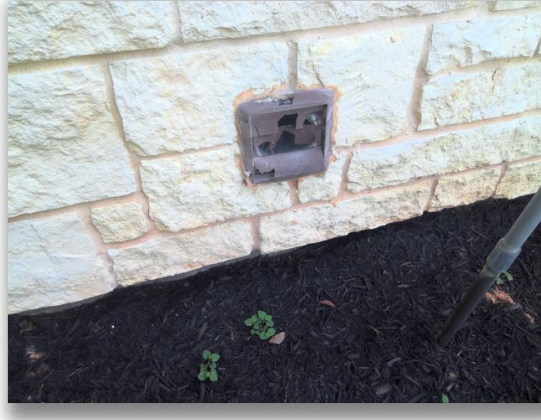
- The exterior dryer duct termination cover is damaged.

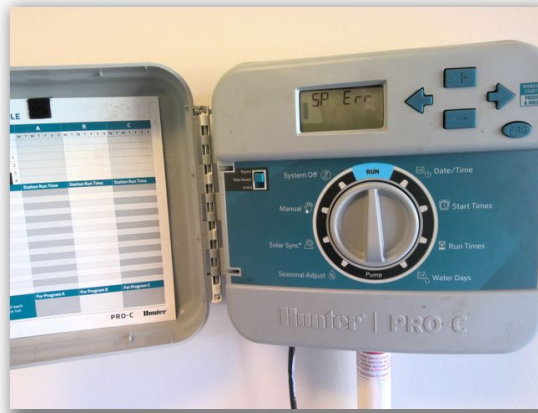
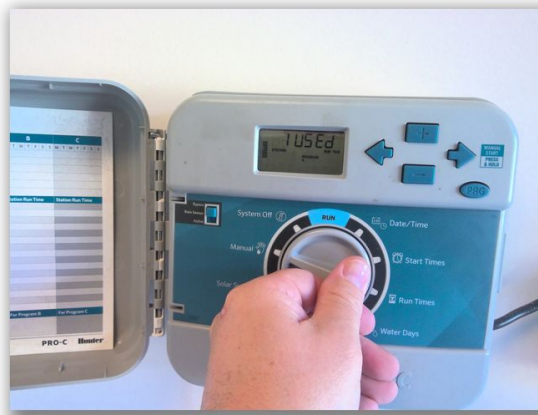
The sprinkler system did not respond to the controls when tested in the manual setting. The cause and remedy should be further evaluated and corrected as necessary.

The sprinkler system and associated components should be further evaluated and/or serviced by a Licensed Irrigation Technician. The observations made to support the rendering of this opinion are listed but not limited to the following:

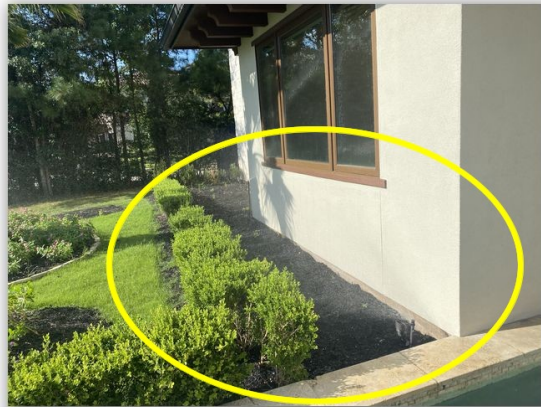
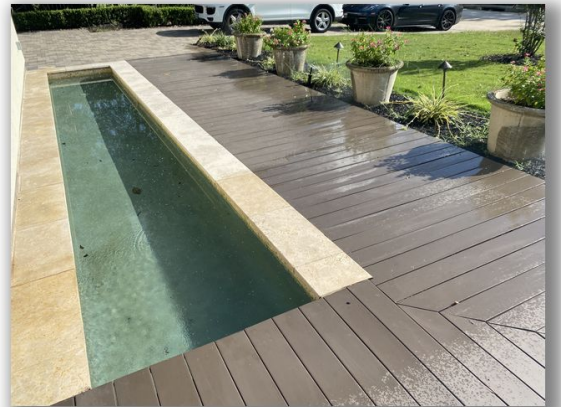
**Note:** The sprinkler system began to run in its auto setting as the inspector was leaving the property. The following observations were made.

- One or more of the sprinkler heads need to be adjusted so not to disperse water onto concrete flatwork (such as; roadways, sidewalks, porches, patios or driveways).
- One or more of the sprinkler heads need to be adjusted so not to spray water onto the exterior walls, surfaces or windows.
- One or more of the sprinkler heads need to be adjusted and/or straightened so to disperse water properly in station(s).

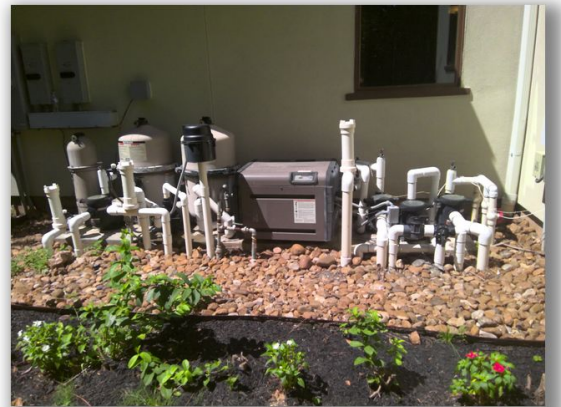
**Swimming Pool and Equipment**

- The water feature & the spa filter gauge has a high pressure reading. Filter pressure should be maintained between 5 to 20 psi.

Some of the pool components appear to have deficiencies that are beyond normal. The buyer should have this condition further evaluated by a pool technician familiar with pool structures and associated pool components for remedial cost estimates. The observations made to support the rendering of this opinion are listed but may not be limited to the following:

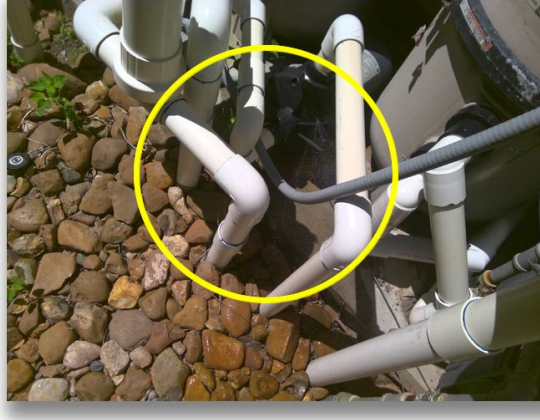
- There is a visible water leak at the sweeper motor.

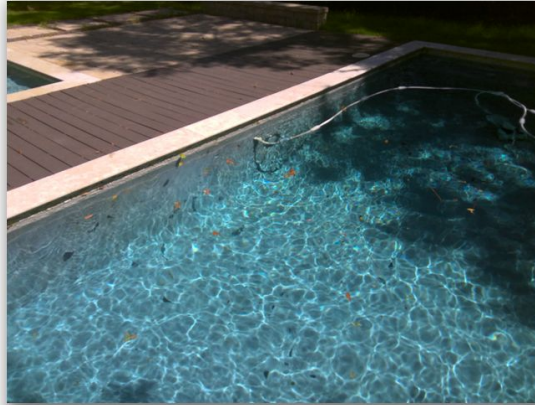
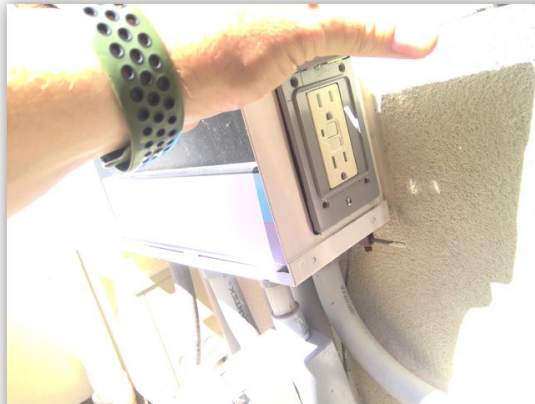
**Pool/Spa Light(s)**

- The pool light is inoperative. The cause and remedy should be further evaluated.
- One or more of the lights in the front area water feature were observed to be inoperative.

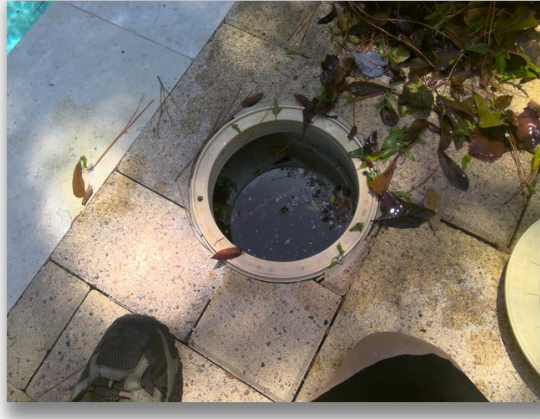
**Skimmer**

- The skimmer basket is missing.

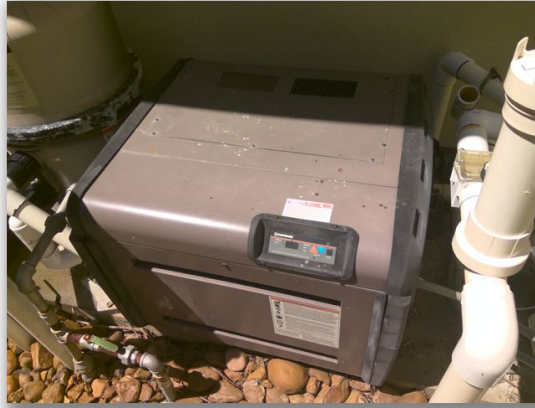
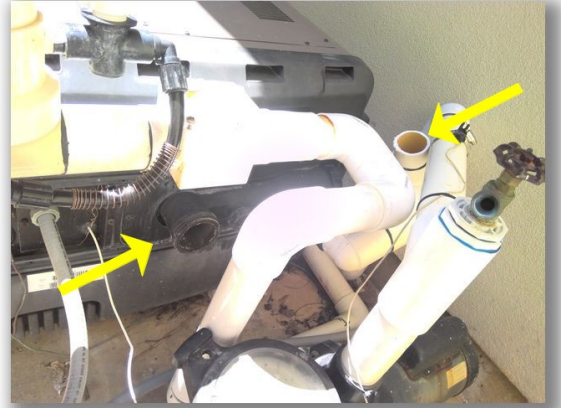
**Heater**

- There was a gas leak detected at the pool heater. The inspector used a TUFF 8900 gas leak detector to locate the leak. This condition needs to be corrected for reason of safety.

- The pool heater is disconnected and was not in use at the time of inspection.

Movement was detected in the gas gauge at the time of the gas check. This indicates a gas leak is present and needs to be investigated and repaired as necessary by a Qualified Licensed Plumber. The observation made to support the rendering of this opinion are listed but not limited to the following:

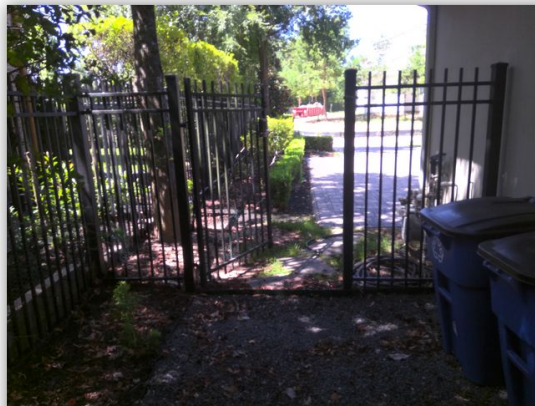
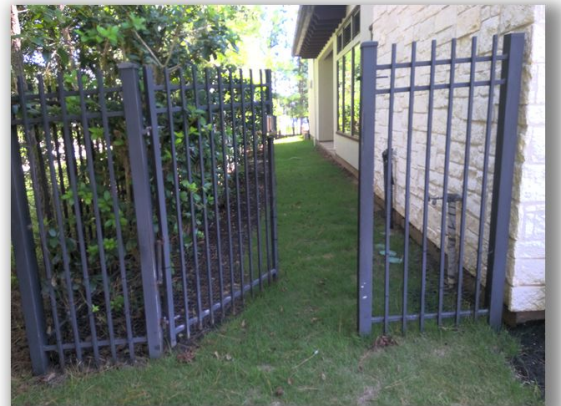
**Barriers**

- All pedestrian access gates should open outward away from the pool and should be self-closing and have a self-latching device. Where the release mechanism is located less than 54 inches from the bottom of the gate. A second release mechanism should be located on the poolside of the gate at least 3 inches below the top of the gate.
- Under current standards, all of the homes entry doors that give access to the pool area should be equipped with an audible alarm that can be heard throughout the house, sound continuously for 30-seconds, and be mounted at least 54-inches from the doors threshold. A self-closing and self-latch door device can be used in lieu of the audible alarm system as long as the protection is not less than the audible alarm.

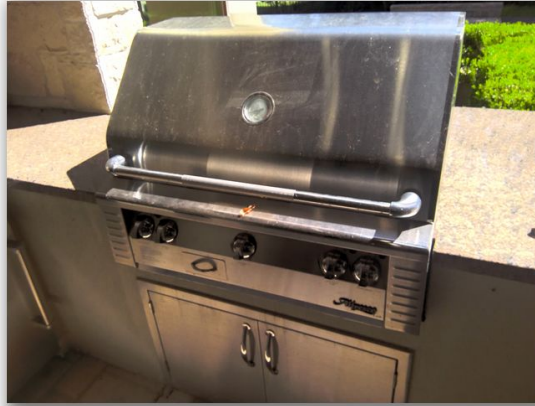
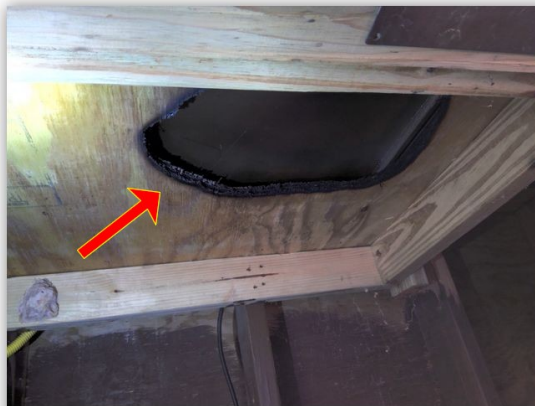
**C. Outdoor Cooking Equipment**

- The outdoor kitchen framework was observed to be made of wood. This condition is a fire hazard.
- Evidence of a previous fire was observed directly under the gas grill area. Further evaluation and correction are needed.

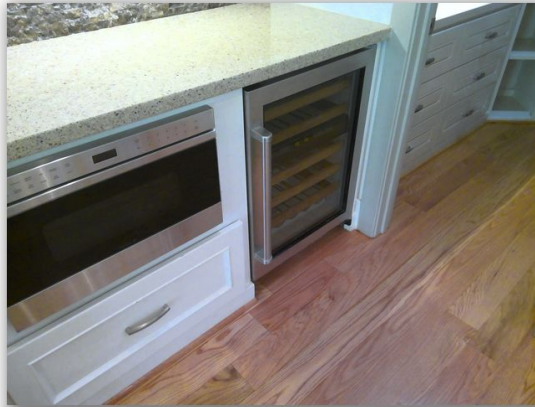
Wine Cooler

All components were found to be performing and in satisfactory condition on the day of the inspection.

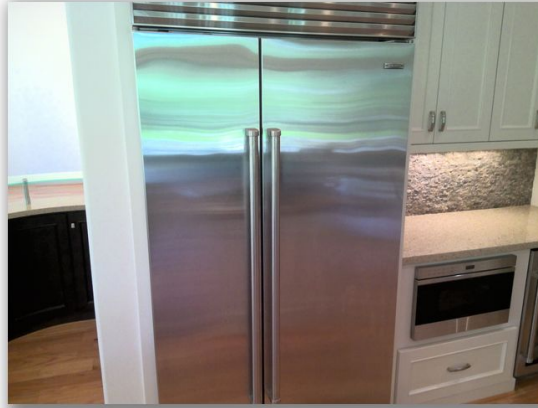
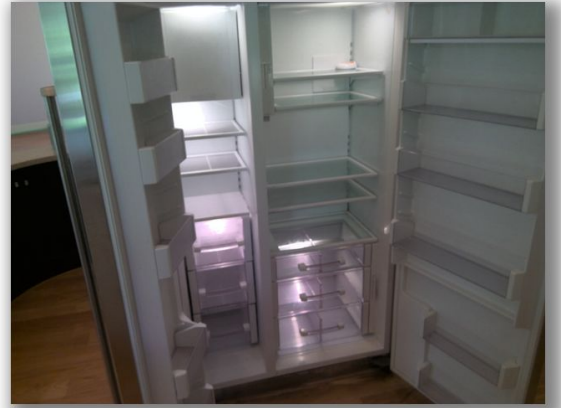
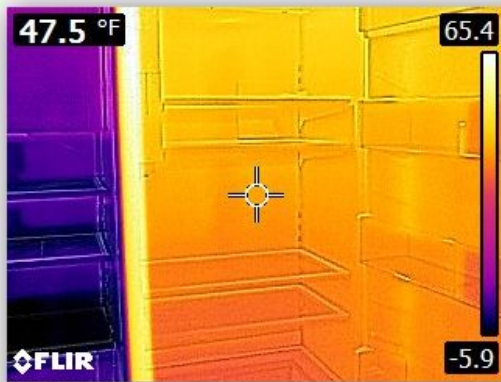
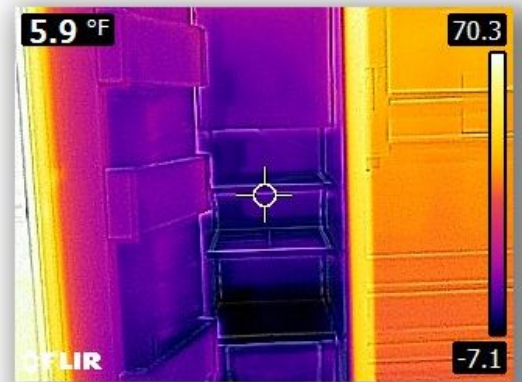
**Kitchen Refrigerator / Built-in**

All components were found to be performing and in satisfactory condition on the day of the inspection.
