PROPERTY INSPECTION REPORT

Prepared For: Gerald Richards
(Name of Client)

Concerning: , Conroe, TX 77385
(Address or Other Identification of Inspected Property)

By: Matthew Brading, Lic #TREC # 22654 09/22/2021
(Name and License Number of Inspector) (Date)

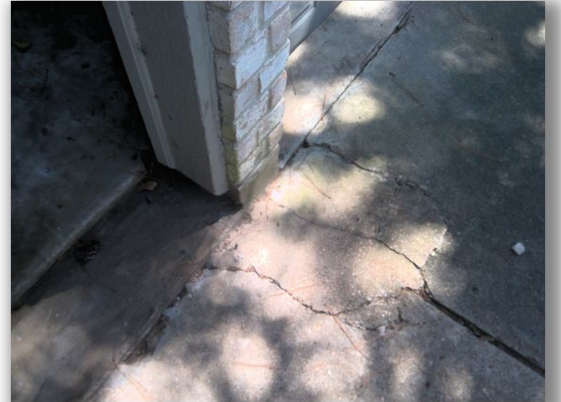
Evidence of Foundation Repair

You should be aware that there is visible evidence of previous foundation repairs. You are strongly encouraged to consult the current homeowner on previous foundation work performed and warranty information. Since I have not reviewed the property prior to the foundation work and I was not present at the time the foundation work was performed, an opinion as to whether the work was performed properly and as to whether foundation movement will continue or, if so, the extent of such movement cannot be rendered.

If any cause of concern is noted on this report, or if you want further evaluation, you should consider an evaluation by an engineer of your choice.

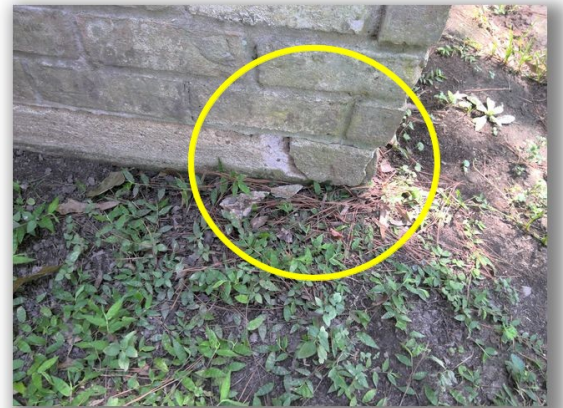
- One or more of the foundation perimeter beam corners were observed to be sheared off (corner pop). This is a common condition to observe and is do to thermal expansion and contraction of the different building materials. This condition does not adversely affect the foundation performance. However, in some cases, some cosmetic improvements may be necessary.

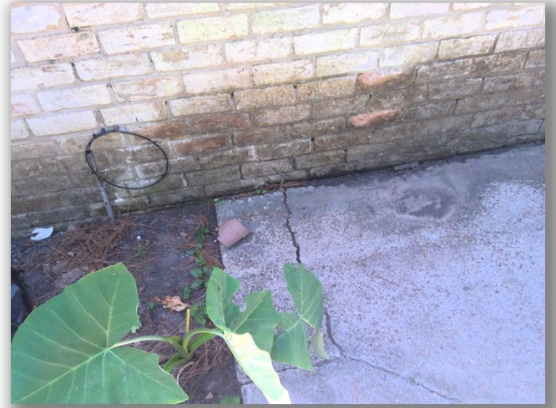
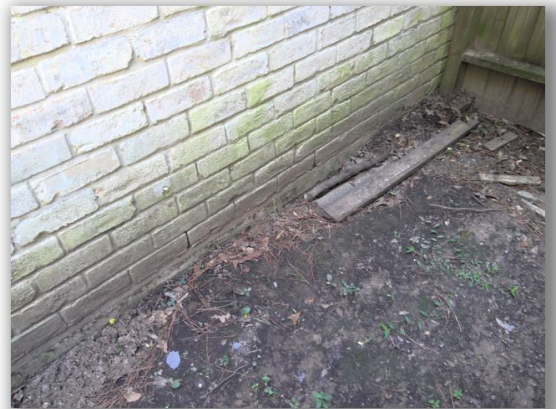
- The soil line is too high on various locations of the structure. Under current building standards there should be at least 4-inches of foundation visible below masonry veneer and 6-inches of foundation visible below wood type veneer.

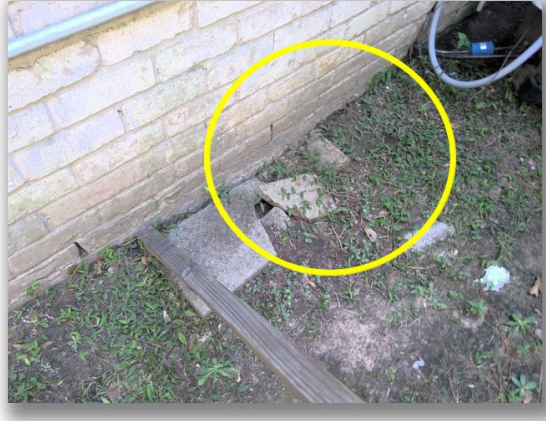
- Fill dirt is needed on the left side of the structure. The low spots in the finished grade (ground) adjacent to the foundation perimeter wall need to be filled in to help prevent water from standing and/or ponding next to the foundation area.

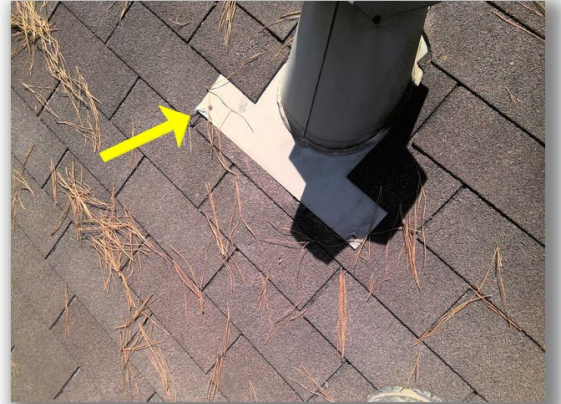
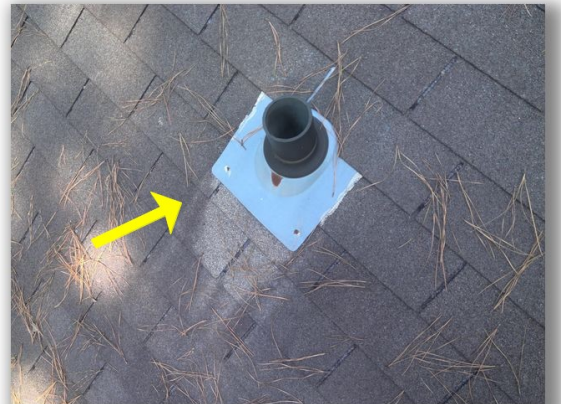
- **Note:** Roof fasteners (nails and/or staples) were observed to be exposed and should be properly sealed at the ridge caps and flashing areas.

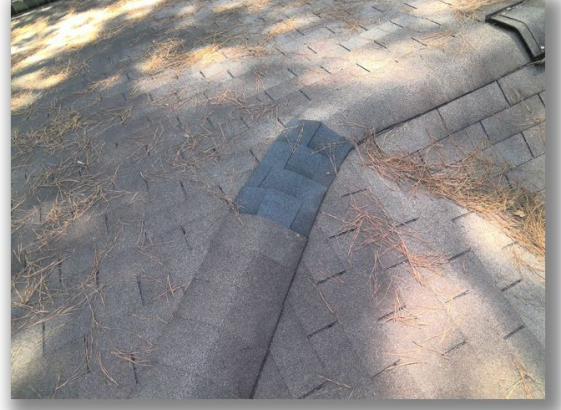
- **Note:** Prior repairs to the roofing material and/or flashing were observed in one or more locations. Improper shingles appear to have been used for these repairs.

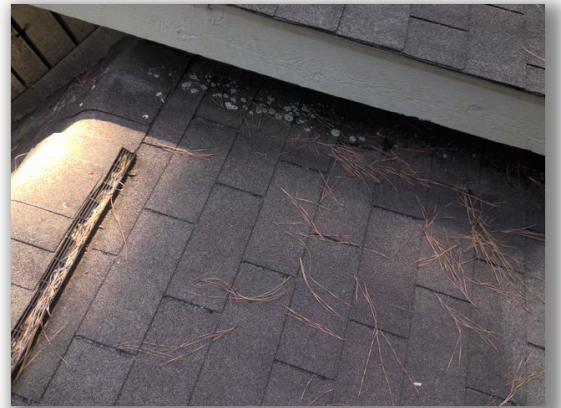
- Algae and/or an organic growth on the roof covering is an indication that the roof is older and may be near the end of its expected serviceable life. Recommend consulting a roofing contractor about the possibility of cleaning and or replacement in the near future.

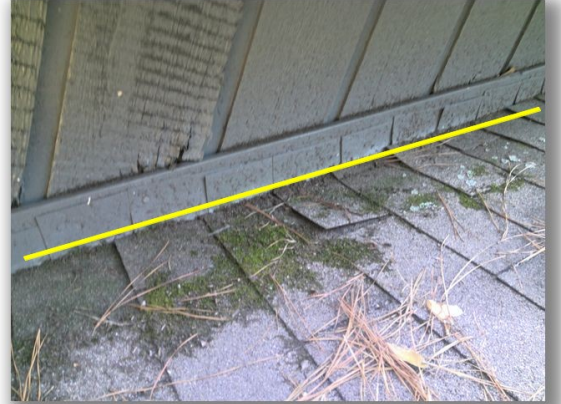
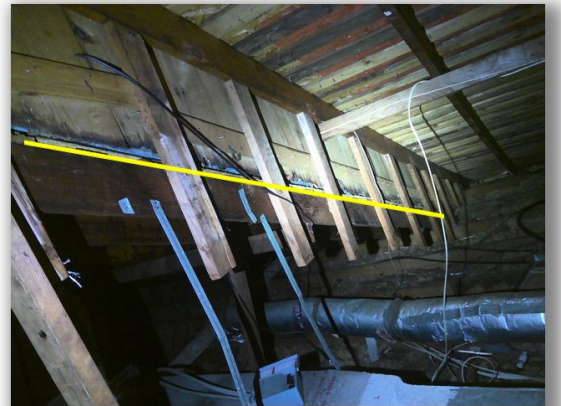
- Counter flashing details were observed to be missing on the left side of the roof structure. This condition could allow water penetration at this point.
- Water staining observed in attic area near missing counter flashing.

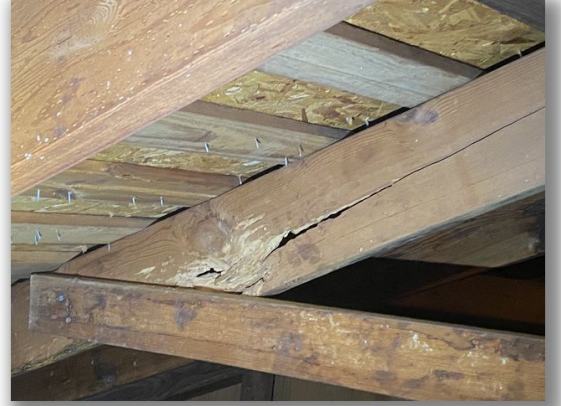
- Split rafter(s) were observed in the attic area over garage the area(s).

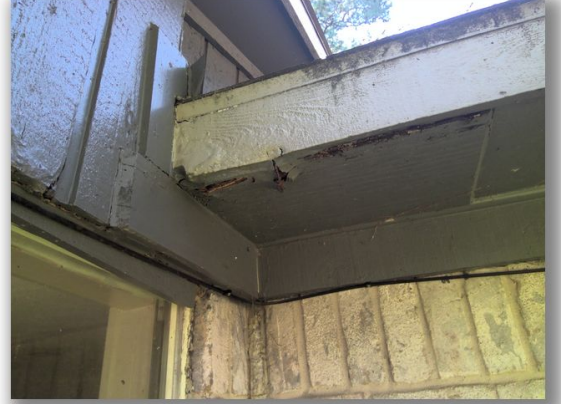
- The soffit material has some deterioration and/or damage on the front and back sides of the roof structure.

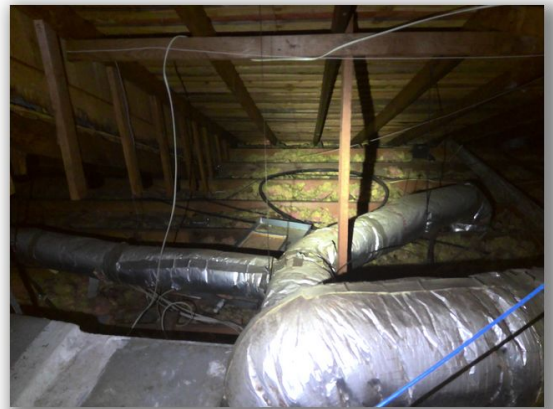
- The attic insulation is lower than typical and it is recommended to add additional insulation to achieve at least a R-30 rating.

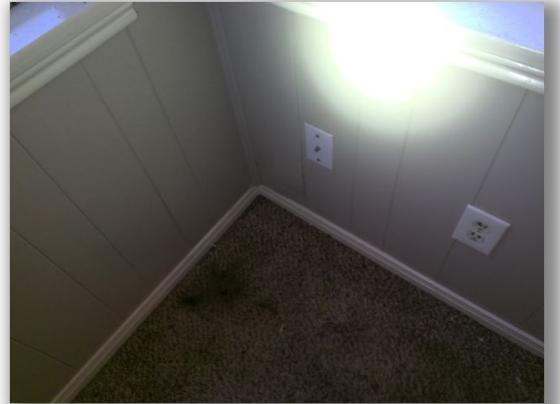
- Wall surface damage was observed in the living room.

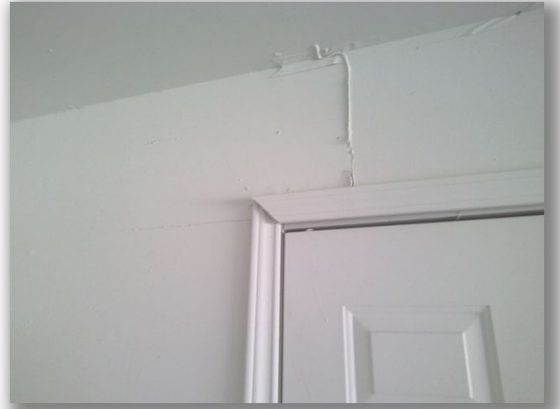
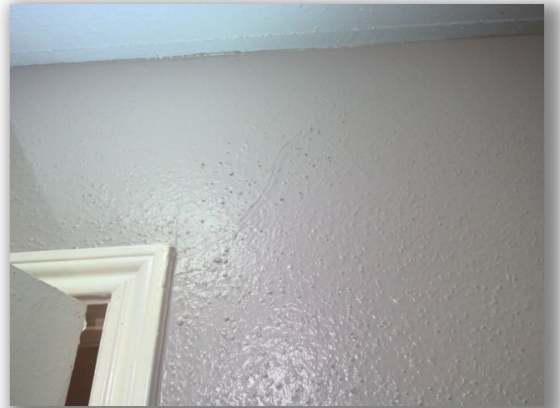
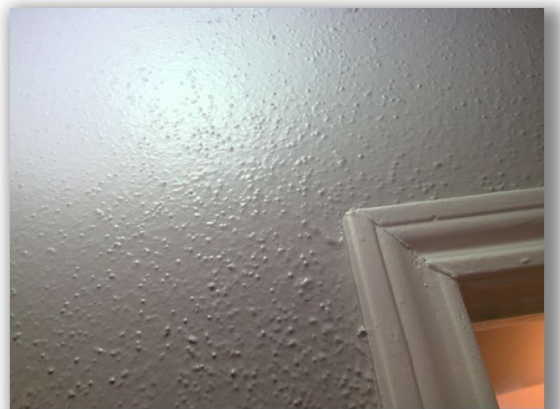
- Interior wall stress cracks were observed in various locations throughout the house.

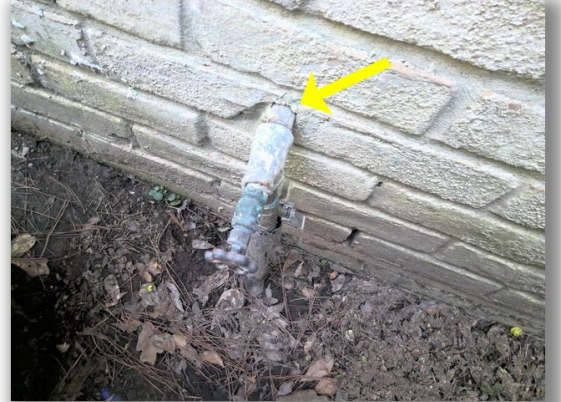
- The area between the exterior cladding / veneer and all of the wall penetrations / openings need to be properly sealed. Areas such as utility connections, downspouts, hose bibbs, lighting fixtures, receptacles etc. It is recommended to use an elastomeric caulking / sealant.

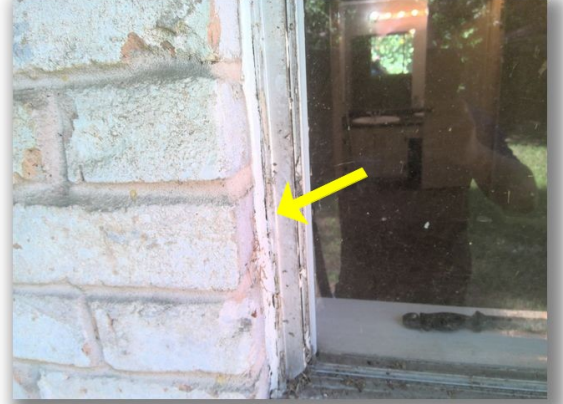
- Caulking improvements are recommended for the area between the exterior veneer and the window frames. It is recommended to use an elastomeric caulking.

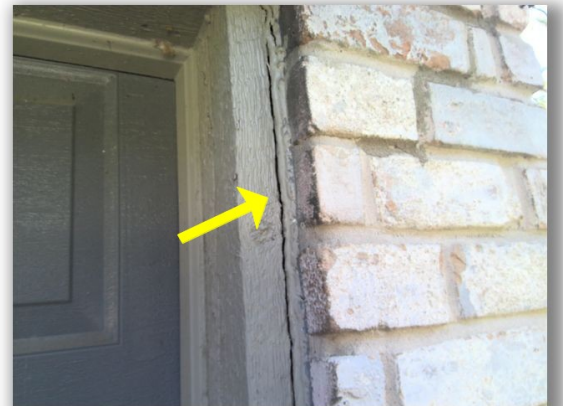
- Caulking improvements are recommended for the area between the exterior veneer and the garage door trim boards. It is recommended to use an elastomeric caulking.

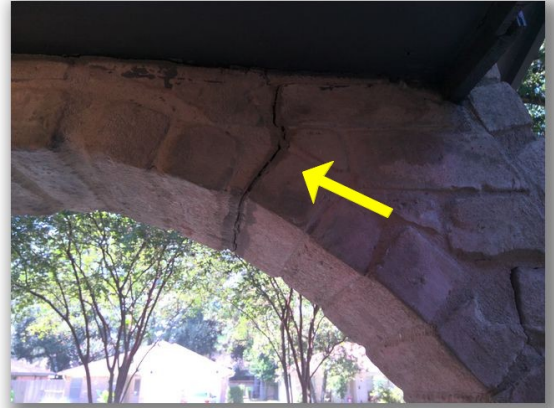
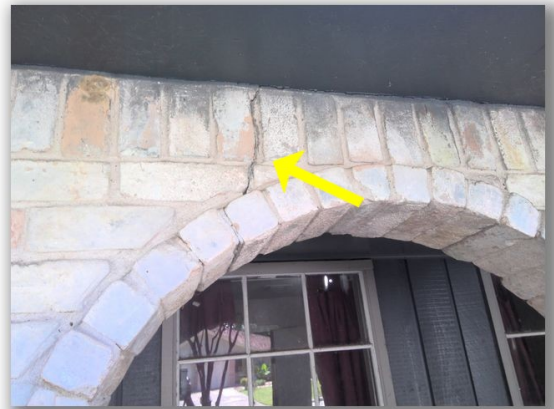
- There are visible cracks in the brick and/or mortar at the front arch. This type of cracking may compromise the integrity of the arch. It is recommended to have this condition further evaluated and corrected as necessary.

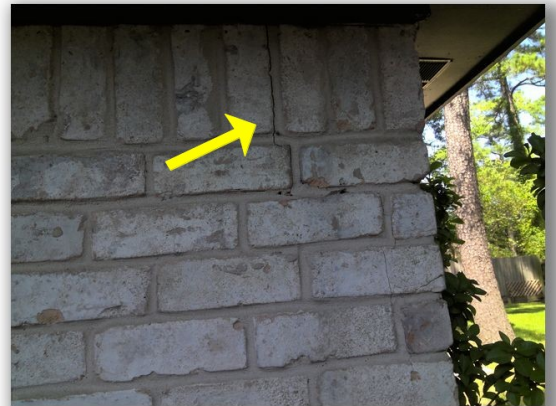
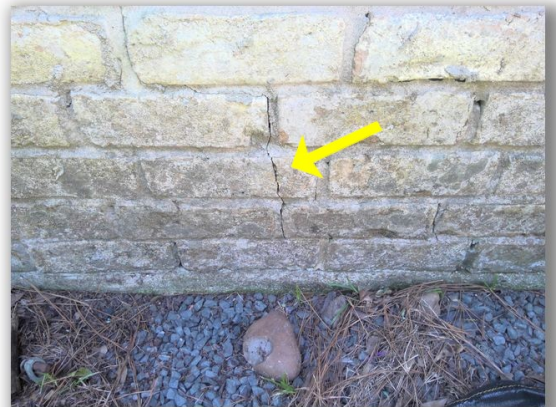
- Deflection cracks were observed in the exterior veneer on various locations of the structure.

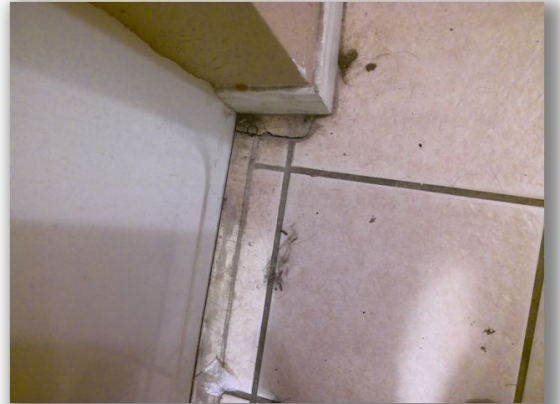
- The floor tile(s) were observed to be cracked and/or damaged in various locations throughout the house.

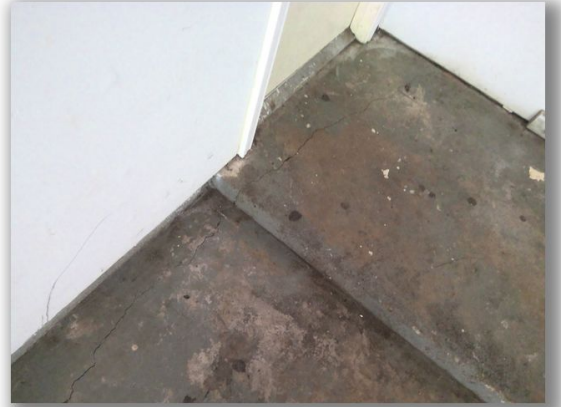
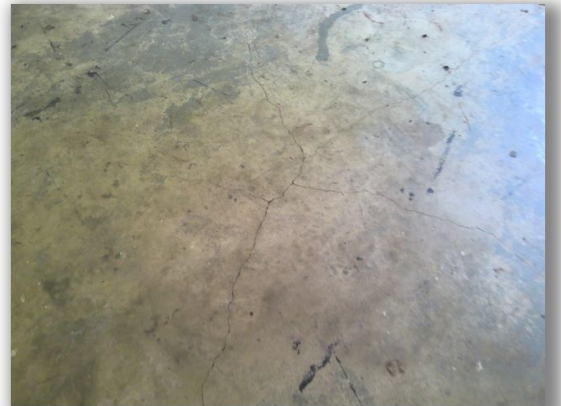
- **Note:** Some cracking of the garage concrete floor finish was observed.

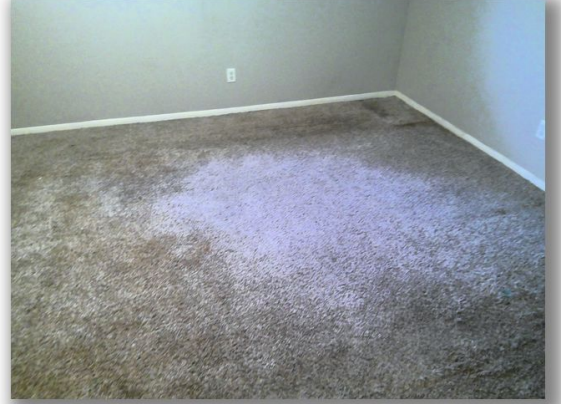
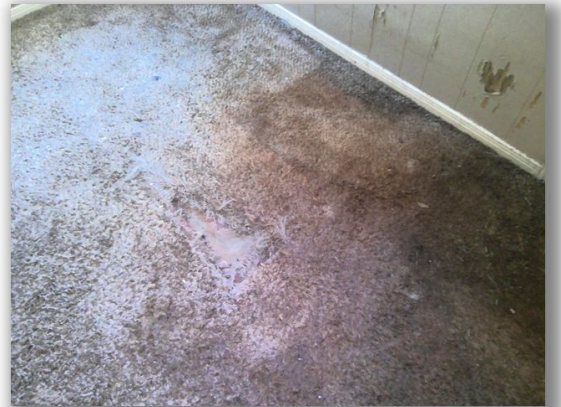
- The floor covering is noticeably stained in one or more locations of the home.
- The floor covering is noticeably worn and/or damaged in one or more locations of the home.

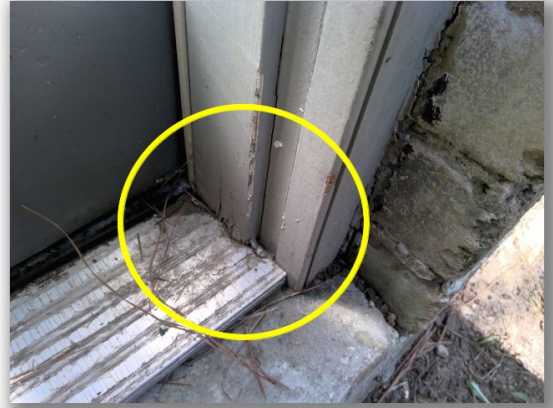
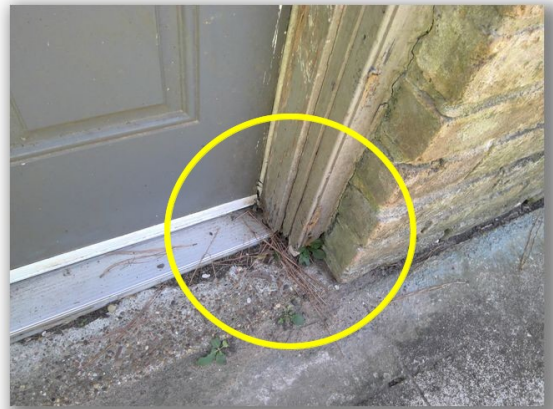
- The door frame has some damage to the backyard entry door & garage to side yard entry door.

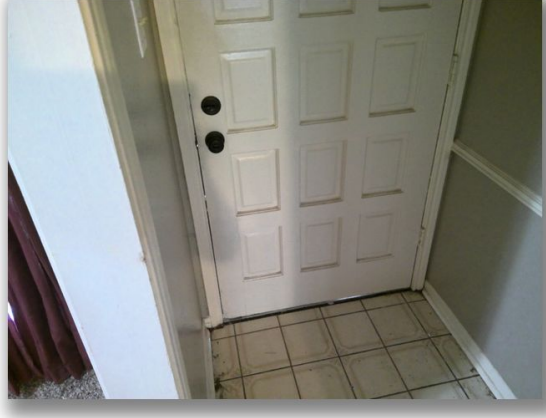
- The door is sticking to the front entry closet.
- Weather-stripping improvements are recommended for the front entry exterior door(s).

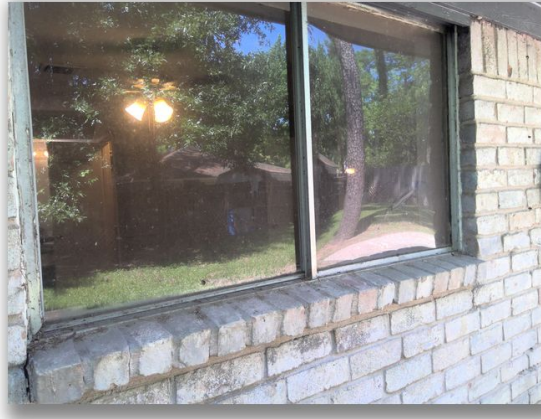
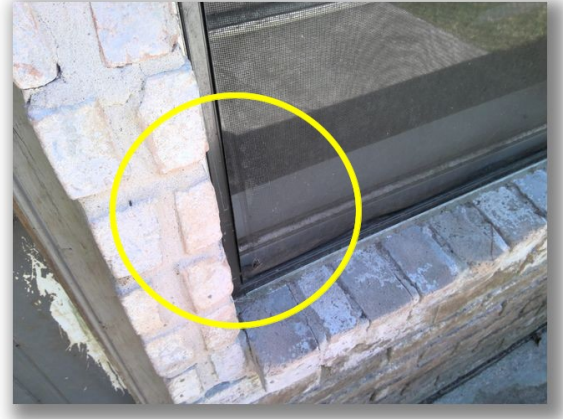
- One or more of the window screens were observed to be damaged.
- One or more of the window screens were observed to be missing.

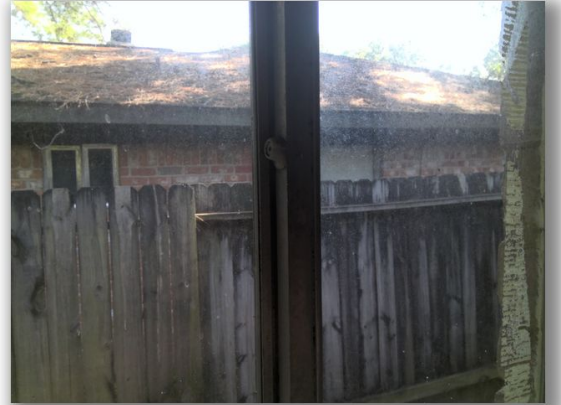
- Window lock(s) were observed to be damaged and/or missing in various locations throughout the house.

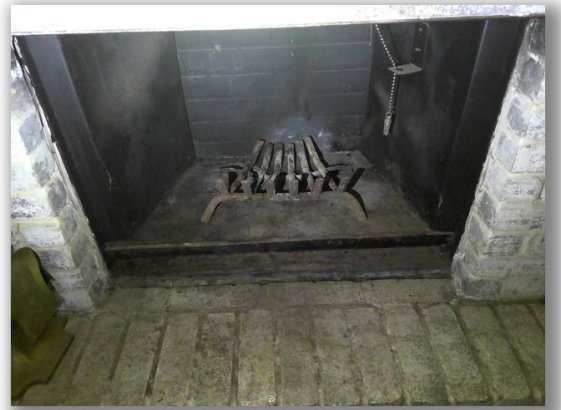
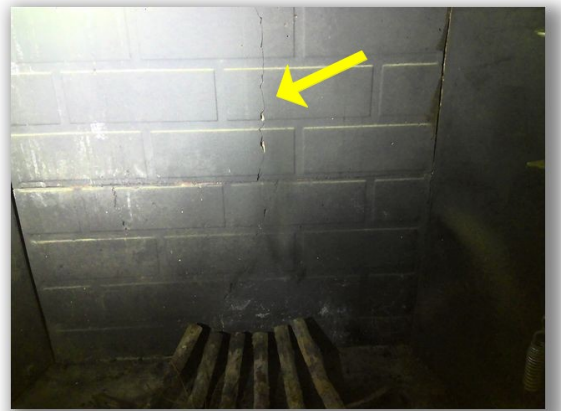
- The back panel in the firebox was observed to be cracked and/or damaged. This condition should be further evaluated and corrected as necessary.

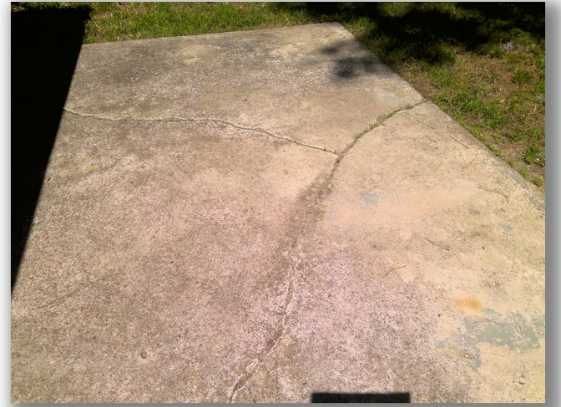
- Some deflection and/or cracking of the patio concrete flatwork was observed.

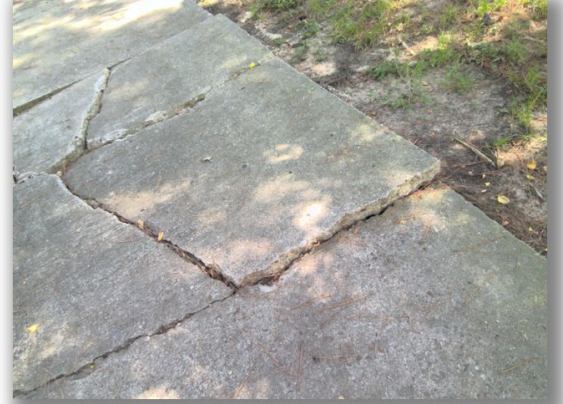
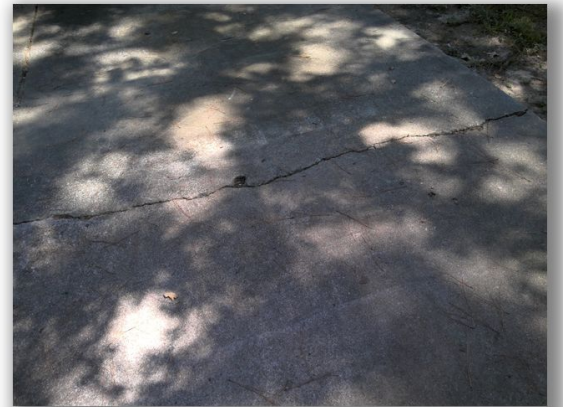
- Larger than typical cracks and/or deficiencies were observed in the driveway.

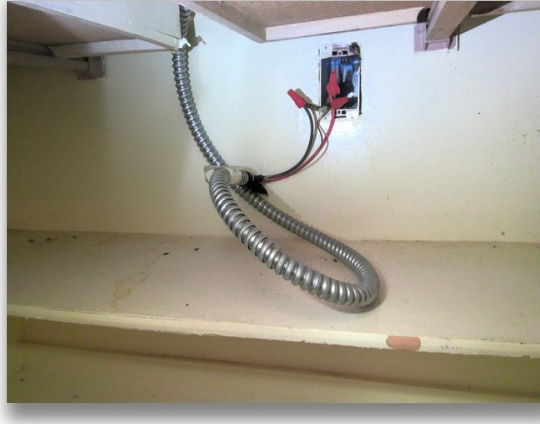
- Spliced wires were observed in the kitchen under the cooktop. The spliced wires need to be properly enclosed in an electrical junction box for reasons of safety.
- All exposed distribution wiring should be properly enclosed in conduit. Exposed wiring was observed in the kitchen cabinet below the cooktop.

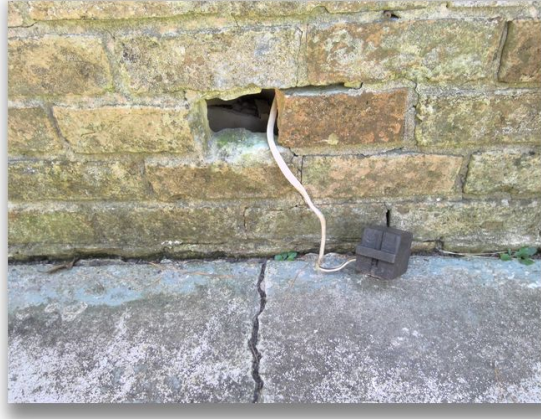
- One or more of the receptacles were observed to be loose at the wall mount in the exterior area.
- All exterior receptacles should have weather tight covers. The receptacle weather cover plate is damaged and/or missing on the north exterior wall.

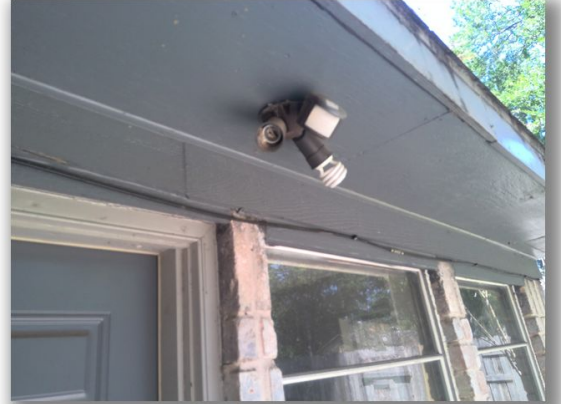
- One or more of the light fixtures appear to be inoperative in various locations throughout the house. This may be due to a bad bulb or some other unknown condition. This condition should be further evaluated and corrected as necessary.

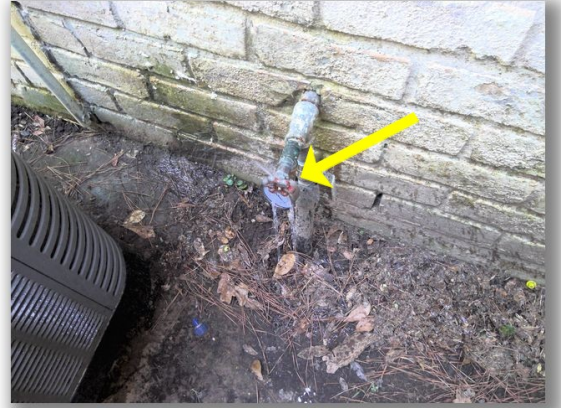
- One or more of the exterior water hose bibbs (faucet) do not have a back-flow or anti-siphon device (Vacuum Breakers) in place. **Note:** *This is not uncommon to observe with a home of this age.*
- The exterior water hose bibb (faucet) is leaking at the handle when operated on the left side of the structure.

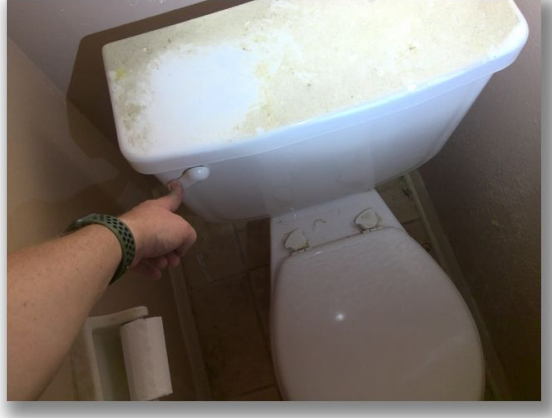
- The commode is inoperative. The cause and remedy should be further evaluated and corrected as necessary.

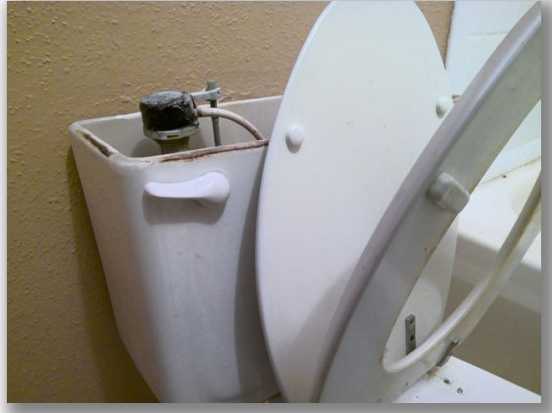
- The tank lid does not fin with the current flushing system in place.

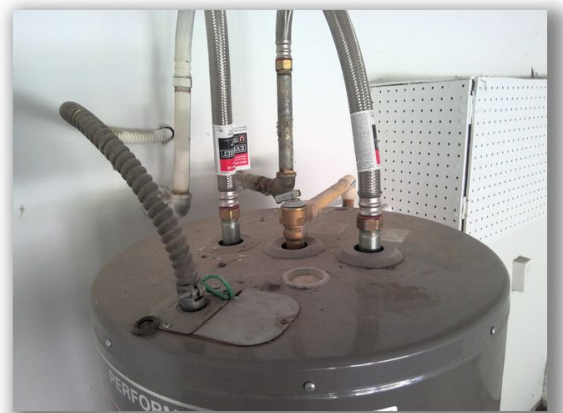
- There was no disconnect observed in sight of the water heating equipment. This condition does not meet current building standards.
- There is no pan installed under the water heater. Because the water heater is located over the area of the garage floor that is level with the finished flooring of the house, a pan and drain line are needed to be installed under the water heater.
- The temperature and pressure relief (TPR) valve discharge pipe is running in an upwards direction in one or more locations. The TPR discharge pipe should run gravitationally downwards at all points.

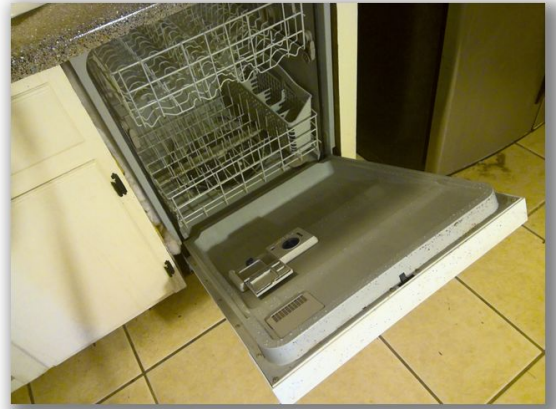
- Some rusting of the dishwasher interior components was observed.

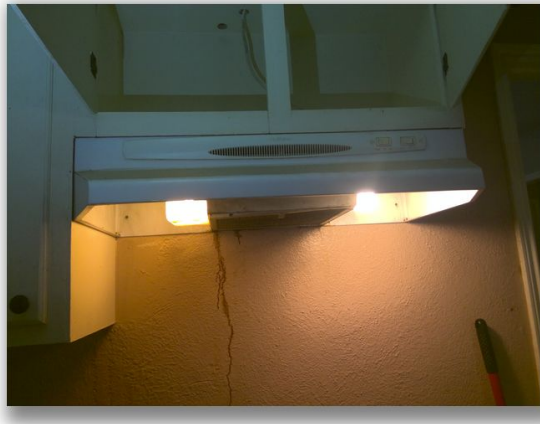
- The range hood in place is ductless. The range hood does not terminate outside and is dependent on the charcoal filter installed. It is recommended to regularly clean your filter system to prevent damage to the structure.

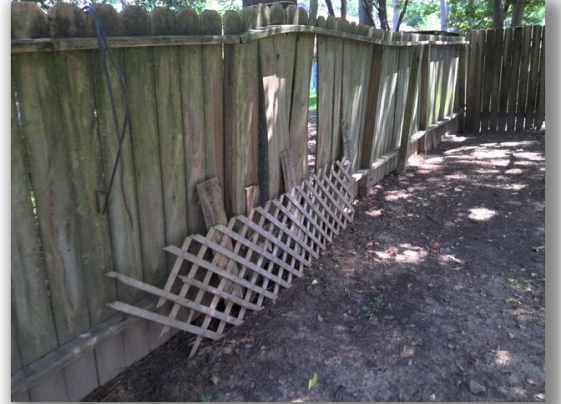
- The overall condition of the fence material, railing and posts are in poor condition and repair or replacement is necessary.
- One or more of the posts are damaged and the fence panels are leaning.
