**Larry McIlroy**  
**2987 Boveda Drive**  
**Spring, TX 77379**

**January 16, 2026**

# PROPERTY INSPECTION REPORT FORM

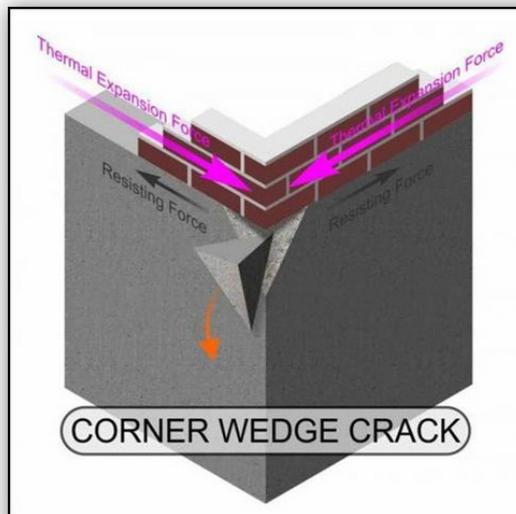
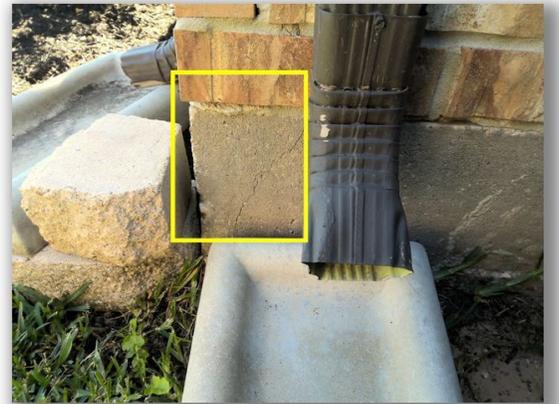
- One or more of the foundation perimeter beam corners were observed to be sheared off (corner pop). This is a common condition to observe and is do to thermal expansion and contraction of the different building materials. This condition does not adversely affect the foundation performance. However, in some cases, some cosmetic improvements may be necessary.

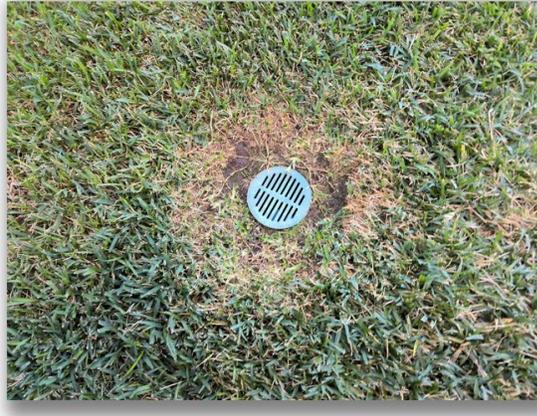
**Notice:** There is an underground and/or surface drainage system in place. The inspector cannot and will not be able to verify the operation, sizing, efficiency or adequacy of the underground and/or surface drainage system. If there are any questions or concerns with this system or the effectiveness of the system, you should consult with the current owner or the appropriate specialist related to this type of system.

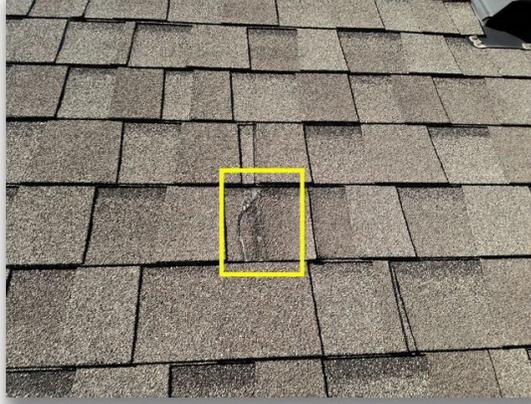
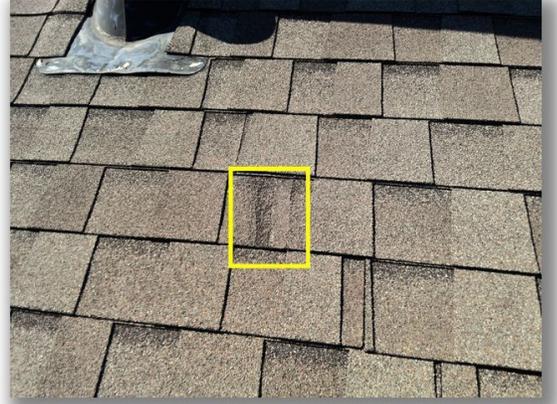
- The composition roofing material has experienced considerable granular loss in various locations throughout the roof.

**Note:** When D (**D=Deficient**) is marked. It is recommended that all of the roofing material and its components be fully evaluated by a Qualified Roofing Specialist, prior to the expiration of any time limitations such as option or warranty periods.

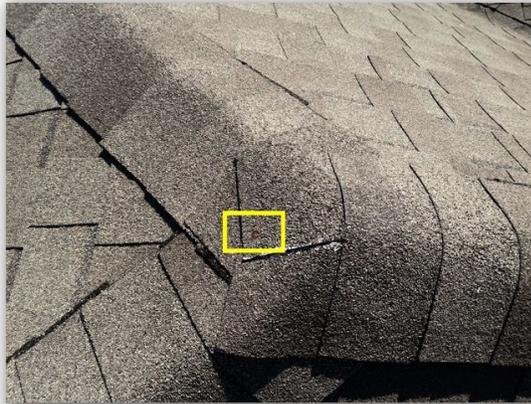
- **Note:** Roof fasteners (nails and/or staples) were observed to be exposed and should be properly sealed at the ridge caps and flashing areas. Examples are pictured below but not limited to:

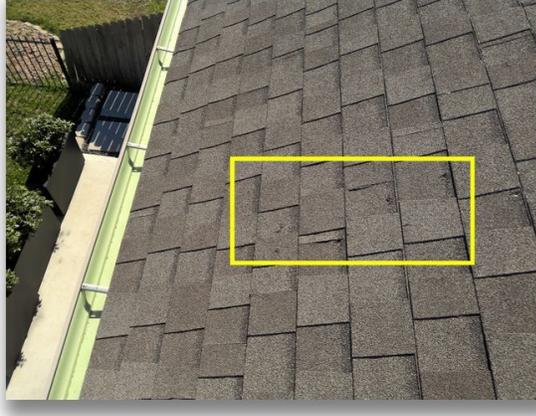
- Damaged shingles were observed on the back side of the roof structure.

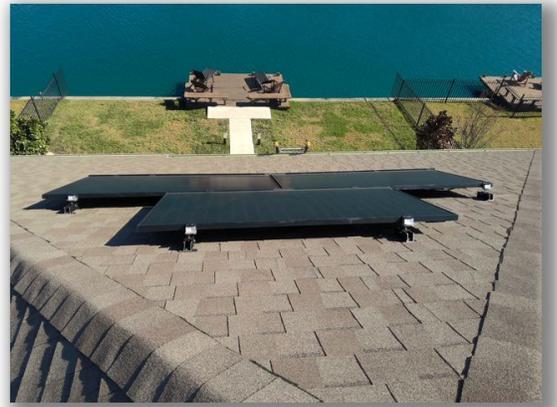
- **Note:** There are solar panels installed on the roof structure over the roofing material. I am unable to visually inspect the roofing material under the solar panels and the solar panel attachments to the roof structure.

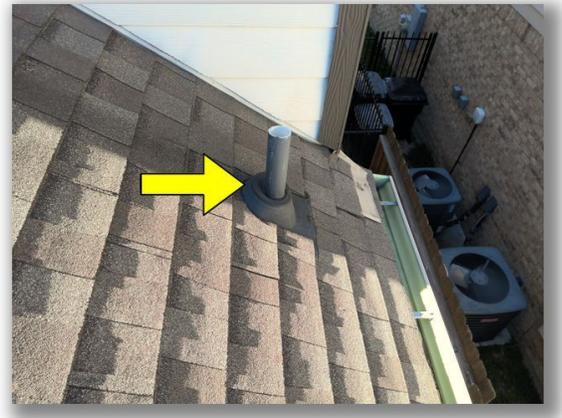
- One or more of the roof level plumbing vent stack flashing details are buckled downward around the plumbing stack. This condition could allow water penetration at this point and corrective measures are recommended.

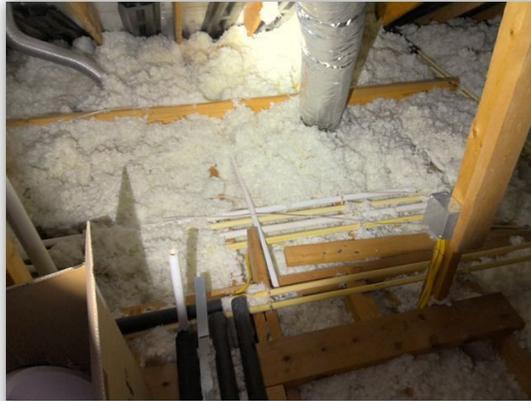
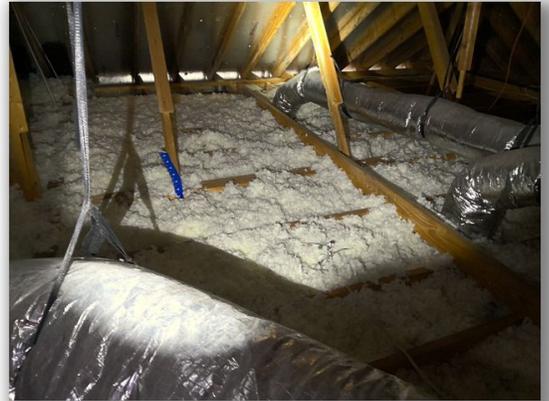
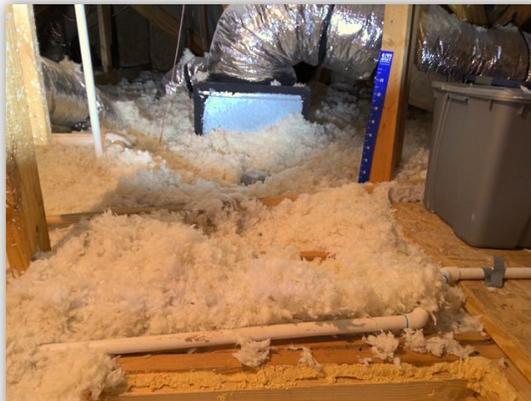
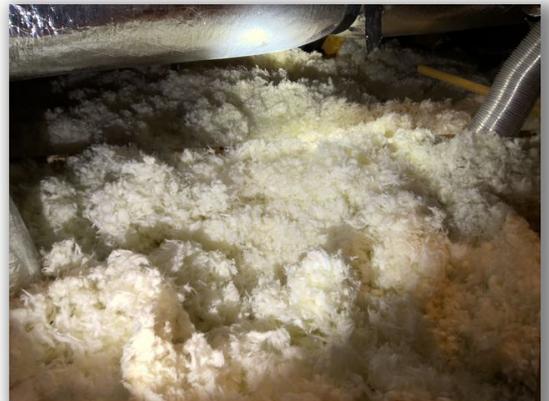
**Attic Insulation**

All components were found to be performing and in satisfactory condition on the day of the inspection.

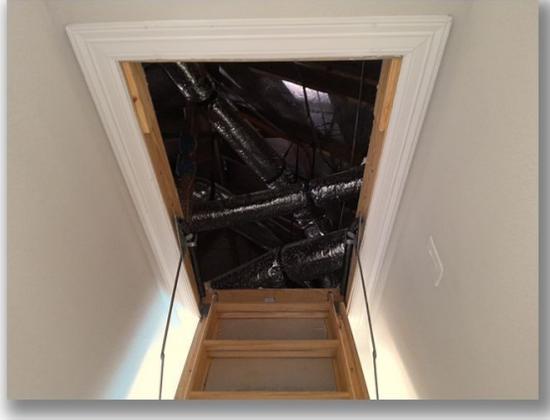
**Attic Ladder**

All components were found to be performing and in satisfactory condition on the day of the inspection.

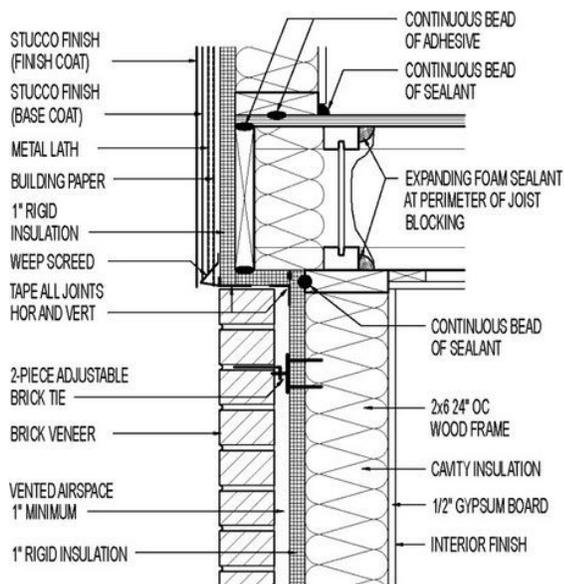
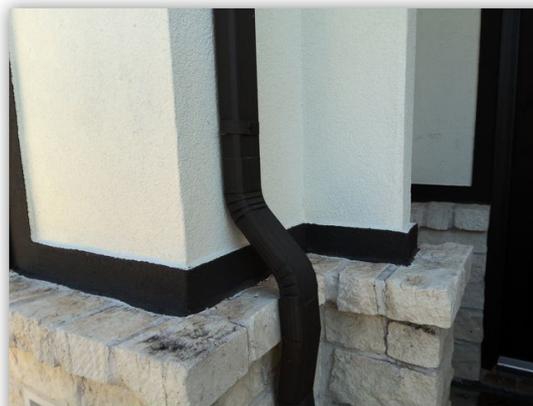
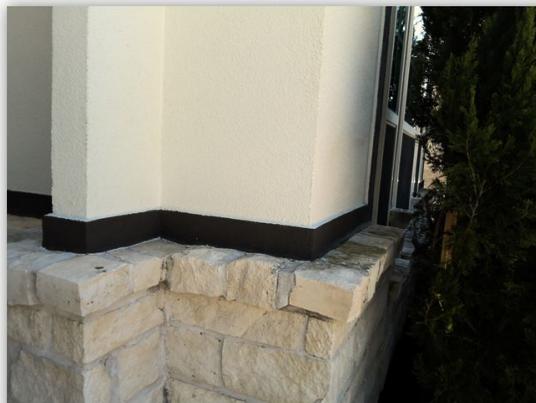
- No weep screed was observed where stucco meets brick/masonry.

There is a stucco type product installed as the exterior veneer / cladding for this structure. Due to the known general misapplication of residential stucco products, associated deficiencies and water intrusion problems; full evaluation of this product requires a specialty inspection from a Properly Certified Third Party Stucco Inspector. Our company does not provide this service. You may consider contacting a Properly Certified Third Party Stucco Inspector to schedule a specialty inspection of the stucco product.

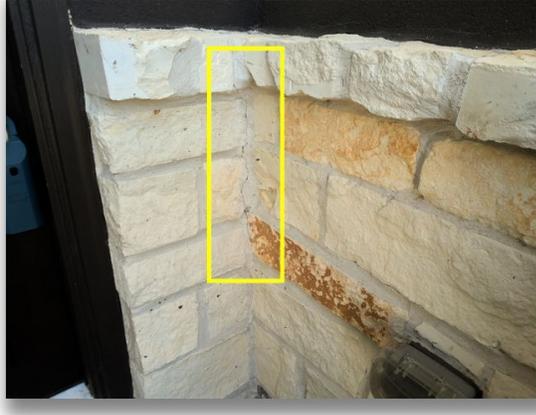
- Mortar improvements are recommended for the exterior masonry veneer on the front side of the structure.

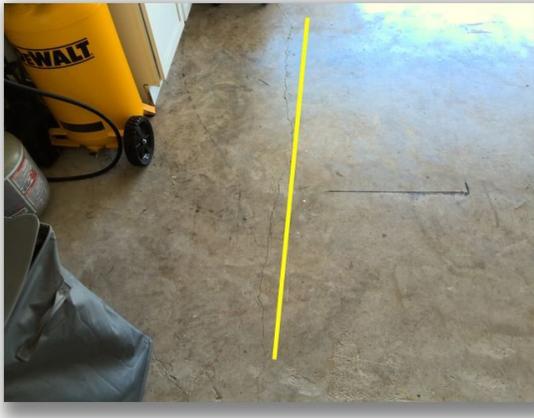
- **Note:** Some cracking of the garage concrete floor finish was observed.

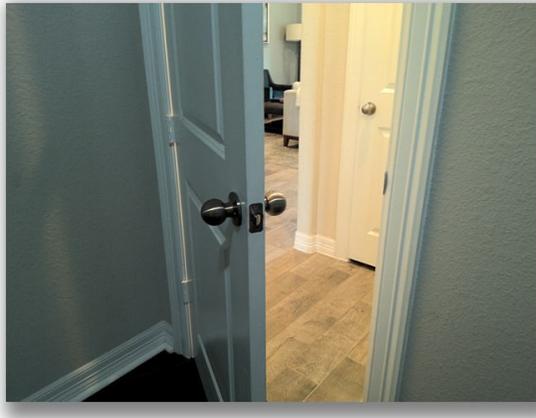
- The door to the side middle bedroom was observed to close by itself. Adjustments are recommend.

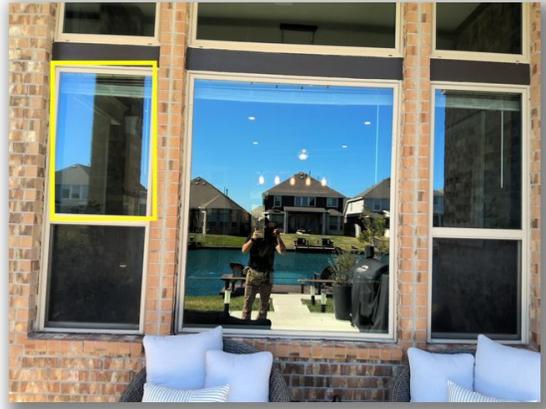
- One or more of the thermal pane windows were observed to have lost their seals. This has resulted in condensation or a fog like film to develop between the panes of glass. The thermal pane windows no longer function as designed when they loose their seal and replacement may be necessary. The windows that have noticeably lost their seals are listed but may not be limited to the following: dining room.

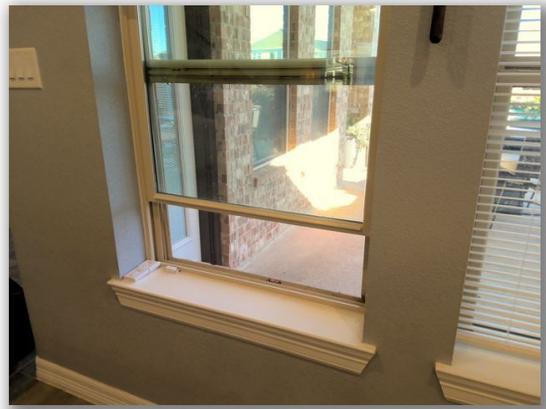
- The window guide was observed to be damaged and the window will not stay in the open position in the kitchen.

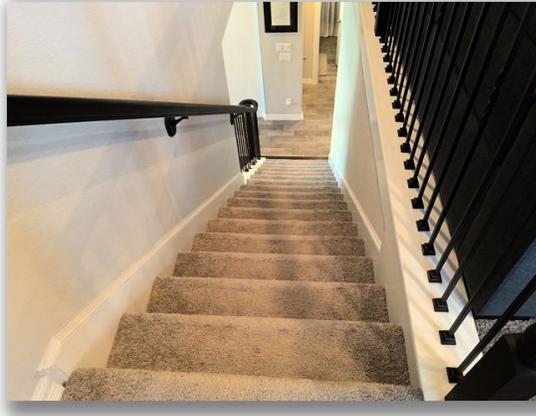
**General Photo(s) of Stairway**

All components were found to be performing and in satisfactory condition on the day of the inspection.

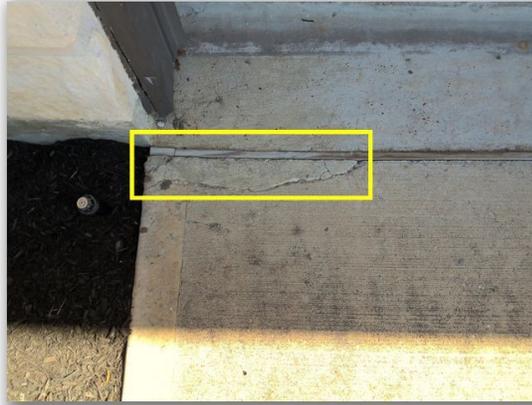
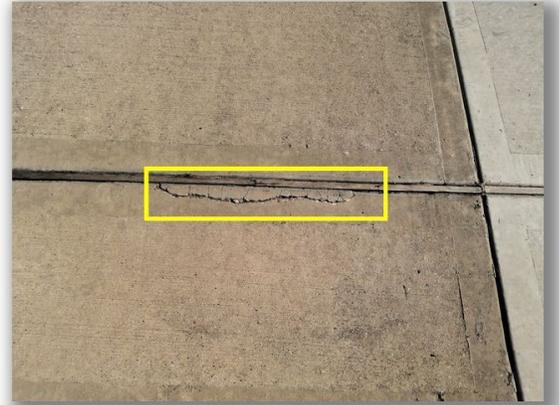
- Larger than typical cracks and/or deficiencies were observed in the driveway.

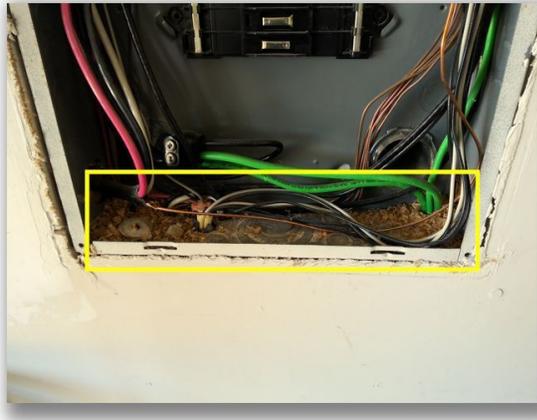
- Wood chip debris was observed inside the main electrical panel. The presence of foreign material inside the panel is a safety concern, as it may interfere with electrical components and increase the risk of overheating or fire. Recommend cleaning, evaluation, and correction of any openings by a qualified electrician.

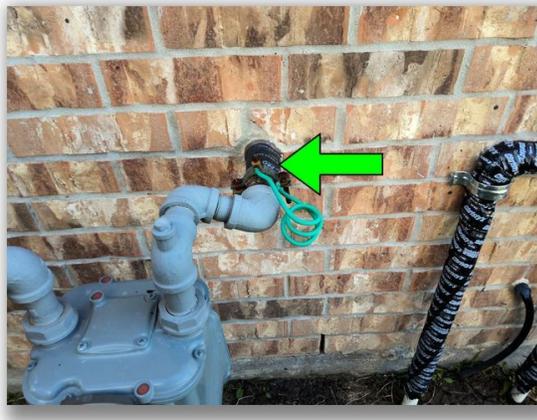
- Gas pipe bonding was observed at the gas meter entrance area.

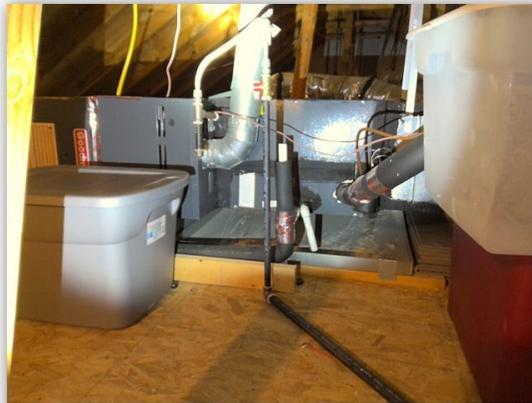
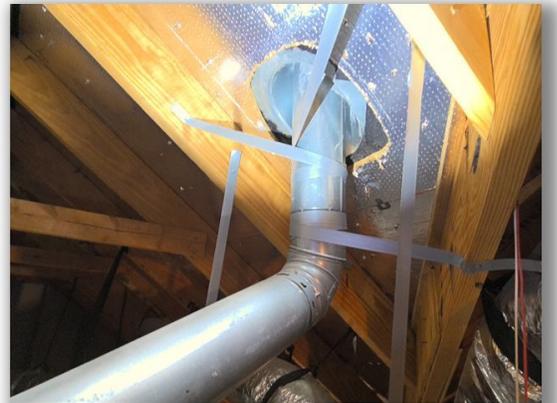
This component appears to be performing adequately at the time of this inspection. It is achieving an operation, function, or configuration consistent with accepted industry practices for its age.

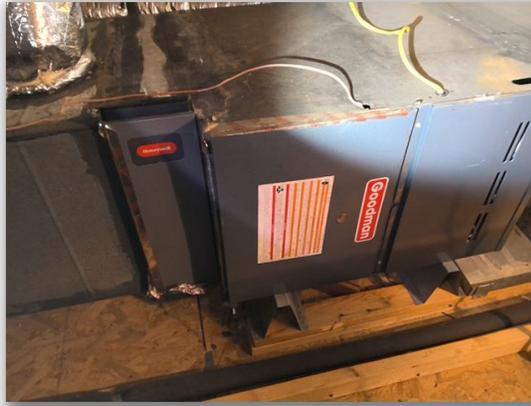
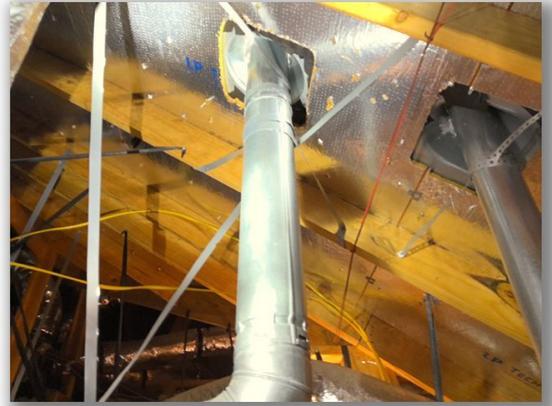
**Downstairs Central Heating System – Energy Source: Gas**  
*Brand Name: Goodman*

This component appears to be performing adequately at the time of this inspection. It is achieving an operation, function, or configuration consistent with accepted industry practices for its age.

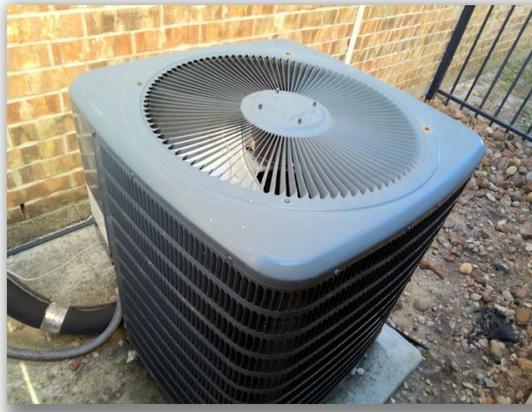
The HVAC system and equipment needs to be checked and serviced by a Qualified / Licensed HVAC Technician. The observations made to support the rendering of this opinion are listed but may not be limited to the following:

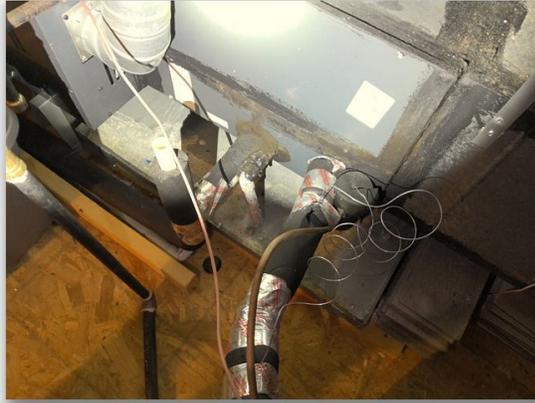
- The water pan for the attic unit is missing a sensor. It is recommended to install a drain pan sensor to detect potential water overflow and prevent water damage in the attic space. Additionally, regular maintenance of the condensate drain line should be performed to reduce the risk of clogs and leaks.

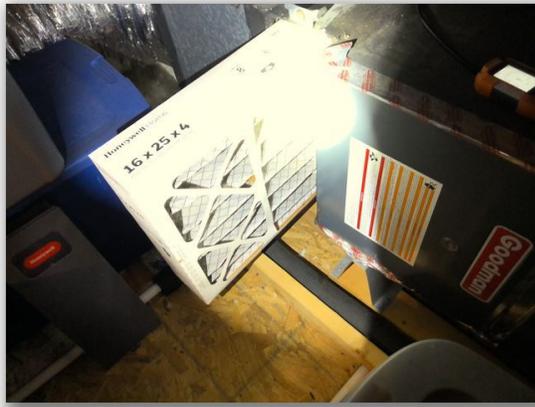
- The dirty air filter should be replaced.

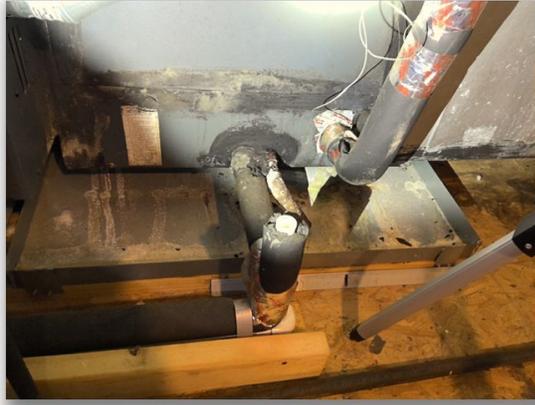
- The water pan for the attic unit is missing a sensor. It is recommended to install a drain pan sensor to detect potential water overflow and prevent water damage in the attic space. Additionally, regular maintenance of the condensate drain line should be performed to reduce the risk of clogs and leaks.

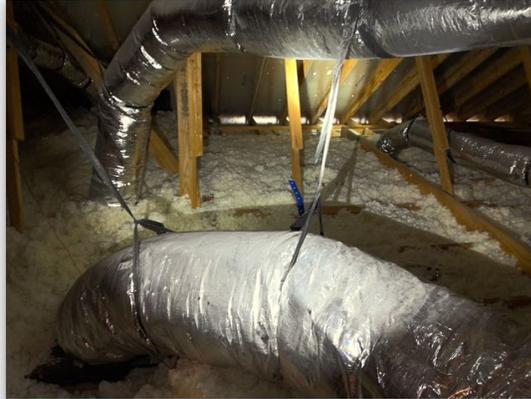
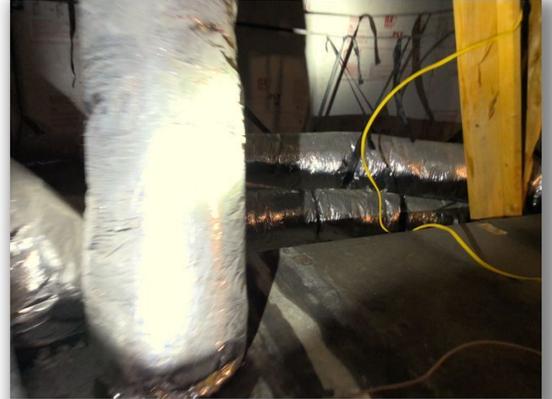
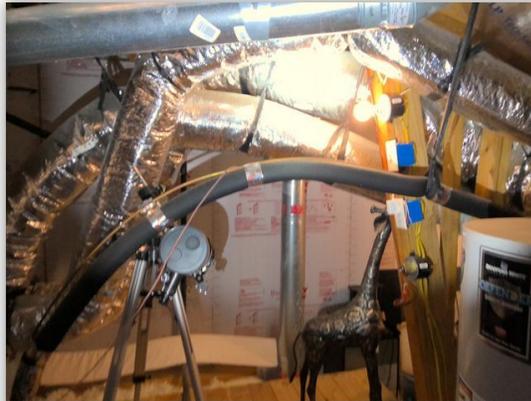
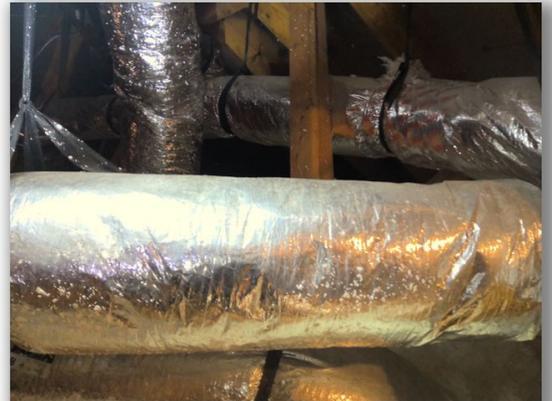
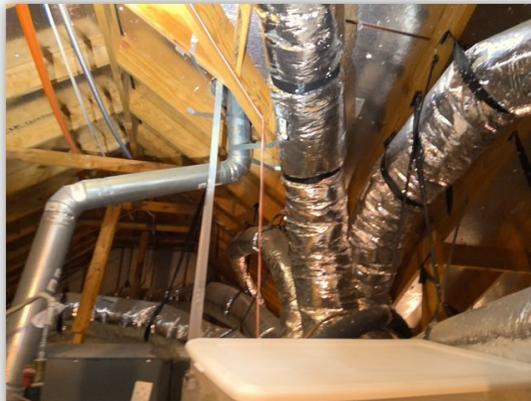
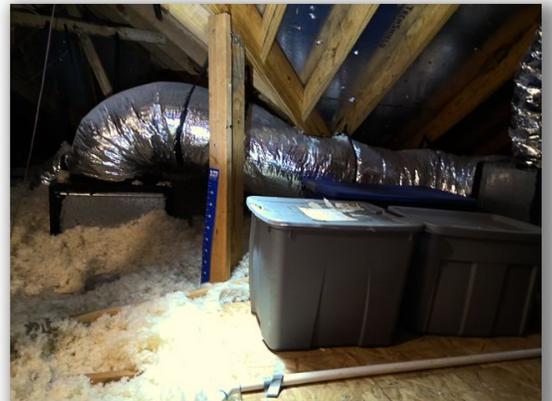
**General Photo(s) of duct work**

All components were found to be performing and in satisfactory condition on the day of the inspection.

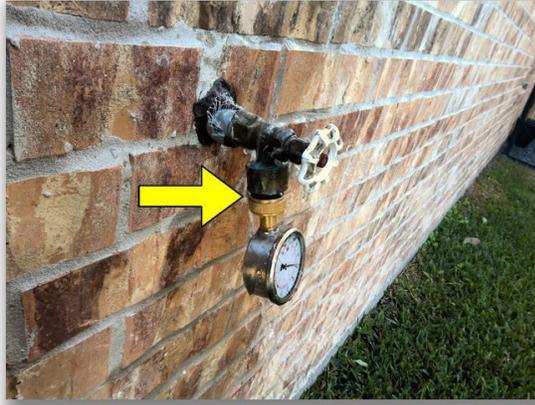
- Water was observed to be leaking back through the vacuum breaker on the right side of the structure. The vacuum breaker is not working as designed.

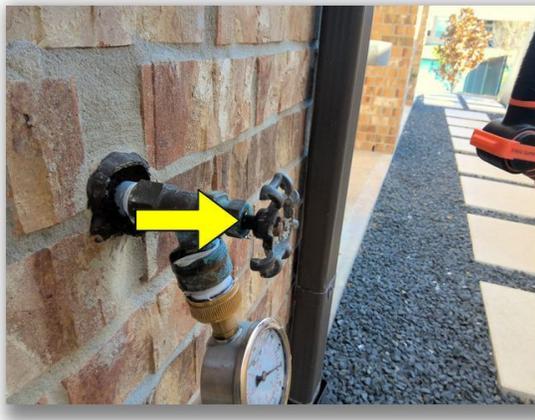
- The exterior water hose bibb (faucet) is leaking at the handle when operated on the right side of the structure.

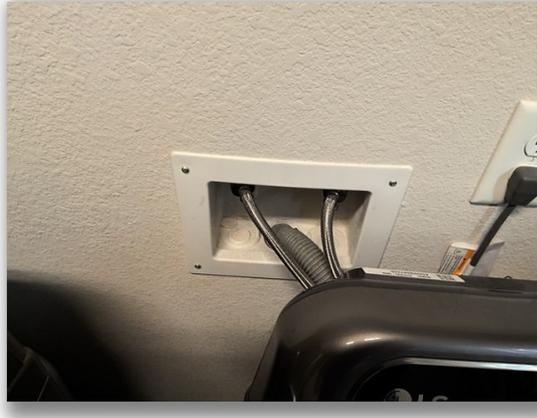
**Laundry Connections**

All components were found to be performing and in satisfactory condition on the day of the inspection.

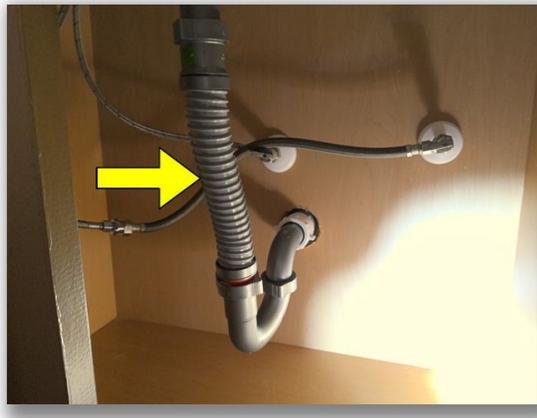
- Observed flexible (accordion style) pipe used in p-trap area. This product is prone problems such as collecting debris.

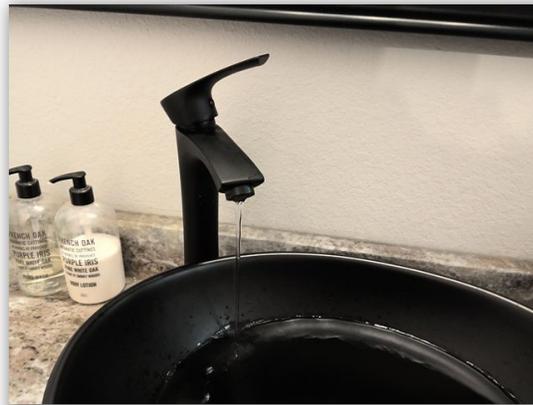
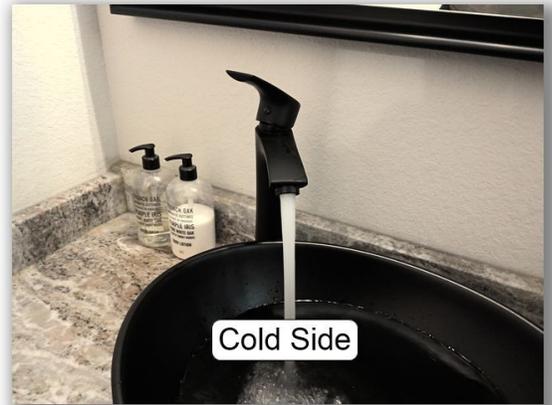
- The faucet appears to have low water pressure on the hot side of the faucet when operated. The cause and remedy should be further evaluated and corrected as necessary.

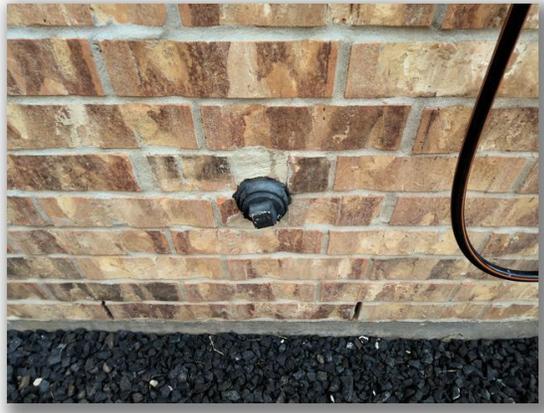
**Note:** The inspector was unable to locate the main plumbing cleanout at the time of inspection.

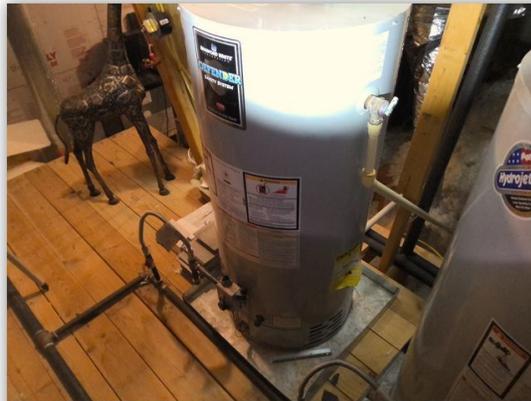
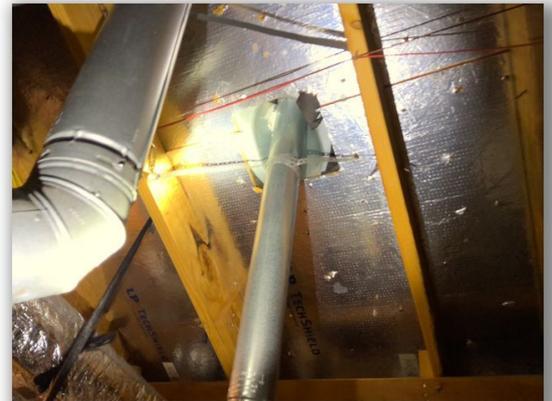
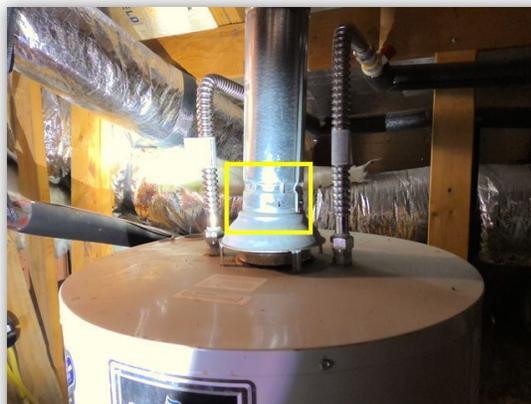
- The water heater flue connector should be mechanically attached to the draft hood or attached with a minimum of three sheet metal screws.

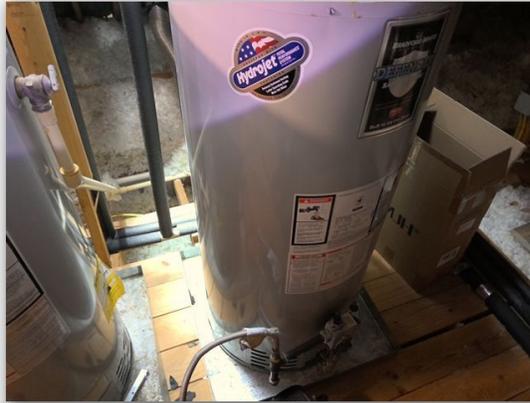
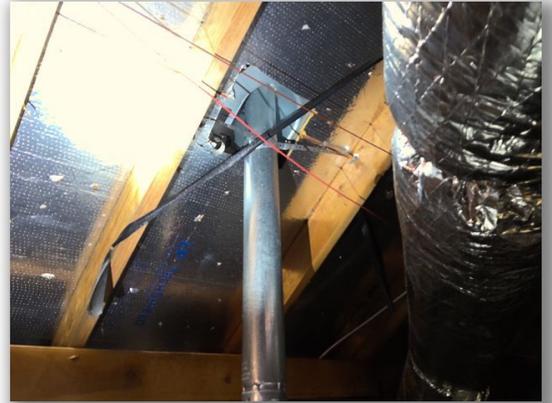
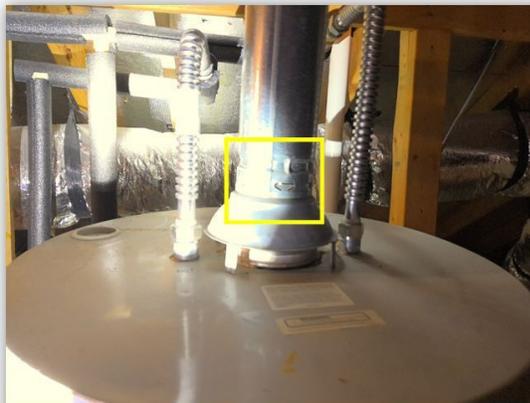
**Water Heater – Energy Source: Gas**  
**Location: Attic**  
**Approximate Capacity: 40 Gallons**  
**Approximate Age: 2019 Approximate Design Life: 15 years**  
**Brand Name: Bradford White**

- The water heater flue connector should be mechanically attached to the draft hood or attached with a minimum of three sheet metal screws.

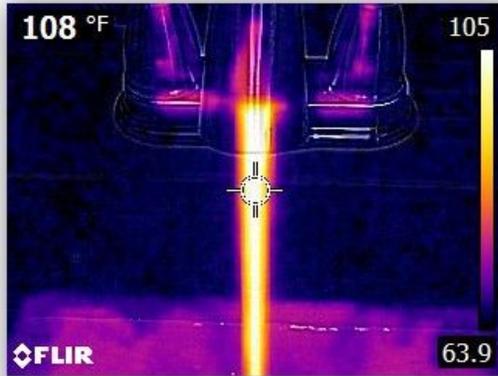
**Note:** Although not considered deficient, CPVC valves used at the water heater have a history of failure and replacement with a metal valve is recommended.

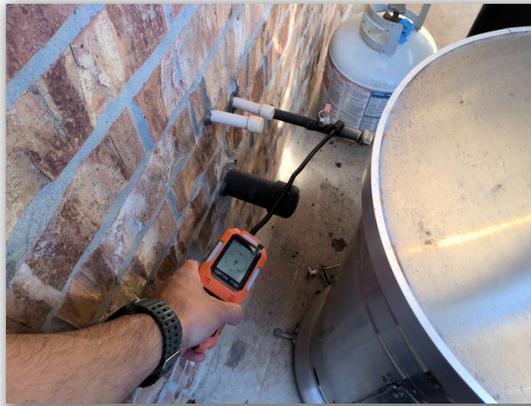
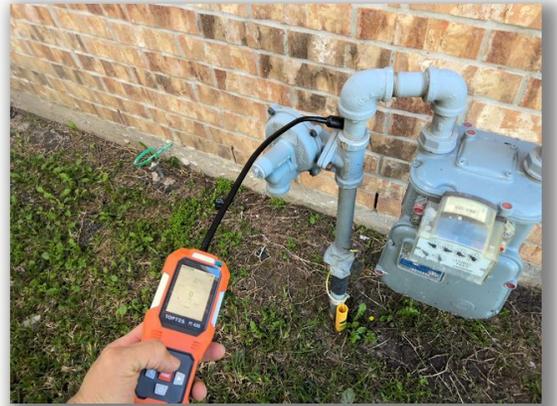
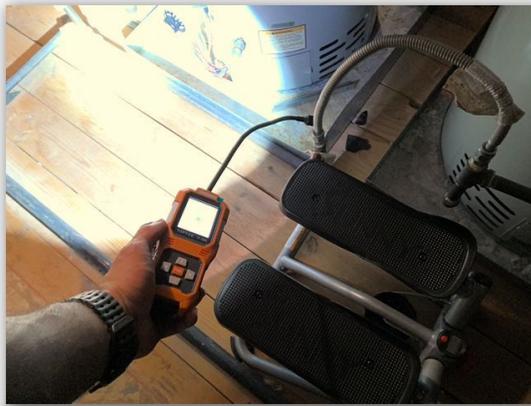
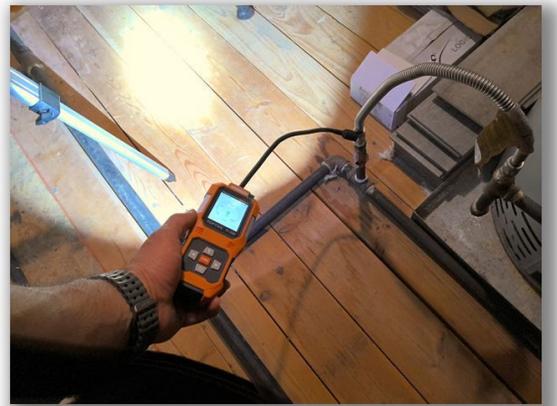
**General Photo(s) of Inspector Checking Gas Lines**

This component appears to be performing adequately at the time of this inspection.

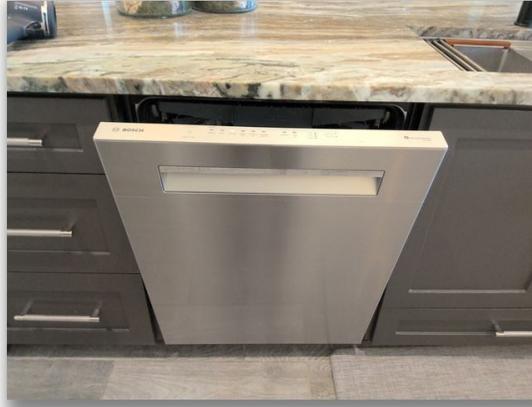
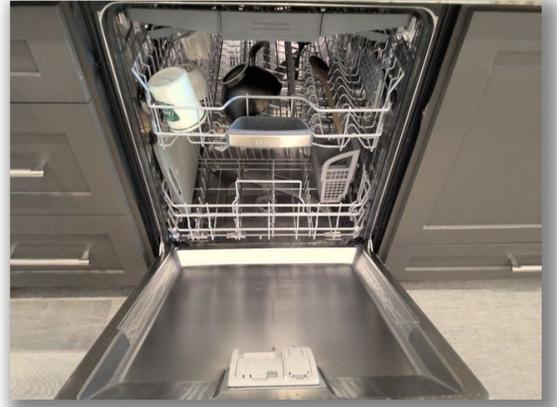
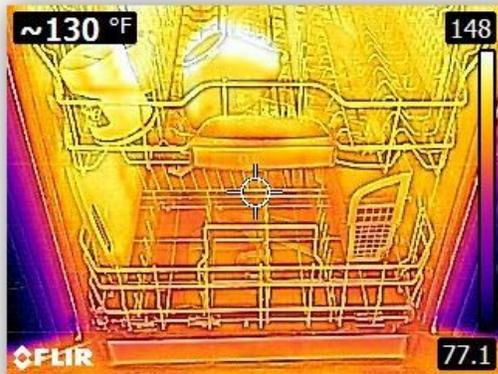
**Brand Name:** Bosch

This component appears to be performing adequately at the time of this inspection.

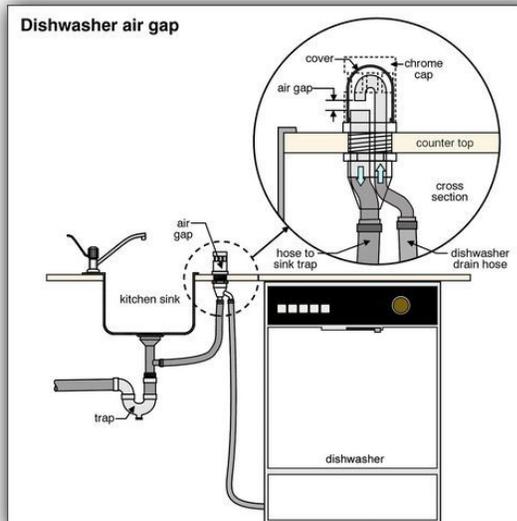
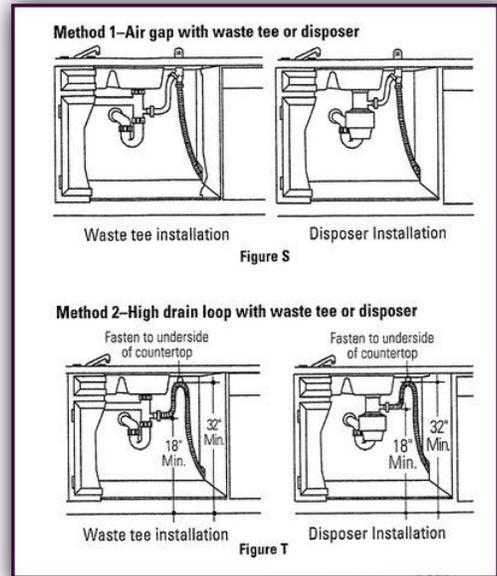
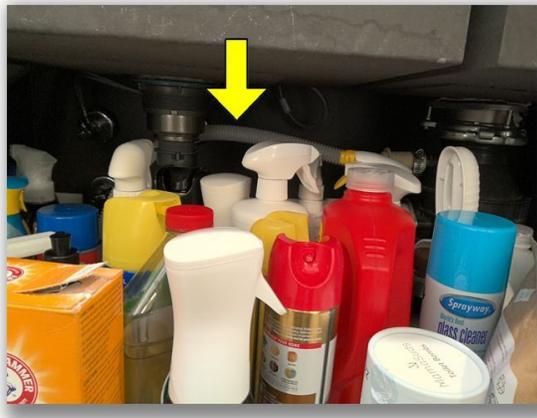
- The dishwasher drain hose is not properly installed to prevent back flow or anti-siphoning. It is recommended that an air gap device or high drain loop be installed in the drain line.

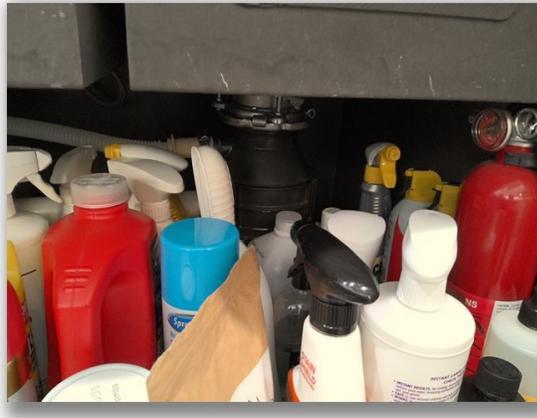
This component appears to be performing adequately at the time of this inspection.

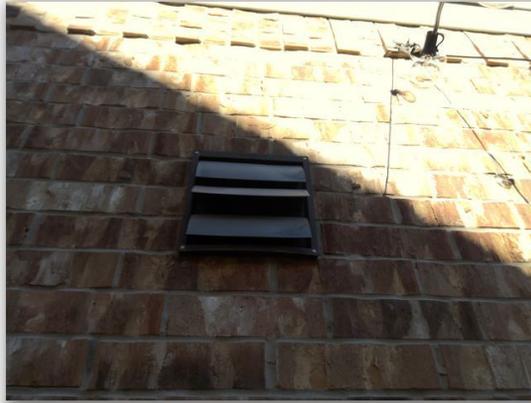
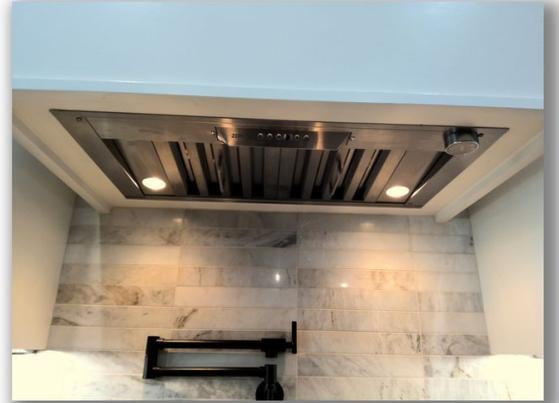
**Range Exhaust Systems**

This component appears to be performing adequately at the time of this inspection.

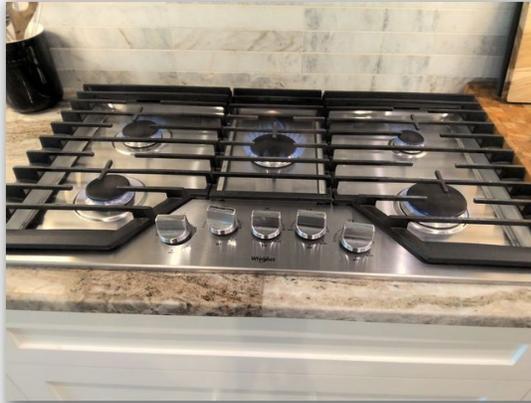
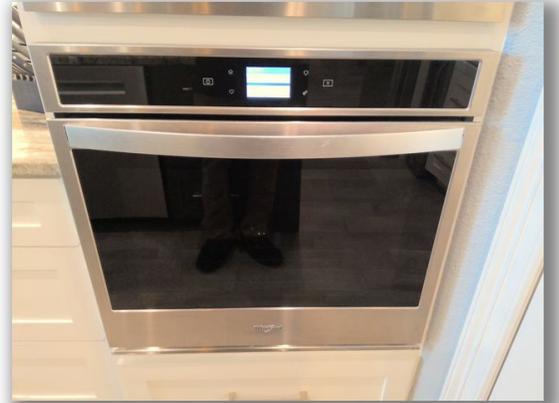
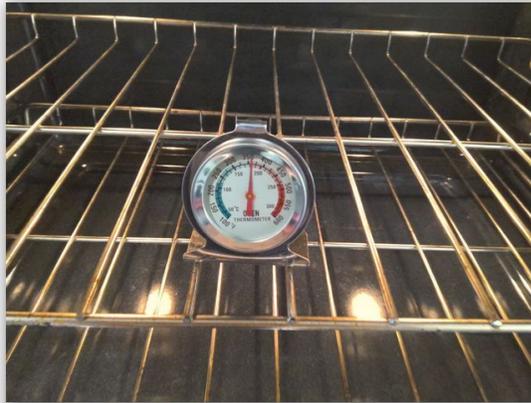
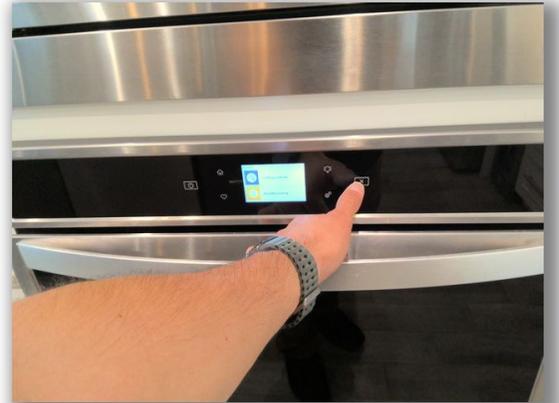
**Built-in Oven Brand Name:** Whirlpool

This component appears to be performing adequately at the time of this inspection.

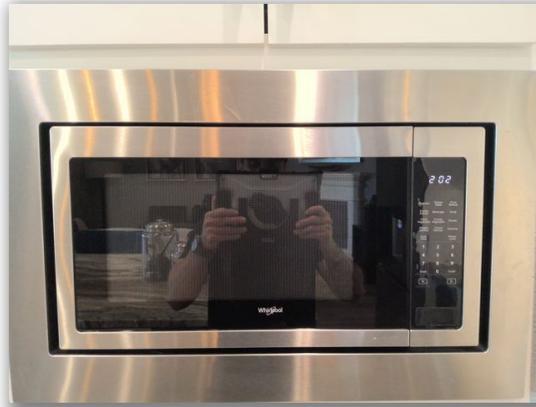
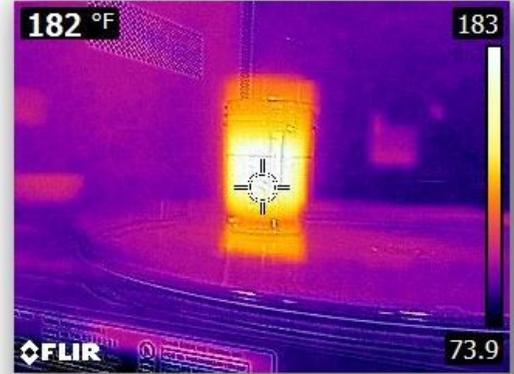
**Brand Name:** Whirlpool

This component appears to be performing adequately at the time of this inspection.

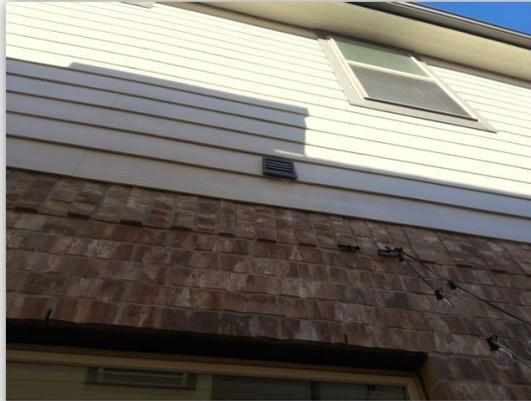
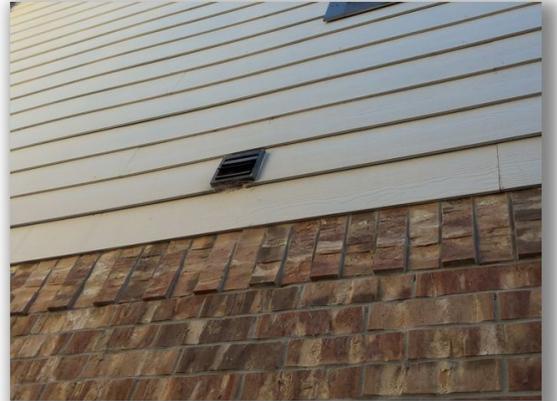
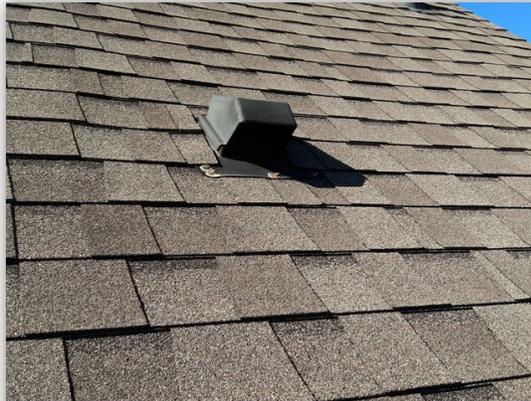
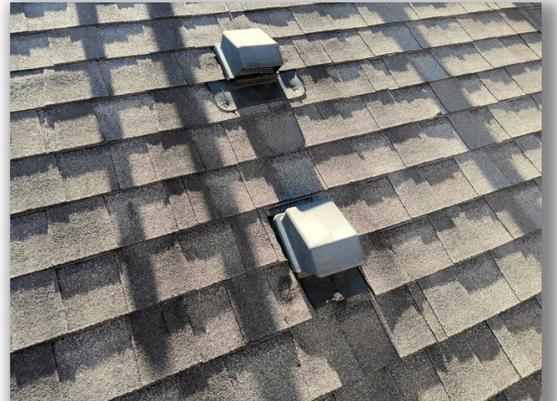
**General Photo(s) of Mechanical Exhaust Vents**

This component appears to be performing adequately at the time of this inspection.

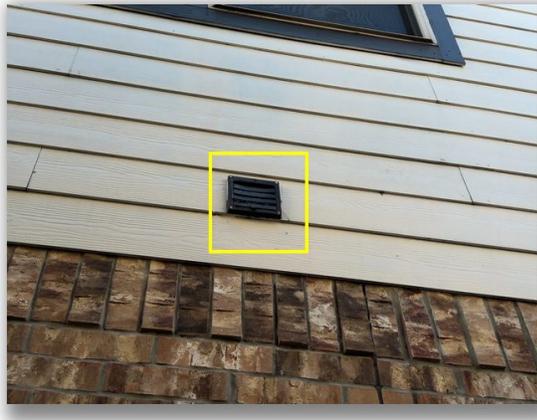
- The dryer exhaust duct (vent pipe) is dirty and needs to be cleaned.

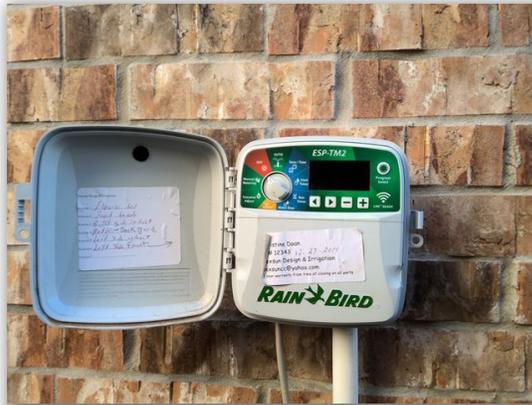
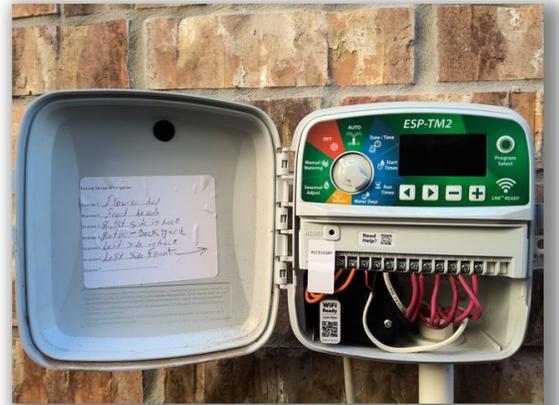
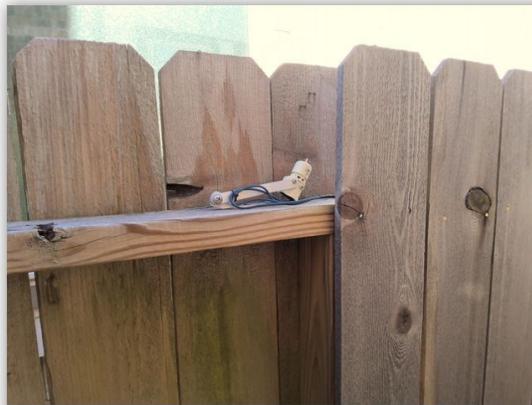
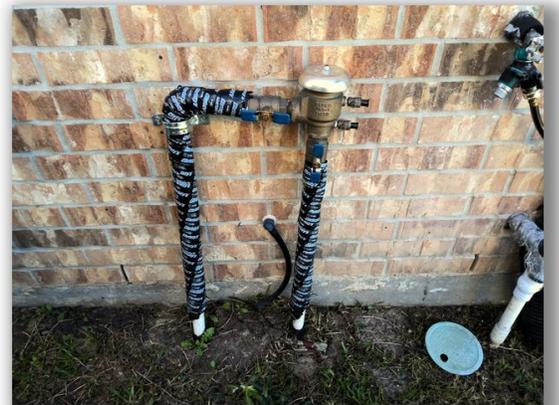
**General Pictures of Sprinkler System Back-flow Preventer, Control Box, & Rain Sensor**

The sprinkler system and associated components should be further evaluated and/or serviced by a Licensed Irrigation Technician. The observations made to support the rendering of this opinion are listed but not limited to the following:

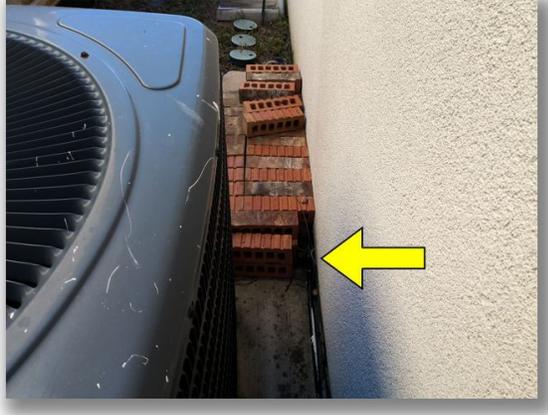
- One or more of the sprinkler heads need to be adjusted so not to spray water onto the exterior walls, surfaces or windows in stations; **5**.
