PROPERTY INSPECTION REPORT

Prepared For: Grant Brewster

Concerning: Sample, Richmond, TX 77406

By: Matthew Brading, Lic #TREC # 22654

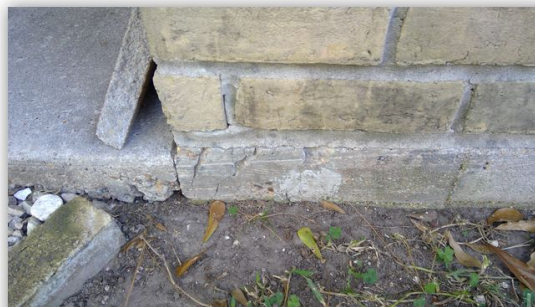
- One or more of the foundation perimeter beam corners were observed to be sheared off (corner pop). This is a common condition to observe and is do to thermal expansion and contraction of the different building materials. This condition does not adversely affect the foundation performance. However, in some cases, some cosmetic improvements may be necessary.

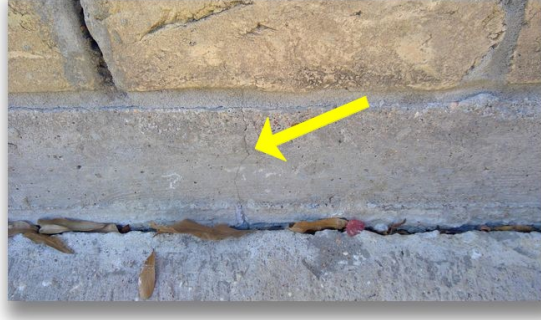
- Hairline crack(s) observed in the foundation grade beam. There was no height differential from one side to the other, and no shearing movement along the crack. We were not able to determine the extent or if this crack continued any distance across the slab due to the floor covering. The degree of visible cracking does not indicate a major structural defect; however, is consistent with a minor to moderate degree of settlement in the foundation system.

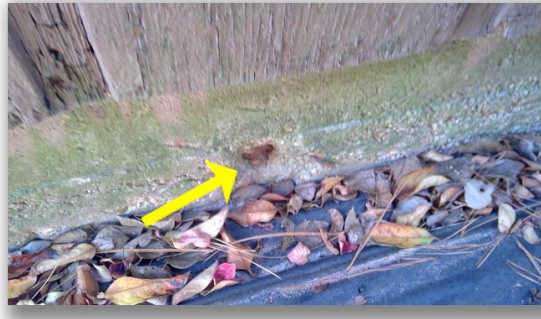
- One or more of the post tension cable ends are exposed and need to be properly sealed on the right side of the detached garage.

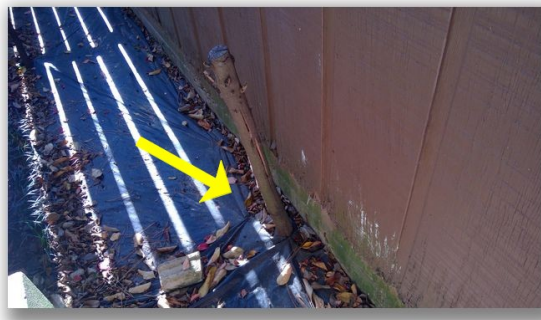
- **Note:** Tree(s) in close proximity of the foundation was observed. Client should consider the installation of a root barrier to reduce the possibility of damage to the foundation from tree roots and moisture removal.

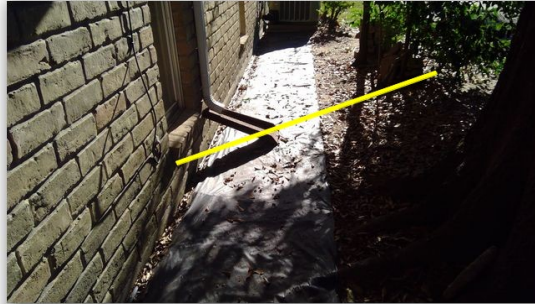
- Ground erosion was observed on the left side of the structure. Fill dirt is needed against the foundation perimeter wall where the soil line is too low to help support the foundation footer properly.

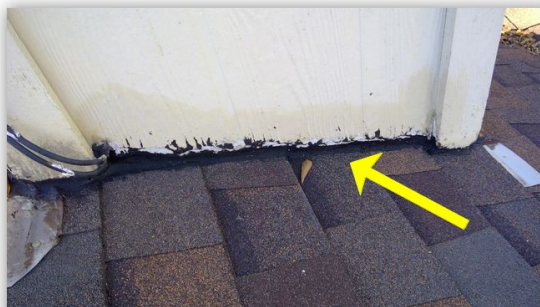
- **Note:** It appears that tar has been used to perform previous roof repairs in one or more locations on the roof. This type of repair is temporary in nature and is not considered to be a long term solution to an existing roofing problem.

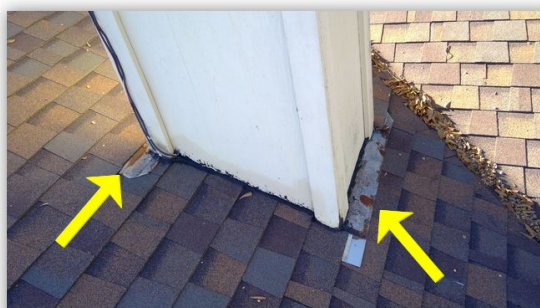
- Some of the metal flashing details were observed to be rusted and should be corrected as necessary.

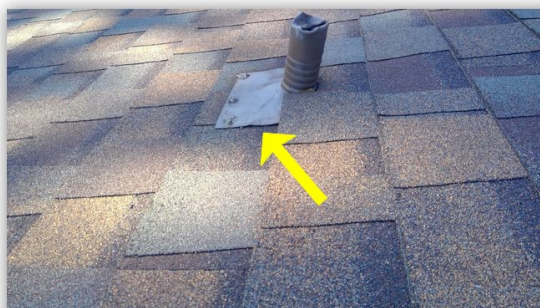
- One or more of the flashing detail flanges are not properly set into the roofing material. This condition needs to be corrected to help prevent water intrusion at this points.

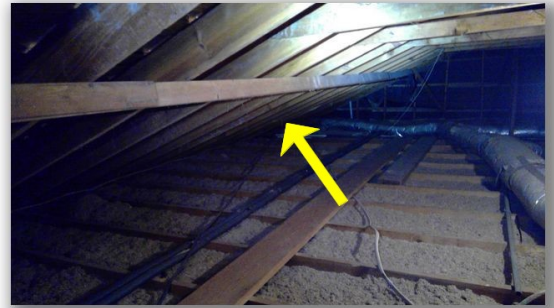
- The roof structure purlins are not properly supported in one or more locations. Under current building standards, the purlins should be supported by 2 x 4 braces installed to load-bearing walls at a slope not less than 45 degrees. The bracing should be spaced not more the 4 feet on center and the unbraced length of brace should not exceed 8 feet.

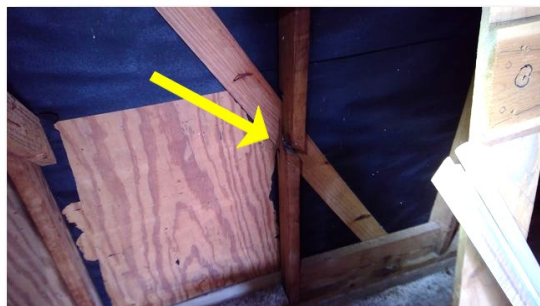
- Damaged framing member observed in detached garage.

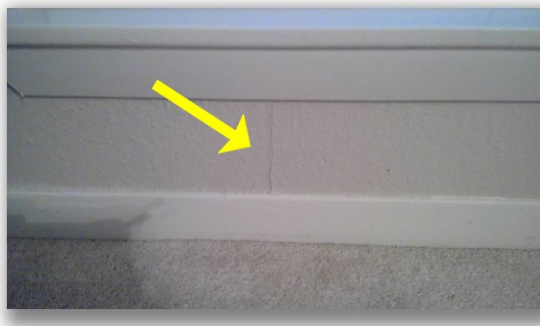
- Interior wall stress cracks were observed in the master bedroom.

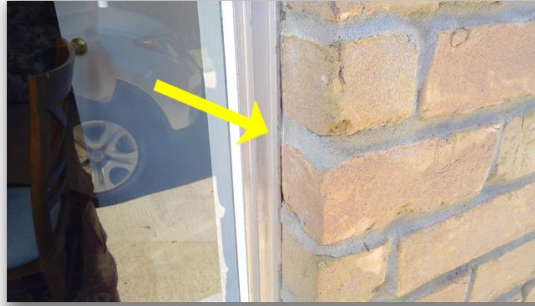
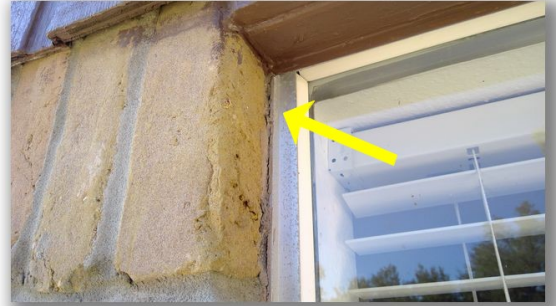
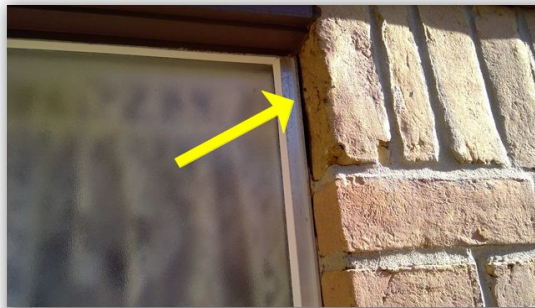
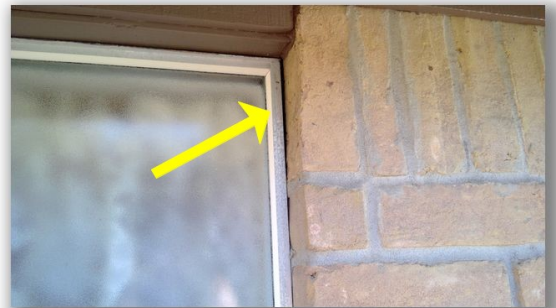
- Caulking improvements are recommended for the area between the exterior veneer and the window frames. It is recommended to use an elastomeric caulking.

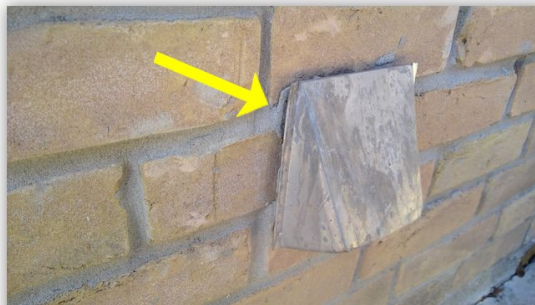
- The area between the exterior cladding / veneer and all of the wall penetrations / openings need to be properly sealed. Areas such as utility connections, downspouts, hose bibbs, lighting fixtures, receptacles etc. It is recommended to use an elastomeric caulking / sealant.

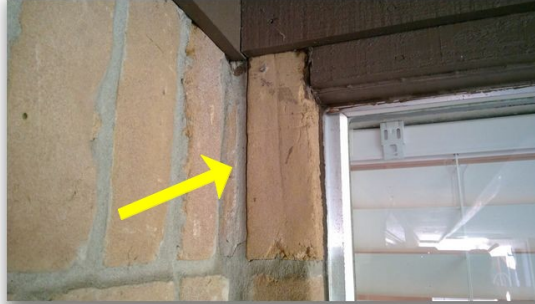
- **Note:** Minor mortar and/or brick cracks were observed in the exterior veneer on the front and left of the structure.

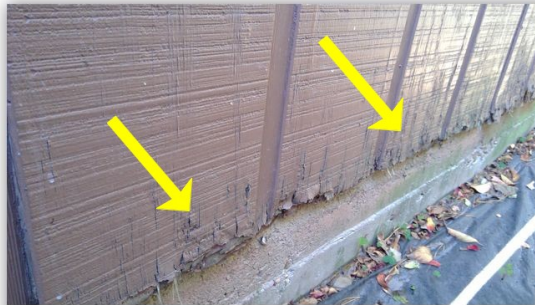
- The wood veneer trim has some deterioration or damage on the back side of the structure & right side of detached garage.

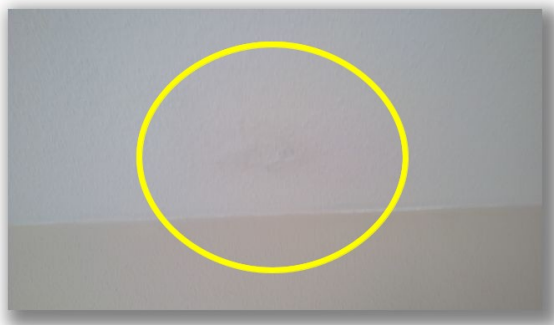
Note: There is evidence of painting and patching to the interior finish and prior interior finish repairs. This condition could limit the Inspectors visual observations and ability to render accurate opinions as to the performance of the structure.

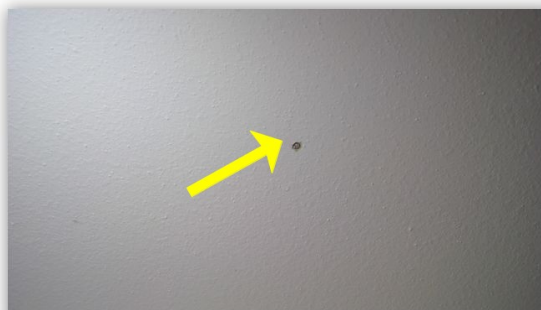
Note: Nail heads were observed to be pushing through the interior finish in one or more locations.

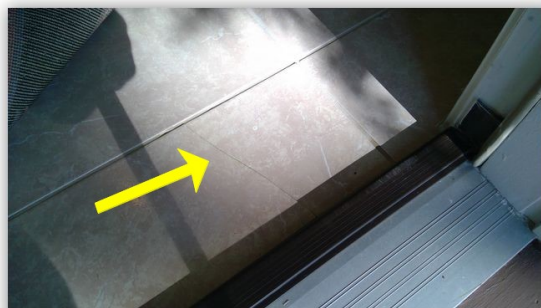
- The floor tile(s) were observed to be cracked and/or damaged in front entrance area.

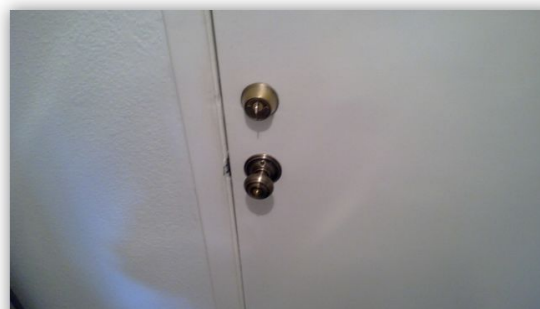
- Double cylinder locks were observed on one or more of the exterior exit (egress) doors. All exterior egress doors should be readily operable from the side from which egress is to be made without the use of a key or special knowledge or effort.

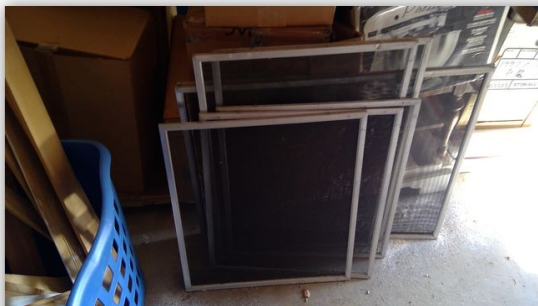
- **Note:** Some Screens are stored in the garage area.

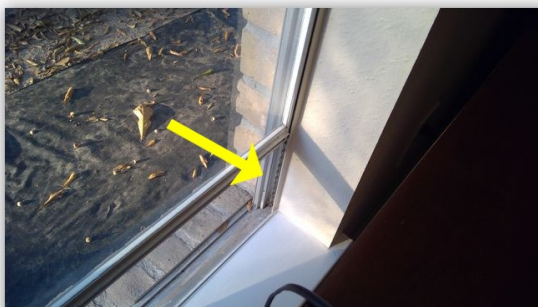
- The window sash guide is damaged in the master bedroom.

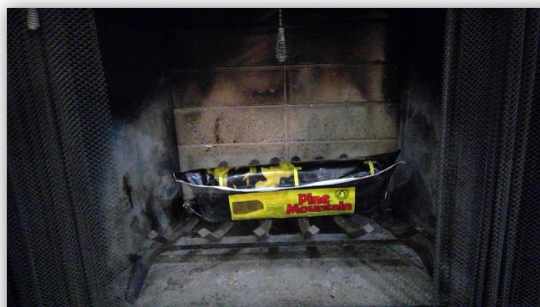
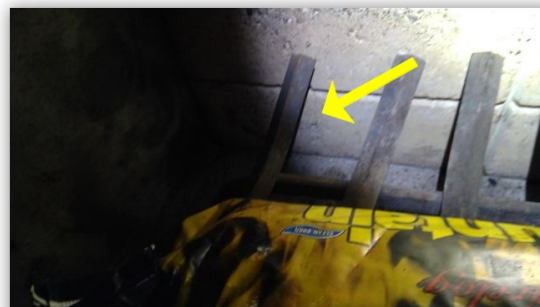
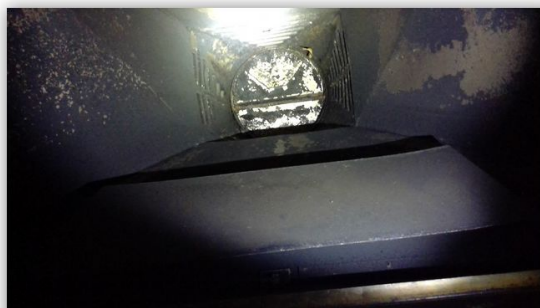
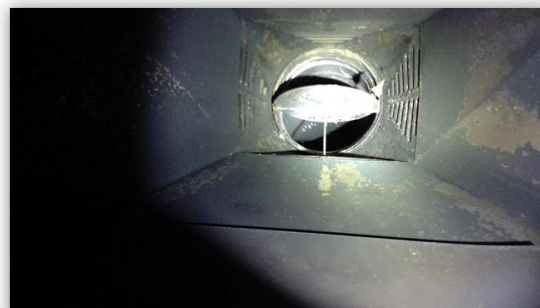
- The back panel in the firebox was observed to be cracked and/or damaged. This condition should be further evaluated and corrected as necessary.

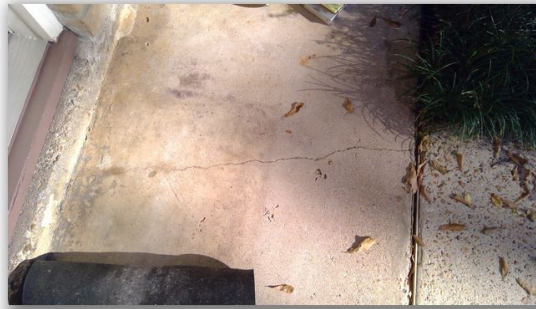
- Some deflection and/or cracking of the patio concrete flatwork was observed.

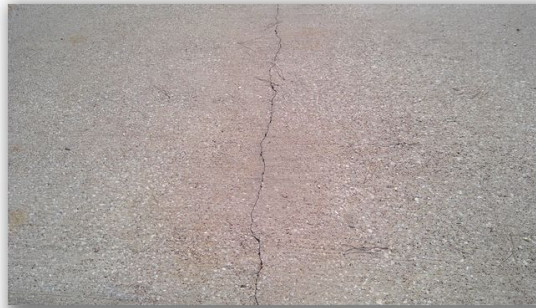
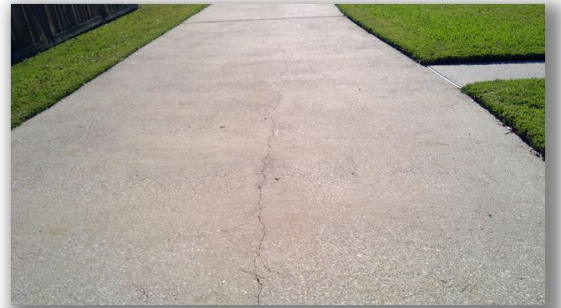
- Minor cracks and/or deficiencies were observed in the driveway.

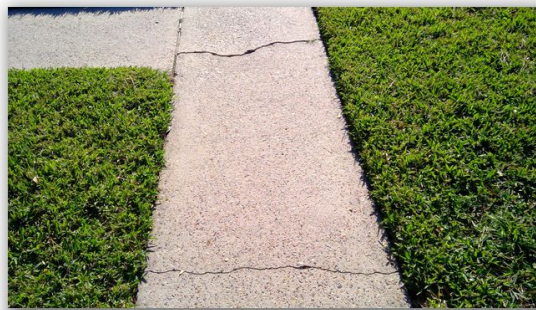
- Minor cracks and/or deficiencies were observed in the sidewalk.

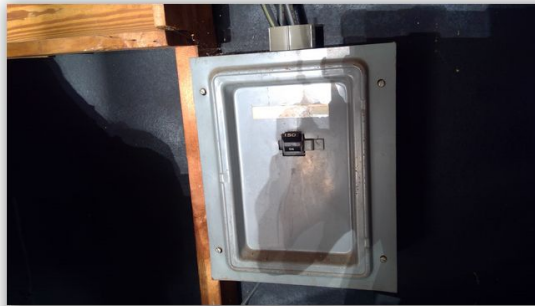
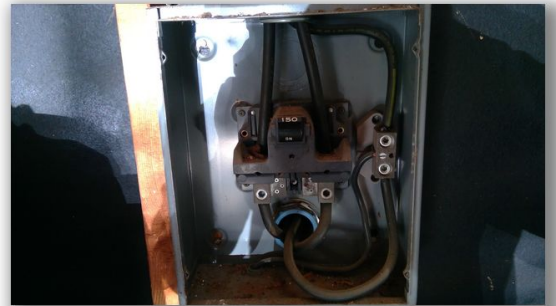
Notice: There is a Federal Pacific Electric - FPE Panel Box in place at the time of the inspection. This panel box is known to have various problems and/or deficiencies. Full evaluation of this panel box is beyond the scope of this inspection. You are strongly encouraged to have the panel box further evaluated by a qualified electrician prior to the expiration of any time limitations such as option or warranty periods.

- The electrical cabinet does not appear to be properly bonded to the electrical system.

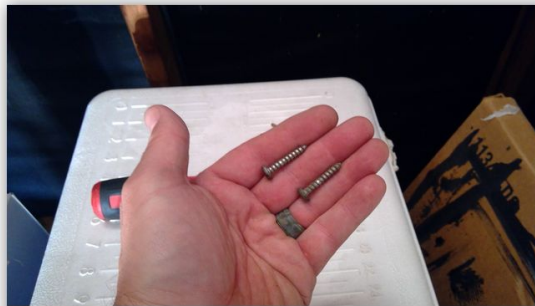
- The electrical cabinet cover plate (dead front) should be installed with blunt tip screws and not sharp wood type screws for reasons of safety.

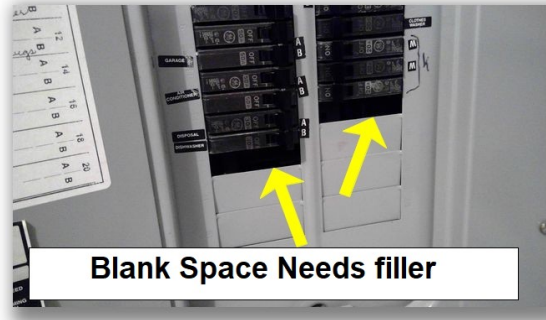
- All openings (missing knockouts) in the electrical cabinet cover plate (dead front) and /or cabinet need to have fillers.
- White hot wires should be labeled with black tape.

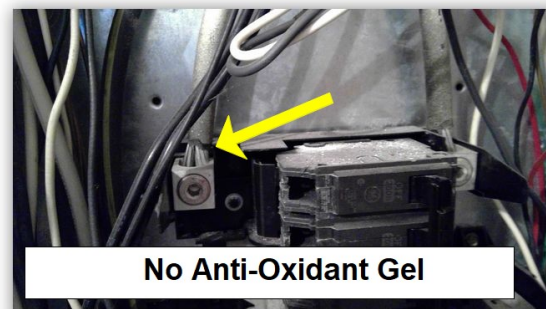
- There was no anti-oxidant gel observed on the exposed aluminum conductor terminations.
- The wires entering the electrical cabinet are not properly secured or protected from the sharp edges of the cabinet.

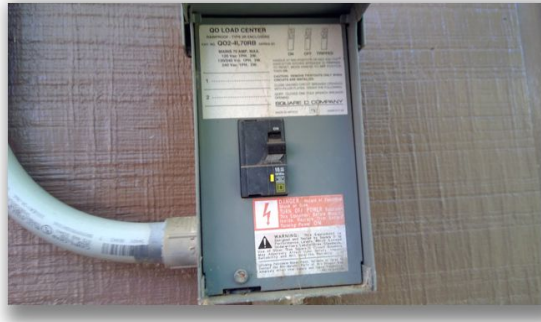
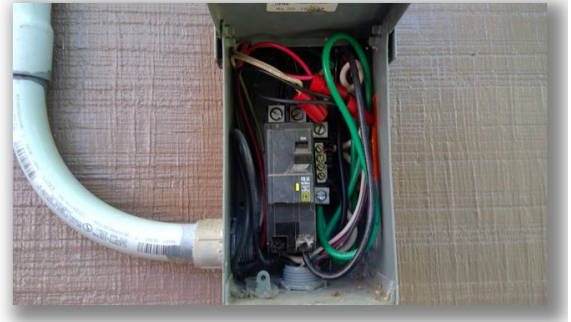
- The ground wires and the neutral wires are not properly separated in the sub-panel electrical cabinet. The neutral wires should be on their own isolated bus bar and the ground wires should be connected to the sub-panel cabinet. Although the sub-panel is functional, it does not meet current National Electrical Code standards.
- The ground wires should be bonded (connected) to the sub-panel electrical cabinet.

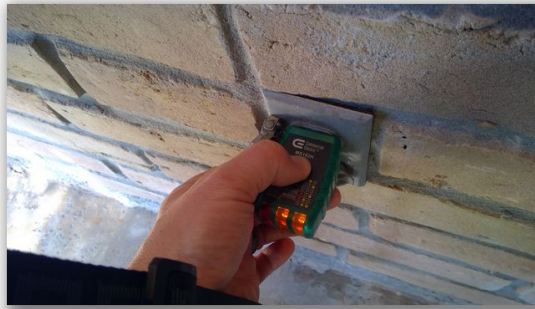
- The exterior receptacles do not appear to be connected to a ground fault circuit interrupter (GFCI) device. Under current electrical standards, all of the exterior receptacles should have GFCI protection.
- The garage receptacles do not appear to be connected to a ground fault circuit interrupter (GFCI) device. Under current electrical standards, all of the garage receptacles should have GFCI protection.
- The laundry room area receptacles do not appear to be connected to a ground fault circuit interrupter (GFCI) device. Under current electrical standards, all of the receptacles in the laundry room area should have GFCI protection.

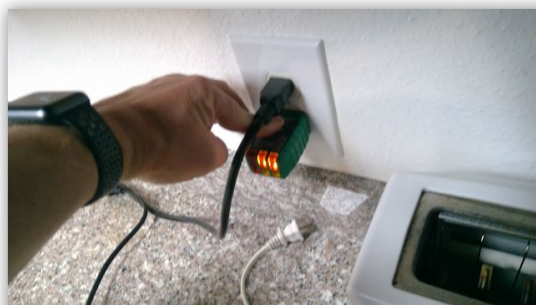
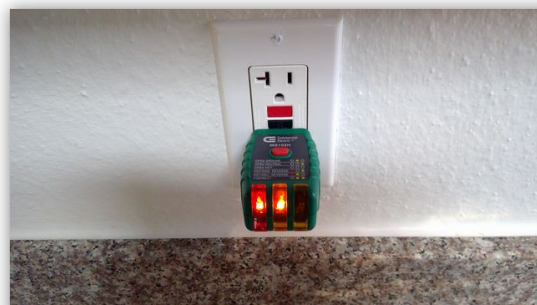
- The kitchen counter top receptacles do not appear to be connected to a ground fault circuit interrupter (GFCI) device. Under current electrical standards, all of the kitchen counter top receptacles and any receptacle within 6-feet of the sink should have GFCI protection.
- One or more of the receptacles appear to have reversed polarity (i.e. it is wired backwards). This receptacle(s) and the circuit should be investigated and improved as necessary. The receptacle(s) in question are located in the kitchen.

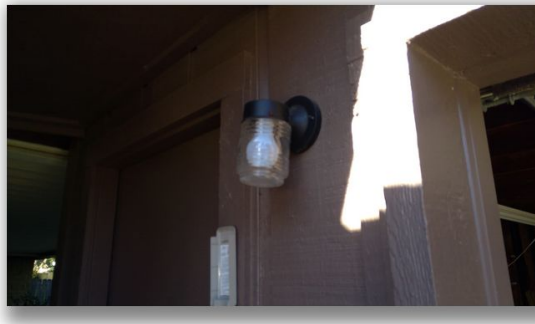
- One or more of the light fixtures appear to be inoperative in the exterior area. This may be due to a bad bulb or some other unknown condition. This condition should be further evaluated and corrected as necessary.

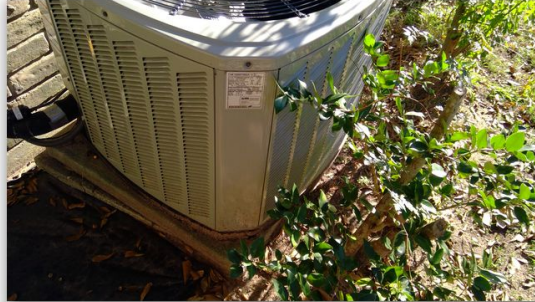
- **Note:** The heavy foliage at and around the outside condenser/coils should be trimmed back a minimum of 18-inches to help improve air circulation.

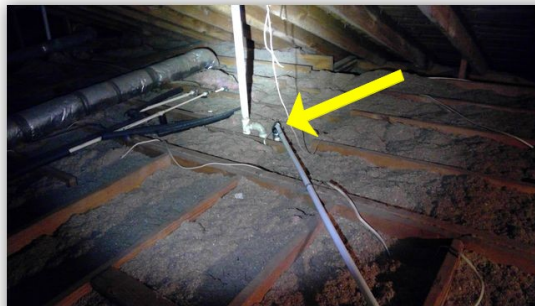
- The primary condensate drain line is improperly terminating into a plumbing vent stack.

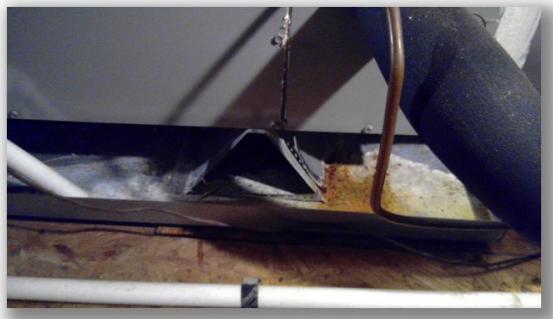
- **Note:** The auxiliary/secondary drain pan under the coil housing has some water staining and/or a rust build-up. This would indicate that the pan has held water in the past and should be closely monitored.

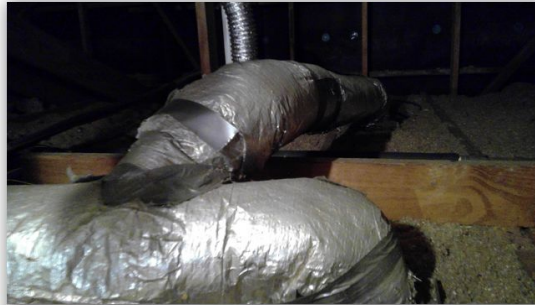
- Duct tape observed used to repair ductwork. Despite its name, duct tape is not an approved material to repair ductwork.

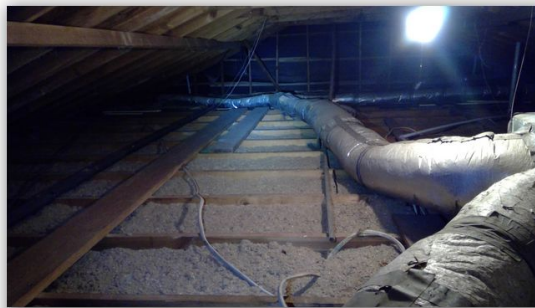
- The duct work in the attic area does not appear to be properly suspended and separated to help prevent condensation from developing. It is recommended to separate and suspend the duct work with supports in minimum intervals of 4-feet that have a minimum width of 1.5-inches.

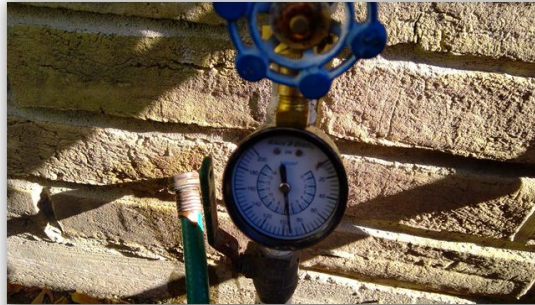
- The water pressure was observed to be above 80 psi at the time of this inspection. Under current plumbing standards the maximum water pressure should be 80 psi. This condition should be further evaluated and corrected as necessary.

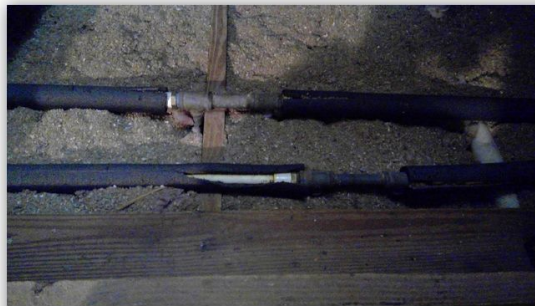
- There are galvanized water lines in use at the time of this inspection. This is an older obsolete water supply system that is prone to water leaks. Full evaluation of all of the galvanized water line components and the integrity of those components are beyond the scope of this inspection. You are strongly encouraged to have the integrity of all of the galvanized water line components further evaluated by a qualified plumber prior to the expiration of any time limitations such as option or warranty periods. All plumber recommended repairs should be made. It would be wise to budget for replacement of all the older galvanized water supply system and to make a conversion over to a newer type of water supply system as soon as it is financially feasible.

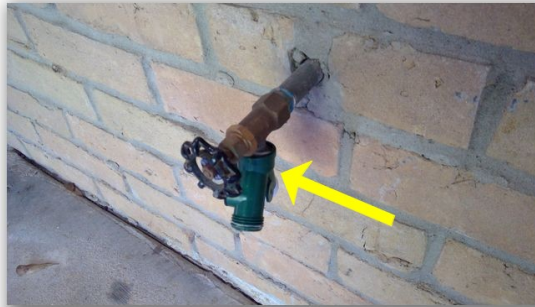
- One or more of the exterior water hose bibbs (faucet) do not have a back-flow or anti-siphon device (Vacuum Breakers) in place. **Note:** *This is not uncommon to observe with a home of this age.*

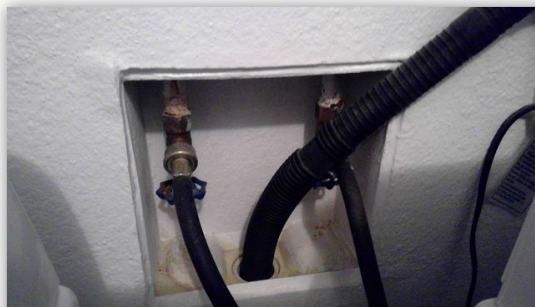
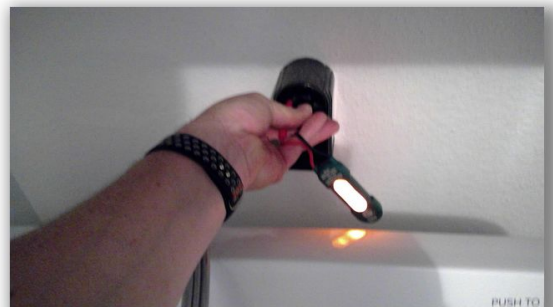
- Some rust and/or corrosion was observed at the laundry connection hose bibbs.

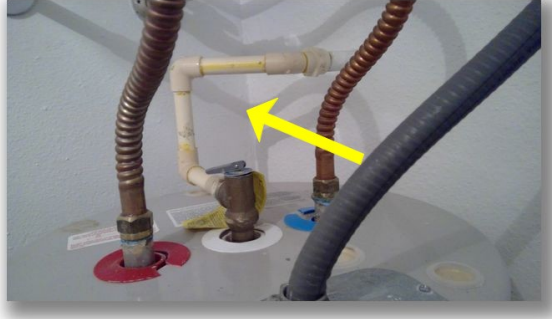
- The temperature and pressure relief (TPR) valve discharge pipe is running in an upwards direction in one or more locations. The TPR discharge pipe should run gravitationally downwards at all points.

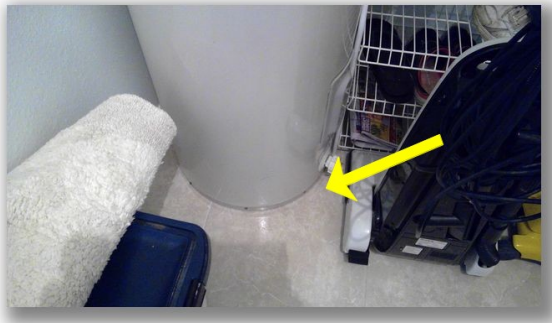
- There is no pan installed under the water heater.

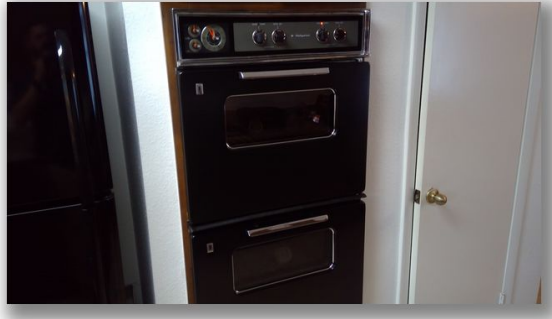
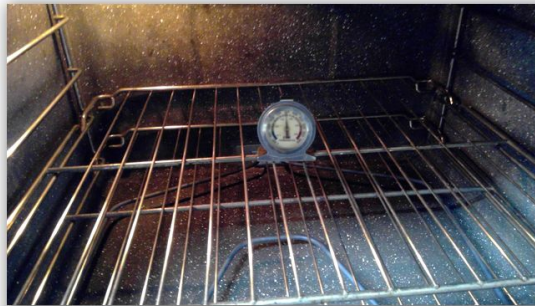
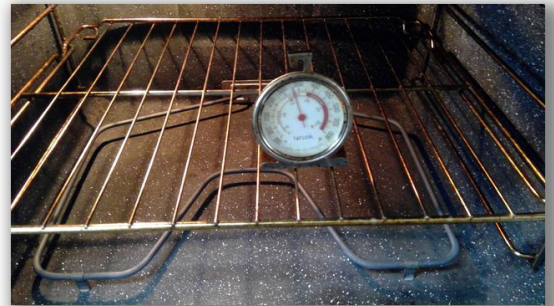
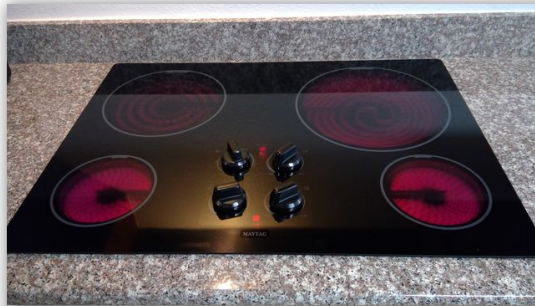
Built-in Oven Brand Name: Hotpoint

This component appears to be performing adequately at the time of this inspection.

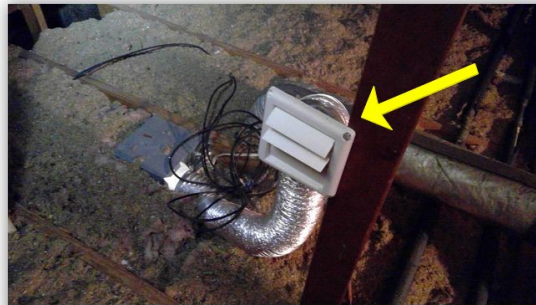
- The mechanical exhaust vents were observed to be venting into the attic area. Under current building standards, all mechanical exhaust vents should vent to the exterior of the structure. This is an “**as-built**” condition.

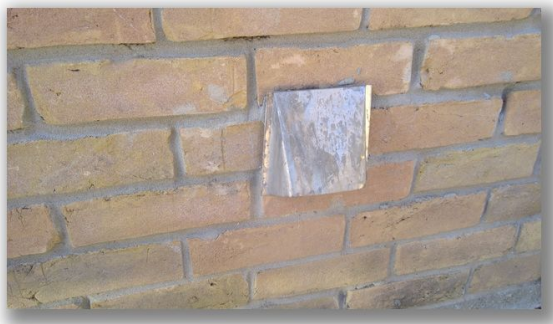
H. Dryer Exhaust Systems

This component appears to be performing adequately at the time of this inspection.
