**January 17, 2020**

## PROPERTY INSPECTION REPORT

Concerning: Sample, Houston, TX 77008  
(Address or Other Identification of Inspected Property)

By: Matthew Brading, Lic #TREC # 22654 01/17/2020  
(Name and License Number of Inspector) (Date)

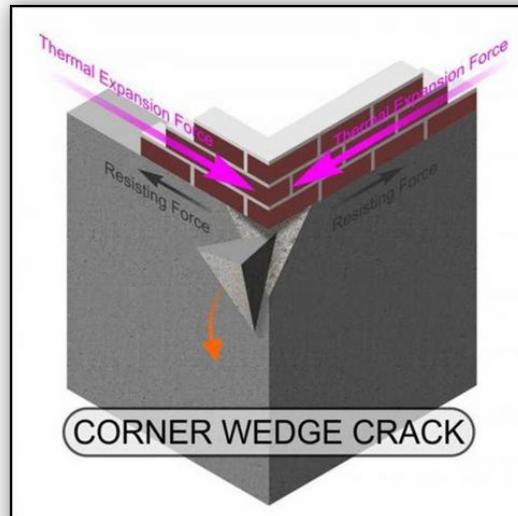
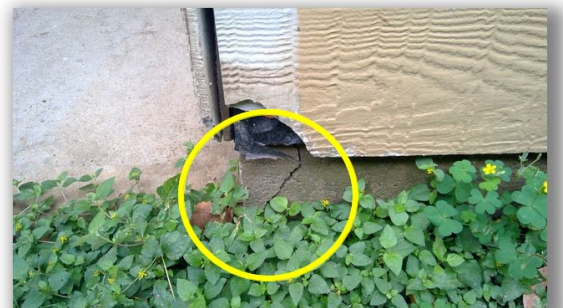
- One or more of the foundation perimeter beam corners were observed to be sheared off (corner pop). This is a common condition to observe and is do to thermal expansion and contraction of the different building materials. This condition does not adversely affect the foundation performance. However, in some cases, some cosmetic improvements may be necessary.

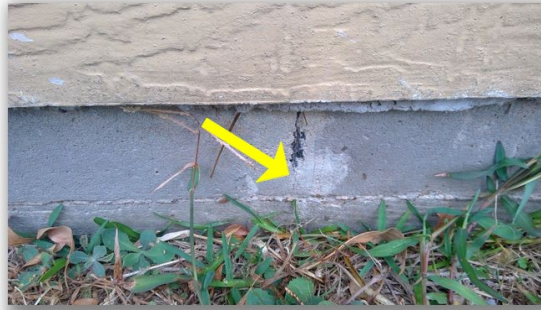
- Hairline crack(s) observed in the foundation grade beam. There was no height differential from one side to the other, and no shearing movement along the crack. We were not able to determine the extent or if this crack continued any distance across the slab due to the floor covering. The degree of visible cracking does not indicate a major structural defect; however, is consistent with a minor to moderate degree of settlement in the foundation system.

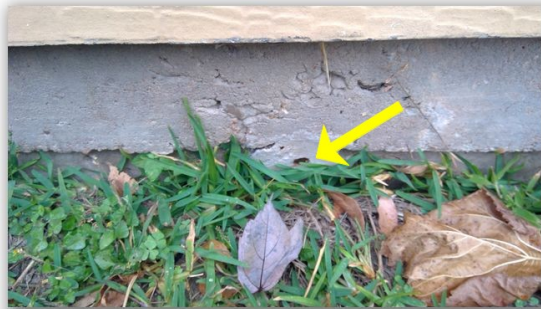
- One or more of the post tension cable ends are exposed and need to be properly sealed on the back side of the structure.

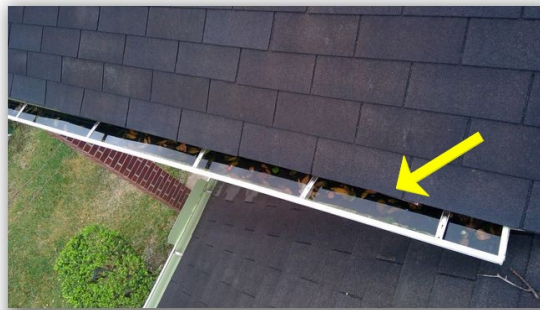
- The gutters do not appear to have sufficient slope to drain properly on the front side of the roof structure. If they do not perform as intended, the slope should be adjusted.

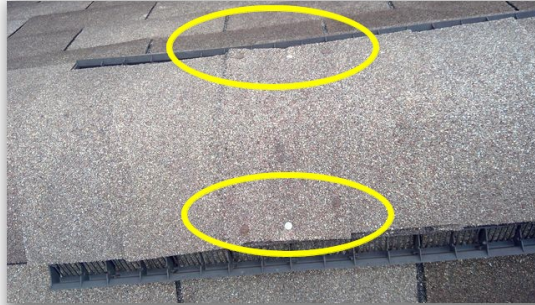
- **Note:** Roof fasteners (nails and/or staples) were observed to be exposed and should be properly sealed at the ridge caps and flashing areas.

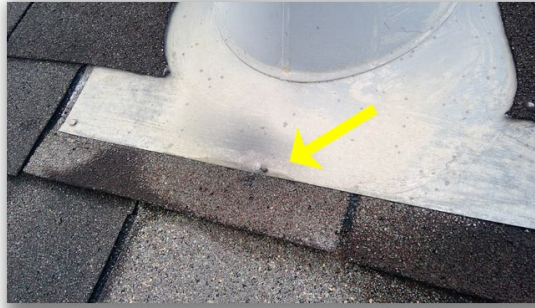
- **Note:** High shingle fasteners (staples and/or nails) were observed in various locations.

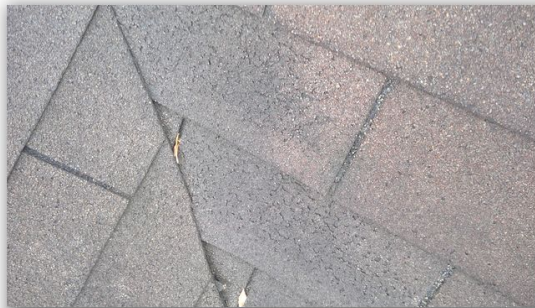
- The composition roofing material has experienced considerable granular loss in various locations throughout the roof.

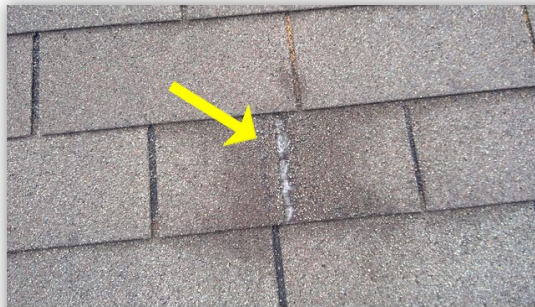
- Damaged shingles were observed on the back side of the roof structure.

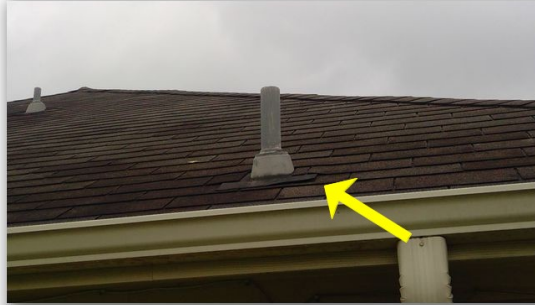
- One or more of the flashing detail flanges are not properly set into the roofing material. This condition needs to be corrected to help prevent water intrusion at this points.

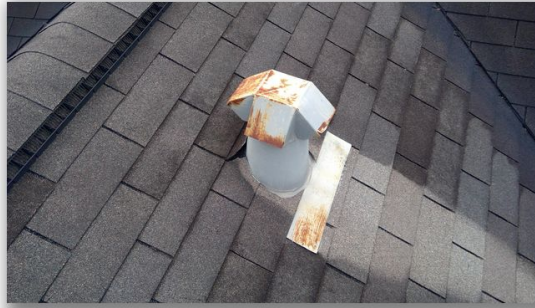
- Some of the metal flashing details were observed to be rusted and should be corrected as necessary.

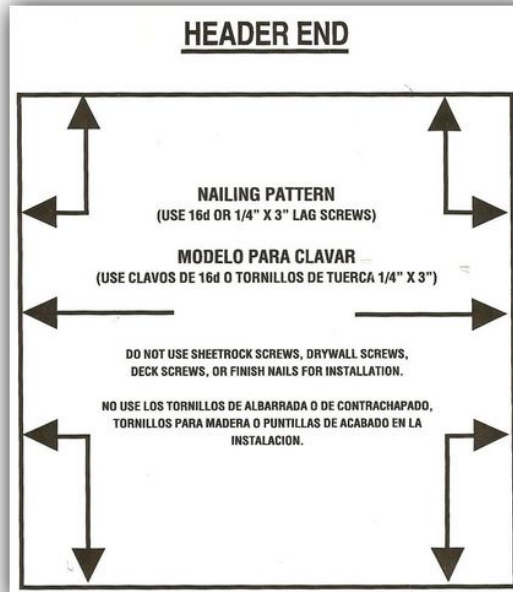
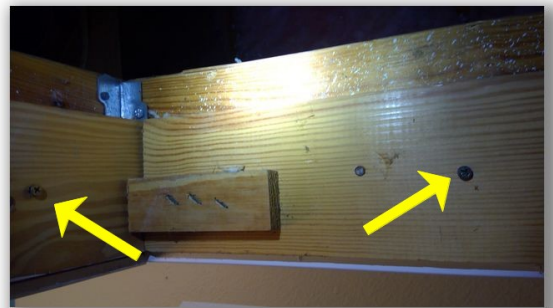
- **Note:** There was not weather-stripping observed around the attic ladder opening. This is an "As Built" condition that does not meet current energy standards. It is recommended to weather-strip the hatch opening after taking position / ownership of the property.
- The attic ladder was observed to be installed with improper fasteners. The attic ladder should be secured in place with 16d nails or 3-inch lag bolts. This condition should be further evaluated and corrected as necessary.
- Attic access insulation observed in poor condition.

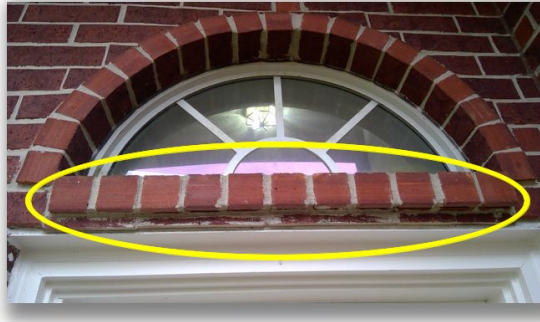
- There were no weepholes observed in the low course of the exterior masonry veneer over the window and door steel lintels. This condition does not meet current building standards and should be corrected as necessary.

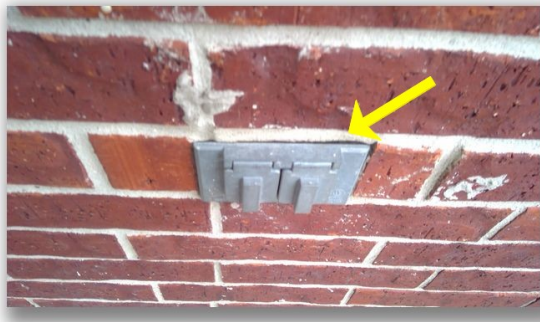
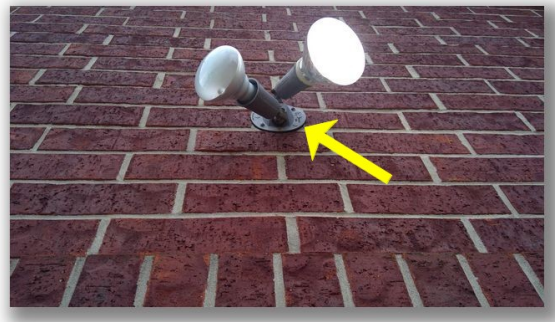
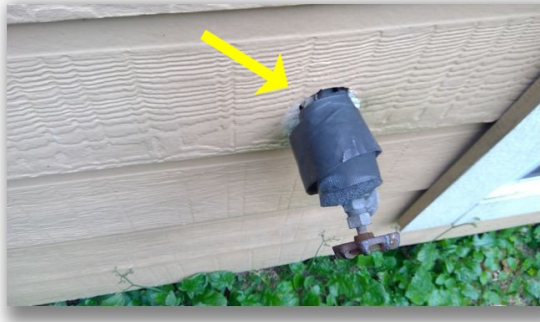
- The area between the exterior cladding / veneer and all of the wall penetrations / openings need to be properly sealed. Areas such as utility connections, downspouts, hose bibbs, lighting fixtures, receptacles etc. It is recommended to use an elastomeric caulking / sealant.

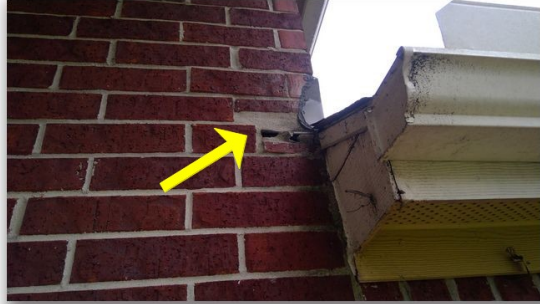
- Mortar improvements are recommended for the exterior masonry veneer on the front side of the structure.

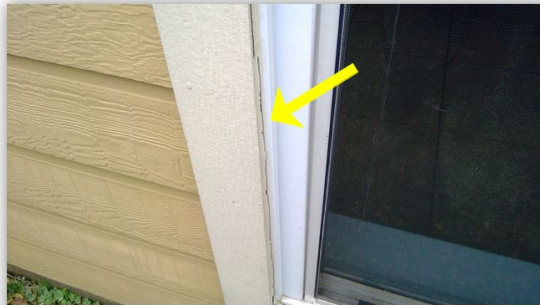
- Caulking improvements are recommended for the area between the exterior veneer and the window frames. It is recommended to use an elastomeric caulking.

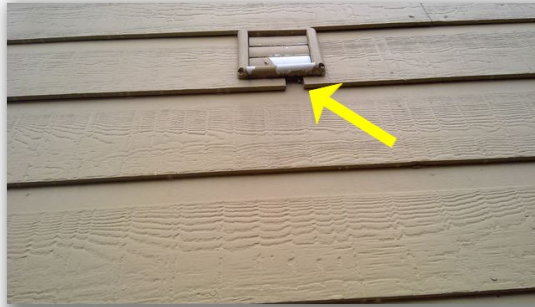
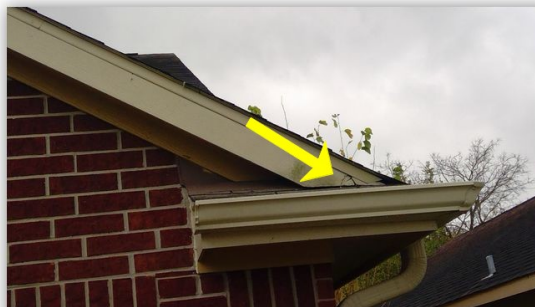
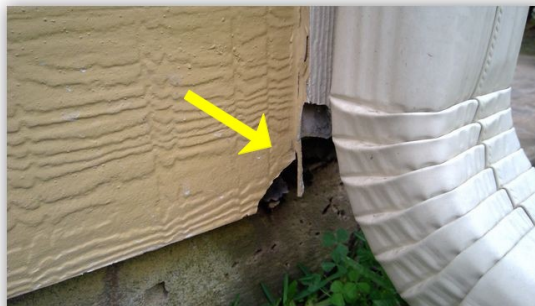
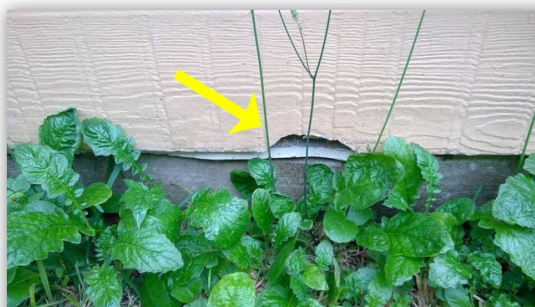
- The exterior veneer / cladding appears to have impact damage on various locations of the structure. This condition needs to be further evaluated and corrected as necessary.

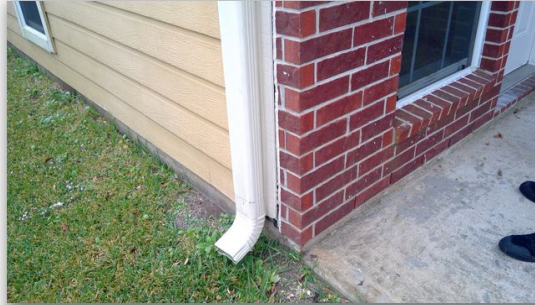
- **Note:** Damaged siding at the front at back of the structure is exposing some framing members. Repairs properly cover exposed framing members are recommended.

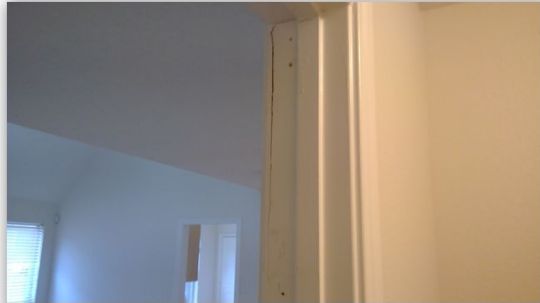
- The door frame has some damage to the laundry room closet.

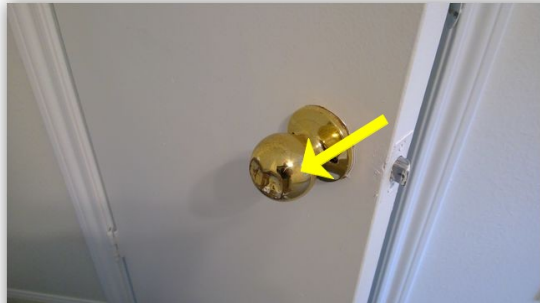
- The door hardware is damaged to the side middle bedroom closet.
- The door to the side middle bedroom requires a key to unlock.

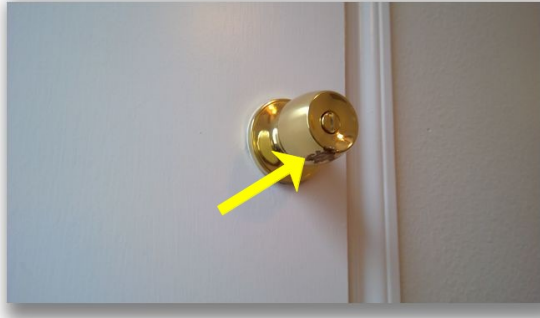
- The door hardware is damaged to the rear corner bedroom, rear corner bedroom closet.

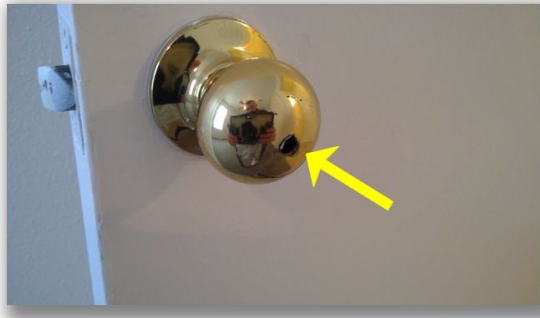
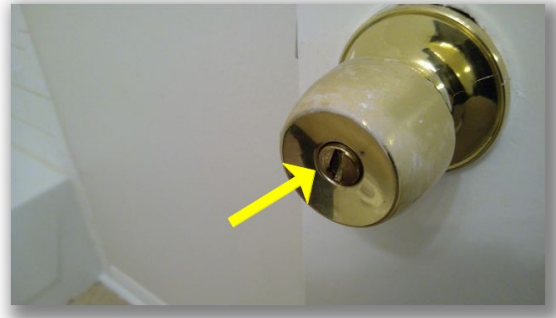
- Door handles to hall bathroom and rear corner bedroom have damaged/sharp metal edges.

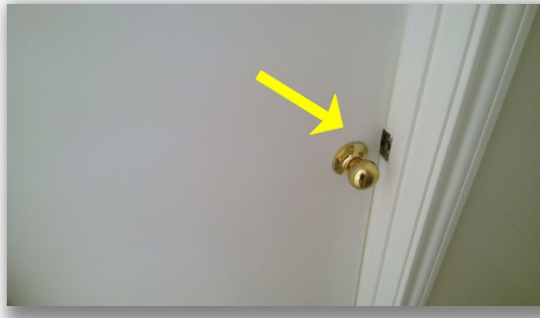
- The door is not latching properly to the master bathroom closet.

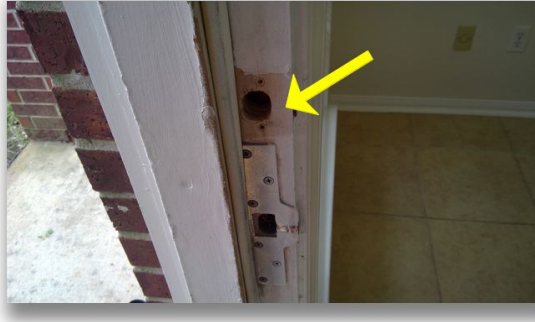
- The door hardware is missing to the front entry door.

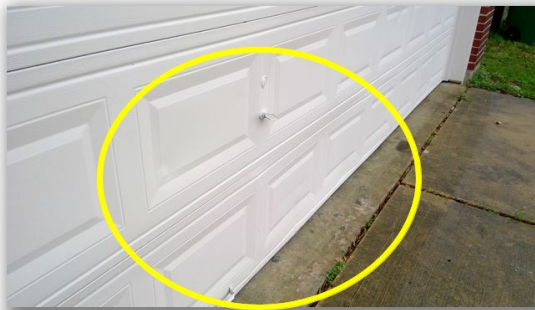
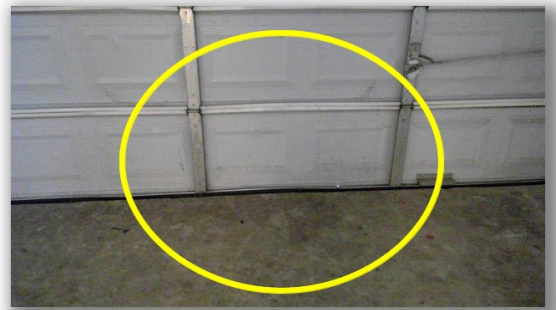
- The overhead garage door panel(s) and/or panel trim has some deterioration and/or damage.

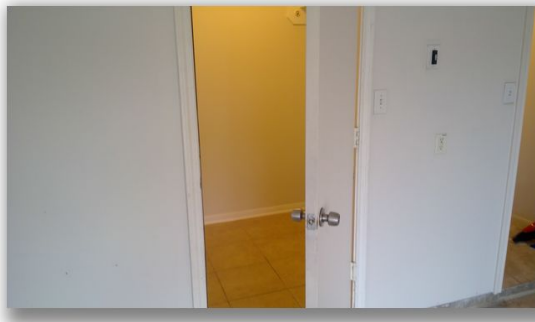
- The garage entry door is not equipped with a self-closing device.

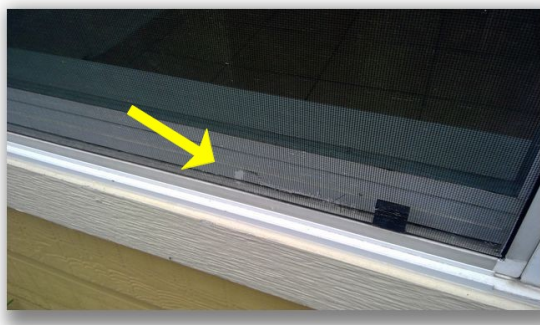
- One or more of the window screens were observed to be damaged.

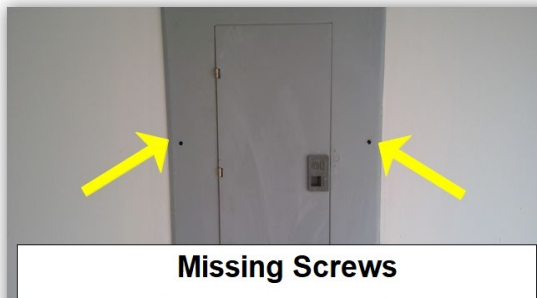
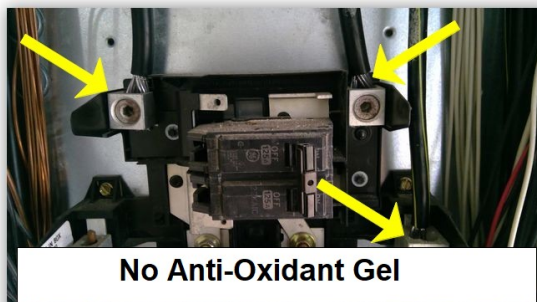
- One or more of the cabinet cover plate screws are missing and need to be replaced.
- White hot wires should be labeled with black tape.
- There was no anti-oxidant gel observed on the exposed aluminum conductor terminations.

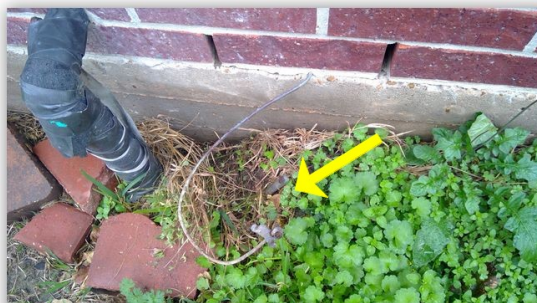
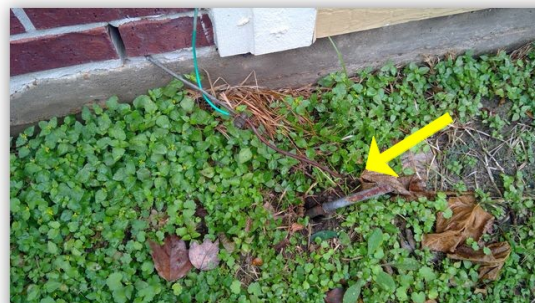
- The bonding wire connection to the ground electrode rod has pulled loose and needs to be repaired as necessary.

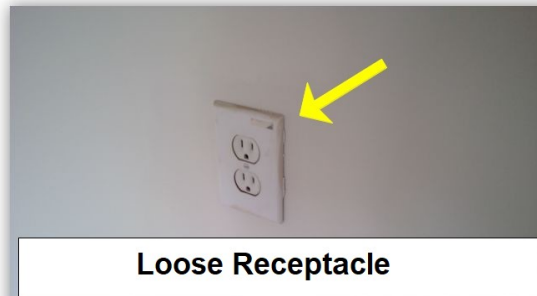
- One or more of the receptacles were observed to be loose at the wall mount in the garage.
- Not all of the garage receptacles appear to be connected to a ground fault circuit interrupter (GFCI) device. Under current electrical standards, all of the garage receptacles should have GFCI protection. There New National Electrical (NEC) Code no longer has an exception for “non-appliance dedicated”.

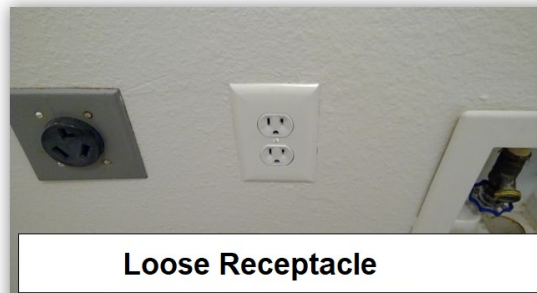
- The switch is loose at the wall mount in the laundry room.
- The laundry room area receptacles do not appear to be connected to a ground fault circuit interrupter (GFCI) device. Under current electrical standards, all of the receptacles in the laundry room area should have GFCI protection.

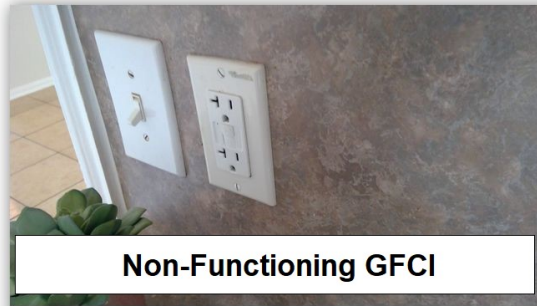
- One of the ground fault circuit interrupter (GFCI) devices does not appear to be functioning properly at the time of this inspection. The device in question is located in the kitchen area.
- Not all of the garage receptacles appear to be connected to a ground fault circuit interrupter (GFCI) device. Under current electrical standards, all of the garage receptacles should have GFCI protection. There New National Electrical (NEC) Code no longer has an exception for “non-appliance dedicated”.
- One or more of the receptacles were observed to be loose at the wall mount in the kitchen.

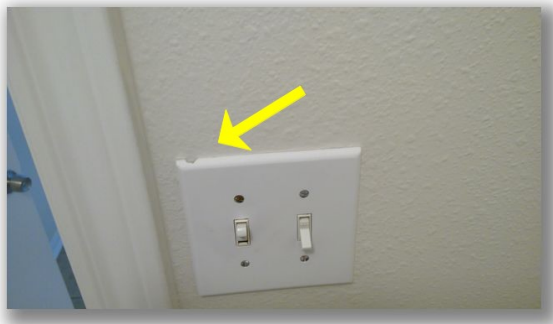
- The switch cover plate is damaged in the laundry room.

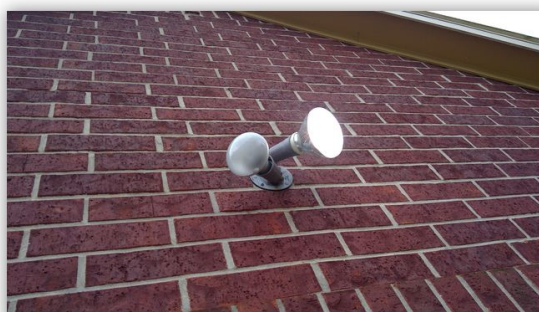
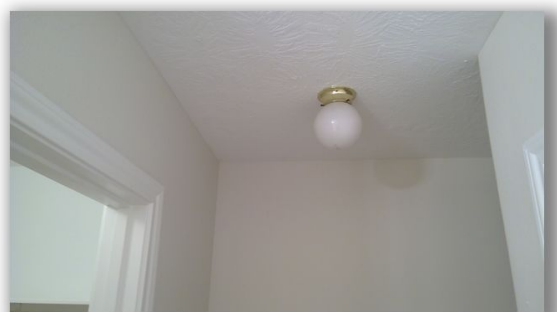
- One or more of the light fixtures appear to be inoperative in the exterior area & master bathroom. This may be due to a bad bulb or some other unknown condition. This condition should be further evaluated and corrected as necessary.

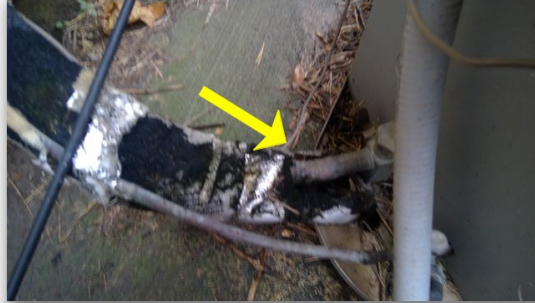
- Damaged, deteriorated and/or missing insulation on the refrigerant lines should be repaired or replaced at the outside condenser.
- The electrical service disconnect is installed behind the outside condenser/coil. This does not meet the clearance requirements of the National Electrical Code or the International Residential Code and should be corrected as necessary.

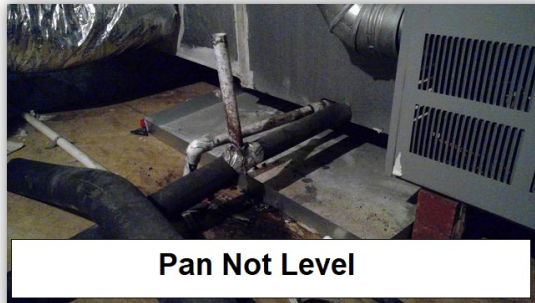
- The drain pan is not level. This may cause the drain pan to not function properly.
- There was water stain/deterioration near the drain pan on the attic floor. No active leak was observed at the time of inspection.

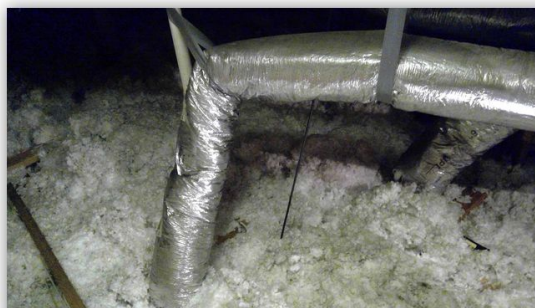
- Some of the ductwork in the attic area has been turned to sharply. This will restrict the airflow through the duct system and affect the airflow balance in some areas of the house.

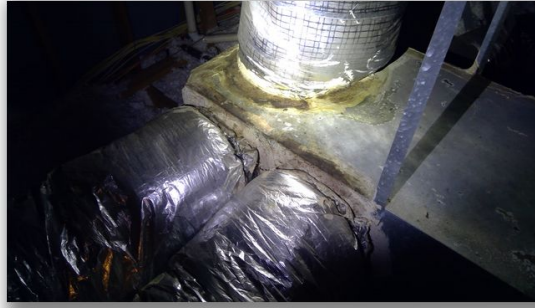
- There was an unknown dark mold like substance observed on the outer surface of the duct work. Evaluation of this substance is beyond the scope of this inspection. If any concerns exist on the type and/or nature of this substance, we recommend further evaluation by a professional in the Air Quality sampling field.

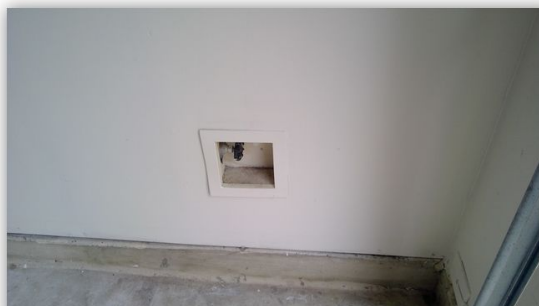
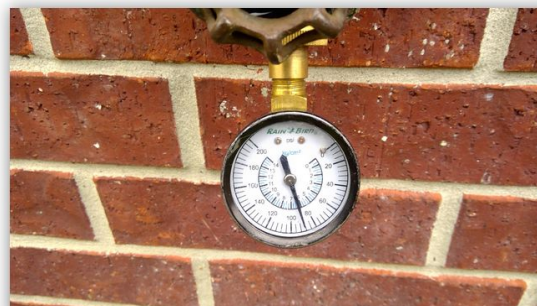
- The water pressure was observed to be above 80 psi at the time of this inspection. Under current plumbing standards the maximum water pressure should be 80 psi. This condition should be further evaluated and corrected as necessary.

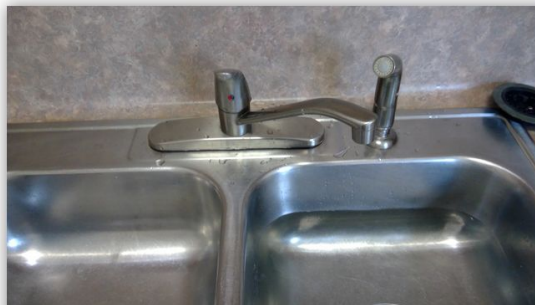
- The sprayer does not appear to be working properly.
- The faucet assembly is loose.

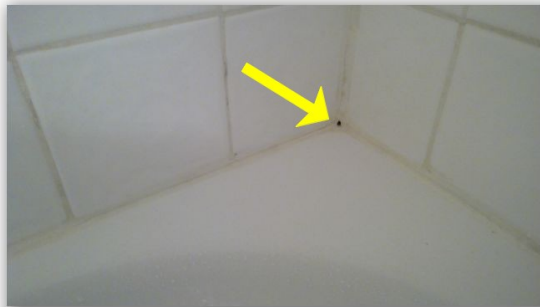
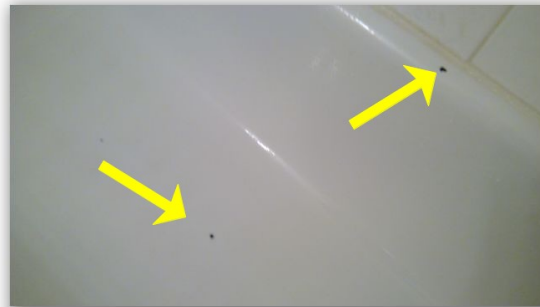
- Cracked, deteriorated and/or missing bathtub enclosure grout and/or caulking should be repaired or replaced as necessary.
- The bathtub has some surface damage.

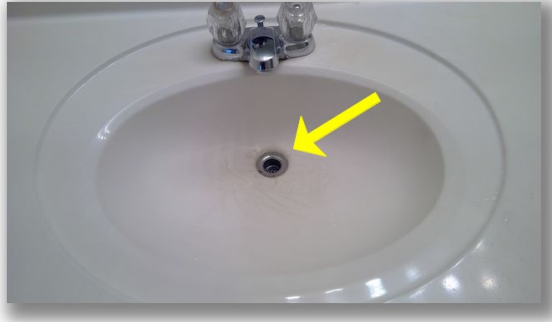
- The stopper is missing.

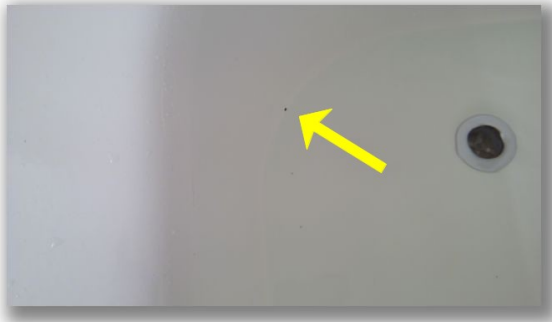
- The bathtub has some surface damage.

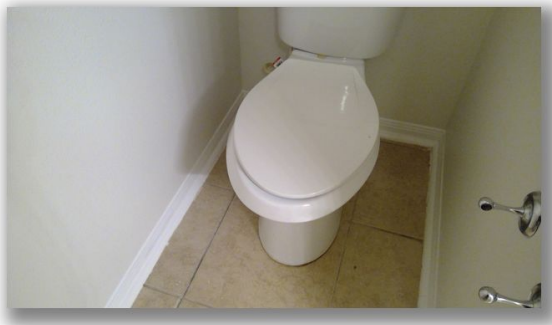
- The commode appears to be excessively loose at the floor mount. This condition should be further evaluated and corrected as necessary.

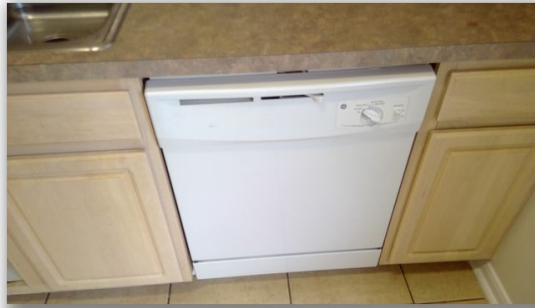
- Some rusting of the dishwasher interior components was observed.

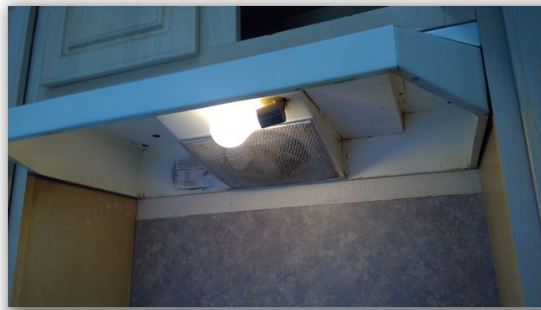
- The range hood in place is ductless. The range hood does not terminate outside and is dependent on the charcoal filter installed. It is recommended to regularly clean your filter system to prevent damage to the structure.

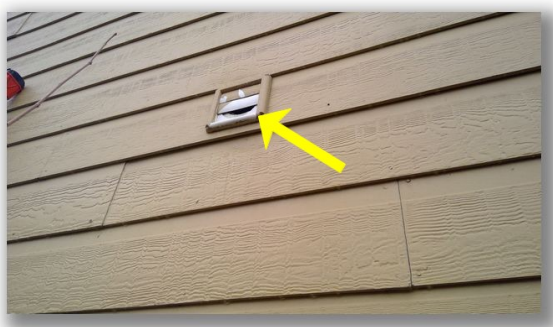
- The exterior cover to one of the mechanical exhaust systems is damaged on the right side of the structure.

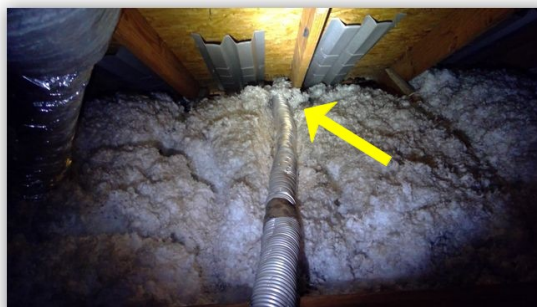
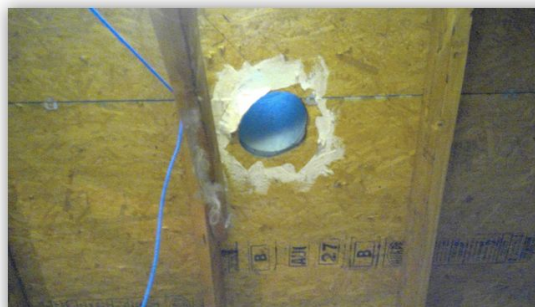
- One or more of the mechanical exhaust vent systems was observed to be terminating to the soffit / eave area. This is an "AS Built" condition that does not meet current manufacturers or mechanical installation standards.

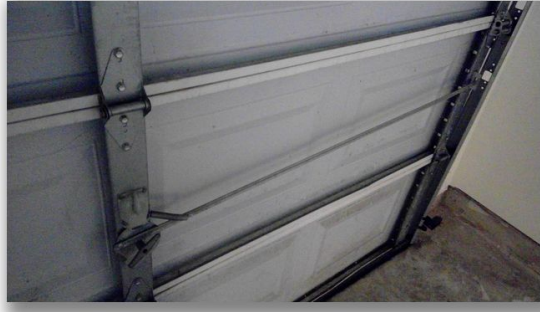
- When an automatic garage door opener is in use, the manual lock should be disabled or removed.
