Home Inspection Report

Inspection prepared for: Sample Report

Date of Inspection: 12/12/2018 Time: 12:30pm

Age of Home: 27 years Size: 2045

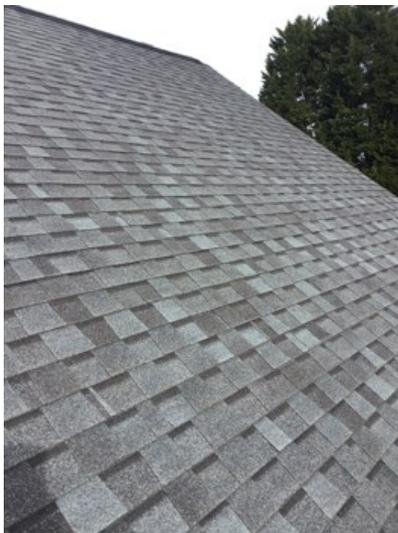
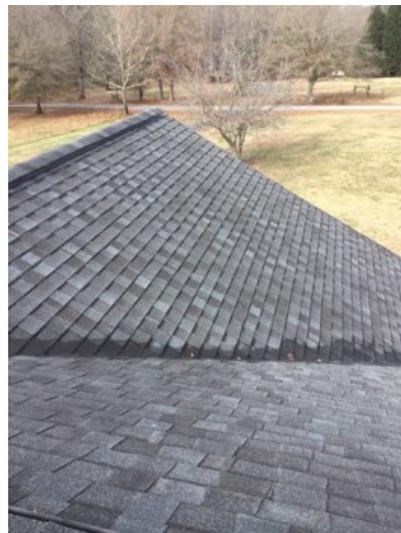
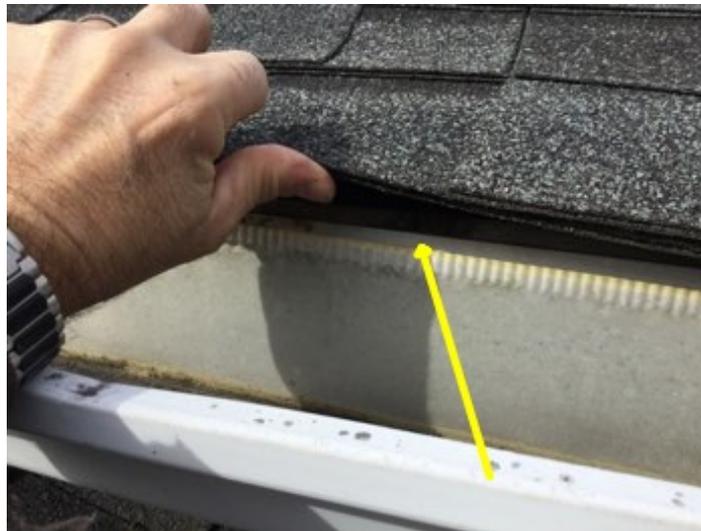
- Roof appeared serviceable at time of inspection. No prediction of future performance or warranties can be offered.
- The roof shows normal wear for its age and type.
- No **Drip edge** installed.

No Drip edge.

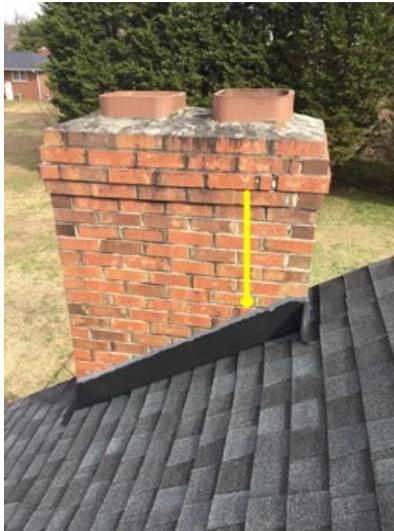
- No step flashing get on chimney, existing flashing looks in good condition.

No Step flashing.

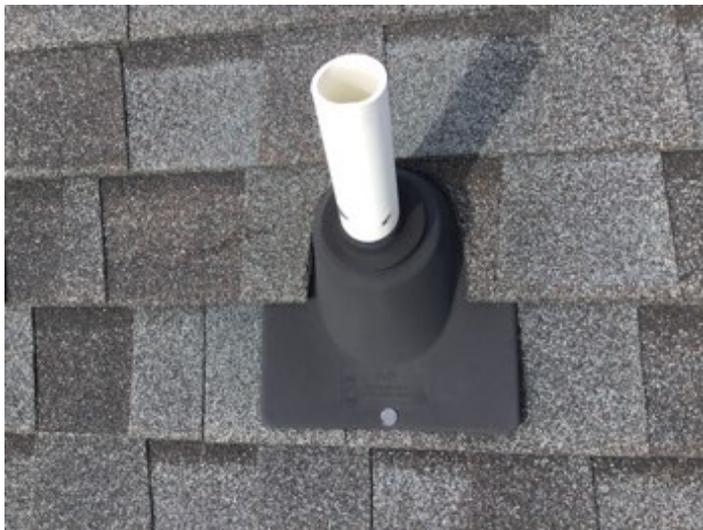
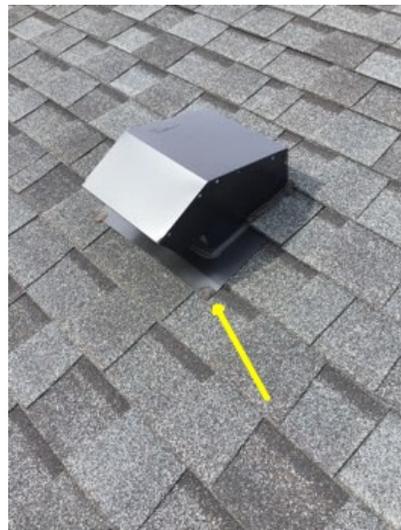
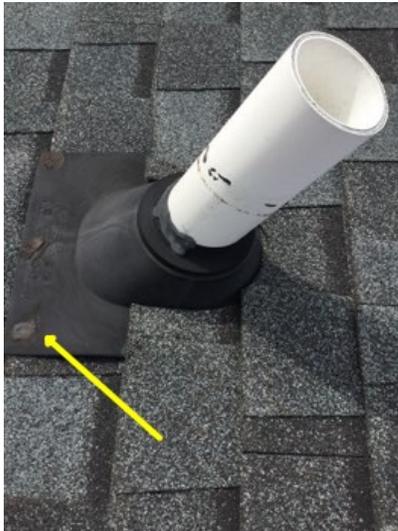
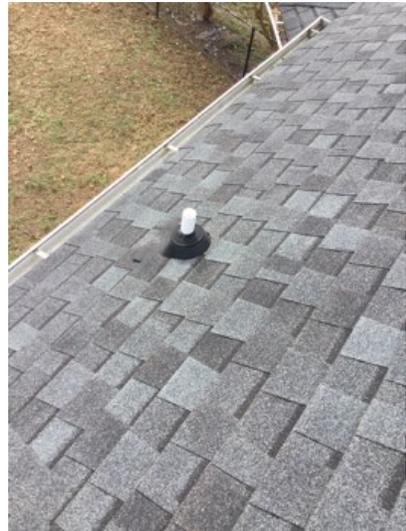
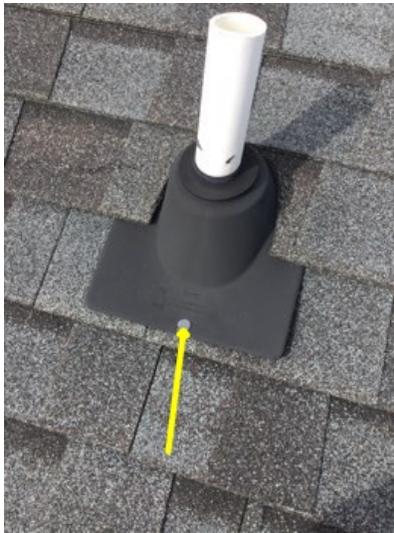
- Exposed nails on vent flashing, should be sealed with roof cement.

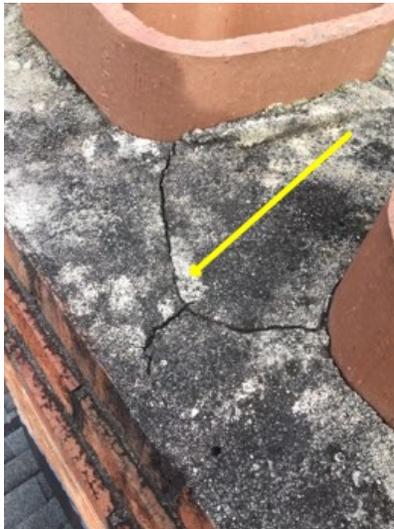
- Spark arrestor present.
- Chimney cap is crack, possible water intrusion.

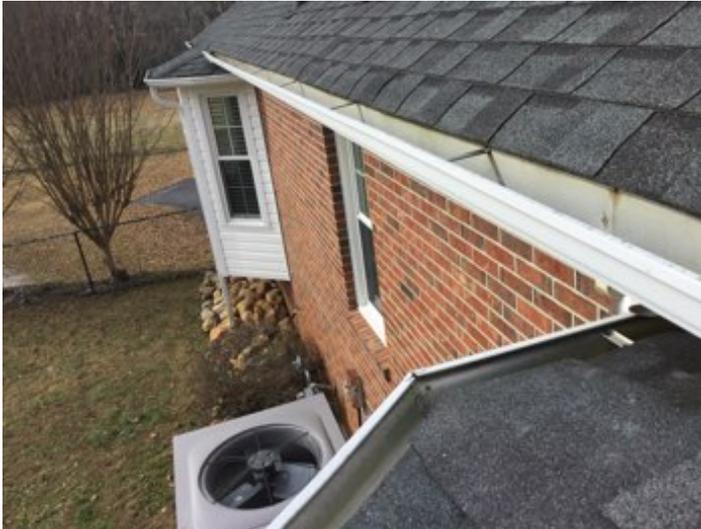
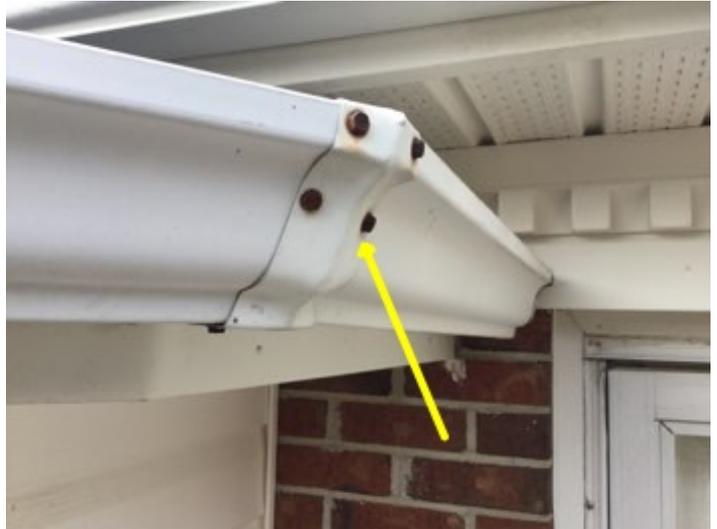
- Suggest cleaning gutters now, and as a normal part maintenance.
- **Rusting screws on some gutters. Recommend painting or replacing screws with corrosion resistant screws**

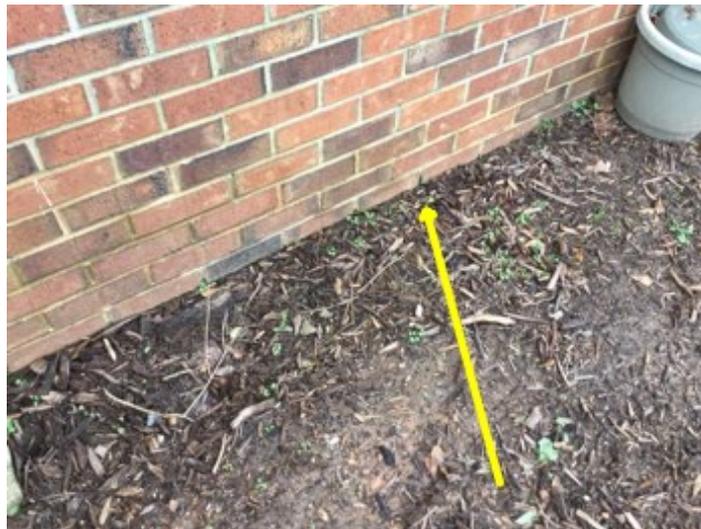
• Brick to earth contact noted. This can result in brick "spalling" or deterioration over time. Re-grading or other protection of brick is recommended.

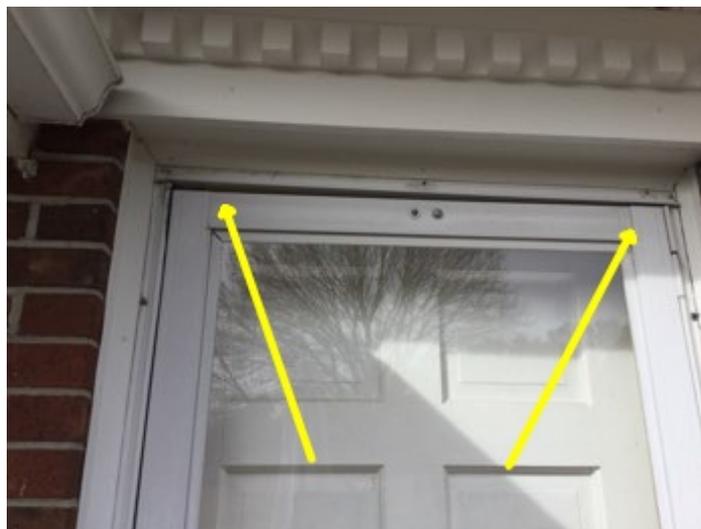
- In the inspectors opinion the rear screen door is near the end of their useful life. It is sagging towards the latch side.

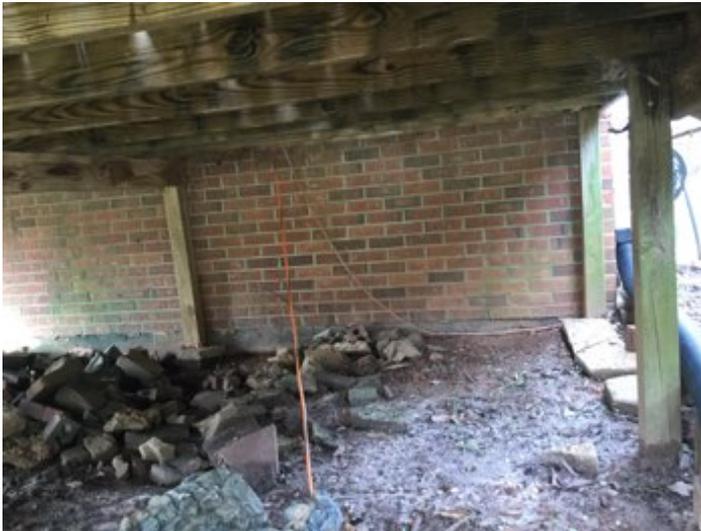
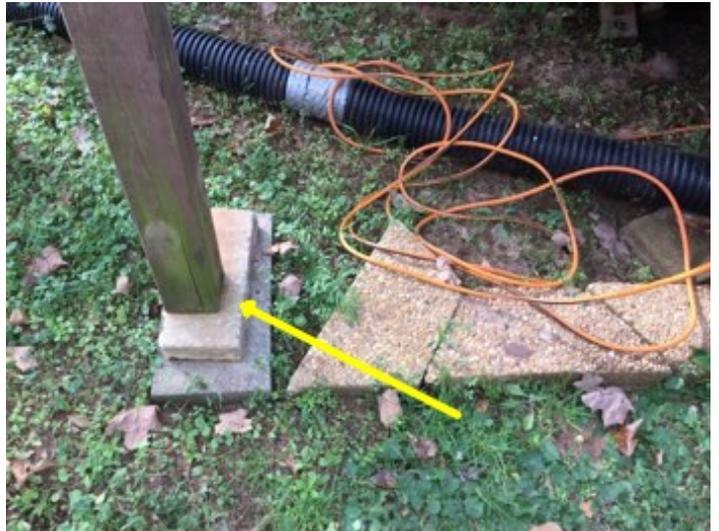
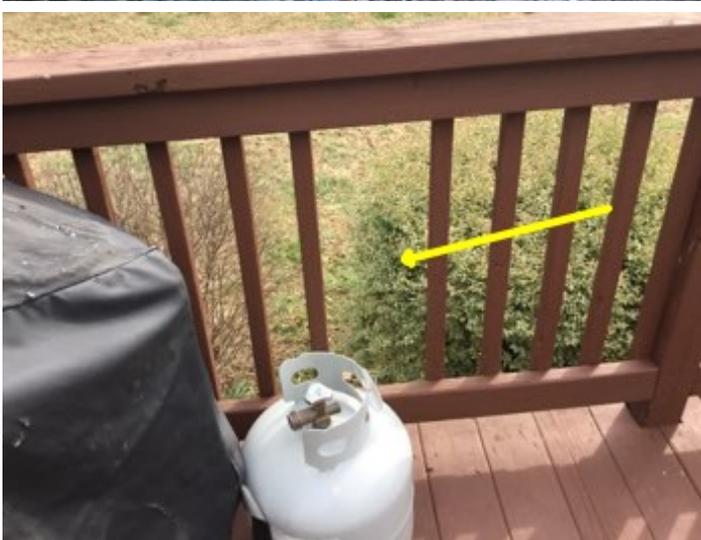
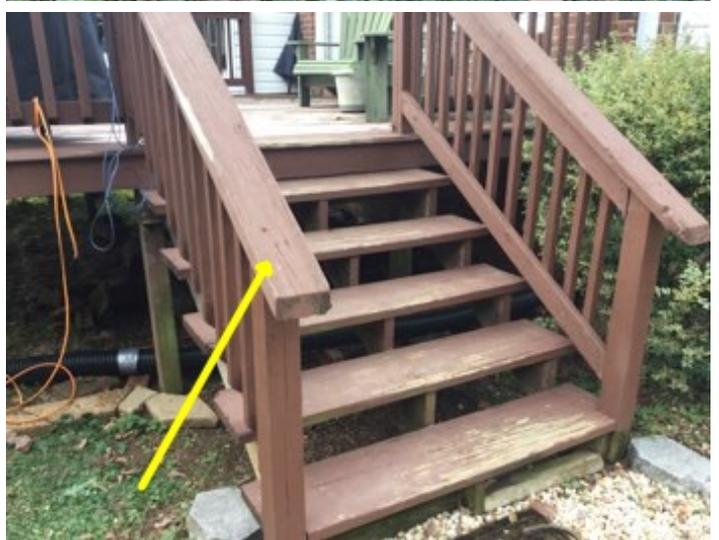
- Peeling paint observed, suggest scraping and painting as necessary.
- Improper deck piers. Support posts are not secured to piers, support posts have direct contact with soil.
- Missing baluster, install new one.
- Deck stair railings are loose and are not graspable.

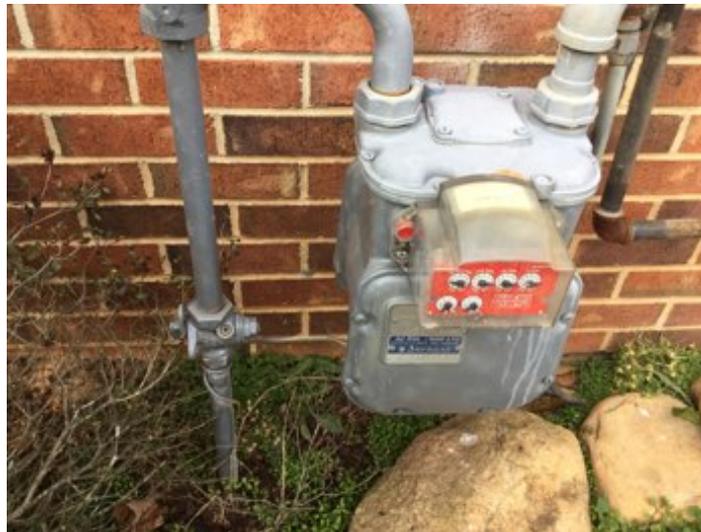
- Main fuel shutoff was located at the meter.
- Should have bush trimmed back from meter to allow access

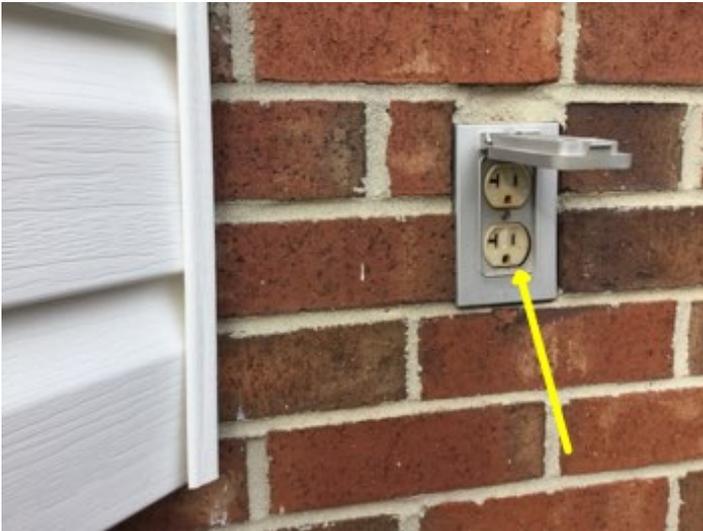
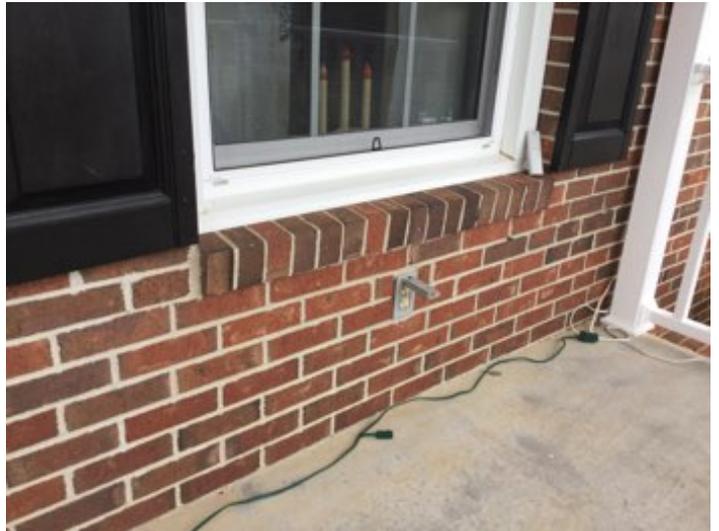
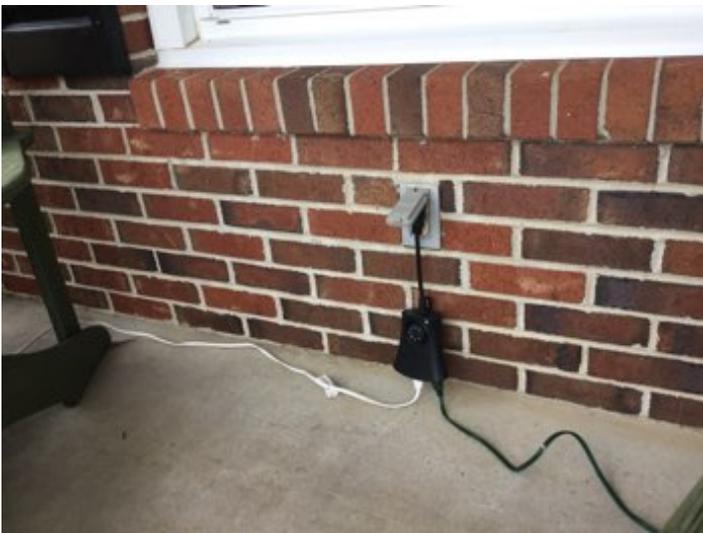
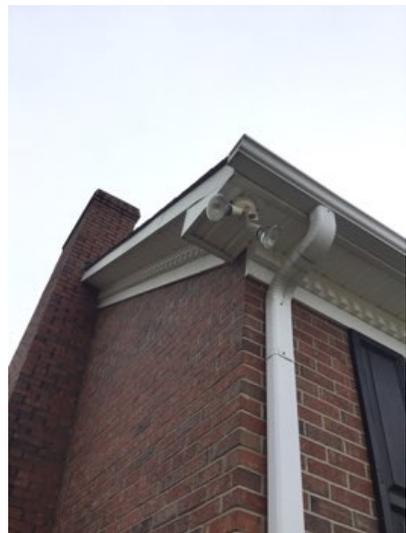
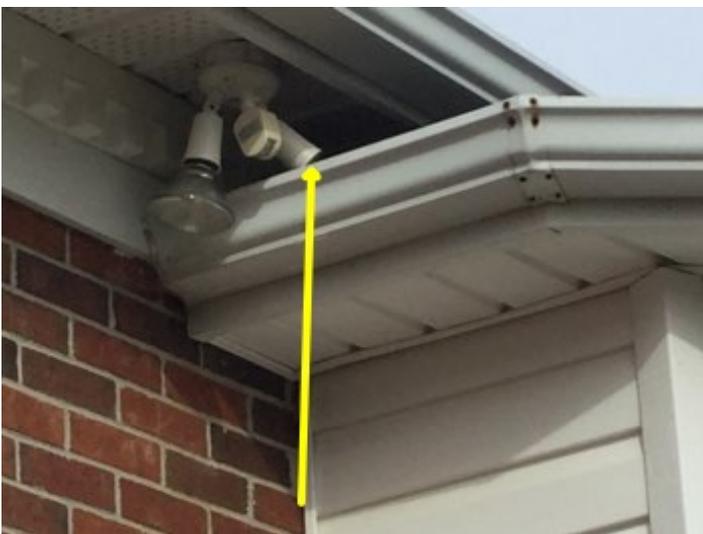
- Security lights on all 4 corners of house. Not tested due to photo cell activated.
- Extension cord running to pond. Cords are not to be buried.
- Recommend moving security light away from roof to avoid fire when bulb is installed.
- All outside outlets need to be GFCI protected. 2 front porch outlets and one rear out need to be GFCI protected.

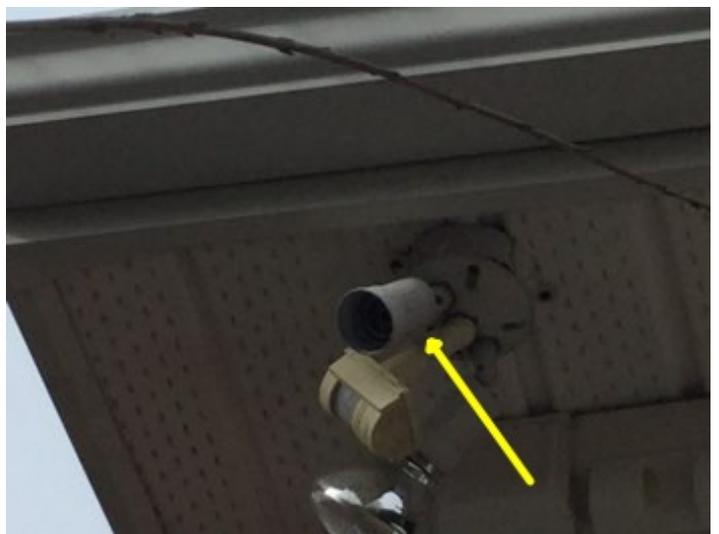
Missing bulb, recommend moving fixture so bulb will not over hang roof and possibly cause a fire.

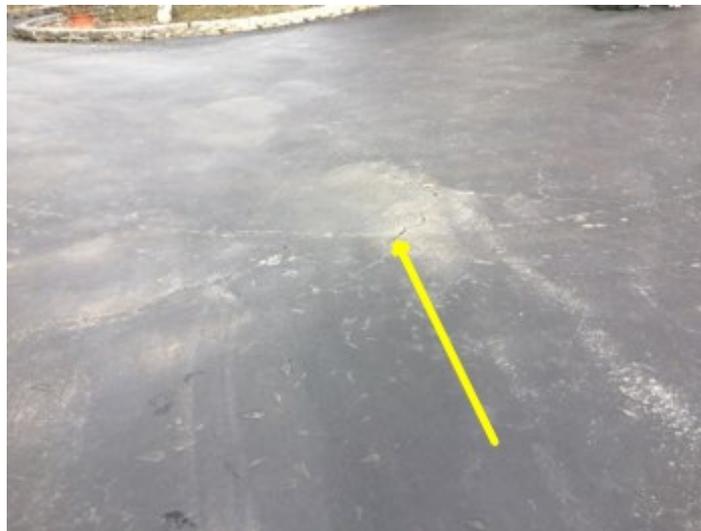
- Common cracks noted.
- Evidence of ponding observed.

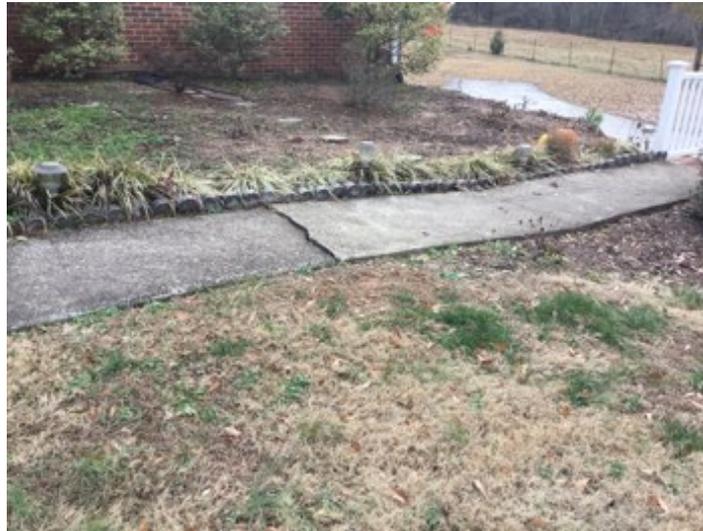
- Common cracks and heaved/settled areas observed.
- Possible trip hazard. This is a safety concern. Suggest repair/replacement as needed to ensure safety.

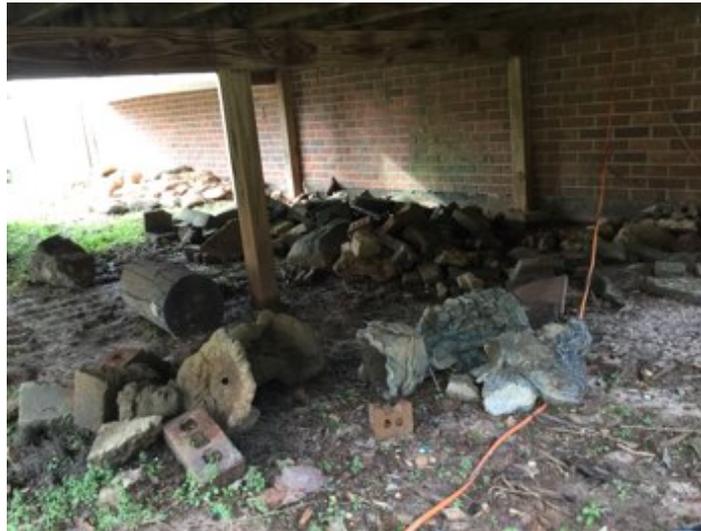
• Area under deck is pitched toward house and forms a pool along the foundation. Area should be re-graded to slope away from house. Recommend 6" drop in 10 feet.

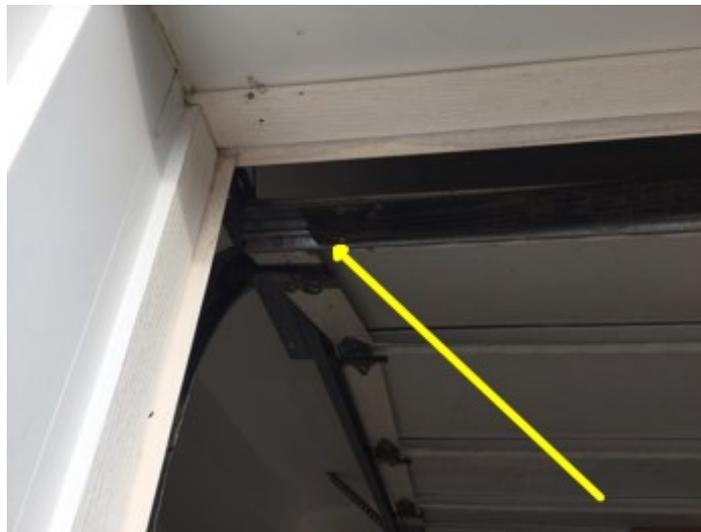
Materials: Metal, Insulated 8' doors. • Roll-up Panel.
 Observations:
 • Bottom weatherstrip is deteriorated, recommend review for repair or replacement, as necessary.

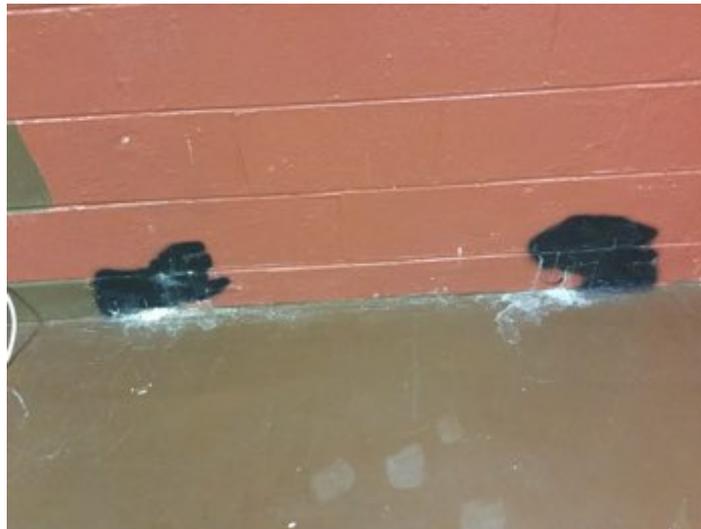
• Efflorescence observed; this is a mineral deposit left behind from exterior water infiltration.

• Active leaks observed at the time of inspection. This area is directly inside of the poor grading under the deck.

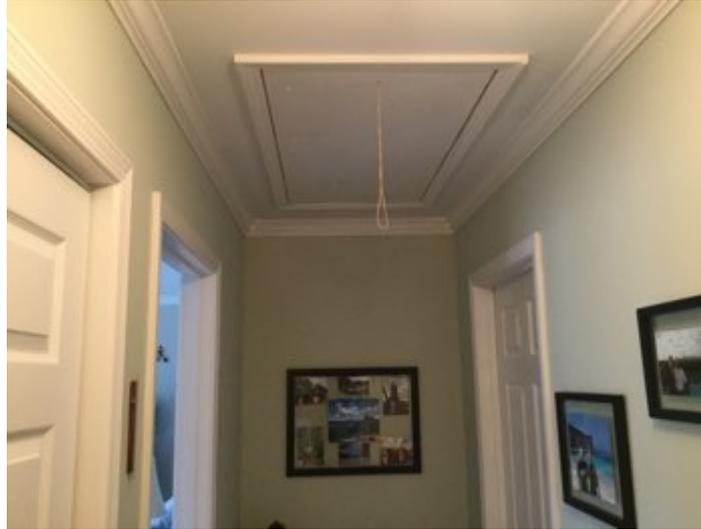
- No insulation on attic access.

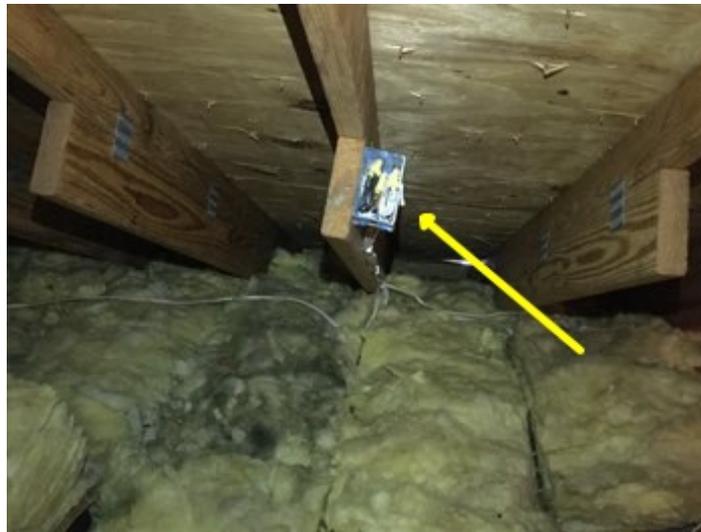
Observations:
 • **Open junction boxes were observed, which is a safety concern. Recommend installing proper covers, as needed, for safety.**

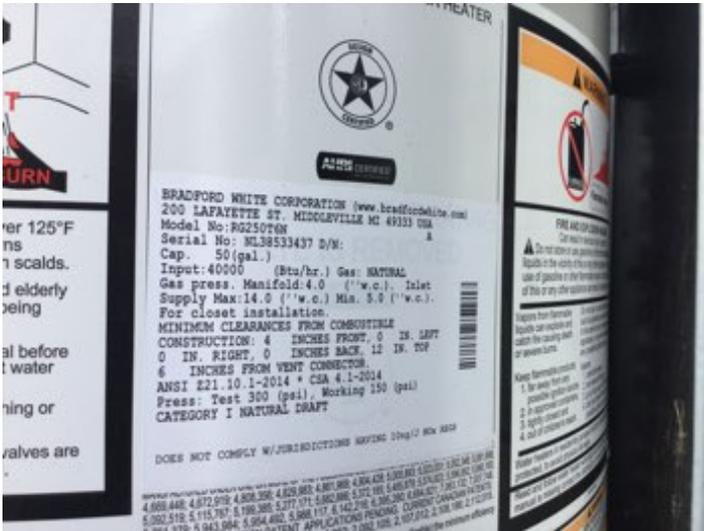
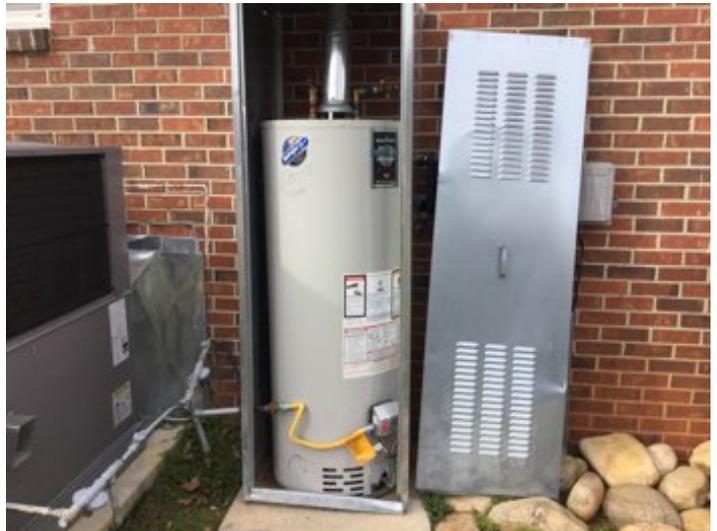
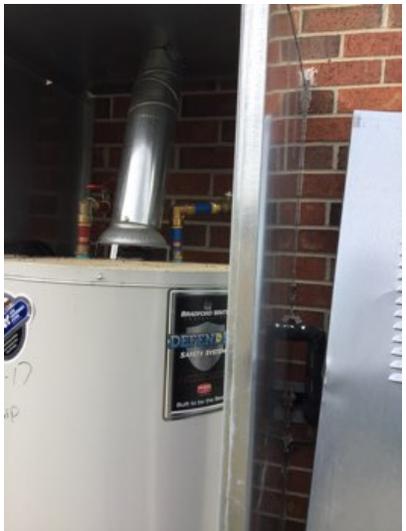
- Water heater is located outside on back of house in a stainless steel enclosure

- There is a shut off valve on the hot water side. This is not allowed. Must be removed.
- Hot/cold water lines are reversed, this condition will cause the water heater to function improperly. Corrections are needed by a licensed plumbing contractor.

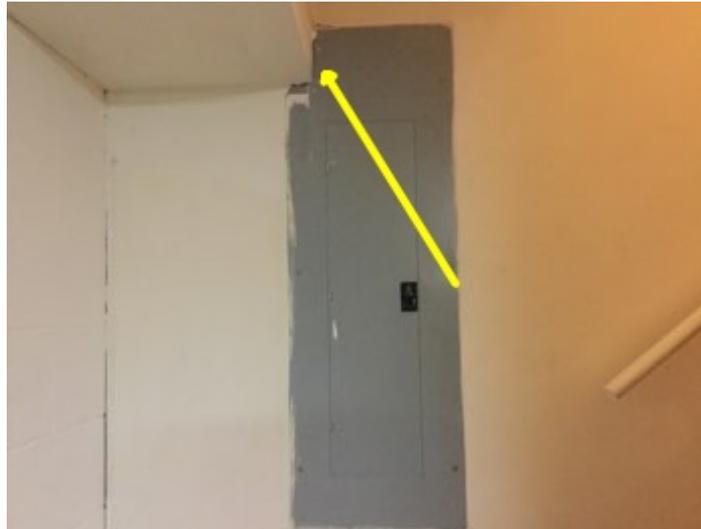
Inspect ed	Not Inspect ed	None	Materials: Breakers. • Service Entrance cables are aluminium. Materials: Basement. Observations: • Panel cover removal is restricted due to soffit framing
<input checked="" type="checkbox"/>	<input type="checkbox"/>	<input type="checkbox"/>

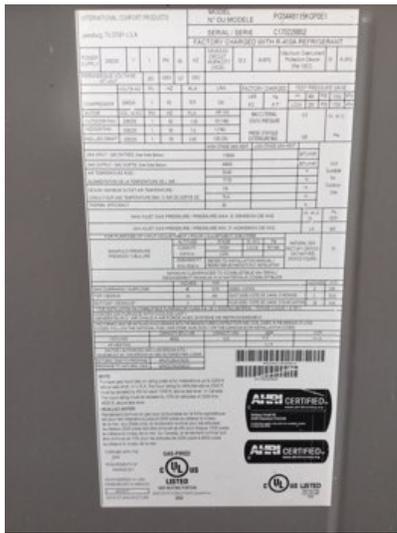
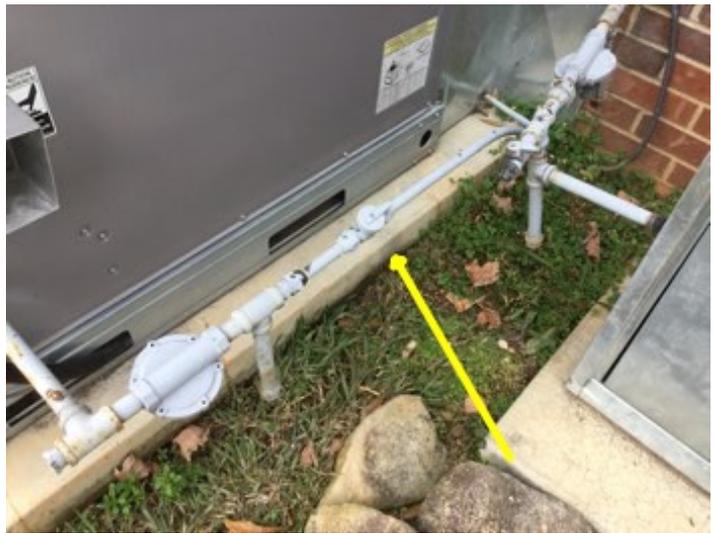
Observations:
 • Temperature at Register...112 degrees
 • Temperature at cold air return...71 degrees

Gas shut off for furnace.

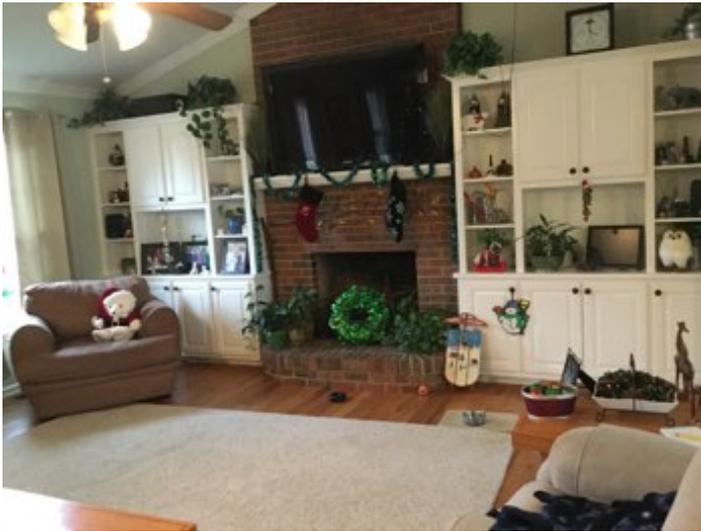
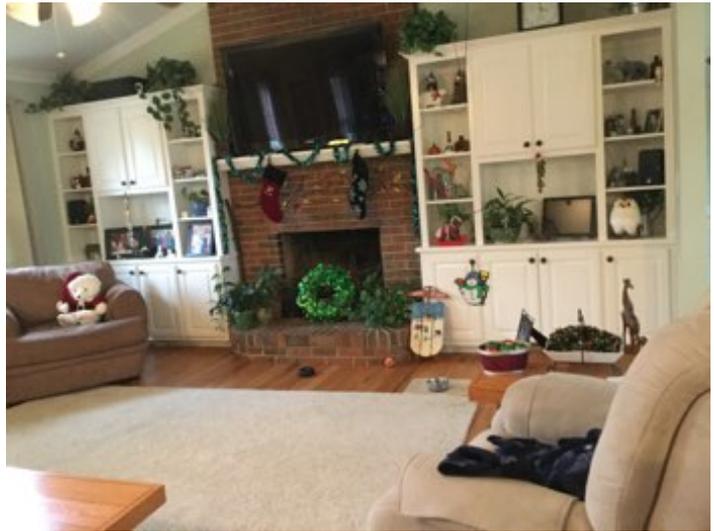
- Recommend further review and cleaning by a qualified professional prior to use.

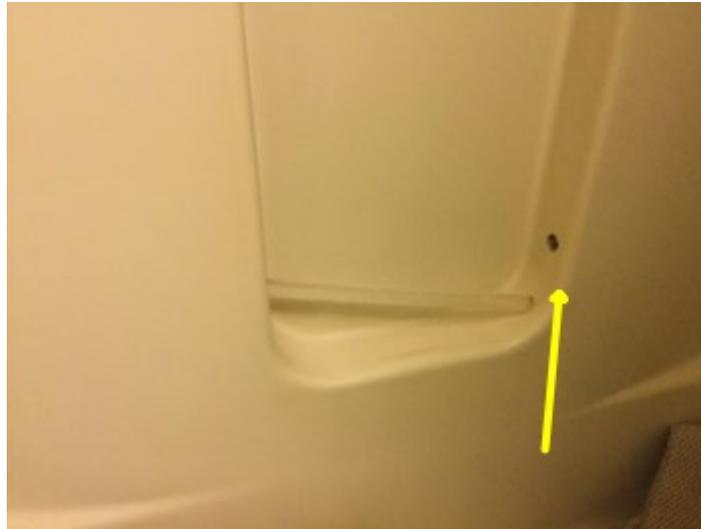
Materials: Fiberglass
 Observations:
 • Broken hand grip.

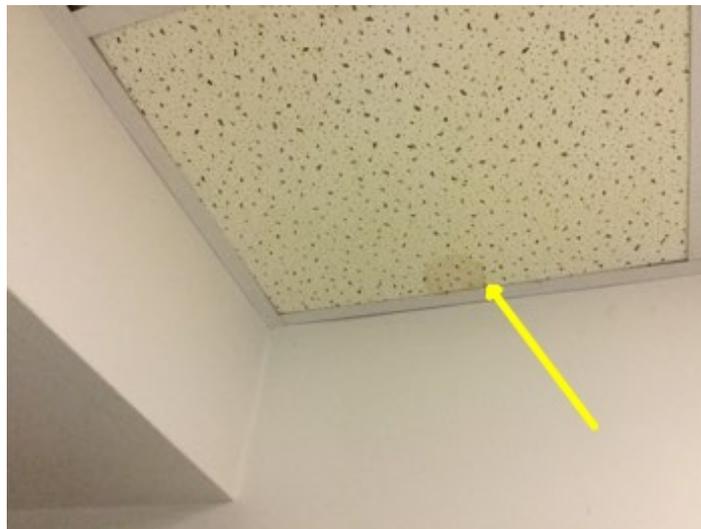
- Drop ceiling has water stain
