INSPECTION REPORT
1234 Nowhere Lane
Nowhere VA 55555

INSPECTED BY
Brad Gunden
All Star Home
Inspection Services
3380001654

INSPECTION DATE
📅 4/13/2020
🕒 09:00 AM

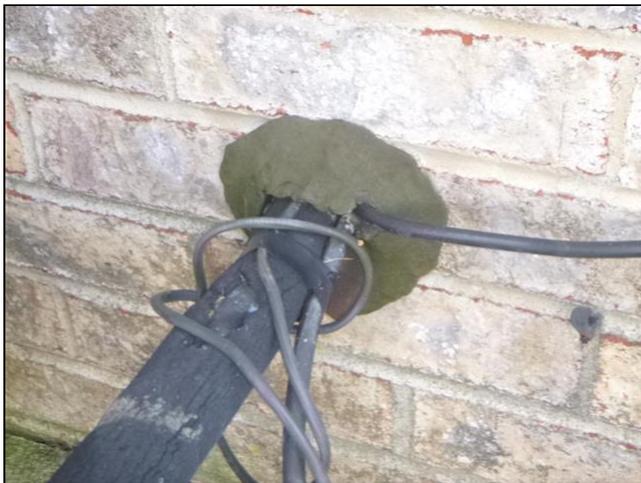
2.0 Item 1(Picture)

Seal around old HVAC line into house is cracked and dry rotted. Recommend re-sealing entry point to minimize moisture intrusion behind brick and into exterior wall.

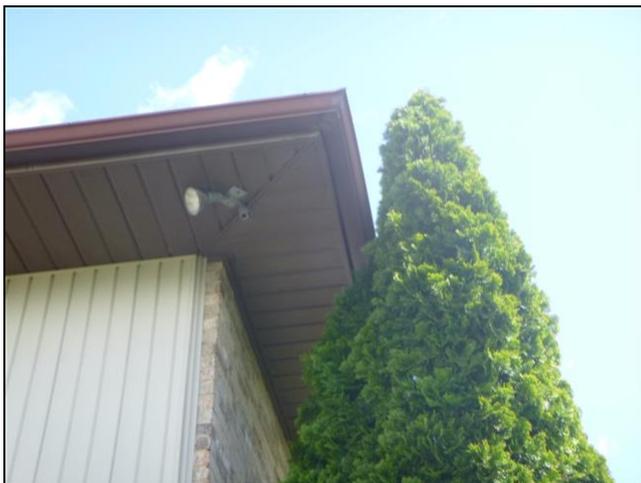
2.4 Item 1(Picture)

Recommend trimming trees back from home to minimize moisture and debris from damaging exterior brick, foundation and guttering.

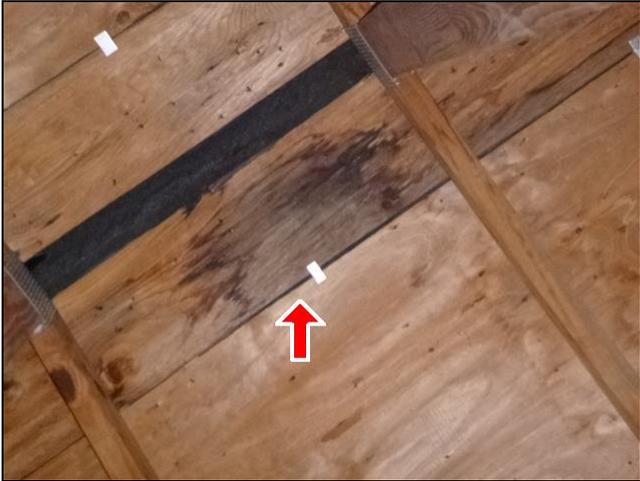
3.0 Old moisture staining in attic on roof sheathing above scuttle hole. Stain is not currently wet and no active leak noted. Monitor after rain to assure that no new moisture is entering.

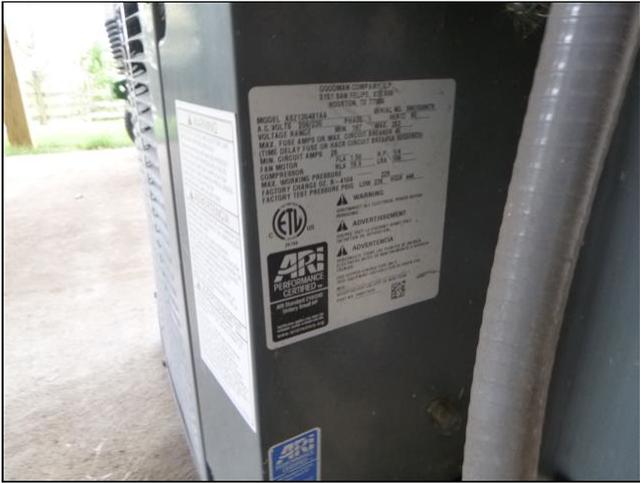
4.0 Data plate on exterior heat pump unit. Photo for informational purposes only. Unit is functioning properly.

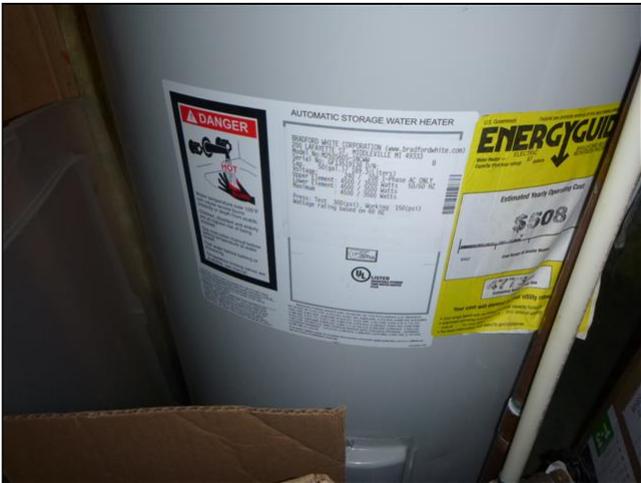
5.0 Data plate on water heater. For informational purposes only. Unit is functioning properly.

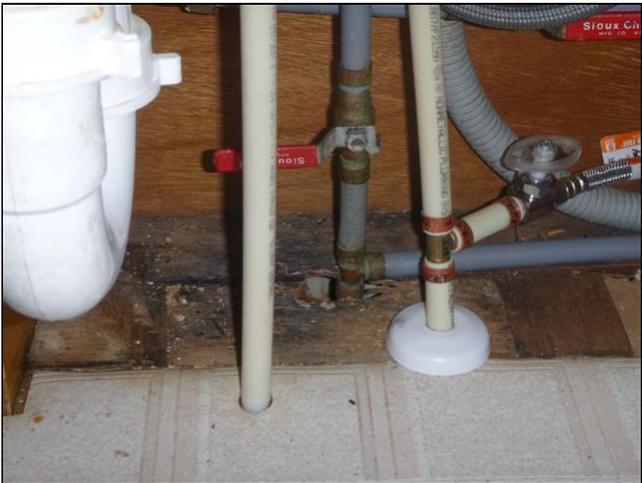
5.1 Old moisture staining noted under kitchen sink. Not currently wet nor any active leak noted.

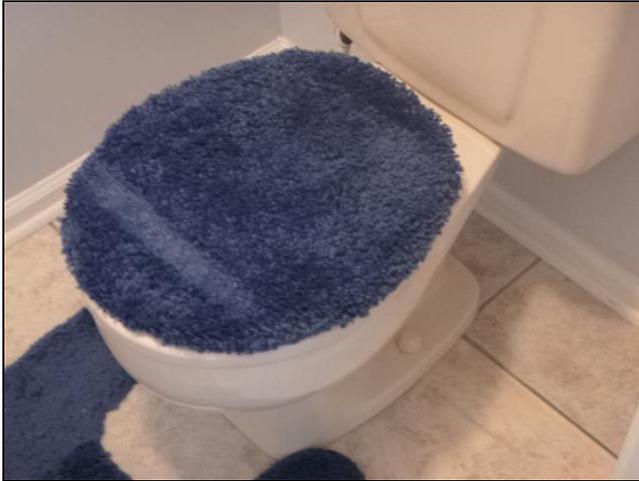
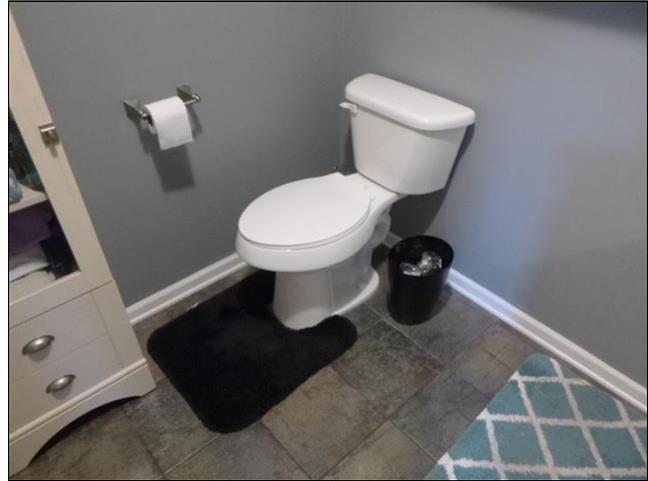
5.1 Item 1(Picture)

Upsairs half bath toilet and basement toilet are loose at the floor. No moisture or active leaks noted. Recommend tightening to the floor to minimize risk of future leaking and water damage.

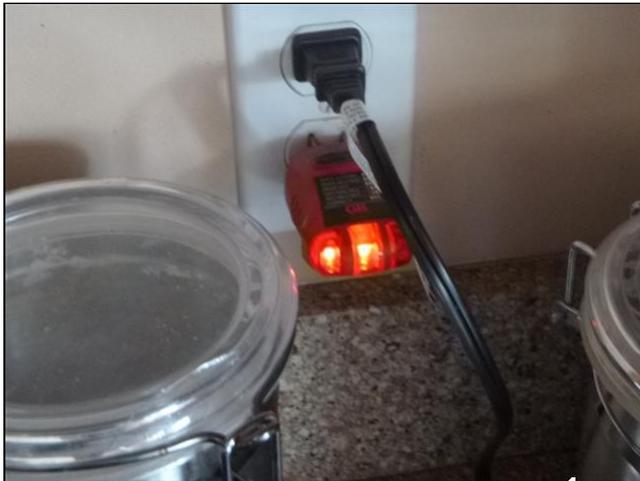
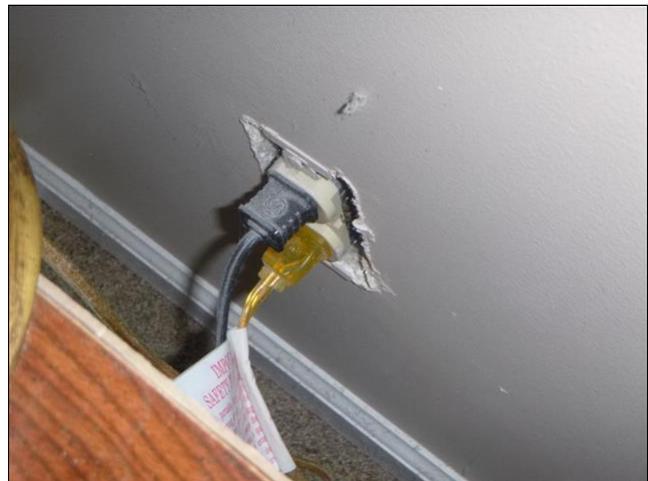
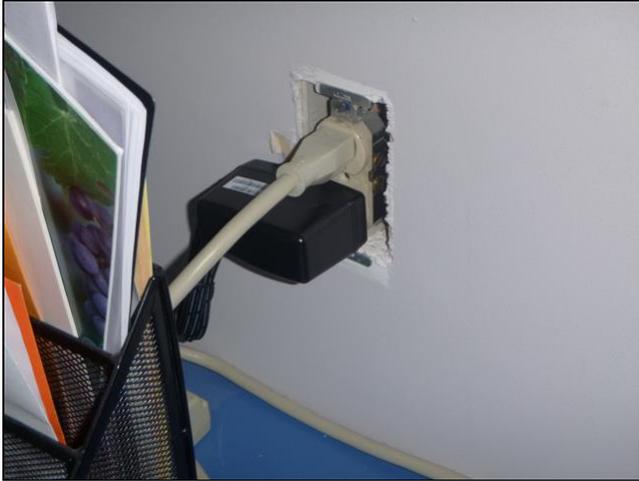
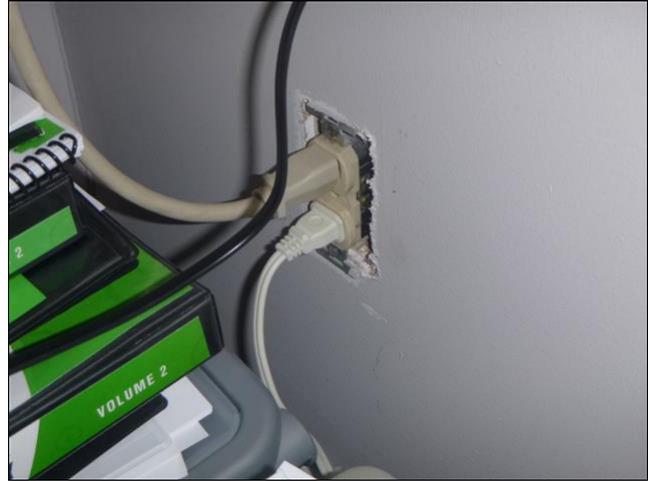
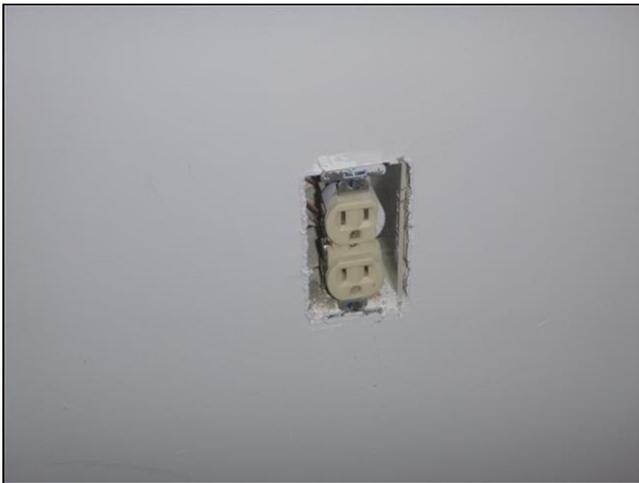
6.4 Item 1(Picture)

Outlet at kitchen counter and outlets in basement have reverse polarity. Recommend a certified electrician to look over electrical system and make corrections as needed.

No GFCI outlets or breakers are noted in the home. GFCI outlets should be installed in any area that is near a water source, like around the kitchen counter tops, bathrooms, wash rooms and all exterior outlets. Recommend a certified electrician to look over the electrical system and possibly install GFCI outlets or breakers for safety purposes.

A number of outlets in upstairs master bedroom and office do not have covers. Recommend installing outlet covers for safety purposes.

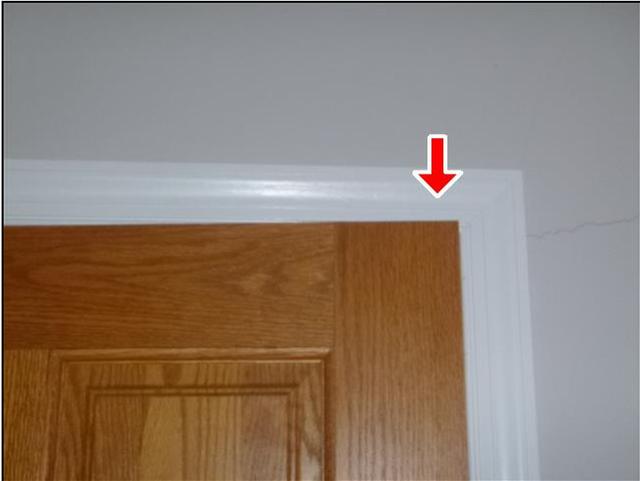
8.0 Office door does not close properly. This is due to normal settling of home which caused the door jamb to shift. No danger or underlying issues noted, but door will likely not ever close unless repairs are made.

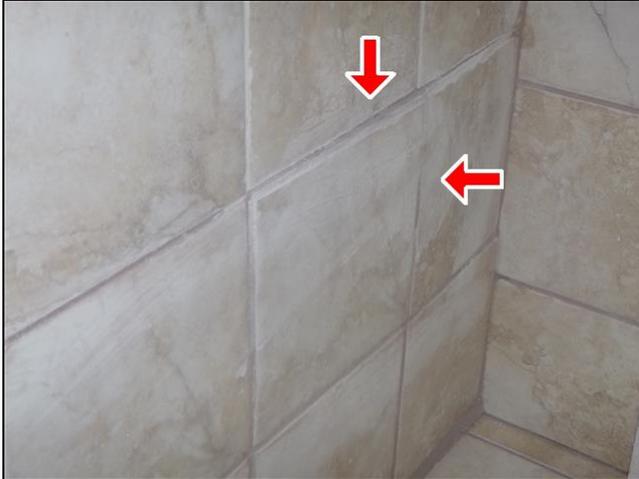
8.1 Item 1(Picture)

Tile is loose on tub surround. Recommend repair to minimize moisture intrusion which will cause more tiles to loosen and eventually fall off. No current moisture was detected in the area.

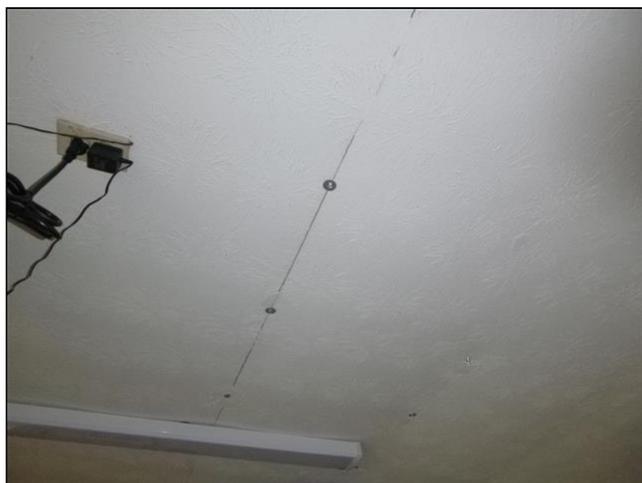
9.0 Cracking noted in garage ceiling due to normal settling and temperature change. Temporary repairs seem to have been made. No danger or underlying problems, but recommend monitoring to assure no future structural damage is noted.

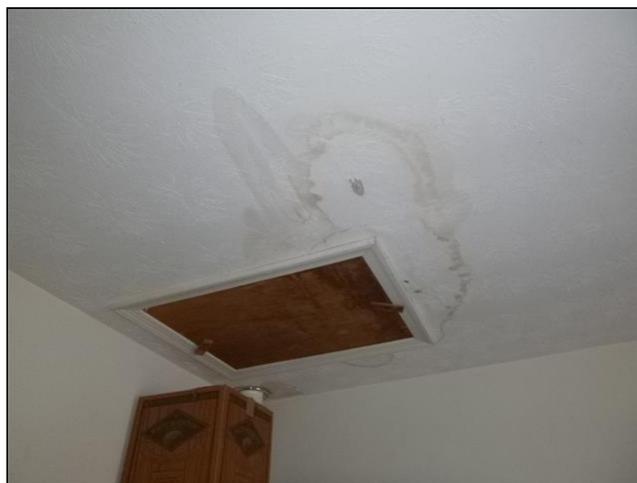
9.1 Old moisture staining was noted on ceiling of garage next to attic access hole. Staining was likely caused by the old leak in the attic (noted above in report.) Not currently wet nor any active leak was noted. Monitor to assure no additional moisture intrusion is present in the future.

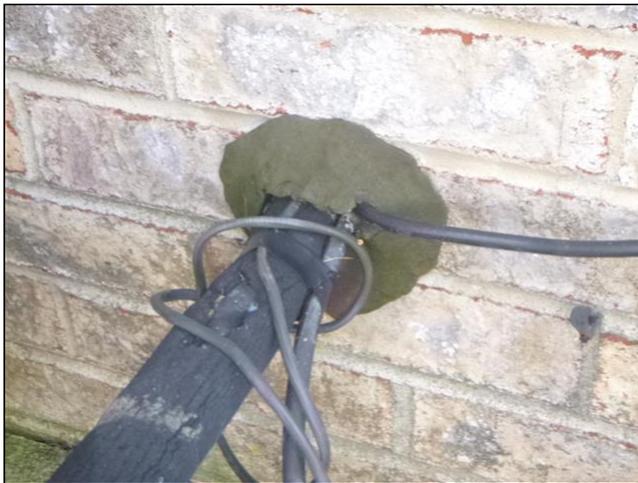
2.0 Item 1(Picture)

Seal around old HVAC line into house is cracked and dry rotted. Recommend re-sealing entry point to minimize moisture intrusion behind brick and into exterior wall.

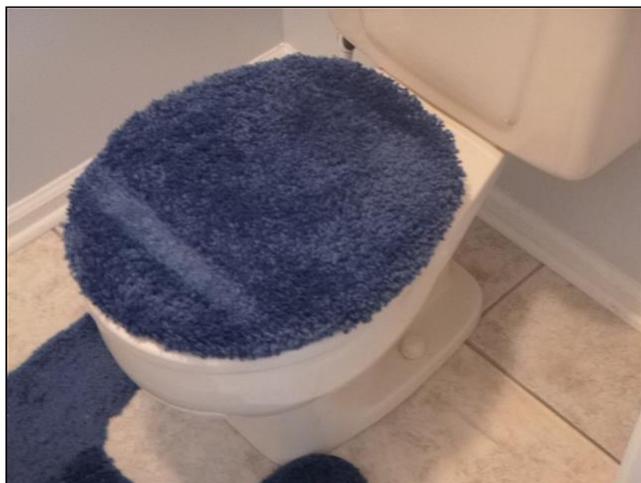
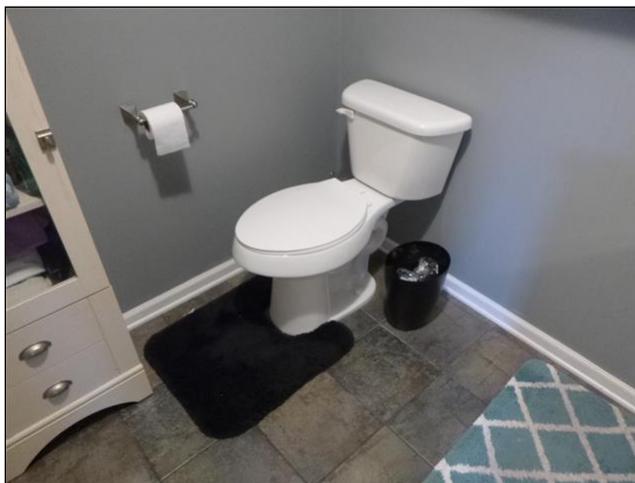
5.1 Item 1(Picture)

Upsairs half bath toilet and basement toilet are loose at the floor. No moisture or active leaks noted. Recommend tightening to the floor to minimize risk of future leaking and water damage.

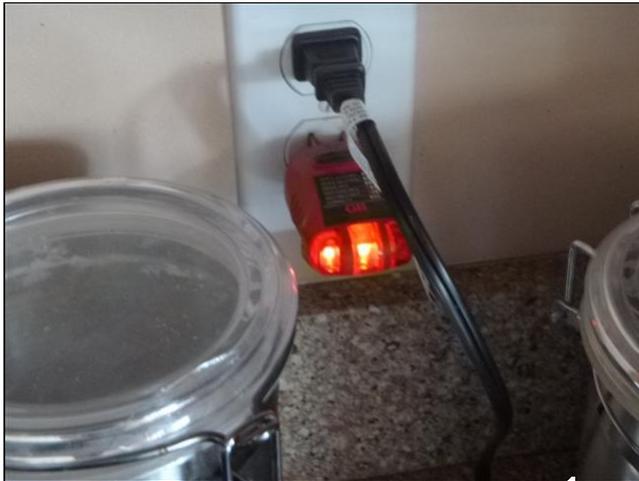
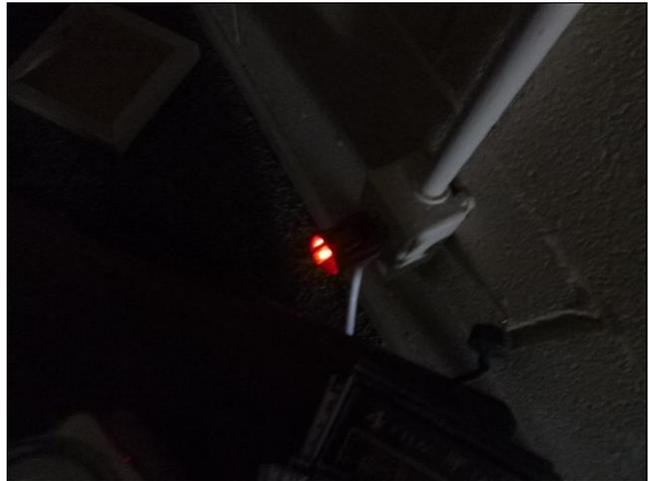
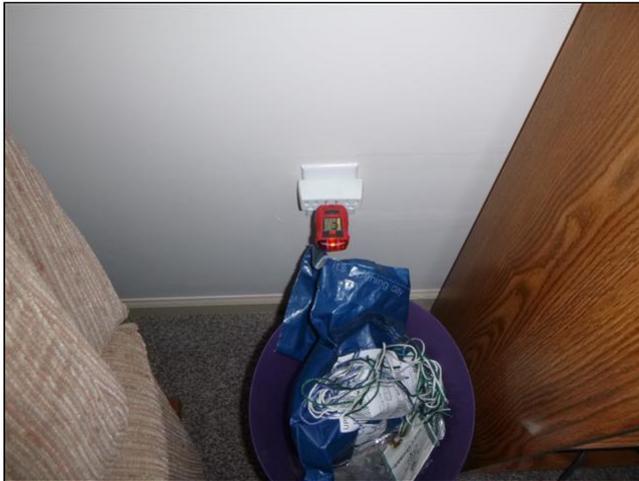
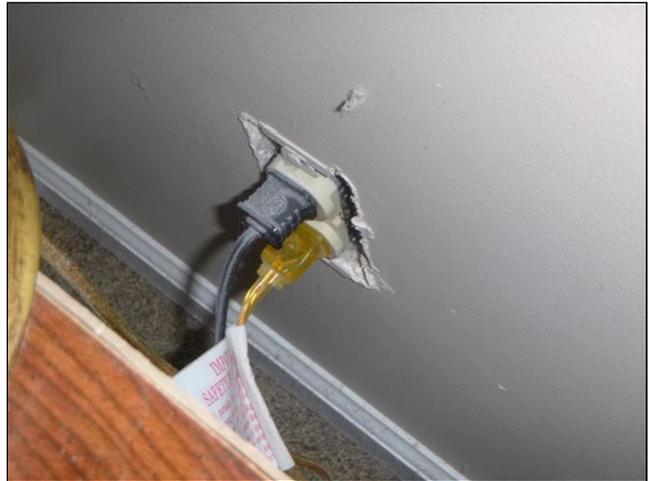
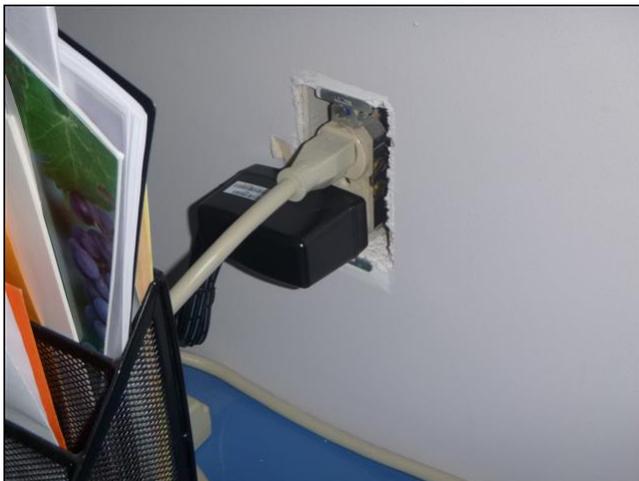
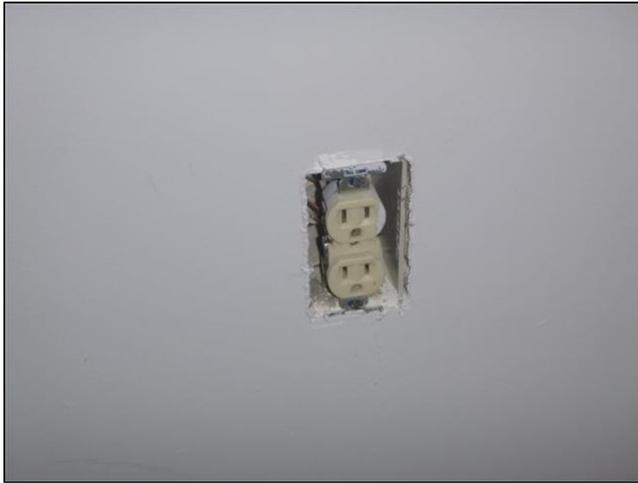
6.4 Item 1(Picture)

Outlet at kitchen counter and outlets in basement have reverse polarity. Recommend a certified electrician to look over electrical system and make corrections as needed.

No GFCI outlets or breakers are noted in the home. GFCI outlets should be installed in any area that is near a water source, like around the kitchen counter tops, bathrooms, wash rooms and all exterior outlets. Recommend a certified electrician to look over the electrical system and possibly install GFCI outlets or breakers for safety purposes.

A number of outlets in upstairs master bedroom and office do not have covers. Recommend installing outlet covers for safety purposes.

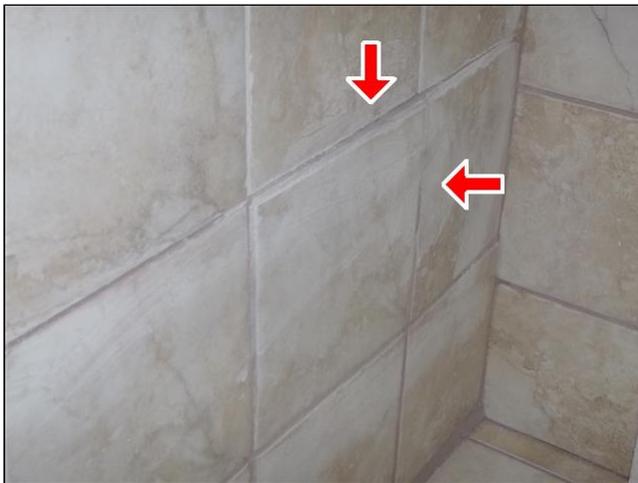
8.1 Item 1(Picture)

Tile is loose on tub surround. Recommend repair to minimize moisture intrusion which will cause more tiles to loosen and eventually fall off. No current moisture was detected in the area.
