Gully Erosion Study – Rangeland Pastures

Summary Report

Upper Walnut/El Dorado Lake Watershed Restoration and Protection Strategy (WRAPS)

Project Number: 2015-W071

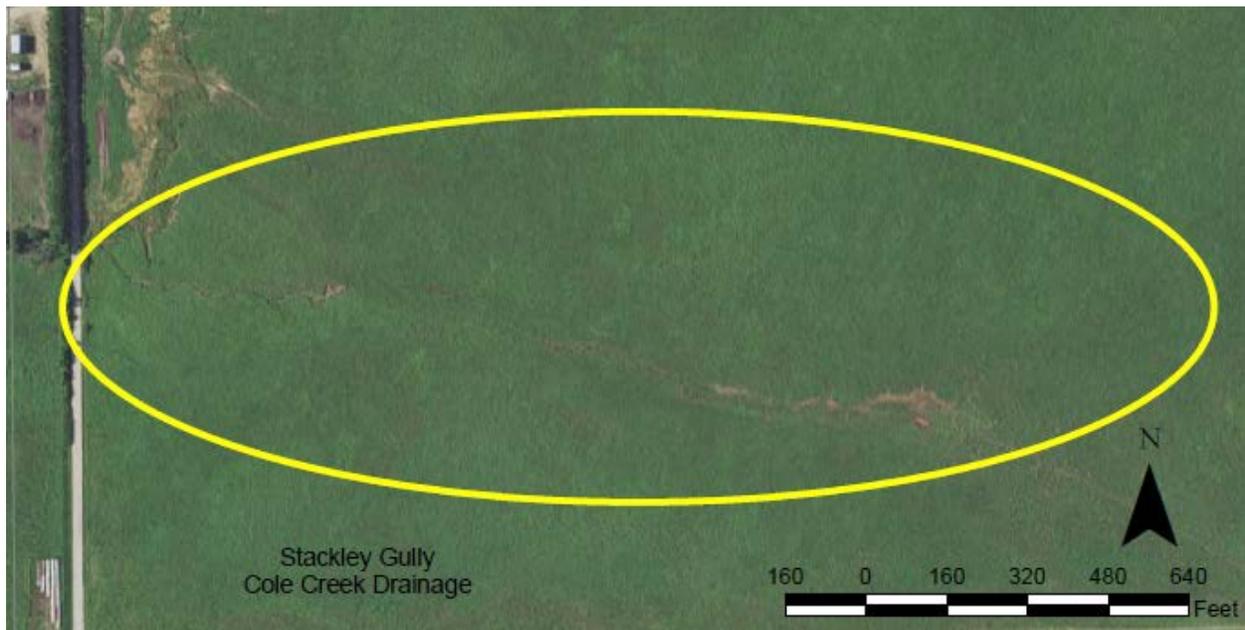
Cole Creek Gully

The gully surveyed in the Cole Creek drainage area was determined by the Soil and Water Assessment Tool (SWAT) model to be in a high priority area for sediment and nutrient runoff. The soil type of the field where the gully is located is Irwin silty clay loam, 1-3% slope and Labette silty clay loam, 3-7% slope. The operator uses this pasture for calving. Cattle are taken off in early summer to allow grass regrowth; cows are put in the pasture in late fall for anticipated calving in early spring (March-May). The past two summers, we have had above average rainfall in the grazing months as well as in late summer allowing a surge of regrowth in the pastures. It was difficult to walk in the pasture in 2017 as we surveyed because there was so much grass and it was even hard to find the gully in spots because of the dense grass growth. The gully length is approximately 1,920 feet long.

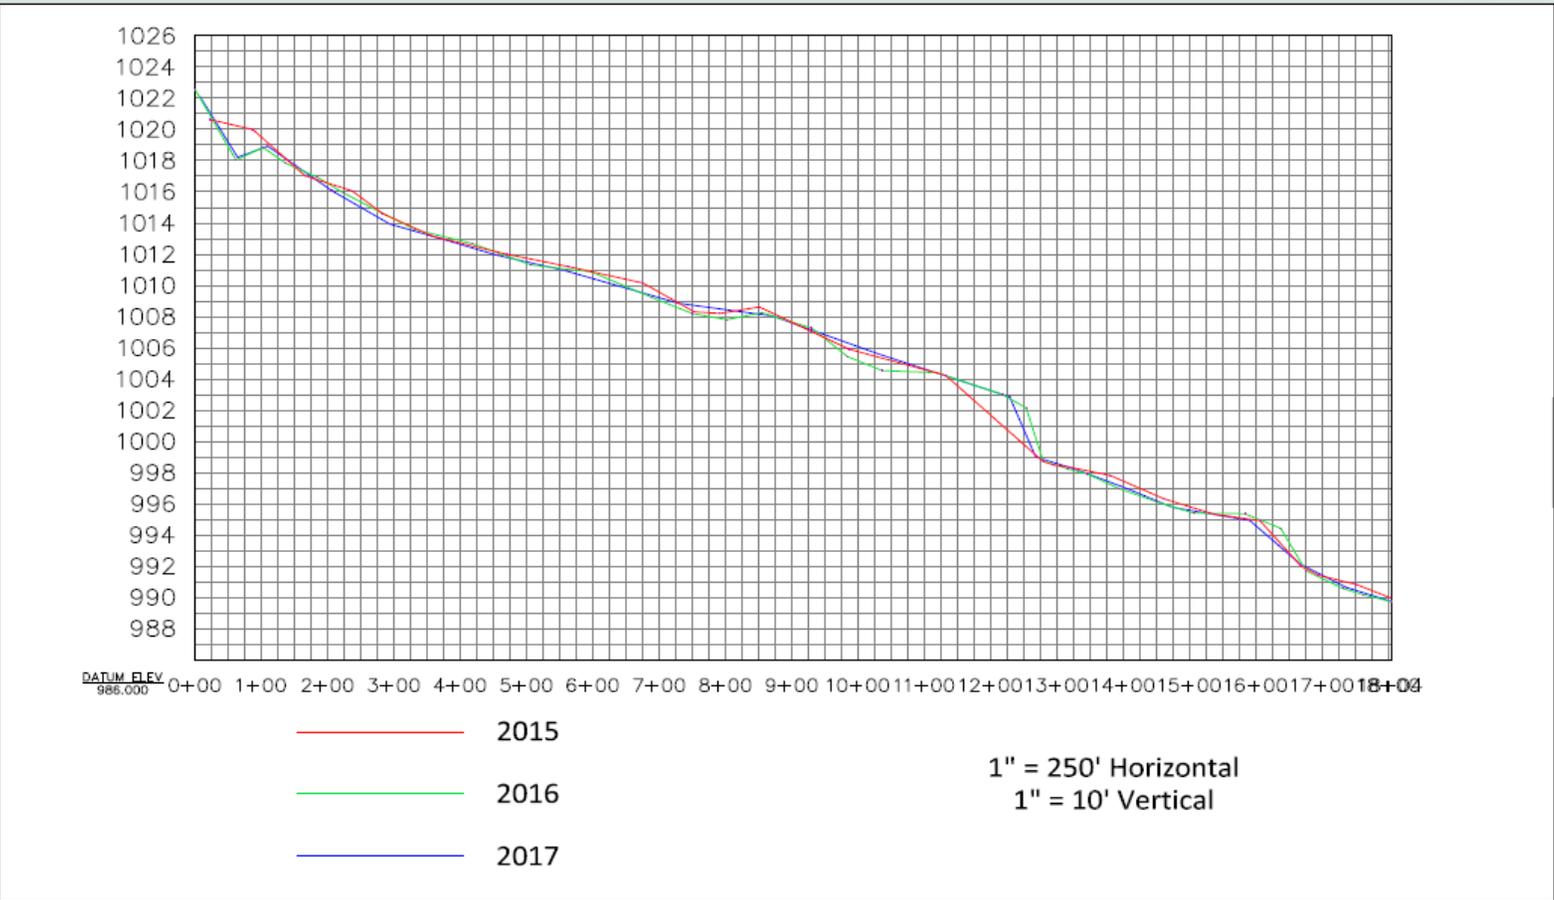
Stackley Gully
Butler County, Kansas
Longitudinal Profile

The Longitudinal Profile below shows the survey data collected in 2015, 2016 and 2017. It was noted that cattle tended to walk along the gully leaving trails next to the gully which could increase erosion in these areas due to the bare spots left by the cattle trails. It appeared (and was verified by the landowner) cattle also liked to “muck” in areas of the gully that held water for longer periods of time causing some areas to erode due to the instability of the soil caused by cattle hooves. Overall, though, this gully was fairly stable.

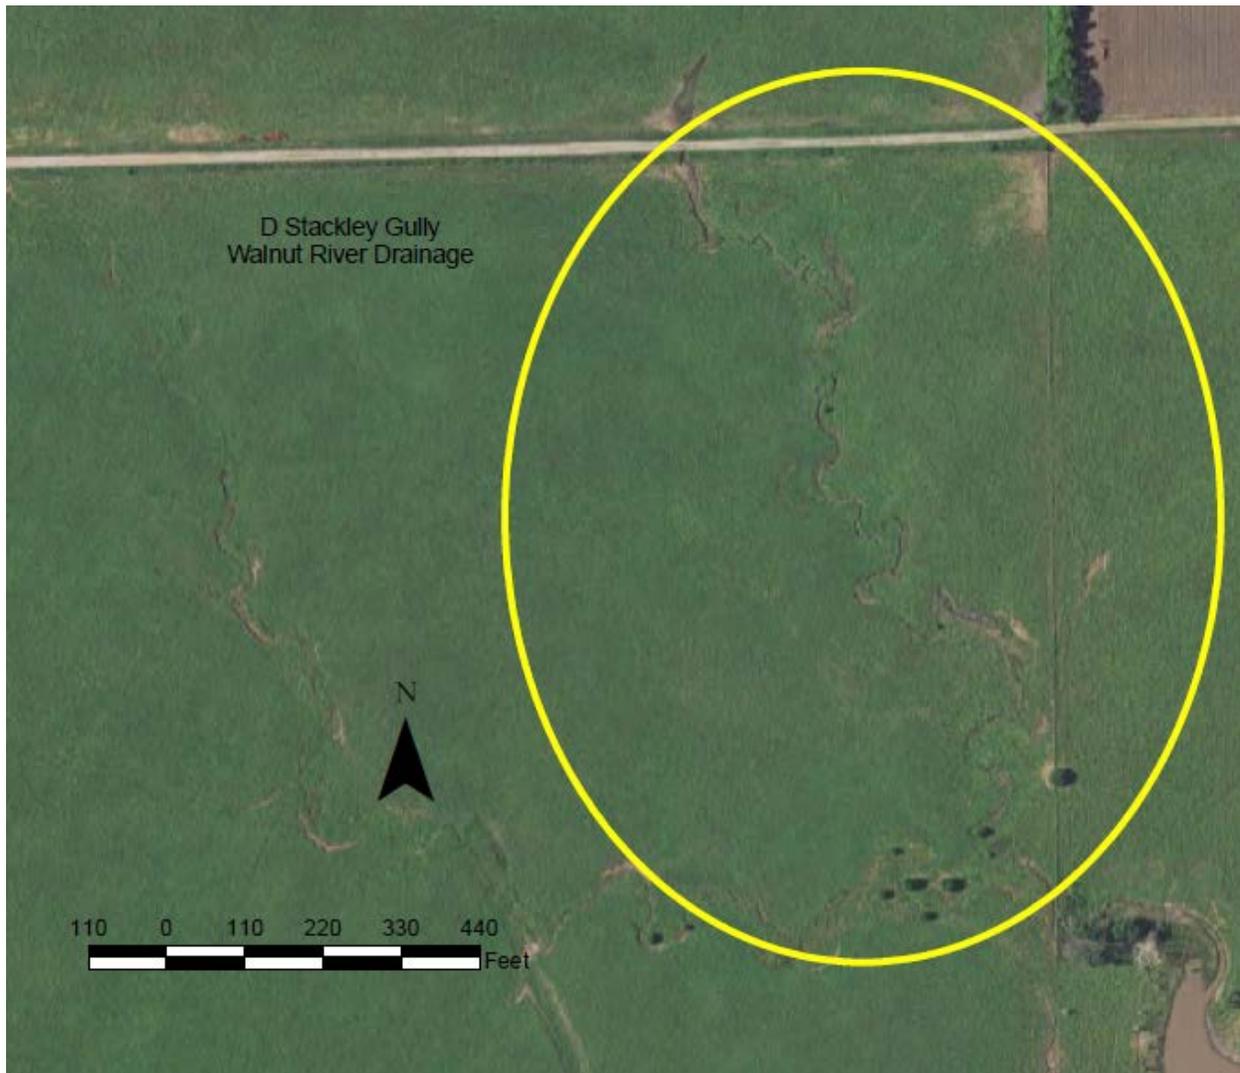
Walnut River Gully

The gully surveyed in the Walnut River drainage area was determined by the Soil and Water Assessment Tool (SWAT) model to be in a medium priority area for sediment and nutrient runoff. The soil type of the field where the gully is located is Irwin silty clay loam, 1-7% slope. Stocker cattle are put in this pasture and it is grazed more intensively than the Cole Creek pasture; even so, there was still a lot of forage left after the grazing season, especially in 2016. The gully length is approximately 1,700 feet long. Some cattle trailing was noted in and around the gully.

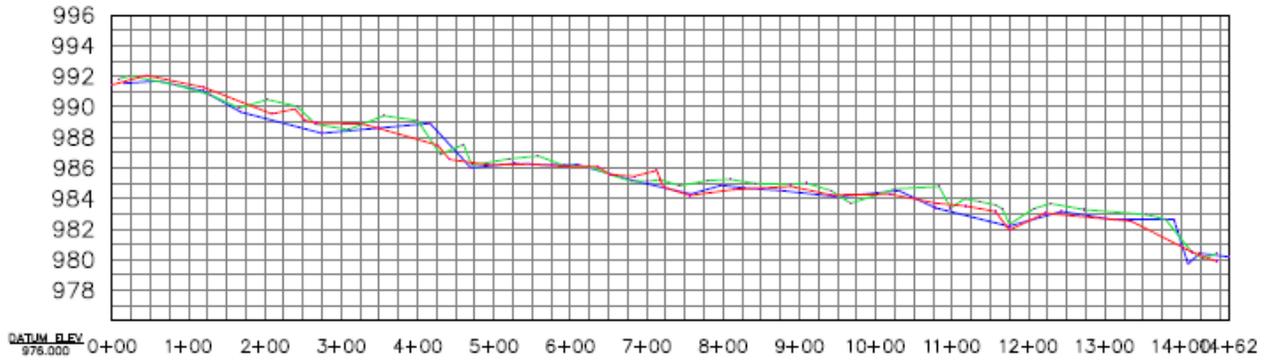
Walnut Gully
Butler County, Kansas
Longitudinal Profile

The Longitudinal Profile below shows the survey data collected in 2015, 2016 and 2017. This gully shows a more active erosion pattern from year to year with some cross sections showing more sediment movement as flood events occur.

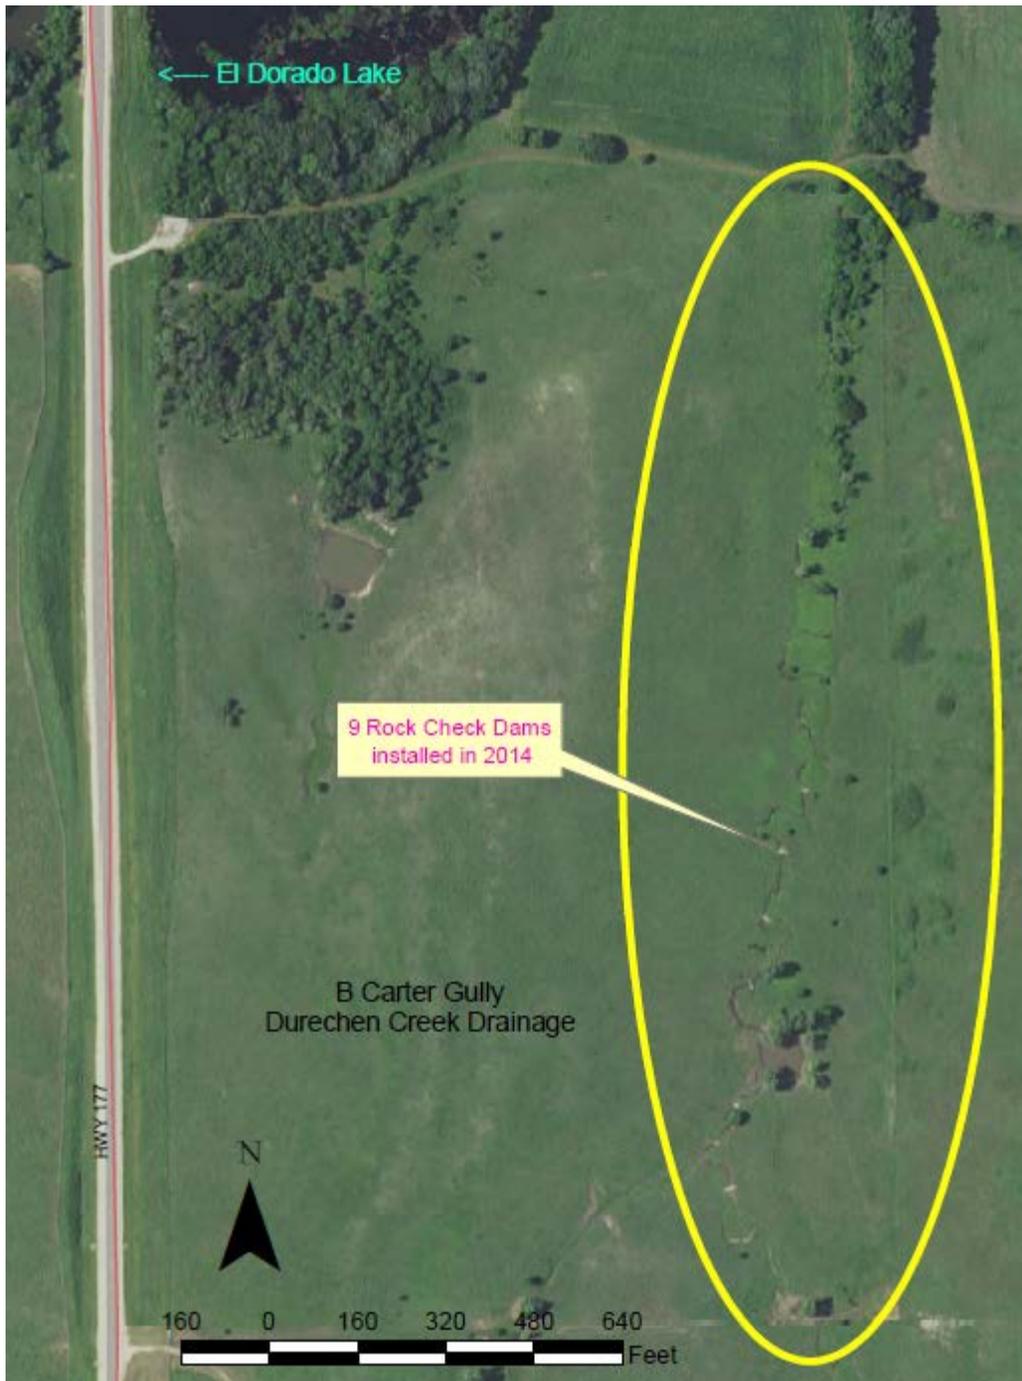
Durechen Creek Gully

The gully surveyed in the Durechen Creek drainage area was determined by the Soil and Water Assessment Tool (SWAT) model to be in a high priority area for sediment and nutrient runoff. The soil type in the field where the gully is located is Labette-sogn silty clay loam, 0-8% slope. This field is burned on a regular basis (every other year). Stocker cattle are put in this pasture from late April to the end of

July. The gully length is approximately 1,500 feet long. In March 2014, 9 rock check dams were placed in the gully to help control erosion.

There are scattered trees along the gully and other areas where water sets longer after a rain. Cattle tend to either loaf in the shade of a tree or in cases where water stands, “muck” in the mud in those spots. Those areas show an increase in erosion (very evident at rock check dam #3 right above the pond (in the shade of a tree), rock check dam #5 and rock check dam #8 (where water sets longer)); however, most of the areas near the rock check dams are filling in as intended and grass is observed growing in the gully now where bare ground had been in 2014.

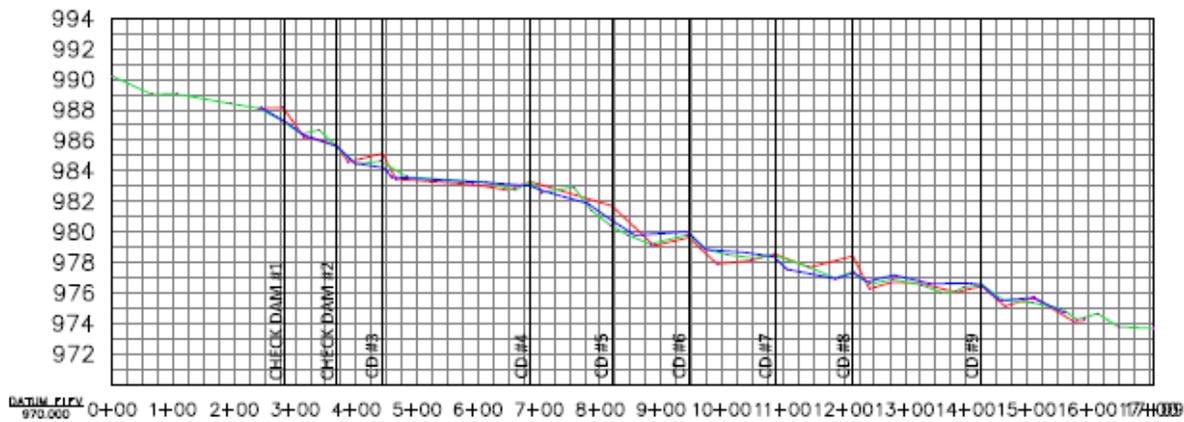
Carter Gully
 Butler County, Kansas
 Longitudinal Profile

The Longitudinal Profile below shows the survey data collected in 2015, 2016 and 2017.

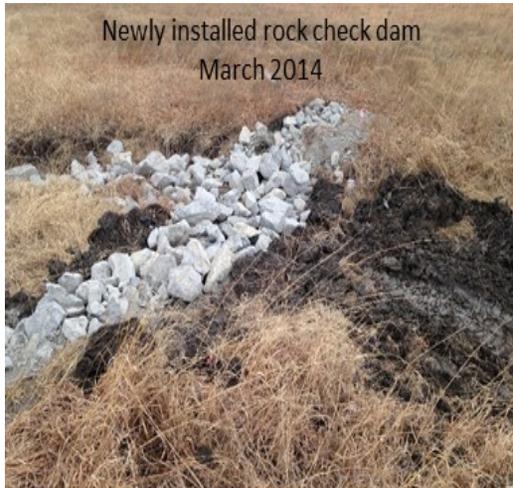
Newly installed rock check dam
March 2014

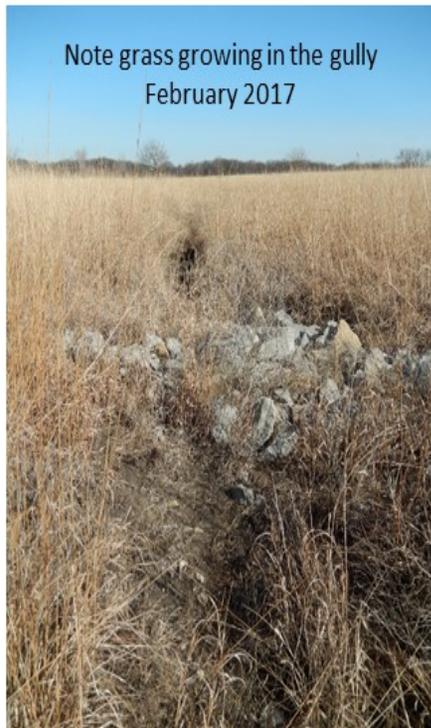
Note grass growing in the gully
February 2017

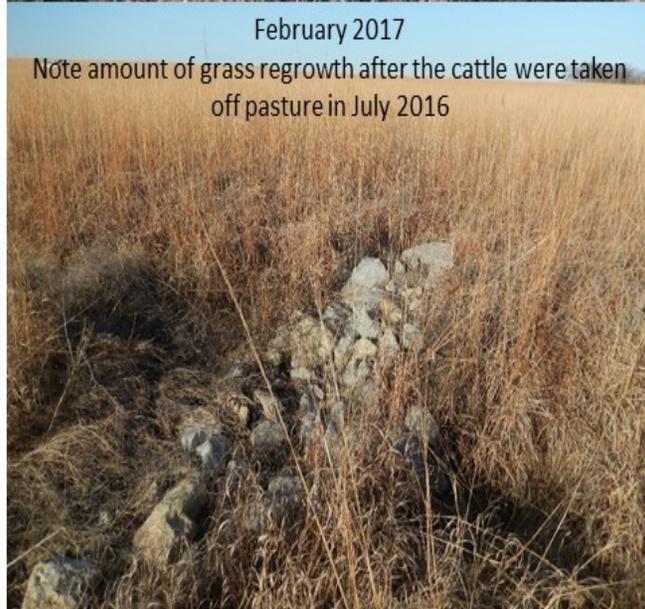
February 2017
Note amount of grass regrowth after the cattle were taken
off pasture in July 2016

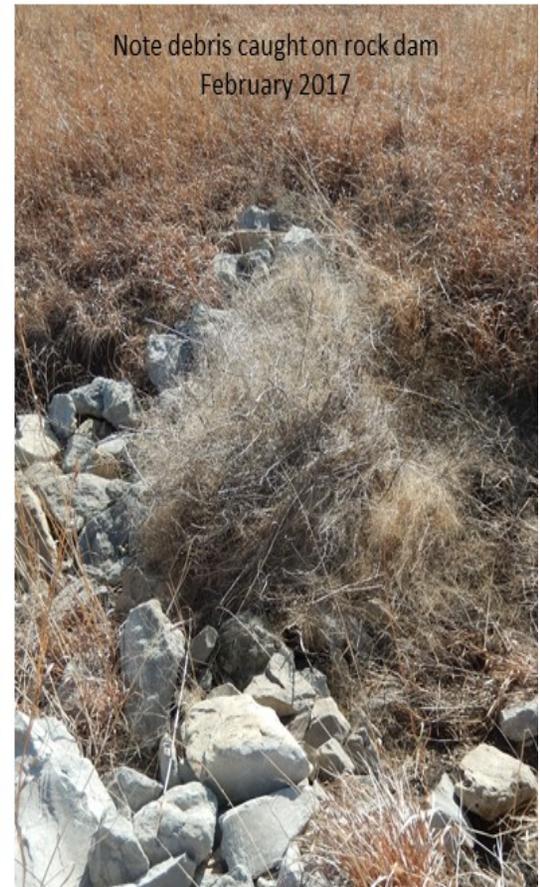
Note debris caught on rock dam
February 2017

- The more grass left in the pasture, the less erosion occurs and cattle don't loaf in the gullies as much.
- From visual observation, the rock check dams in the Carter gully are slowing down water flow in the gully and depositing sediment upstream the rock dams; as they were designed to do. It did not appear the cattle loafed around the rock check dams (except for the one that was next to a tree) therefore not causing another issue with erosion caused by hoof action.

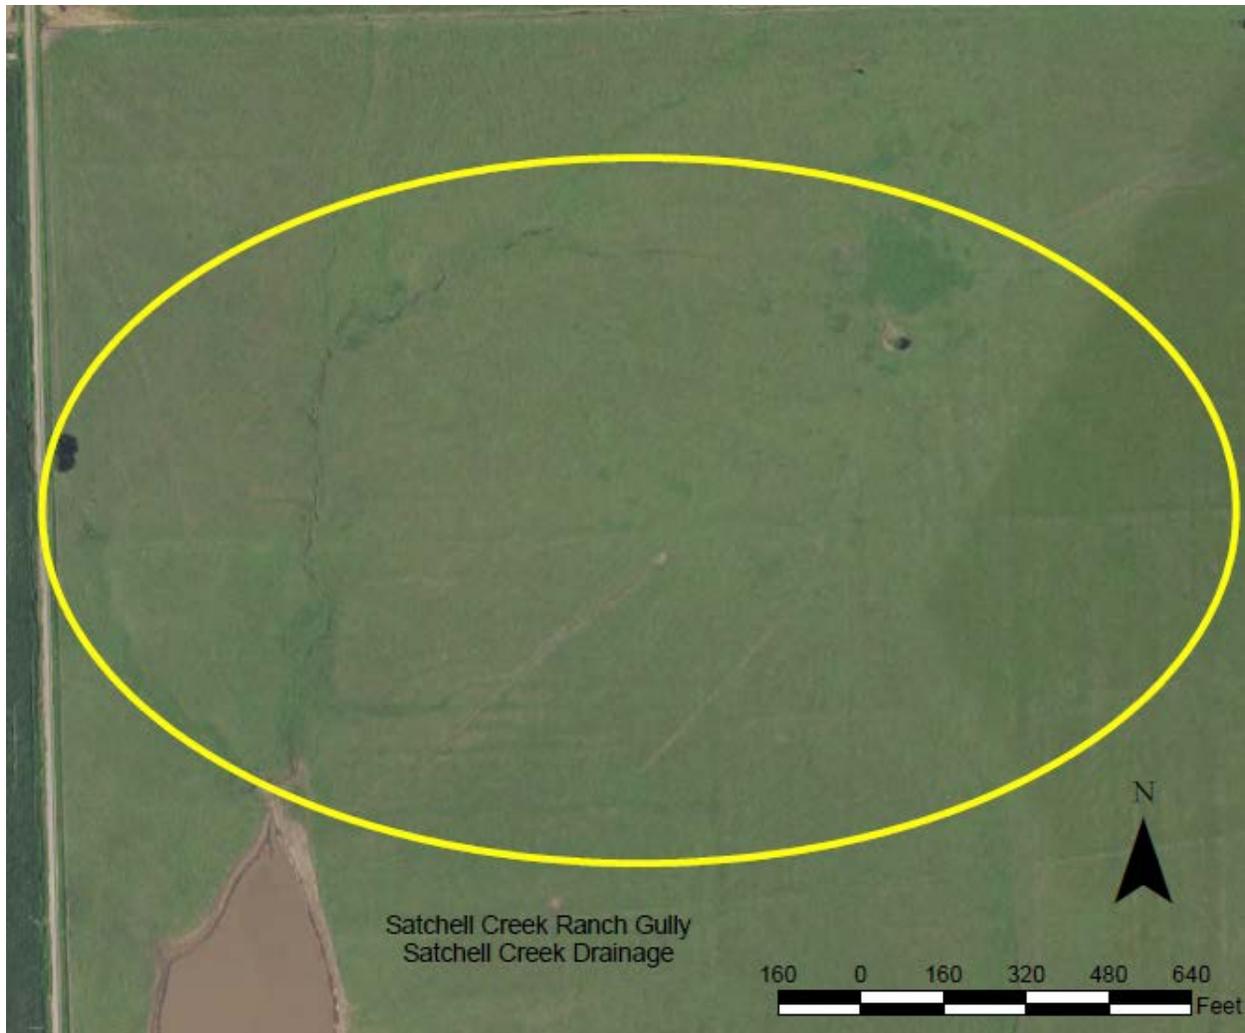
Satchell Creek Gully

The gully surveyed in the Satchel Creek drainage area was determined by the Soil and Water Assessment Tool (SWAT) model to be in a high priority area for sediment and nutrient runoff. The soil type of the lower part of the gully is Labette-Dwight Complex, 0-3% slope and the soil type in the upper part of the gully is Dwight silt loam, 0-1% slope. The operator uses this pasture for stocker cattle with grazing from May to August. This pasture also had dense grass growth making it difficult to walk in 2017 in addition to making it hard to locate the gully due to the grass. The gully had a few spots that held water where cattle might “muck” around. The gully length is approximately 1,740 feet long. It was noted that cattle tended to walk along the gully on their way to drink water from the pond leaving trails next to the gully which could increase erosion in these areas due to the bare spots left by the cattle trails.

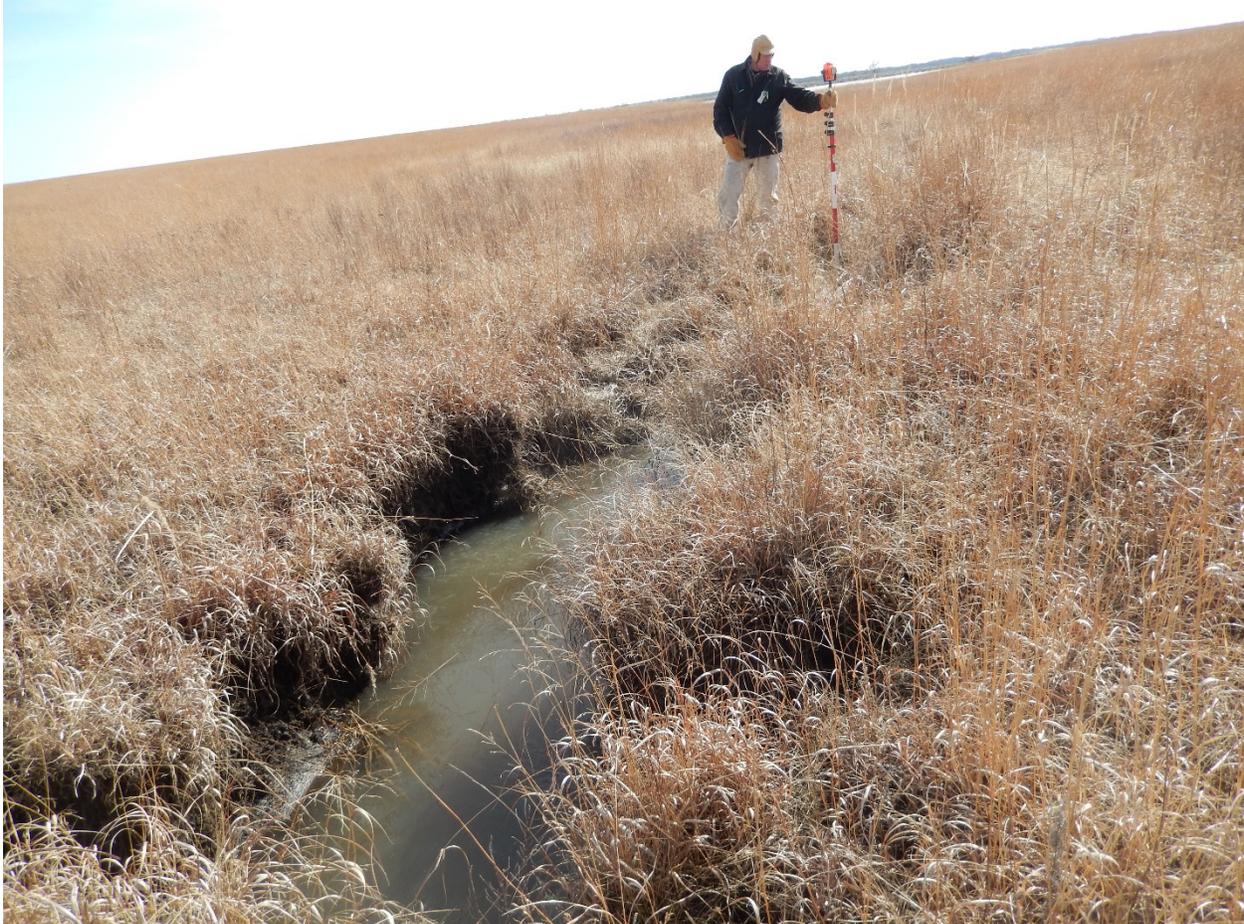
Gully surveying on Satchell Creek Ranch. Water setting in the gully in February 2017 in the upper part of the survey area (note pond behind surveyor; gully winds its way down to the pond)

The Longitudinal Profile below shows the survey data collected in 2015, 2016 and 2017. It is noted on the longitudinal cross section the gully itself shows a downward trend (gully getting deeper) and this is contributed to the cattle trailing to the pond for drinking causing the gully to erode. An alternative water source or sources made available to the cattle in this pasture would help with grazing distribution and reduce the impact of cattle trailing along this gully.

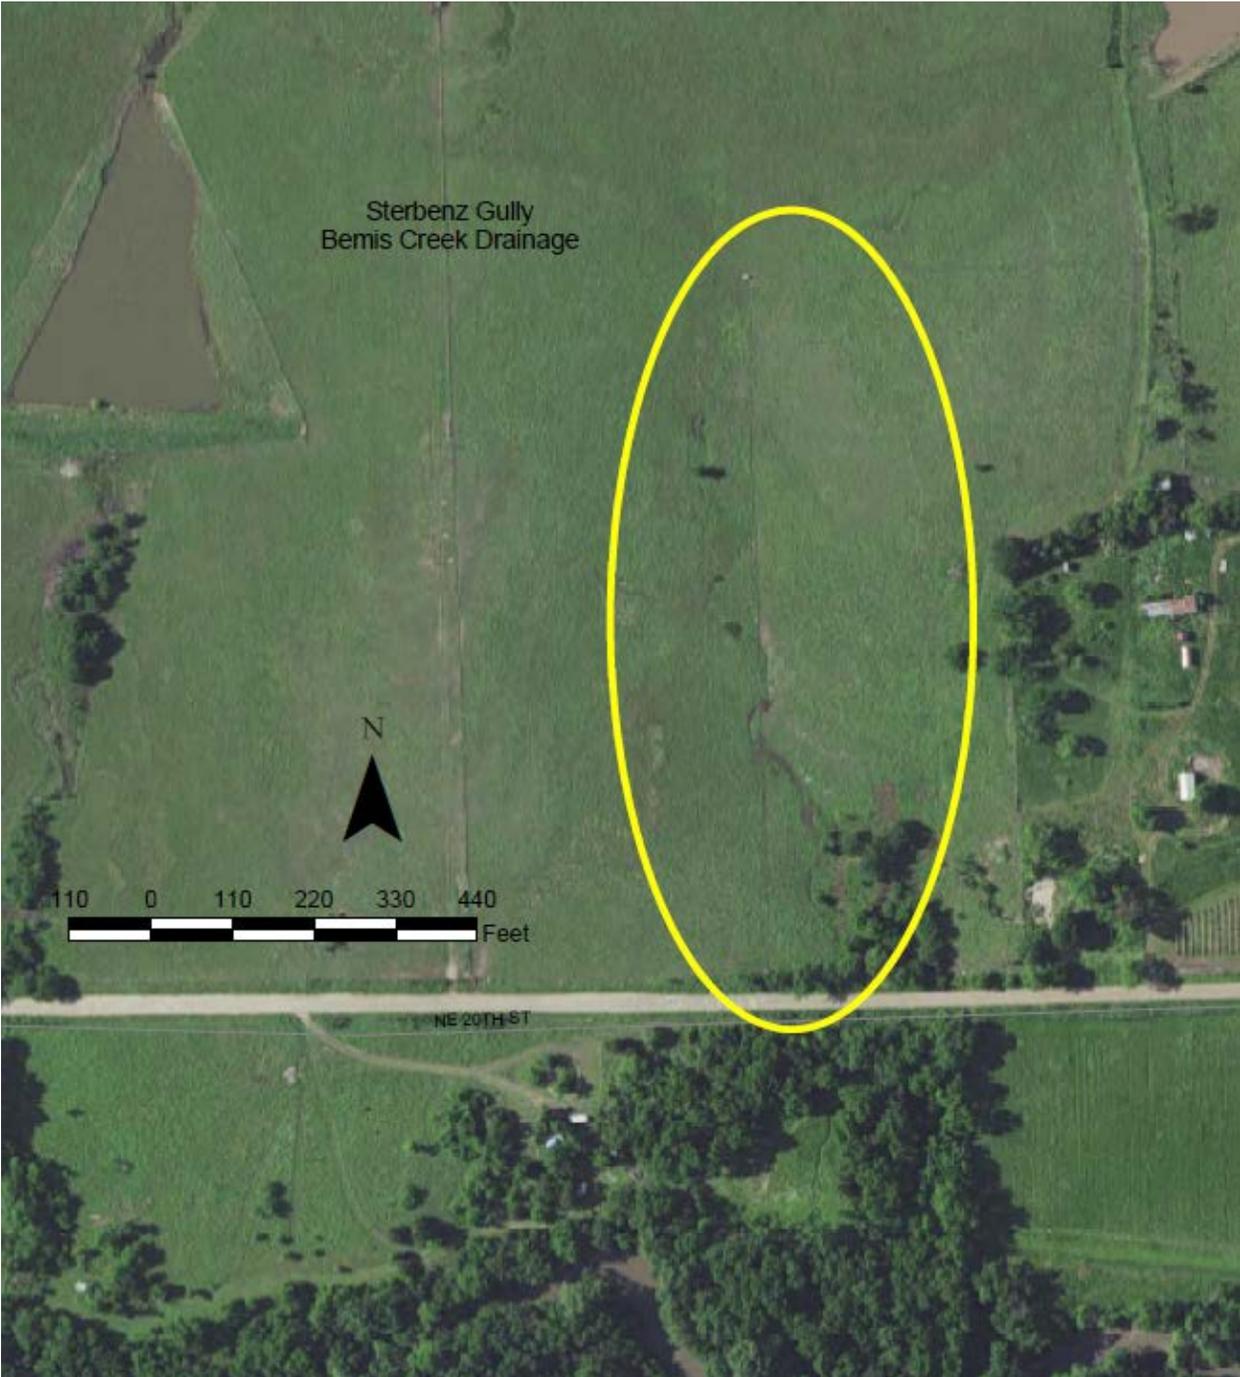
Bemis Creek Gully

The gully surveyed in the Bemis Creek drainage area was determined by the Soil and Water Assessment Tool (SWAT) model to be in a low priority area for sediment and nutrient runoff. The soil type on the lower part of the gully is Vanoss silt loam, 0-3% slope; in the middle is Labette-sogn silty clay loam, 0-8% slope and the upper part of the gully is Sogn silty clay loam, 0-10% slope. A fence separates the pasture on the lower end but does not enclose the pasture. The gully happens to criss-cross the fence in three different places. Cattle are allowed access to the entire 70 acres as the only water source is the pond in the northeast end of the pasture. Several trees are located in the stretch of gully and cattle tend to frequent these areas for shade which can also cause some additional erosion as cattle stomp in the water/mud holes. The pasture was rested the prior year of the first survey and grazed with stocker cattle the other two years of the survey period. The gully length is approximately 1,100 feet long.

The Longitudinal Profile below shows the survey data collected in 2015, 2016 and 2017. This gully is fairly stable and even shows improvement in some areas. This is attributed to the improved pasture management practices of a new operator who took over at the beginning of the study period. Again, issues occur where the gully criss crosses the fence and where trees are located. Cattle walk the fence/gully area as they graze or go for water and then loaf in areas where trees are located causing bare spots.

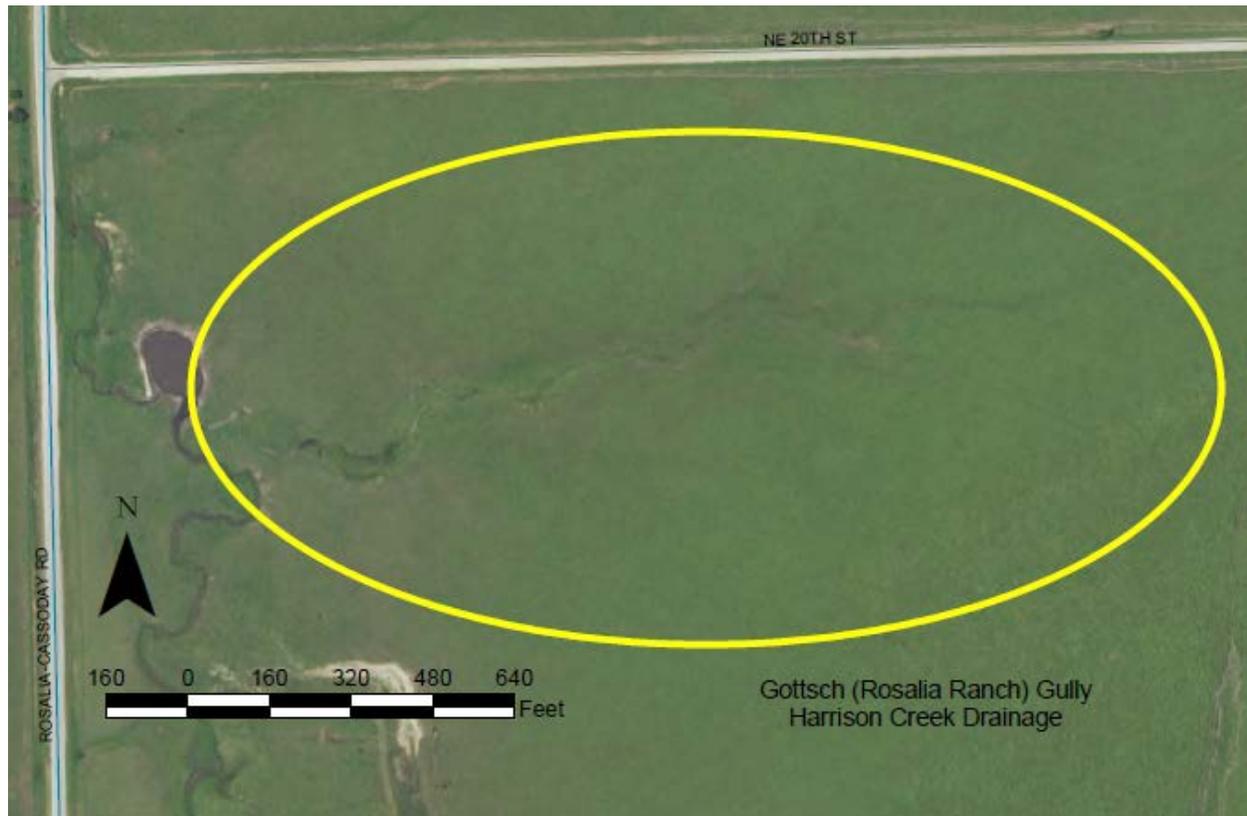
Harrison Creek Gully

The gully surveyed in the Harrison Creek drainage area was determined by the Soil and Water Assessment Tool (SWAT) model to be in a low priority area for sediment and nutrient runoff. The soil type on the lower part of the gully is Verdigris, frequently flooded, the soil type in the middle (the majority of the length of the gully) is Florence cherty silt loam, 5-15% slope and the upper part (the last 300 feet) is Irwin silty clay loam, 1-3% slope. A spring is located on the lower end of the gully about 400 feet east of the pond. This gully was only surveyed in 2015 and 2017; as there was a death in the family of the ranch manager during the time we surveyed in 2015. The ranch manager runs stocker cattle on this pasture 9 months out of the year (May to August and November to March). The pasture size is 640 acres. There are 3 ponds on the north end. The gully length is approximately 2,080 feet long.

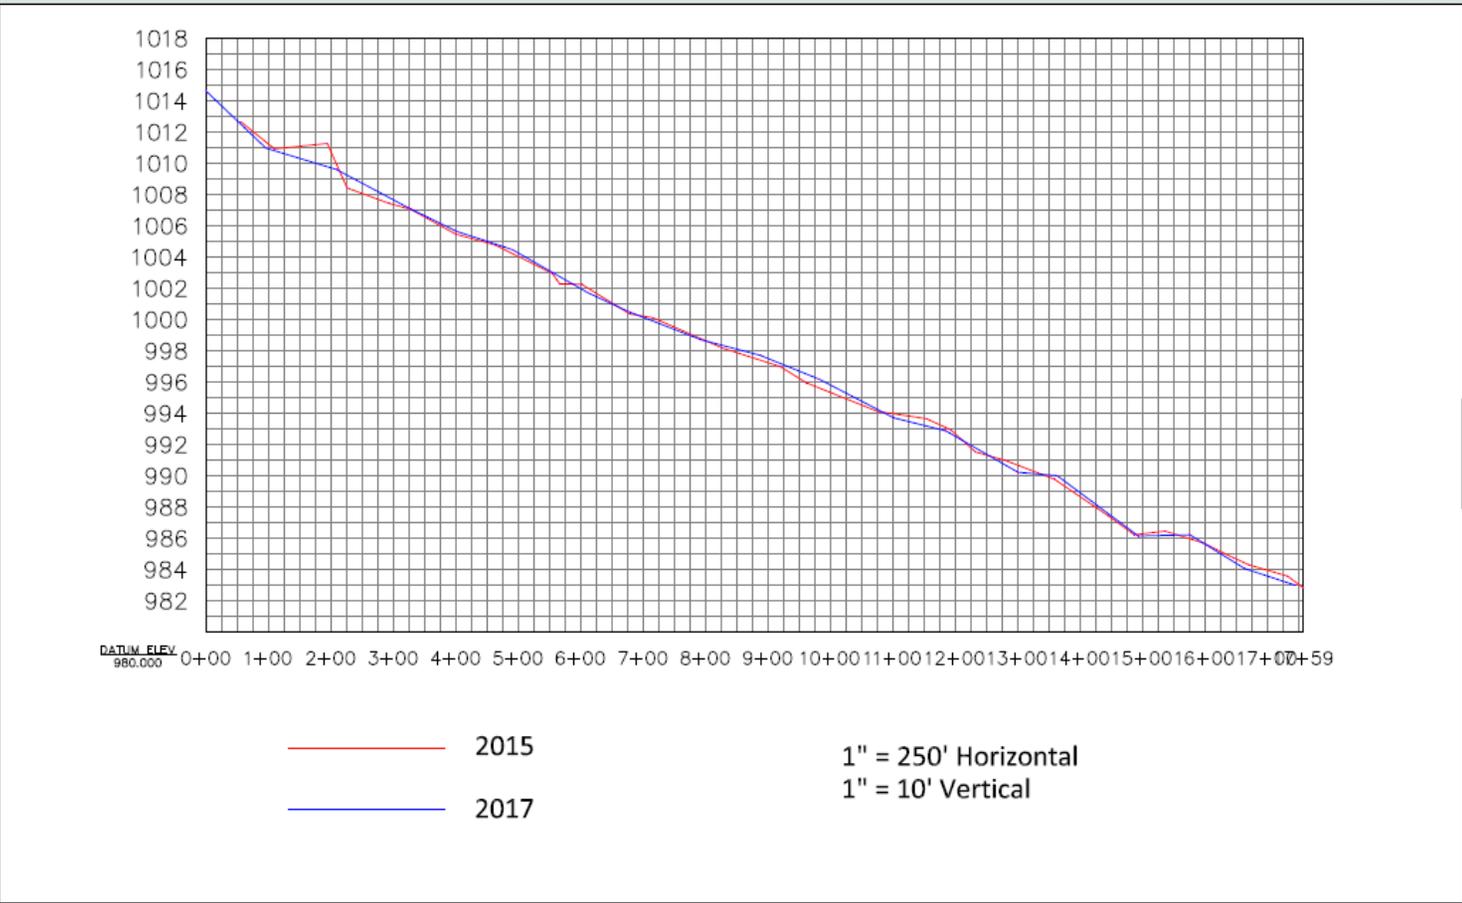
Gottsch Gully
Butler County, Kansas
Longitudinal Profile

The Longitudinal Profile below shows the survey data collected in 2015 and 2017. This gully is stable except for the areas where water sets in the gully and cattle loaf leaving bare spots.
