**IVIE RISK SOLUTIONS**  
INSURANCE INSPECTIONS

# 2026 RISK CONTROL ASSESSMENT

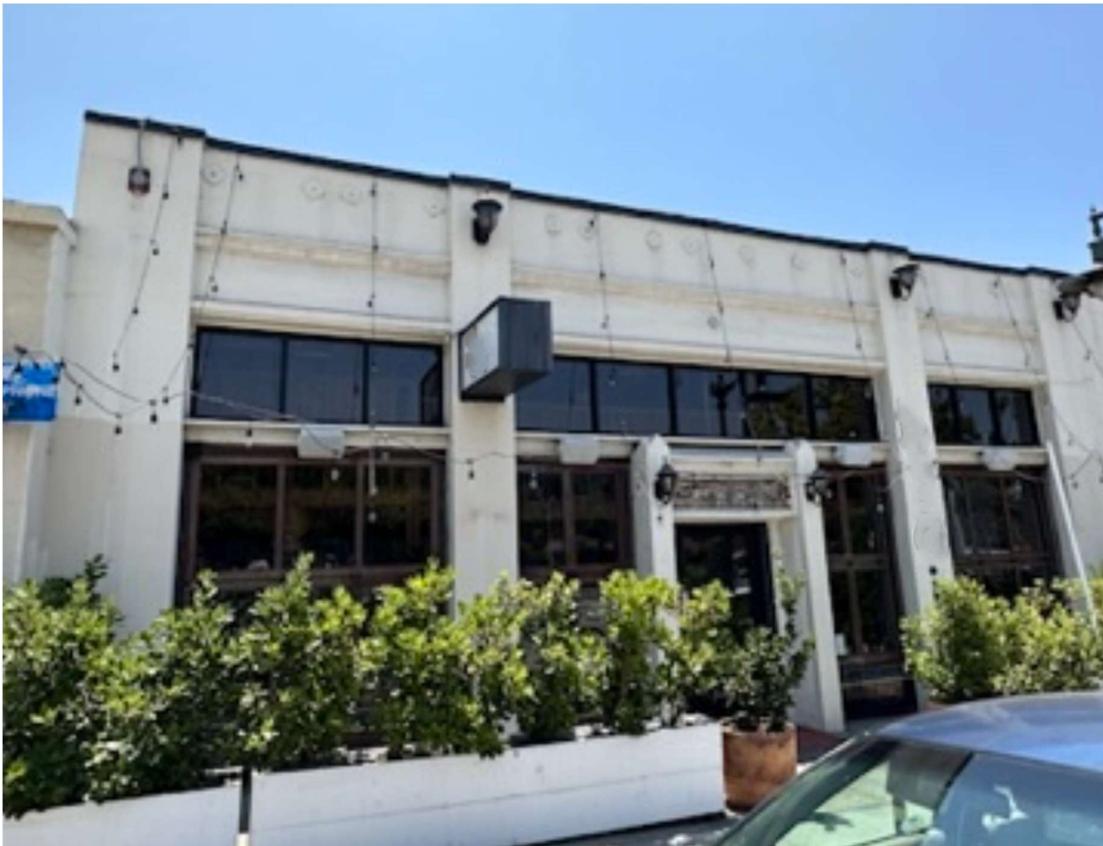
Photo 1 – Overall exterior or aerial view

The following image provides visual orientation of the site and representative conditions observed during the assessment.

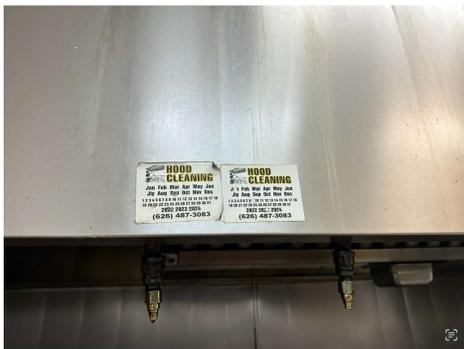
**Hood Cleaning Overdue / Expired**

Kitchen exhaust hood cleaning service interval has expired, as evidenced by outdated service stickers and visible grease accumulation. Grease accumulation within the hood and exhaust system is a leading cause of restaurant fires. Failure to maintain cleaning intervals significantly increases the likelihood of a grease fire extending into ductwork and the roof structure. Schedule professional hood and exhaust system cleaning immediately and maintain service in accordance with NFPA 96 requirements.

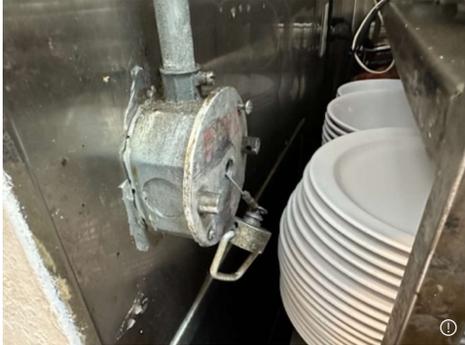
### **Broken Manual Pull Device – Automatic Extinguishing System (AES)**

The manual pull station for the kitchen fire suppression system appears damaged or inoperable. An impaired manual pull device delays fire suppression activation, increasing fire spread potential and property damage. Repair or replace the manual pull station and confirm full operational functionality.

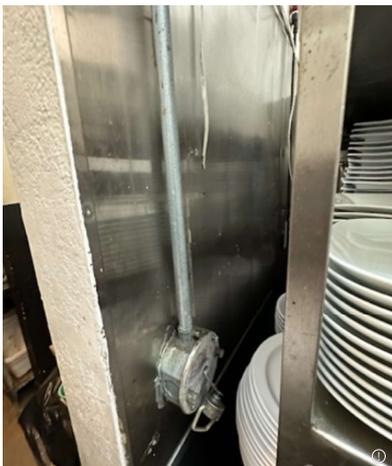
### **Missing Service Tag for Automatic Extinguishing System**

No current service tag or documentation visible for the kitchen automatic fire suppression system. Lack of service verification raises concerns regarding system readiness and compliance with maintenance requirements. Have a licensed contractor inspect and service the system and affix a current service tag.

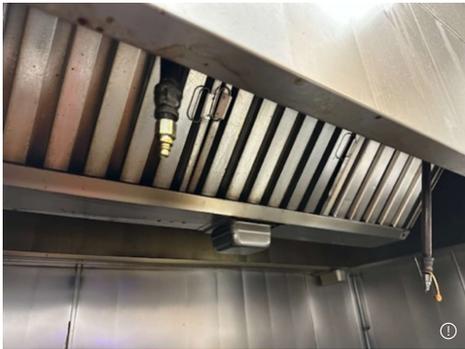
### No Protective Caps on Suppression Nozzles

Fire suppression nozzles within the hood lack protective caps. Missing caps allow grease buildup inside nozzles, which can obstruct discharge and impair fire suppression performance. Install manufacturer-approved protective caps on all suppression nozzles and verify they remain unobstructed.

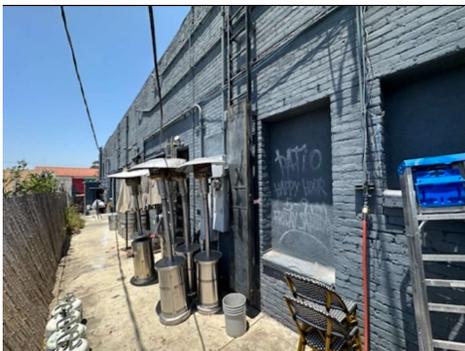
### Propane Tanks Improperly Stored in Rear Exterior Walkway

Multiple propane cylinders stored unsecured in a rear exterior walkway and not housed in a protective cage. Improperly stored propane tanks increase fire, explosion, and impact exposure and create an obstruction hazard in an exit or service pathway. Relocate propane cylinders to a secured, ventilated, code-compliant cage away from building openings and walkways.

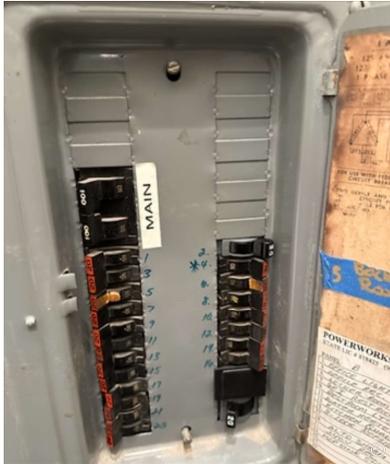
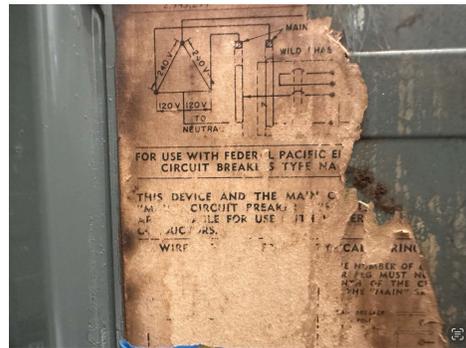
## Federal Pacific Electrical Subpanels Present

Electrical subpanels identified as Federal Pacific / Stab-Lok type. These panels are known to fail to trip during overload conditions, increasing electrical fire risk. Have a licensed electrician evaluate and replace Federal Pacific panels with modern, listed equipment.

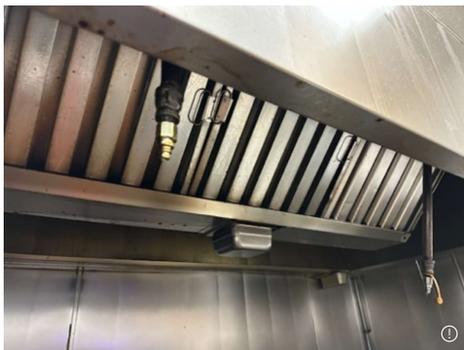
### Grease Filters Not Cleaned on a Weekly Basis

Grease filters show signs of buildup inconsistent with weekly cleaning. Dirty filters restrict airflow and allow grease accumulation, increasing fire ignition potential within the hood system. Establish and document a weekly grease filter cleaning schedule.

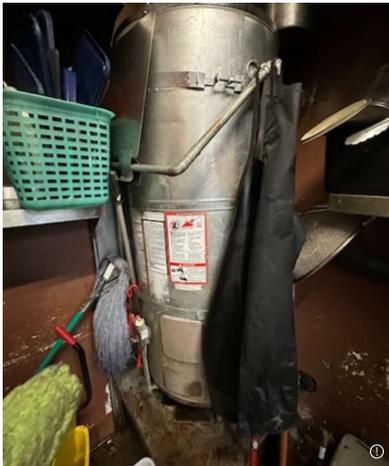
### Storage Placed on Water Heater

Items stored directly on or against the water heater. Combustible storage near heat-producing equipment increases ignition risk and interferes with proper maintenance access. Remove all stored items and maintain required clearance around the water heater.

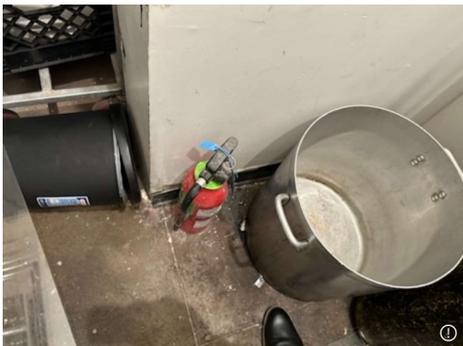
### ABC Fire Extinguisher Not Properly Mounted

ABC fire extinguisher observed resting on the floor rather than mounted. Unmounted extinguishers may be damaged, obstructed, or inaccessible during an emergency. Mount extinguishers on approved brackets at proper height and maintain clear access.
