**IVIE RISK SOLUTIONS**  
INSURANCE INSPECTIONS

# 2026 RISK CONTROL ASSESSMENT

Prepared for :  
**Property Owner &  
Management  
Company**

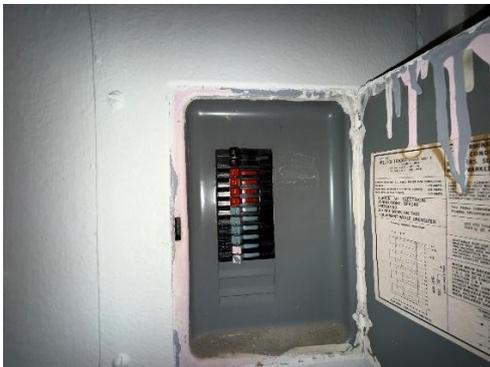
**Hazardous electric breakers**

Sylvania and Sylvania-GTE electrical subpanels, some of which may be re-branded Zinsco-style panels manufactured between 1973–1981, were observed in residential units, the laundry room, and exterior electrical areas. These panels are known to have defective designs that may not safely interrupt over-current conditions, increasing the risk of overheating, arcing, and electrical fire. It is recommended that a licensed electrician evaluate all affected panels and replace any confirmed Zinsco-style subpanels with modern, approved electrical panels to reduce life safety and fire exposure. Failure to address this exposure may lead to coverage restrictions, increased premiums, corrective action timelines, or non-renewal.

Zinsco breakers

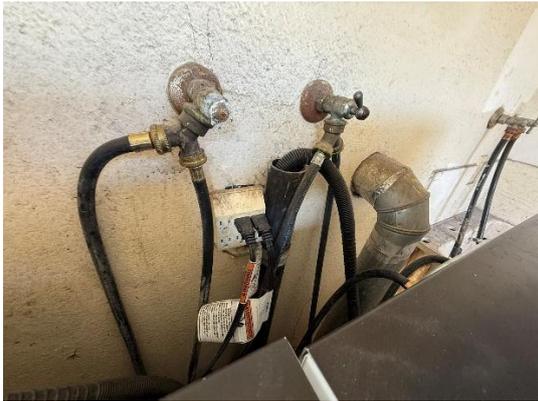
**Excessive use of extension cords**

Electrical connectors and extension cords are being used near the washing machines in the laundry room, creating a significant fire hazard because these temporary connections are not designed for continuous use. Prolonged use can lead to overheating, damage, and loose connections, increasing the risk of electrical fire in a high-load, high-moisture area. It is recommended that a licensed electrician install additional permanent outlets to provide dedicated power sources and eliminate reliance on temporary connectors.

Electric Connectors in laundry room

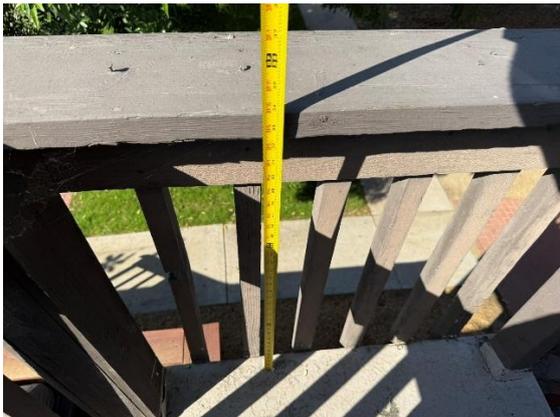
### Balcony guardrail height

The balcony guardrail near Unit 21 is below the current minimum height requirement, which increases the risk of falls and serious injury to occupants. To improve safety and reduce liability exposure, a qualified contractor should raise or modify the guardrail to meet the current standard of at least 42 inches in height, in accordance with applicable local building codes and standards.

Balcony rails height is below 42"

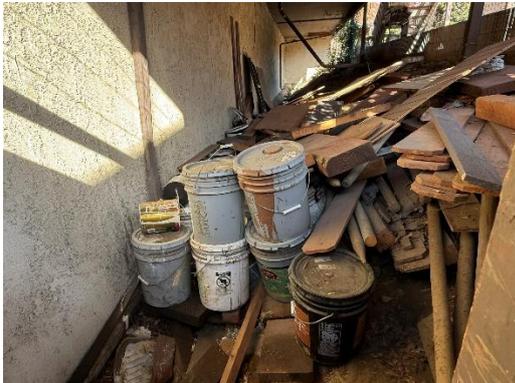
Deferred maintenance issues observed throughout the property include deteriorated deck rails, uplifted or weathered decks and walkways, cracked stairways, weathered expansion joints, and cracks in exterior walls. Housekeeping deficiencies include missing signage, stored debris, cluttered balconies, and improper storage near Unit 27. Additional concerns include excessive water in trenches and a hole in the wall exposing wiring near the electrical subpanel. These conditions increase the risk of slips, trips, structural failure, property damage, and liability. A qualified contractor should inspect and repair or replace damaged structural components and surfaces, apply protective coatings or sealants where appropriate, correct storage and drainage issues, properly enclose electrical components, and implement a regular maintenance schedule to prevent further deterioration and support safety and insurance standards.

Stored debris

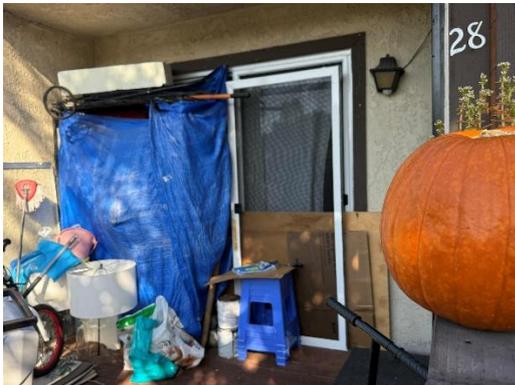
Cluttered balconies

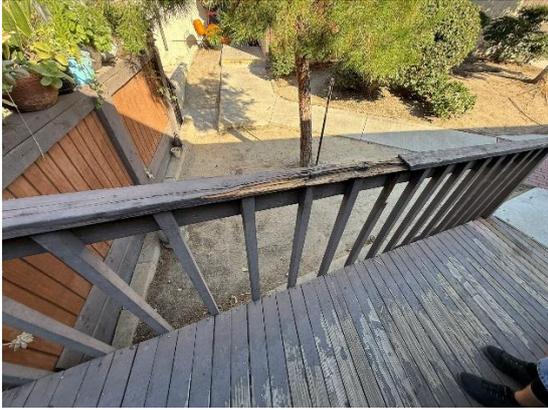
Deteriorated deck rails

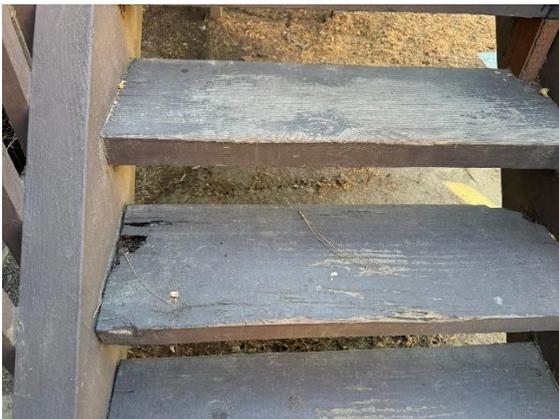
Cracked stairways

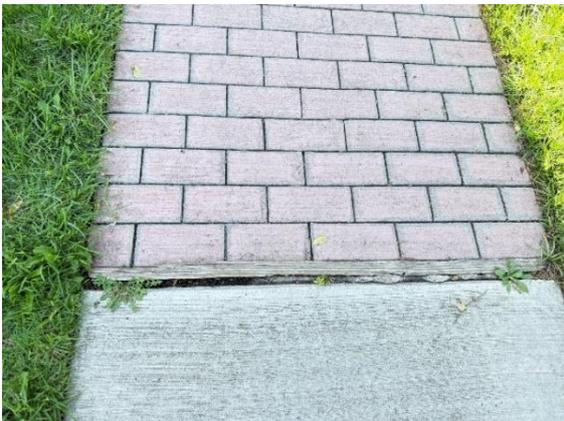
Weathered expansion joints in common area walkway

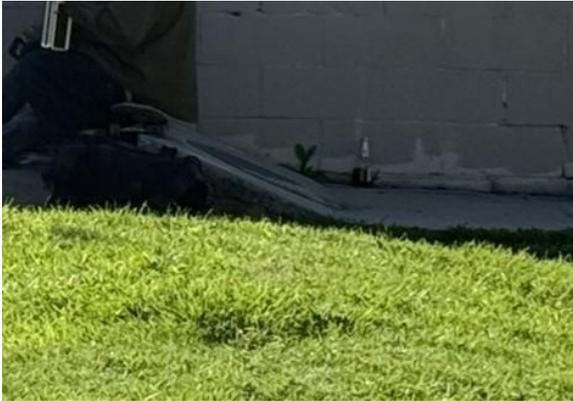
Some decks and walkways were observed to be uplifted or weathered, creating uneven surfaces that increase the risk of slips, trips, and falls. A qualified contractor should inspect all affected areas and repair or replace damaged sections as needed, and apply protective coatings or sealants to maintain structural integrity and extend service life.

Uplifted section of concrete walkway right side of premises towards the rear

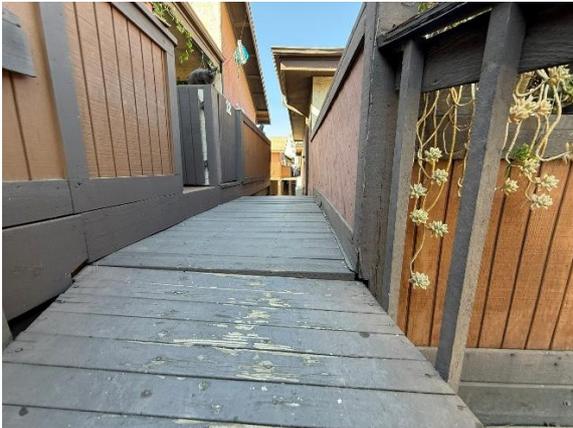
Uplifted section of wood deck in center of premise

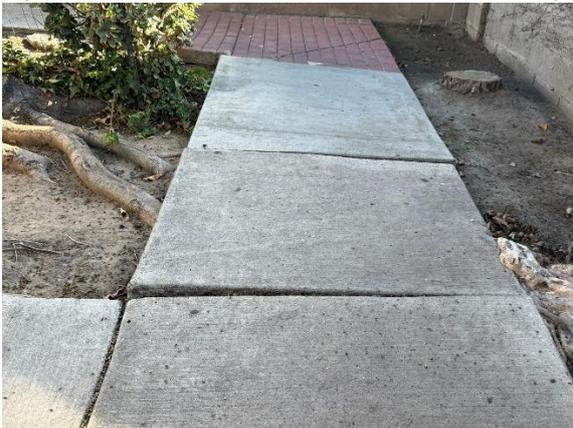
Uplifted section of common area walkway

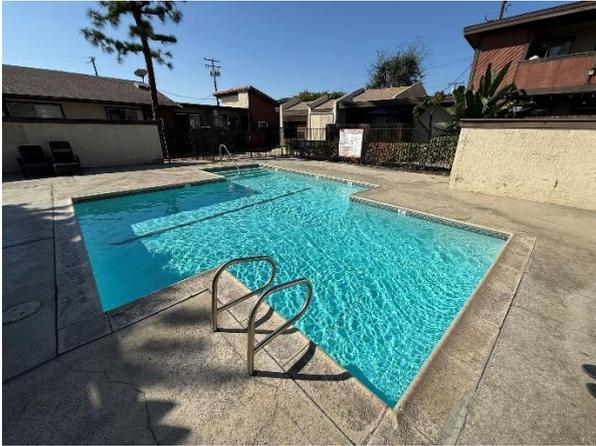
Water depth markers were observed on the interior pool surface, but none were displayed on the exterior pool deck. Exterior depth markers provide clear visibility for swimmers, guests, and emergency personnel, which helps prevent accidents and improves overall safety. Best practice is to install water depth markers on the exterior pool deck or perimeter in addition to the interior markings.

Missing depth markers on exterior of pool surface

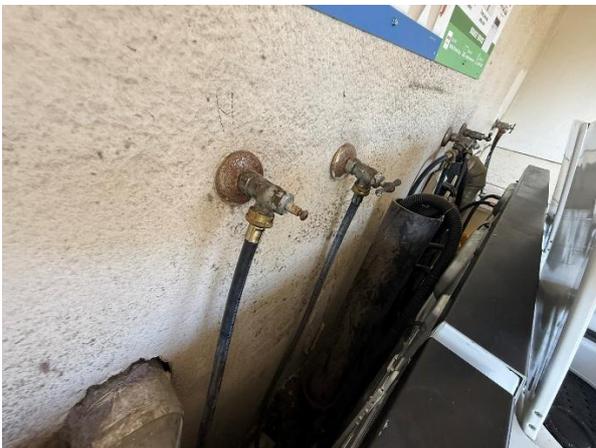
The washing machine in the laundry room is connected with rubber water supply lines, which are more prone to deterioration and rupture over time. This increases the risk of sudden hose failure and significant water damage to the building. Best practice is to replace rubber supply lines with braided metal water supply lines to improve durability and reduce the likelihood of leaks or ruptures.

Rubber water hose of washing machine

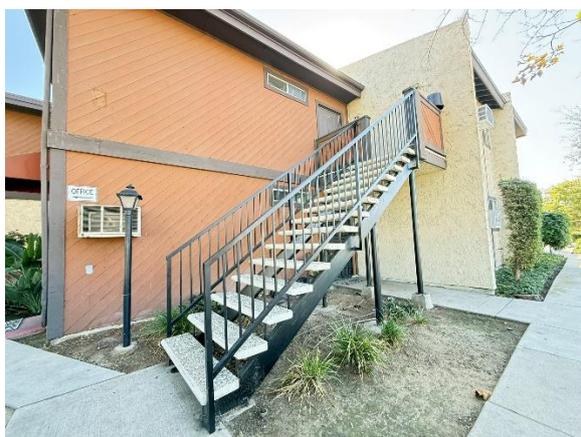
Each building was observed to have only one to two fire extinguishers, with no extinguishers present on the second floors and the distance between some extinguishers exceeding 75 feet. This reduces the ability to quickly access fire suppression equipment during an emergency, increasing the risk of fire spread and potential property damage or injury. Additional fire extinguishers should be installed in each building, particularly on the second floors, to ensure coverage within 75 feet of all areas. Extinguishers should be clearly visible, easily accessible, properly mounted, and regularly inspected and maintained to ensure readiness.

Missing fire extinguisher on 1<sup>st</sup> and 2<sup>nd</sup> floor

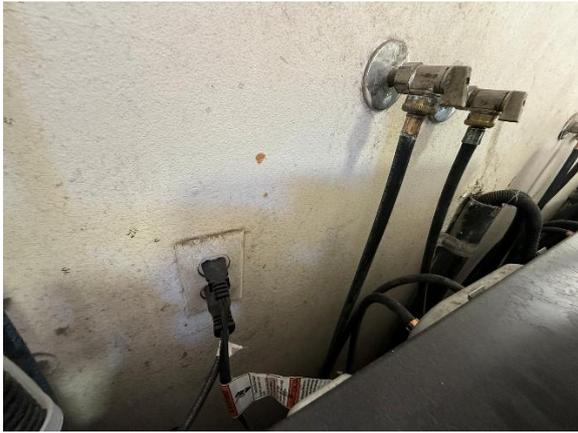
GFCI protection was not observed on outlets near the washers in the laundry room. Without GFCI protection, there is an increased risk of electrical shock due to the presence of water and moisture in the laundry area. To reduce this risk and enhance safety, install GFCI-protected outlets for all receptacles near washers and sinks in the laundry room.

No GFCI installed near washing machine in laundry room

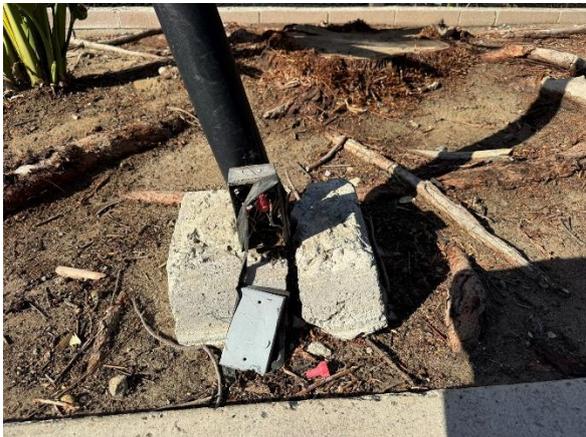
An open junction box housing electrical cables was observed near Unit #25 (far left side of premises) next to the pole in the common area walkway. Open junction boxes expose wiring to physical damage and environmental elements, increasing the risk of electrical shock, arcing, and fire. Ensure the junction box is properly closed and secured at all times, and have a qualified electrician inspect the area to confirm all electrical connections are safely enclosed and protected.

Exposed junction box

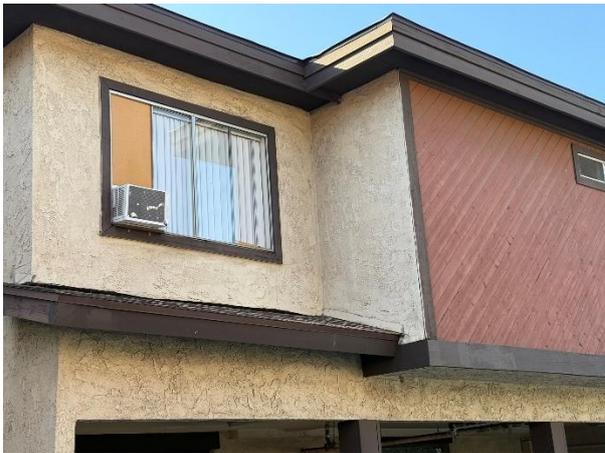
Window and wall-mounted air conditioning units were observed throughout the property, and some window units were not properly secured, creating a risk of falling if the window is opened. Unsecured units can detach and fall, posing a serious risk of injury to occupants and pedestrians, and increasing liability exposure. To reduce this risk, all window units should be securely fastened using sturdy brackets beneath the unit, and wall-mounted units especially on upper floors should be properly braced or anchored per manufacturer instructions and applicable building codes.

No bracing for window AC unit

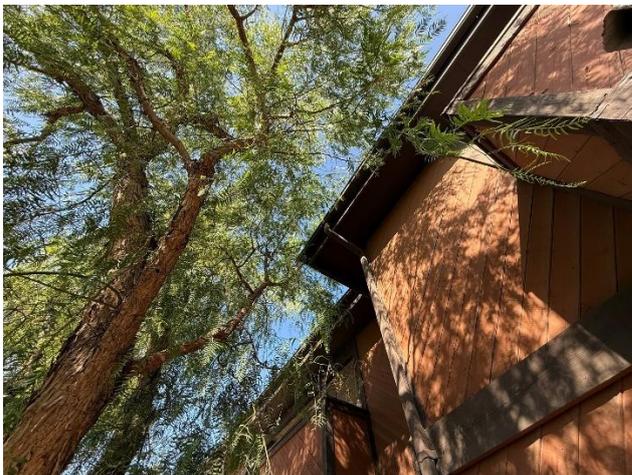
Tree branches near units 53–63 and 36–43 were observed touching or overhanging the building rooflines. This increases the risk of property damage, fire spread, and pest intrusion, as branches can scrape roofing materials, provide a path for fire, and allow animals to access the structure. To reduce these risks, all tree branches should be trimmed to maintain at least 18 inches of clearance from the roofline, and regular inspections should be conducted to ensure ongoing compliance and safety.

Tree overhanging the building and touching roof

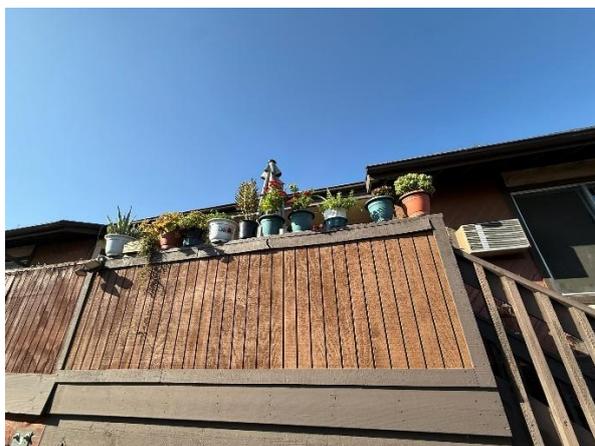
Plant pots, buckets, and other items were observed placed on balcony railings and surfaces. These items can fall from elevated areas, posing a serious risk of injury to pedestrians below and potential property damage. To reduce liability and improve tenant safety, all items should be removed from upper-floor balcony railings and stored safely on the balcony floor or inside the units, keeping railings clear at all times

Plant pots on edge of balcony

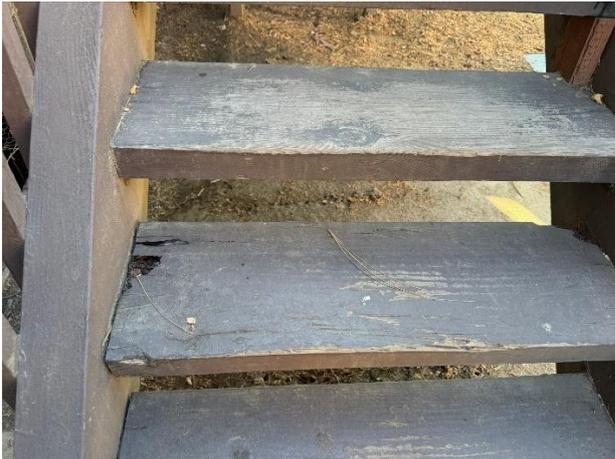
Worn stair treads were observed on stairways, creating slippery and uneven walking surfaces that increase the risk of slips, trips, and falls. To reduce injury risk and improve tenant safety, worn steps should be repaired or replaced as needed, and non-slip protection (such as anti-slip tape, treads, or coatings) should be installed on all exposed steps. Regular inspections should also be conducted to ensure stairway surfaces remain safe for tenants and visitors.

Worn exterior steps

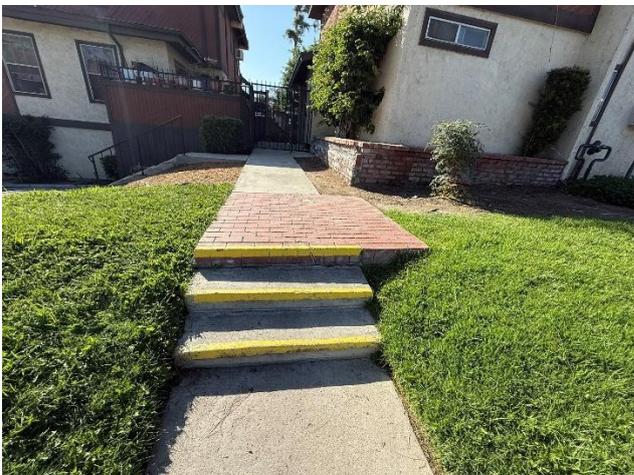
Steps with more than two risers were observed to lack handrails throughout all buildings, creating a potential fall hazard for residents and visitors. Without handrails, occupants have reduced support when ascending or descending stairs, increasing the risk of slips, trips, and falls, which can lead to injury and liability claims. Properly secured handrails should be installed on both sides of all steps with more than two risers to enhance safety and reduce liability exposure. Insurance carrier requirements may vary, but many carriers view missing handrails as a significant risk and may require correction as a condition of coverage.

Missing rails of common area steps

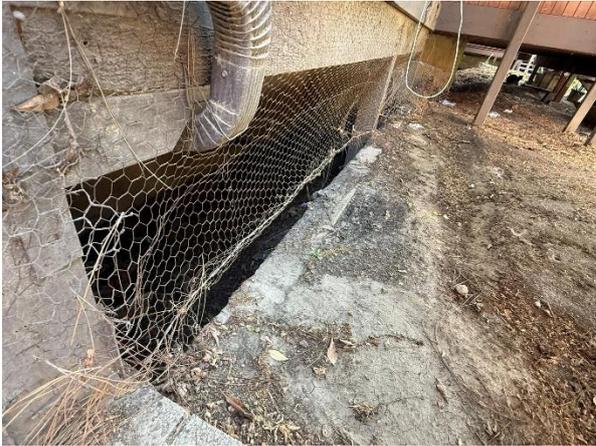
The crawl space at the property was observed to be exposed, which may allow moisture intrusion, pest entry, and potential structural deterioration over time. This can lead to water damage, mold growth, Pest infestations, and compromised structural integrity, increasing liability and repair costs. To reduce these risks, the crawl space should be properly enclosed or repaired by a qualified contractor, including installing a barrier or access cover, ensuring proper ventilation, and addressing any water or structural concerns in accordance with applicable building codes.

Exposed crawl space

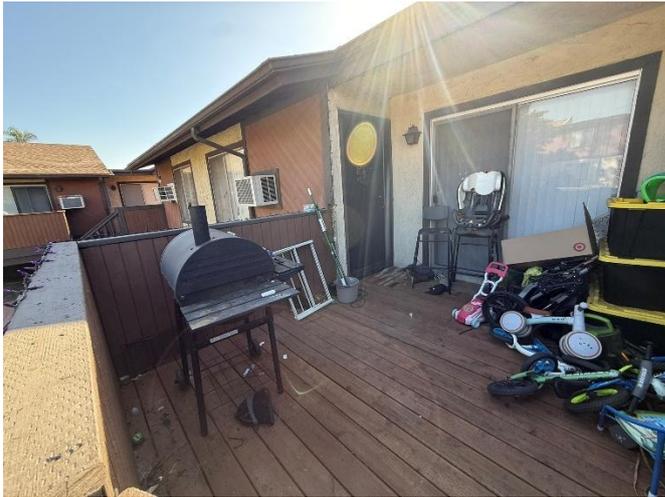
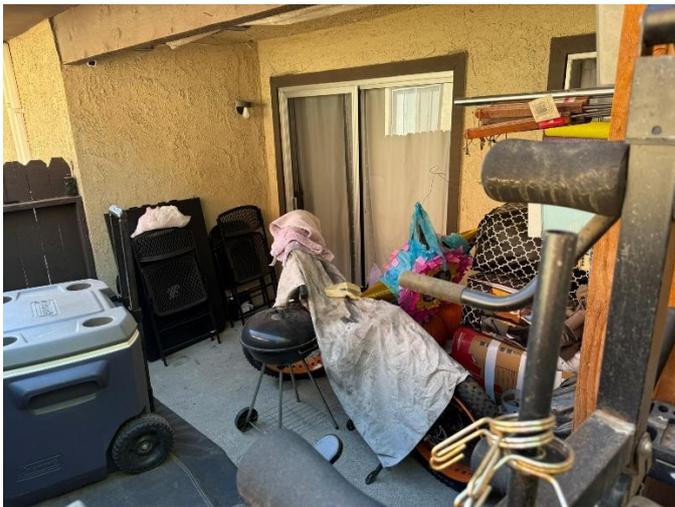
Charcoal grills were found on decks and balconies, which can be dangerous because sparks and hot coals can easily start a fire or cause burns when used near the building. To keep everyone safe, charcoal grills should not be used on balconies, elevated walkways, roofs, or decks. Instead, tenants should be asked to use grills only in open outdoor areas at least 10 feet away from any structure, and management should share this policy in writing so everyone knows the rules.

Charcoal barbecue grill on patio too close to building
