**IVIE RISK SOLUTIONS**

# RISK CONTROL ASSESSMENT

## Restaurant Survey

Address: 5000 Avalon Ave, Los Angeles, CA

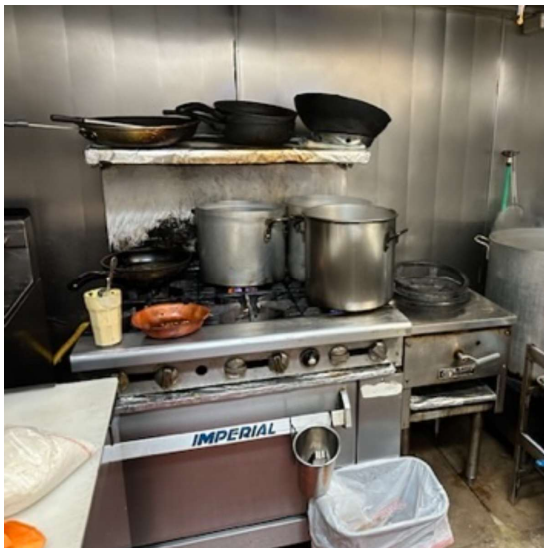
Cooking line

No metal baffle plate or required separation was observed between open-flame cooking equipment and the fryer. This condition increases the risk of flash fire and grease fire ignition. Install a listed metal baffle plate or maintain required separation distances immediately.

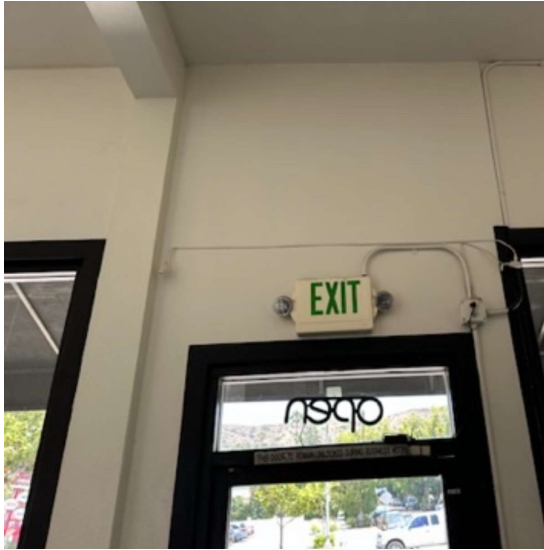
Exit sign

| Exit signs and lighting in good condition: | Yes |

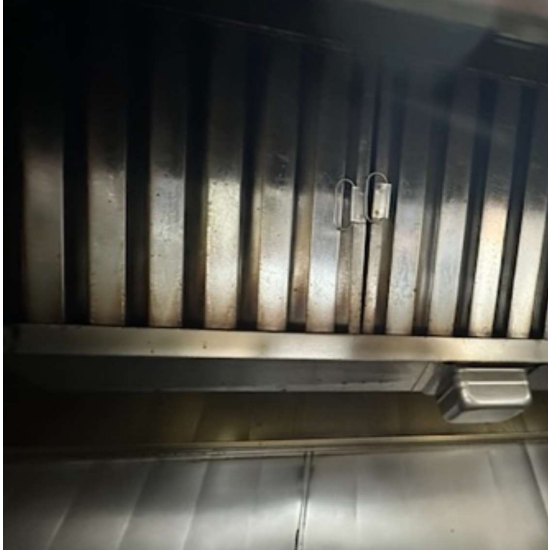
## Grease filters

| Filters clean at time of inspection: | Yes |

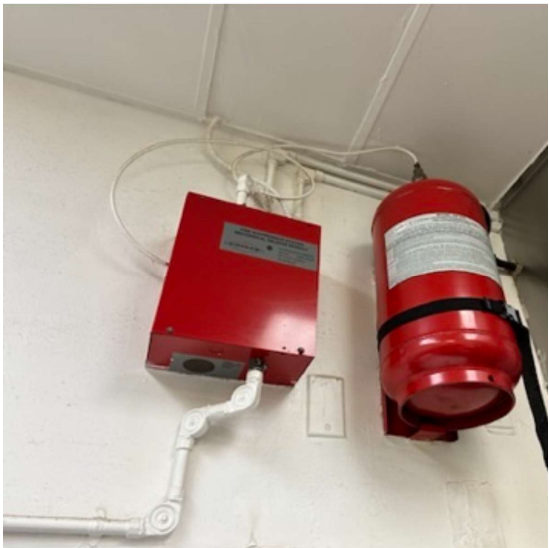
AES Tank

Automatic extinguishing system was observed in damaged condition. Missing pull type station, without a current service tag, and partially obstructed by storage. System impairment may delay or prevent fire suppression during a kitchen fire. Have the system inspected and serviced immediately by a qualified contractor and maintain clear access at all times.

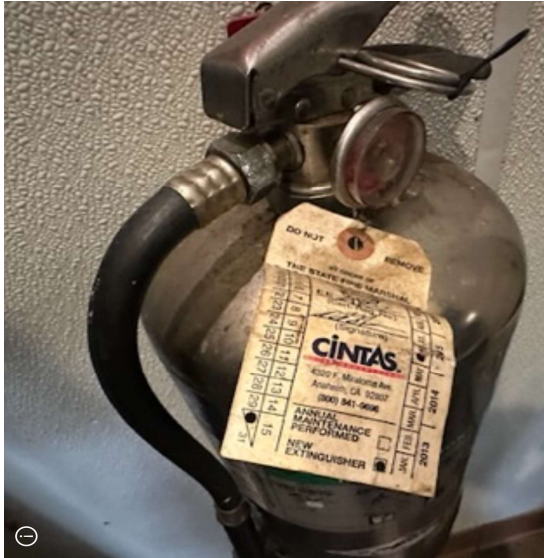
K Type fire extinguisher

Class K fire extinguisher inspection and service requirements are expired. An unmaintained extinguisher may fail during a grease fire, increasing the risk of uncontrolled fire spread. Replace or service the extinguisher immediately and maintain inspections in accordance with NFPA standards.
