# Inspection Report

## Customer Example

**HERO Home Inspection Services**

<b>Date:</b> 1/1/2020	<b>Time:</b> 10:00 AM	<b>Report ID:</b>
<b>Property:</b> Your Address Your City GA Your Zip Code	<b>Customer:</b> Customer Example	<b>Real Estate Professional:</b> Your Realtor Example Real Estate Brokerage

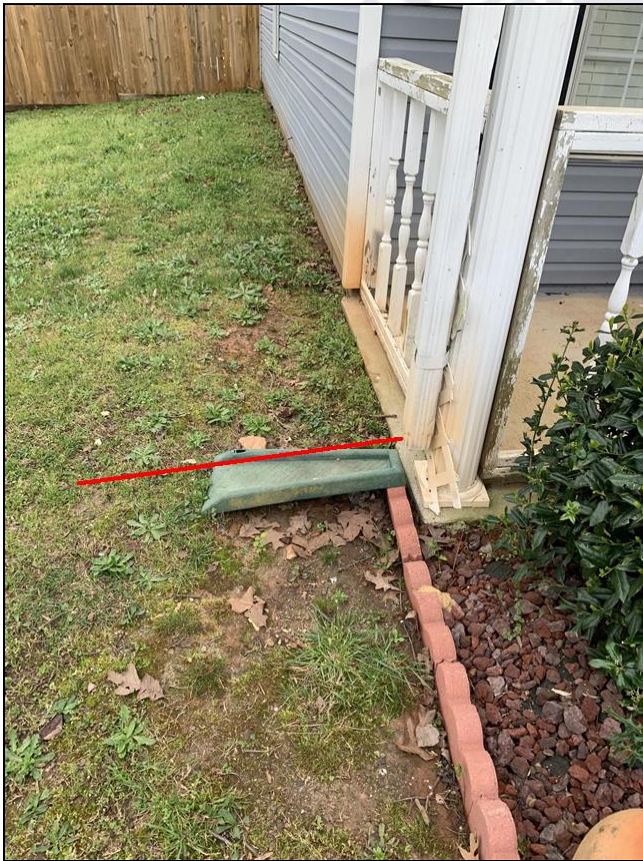
1.3 Item 1(Picture)

**1.3 (1)** One or more downspouts discharged roof drainage next to the foundation. This condition can effect the ability of the soil to support the weight of the structure above and can cause damage related to soil/foundation movement. The Inspector recommends the installation of downspout extensions to discharge roof drainage a minimum of 6 feet from the foundation.

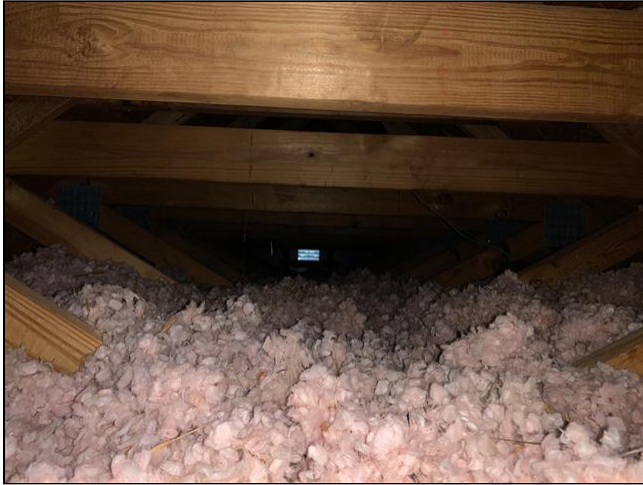
2.0 Item 1(Picture)

**2.0** The attic space lacked adequate headroom for safe entry. As a result, inspection of the attic space lies beyond the scope of the General Home Inspection and it was not fully inspected. The interior wall accesses were painted shut and was not accessed by the inspector.

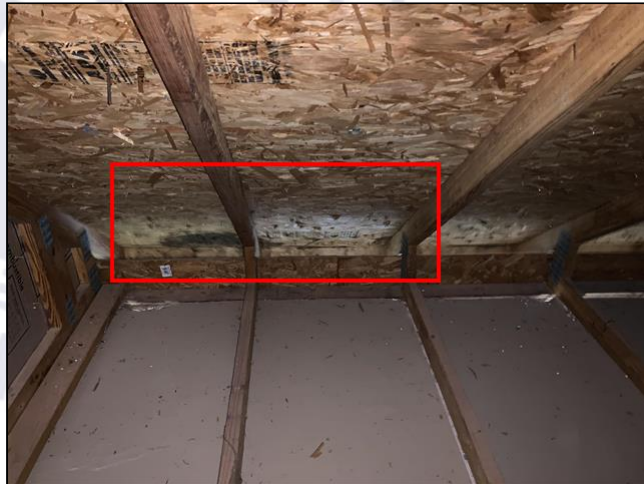
2.3 Item 1(Picture)

**2.3** Roof sheathing had areas of discoloration that appeared to be the result of roof leakage. Although the roof had experienced recent rain, sheathing did not have elevated moisture levels at the time of the inspection. The source of the leak appeared to have been corrected.

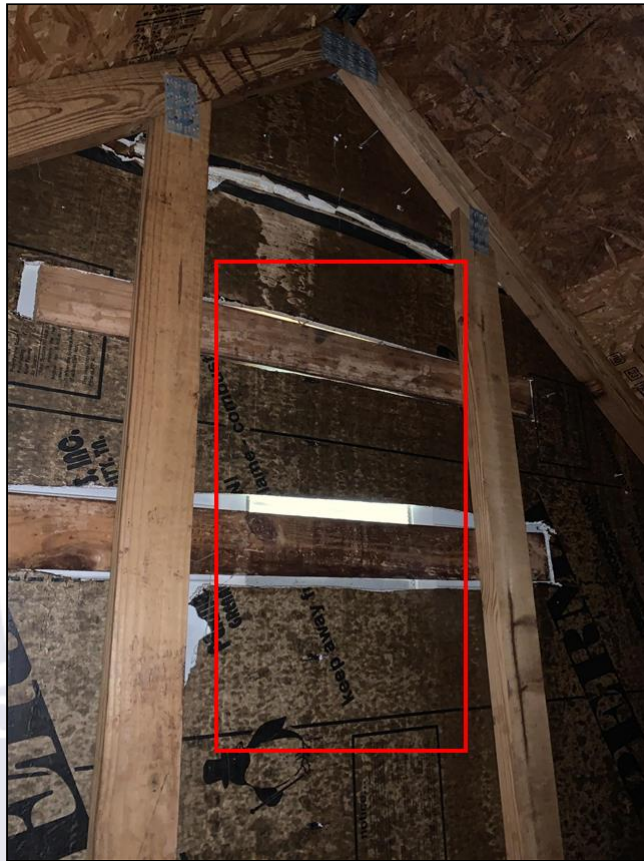
2.4 Item 1(Picture)

**2.4** Gable vents were installed as attic ventilation devices. The performance of gable vents can vary with wind direction and opening size. This vent was likely sealed with the new roof install and may not be necessary due to installation of ridge vent.

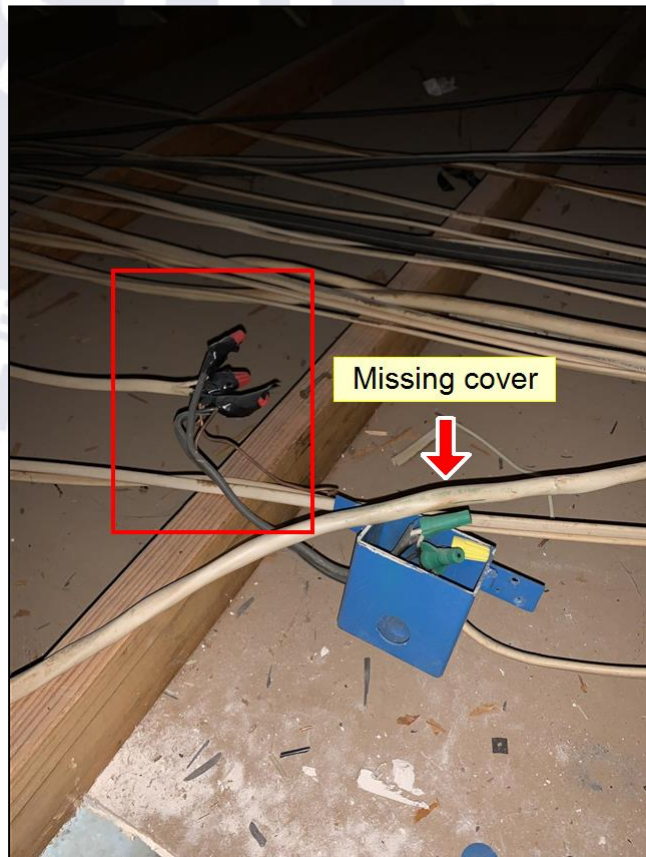
2.5 Item 1(Picture)

**2.5** Energized electrical splices not contained within a junction box and exposed to touch were visible in the attic at the time of the inspection. Electrical splices should be contained within an approved junction box with a cover plate installed. This condition is a shock/ electrocution and potential fire hazard and should be corrected by a qualified electrical contractor.

Energized electrical splices not contained within a junction box and exposed to touch were visible in the attic at the time of the inspection. Electrical splices should be contained within an approved junction box with a cover plate installed. This condition is a shock/electrocution and potential fire hazard and should be corrected by a qualified electrical contractor.

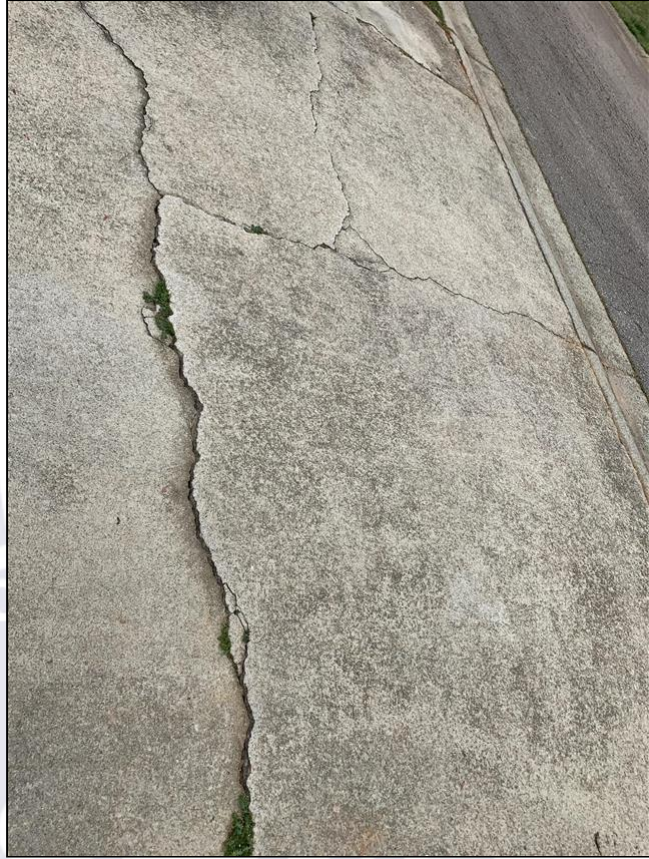
3.0 Item 1(Picture)

**3.0** Significant cracks visible in the driveway at the time of the inspection should be filled with an appropriate sealant to avoid continued damage to the driveway surface from freezing moisture.

Significant cracks visible in the driveway at the time of the inspection should be filled with an appropriate sealant to avoid continued damage to the driveway surface from freezing moisture.

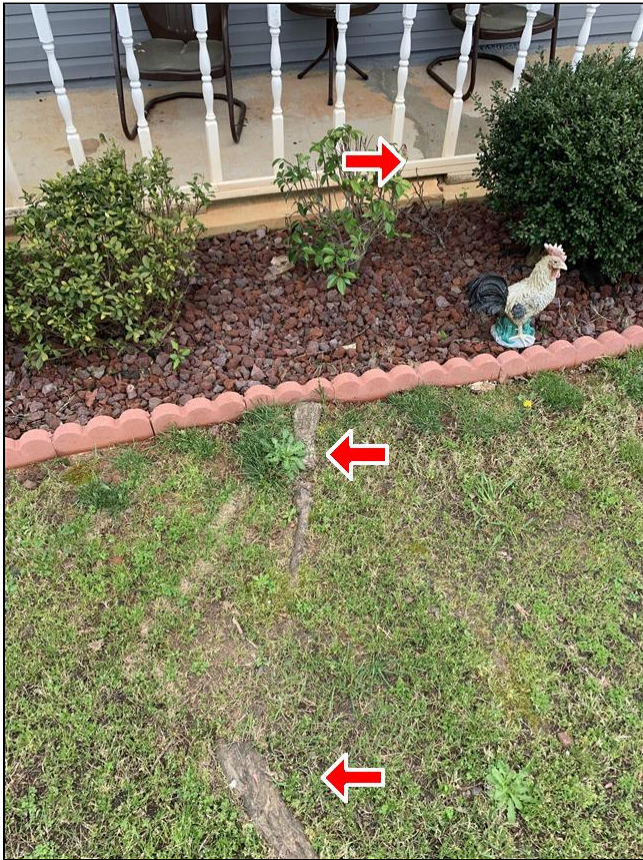
3.1 Item 1(Picture)

**3.1** Tree roots had caused heaving and damage to walkways. These areas are trip hazards. The roots should be removed to prevent future growth and damage to the home's foundation. All work to be performed by a licensed contractor.

Tree roots had caused heaving and damage to walkways. These areas are trip hazards. The roots should be removed to prevent future growth and damage to the home's foundation. All work to be performed by a licensed contractor.

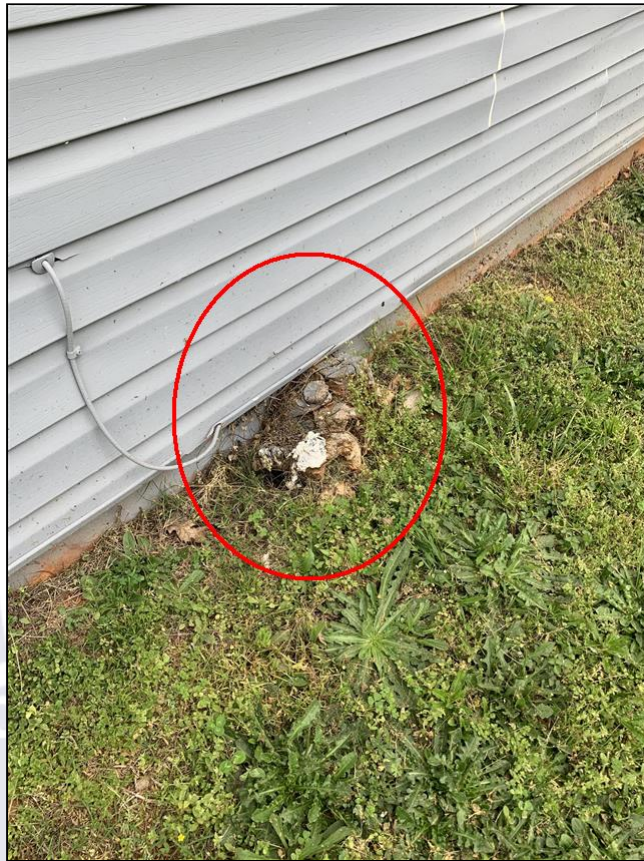
3.2 Item 1(Picture)

**3.2 (1)** The roots should be removed to prevent future growth and damage to the home's foundation. All work to be performed by a licensed contractor.

(1) The roots should be removed to prevent future growth and damage to the home's foundation. All work to be performed by a licensed contractor.

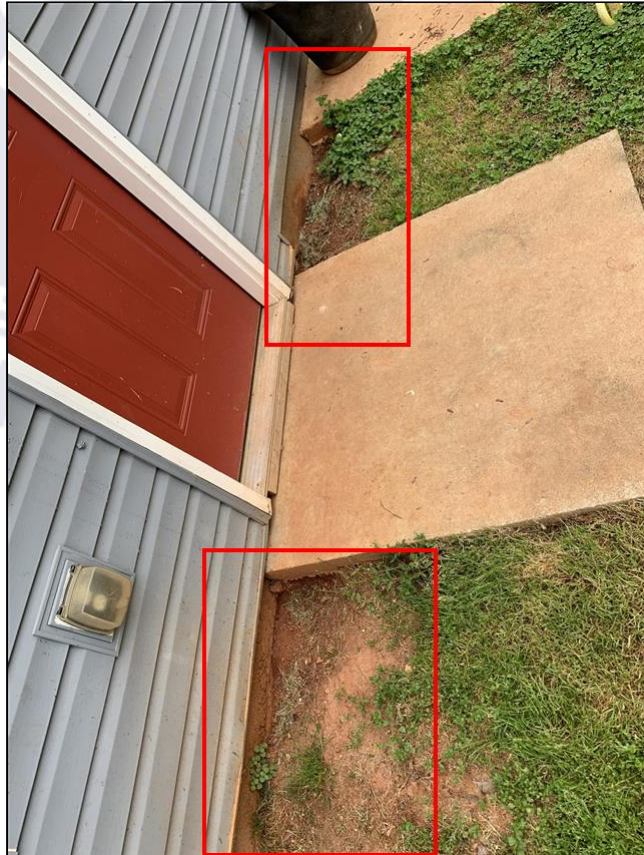
3.2 Item 2(Picture)

**3.2 (2)** The home had areas of erosion visible that will continue unless action is taken to prevent it. The Inspector recommends that before the expiration of your Inspection Objection Deadline you consult with a qualified landscape contractor to gain an idea of options and costs for correction.

(2) The home had areas of erosion visible that will continue unless action is taken to prevent it. The Inspector recommends that before the expiration of your Inspection Objection Deadline you consult with a qualified landscape contractor to gain an idea of options and costs for correction.

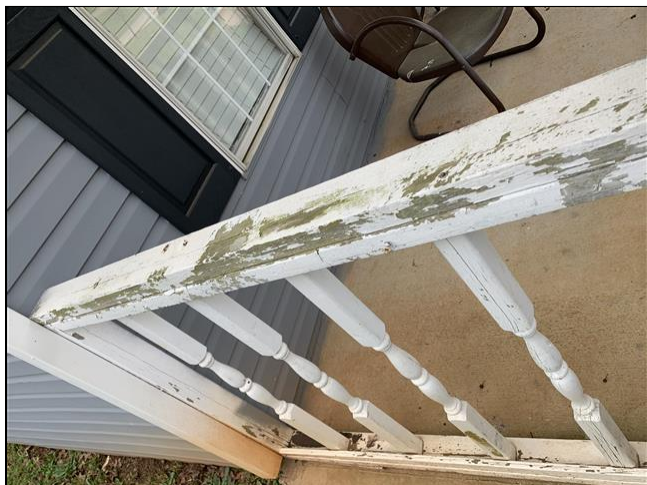
3.4 Item 1(Picture)

**3.4** The porch had peeling paint that needed maintenance. Failure to maintain the finish coating will allow Ultra Violet (UV) radiation from sunlight, heat, moisture and freezing moisture to reduce the lifespan of bare wood exposed to weather. The Inspector recommends that before the expiration of your Inspection Objection Deadline, you consult with a qualified contractor to discuss options and costs for refinishing wood components as necessary.

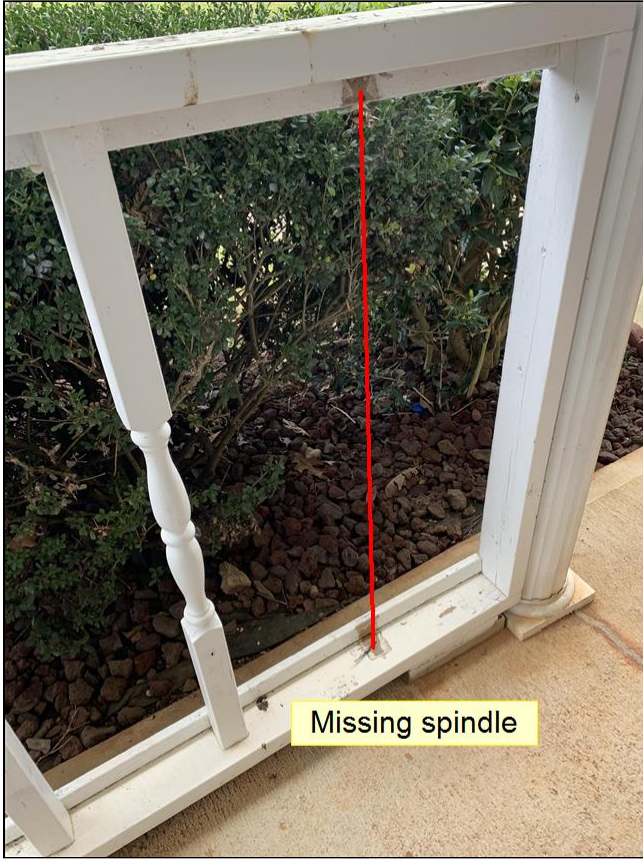
3.4 Item 3(Picture)

Missing spindle

The porch had peeling paint that needed maintenance. Failure to maintain the finish coating will allow Ultra Violet (UV) radiation from sunlight, heat, moisture and freezing moisture to reduce the lifespan of bare wood exposed to weather. The Inspector recommends that before the expiration of your Inspection Objection Deadline, you consult with a qualified contractor to discuss options and costs for refinishing wood components as necessary.

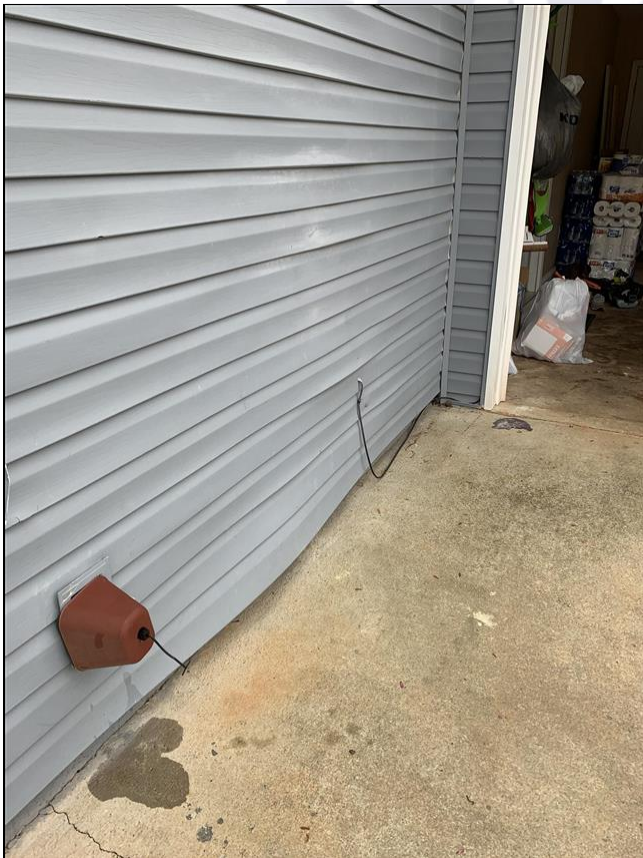
4.4 Item 1(Picture)

**4.4** Areas of loose or sagging vinyl siding covering exterior walls indicated failure of the fastening method. Vinyl siding in these areas should be re-fastened or replaced to prevent damage to the siding and to prevent potential damage from moisture intrusion to the home materials, the exterior wall structure and to prevent development of microbial growth such as mold. All work should be performed by a qualified contractor.

Areas of loose or sagging vinyl siding covering exterior walls indicated failure of the fastening method. Vinyl siding in these areas should be re-fastened or replaced to prevent damage to the siding and to prevent potential damage from moisture intrusion to the home materials, the exterior wall structure and to prevent development of microbial growth such as mold. All work should be performed by a qualified contractor.

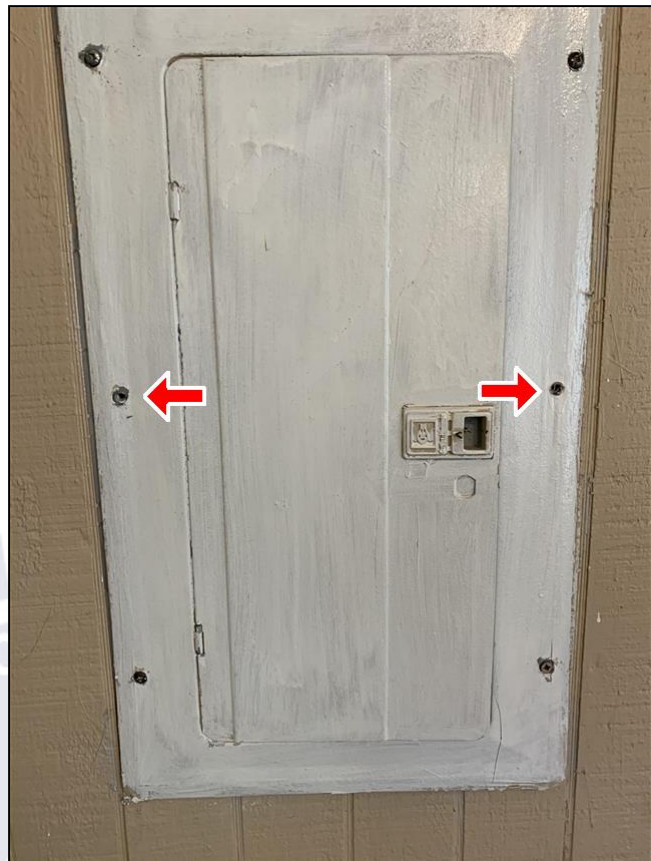
6.7 Item 1(Picture)

**6.7** The service panel cabinet was missing mounting screws at the time of the inspection. The Inspector recommends replacement by a qualified electrical contractor.

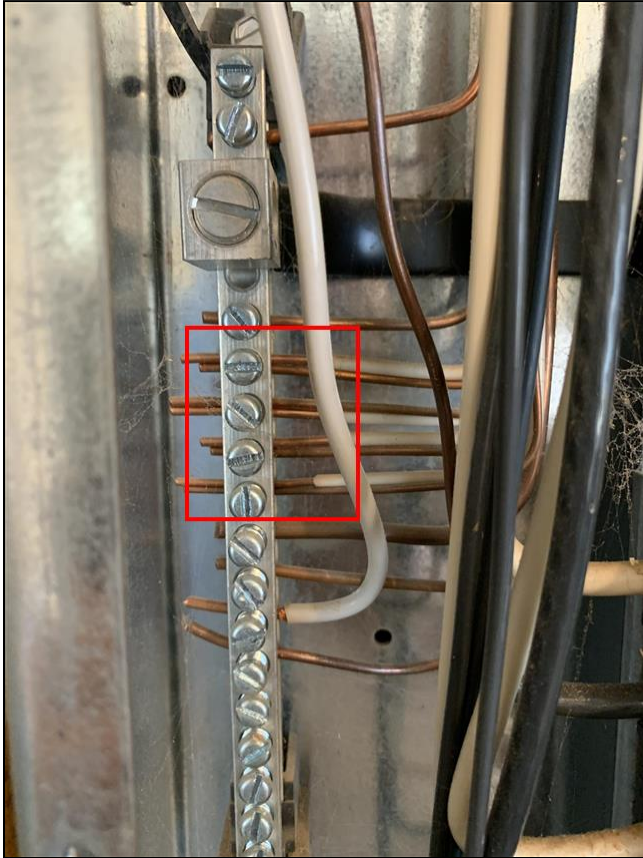
6.8 Item 1(Picture)

**6.8** In the service panel, two conductors were installed in a neutral lug designed for only one. This condition is improper. The inspector recommends correction by a qualified electrical contractor.

In the service panel, two conductors were installed in a neutral lug designed for only one. This condition is improper. The inspector recommends correction by a qualified electrical contractor.

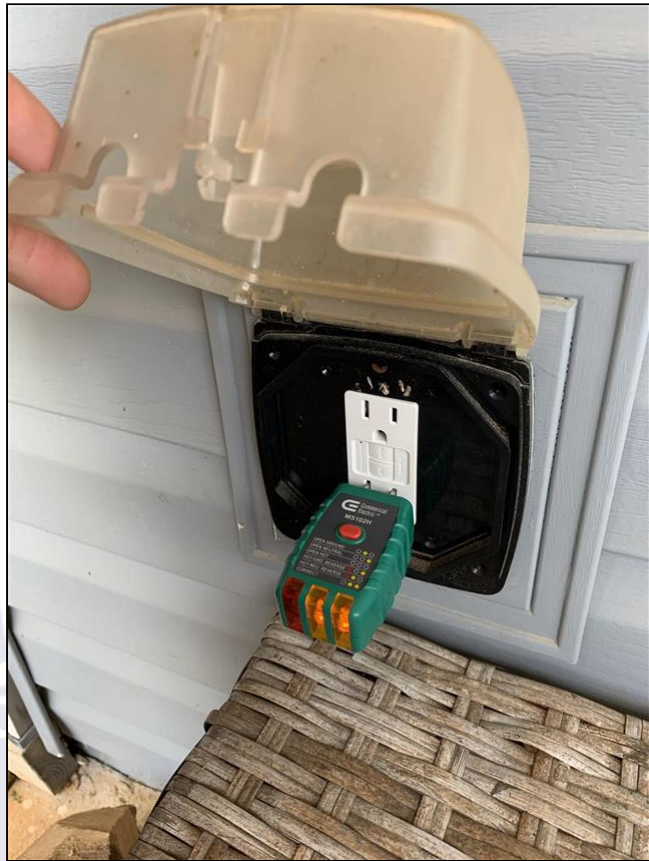
6.13 Item 1(Picture)

**6.13** At the time of the inspection, the inspector observed no deficiencies in the condition of the home exterior electrical receptacles.

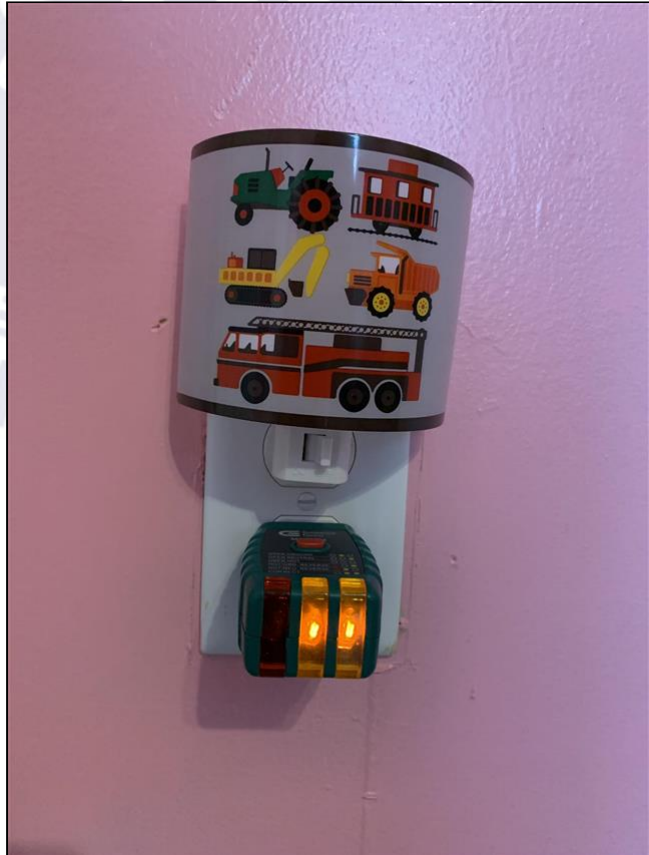
6.14 Item 1(Picture)

**6.14** At the time of the inspection, the Inspector observed no deficiencies in the condition of electrical receptacles in the home.

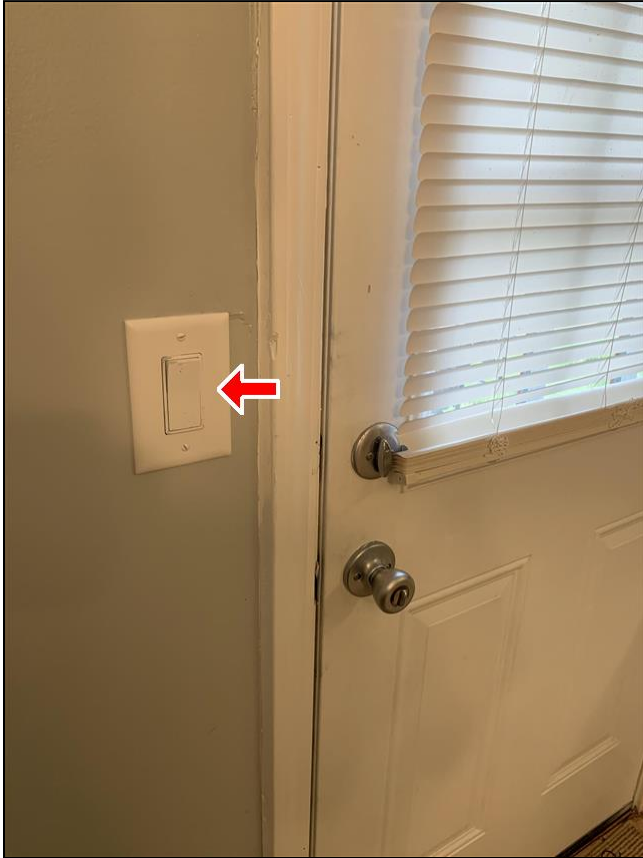
6.16 Item 1(Picture)

**6.16** A light fixture controlled by a switch appears to have been removed in the rear of the home. The inspector recommends asking the homeowner about the condition.

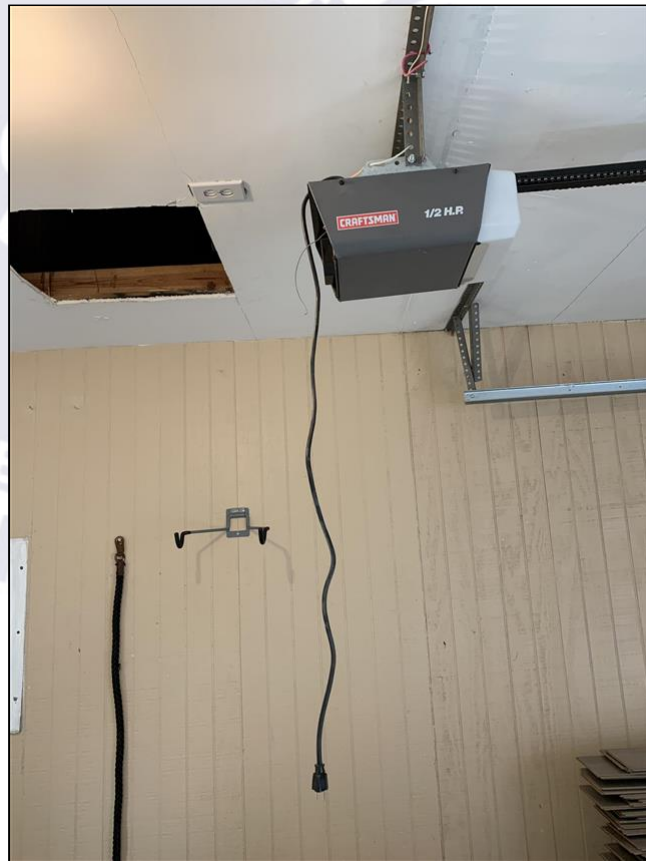
7.0 Item 1(Picture)

**7.0** One automatic opener was unplugged at the time of the inspection. Plugging in disconnected appliances exceeds the scope of the General Home Inspection. You should ask the seller about the operation of any unplugged openers before attempting to operate them.

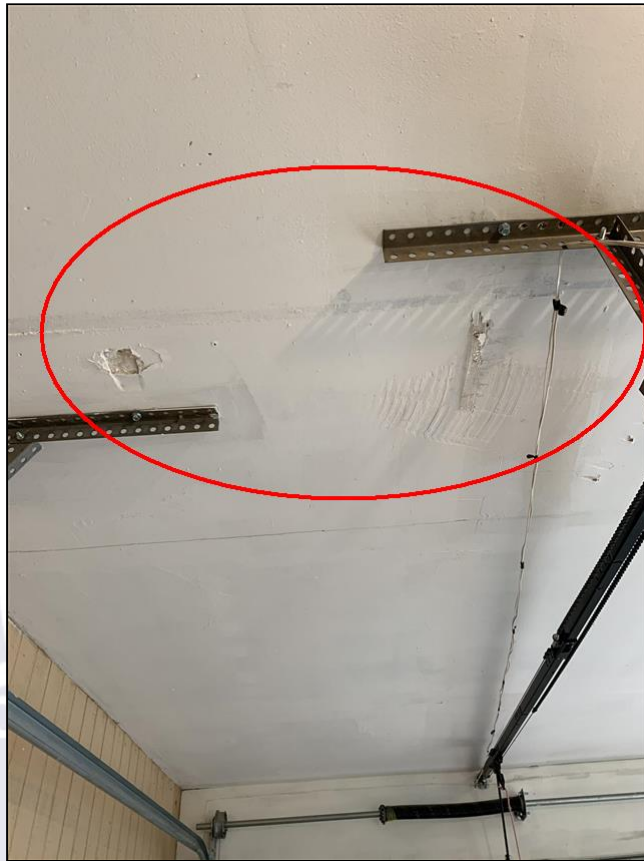
7.4 Item 1(Picture)

**7.4** The garage ceilings had minor damage visible at the time of the inspection that is likely related to poor install.

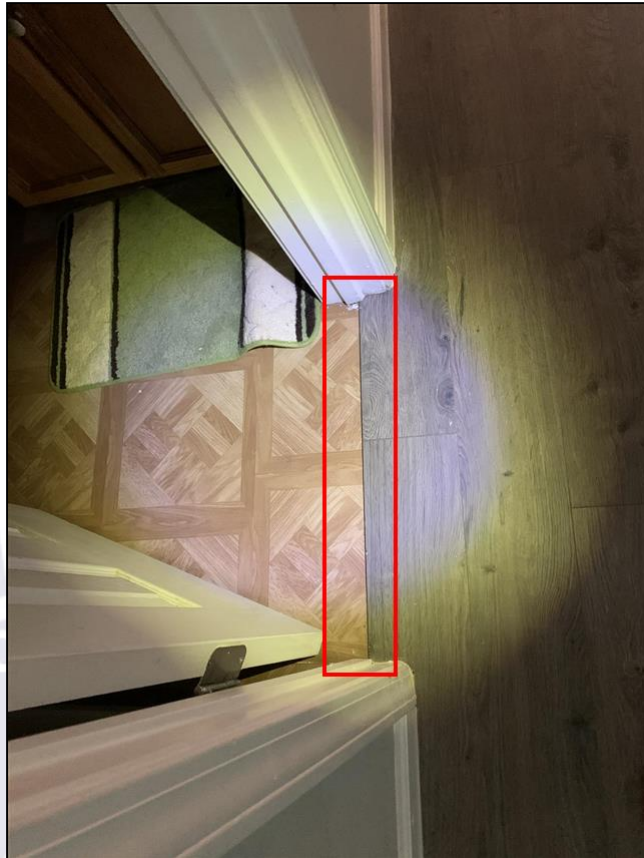
8.0 Item 1(Picture)

**8.0** The inspector noted a missing flooring threshold in the bathroom floor transition. This can lead to separation of flooring material and toe injury. The inspector recommends the installation of threshold by a qualified person.

The inspector noted a missing flooring threshold in the bathroom floor transition. This can lead to separation of flooring material and toe injury. The inspector recommends the installation of threshold by a qualified person.

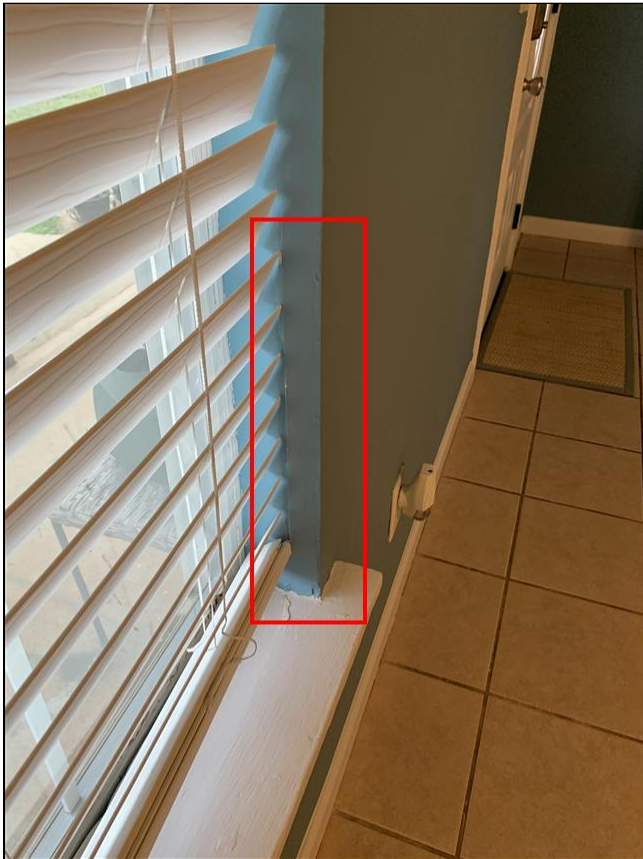
8.1 Item 1(Picture)

8.1 Drywall in the living room exhibited evidence of poor installation practices at the time of the inspection.

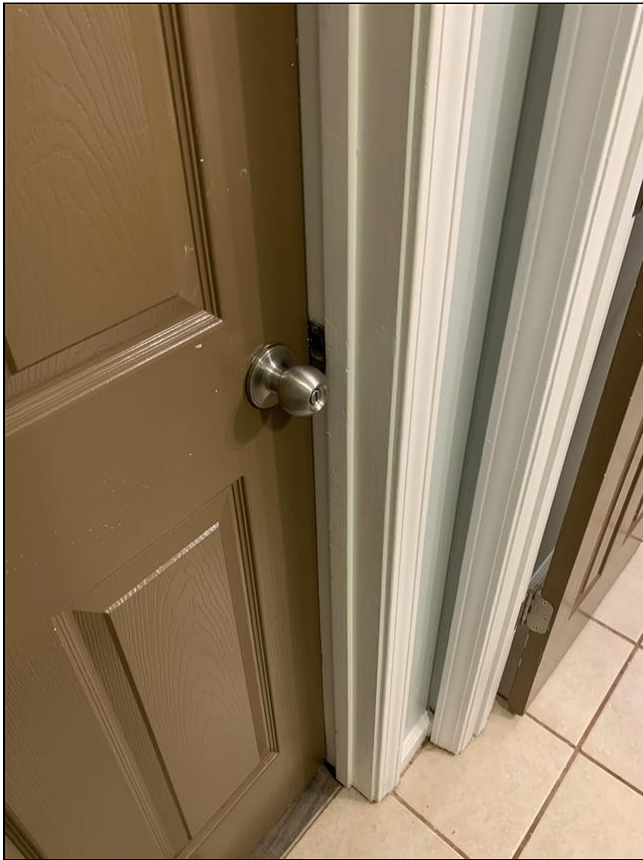
8.5 Item 1(Picture)

**8.5** The latch bolts of these interior doors did not align with the hole in the strike plate and did not hold the door closed. This door will need adjustment to operate properly. The Inspector recommends service by a qualified contractor.

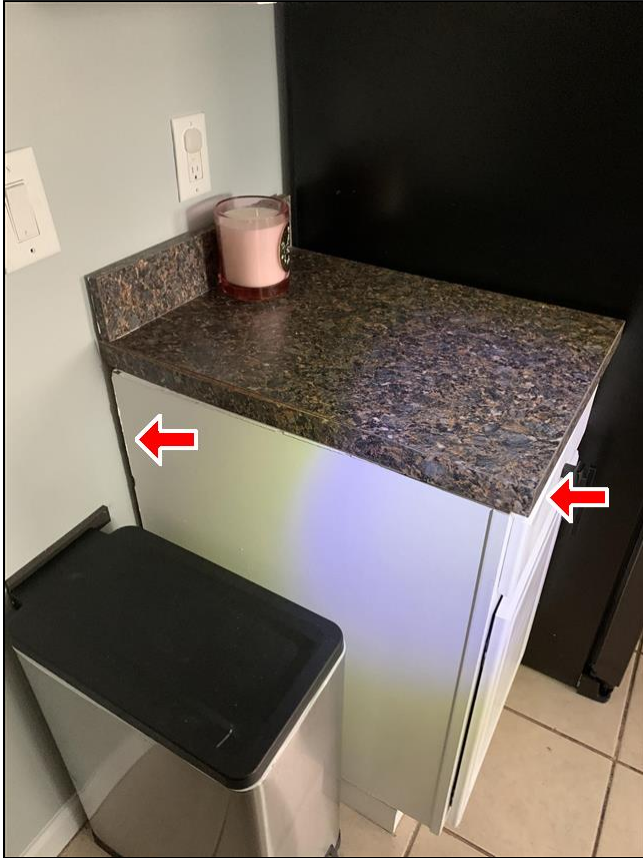
8.8 Item 1(Picture)

8.8 In the kitchen, countertops were not completely fastened to the cabinets. This condition should be corrected by a qualified contractor.

In the kitchen, countertops were not completely fastened to the cabinets. This condition should be corrected by a qualified contractor.

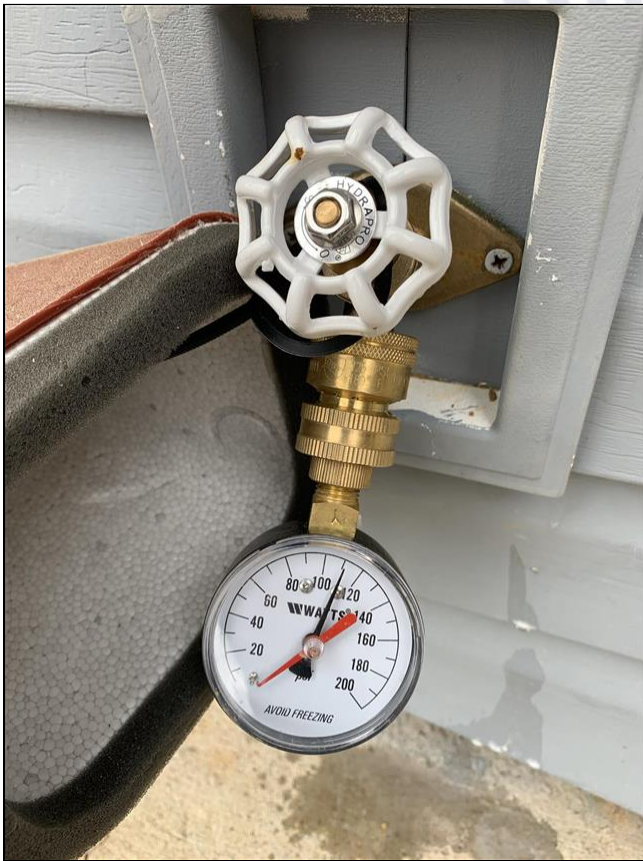
9.0 Item 1(Picture)

**9.0** At the time of the inspection, the Inspector observed no deficiencies in the condition of exterior water faucets.

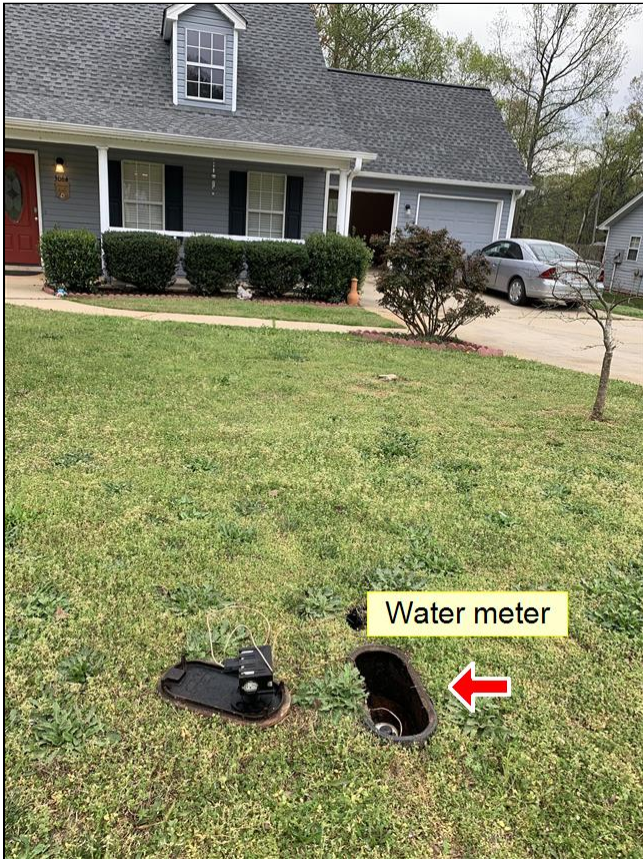
9.1 Item 1(Picture)

9.1 The home water was supplied from a public source.

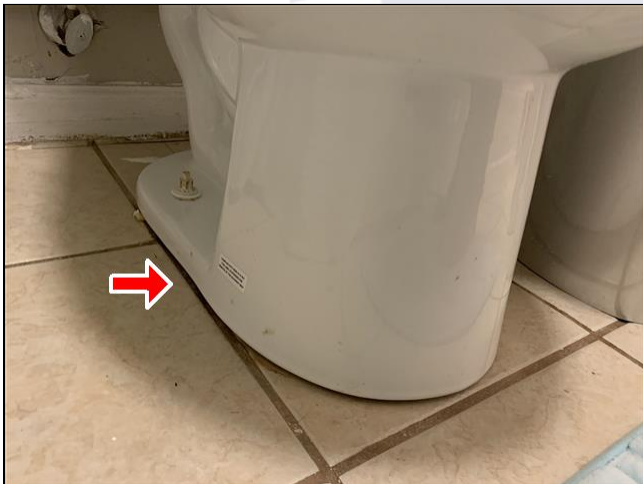
12.10 Item 1(Picture)

**12.10** In the upstairs hallway bathroom and main floor hallway bathroom, the toilet was loose at the floor and should be re-attached by a qualified plumbing contractor.

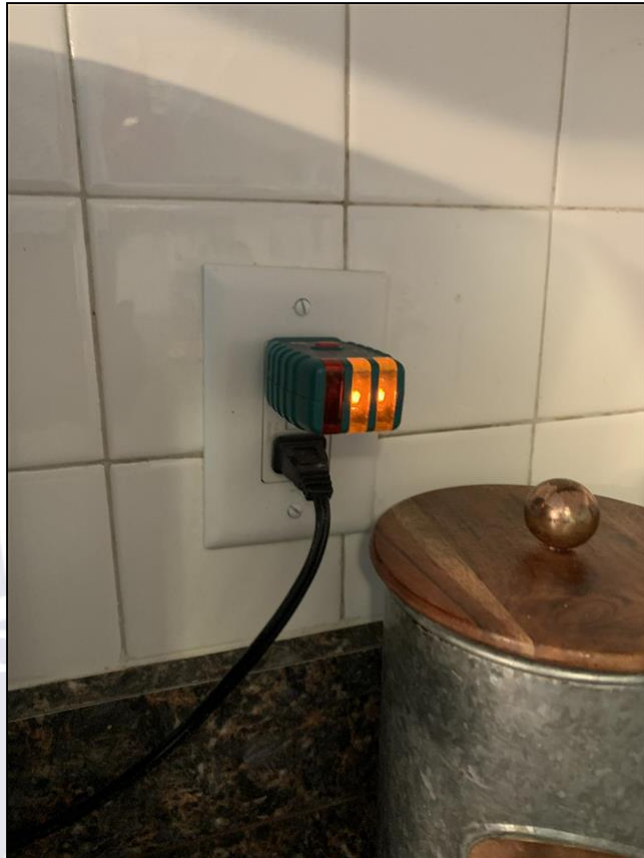
13.6 Item 1(Picture)

**13.6** A ground fault circuit interrupter (GFCI) electrical receptacle in the kitchen did not respond to testing at the time of the inspection. The Inspector recommends that this receptacle be replaced with a new GFCI receptacle by a qualified electrical contractor.

A ground fault circuit interrupter (GFCI) electrical receptacle in the kitchen did not respond to testing at the time of the inspection. The Inspector recommends that this receptacle be replaced with a new GFCI receptacle by a qualified electrical contractor.

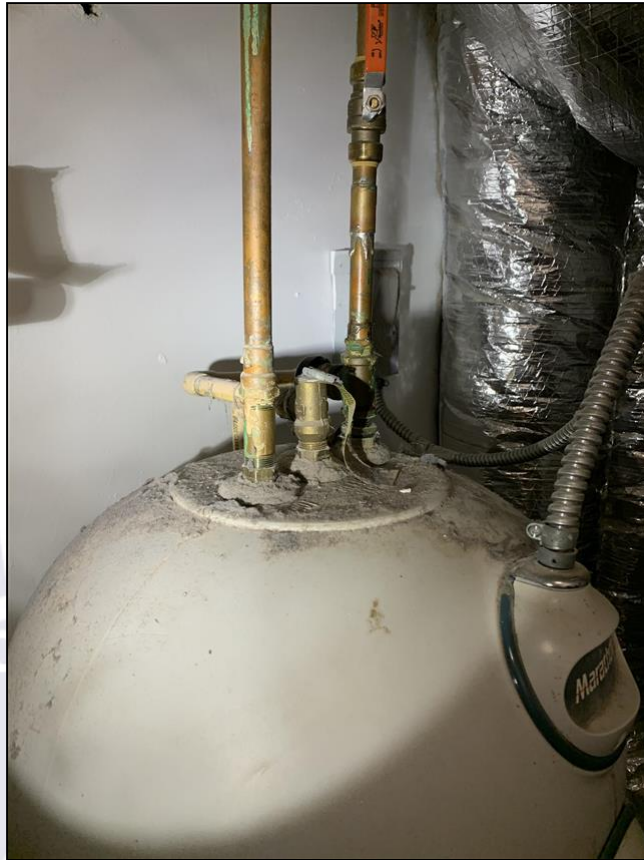
14.8 Item 1(Picture)

**14.8** The inspector noted lint buildup in areas of the laundry room which is usually suggestive of a damaged exhaust duct. The inspector did not locate any damage along the duct. Removal of debris and monitoring for future buildups is recommended along with repair as needed.
