Subject	Catch Basin #7 along 24/26 Talcott. Sediment approximately 3-1/2 below invert. Approximately 15 inches of sediment.	1
Site	Talcott Glen Storm Sewer System	
Date	9/26/2020

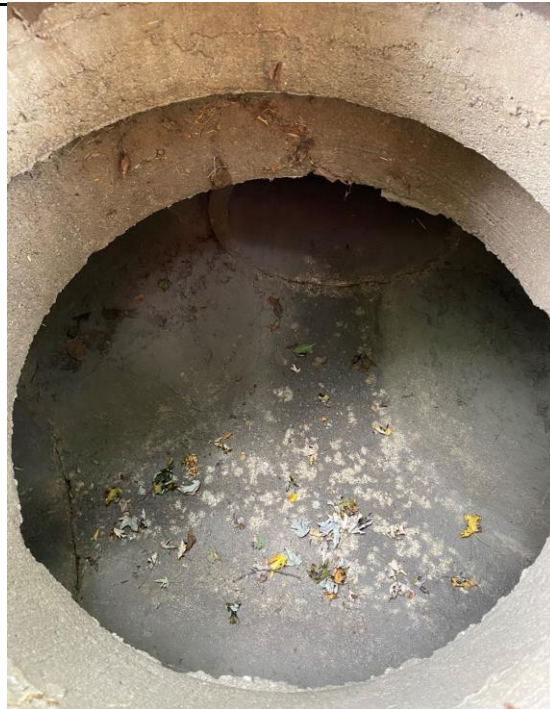
Subject	Manhole #5, backyard of 19 Talcott. Structure receives flow from both cul-du-sacs. Clean - no sediment.	2
Site	Talcott Glen Storm Sewer System	
Date	9/26/2020

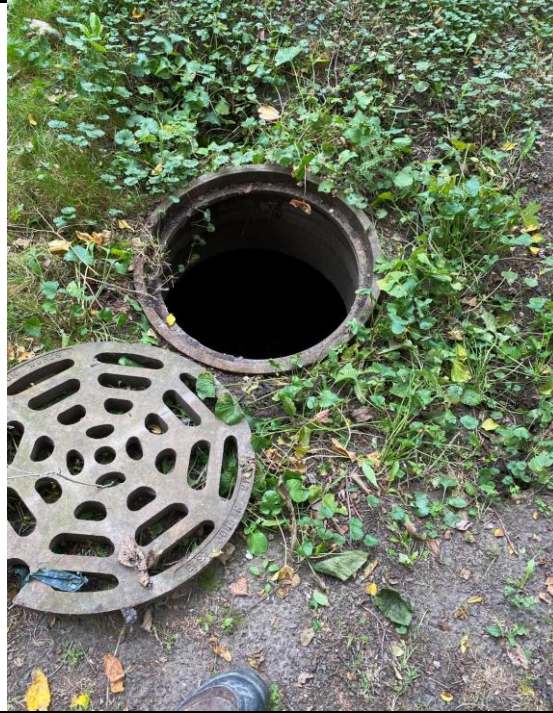
Subject	Catch Basin #4, backyard of 67 Talcott. Needs topsoil around structure.	3
Site	Talcott Glen Storm Sewer System	
Date	9/26/2020

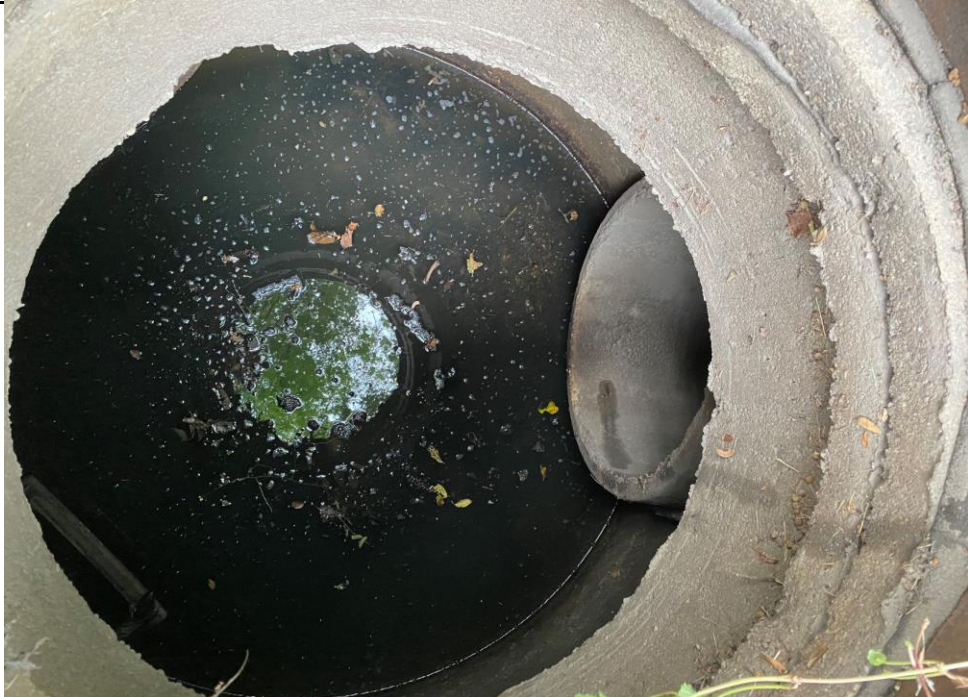
Subject	Catch Basin #4, 67 Talcott. Sediment 8 inches below invert. Approx 30 inches sediment.	4
Site	Talcott Glen Storm Sewer System	
Date	9/26/2020

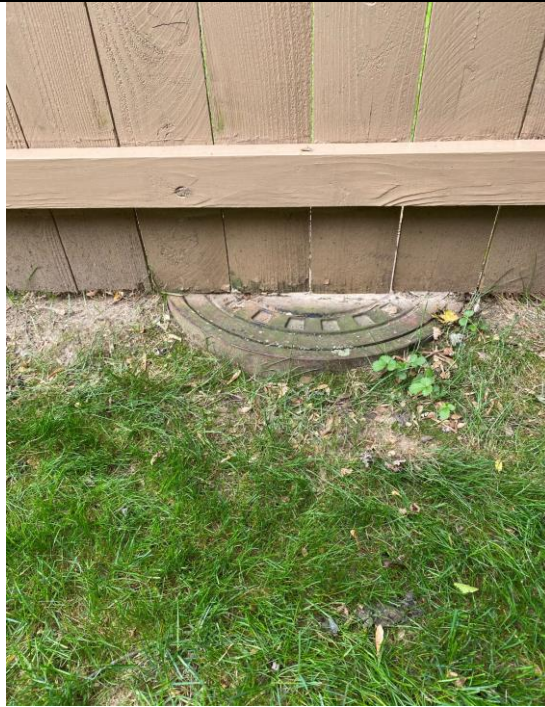
Subject	Manhole #7, along 44/46 Talcott. Fence owned by 44 Talcott constructed over manhole.	5
Site	Talcott Glen Storm Sewer System	
Date	9/26/2020

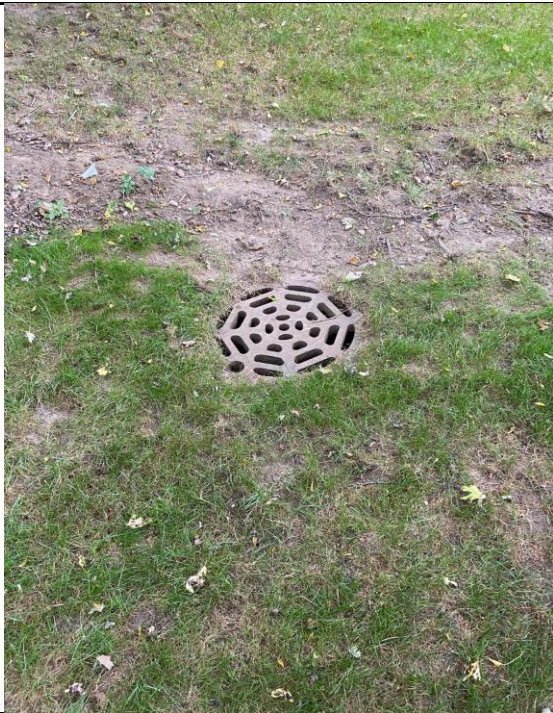
Subject	Catch Basin #14, along 46/48 Talcott. Clean, no sediment.	6
Site	Talcott Glen Storm Sewer System	
Date	9/26/2020

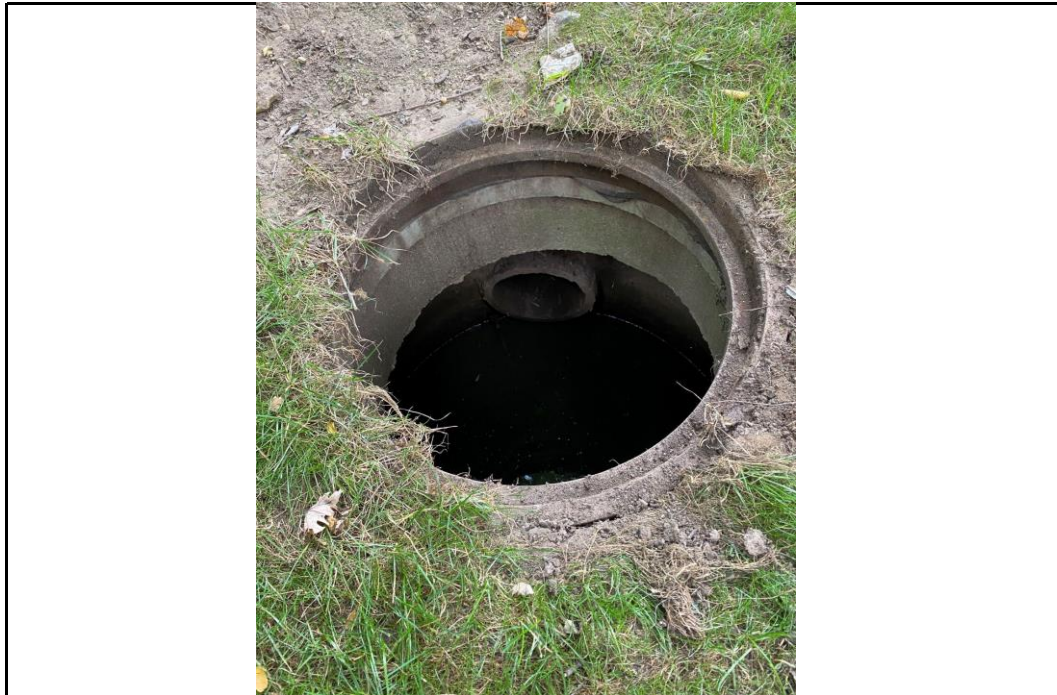
Subject	Catch Basin #14, along 46/48 Talcott. Clean, no sediment.	7
Site	Talcott Glen Storm Sewer System	
Date	9/26/2020

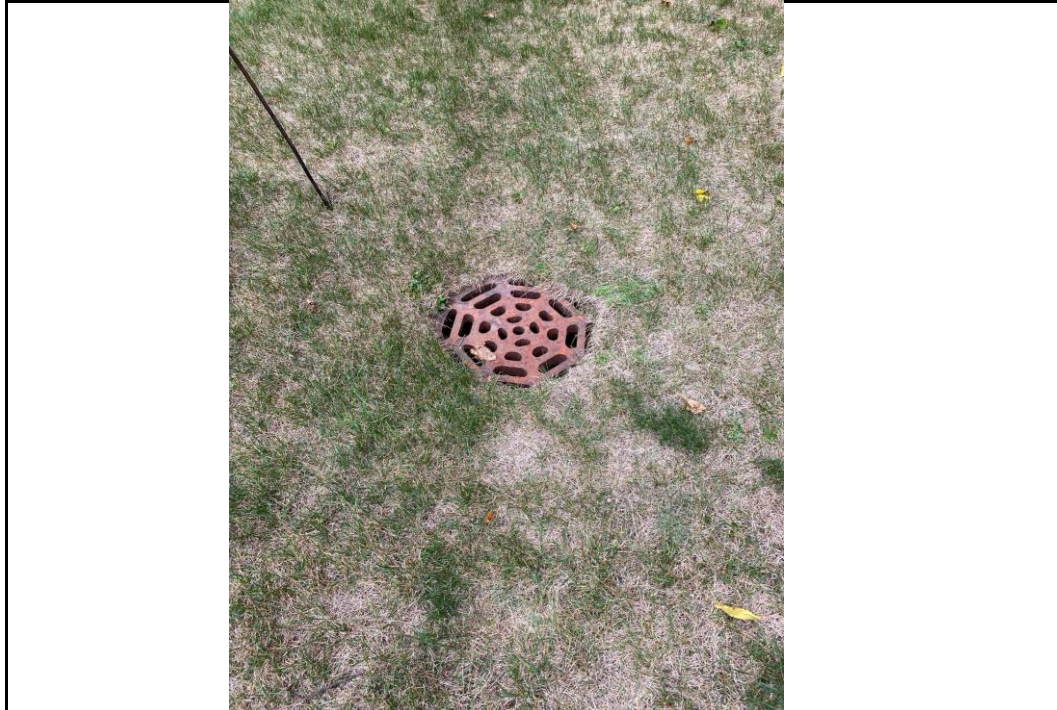
Subject	Catch Basin #25 backyard of 48 Talcott.	8
Site	Talcott Glen Storm Sewer System	
Date	9/26/2020

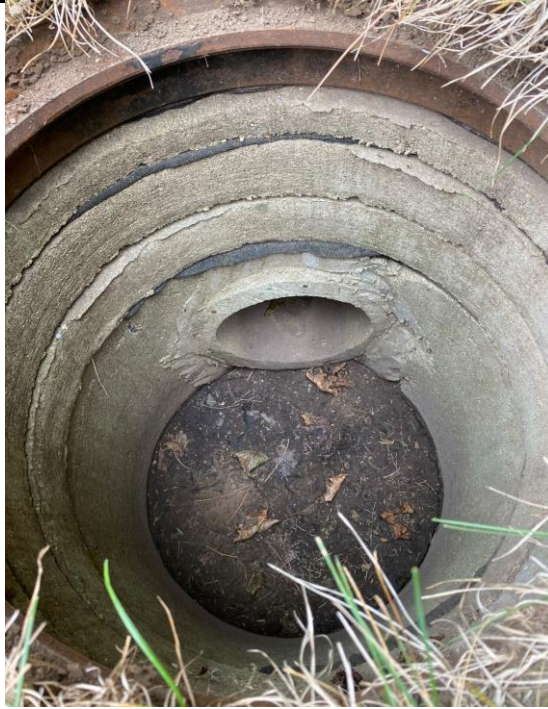
Subject	Catch Basin #25 backyard of 48 Talcott. Dry sediment 3 inches below invert. Approx 13 inches sediment at thickest point.	9
Site	Talcott Glen Storm Sewer System	
Date	9/26/2020

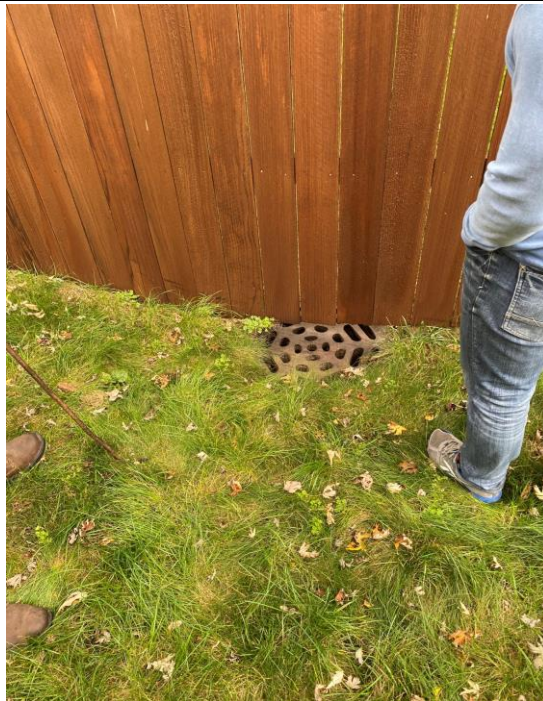
Subject	Catch Basin #2. Fence along 42/44 Talcott built over catch basin, owned by 44 Talcott	10
Site	Talcott Glen Storm Sewer System	
Date	9/26/2020

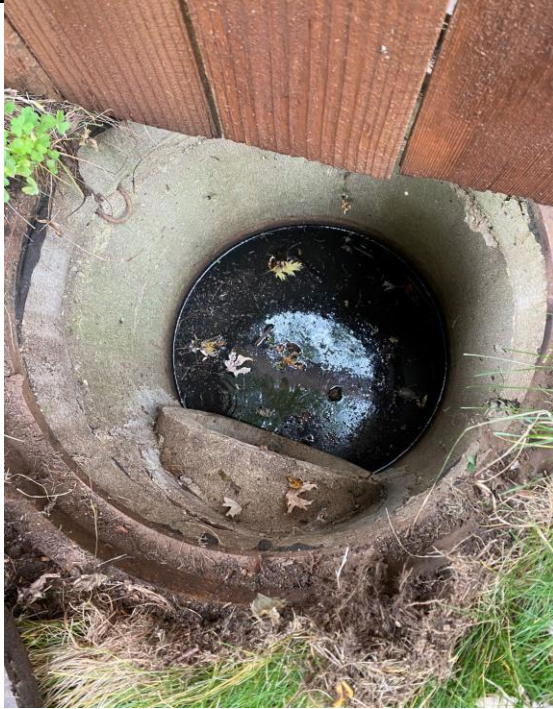
Subject	Catch Basin #2, 44 Talcott. Sediment 4 inches below invert. Approx 13 inches sediment.	11
Site	Talcott Glen Storm Sewer System	
Date	9/26/2020

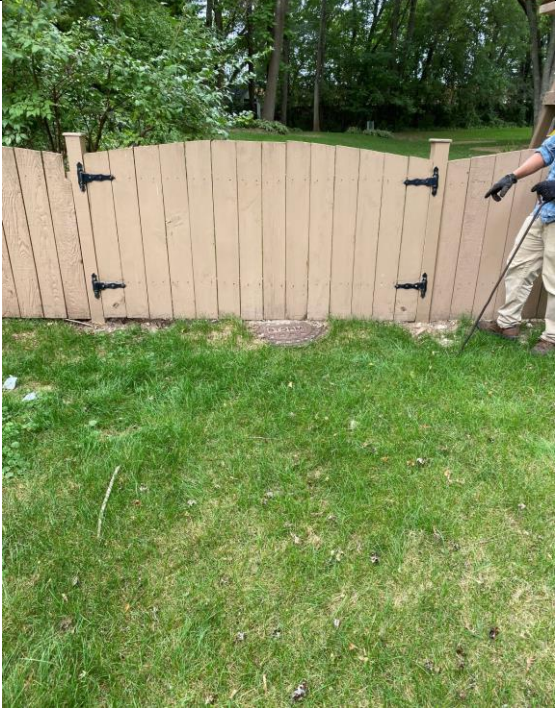
Subject	44/46 Talcott. Manhole #7. Removable fence owned by 44 Talcott overlies structure.	12
Site	Talcott Glen Storm Sewer System	
Date	9/26/2020

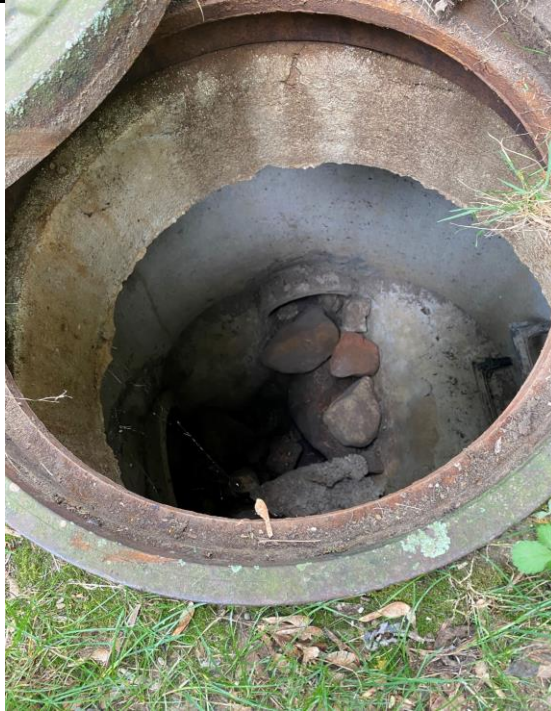
Subject	44/46 Talcott. Manhole #7. Clean, no sediment, few rocks.	13
Site	Talcott Glen Storm Sewer System	
Date	9/26/2020

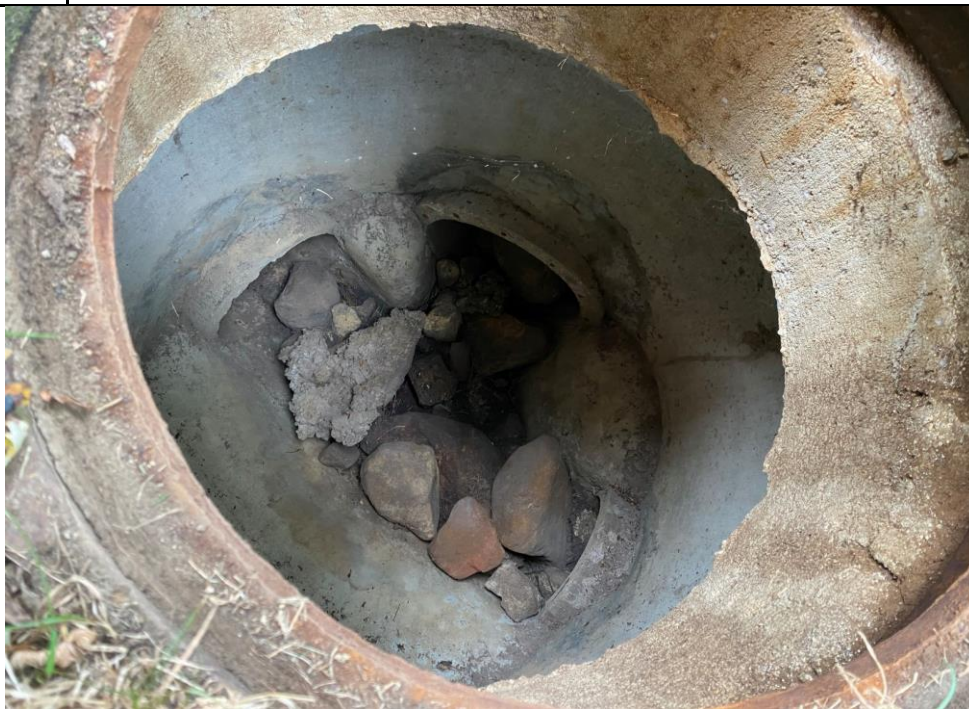
Subject	44/46 Talcott. Manhole #7. Clean, no sediment, few rocks.	14
Site	Talcott Glen Storm Sewer System	
Date	9/26/2020

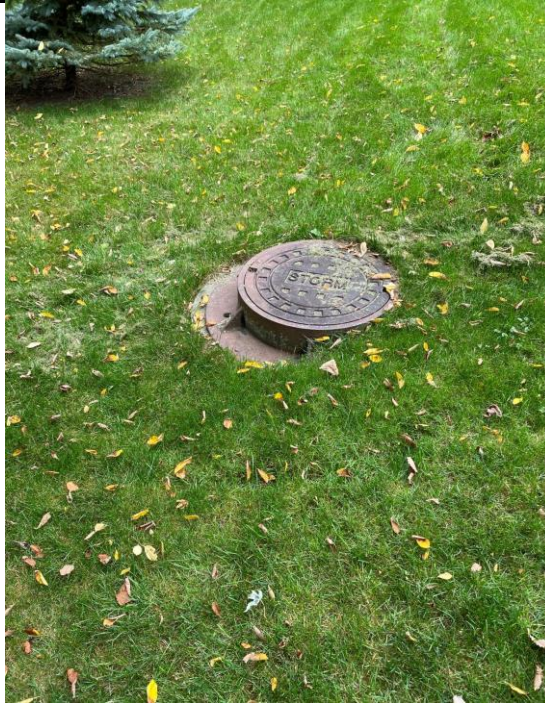
Subject	Manhole #12 behind 75 Talcott.	15
Site	Talcott Glen Storm Sewer System	
Date	9/26/2020

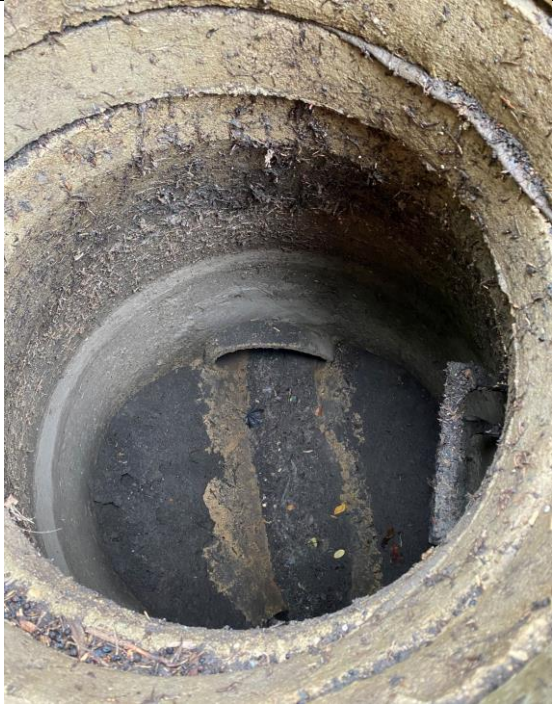
Subject	Manhole #12 behind 75 Talcott. Approximately 1/8 inch of sediment in invert.	16
Site	Talcott Glen Storm Sewer System	
Date	9/26/2020

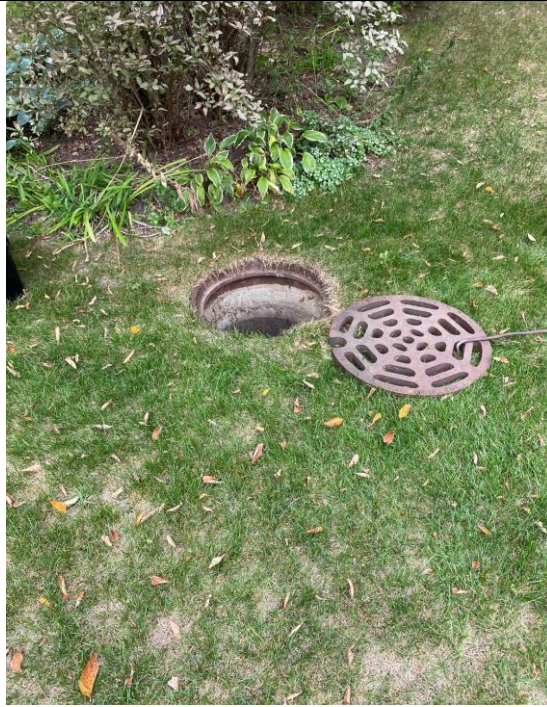
Subject	Manhole behind 77/81 Talcott.	17
Site	Talcott Glen Storm Sewer System	
Date	9/26/2020

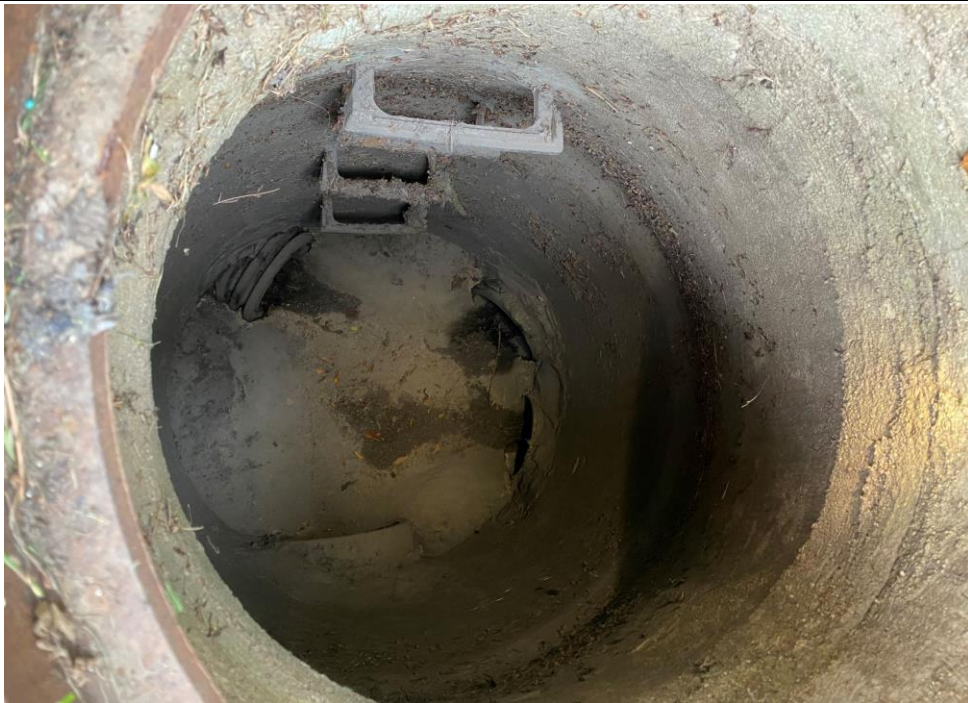
Subject	Manhole behind 77/81 Talcott. No sediment.	18
Site	Talcott Glen Storm Sewer System	
Date	9/26/2020

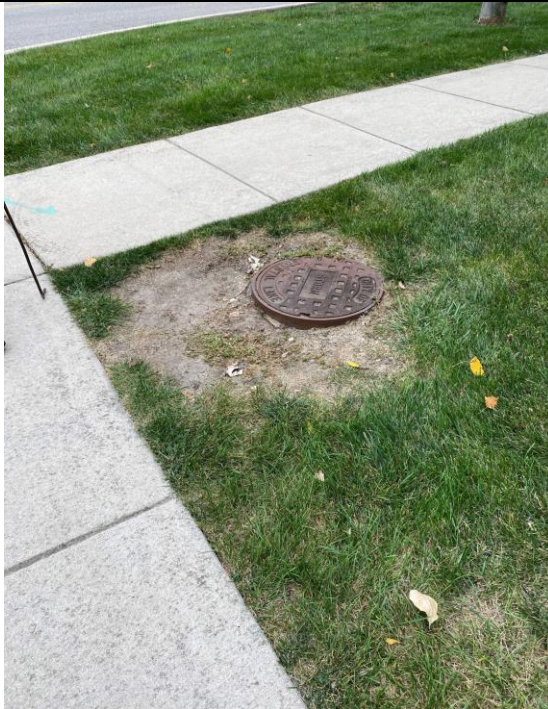
Subject	Catch Basin #18 on west side of subdivision entrance at Crystal Lake Ave, behind 4 Talcott.	19
Site	Talcott Glen Storm Sewer System	
Date	9/26/2020

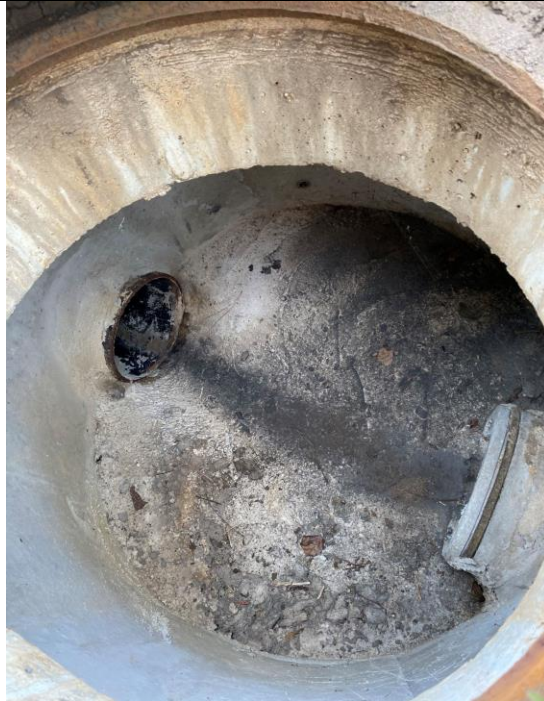
Subject	Catch Basin #18, clean, no sediment.	20
Site	Talcott Glen Storm Sewer System	
Date	9/26/2020

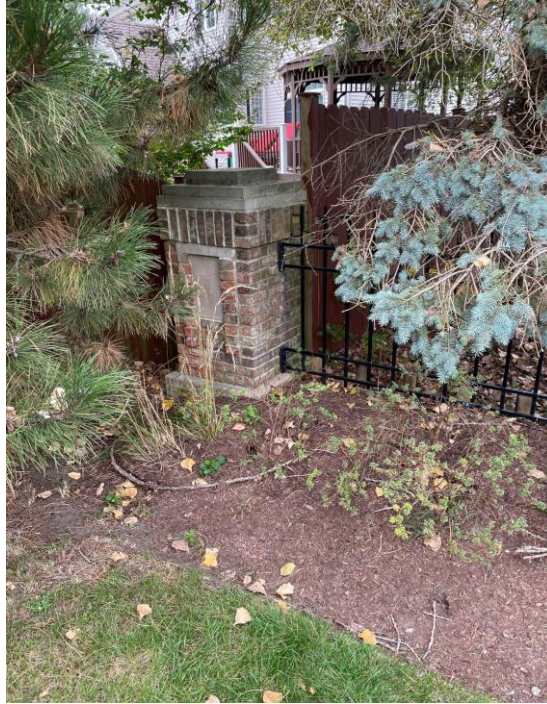
Subject	Monumentation on west side of entrance, westernmost section. Missing plate on monument.	21
Site	Talcott Glen Storm Sewer System	
Date	9/26/2020

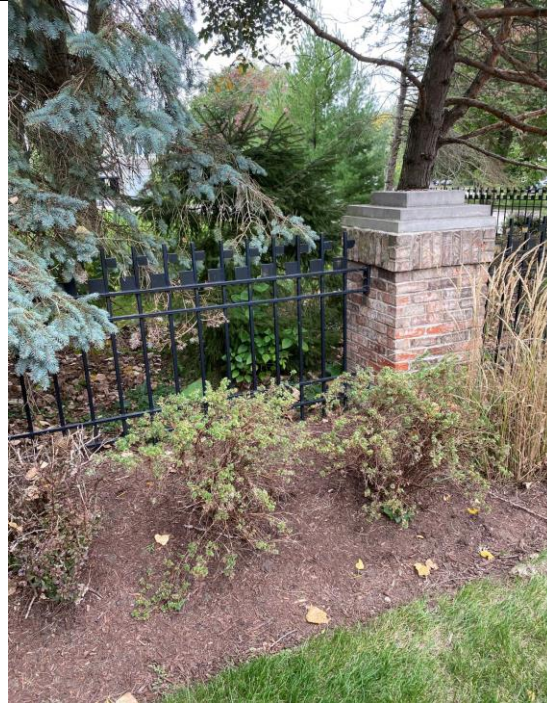
Subject	Monumentation on west side of entrance, west-central section.	22
Site	Talcott Glen Storm Sewer System	
Date	9/26/2020

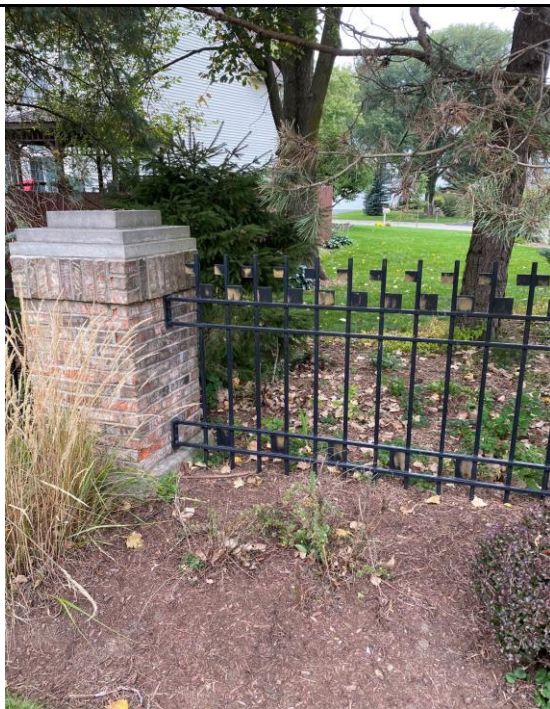
Subject	Monumentation on west side of entrance, east-central section.	23
Site	Talcott Glen Storm Sewer System	
Date	9/26/2020

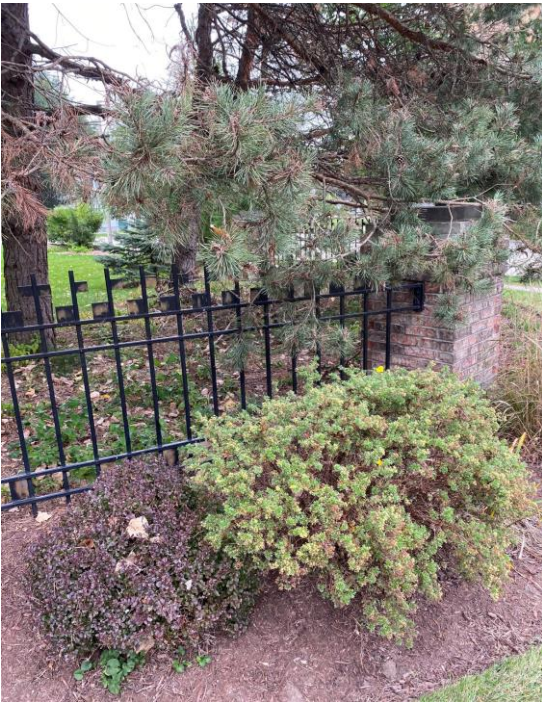
Subject	Monumentation on west side of entrance, northeasternmost section.	24
Site	Talcott Glen Storm Sewer System	
Date	9/26/2020

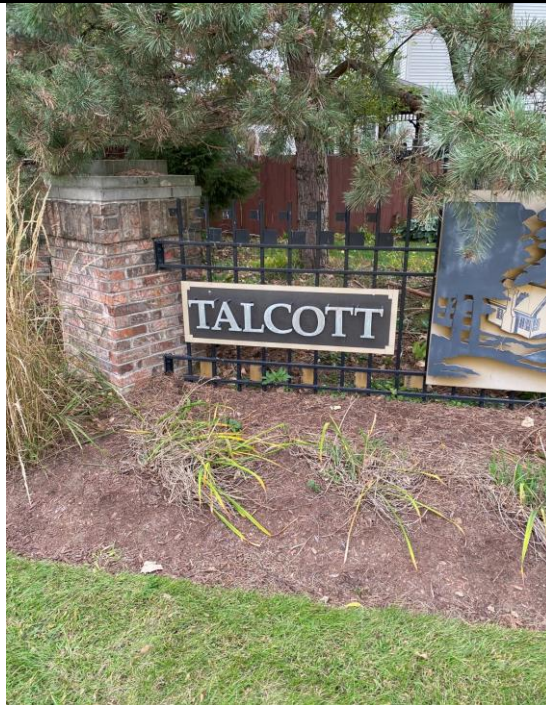
Subject	Monumentation on east side of entrance, west-central section.	25
Site	Talcott Glen Storm Sewer System	
Date	9/26/2020

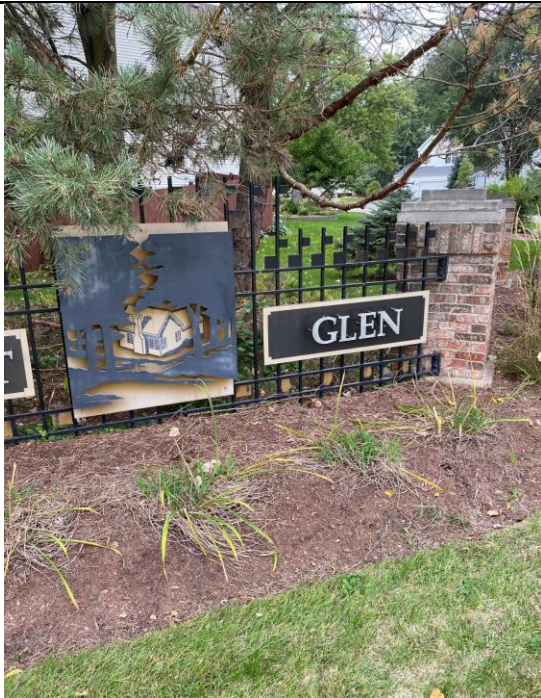
Subject	Monumentation on east side of entrance, east-central section.	26
Site	Talcott Glen Storm Sewer System	
Date	9/26/2020

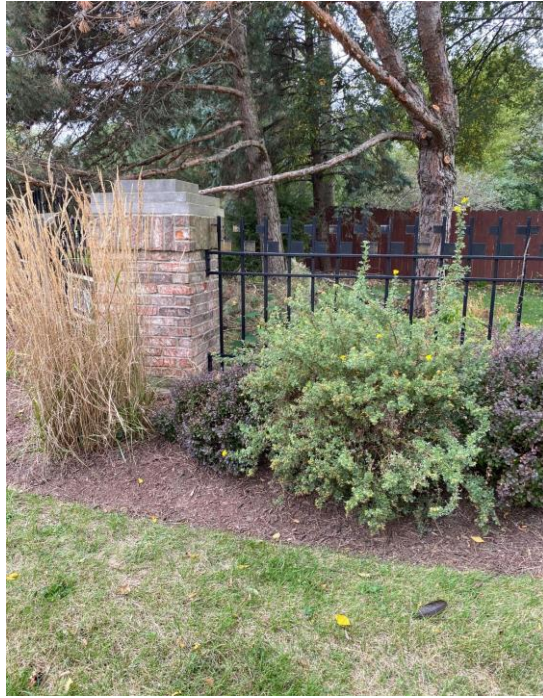
Subject	Monumentation on east side of entrance, east-central section.	27
Site	Talcott Glen Storm Sewer System	
Date	9/26/2020

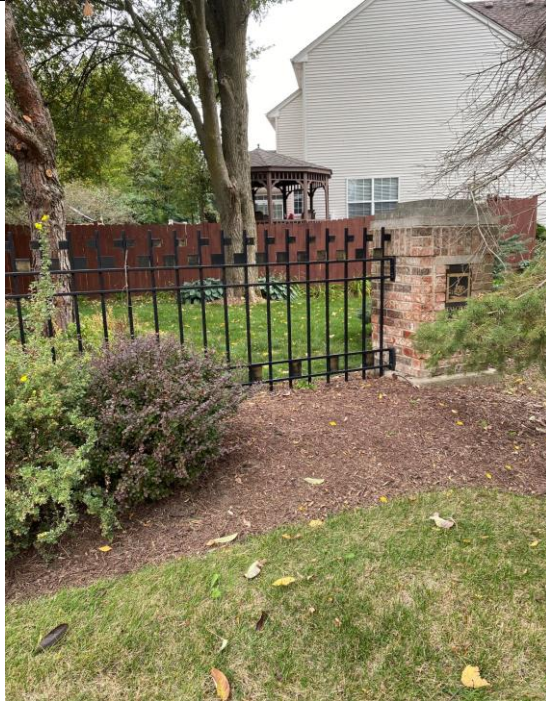
Subject	Monumentation on east side of entrance, easternmost section.	28
Site	Talcott Glen Storm Sewer System	
Date	9/26/2020

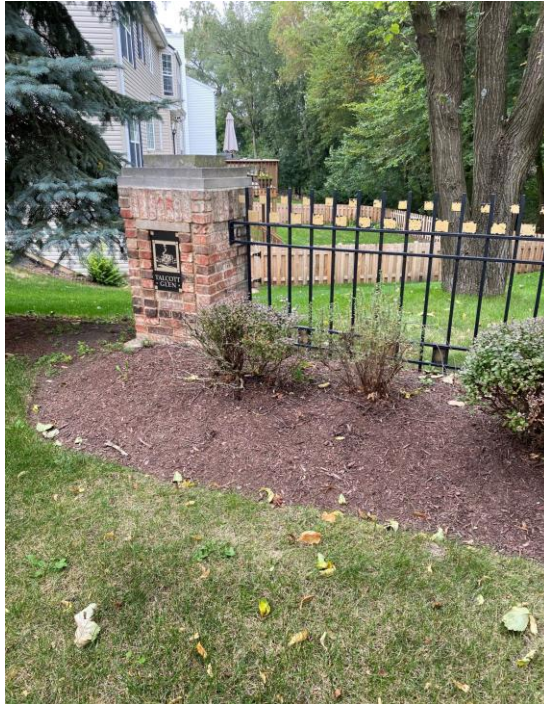
Subject	Monumentation on east side of entrance, north-westernmost section.	29
Site	Talcott Glen Storm Sewer System	
Date	9/26/2020

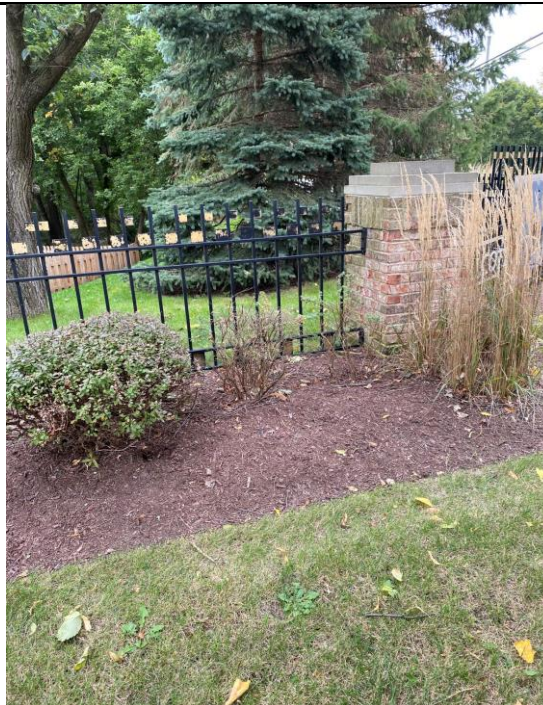
Subject	Monumentation on east side of entrance, north-westernmost section.	30
Site	Talcott Glen Storm Sewer System	
Date	9/26/2020

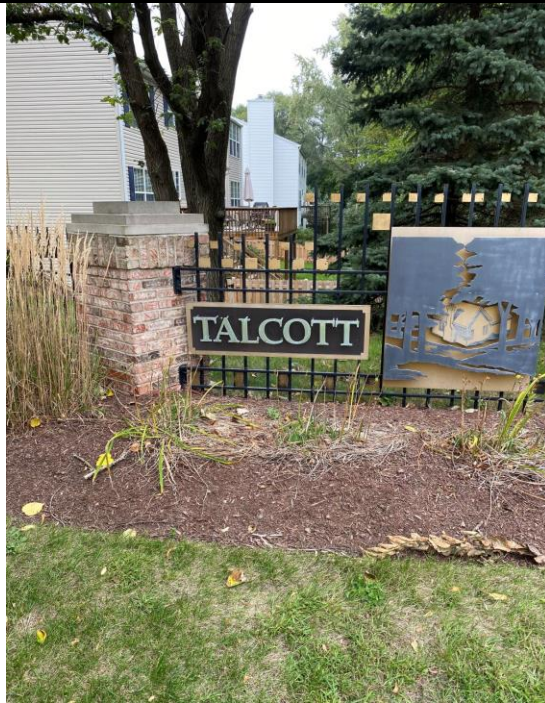
Subject	Monumentation on east side of entrance, sign area.	31
Site	Talcott Glen Storm Sewer System	
Date	9/26/2020

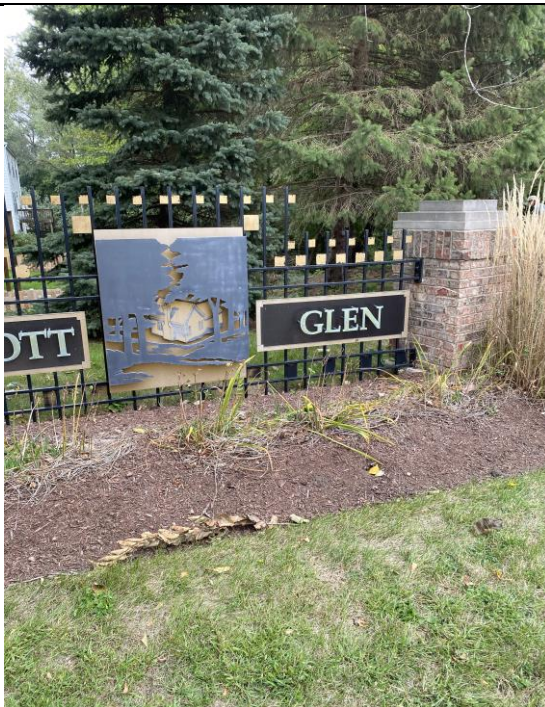
Subject	Monumentation on east side of entrance, sign area.	32
Site	Talcott Glen Storm Sewer System	
Date	9/26/2020

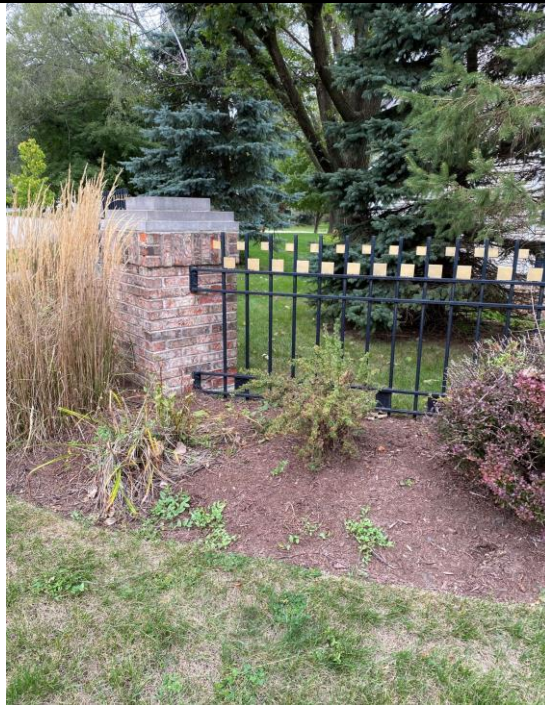
Subject	Monumentation on east side of entrance, showing gold paint on wrought iron fence.	33
Site	Talcott Glen Storm Sewer System	
Date	9/26/2020

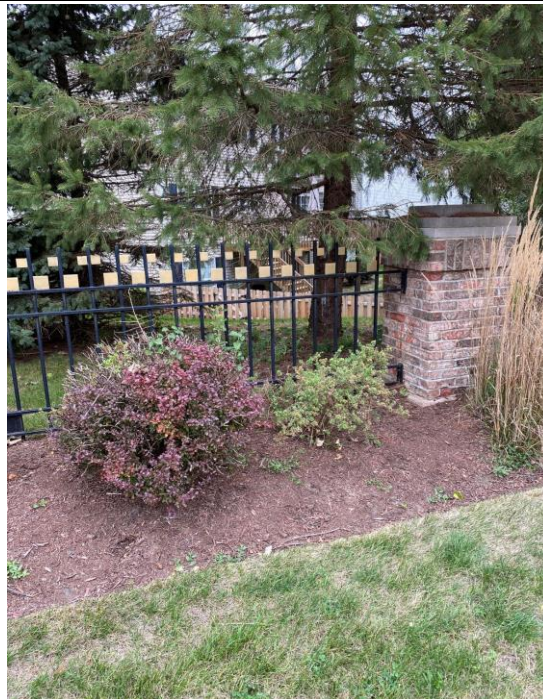
Subject	Gold paint on wrought iron fence.	34
Site	Talcott Glen Storm Sewer System	
Date	9/26/2020
