Environmental Assessment for

The Arroyos Preserve

New subdivision and proposed right-of-way access road near
Quartzsite, Arizona

NEI Project No. 06-074

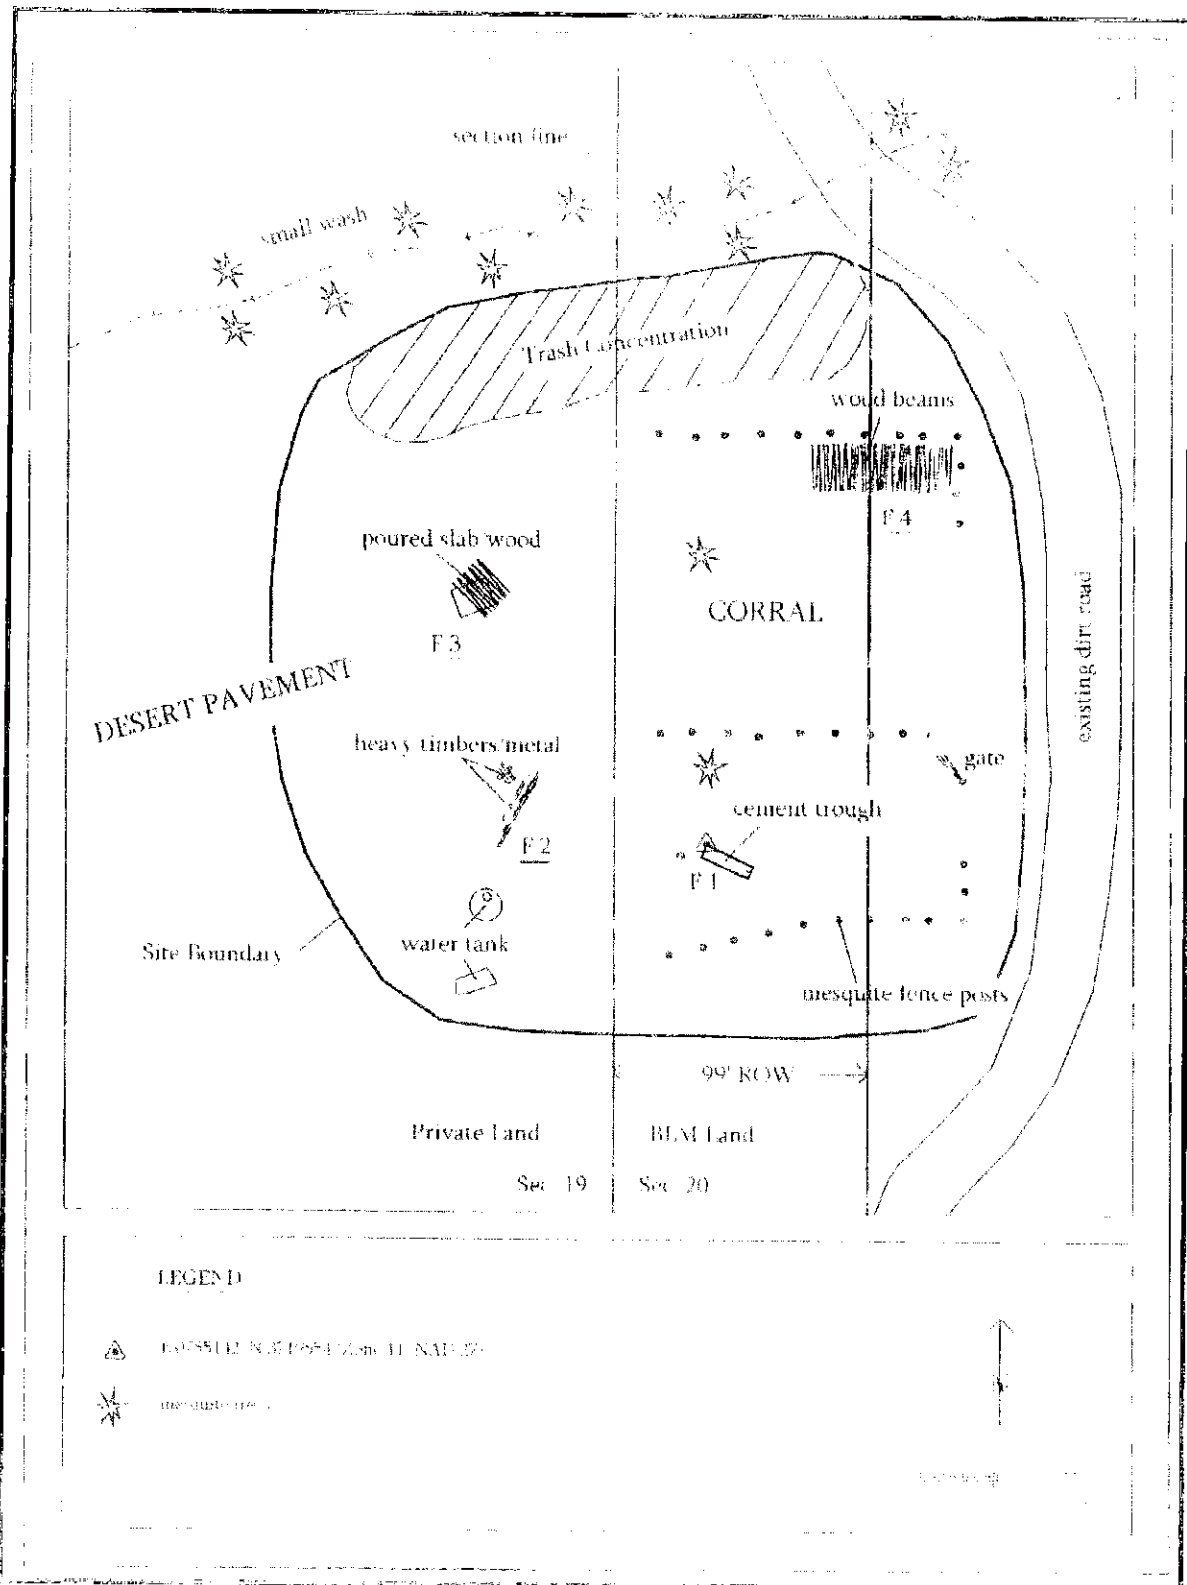
Figure 5. AZ R:7:120 site map.

- Feature 4: Feature 4 is the fallen remains of a wooden ramada (Figure 9). It measures approximately 10 feet by 25 feet and is located within the northeast corner of the corral (see Figure 5).

Two pieces of a defunct water tank are present in the southwest portion of AZ R:7:120 (see Figure 5). They are made from galvanized metal and consist of the top and a portion of the side (see Figure 10).

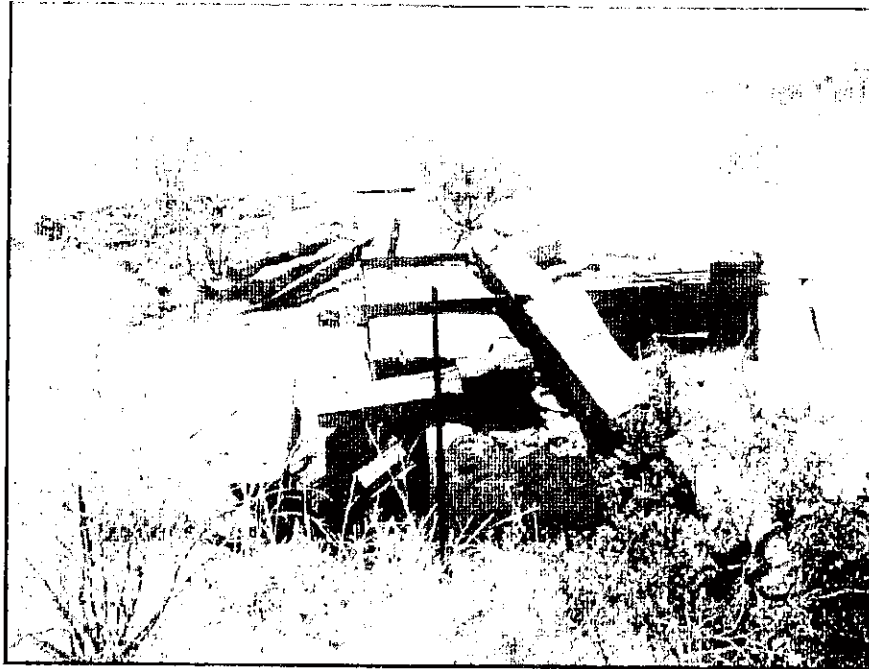
Figure 7. Feature 2 at AZ R:7:120, possible remains of a windmill. View to the southwest.

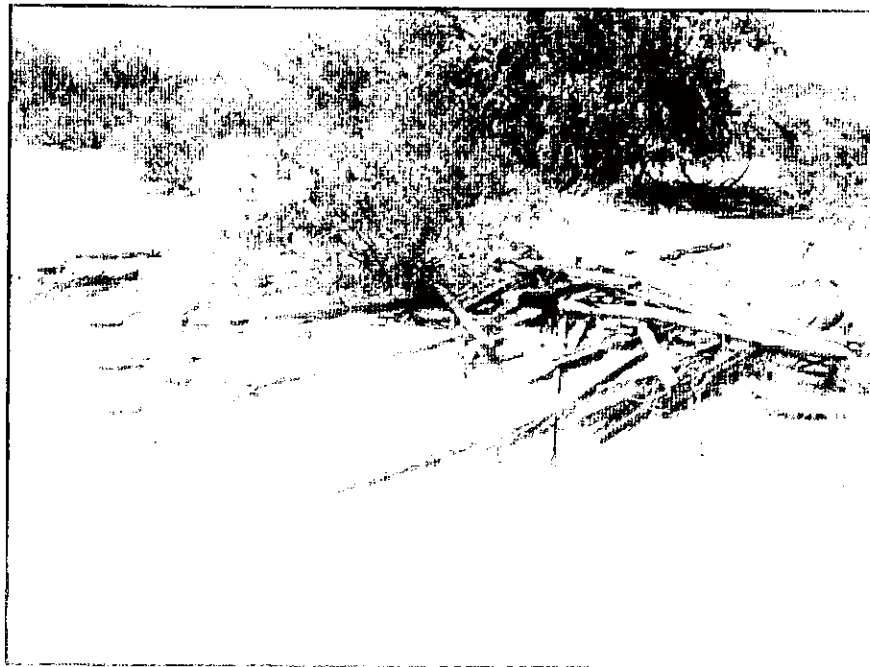
Figure 8. Feature 3 at AZ R:7:120, poured cement slab and associated wood beams. View to the northwest.

- Feature 3: Feature 3 is a poured cement slab measuring approximately 8 feet by 10 feet. Several wooden 2-inch by 4-inch beams also are present (Figure 8). It is possible that this feature contains buried cultural deposits as it may represent the remains of a structure.

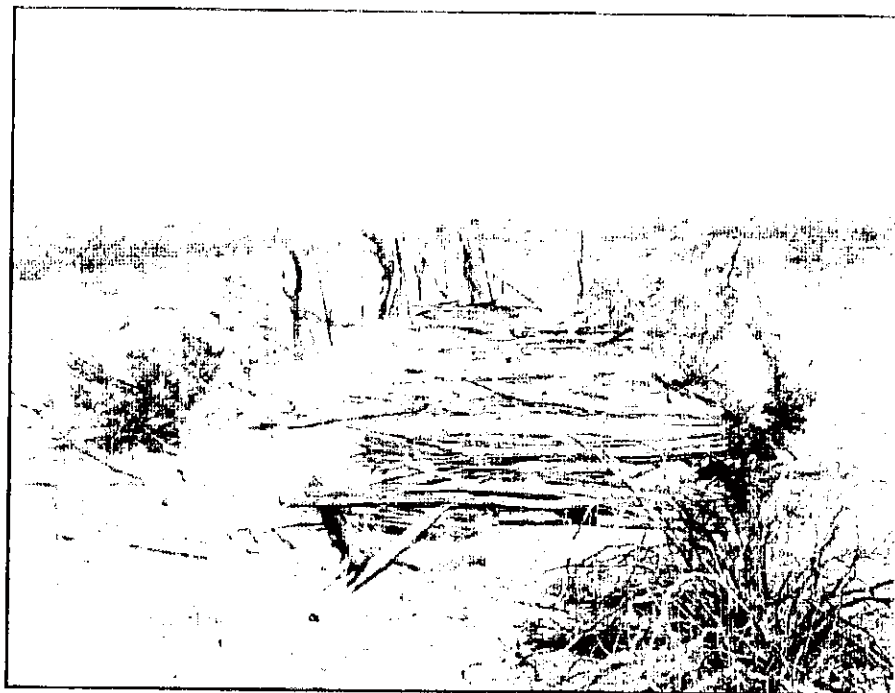
Figure 9. Feature 4 at AZ R:7:120, fallen ramada. View to the east.

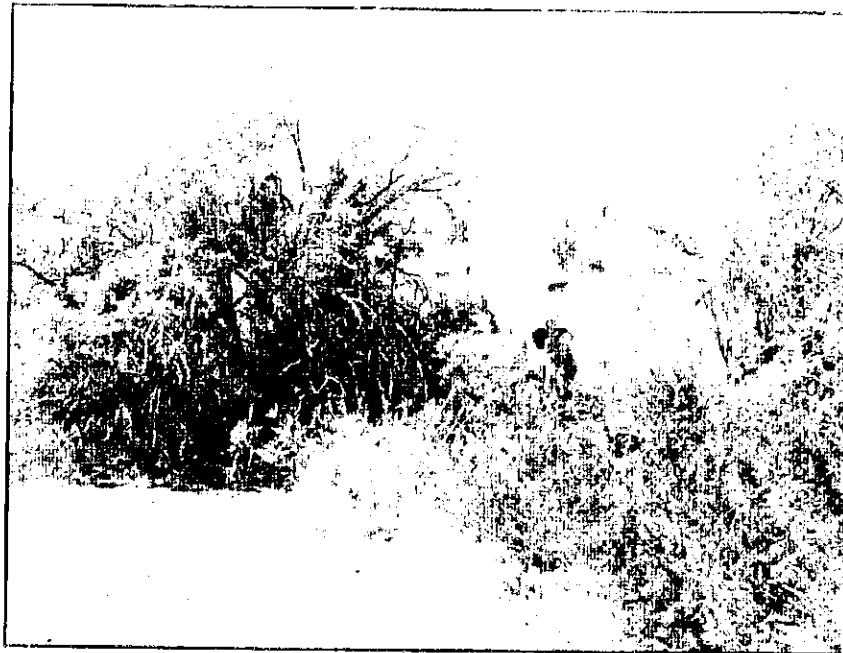
Figure 12. Feature 2 at AZ R:7:121. View to the northwest.

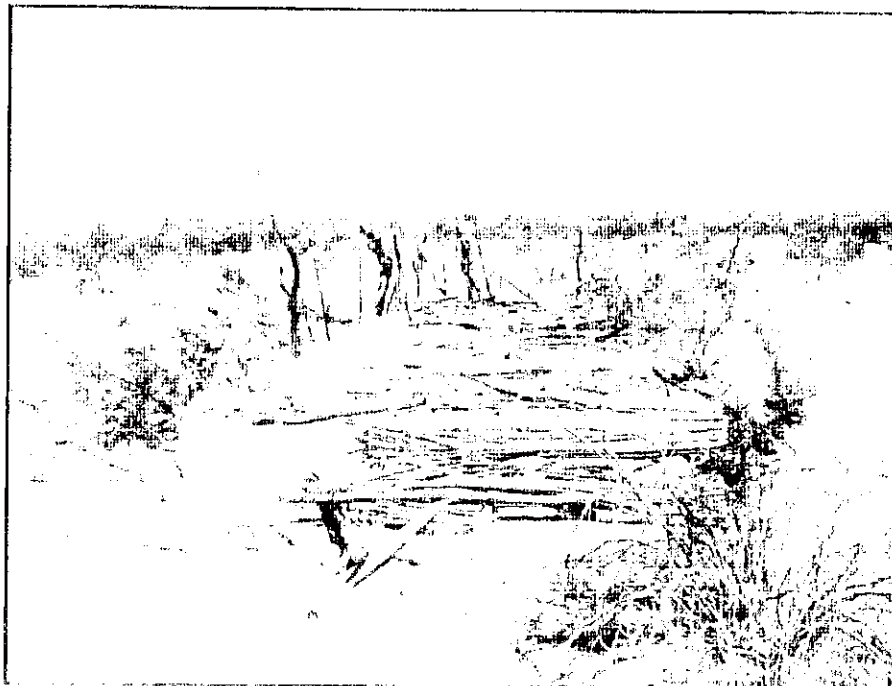
Feature 4 is the fallen remains of a wooden ramada. It measures approximately 10 feet by 25 feet and is located within the northeast corner of the corral.

Feature 4 at AZ R:7:120, fallen ramada. View to the east.

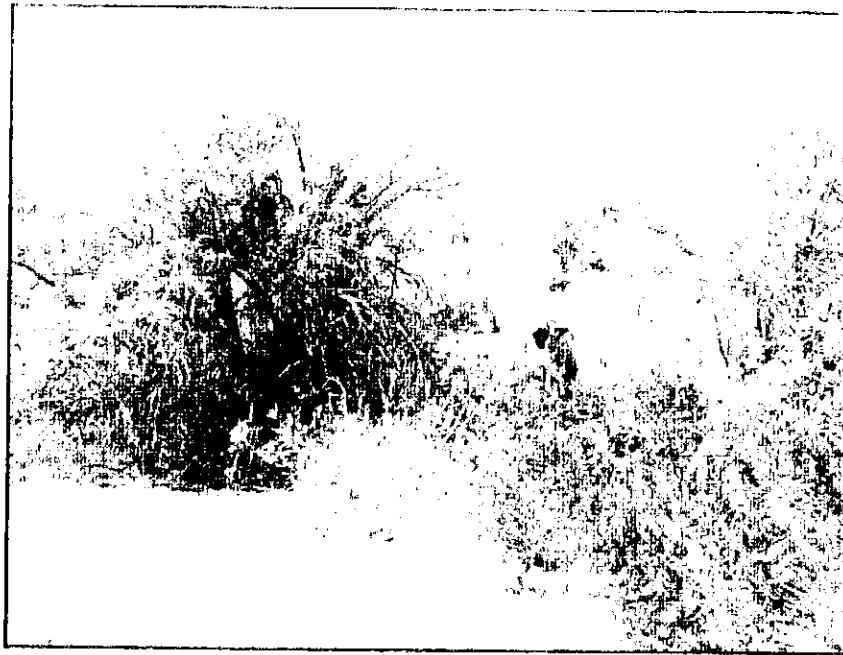
Feature 2 consists of a shallow depression measuring 30 feet in diameter and 3 feet in depth. Vegetation is heavy around this feature which probably represents the remains of the original well.

Feature 2 at AZ R:7:121. View to the northwest.
