# 2014 Annual Monitoring Report For Crystal Pond,

Eastford & Woodstock, CT

**Northeast Aquatic Research**

April 10, 2015

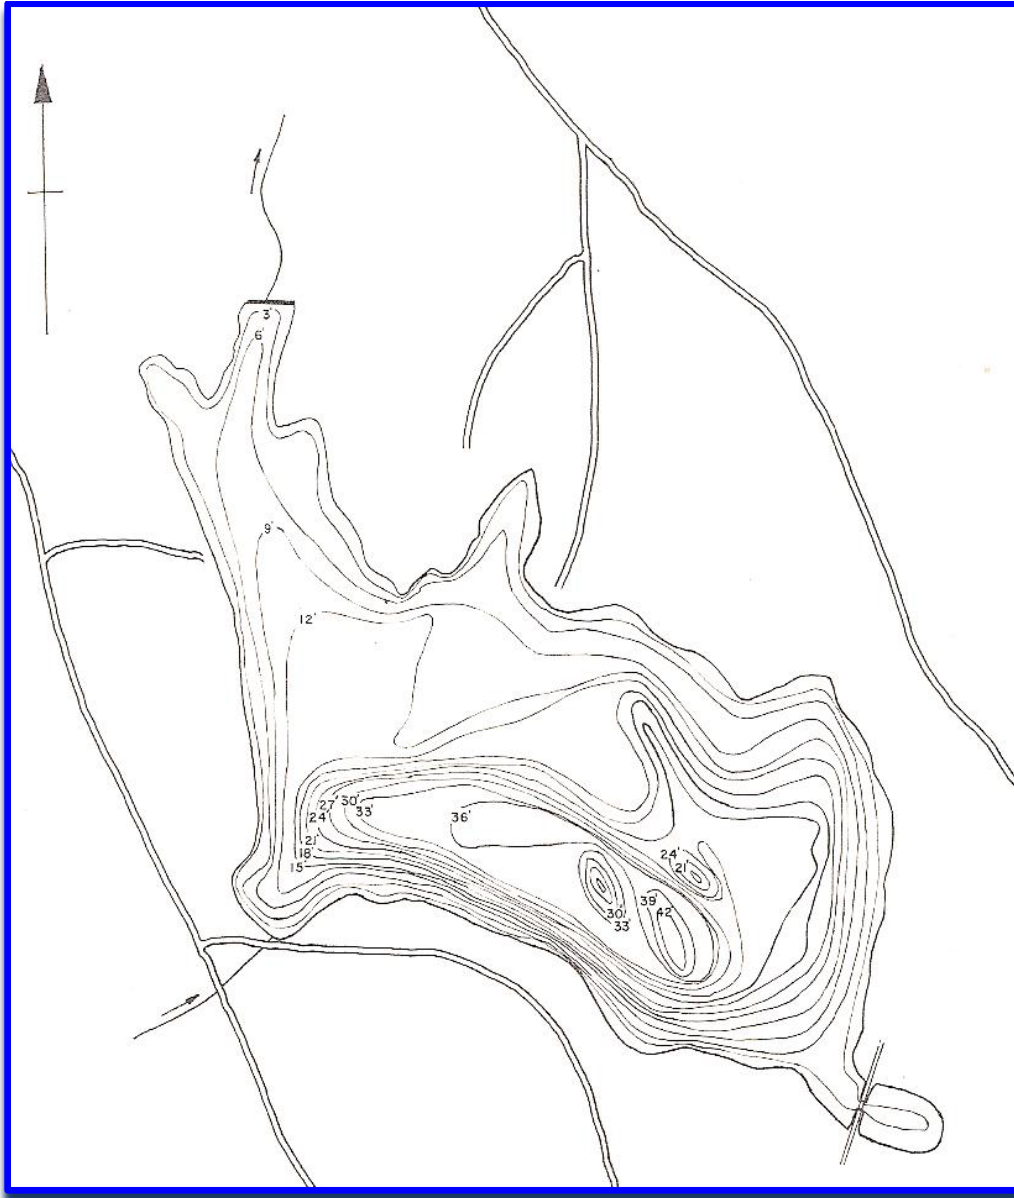
As lakes age, they accumulate sediment from the watershed and become shallower over time. The Connecticut DEEP published a bathymetric map of Crystal Pond in 1959 that showed the maximum depth of the deep hole at 42 feet (**Figure 1**). After years of not being able to find water of that depth in the lake, NEAR suggested that it was time to undertake a more thorough bathymetric survey of Crystal Pond and update the maps and volume estimates. In 2014, NEAR collected depth data at over 200 points around the lake and created an updated bathymetric map for Crystal Pond (**Figure 2**). This map indicates that considerable sedimentation has decreased the maximum depth of the lake from 42 ft. in 1959 (**Figure 2**) to a current maximum depth of 31 ft. The mean water depth of the lake was, using old bathymetry, 14.7 feet, but decreased to 13.4 ft. with the new water depths. The old volume of Crystal Pond was estimated to be 2,201 acre-feet, decreasing to 1,881 acre-feet with the new contours (an acre-foot of water refers to a volume that is one acre in area by one foot in depth). We will continue to refine the bathymetric contours in 2015 with new soundings in areas missed during the 2014 survey.

Figure 1 – Historical Crystal Pond water depth contours from *A Fishery Survey of the Lakes and Ponds of Connecticut* (1959).

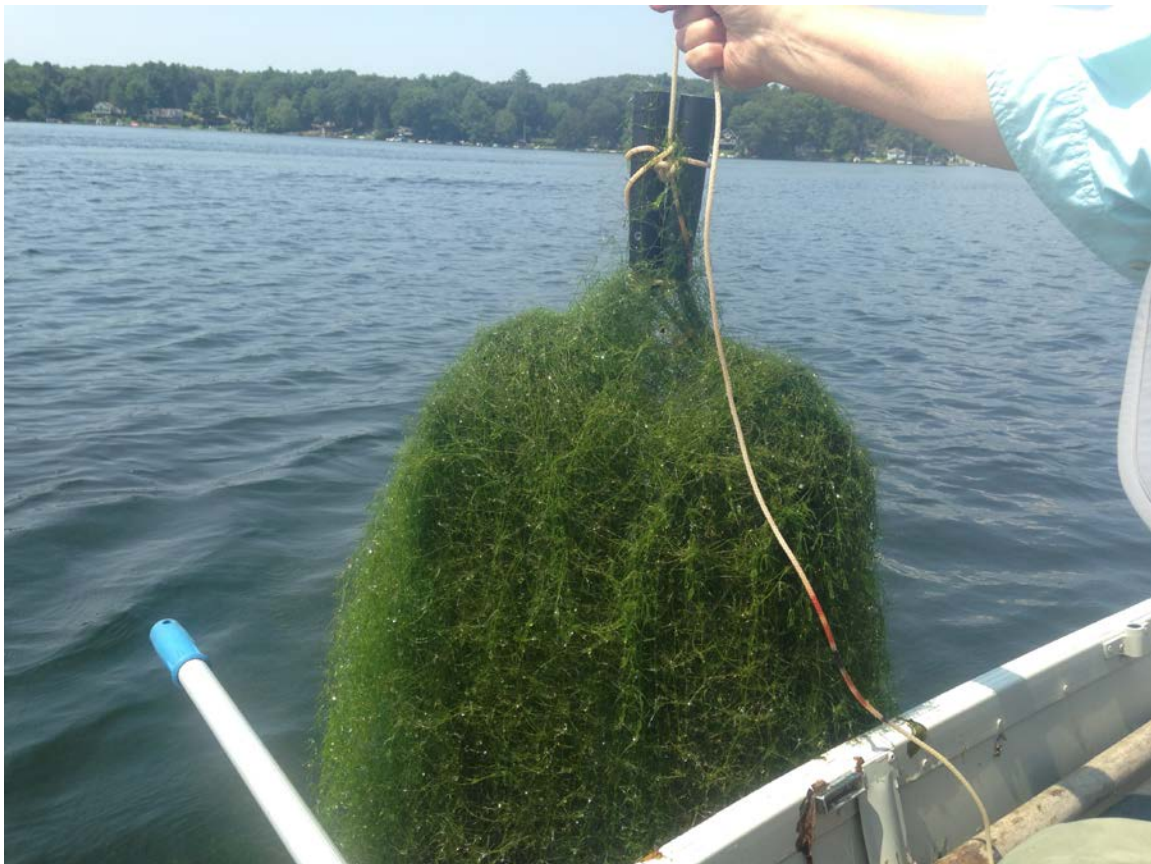
**Figure 8 – *Nitella* in Crystal Pond August 2014**

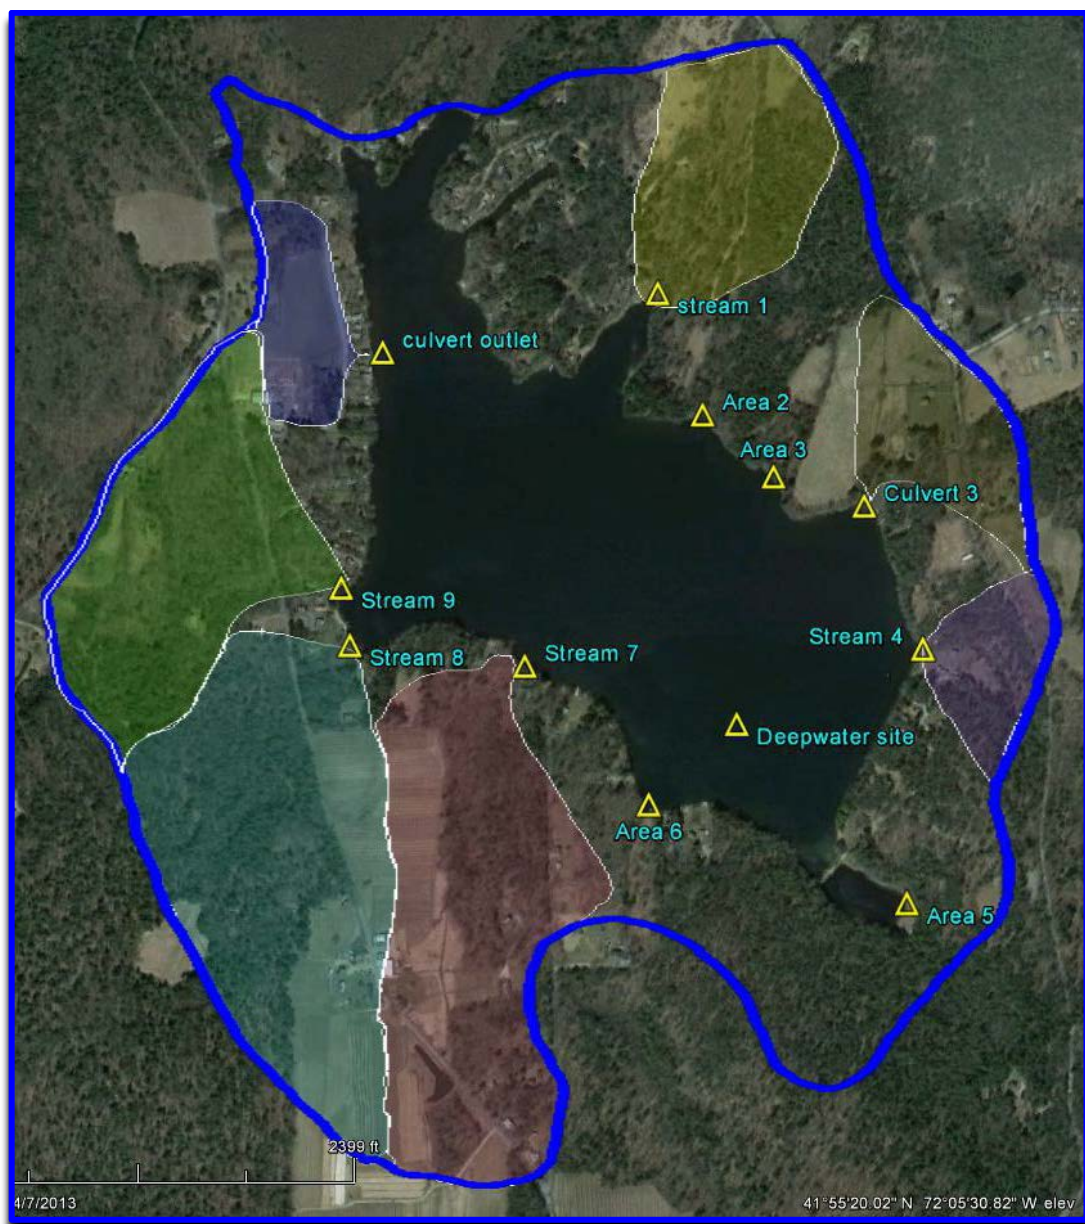
The locations where water was found be flowing into the lake are labeled as Streams 1, 4, 7, 8 and 9 in **Figure 10**. In addition, a culvert was found at the site labeled Culvert 3, but no water was flowing at the time of the visit but is likely to carry storm water during

rain events. Other sites, labeled as Areas 2, 3, 5, and 6, indicate where the shoreline was searched because topographic contours suggested inflows are present. Upon inspection, however, no flowing water or drainage conveyance could be identified in these areas, ruling them out as sites of surface drainage into the lake. At the location marked as Culvert Outlet, the end of a culvert was found in approximately 5 feet of water. The culvert pipe was buried with only the very top edge of the pipe visible. It appeared to be the outlet pipe for runoff from a field and roads on the western shore of the lake.

Figure 10 - Drainage basin of Crystal Pond showing seven inlets and sub-basins

Watershed-monitoring has shown elevated nitrate levels at Stream 1 and moderately elevated phosphorus and nitrate levels at Stream 7. These levels are not alarming but could be cause for concern if they remain elevated. We would like to conduct a brief exploration of the sub-watershed of stream 1 to determine if there are any obvious sources of nutrients to explain the elevated levels.

### **CONTINUE WITH ONE INLET MONITORING VISIT IN 2015**
