# 2015 Annual Monitoring Report For Crystal Pond,

Eastford & Woodstock, CT

**Northeast Aquatic Research**

March 7, 2016

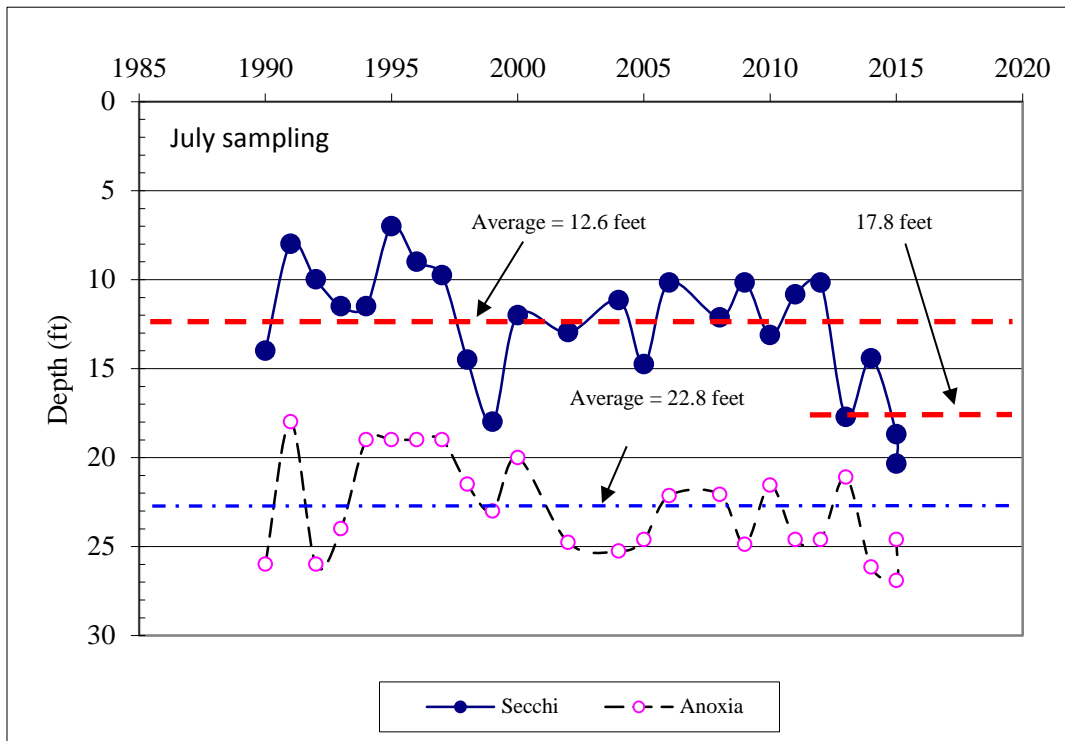
**Figure 4 - Secchi Depths and Anoxic Boundaries at Crystal Pond, 1990-2015**

The long-term average July Secchi disk depth (1990-2015) is 12.6 feet, although the average of 2013-2015 July readings is 17.8 feet considerable better than prior years (Figure 4).

The location of the anoxic boundary during the month of July has fluctuated between 19 and 27 feet with an average of 22.8 over the period on record (see **Figure 4** for the trend in anoxic boundary). In 2015, the anoxic boundary was located at 26.9/24.6 feet below the surface, better than average. During conditions of very deep anoxic boundary of 25 feet or more only a very small portion of the lake bottom exposed to anoxic conditions, less than 15% of the surface area and less than 4% of the lake volume.

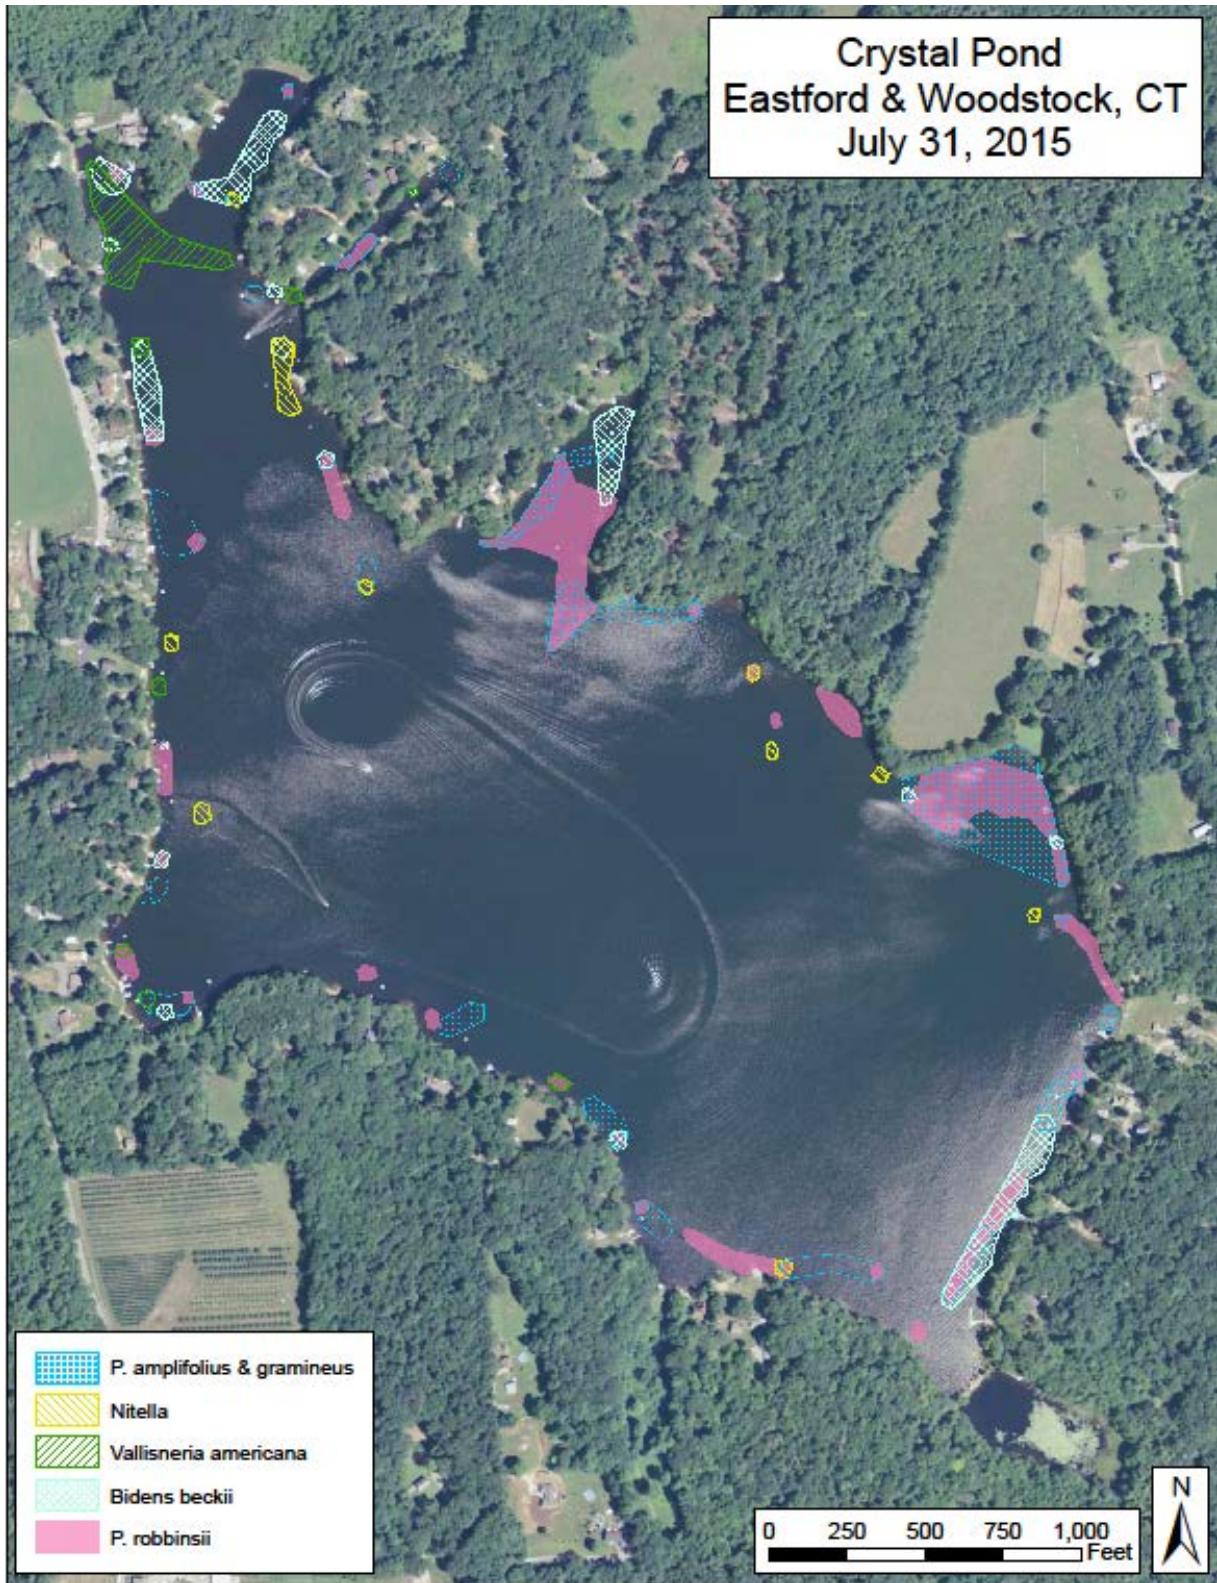
Figure 5 – Aquatic Plants in Crystal Pond 2015

The aquatic plants in Crystal Pond were surveyed in-detail during the July 31<sup>st</sup>, 2015 visit (see **Figure 5** for distribution map of dominant plants during that survey) – no invasive species were found (specifically fanwort). Generally plant beds were similar to those mapped in 2014 (Figure 6). Dominant plants noted in **Table 5** appear to be increasing in distribution and abundance, although we have also noted some shifting of bed location. In July 2015, NEAR found 29 species of aquatic plants, more species than any prior single survey (**Table 5**).

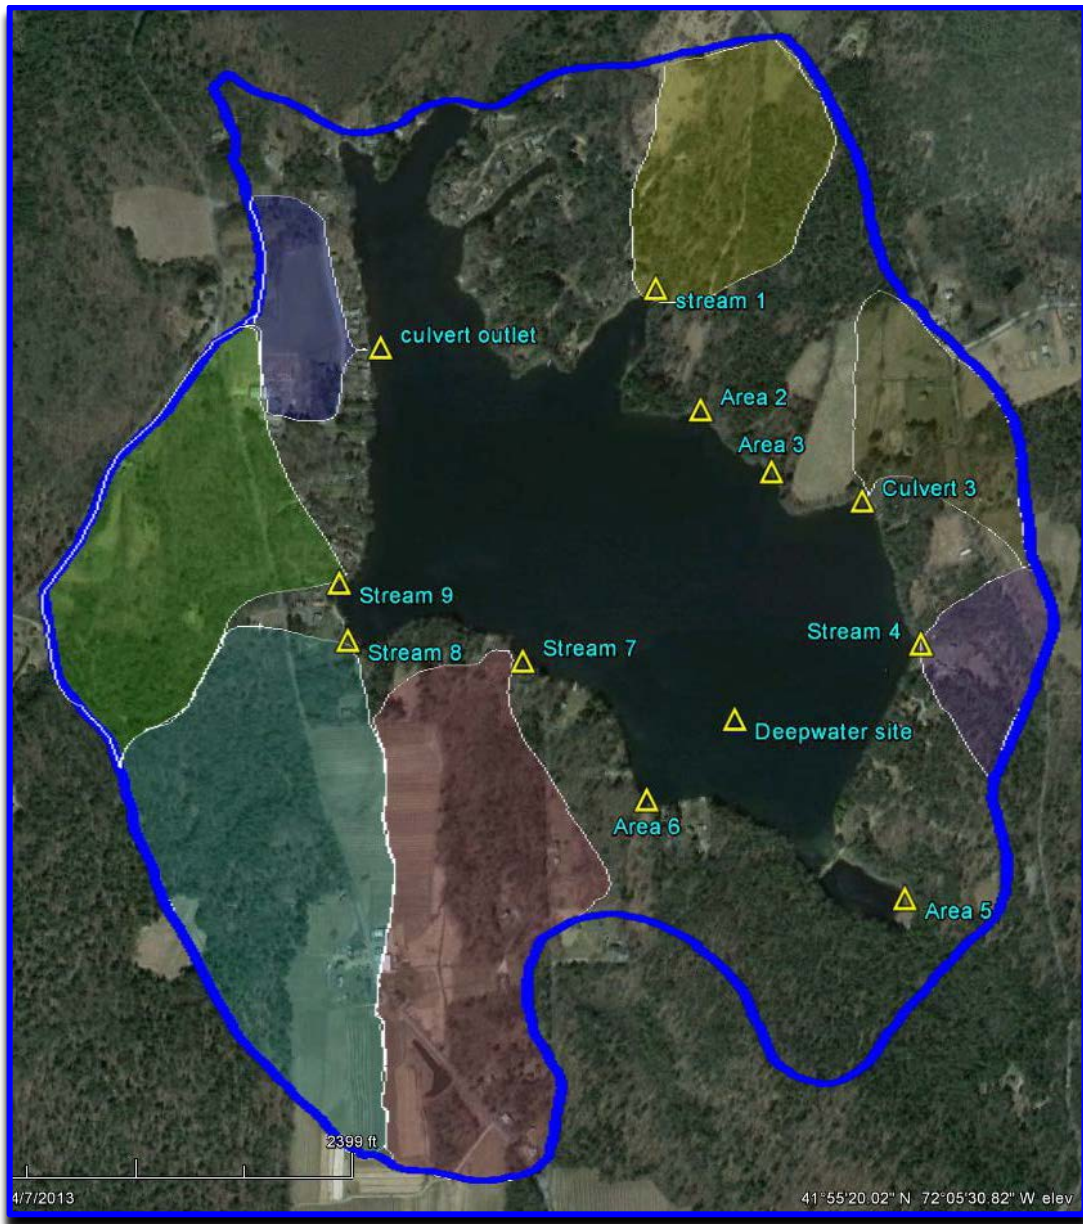
Figure 8 - Drainage basin of Crystal Pond showing seven inlets and sub-basins

The locations where water was found be flowing into the lake are labeled as Streams 1, 4, 7, 8 and 9 in **Figure 8**. Other sites, Culvert 3, and Areas 2, 3, 5, and 6, have not had flowing water on any of the sampling visit. At the location marked as Culvert Outlet, the end of a culvert was found in approximately 5 feet of water. The culvert pipe was buried with only the very top edge of the pipe visible. It appeared to be the outlet pipe for runoff from a field and roads on the western shore of the lake.
