2017 Crystal Pond Monitoring Report

Eastford & Woodstock, CT

Crystal Pond Association

Northeast Aquatic Research

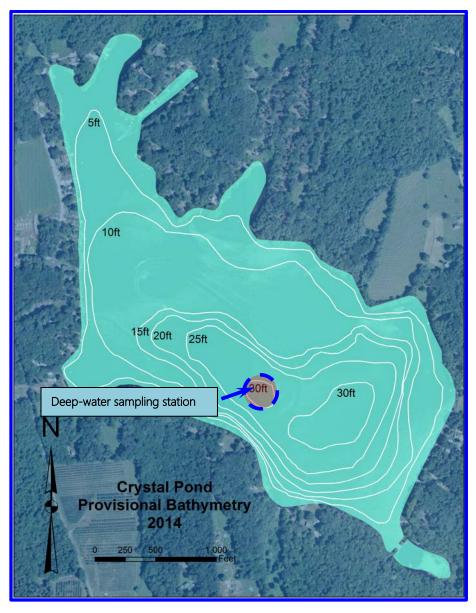
These tests have been conducted at the same station in the lake located over deepest water —about 30 feet (9.8 meters), since 1992 (**Figure 1**).

Figure 1 – Crystal Pond water depth contours as mapped by NEAR during 2014, showing deep-water sampling station.

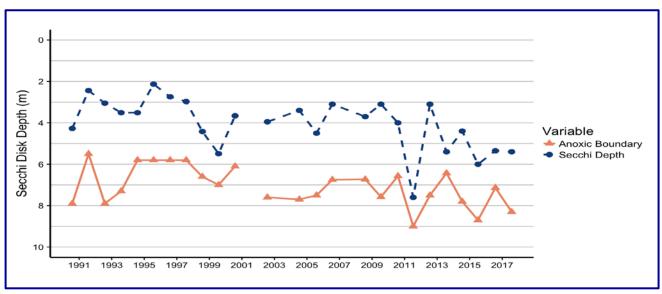
The water clarity in Crystal Pond was excellent in 2017, with readings between 5.4m and 7.75m. The 7.75m reading recorded in September 2017, was the best clarity reading recorded in the lake since monitoring began in 1990. Keep in mind that the lake is only 9 meters deep at its deepest. A Secchi disk reading this high in Crystal Pond is only 4 feet from the bottom. The data in **Figure 2** shows that beginning in 2011 water clarity has been considerably and consistently better than the all preceding years. When all the data is considered as shown in **Table 2**, seven readings of 6 meters or more--considered Oligotrophic in **Table 1**—have occurred since 2011--while prior to that year there were none. The best clarity prior to 2011 was 5.49 meters, an outlier among all other readings which varied between 2 and 4.5 meters more characteristic of meso-eutrophic lakes (**Table 1**). The second best clarity reading between 1990 and 2010 (4.5 meters) has been exceeded 9 times since 2011.

Figure 2 - Secchi depths and anoxic boundaries at Crystal Pond in July 1990-2017

The location of the anoxic (anoxia is where the dissolved oxygen has declined to less than 1 mg/L) boundary at the time of the late July sampling has fluctuated between 5.5 and 7.9 meters between 1990 and 2011 (Figure 2). Beginning in 2012 the anoxic boundary has been erratic but has been generally better—that is deeper in the lake; with three readings showing the anoxic boundary deeper than 8 meters, and only minor anoxic development at the very bottom in 2012 see Figure 5.

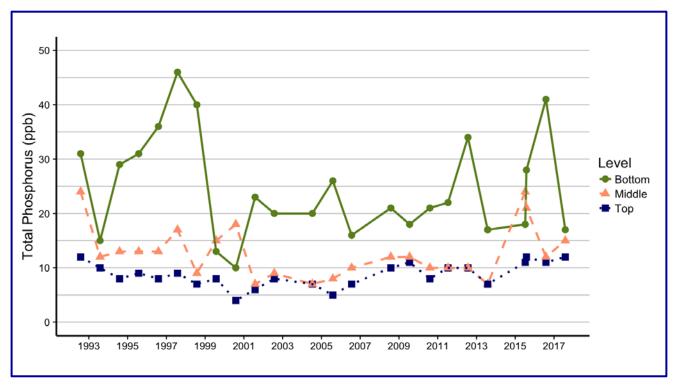
Total phosphorus concentrations in the surface waters of Crystal Pond have consistently remained near or below 10ppb although the last three years has seen TP at 1m at slightly higher than 10ppb (Figure 3). Total phosphorus at the bottom of the deep spot in 2017 was lower than the previous two years, with concentrations between 10ppb and 20ppb suggesting that internal loading doesn't occur to any great degree. All total phosphorus test results from 1992 – 2017 are presented in **Table 6** in the appendix.

Figure 3 – Trends in July total phosphorus values from the top, middle, and bottom depths at Crystal Pond 1992-2017

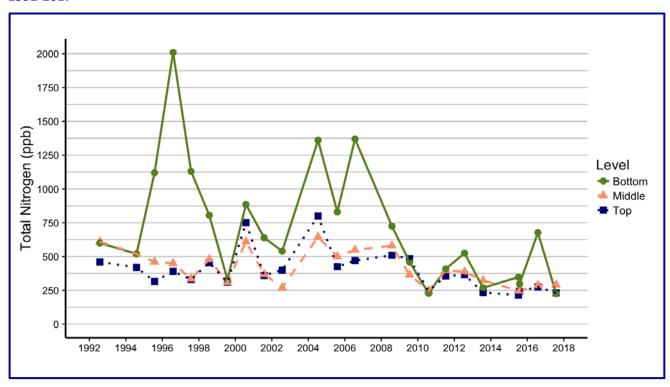
Total nitrogen (TP) includes fractions of nitrate, ammonia, and organic components. The goal for total nitrogen in lake water is 200ppb. Crystal Pond has had high, to very high, total nitrogen values over the years with surface concentrations as high as 750 ppb and bottom values as high as 2,000ppb (Figure 4). The long term trends show that beginning in 2010, total nitrogen in the lake has declined at all sampling depths. In 2017, Aug 1st total nitrogen concentrations were all below 300ppb. The decline in nitrogen in the lake may have a large part to play in the improvement of water clarity. The results for total nitrogen sampling over the last 25 years are presented in Table 7 in the appendix.

Figure 4 – Trends in July total nitrogen values from the top, middle, and bottom depths at Crystal Pond 1992-2017

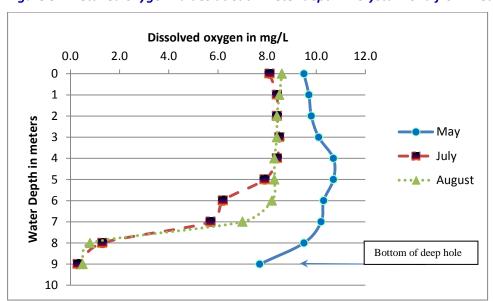
Figure 5 – Detailed oxygen values at each meter depth in Crystal Pond from measurements made in 2017

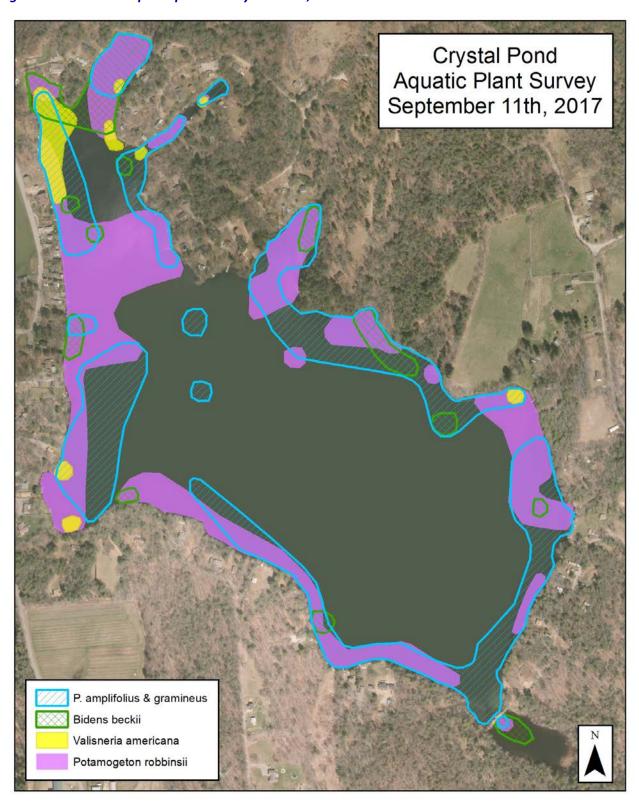
The aquatic plants in Crystal Pond were surveyed on September 11th, 2017 (see **Figure 6** for distribution map of dominant plants found during the survey). No invasive species were found in the lake during this survey.

Five species, all of which are native, have remained dominant in the lake in all eight surveys (2004, 2011-2017). Potamogeton robbinsii (Robbins pondweed), Bidens beckii (water marigold), Potamogeton gramineus (grassy pondweed), and Potamogeton amplifolius (large-leaf pondweed) are consistently present at frequencies over 20%. Vallisneria americana (tape grass) is not as abundant as the other four species and has for years been mostly limited to beds in the northern shallow cove. However, the plant has been increasing in abundance over the last several years. Robbins pondweed and water marigold remain close to the lake bottom, never extending up far into the water column. Conversely, large-leaf pondweed and grassy pondweed form dense beds and grow to the water's surface where they develop floating leaves. These two species have been expanding in the lake over the past several years; now present along nearly the entire lake perimeter and in somewhat shallower water in the center of the lake (Table 3). These two species have the potential to become a nuisance in the lake by deterring boat access. The increased plant growth and distribution is likely due to increased light penetration due to much better water clarity.

Not shown in **Figure 6** are floating leaved plants that have spread in the southern lagoon. Our survey in 2017 found all areas not occupied by the pondweeds to have dense floating leaved cover or about 2/3rds of the area.

Figure 6 – Dominant aquatic plants in Crystal Pond, 2017

- 8. Potamogeton amplifolius (large-leaf pondweed) and Potamogeton gramineus (grassy pondweed) are native species that are abundant in the lake and grow to the water's surface in dense patches. These plants do not appear to be an issue at this time but if they continue to expand and deter boat access, management measures may need to be considered.

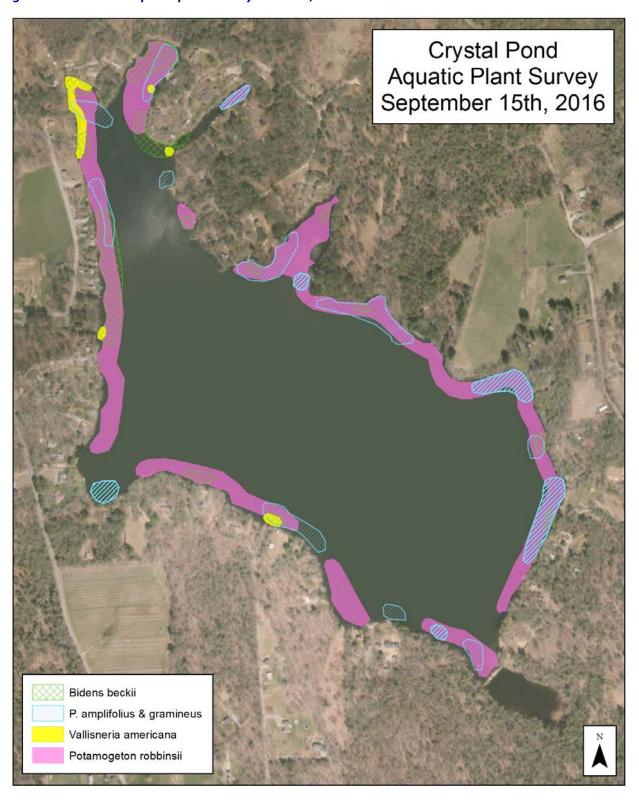
Figure 7 – Dominant aquatic plants in Crystal Pond, 2016

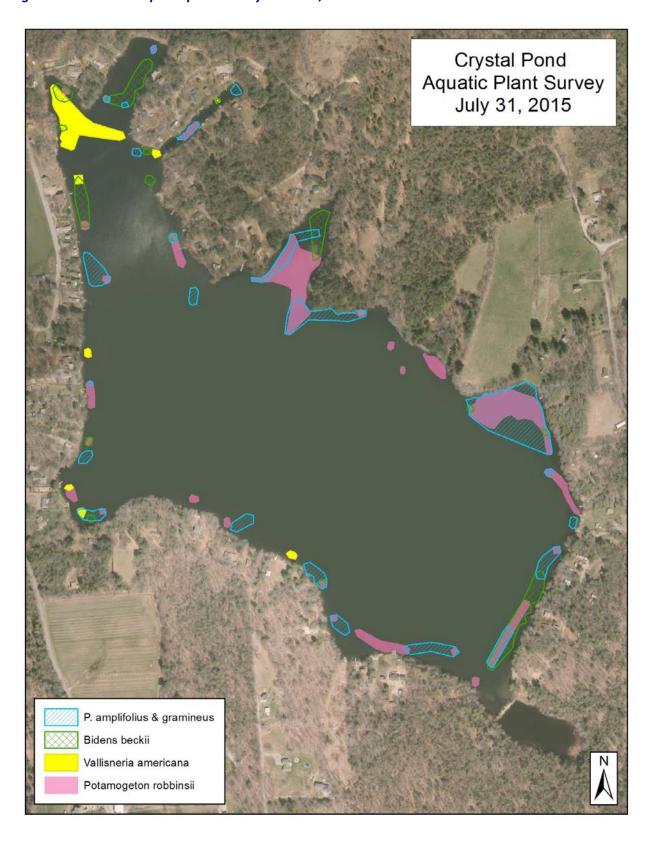
Figure 8 – Dominant aquatic plants in Crystal Pond, 2015

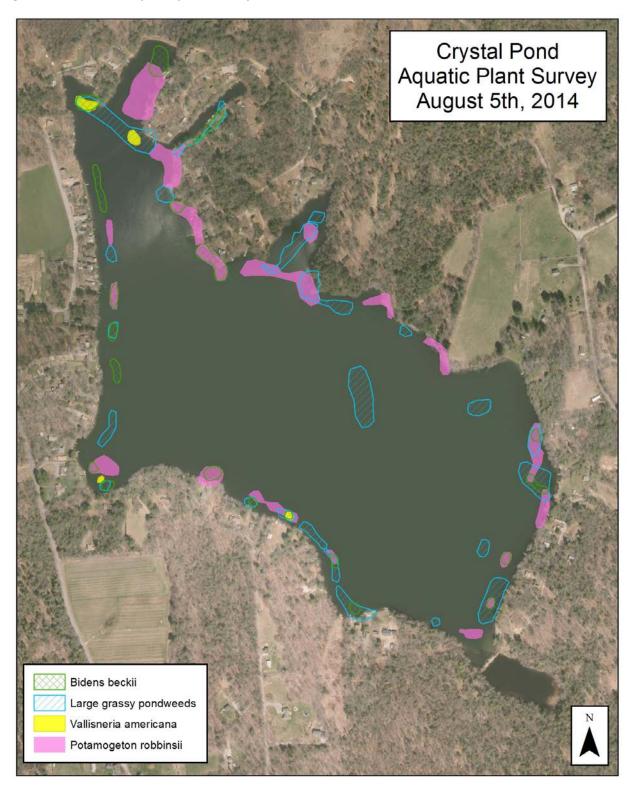
Figure 9 – Dominant aquatic plants in Crystal Pond, 2014

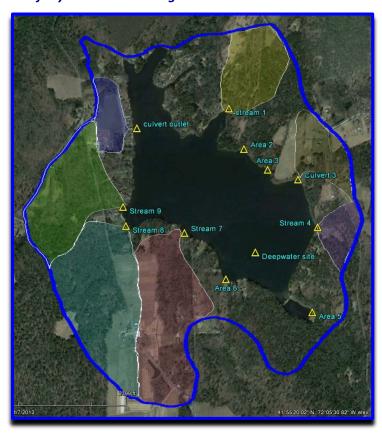
Crystal Pond has a watershed area of 545 acres and a drainage area of only 400 acres (watershed minus the lake area). The lake has no large inlets; instead, water flows into the lake via several small creeks and drains. The map below (Figure 8), showing the drainage basin of Crystal Pond, identifies nine natural sites where surface water could flow into Crystal Pond based on topography. The map doesn't show possible drainage conveyance in the northwestern shoreline area. Investigation of each verified that only sites 1, 4, 7, 8, and 9 were actual tributary locations Figure 9, draining 206.7 acres or roughly half the total watershed area. The remaining 193 acres presumably drains to the lake via overland flows or is infiltrated into soils and flows into the lake as ground water. Site 10 has subsequently been identified as a culvert that enters the lake subsurface so cannot be sampled. Table 5, lists the approximate drainage area of each basin.

Figure 11 - Drainage basin of Crystal Pond showing inlets and sub-basin areas

The locations of flowing streams into the lake are labeled as Streams 1, 4, 7, 8 and 9 in **Figures 8 & 9**. Other sites (Culvert 3, and Areas 2, 3, 5, and 6) have not had flowing water on any of our sampling visits. At the location marked as 'Culvert Outlet', the end of a culvert was found in approximately 5 feet of water. The culvert pipe was buried with only the top 5-6 inches visible. It appeared to be the outlet pipe for runoff from a field and roads on the adjacent western shore of the lake.
