2018 Crystal Pond Monitoring Report

Crystal Pond Association

Northeast Aquatic Research

January 22, 2019

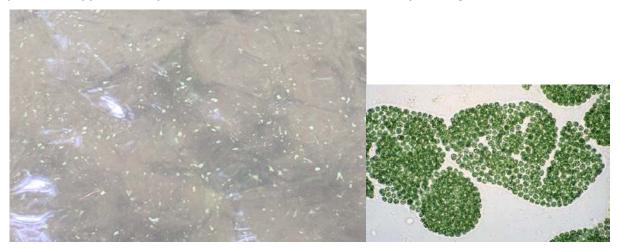
We visited the lake in October because of possible cyanobacteria bloom, first reported in late September. The lake was found to have huge buoyant colonies of the cyanobacteria; microcystis. The colonies were spread out openly across the whole lake down to a meter or so deep (**Figure 6**). Colonies were huge clumps of many 1000s of Microcystis cells (**Figure 6**-insert). A sample of the lake water was tested for microcystin a cyanotoxin, test was negative.

Figure 6 – Photograph of Microcystis colonies in Crystal Pond October 4, 2018. Colonies, green speckles in the photo, are approximately ½ to ½ inch in size. Insert shows Microcystis magnified ~1000x

- 1. Continue the in-lake water quality monitoring. It would be beneficial to gather lake data once per month from May through October to track the full extent of seasonal fluctuations, including peak extent of anoxic water, best and worst seasonal clarity, and peak nutrient concentrations. The Microcystis likely came from resting spores on the bottom sediments with growth triggered by some set of conditions that were just right. More frequent testing in the summer and late fall would help understand how and why the bloom occurred.

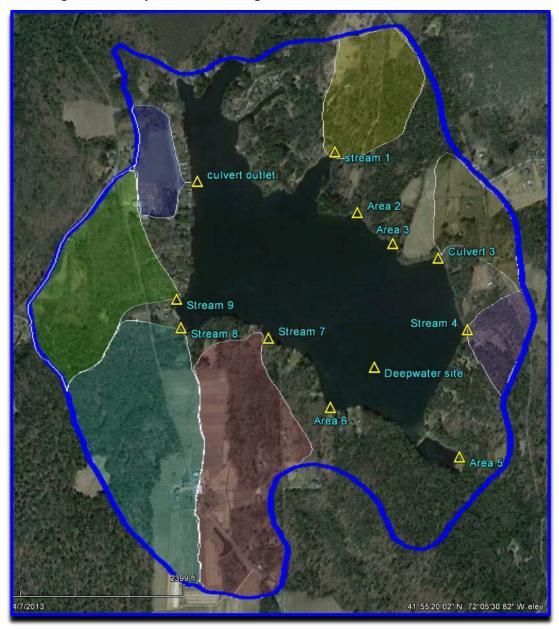
Figure 12 - Drainage basin of Crystal Pond showing inlets and sub-basins.

The locations where water was found to be flowing into the lake are labeled as Streams 1, 4, 7, 8 and 9 in **Figures 10 & 11**. Other sites (Culvert 3, and Areas 2, 3, 5, and 6) have not had flowing water on any of our sampling visits. At the location marked as 'Culvert Outlet', the end of a culvert was found in approximately 5 feet of water. The culvert pipe was buried with only the top 5-6 inches visible. It appeared to be the outlet pipe for runoff from a field and roads on the adjacent western shore of the lake.

- 2. Collect inlet samples from all flowing inlets in May and test the samples for total phosphorus and nitrate nitrogen. Inlet #4 had high phosphorus this May and inlet #7 had high nitrate. Some investigation in the watershed should be conducted to note anything obviously different.
