Crystal Pond Watershed Inspection 7/19/2021 Notes:

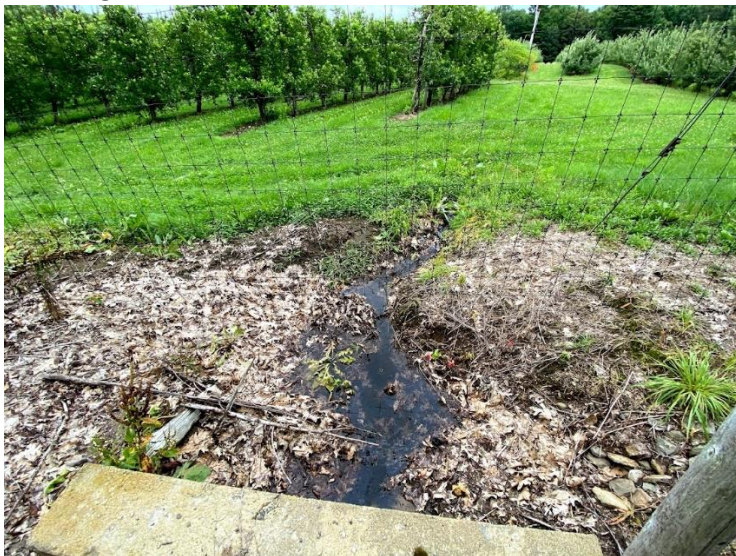
Soil erosion just uphill of Inlet (Culvert) 9 on Lake Drive, just around the corner from Crystal Pond Road private property runoff from construction land disturbance – could use catch basin filters to prevent sediment from flowing into the basins during high-flow storms. (41.918475, -72.105042)

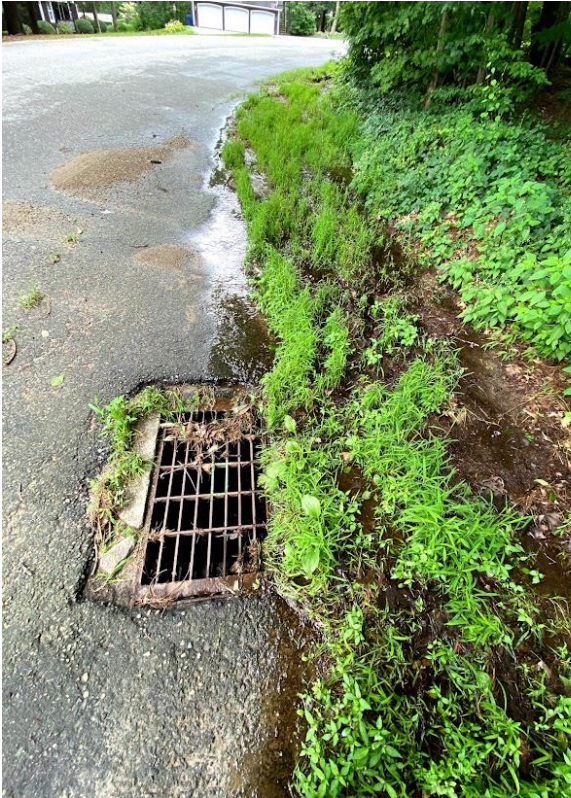
Would be best to discourage property owners from storing large amounts of open sediment near the side of the road. Machinery can easily track soil into the road, bringing large amounts of phosphorus attached to soil particles that will eventually get washed into the catch basin system during rainfall events.

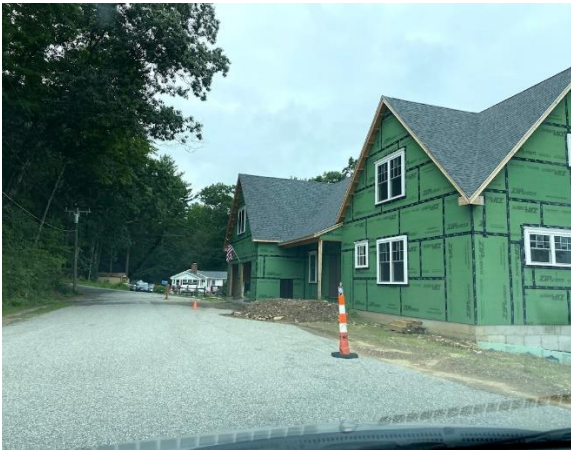
Home construction not using adequate soil and erosion control practices. Contractors should prevent tracking soil onto the road and install silt fences to prevent erosion of open soil.

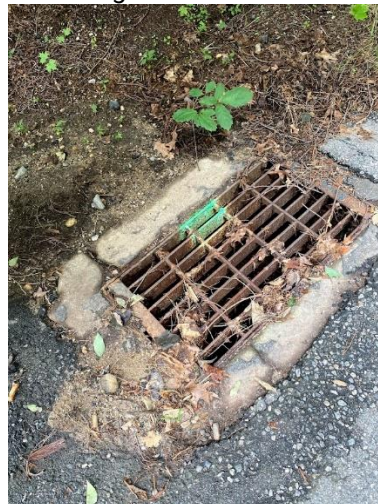
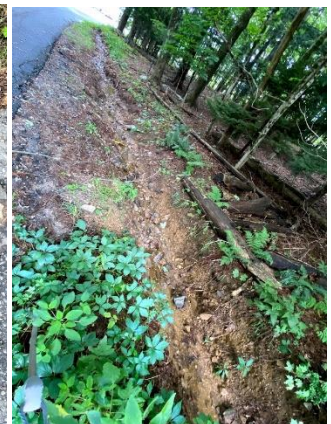
Corner of Lake Drive & Cove Road

Both the northeastern side of Crystal Pond Road and the E. Lake Rd/Cove Rd had significant roadside and roadway erosion. It is incredibly important to make sure that dirt roads are not impairing downstream areas. Contrary to popular belief, dirt roads are not permeable and runoff is still high, like that of a regular paved road, except dirt roads bring more phosphorus via runoff through eroding soil particles, particularly fine clays. This area will impact Inlet 1, could not investigate further due to private roads (Photos from approximately 41.928306, -72.098892)

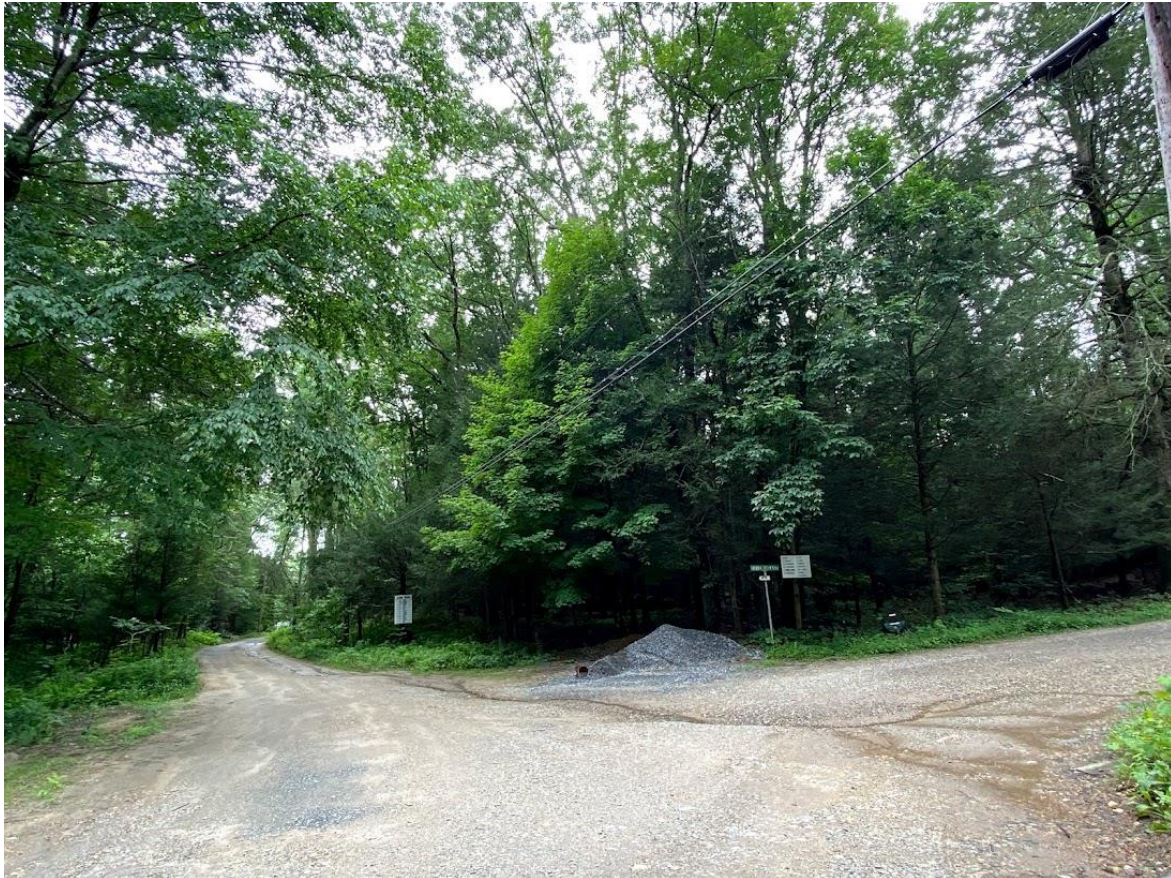
Corner of Crystal Pond Rd and Kenyonville Rd, private driveway very muddy after the rain. Soil erosion present near entrance to Kenyon Woods. Private property, could not access for further investigation. Horses observed in the fields. Horses do generally present a threat of nitrogen waste through surface and groundwater, but a small number of horses may not be a major concern. Ultimately the threat of nutrient pollution from horses and other farm animals depends on how close to a stream or culvert the animals reside. The likely area to be affected is Area 2, 3, or Culvert 3. Increase general community awareness around how soil erosion impacts streams and the lake water quality; encourage best management practices on private lands.
