## **Safety Alert: Near Miss (PSIF) Incident**

Near Miss – PSIF Incident

While on a building roof, an associate followed a contractor back to the access point and stepped on a weak point and fell through, resulting in a Near Miss (PSIF) Incident.

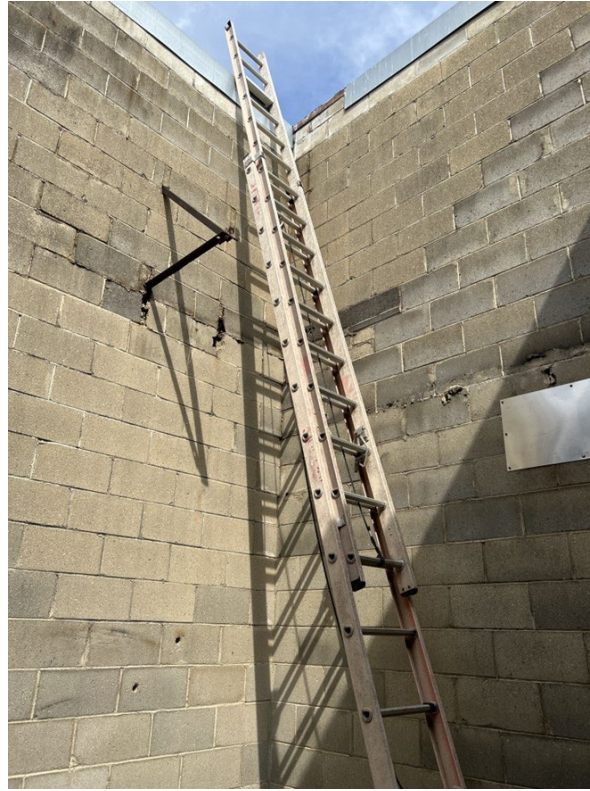
Ladder used to access roof.

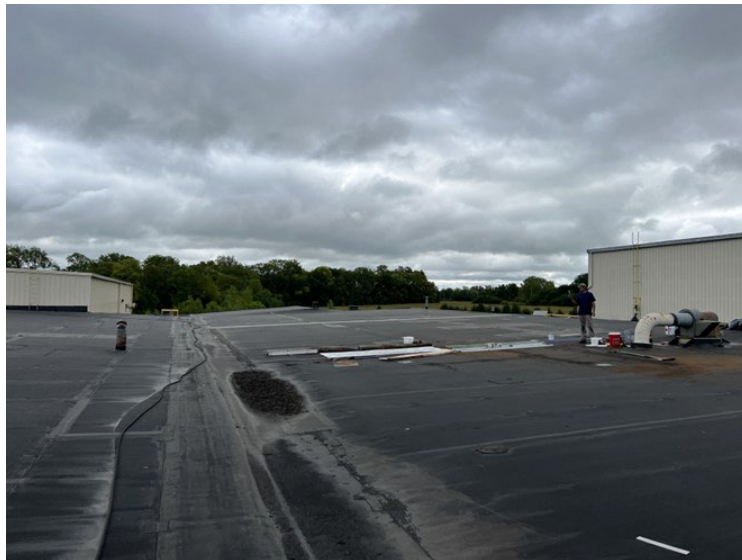
Roof before the incident occurred.

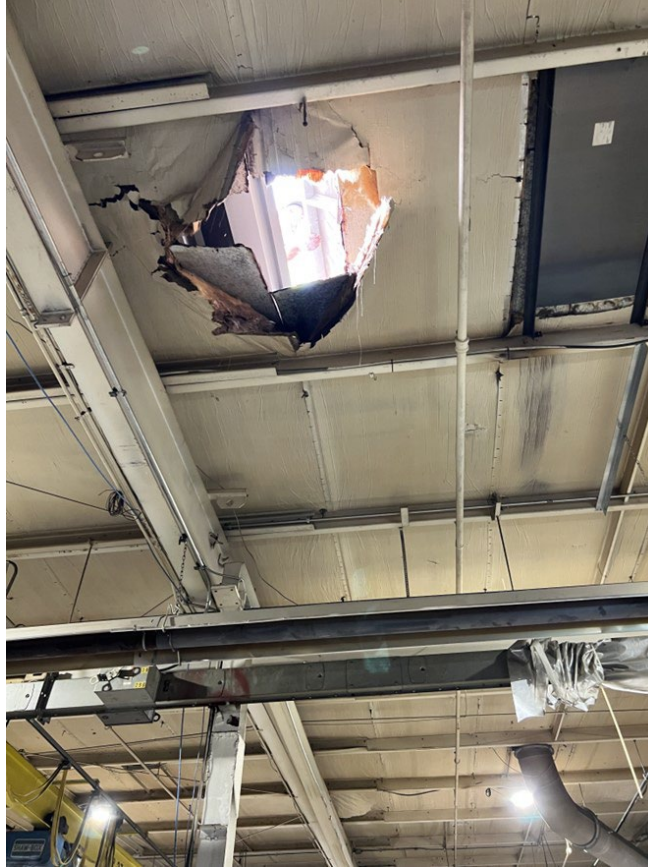
At approximately 11:15 AM, on September 8, 2023, an associate ascended a ladder to access the job site where a roofing contractor worked. The associate observed the crew for approximately 10 minutes, and then followed a contractor back towards the access point. The associate stepped on an unmarked soft spot, which did not support the associate's weight, and the associate fell through the roof. The associate extended both arms which prevented the associate from falling to the ground below. The contractors assisted the SMG associate out of the hole and back to the surface of the roof.

Weak area of roof where associate fell through. The view is from inside of the client's shop. The approximate height from the floor to roof is 15-20 feet.

1. The roofing contractor did not provide a Controlled Access Zone per 29 CFR Subpart M, Fall Protection, 1926.502(g). There was no warning-line system used and no fall protection system was available for use [Low-slope Roofs – 1926.501(b)(10)].
2. The client left a door open which led to a fiberglass ladder used to access the roof. The side rails had exposed fibers and the ladder should have been extended at least three (3) feet above the structure. It is recommended the door remains closed and locked. The ladder should be inspected and if deemed unserviceable, the ladder should be red-tagged and removed from use.
3. A designated walking path and the working areas should be clearly marked. Any identified potentially weak roof areas should be marked and barricaded.
4. It is highly recommended a Fall Protection Plan & a Rescue Plan are created and approved as required.
