# Home Inspection Report

Report Number:  
**2018070302**

Inspection Address:  
**2082 Henry Hart Drive  
Brentwood, CA**

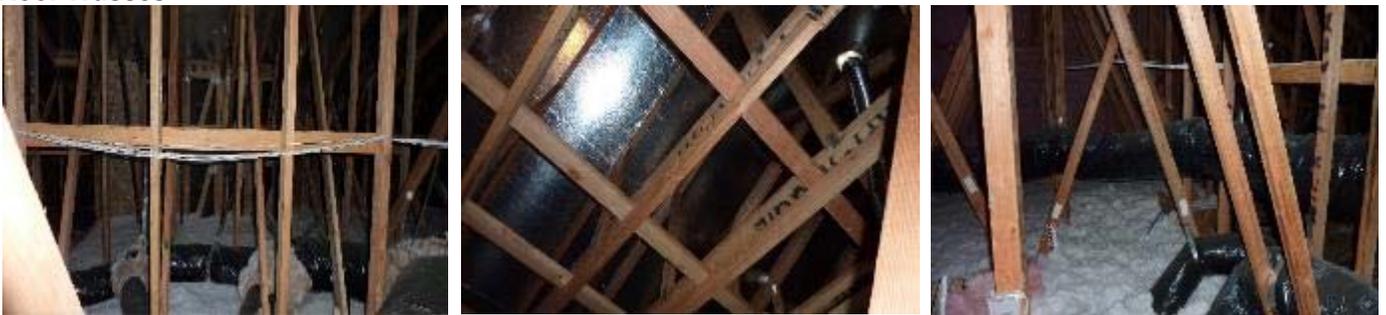
### Roof Trusses

The visible trusses were generally in acceptable condition and had performed adequately since their installation.

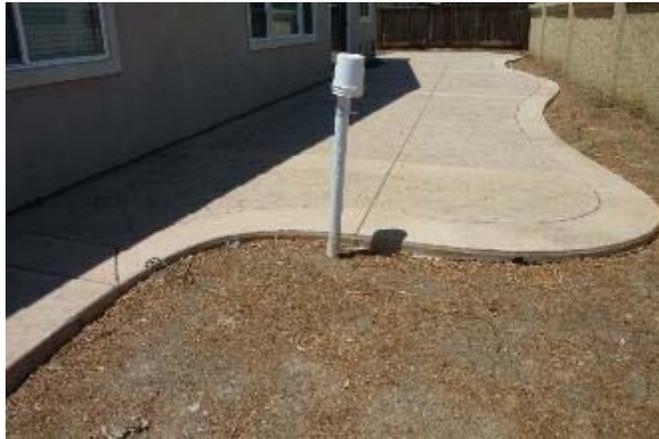
A drain pipe extends well above grade and will not be effective for drainage. We recommend the pipe be lowered to grade and a drain grate be installed.

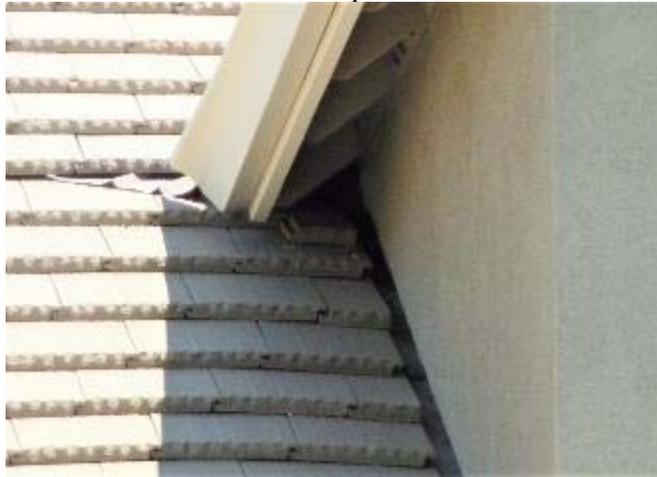
**A roof tile at the left side of the dormer has slid out of place. We recommend the tiles be repositioned and resecured by a qualified roofing contractor.**

1. **A roof tile at the left side of the dormer has slid out of place. We recommend the tiles be repositioned and resecured by a qualified roofing contractor.**

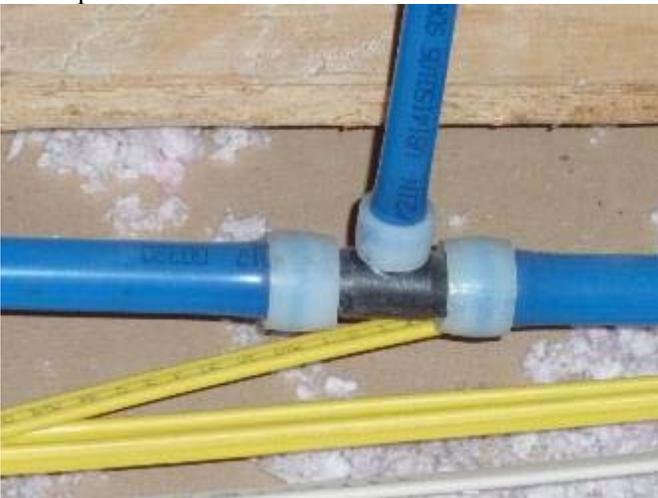
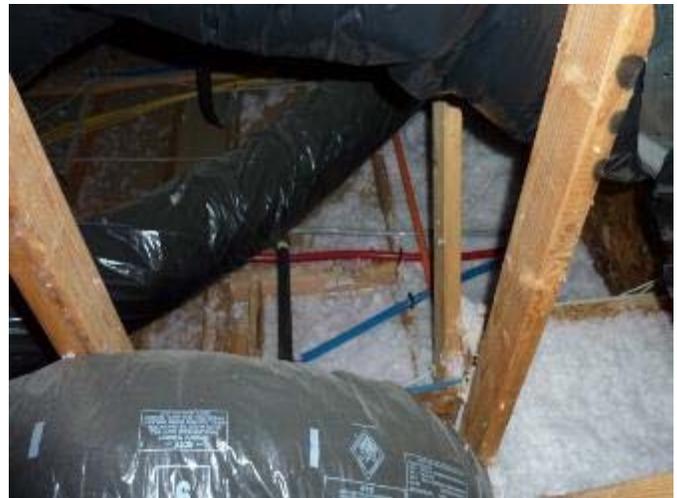
Portions of the polyethylene supply piping were exposed to sunlight in the attic. Over time the cross-linked polyethylene piping could become damaged by the sunlight coming through the attic vents. We recommend the piping be covered by insulation as preventive maintenance.

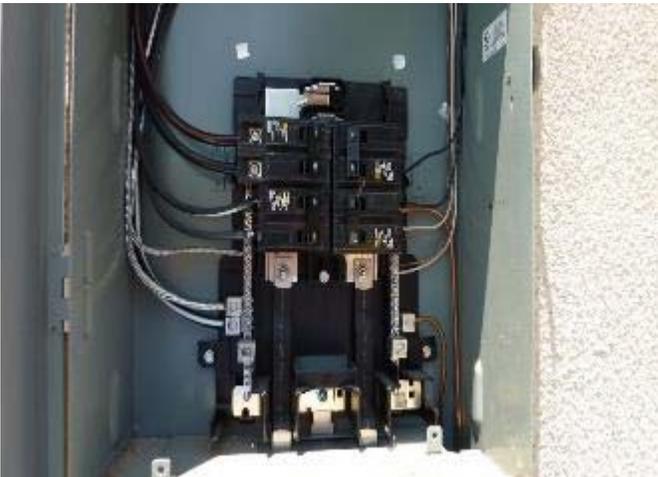
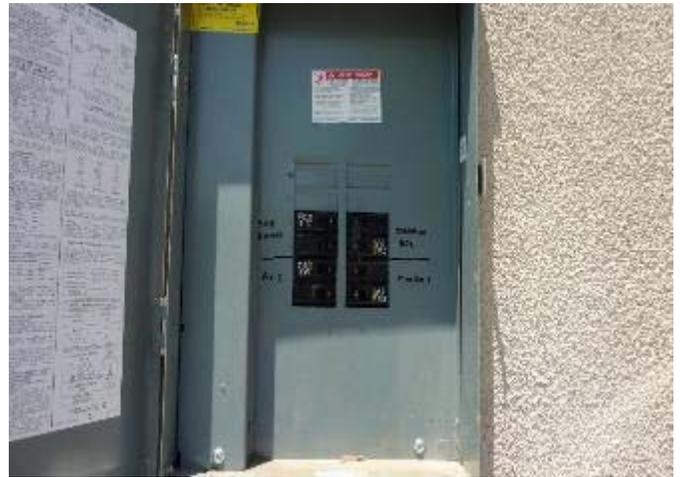
### The Main Distribution Panel

The main distribution panel was in acceptable condition with circuitry generally installed and protected in an acceptable manner.

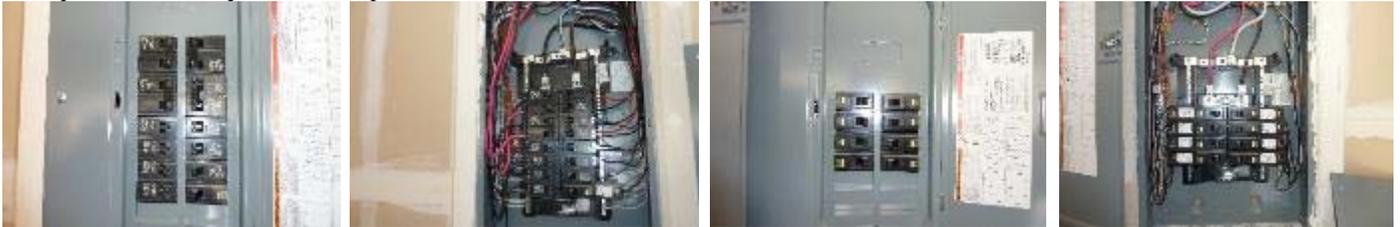
Inspected circuitry in this subpanel was in acceptable condition.

Circuits in each of the subpanels were labeled. The accuracy of the labeling was not verified. When the opportunity arises, we recommend verifying the accuracy of the labeling by actually operating the breakers.

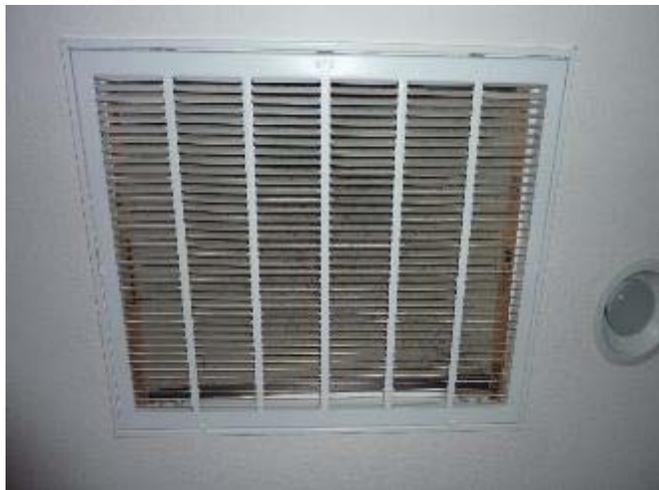
**The filter had accumulated debris that decreased its effectiveness and blocked airflow. This condition can dramatically decrease the efficiency of the system, decrease the service life of the furnace and increase maintenance costs. A properly sized new replacement air filter should be installed and secured in the correct orientation in this unit.**

3. **The filter had accumulated debris that decreased its effectiveness and blocked airflow. This condition can dramatically decrease the efficiency of the system, decrease the service life of the furnace and increase maintenance costs. A properly sized new replacement air filter should be installed and secured in the correct orientation in this unit.**

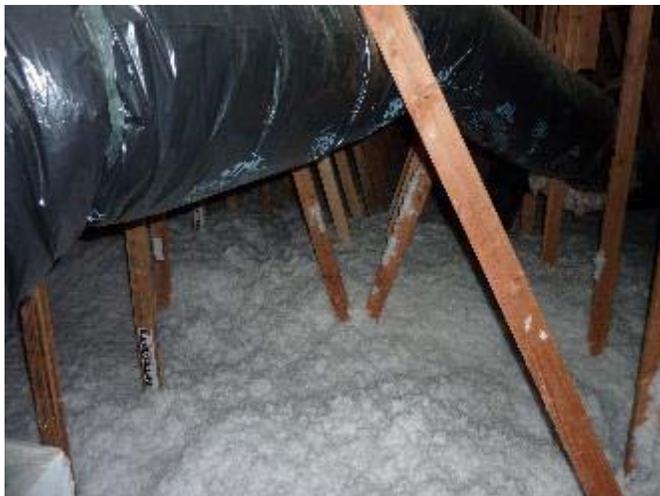
### Attic Insulation Conditions

The insulation had settled or had been compressed and no longer provided the same R-value as when it was installed. At the least, additional insulation should be installed to restore the original thermal efficiency of the attic. Even better would be to add insulation to bring the level up to current industry standards.

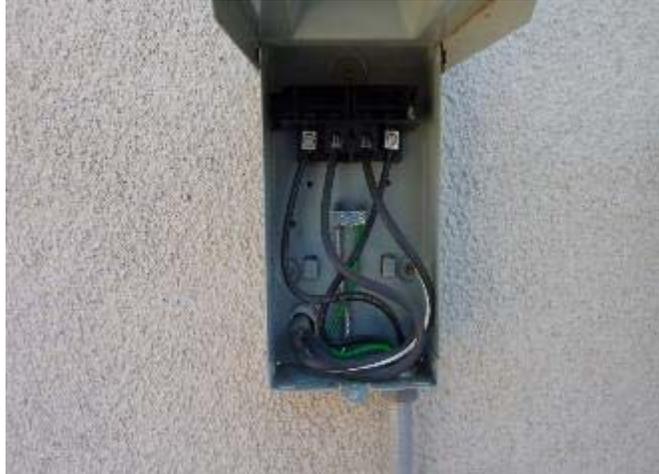
## Cooling System Electrical Wiring

The visible and accessible wiring for the electrical supply was in acceptable condition.

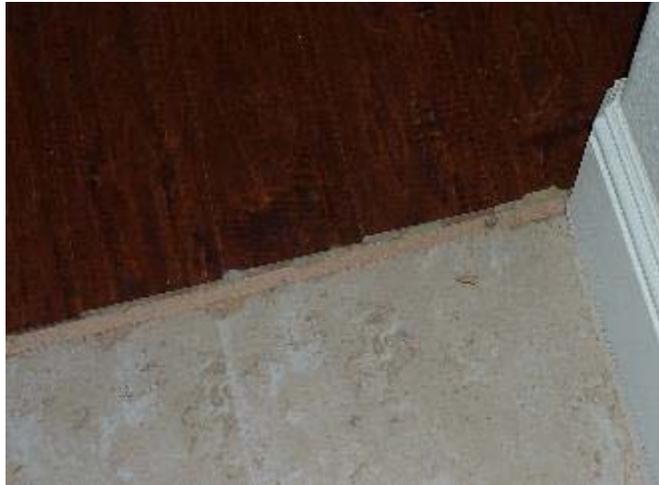
There was a gap at the transition at the entry. We recommend repairs be made for improved appearance.

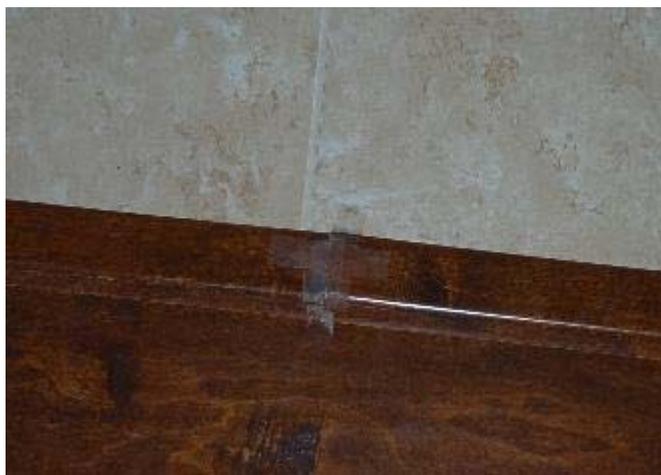
There was damage to a transition strip at the family room/kitchen. We recommend repairs be made for improved appearance.

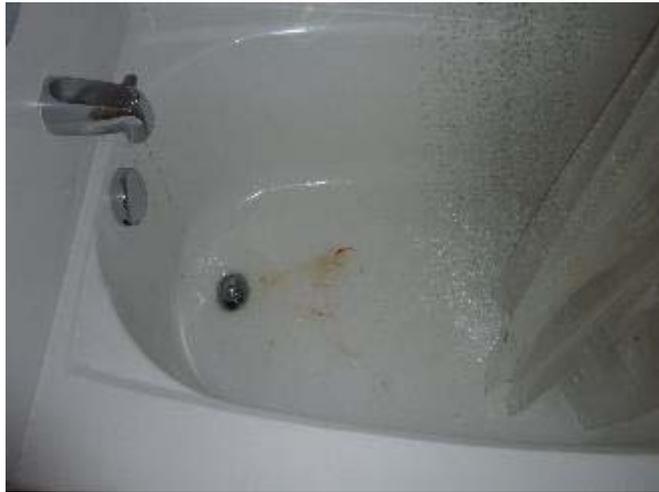
The bathtub was rusted. We recommend repairs be made by a qualified professional.
