Inspection Report

Property Address:

1234 Main St
Anytown WA 98000

Right Start Inspection Services

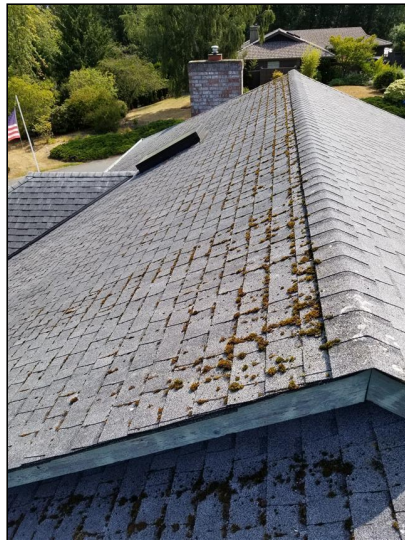
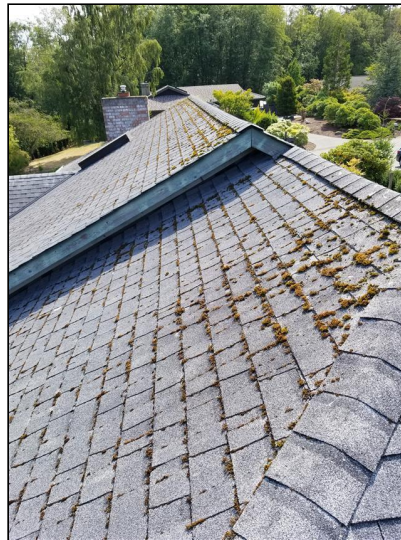
(1) There is moss buildup on the north side of the roof. Moss can do permanent damage to roof coverings and should be removed.

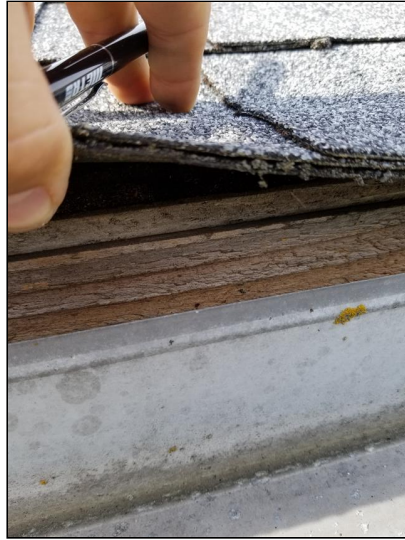
1.0 Item 3(Picture)

(2) Roofing is single layer of architectural shingle.

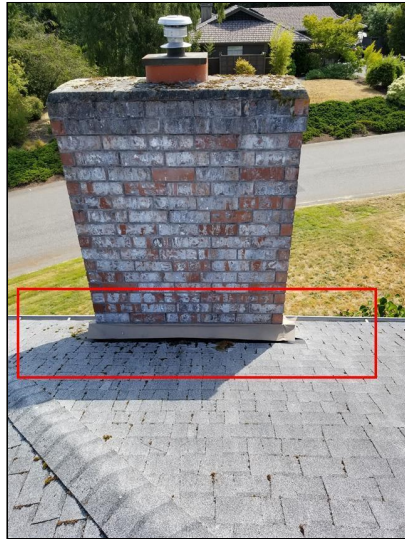
1.2 Item 1(Picture)

(1) Chimney is 63" wide with no cricket and some Moss build up. Chimneys over 34" wide should have a cricket installed to prevent water and debris from building up behind the chimney.

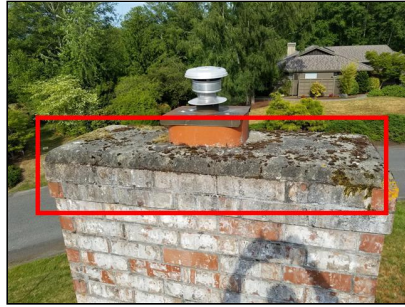
1.2 Item 2(Picture)

(2) Concrete chimney cap is deteriorated and should be repaired by a qualified contractor.

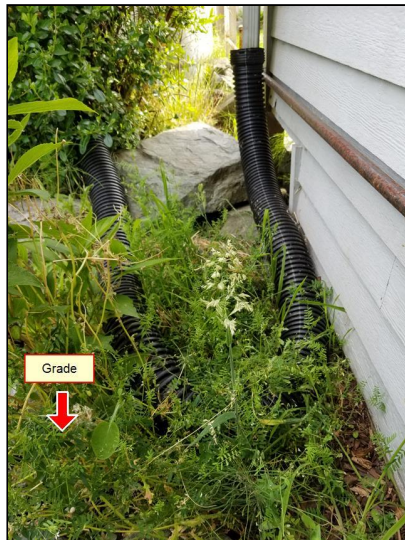
1.3 Item 1(Picture)

(1) Downspout at southeast corner of house is connected to a black flexible pipe which loops uphill. This pipe should be rerouted so that water from gutter can flow away from the building.

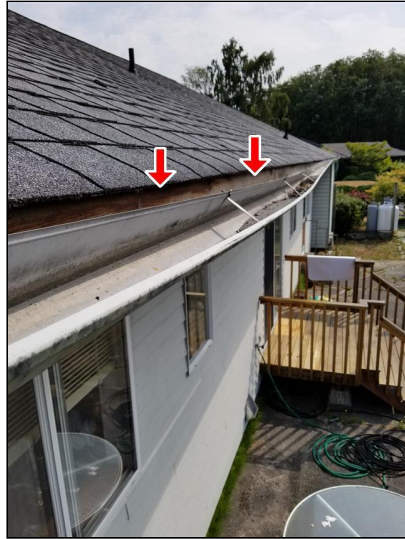
1.3 Item 2(Picture)

(2) Gutter separated from the building at back side of the house, which may cause water intrusion into house. Gutter should be reattached or replaced as required.

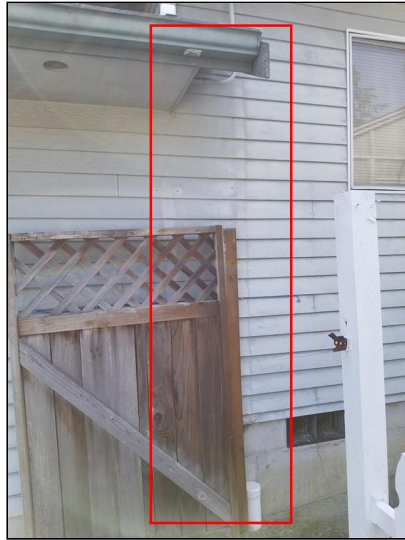
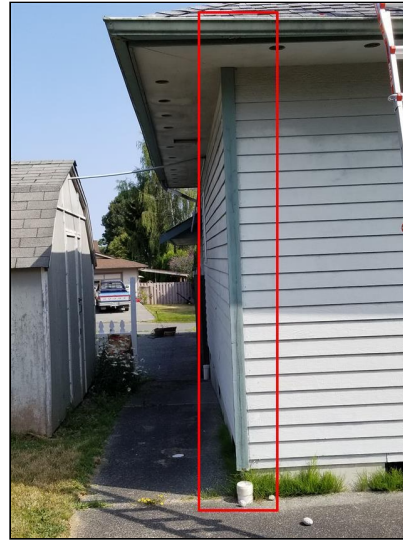
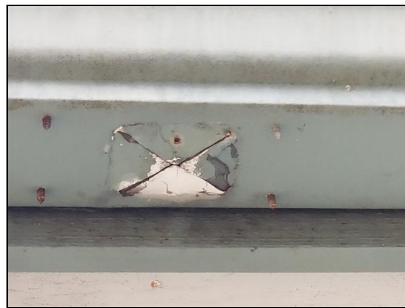
(3) Downspouts on the south and west sides of building have been removed and openings in gutters blocked off. Currently the requirement of one downspout per 40' of gutter is not being met. Downspouts should be installed at these two locations.

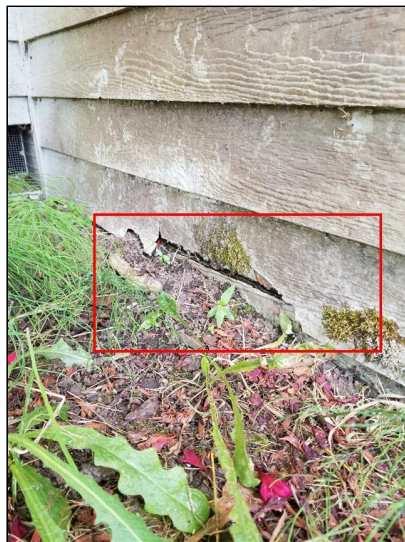
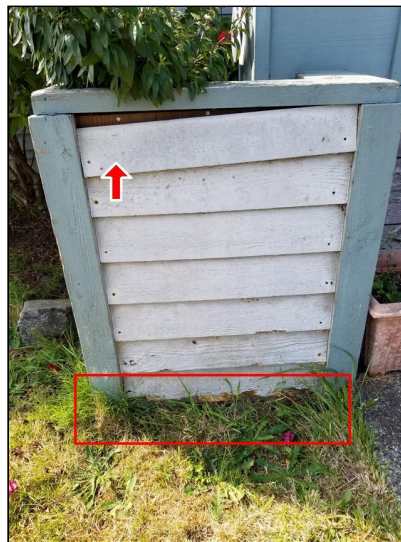
(1) Siding is in contact with grade and significantly deteriorated around planter boxes at front of house. Some siding is also loose on the planter boxes. Recommend adjusting grade away from siding and having damaged pieces replaced.

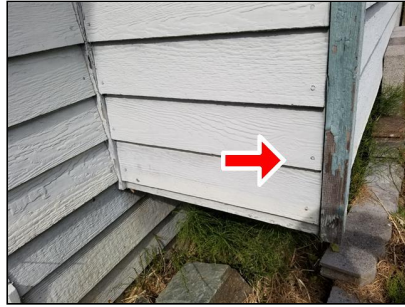
2.0 Item 3(Picture)

(2) Paint peeling on siding at the rear of the house. Needs prep and paint to prevent deterioration of siding.

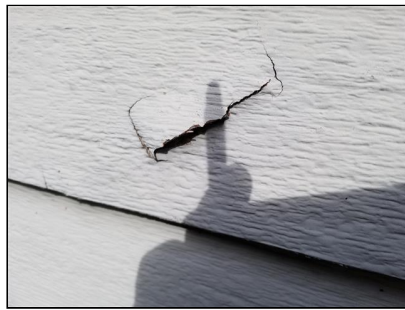
2.0 Item 4(Picture)

(3) Multiple paint blisters exist on south side of house. Paint should be sanded and touched up as required.

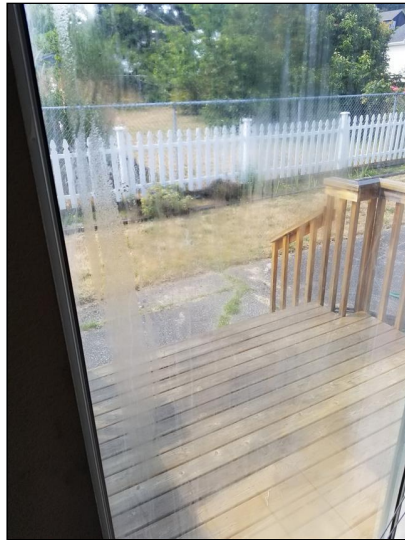
2.1 Item 1(Picture)

Sliding glass door at back of house has a broken seal.

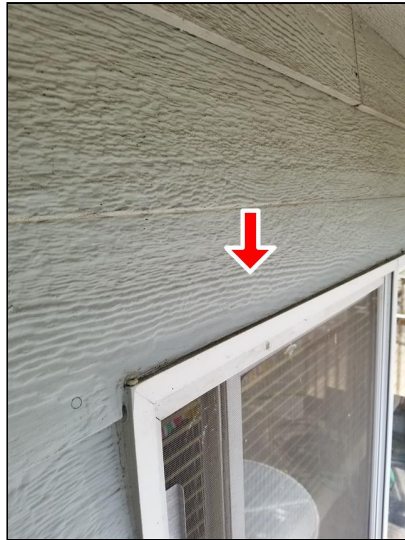
2.2 Item 1(Picture)

No flashing seen above windows. No deterioration noted at this time but windows should be monitored for water intrusion in the future.

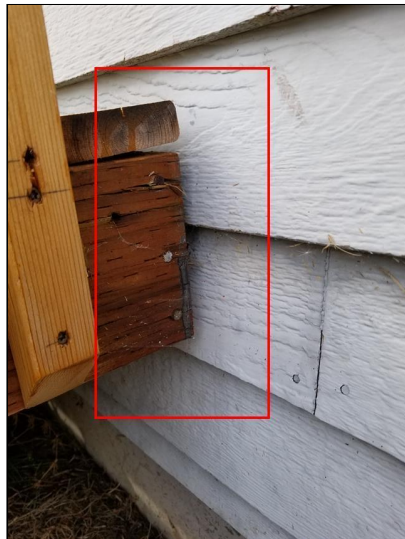
2.3 Item 1(Picture)

(1) Back deck is attached over siding. All decks should be attached directly to framing. Siding should be cut back and deck re-installed by a qualified contractor.

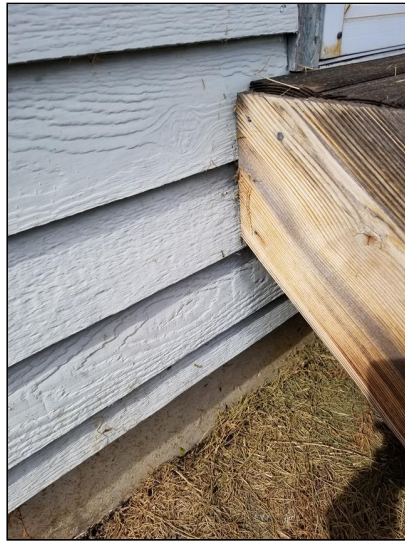
2.3 Item 2(Picture)

(2) Stairs at back of house (master bedroom door) attached on top of siding. Stairs should be attached directly to framing by a qualified contractor.

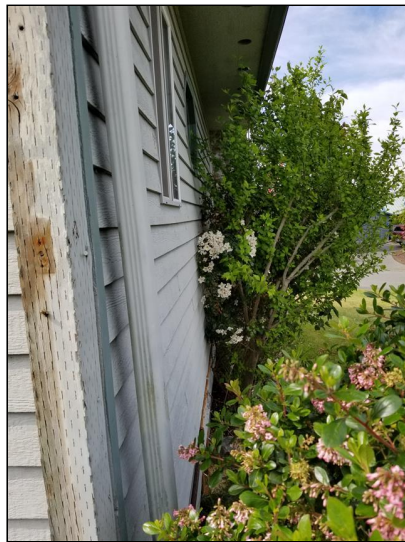
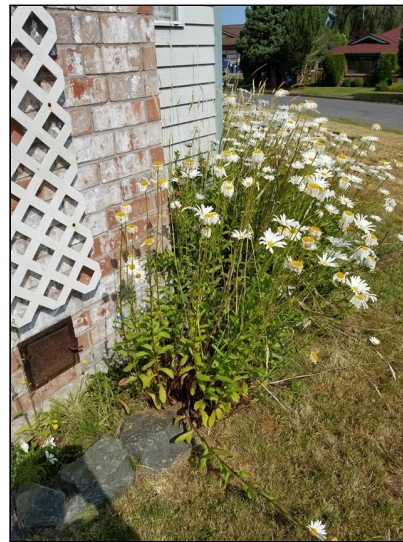
(1) Plants are in contact with building in multiple areas. Plants should be trimmed back from building at least 6" or removed as they can cause damage to structure and provide a means for pests to enter the home.

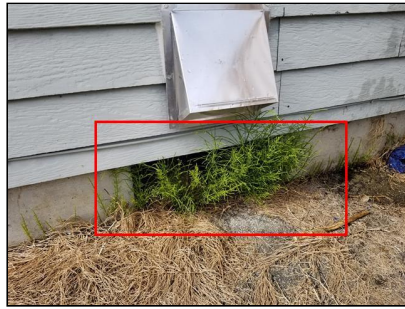
2.4 Item 3(Picture)

(2) Vegetation and debris partially blocking foundation vent. Trim back vegetation and debris to promote ventilation.

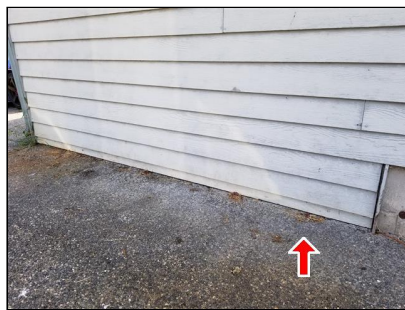
2.4 Item 4(Picture)

(3) Siding is in contact with concrete on side of garage. Siding should be a minimum of 6" above grade.

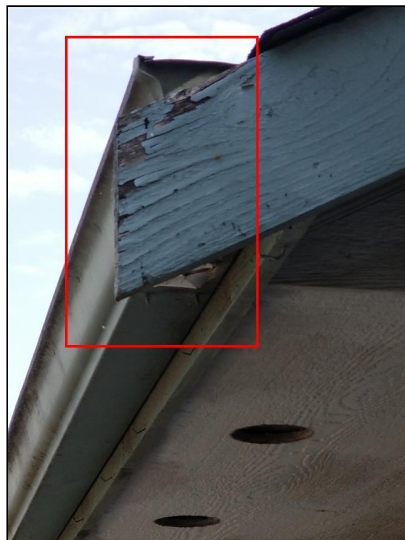
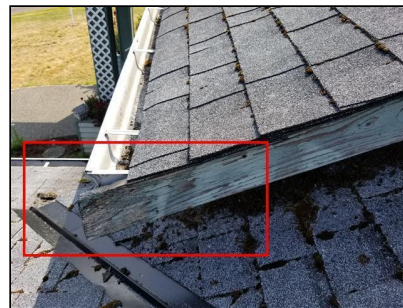
The paint on the fascia is peeling. Recommend prep and paint on the west side.

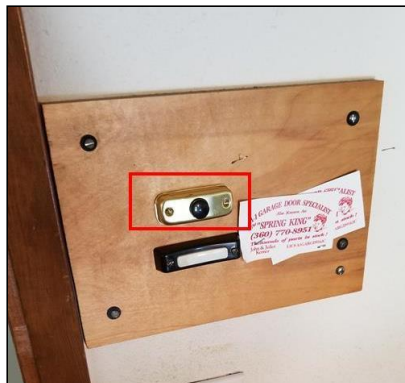
3.5 Item 1(Picture)

Both garage doors will reverse when met with resistance. West garage door opener switch not working. Vehicle remote will operate door. Switch should be repaired as needed by a qualified contractor.

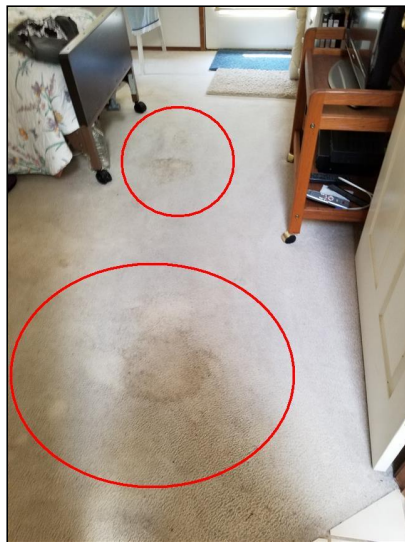
4.2 Item 1(Picture)

Stains on carpet in master bedroom.

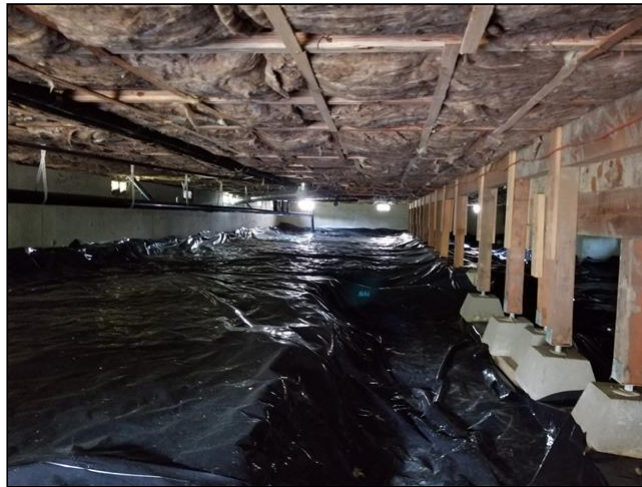
5.0 Item 1(Picture)

- (1) Crawl space recently cleaned and Vapor Barrier replaced

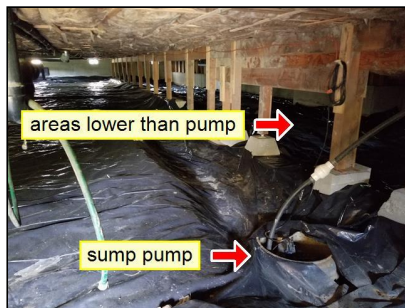
5.0 Item 2(Picture)

- (2) Standing water in crawl space below level of sump pump. Sump pump is operating correctly, however, some areas of crawl space are excavated lower than the pump and have standing water under the vapor barrier. Suggest having the sump pump moved lower to alleviate the problem. Although there are some water marks on the foundation walls, all structural components appear undamaged.

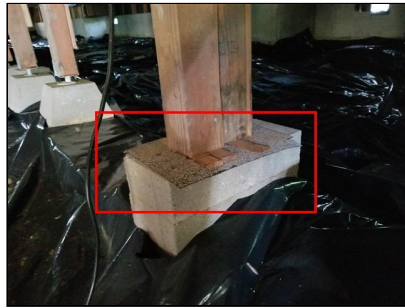
5.2 Item 1(Picture)

Two columns have been installed without attachment to Foundation. Columns should be attached at top and bottom to resist seismic activity. We recommend having brackets installed by a qualified contractor.

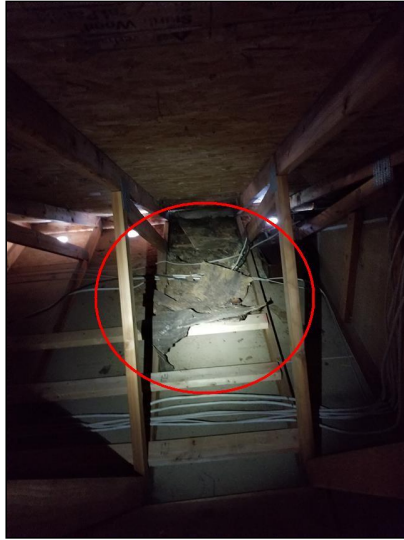
5.5 Item 1(Picture)

(1) Debris left in attic above garage should be removed.

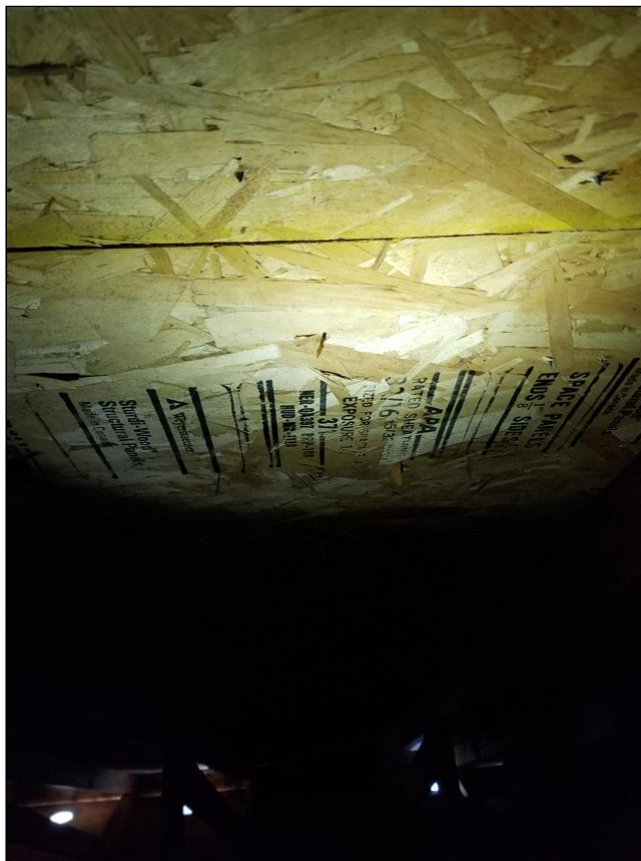
5.5 Item 2(Picture)

(2) No "H" clips installed in between courses of roof sheathing. No action required.

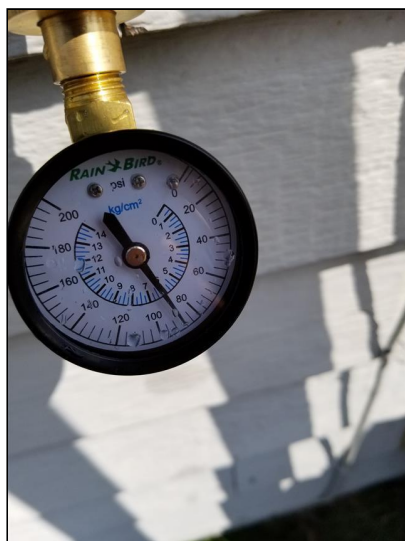
6.1 Item 1(Picture)

Water pressure 82 PSI measured at the hose bib at the back of the house. Water pressure between 40 and 80 PSI is considered acceptable. Excessive water pressure can cause damage and leaks in piping and fixtures. Suggest installing a water pressure regulator to protect fixtures and for occupant comfort.

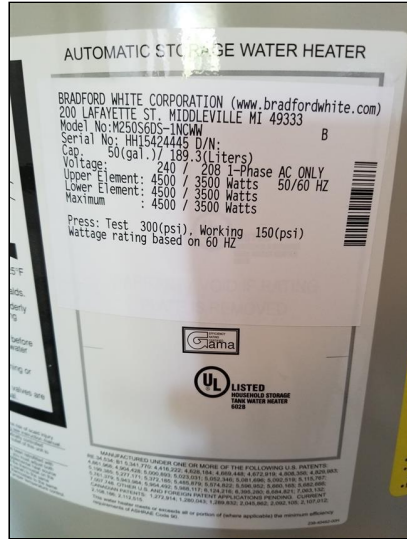
6.2 Item 1(Picture)

(1) Water heater manufacturer label. Water heater was manufactured in 2011.

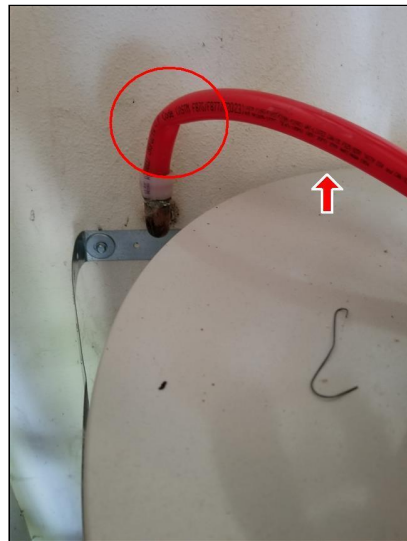
6.2 Item 2(Picture)

(2) The T&P (Temperature and Pressure) valve on water heater is PEX which is bent up slightly and kinked, which may hinder water flow. T&P valve piping should be 3/4" ridged copper or CPVC. Piping should be replaced with a proper material by a licensed plumber.

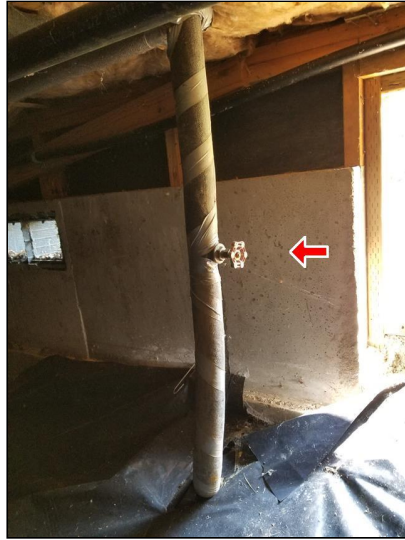
6.3 Item 1(Picture)

Main water shut-off is in crawl space next to access door.

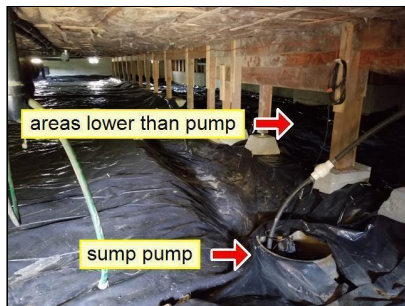
6.6 Item 1(Picture)

Sump pump should be relocated by a qualified contractor to more effectively remove water from the crawlspace.

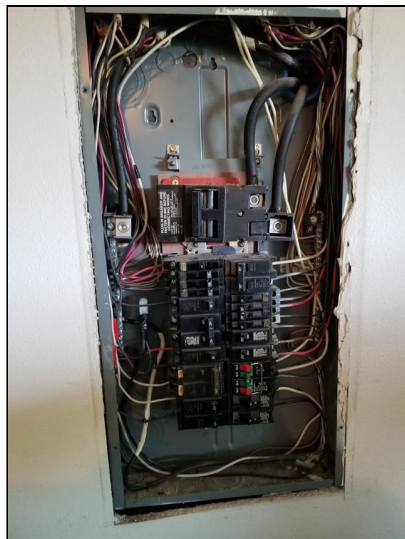
7.1 Item 1(Picture)

(1) Inside of main service panel.

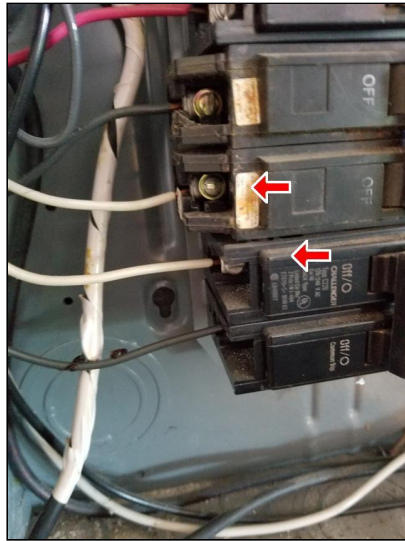
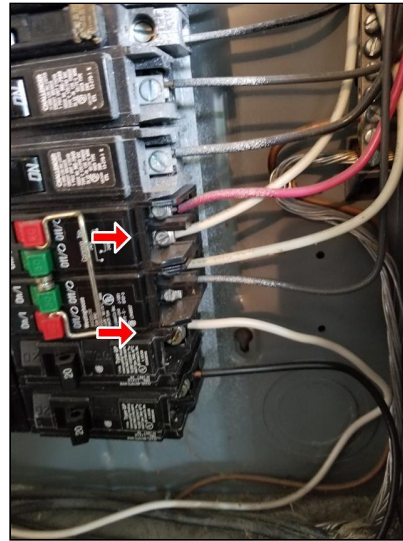
(2) Multiple white wires used as hot. These wires should be labeled to avoid short circuiting and electric shock. Recommend having wires checked and labeled by a certified electrical contractor.

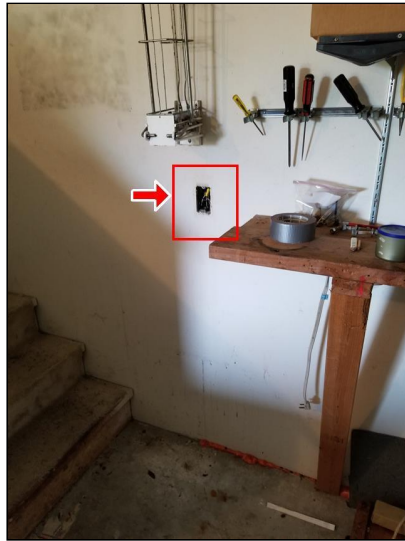
7.3 Item 1(Picture)

(1) Junction box in garage has no cover. Cover should be installed to prevent against electric shock.

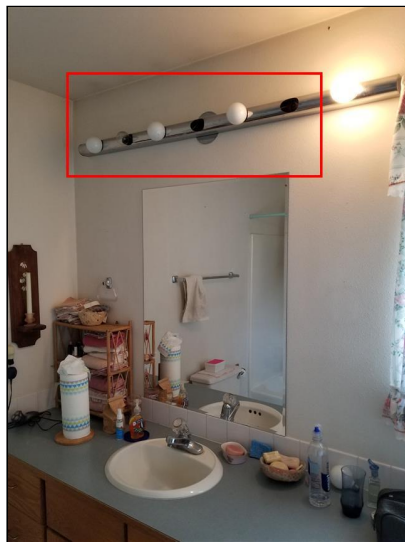
7.3 Item 2(Picture)

(2) Multiple bulbs in guest bathroom are burned out or missing.

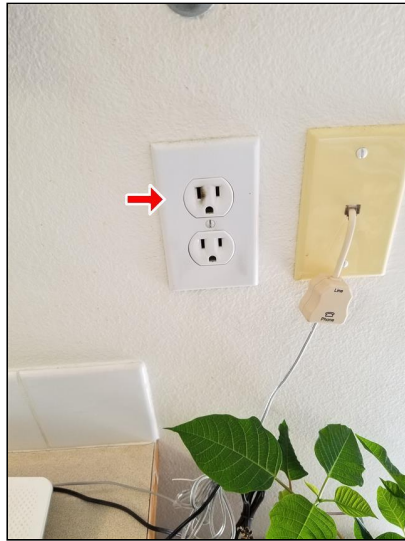
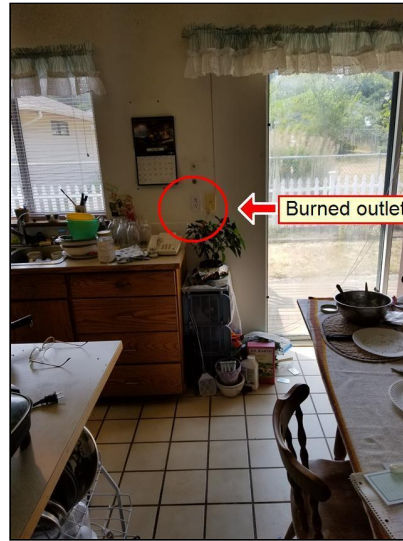
(3) Outlet in kitchen not working and has a burn mark. Recommend outlet not be used until it can be repaired or replaced by a certified electrician.

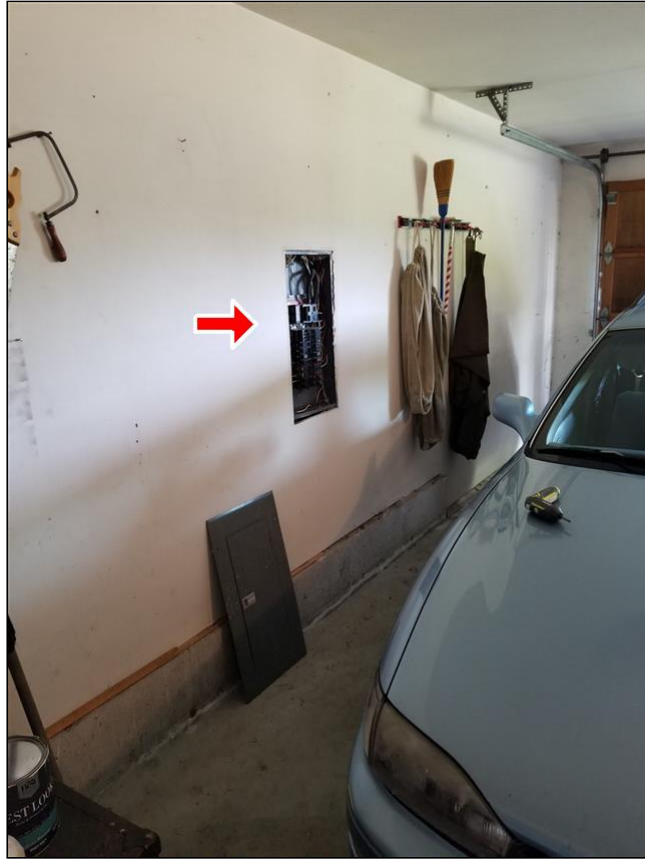
7.7 Item 1(Picture)

Main panel located on west wall of garage.

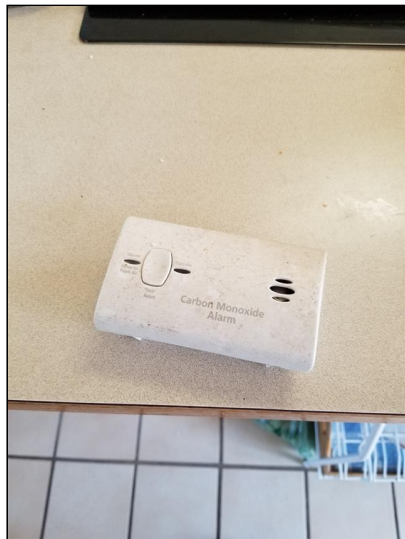
7.9 Item 1(Picture)

Carbon monoxide detector sitting on counter and needs to be installed permanently.

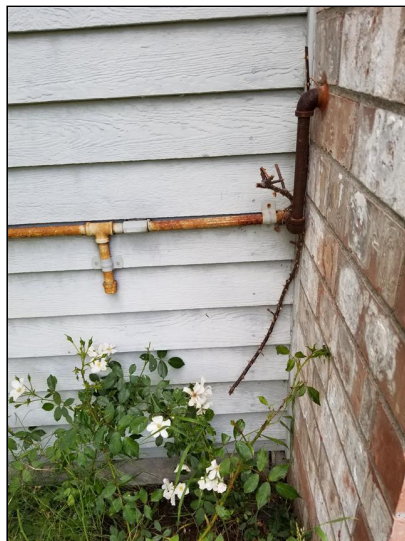
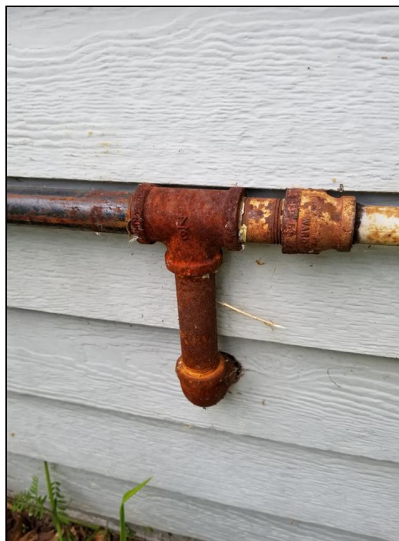
Gas supply piping is rusty and should be prepped and painted to avoid further deterioration.

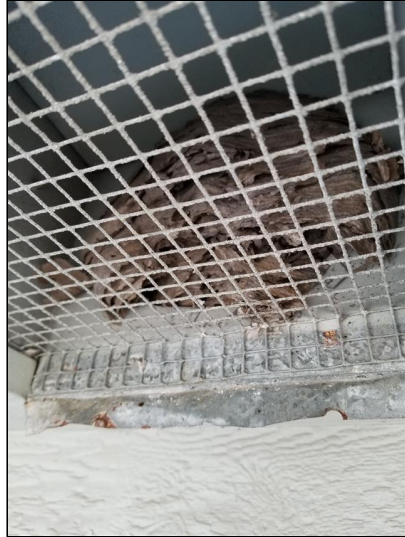
8.5 Item 1(Picture)

A wasp's nest is blocking the intake for the heat exchanger. Nest appears to be vacant. A qualified person should remove the nest before operating the heat exchanger.

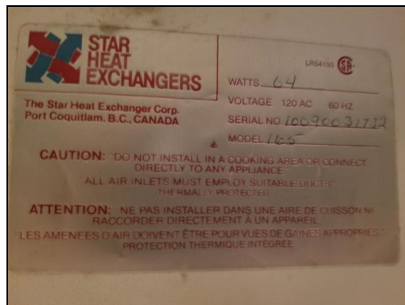
8.8 Item 1(Picture)

(1) Heat exchanger manufacturer label.

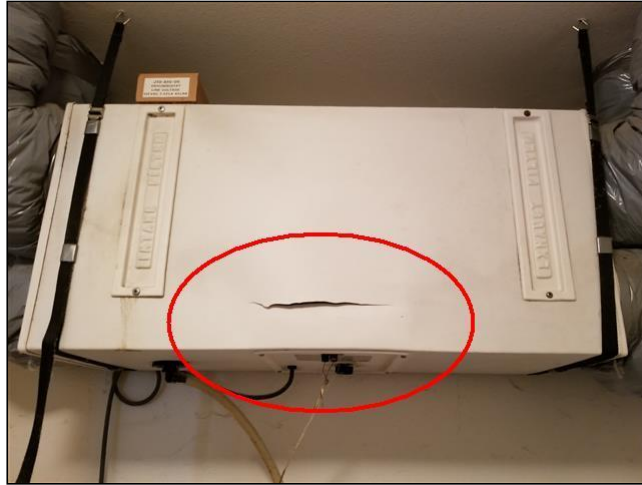
8.8 Item 2(Picture)

(2) There is a crack in the casing of the heat exchanger. Recommend having the heat exchanger repaired or replaced by a qualified HVAC contractor before operating.
