# **Geotechnical Study and Foundation Recommendation Report**

N5012 Sanostee Wash Bridge  
Sanostee, New Mexico  
Project # 19-517-00007

Subject: **Geotechnical Study and Foundation Recommendations Report  
N5012 Sanostee Wash Bridge  
Sanostee, New Mexico**

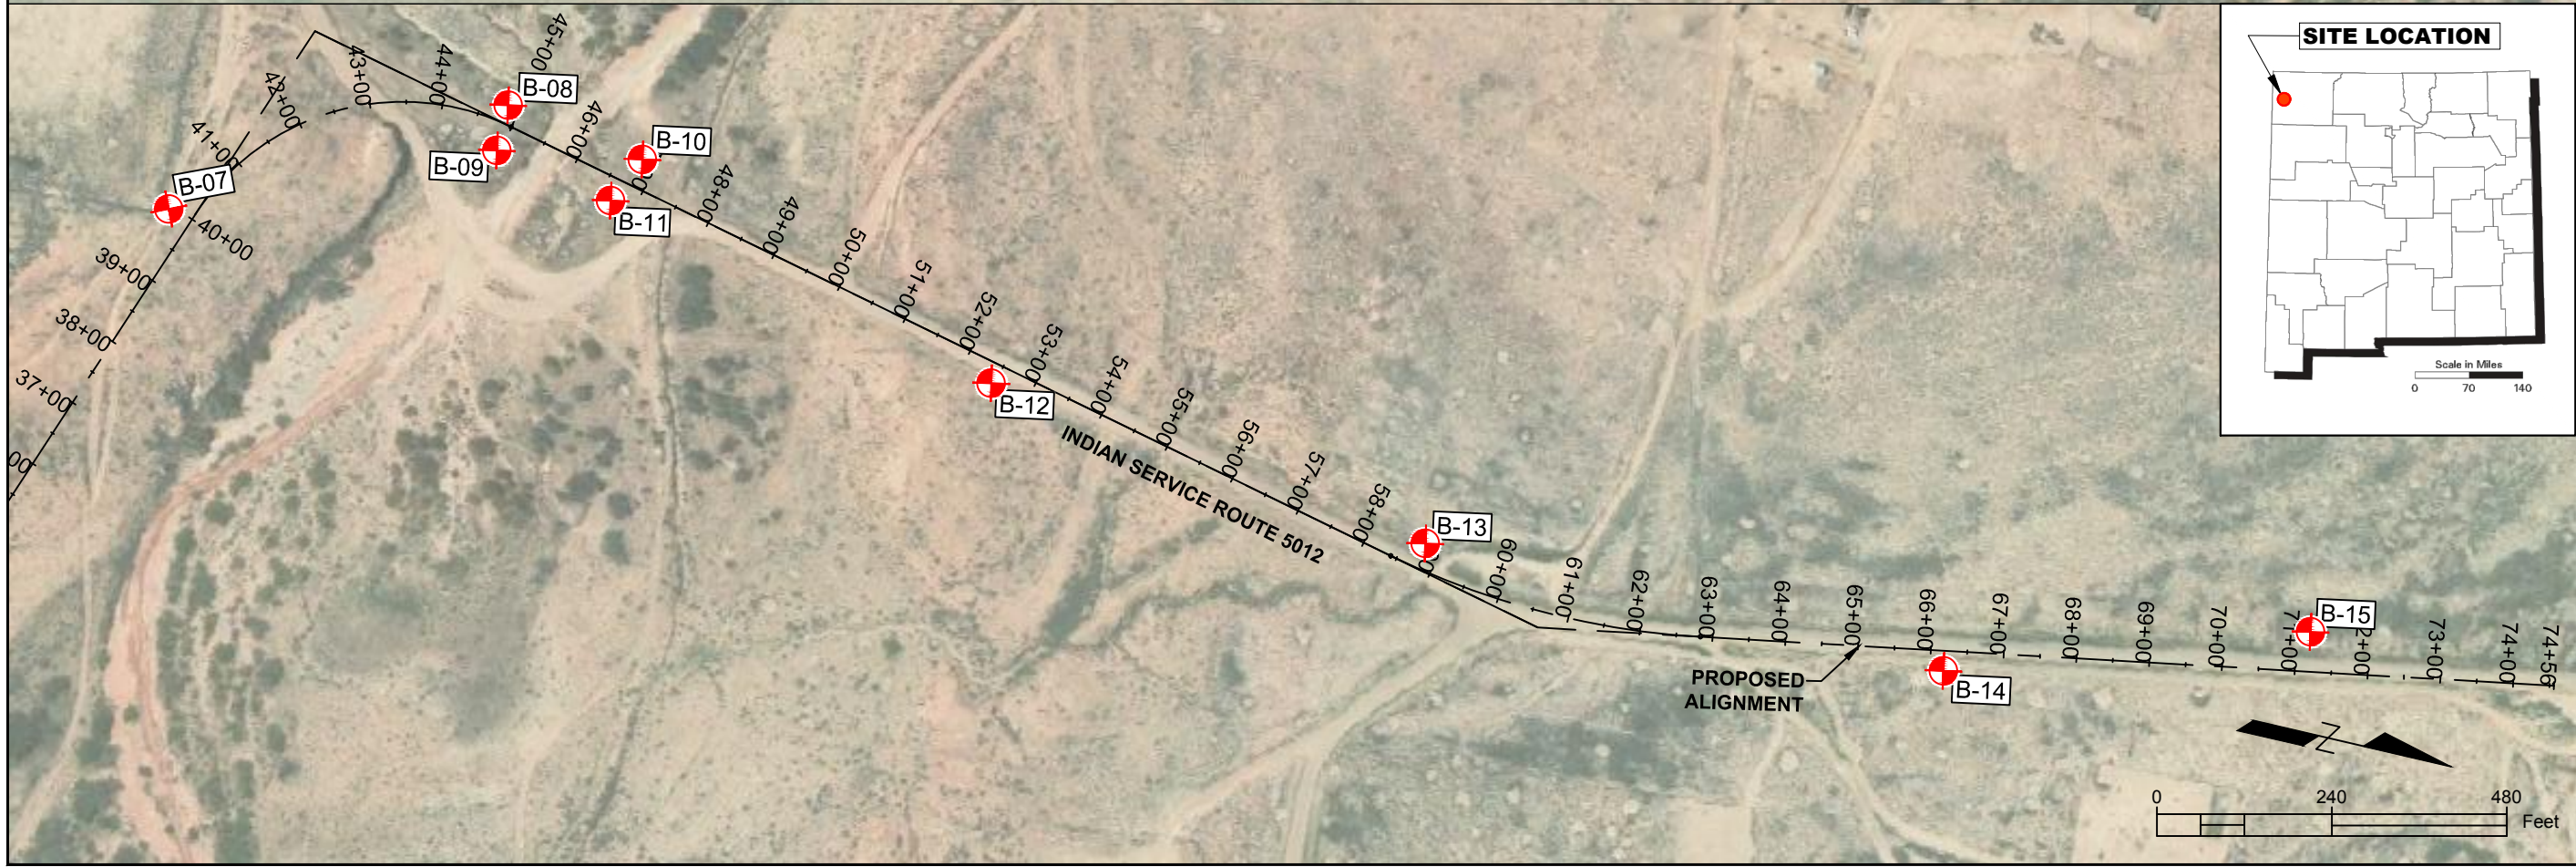
FIGURE NO: **1**

TITLE:  
**SITE AND EXPLORATION PLAN**

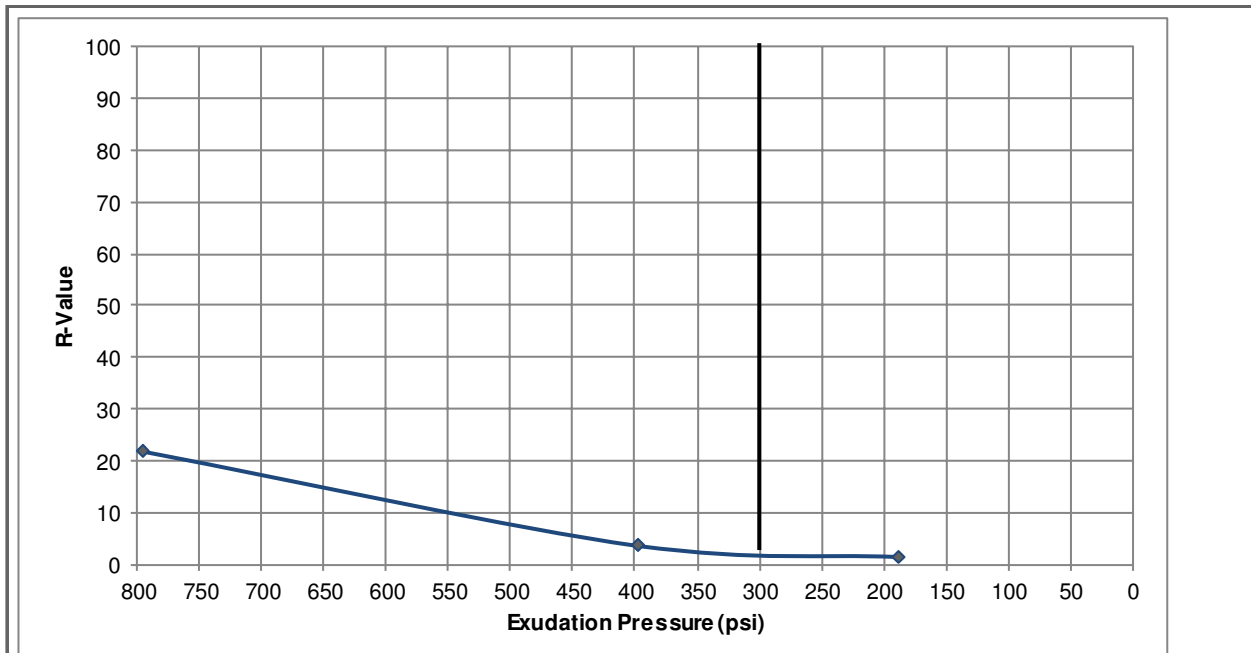
**RESISTANCE R-VALUE AND EXPANSION PRESSURE OF COMPACTED SOILS (AASHTO T190-09)**

**R-Value at 300psi:** 2

Based on the results of the study, the soils between stations 0+00 to 21+00 are predominately clayey with an R-value of 2. The portion of N5012 north of the bridge site is also considered to be clayey based on the field investigation and has similar R-Value laboratory results. The soils between stations 21+00 and 52+00 were observed to be more granular and samples tested resulted in an R-Value of 18. Two soil support conditions were modeled for providing these recommendations. Soil Support A represents the soil conditions between Stations 21+00 and 52+00 with a Resilient Modulus ( $M_r$ ) 7,000 psi using Mechanistic and Empirical Design Correlations (MEPDG). Soil support B represents the clayey portions of the project alignment, and was modeled using a resilient modulus of 2,500 psi.

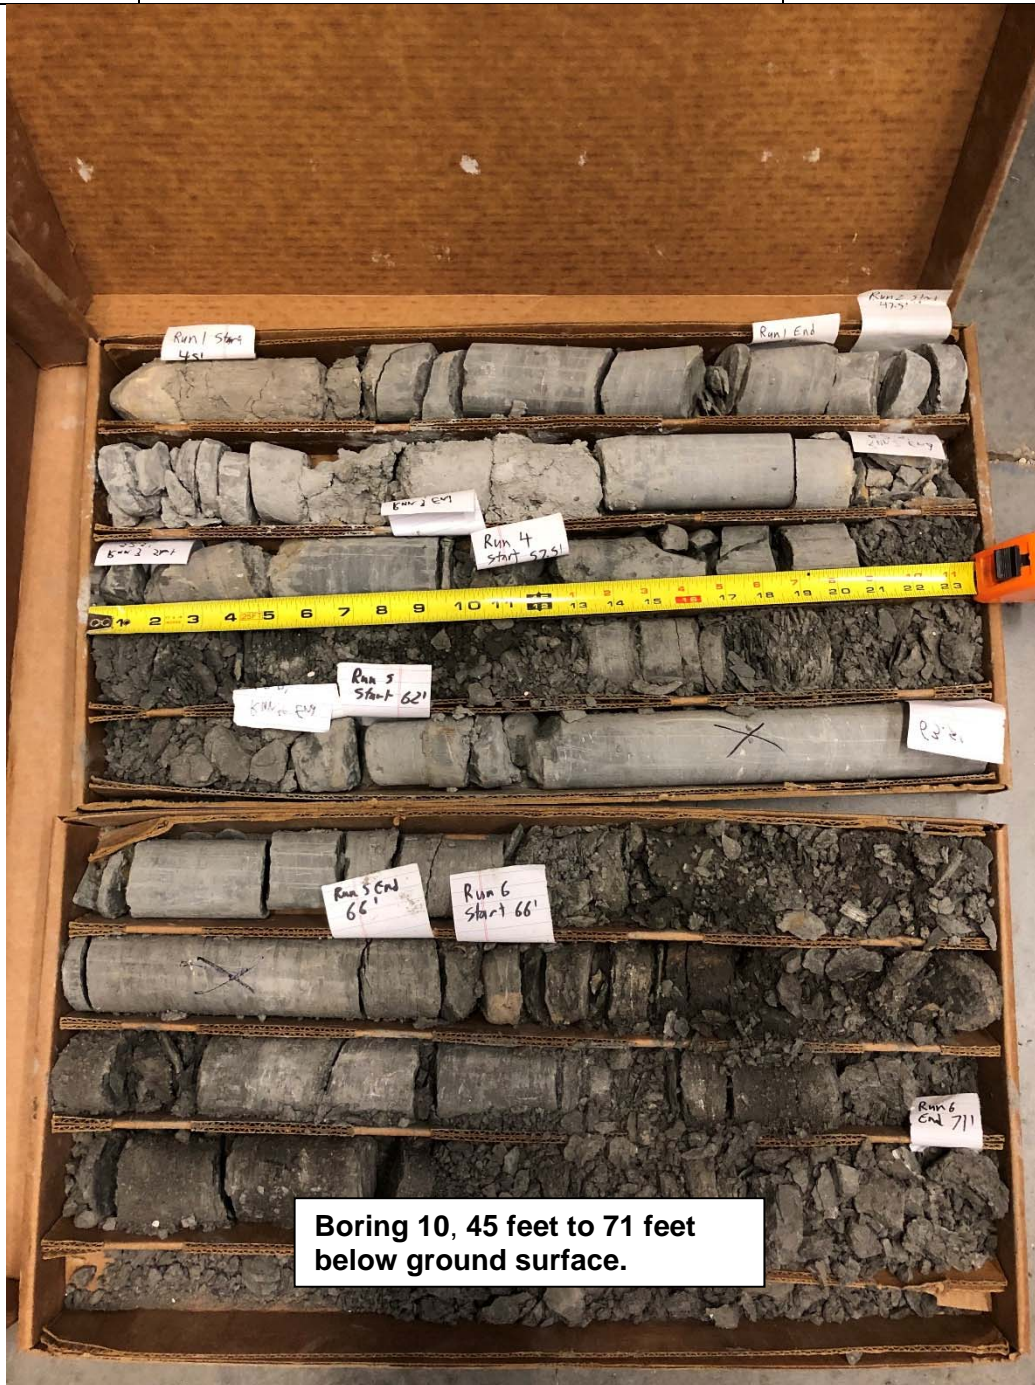
**Boring 10, 45 feet to 71 feet below ground surface.**

It was necessary to quantify the properties of the rock mass encountered to make recommendations for end bearing (tip resistance). AASHTO 2014 Sections 10.8.3.5.4c-1 and 10.8.3.5.4b were reviewed and utilized to quantify the properties of the rock. A GSI of 35 and RQD of 26% were derived using the "Quantification of the Geological Strength Index chart" by E. Hoek, et al. Unconfined compressive testing was performed on select samples using ASTM D7012. Results of unconfined compression testing are shown below. It can be observed that the results are highly variable. Not all of the tests are considered to be representative due to sample disturbance during removal from core drill in the field and drying shrinkage during specimen transport. A representative value of 2400 psi was utilized for unconfined compressive strength of the rock deposit given the data and our experience with the shales present in this part of the state.

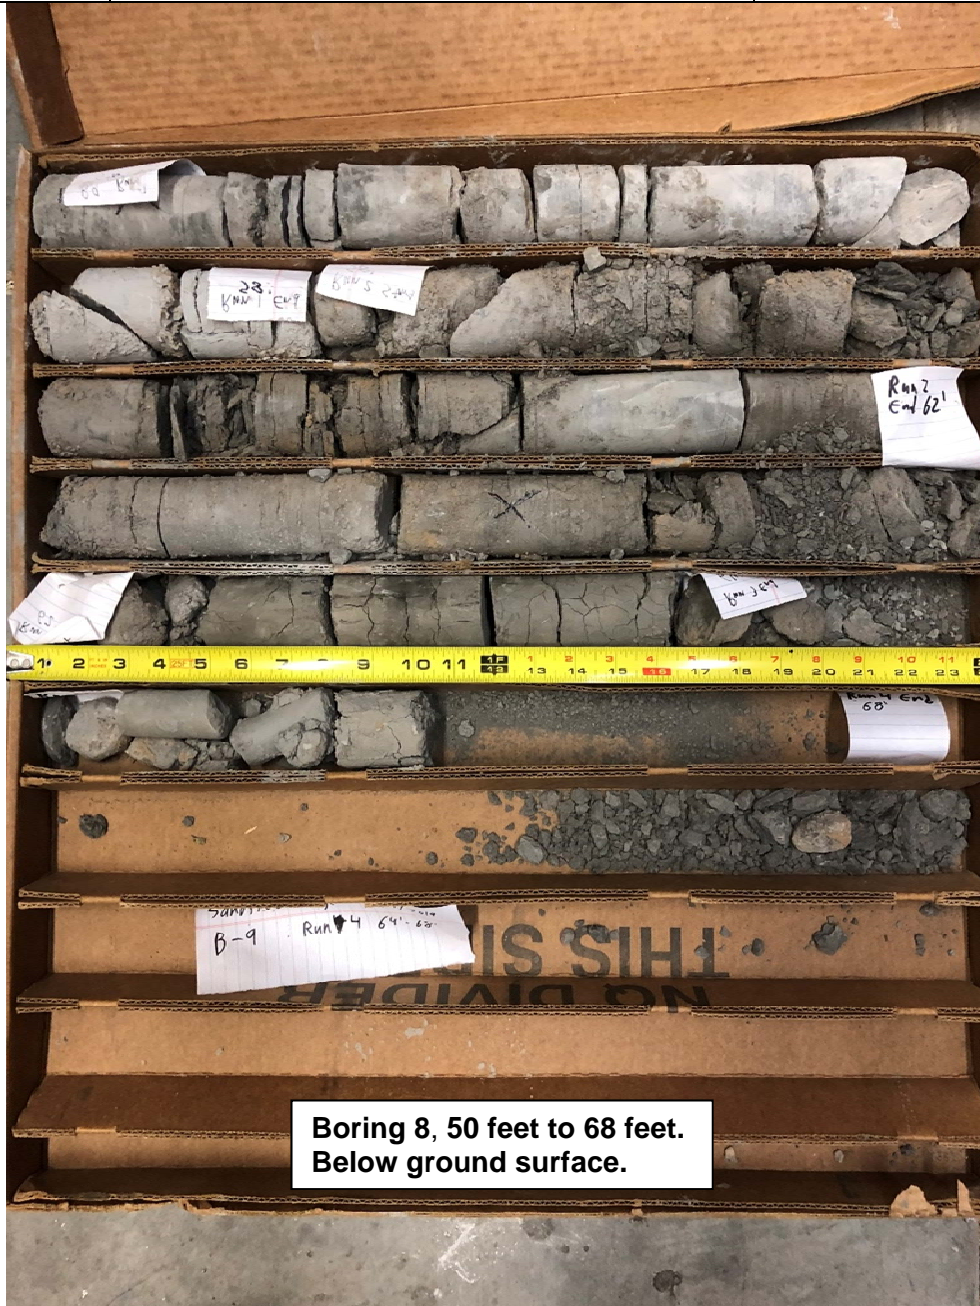
**Boring 8, 50 feet to 68 feet.  
Below ground surface.**

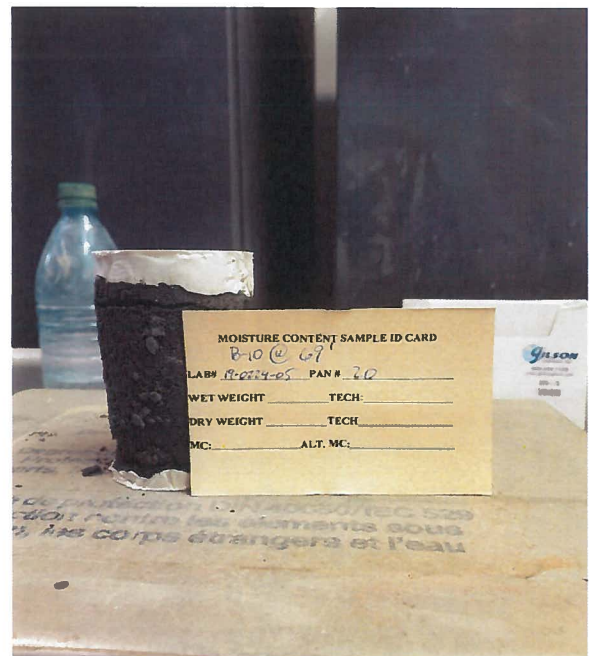
PROJECT: Sanostee Wash Bridge  
 LOCATION: Sanostee, NM  
 BOREHOLE NO.: B-10  
 DEPTH (ft): 69  
 MATERIAL: Rock Core

<b>Failure Stress (psi)</b>	<b>45</b>
-----------------------------	-----------

Prefailure Photo

Post-failure Photo
