**GEOTECHNICAL REPORT  
BIA ROUTE N55 (1-1) 2&4  
NAVAJO NATION, NEW MEXICO  
KLEINFELDER PROJECT NO. 20162433.001A**

**Revised June 23, 2016**

**SUBJECT: Draft Geotechnical Report  
BIA Route N55  
BIA Project N55 (1-1)2&4  
Navajo Nation, New Mexico**

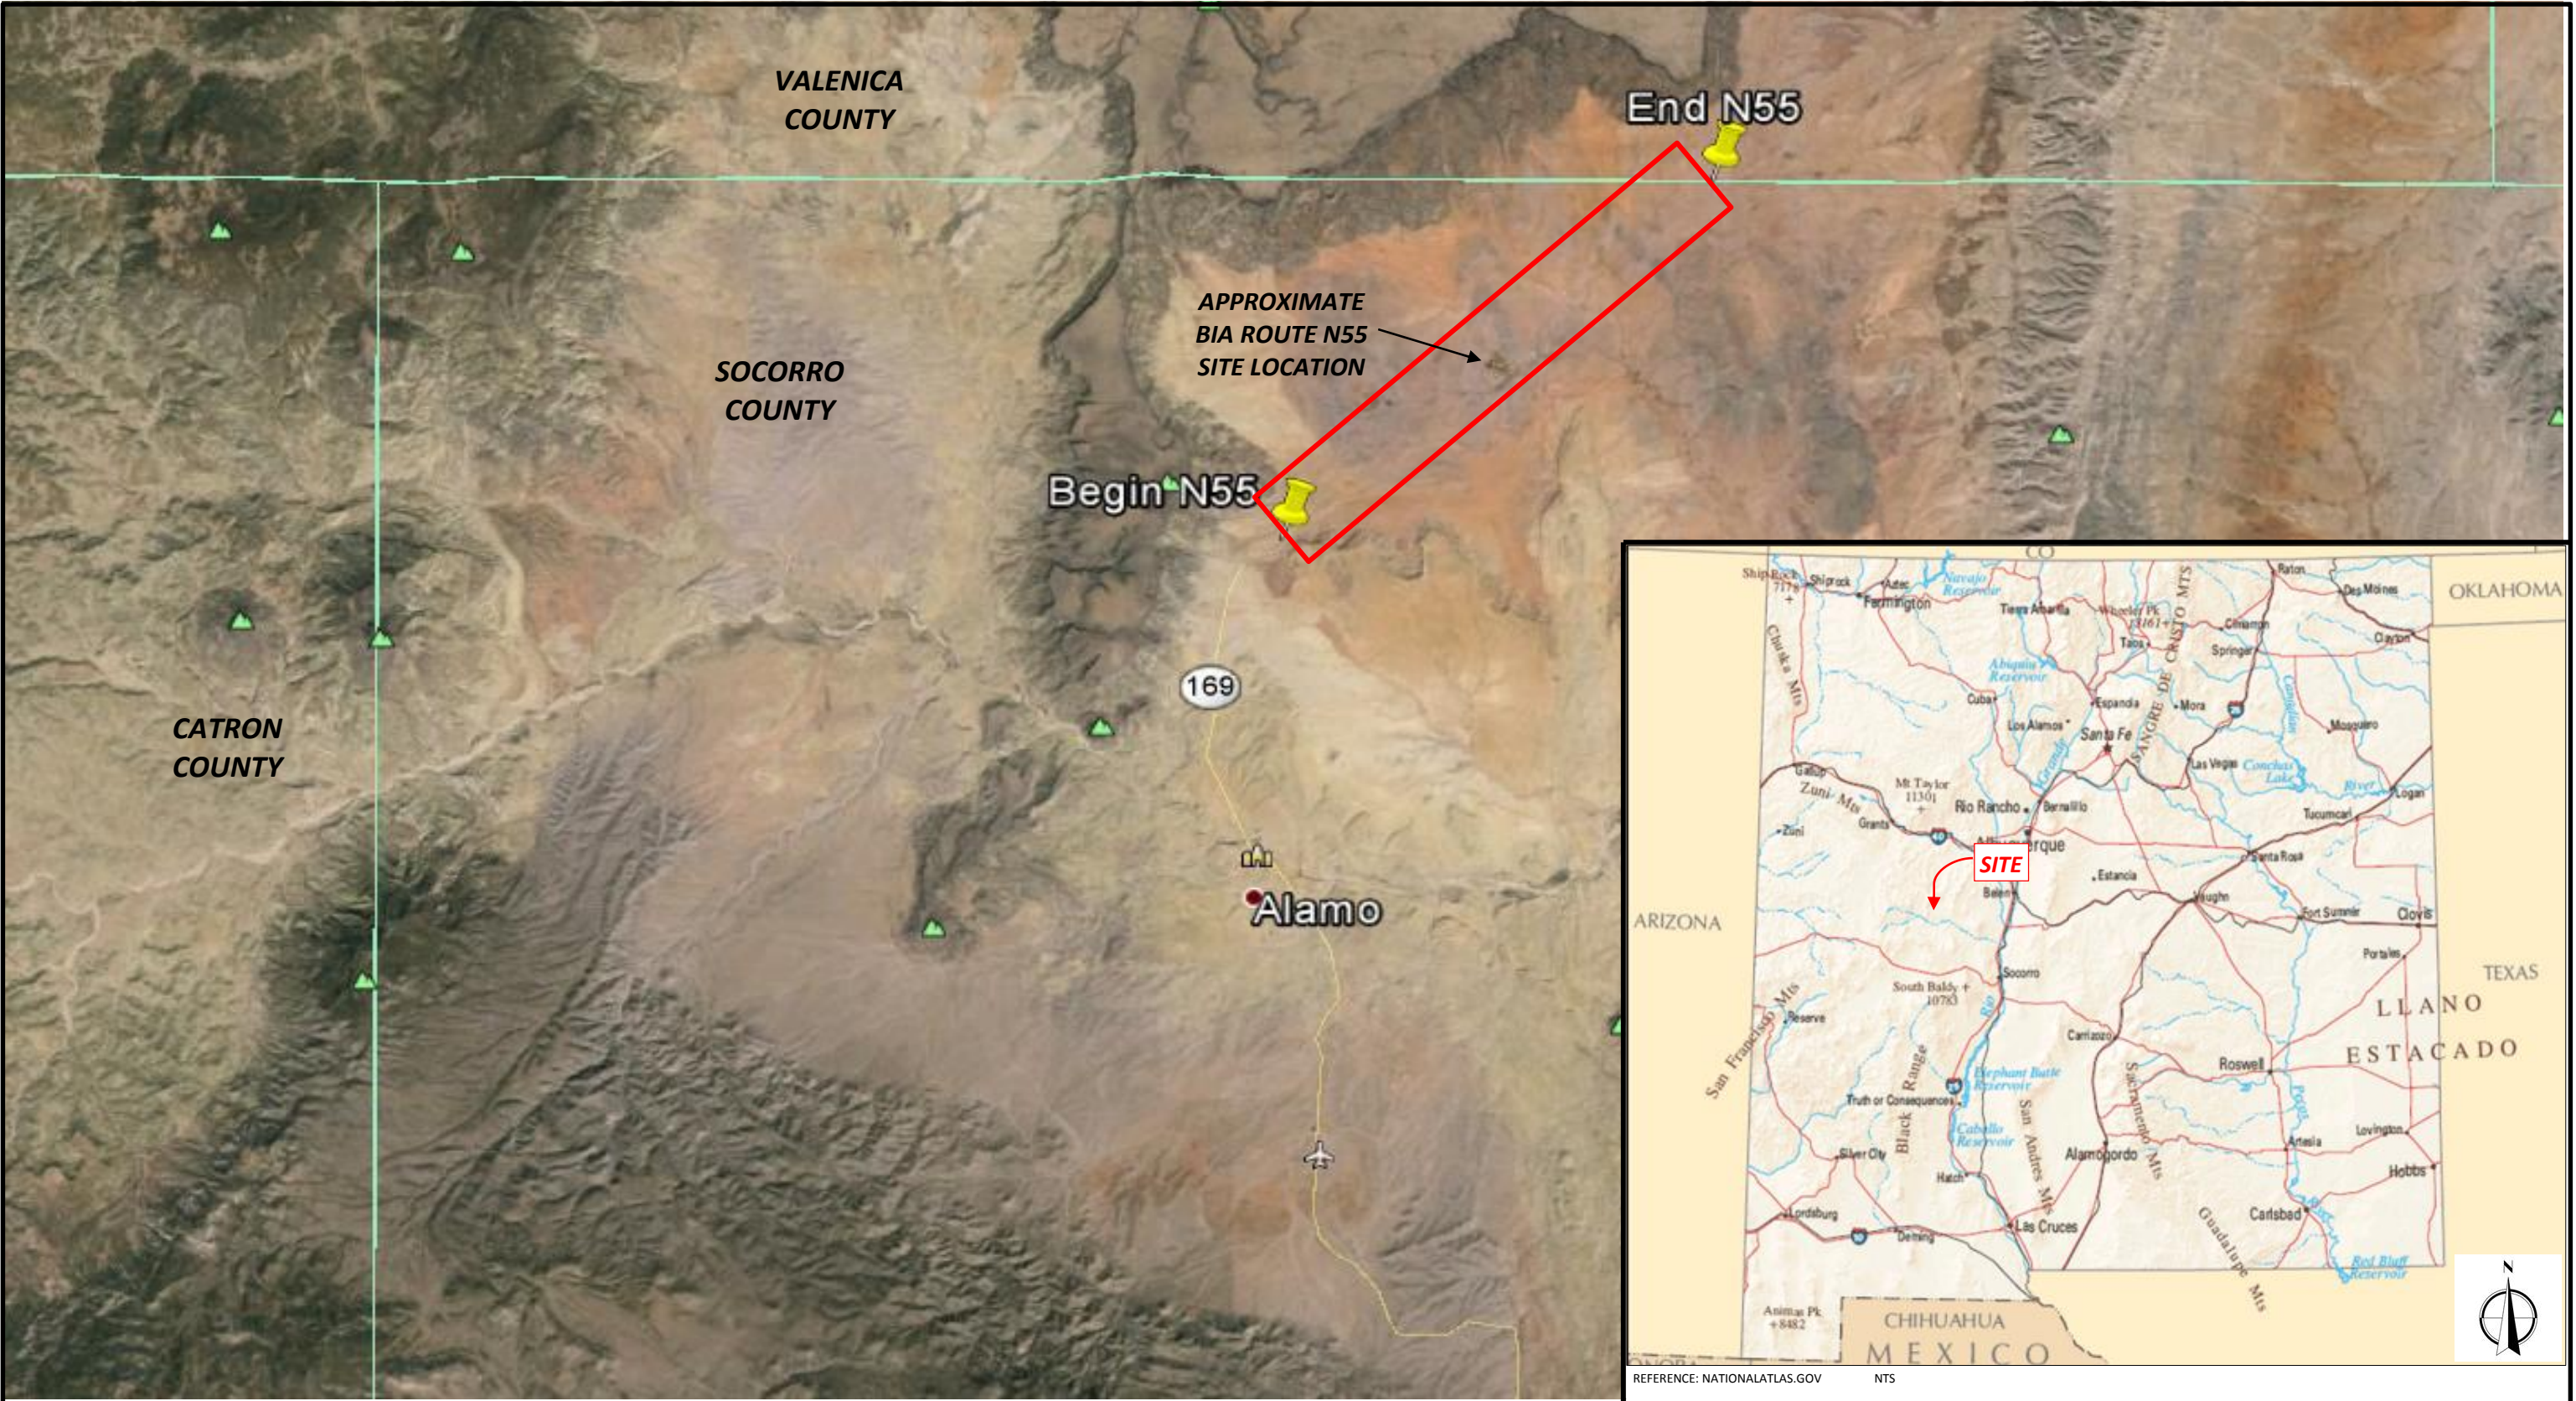
**1**

The subsurface conditions along Route N55 were explored by drilling 34 borings at the subject site. The boring locations are shown in Figure 2, Sheets 1 through 3. Logs of the borings are presented in Appendix A. The borings were advanced by hollow-stem auger drilling using a truck-mounted drill rig. A summary of the GPS NAD 83 coordinates associated with each boring is presented in Table 2.1.

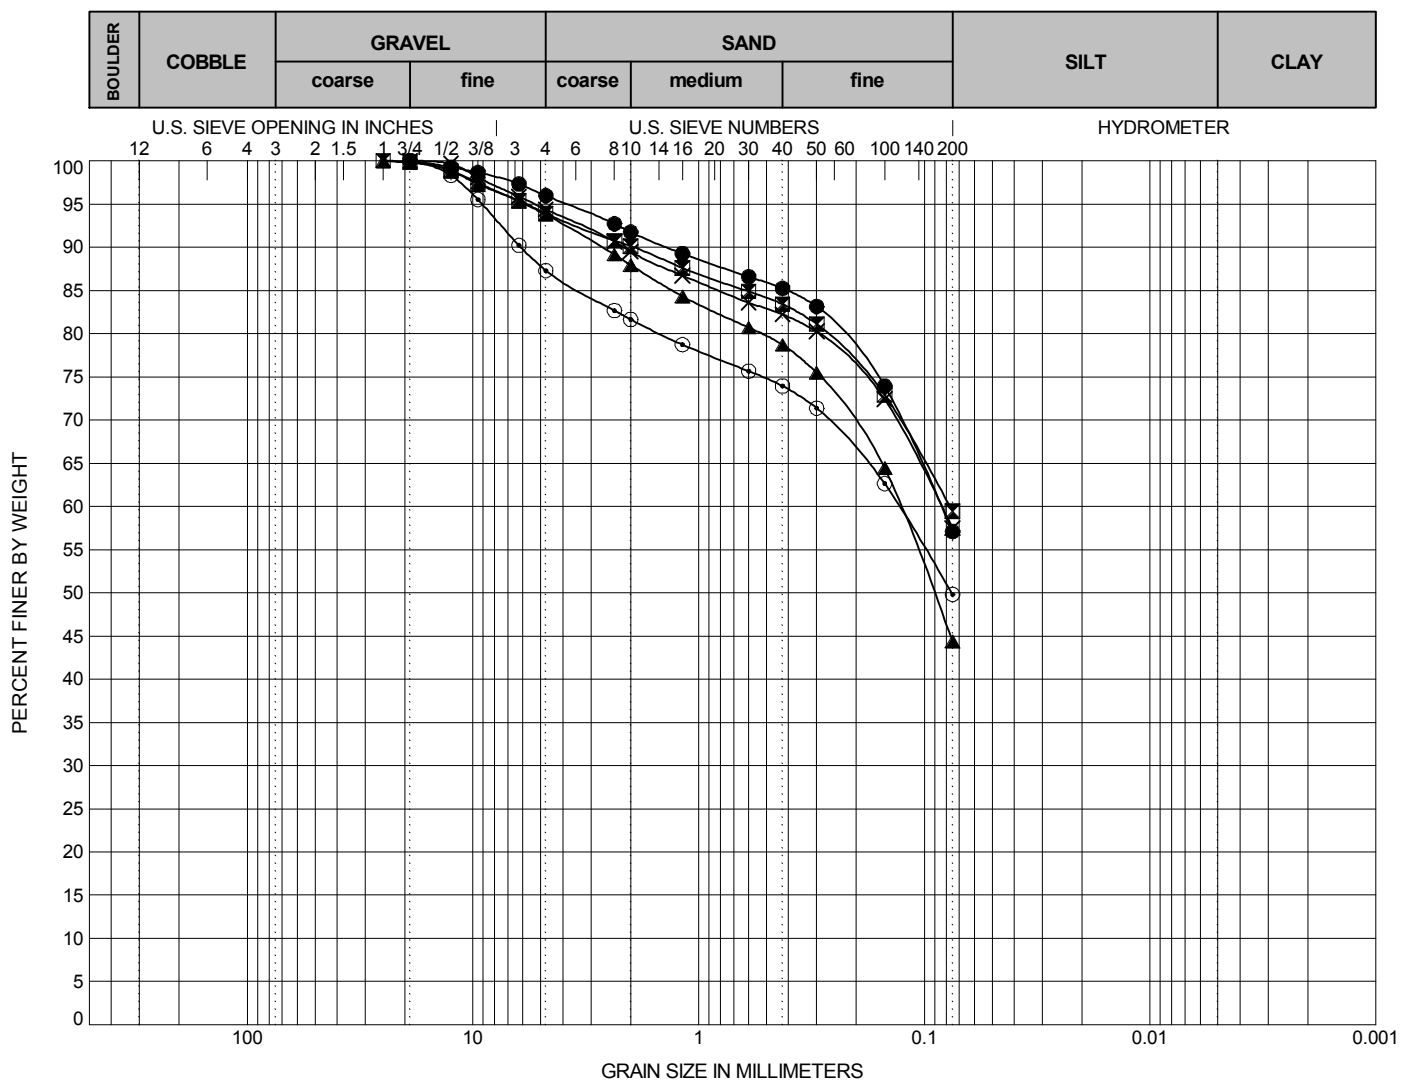
Exploration ID			Depth (m.)	Sample Description							LL	PL	PI	
●	Boring-1	0.3 - 1.22	SANDY LEAN CLAY (CL)							39	14	25		
☒	Boring-2	0.15 - 1.22	SANDY LEAN CLAY (CL)							43	14	29		
▲	Boring-3	0.3 - 1.22	CLAYEY SAND (SC)							35	18	17		
✕	Boring-4	0.15 - 1.22	SANDY LEAN CLAY (CL)							43	15	28		
◎	Boring-5	0.3 - 1.22	CLAYEY SAND (SC)							47	18	29		
Exploration ID			Depth (m.)	D <sub>100</sub>	D <sub>60</sub>	D <sub>30</sub>	D <sub>10</sub>	C <sub>c</sub>	C <sub>u</sub>	Passing 3/4"	Passing #4	Passing #200	%Silt	%Clay
●	Boring-1	0.3 - 1.22	19	0.085	NM	NM	NM	NM	NM	100	96	57	NM	NM
☒	Boring-2	0.15 - 1.22	25	0.077	NM	NM	NM	NM	NM	100	94	59	NM	NM
▲	Boring-3	0.3 - 1.22	25	0.129	NM	NM	NM	NM	NM	100	94	44	NM	NM
✕	Boring-4	0.15 - 1.22	19	0.084	NM	NM	NM	NM	NM	100	94	57	NM	NM
◎	Boring-5	0.3 - 1.22	19	0.13	NM	NM	NM	NM	NM	100	87	50	NM	NM

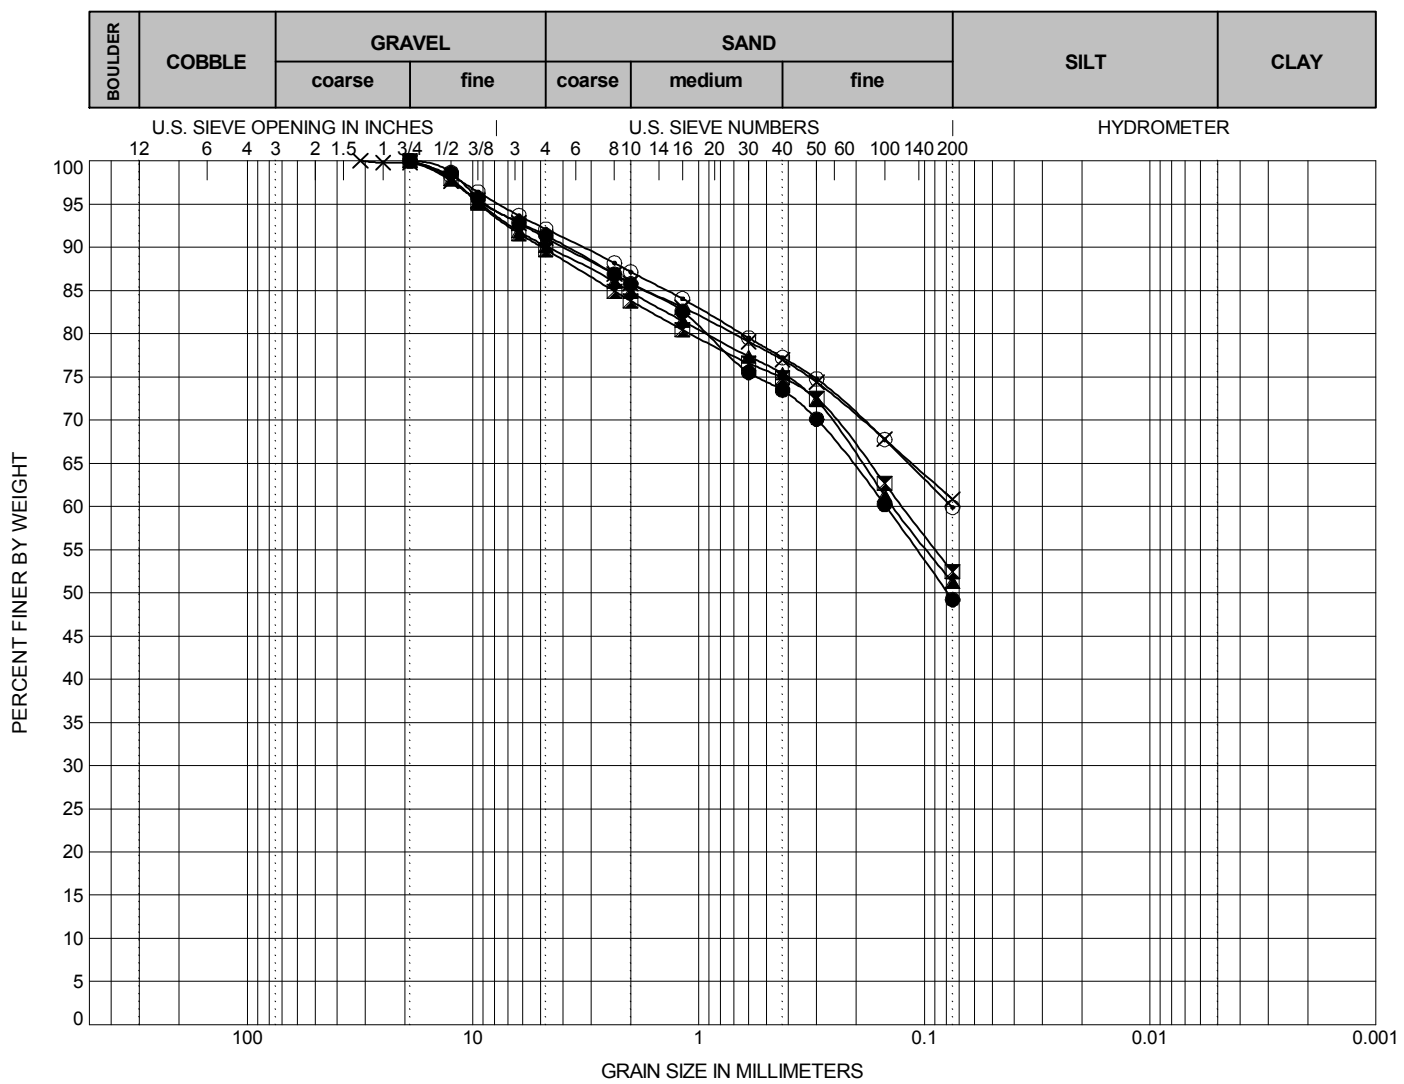
Exploration ID		Depth (m.)	Sample Description								LL	PL	PI
●	Boring-6	0.3 - 1.22	CLAYEY SAND (SC)								46	21	25
☒	Boring-7	0.3 - 1.22	SANDY LEAN CLAY (CL)								43	21	22
▲	Boring-8	0.15 - 1.22	SANDY LEAN CLAY (CL)								42	18	24
✕	Boring-9	0.3 - 1.22	SANDY FAT CLAY (CH)								59	19	40
⊙	Boring-10	0.3 - 1.22	SANDY LEAN CLAY (CL)								47	20	27
Exploration ID		Depth (m.)	D <sub>100</sub>	D <sub>60</sub>	D <sub>30</sub>	D <sub>10</sub>	C <sub>c</sub>	C <sub>u</sub>	Passing 3/4"	Passing #4	Passing #200	%Silt	%Clay
●	Boring-6	0.3 - 1.22	19	0.148	NM	NM	NM	NM	100	91	49	NM	NM
☒	Boring-7	0.3 - 1.22	19	0.125	NM	NM	NM	NM	100	90	52	NM	NM
▲	Boring-8	0.15 - 1.22	19	0.138	NM	NM	NM	NM	100	90	51	NM	NM
✕	Boring-9	0.3 - 1.22	31.5	NM	NM	NM	NM	NM	100	91	61	NM	NM
⊙	Boring-10	0.3 - 1.22	19	0.076	NM	NM	NM	NM	100	92	60	NM	NM

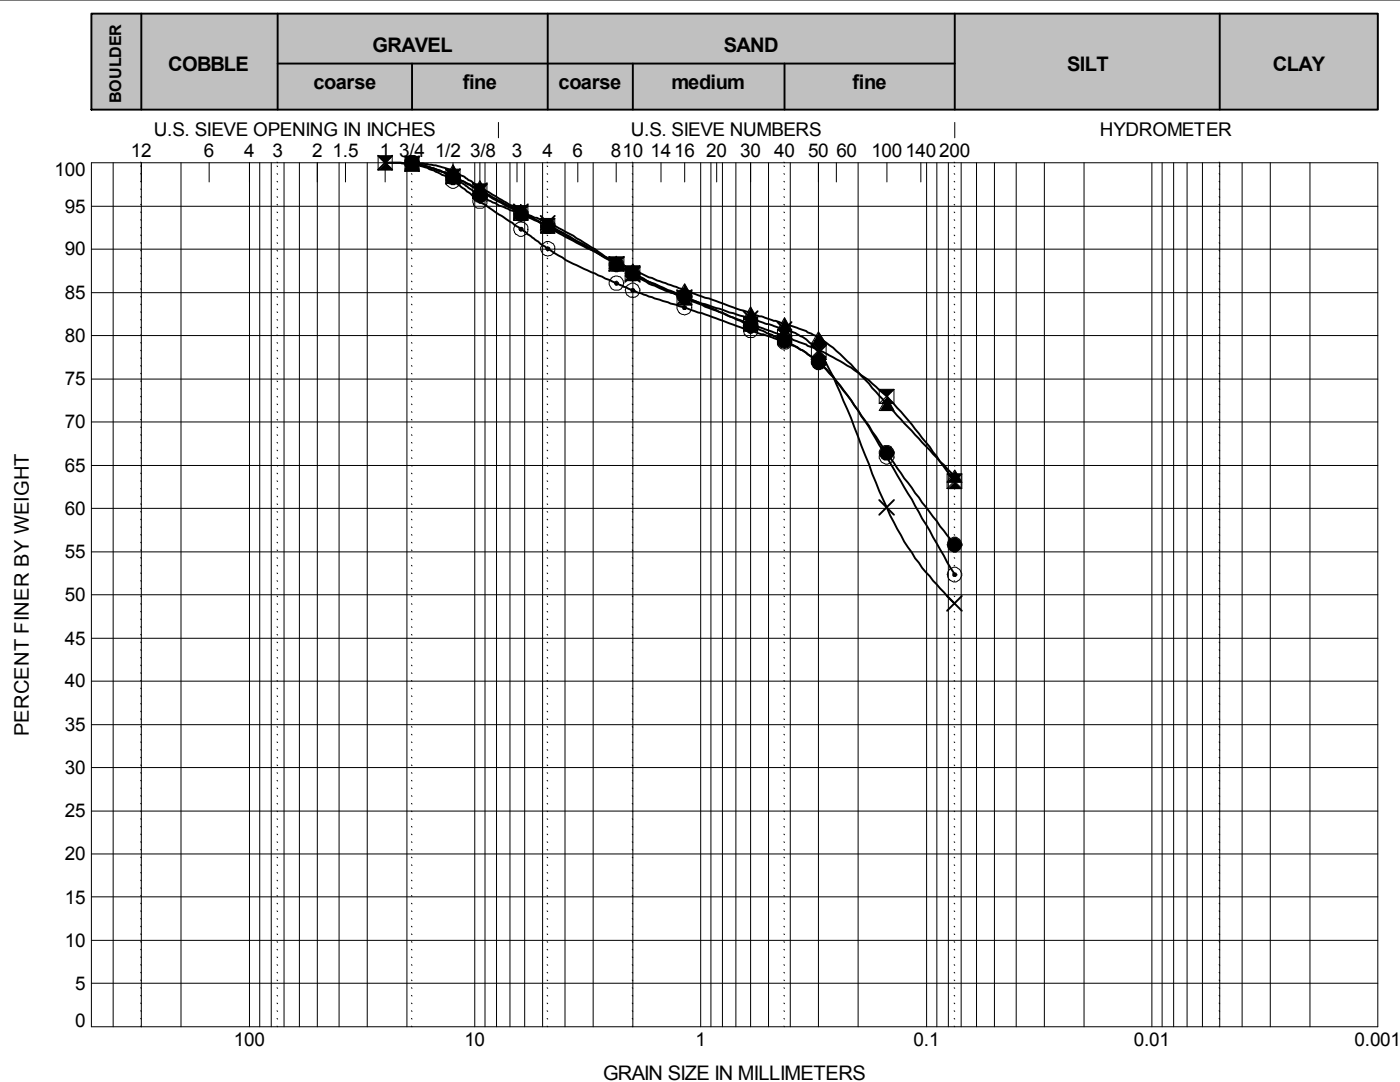
Exploration ID		Depth (m.)	Sample Description									LL	PL	PI
●	Boring-11	0.3 - 1.22	SANDY LEAN CLAY (CL)									46	17	29
☒	Boring-12	0.3 - 1.22	SANDY FAT CLAY (CH)									50	17	33
▲	Boring-13	0.3 - 1.22	SANDY LEAN CLAY (CL)									42	15	27
✕	Boring-14	0.3 - 1.22	CLAYEY SAND (SC)									31	13	18
⊙	Boring-15	0.3 - 1.22	SANDY LEAN CLAY (CL)									39	14	25
Exploration ID	Depth (m.)	D <sub>100</sub>	D <sub>60</sub>	D <sub>30</sub>	D <sub>10</sub>	Cc	Cu	Passing 3/4"	Passing #4	Passing #200	%Silt	%Clay		
●	Boring-11	0.3 - 1.22	19	0.099	NM	NM	NM	NM	100	93	56	NM	NM	
☒	Boring-12	0.3 - 1.22	25	NM	NM	NM	NM	NM	100	93	63	NM	NM	
▲	Boring-13	0.3 - 1.22	19	NM	NM	NM	NM	NM	100	93	64	NM	NM	
✕	Boring-14	0.3 - 1.22	25	0.149	NM	NM	NM	NM	100	93	49	NM	NM	
⊙	Boring-15	0.3 - 1.22	19	0.111	NM	NM	NM	NM	100	90	52	NM	NM

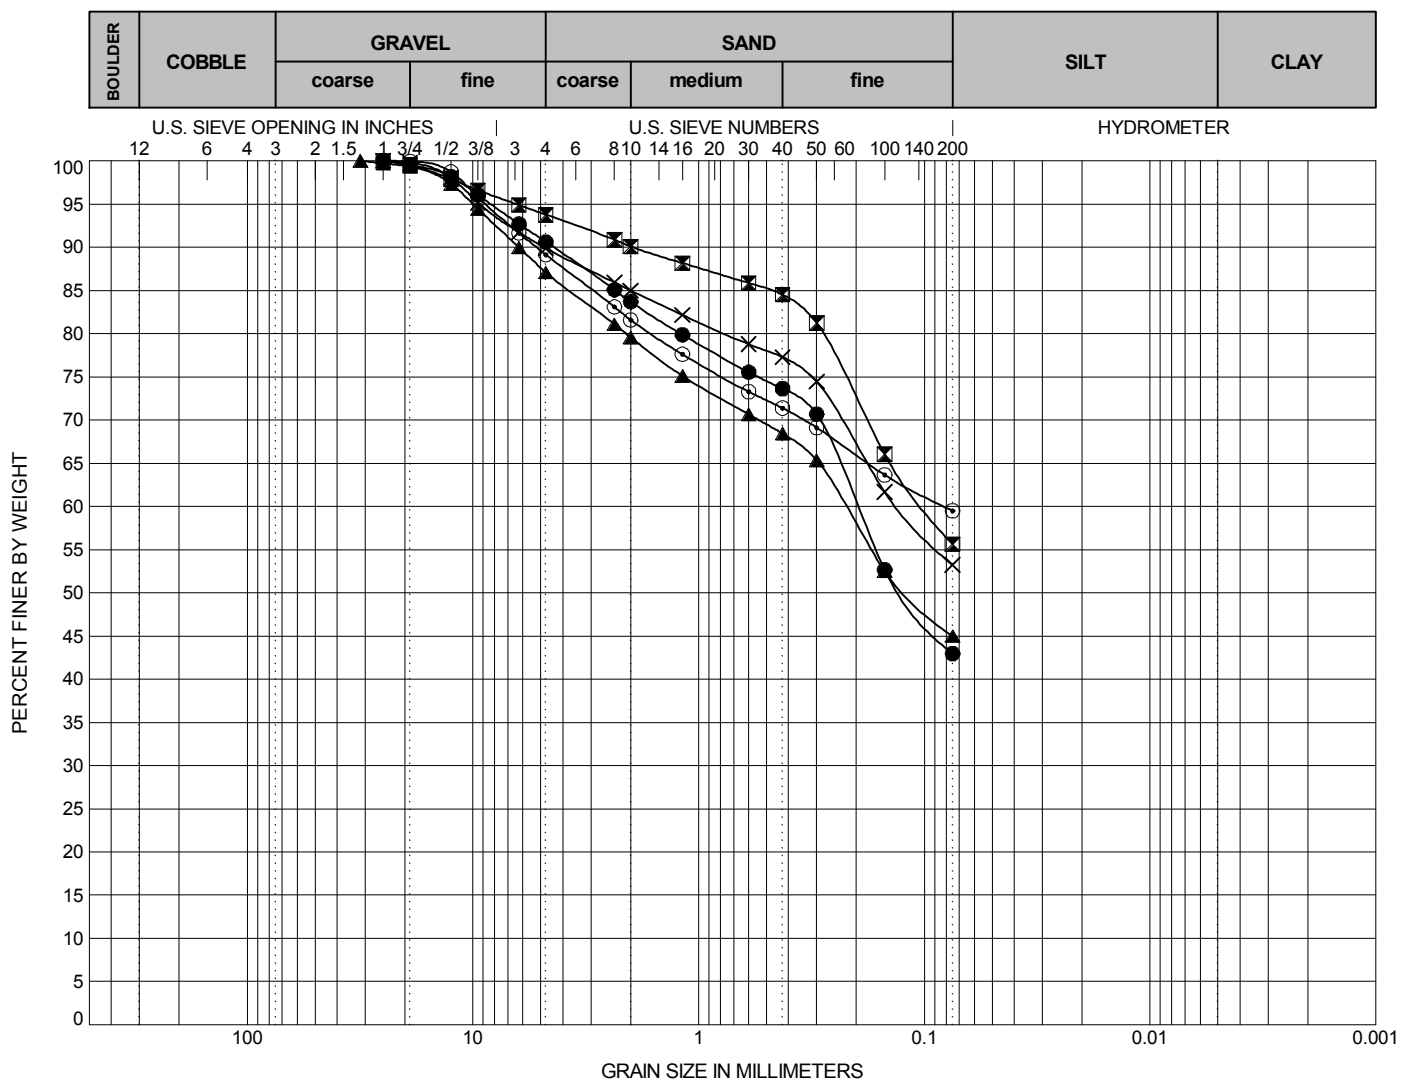
Exploration ID	Depth (m.)	Sample Description	LL	PL	PI
● Boring-16	0.3 - 1.22	CLAYEY SAND (SC)	40	17	23
☒ Boring-17	0.3 - 1.22	SANDY LEAN CLAY (CL)	38	16	22
▲ Boring-18	0.3 - 0.91	CLAYEY SAND (SC)	38	16	22
✕ Boring-19	0.3 - 1.22	SANDY LEAN CLAY (CL)	45	17	28
⊙ Boring-20	0.15 - 1.22	SANDY FAT CLAY (CH)	52	19	33

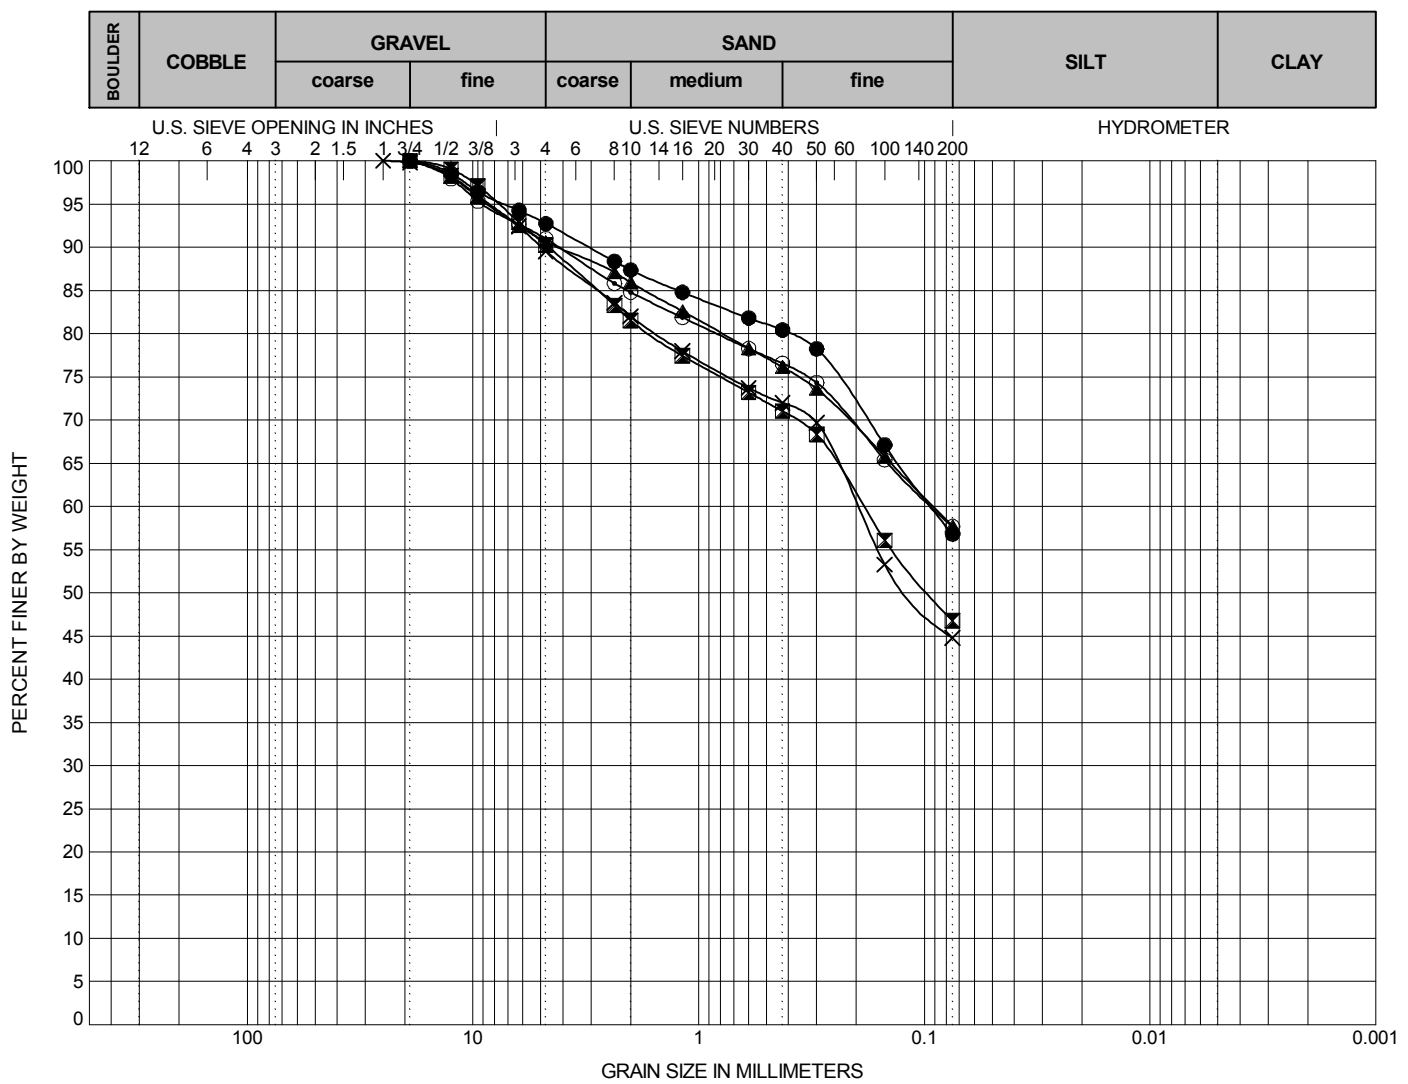
Exploration ID			Depth (m.)	Sample Description							LL	PL	PI	
●	Boring-26	0.46 - 1.22	SANDY LEAN CLAY (CL)							36	14	22		
☒	Boring-27	0.61 - 1.22	CLAYEY SAND (SC)							40	17	23		
▲	Boring-28	0.61 - 1.22	SANDY LEAN CLAY (CL)							46	19	27		
✕	Boring-29	0.61 - 1.22	CLAYEY SAND (SC)							40	16	24		
⊙	Boring-30	0.61 - 1.22	SANDY LEAN CLAY (CL)							49	17	32		
Exploration ID			Depth (m.)	D <sub>100</sub>	D <sub>60</sub>	D <sub>30</sub>	D <sub>10</sub>	C <sub>c</sub>	C <sub>u</sub>	Passing 3/4"	Passing #4	Passing #200	%Silt	%Clay
●	Boring-26	0.46 - 1.22	19	0.093	NM	NM	NM	NM	NM	100	93	57	NM	NM
☒	Boring-27	0.61 - 1.22	19	0.187	NM	NM	NM	NM	NM	100	90	47	NM	NM
▲	Boring-28	0.61 - 1.22	19	0.091	NM	NM	NM	NM	NM	100	91	58	NM	NM
✕	Boring-29	0.61 - 1.22	25	0.199	NM	NM	NM	NM	NM	100	90	45	NM	NM
⊙	Boring-30	0.61 - 1.22	19	0.092	NM	NM	NM	NM	NM	100	91	58	NM	NM

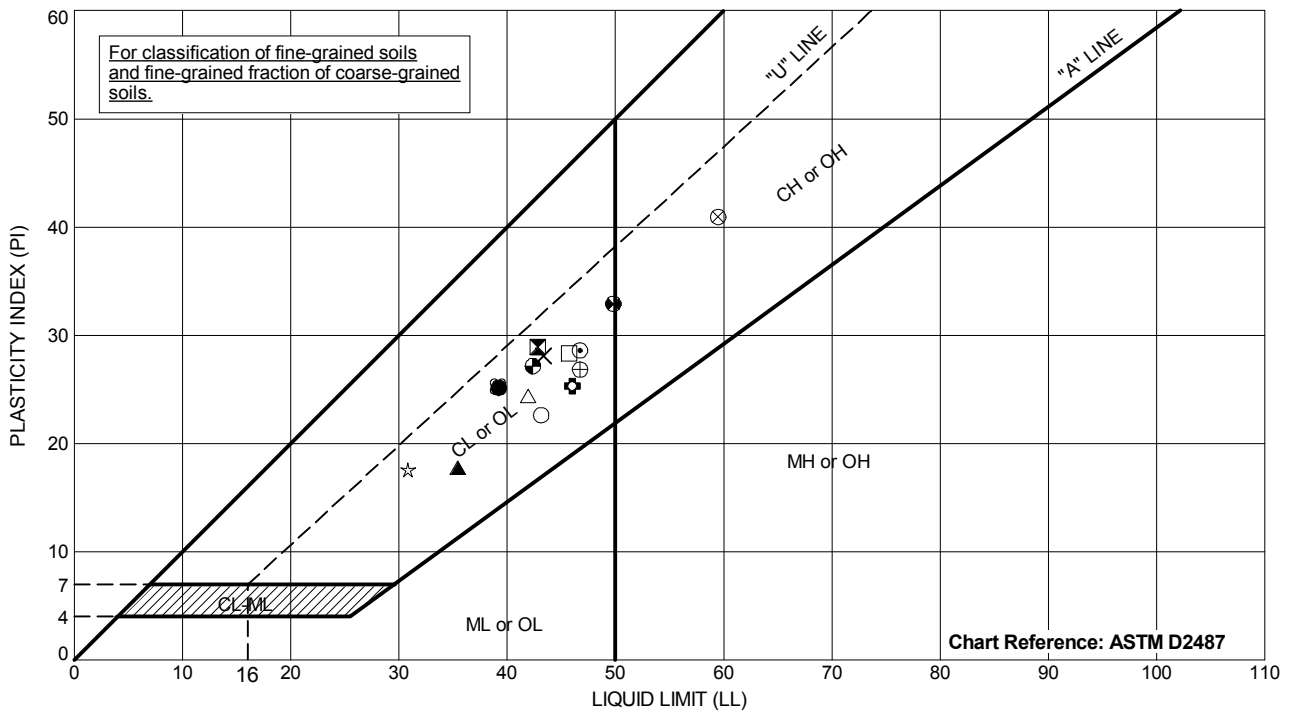
Exploration ID	Depth (m.)	Sample Description	Passing #200	LL	PL	PI
● Boring-1	0.3 - 1.22	SANDY LEAN CLAY (CL)	57	39	14	25
⊠ Boring-2	0.15 - 1.22	SANDY LEAN CLAY (CL)	59	43	14	29
▲ Boring-3	0.3 - 1.22	CLAYEY SAND (SC)	44	35	18	17
⊗ Boring-4	0.15 - 1.22	SANDY LEAN CLAY (CL)	57	43	15	28
⊙ Boring-5	0.3 - 1.22	CLAYEY SAND (SC)	50	47	18	29
⊕ Boring-6	0.3 - 1.22	CLAYEY SAND (SC)	49	46	21	25
○ Boring-7	0.3 - 1.22	SANDY LEAN CLAY (CL)	52	43	21	22
△ Boring-8	0.15 - 1.22	SANDY LEAN CLAY (CL)	51	42	18	24
⊗ Boring-9	0.3 - 1.22	SANDY FAT CLAY (CH)	61	59	19	40
⊕ Boring-10	0.3 - 1.22	SANDY LEAN CLAY (CL)	60	47	20	27
□ Boring-11	0.3 - 1.22	SANDY LEAN CLAY (CL)	56	46	17	29
⊕ Boring-12	0.3 - 1.22	SANDY FAT CLAY (CH)	63	50	17	33
⊕ Boring-13	0.3 - 1.22	SANDY LEAN CLAY (CL)	64	42	15	27
☆ Boring-14	0.3 - 1.22	CLAYEY SAND (SC)	49	31	13	18
⊗ Boring-15	0.3 - 1.22	SANDY LEAN CLAY (CL)	52	39	14	25

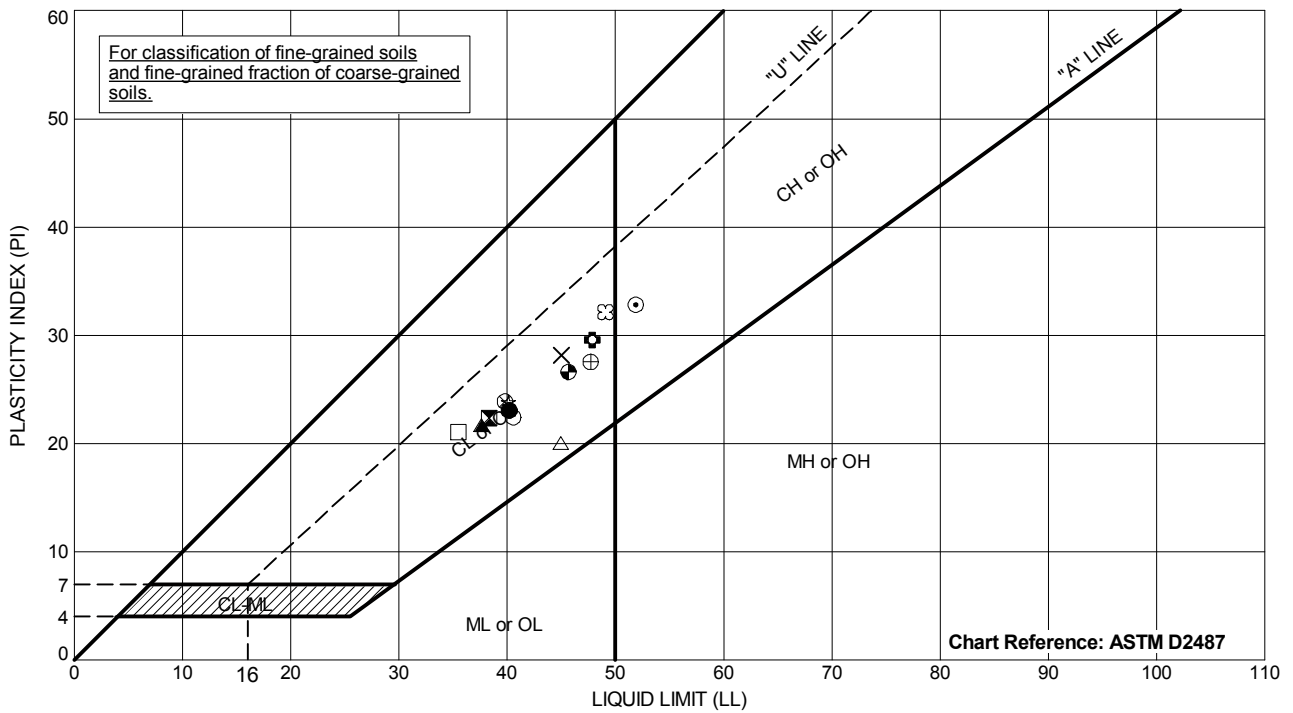
Exploration ID	Depth (m.)	Sample Description	Passing #200	LL	PL	PI
● Boring-16	0.3 - 1.22	CLAYEY SAND (SC)	43	40	17	23
☒ Boring-17	0.3 - 1.22	SANDY LEAN CLAY (CL)	56	38	16	22
▲ Boring-18	0.3 - 0.91	CLAYEY SAND (SC)	45	38	16	22
✕ Boring-19	0.3 - 1.22	SANDY LEAN CLAY (CL)	53	45	17	28
⊙ Boring-20	0.15 - 1.22	SANDY FAT CLAY (CH)	59	52	19	33
⊕ Boring-21	0.3 - 1.22	SANDY LEAN CLAY (CL)	67	48	18	30
○ Boring-22	0.3 - 1.22	CLAYEY SAND (SC)	49	41	18	23
△ Boring-23	0.3 - 0.91	SANDY LEAN CLAY (CL)	52	45	25	20
⊗ Boring-24	0.46 - 0.91	SANDY LEAN CLAY (CL)	54	40	16	24
⊕ Boring-25	0.61 - 1.22	SANDY LEAN CLAY (CL)	64	48	20	28
□ Boring-26	0.46 - 1.22	SANDY LEAN CLAY (CL)	57	36	14	22
⊗ Boring-27	0.61 - 1.22	CLAYEY SAND (SC)	47	40	17	23
⊕ Boring-28	0.61 - 1.22	SANDY LEAN CLAY (CL)	58	46	19	27
☆ Boring-29	0.61 - 1.22	CLAYEY SAND (SC)	45	40	16	24
⊗ Boring-30	0.61 - 1.22	SANDY LEAN CLAY (CL)	58	49	17	32

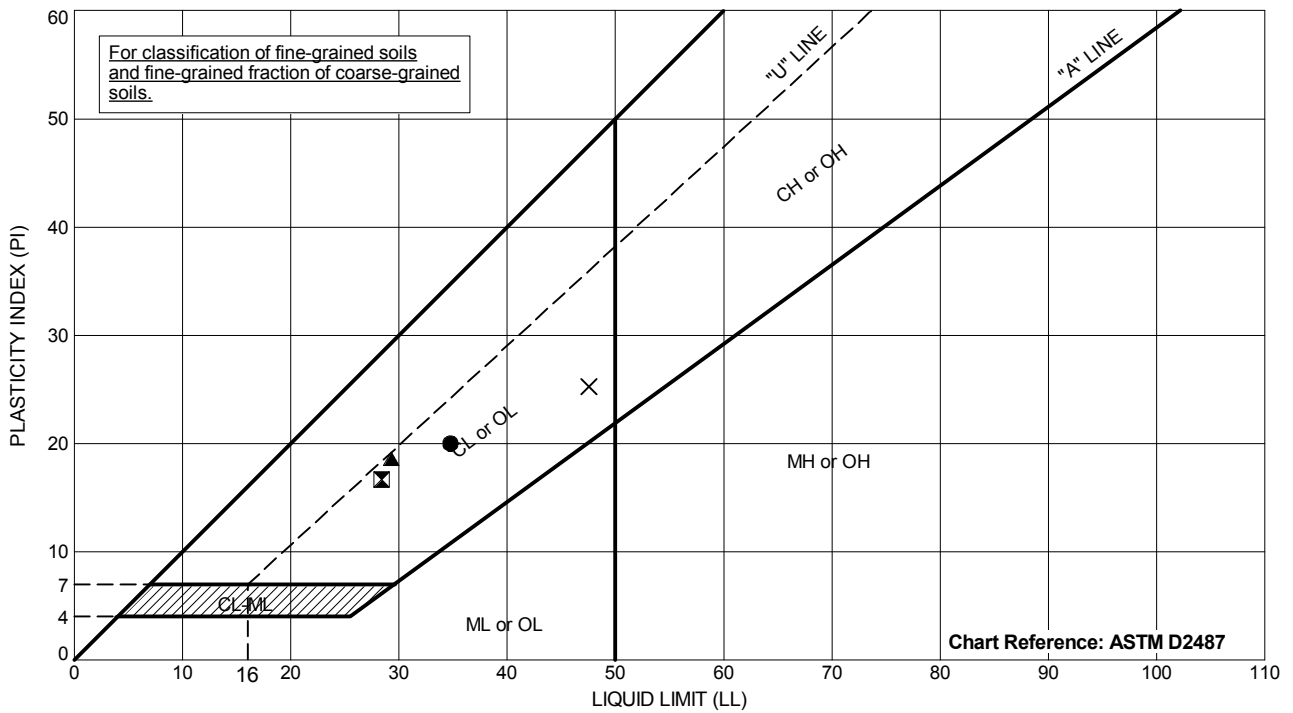
Exploration ID	Depth (m.)	Sample Description	Passing #200	LL	PL	PI
● Boring-31	0.61 - 1.22	CLAYEY SAND (SC)	46	35	15	20
⊠ Boring-32	0.61 - 0.91	LEAN CLAY (CL)	95	28	12	16
▲ Boring-33	0.61 - 1.22	CLAYEY SAND (SC)	44	29	11	18
X Boring-34	0.61 - 1.22	LEAN CLAY (CL)	88	48	22	26

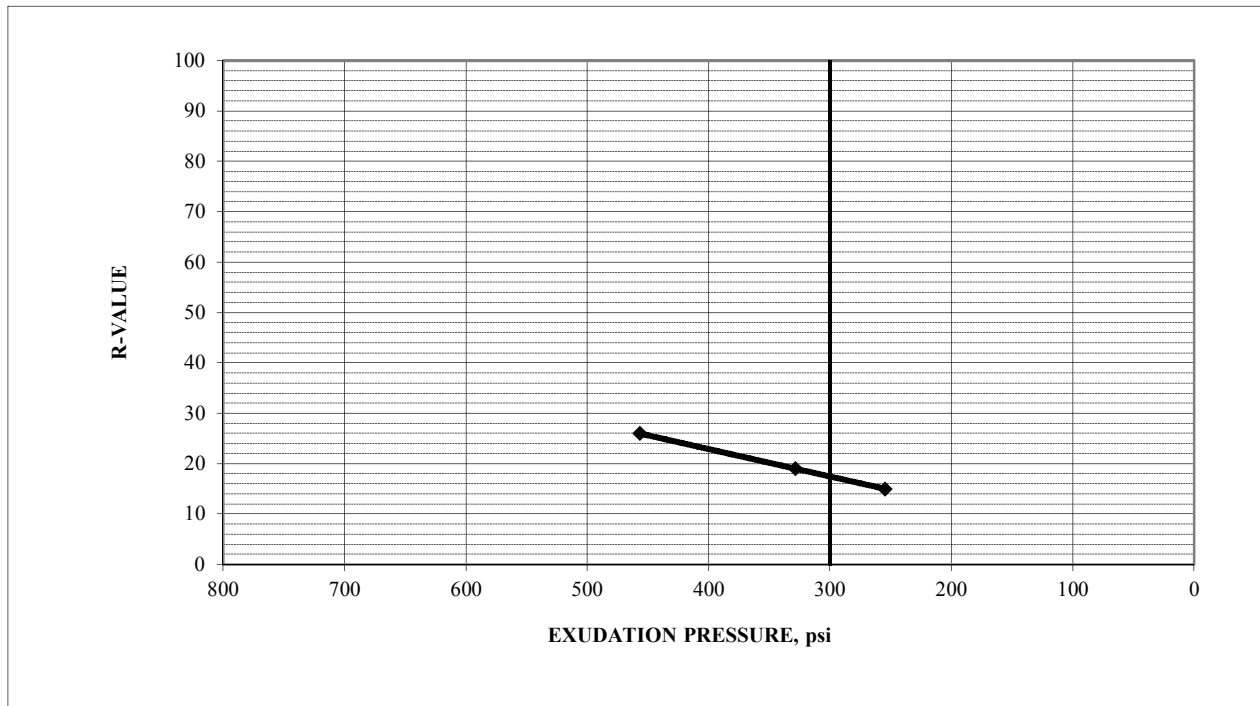
Briquette No.	A	B	C
Moisture at Test, %	17.4	18.4	16.5
Dry Unit Weight at Test, pcf	113.8	111.5	117.5
Expansion Pressure, psf	0	9	26
Exudation Pressure, psi	329	255	457
Resistance Value	19	15	26
R - Value at 300 psi Exudation Pressure:			18

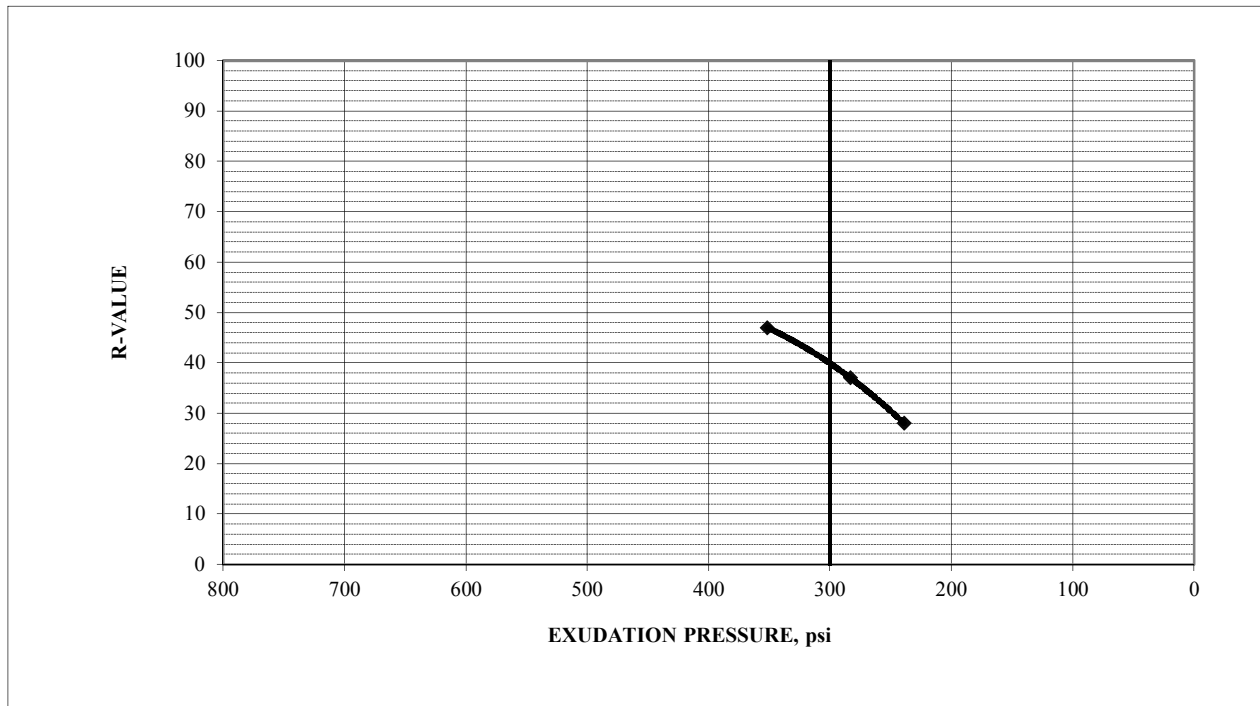
Briquette No.	A	B	C
Moisture at Test, %	18.1	17.1	16.2
Dry Unit Weight at Test, pcf	111.2	112.4	115.1
Expansion Pressure, psf	26	22	39
Exudation Pressure, psi	239	283	352
Resistance Value	28	37	47
R - Value at 300 psi Exudation Pressure:			40

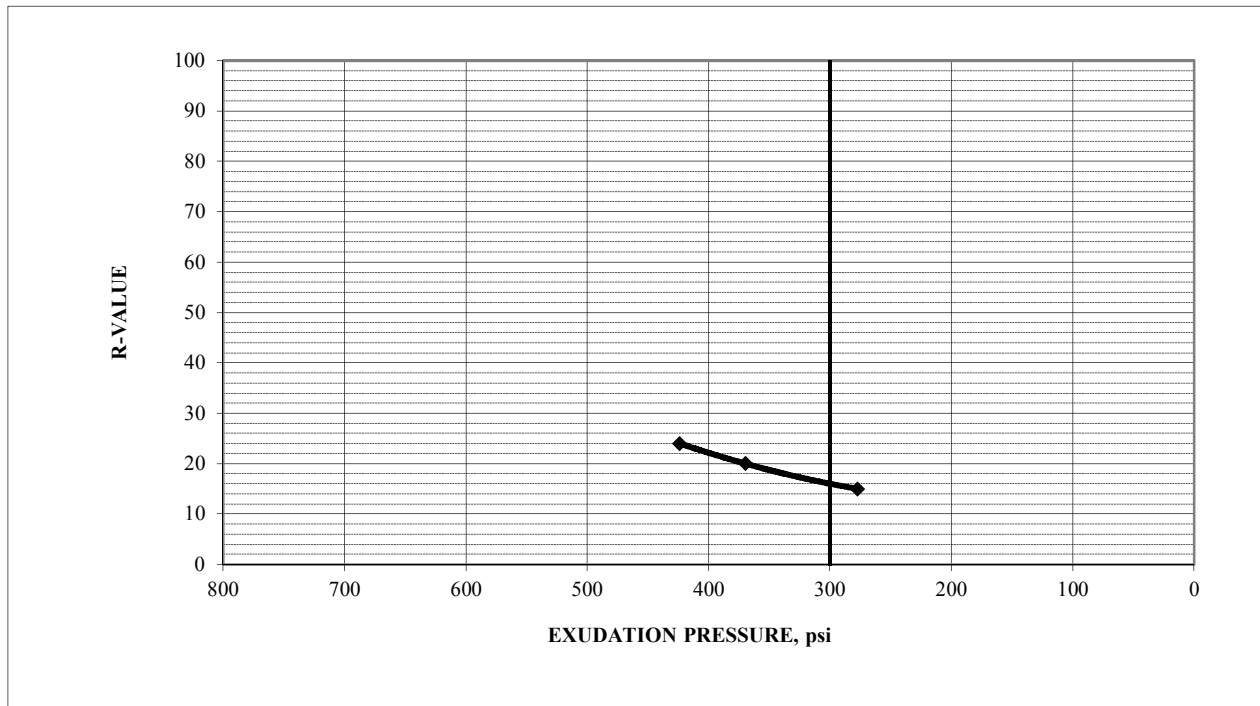
Briquette No.	A	B	C
Moisture at Test, %	19.4	20.4	21.4
Dry Unit Weight at Test, pcf	112.0	108.5	107.3
Expansion Pressure, psf	39	13	22
Exudation Pressure, psi	424	370	278
Resistance Value	24	20	15
R - Value at 300 psi Exudation Pressure:			16

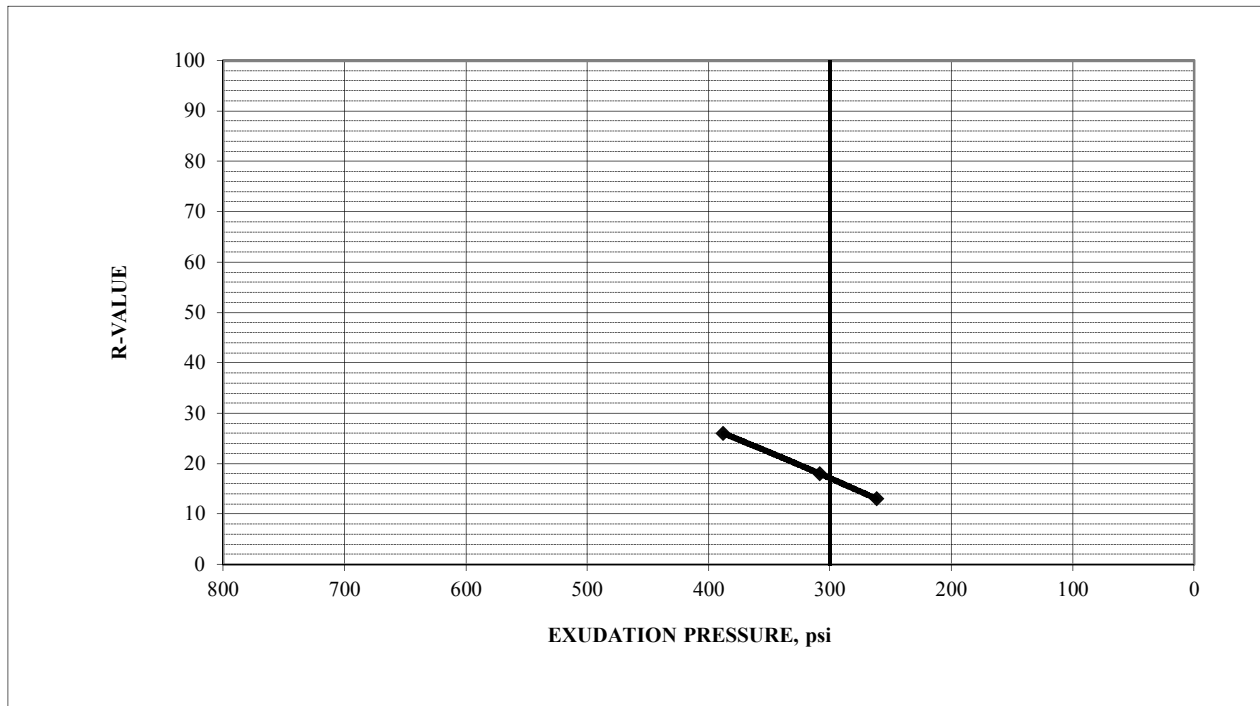
Briquette No.	A	B	C
Moisture at Test, %	16.9	16.0	15.0
Dry Unit Weight at Test, pcf	114.4	119.3	120.0
Expansion Pressure, psf	35	13	52
Exudation Pressure, psi	262	308	388
Resistance Value	13	18	26
R - Value at 300 psi Exudation Pressure:			17

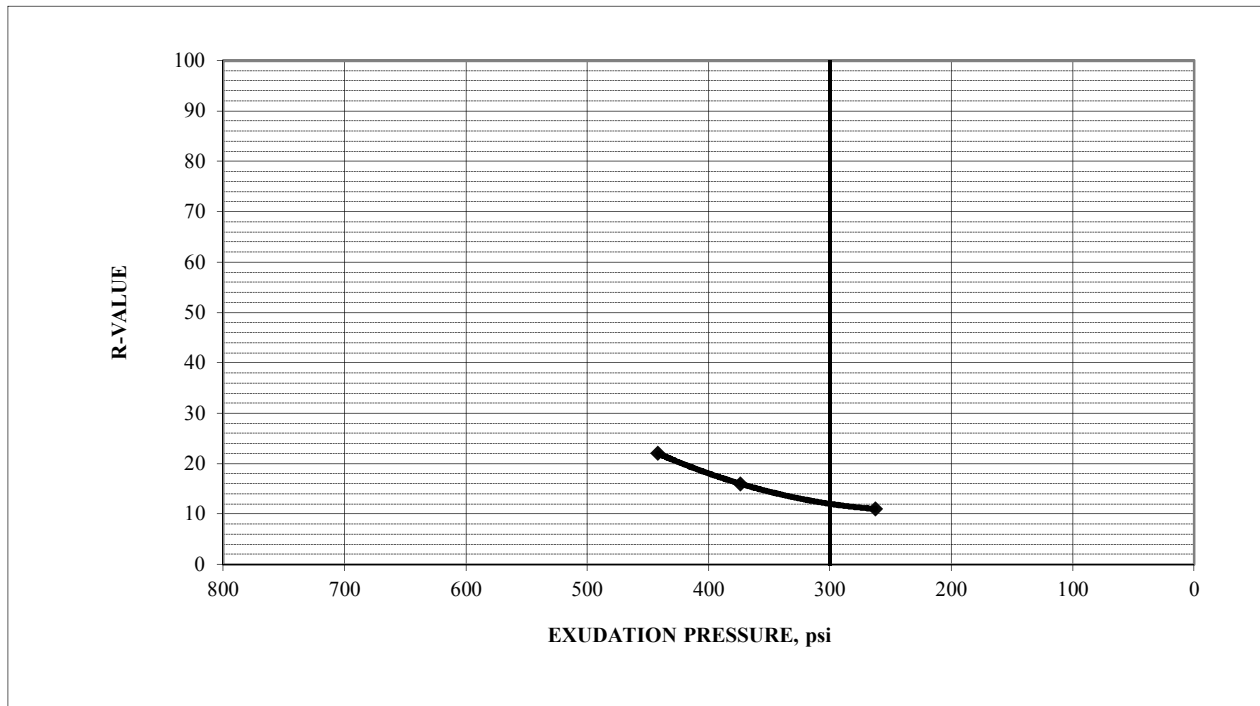
Briquette No.	A	B	C
Moisture at Test, %	20.4	19.5	18.6
Dry Unit Weight at Test, pcf	112.5	110.9	109.5
Expansion Pressure, psf	13	22	17
Exudation Pressure, psi	262	374	442
Resistance Value	11	16	22
R - Value at 300 psi Exudation Pressure:			12

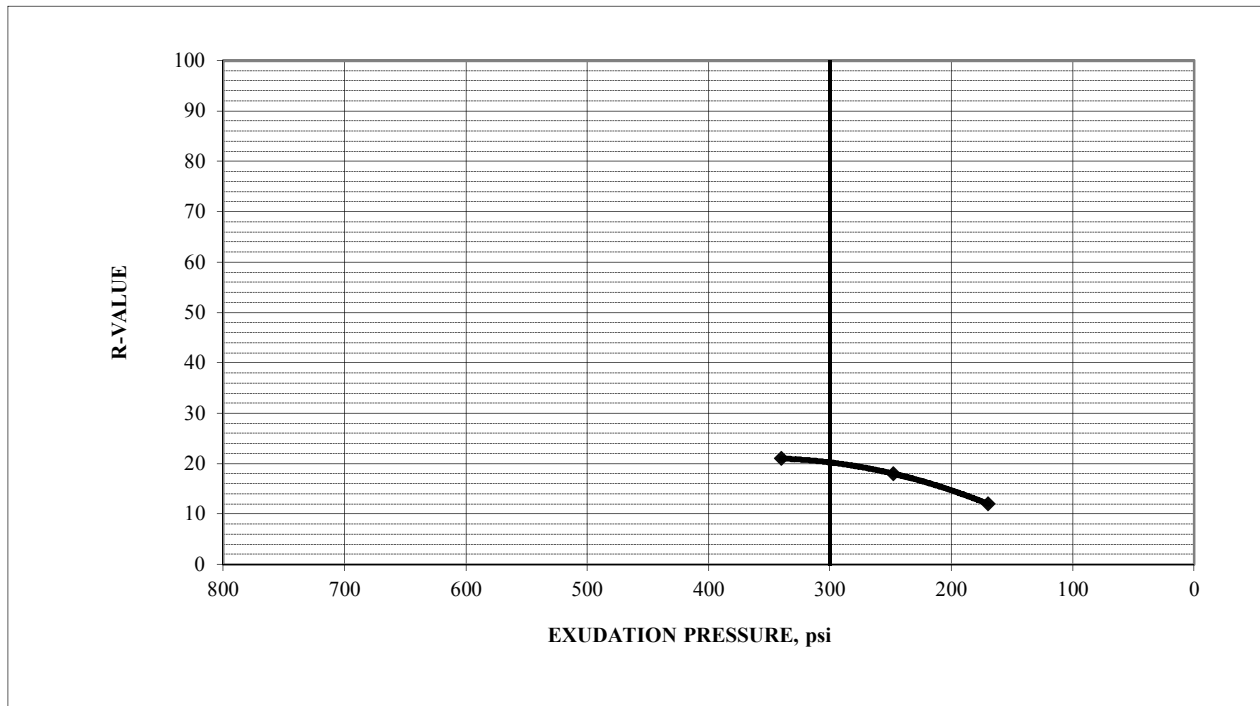
Briquette No.	A	B	C
Moisture at Test, %	18.5	17.5	16.6
Dry Unit Weight at Test, pcf	111.6	113.4	115.0
Expansion Pressure, psf	30	30	48
Exudation Pressure, psi	170	248	340
Resistance Value	12	18	21
R - Value at 300 psi Exudation Pressure:			20

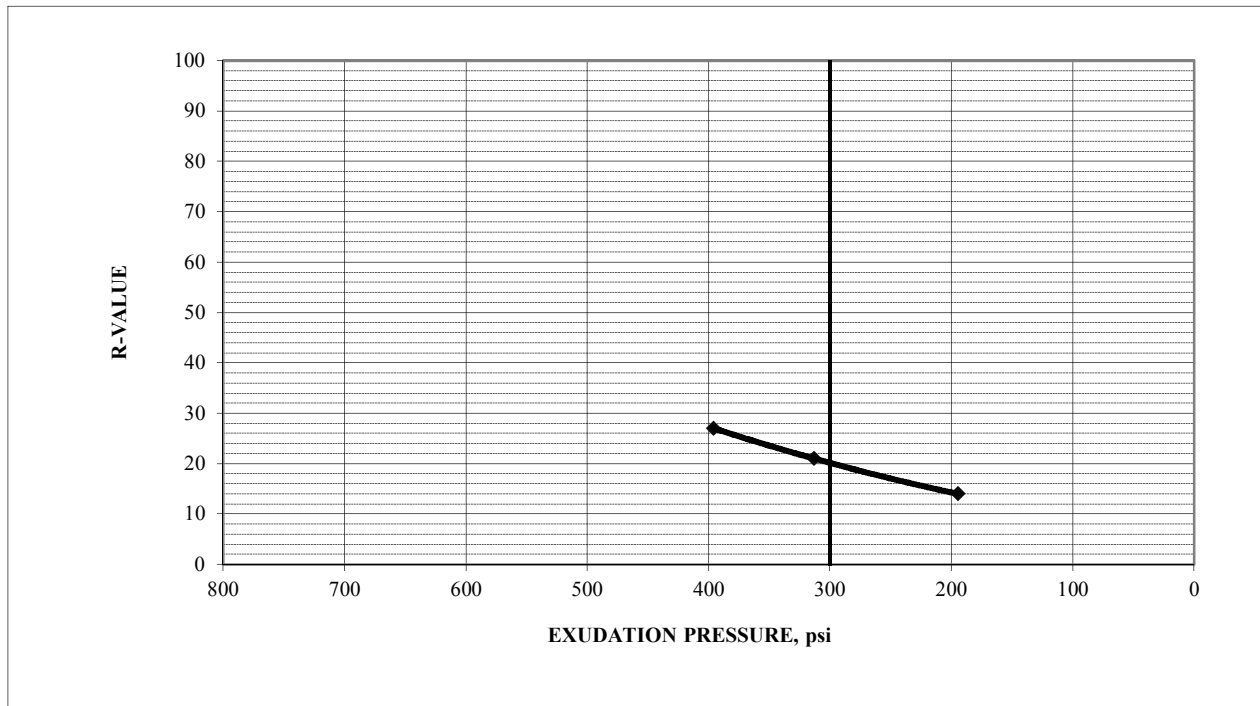
Briquette No.	A	B	C
Moisture at Test, %	17.6	16.7	15.7
Dry Unit Weight at Test, pcf	113.4	117.0	119.2
Expansion Pressure, psf	17	0	0
Exudation Pressure, psi	195	313	396
Resistance Value	14	21	27
R - Value at 300 psi Exudation Pressure:			20
