**GEOTECHNICAL REPORT  
BIA ROUTE N55 (1-1) 2&4  
NAVAJO NATION, NEW MEXICO  
KLEINFELDER PROJECT NO. 20162433.001A**

**Revised June 23, 2016**

**SUBJECT: Draft Geotechnical Report  
BIA Route N55  
BIA Project N55 (1-1)2&4  
Navajo Nation, New Mexico**

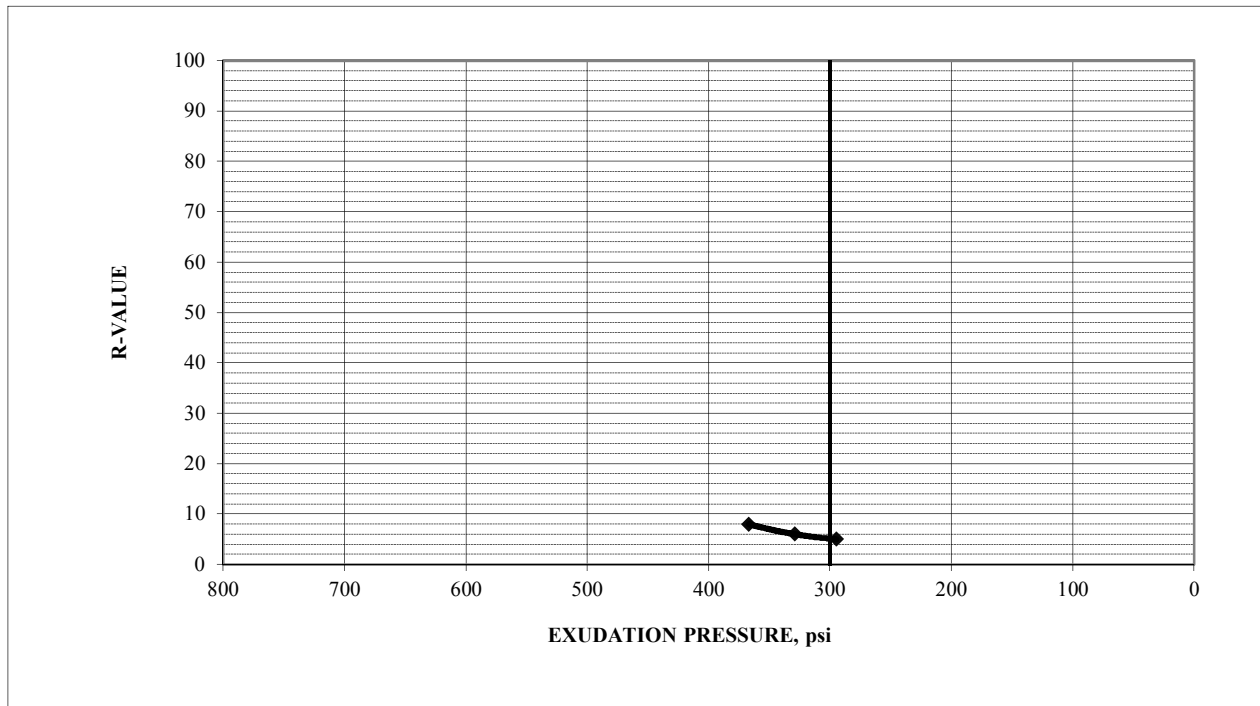
Briquette No.	A	B	C
Moisture at Test, %	21.0	22.9	22.0
Dry Unit Weight at Test, pcf	106.8	103.6	106.2
Expansion Pressure, psf	104	82	91
Exudation Pressure, psi	367	294	329
Resistance Value	8	5	6
<b>R - Value at 300 psi Exudation Pressure:</b>			<b>5</b>

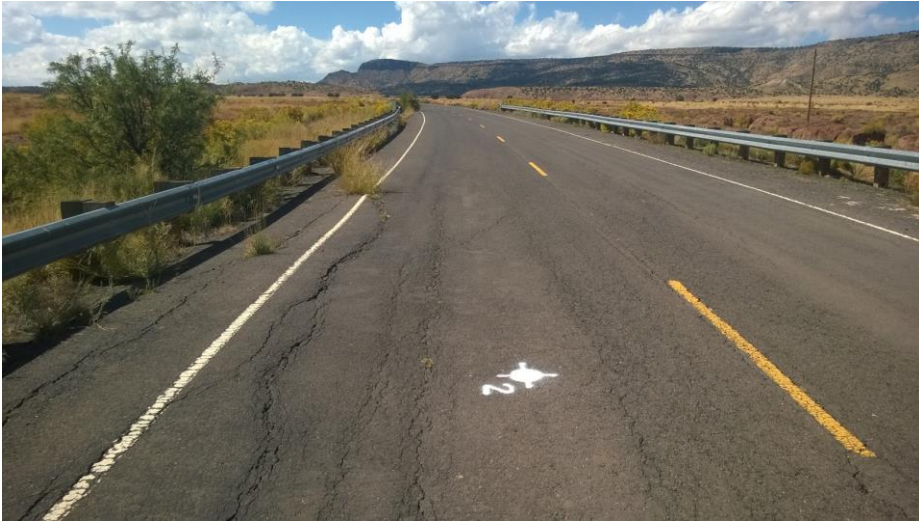
Heaving outside of wheelpath at location of boring B-2

The existing roadway pavement has undergone excessive distress likely caused by heaving of the supporting soils. A contributing factor to heaving subgrade is the presence of highly plastic or potentially sulfate laden clay soils that undergo expansion and contraction in response to wetting and drying cycles. The pavement distress consisted primarily of wide spread low to high severity longitudinal cracking, and low to moderate severity rutting and associated fatigue cracking in the wheel paths. The elevation of the pavement surface along BIA Route N55 is notably varied along the alignment, illustrating the effect of the heaving/settling underlying soils. The types of distress noted in the pavement are indicative of subgrade issues, as opposed to defects in the asphalt pavement. However as shown in Table 4.1, the thickness of the ABC was less than the original design section in many of the boring locations. The locations meeting the design thickness included B-13, B-18, B-19 and B-27 through B-34.

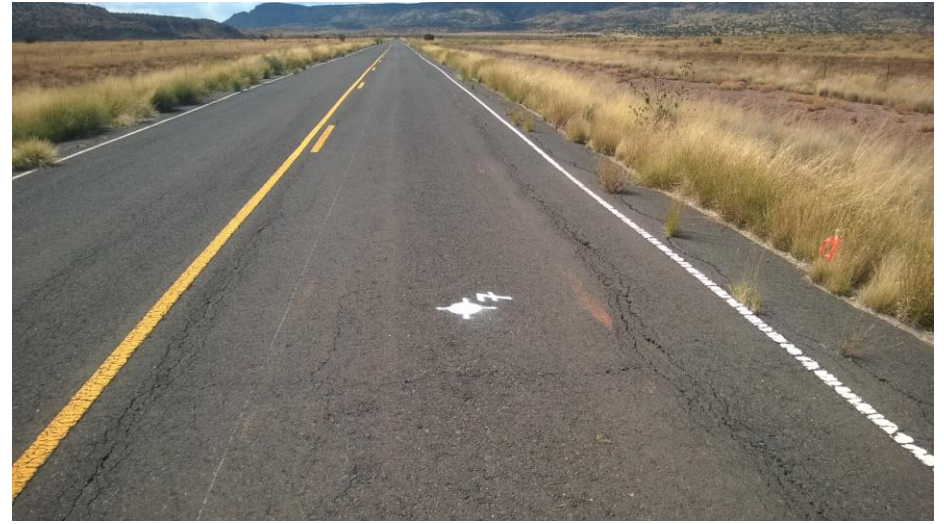
Longitudinal cracking outside of wheelpath at location of boring B-7

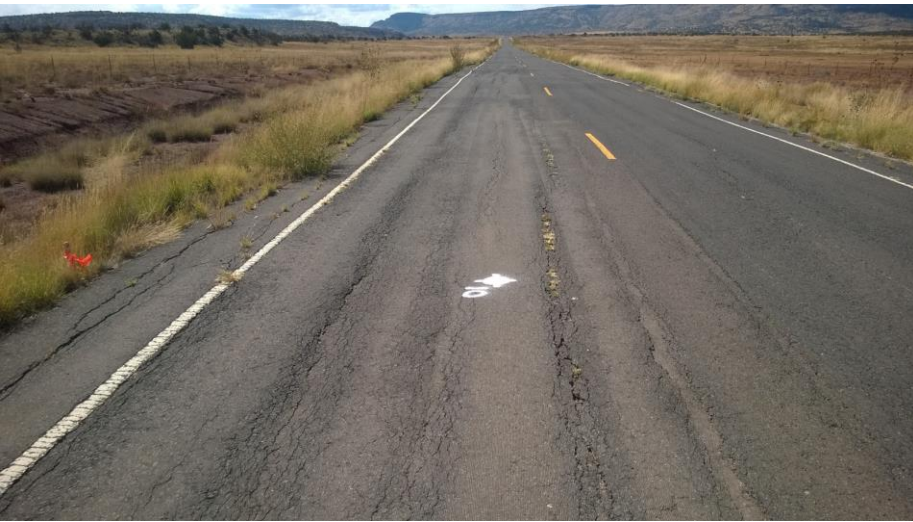
Rutting in wheelpath at location of boring B-10

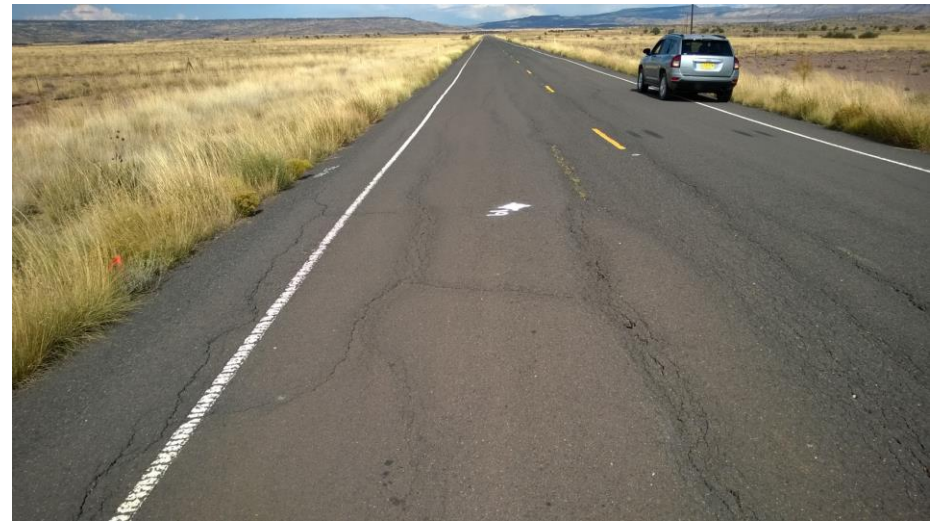
Longitudinal/transverse cracking in location of boring B-19
