# Opposition to Quail Meadows Apartments Project, Case # MULTI-003751-2020; DR-003759-2020 & CDP-003761-2020

Focused Concern:  
Drainage Plan

Kathleen McDowell  
October 03, 2024

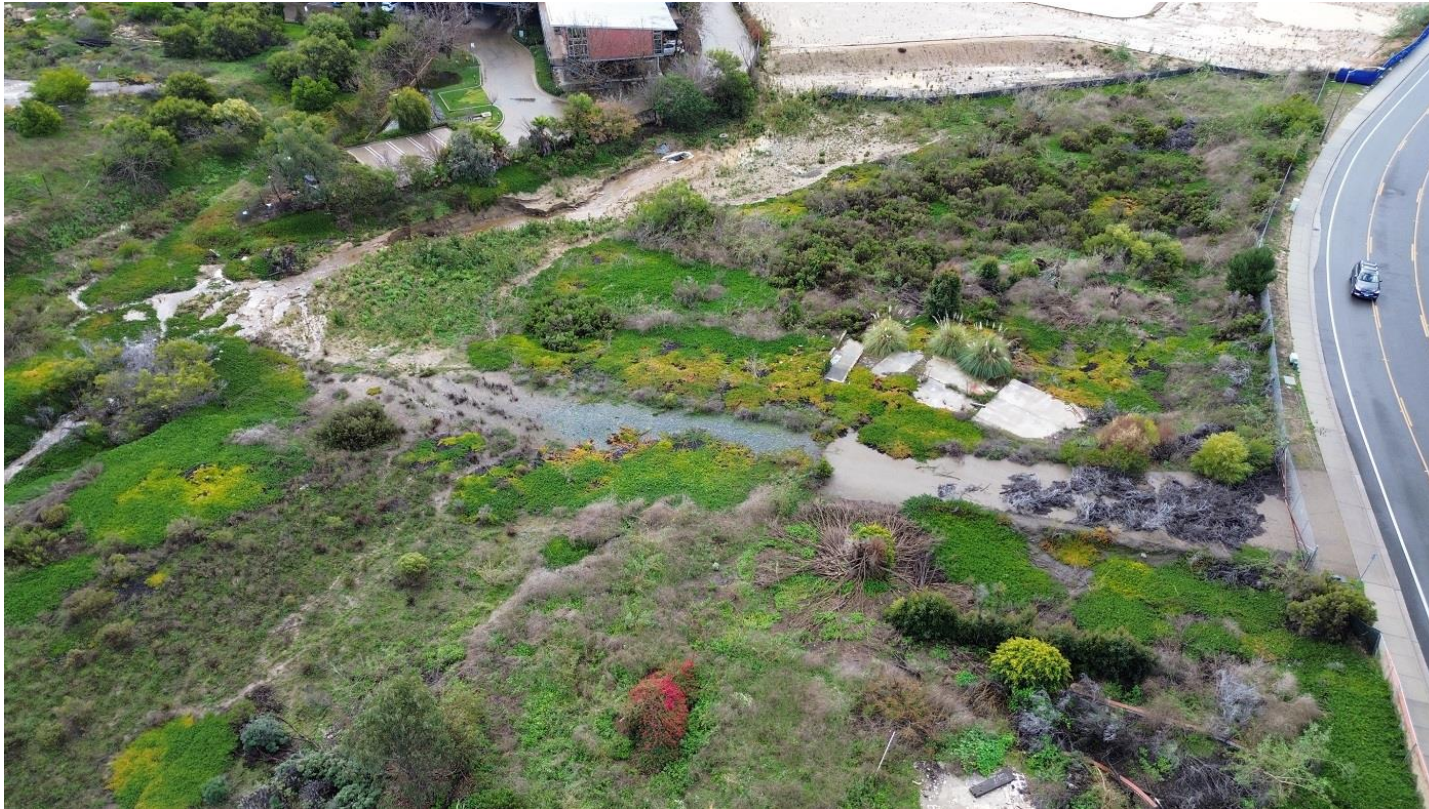
Aerial photo taken February 8, 2024 showing flooding, seasonal creek, and erosion along flow pathway

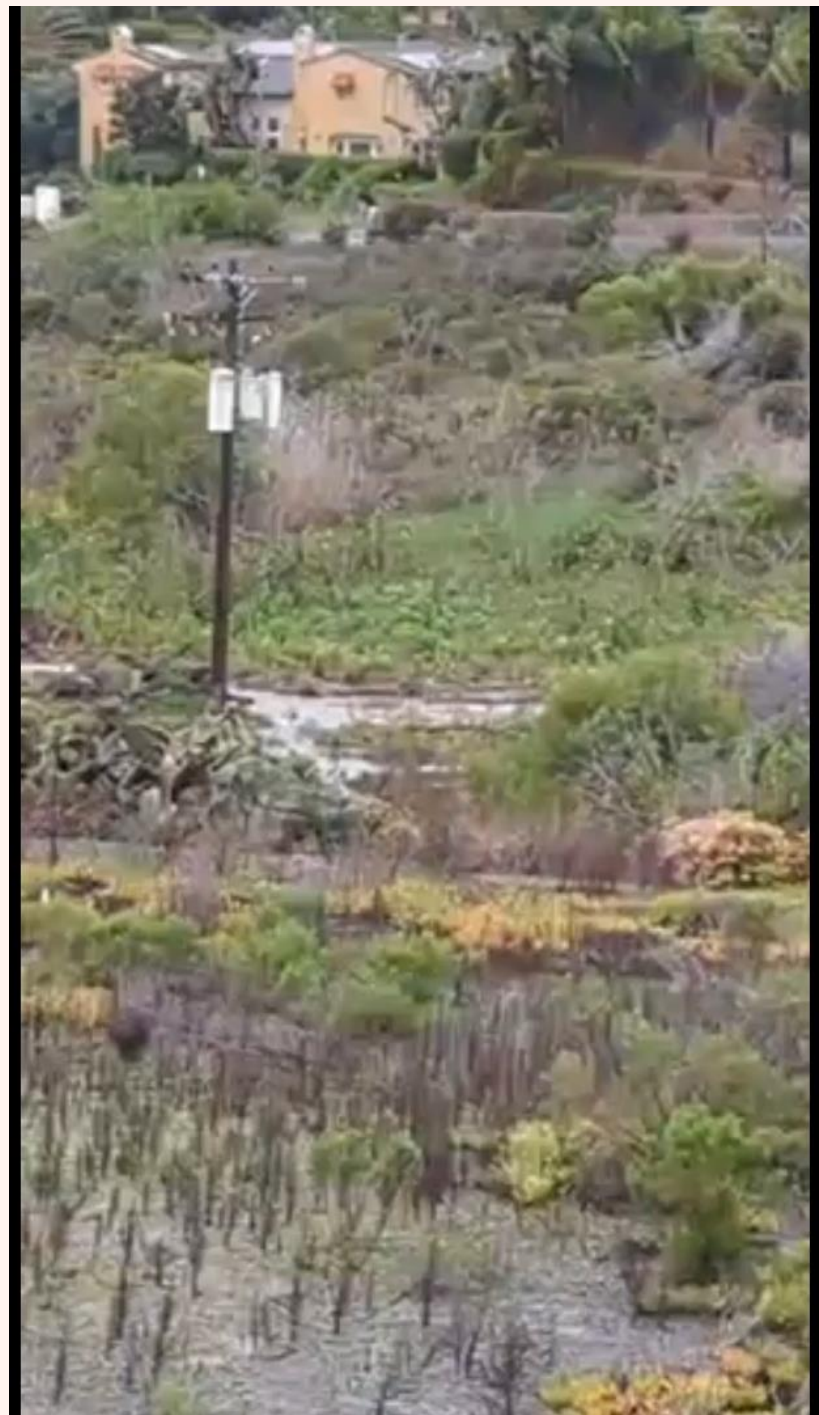
- Seasonal creek observable annually from approx. November through March
- Significant erosion and flooding due to storm events
- Heavy rainfall due to an atmospheric river resulted in ~2.4 inches of precipitation between February 5 and 7, 2024<sup>1</sup>
- Video shows active water flow on February 6, 2024

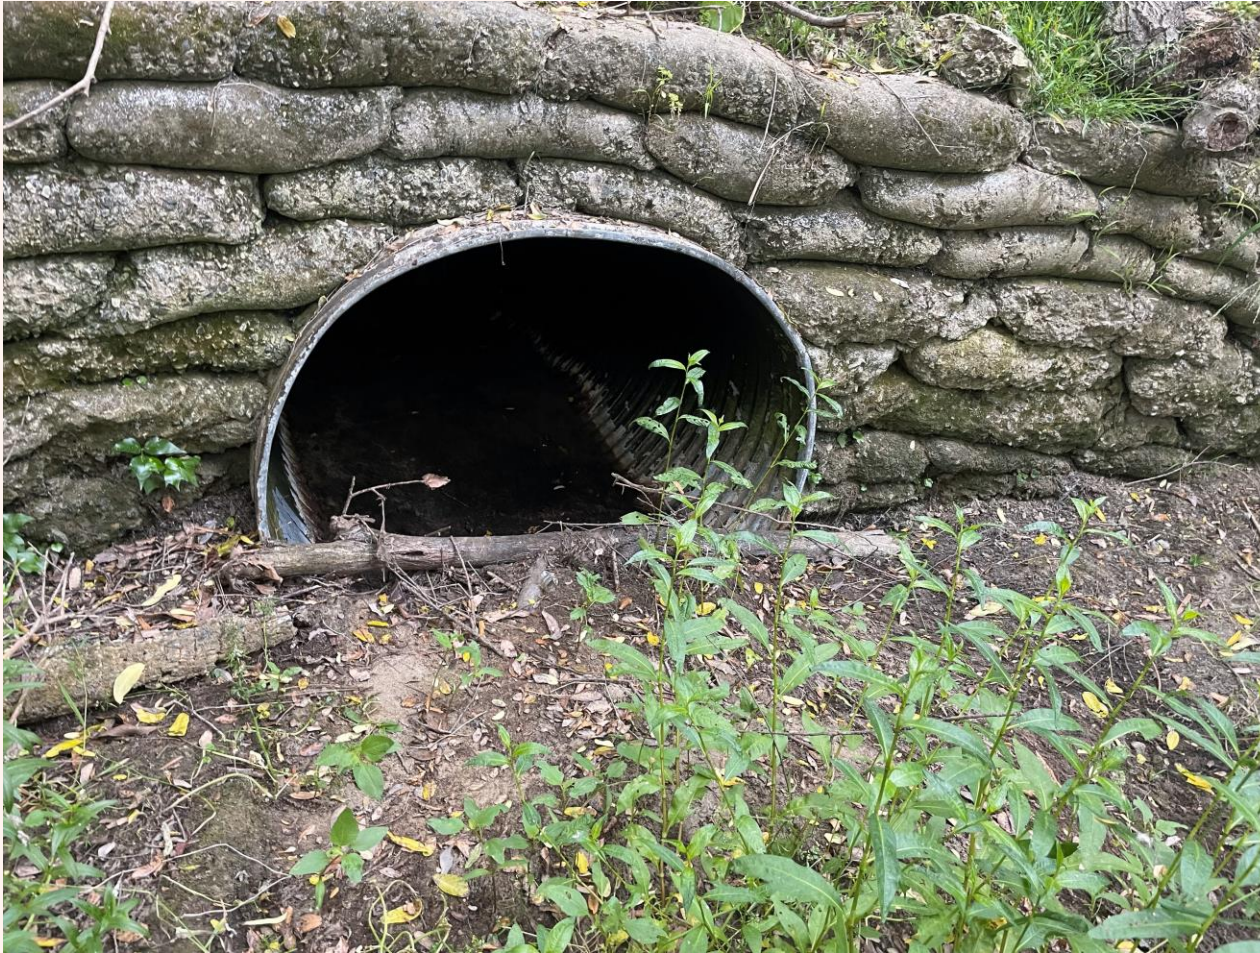
Photo of 48" pipe taken February 2024

- Relies on existing 48" corrugated metal pipe and historic headwall<sup>2</sup> of uncertain integrity or functionality
- No permitting information available

- Data for flow conditions and pipe capacity is modeled based on information from 2008
- Pipe's estimated capacity is only 18% of the peak flow rate from 2008
- Applicant deemed modeling to quantify exact storm event return frequency and peak flow rate for an assessment of current conditions was out-of-scope.<sup>2</sup>

- Relies on questionable existing infrastructure integrity which has not been sufficiently assessed.
- Uses outdated information to model potential conditions at the site.
- Outdated information will result in improper drainage planning; inundated stormwater systems likely to fail as severe weather patterns become our new normal.
- Flooding and poor stormwater management has a high potential for negative impacts to public safety.
- Planning Commission should consider this plan as part of a greater mitigation and cumulative impact strategy rather than on a per-project basis.

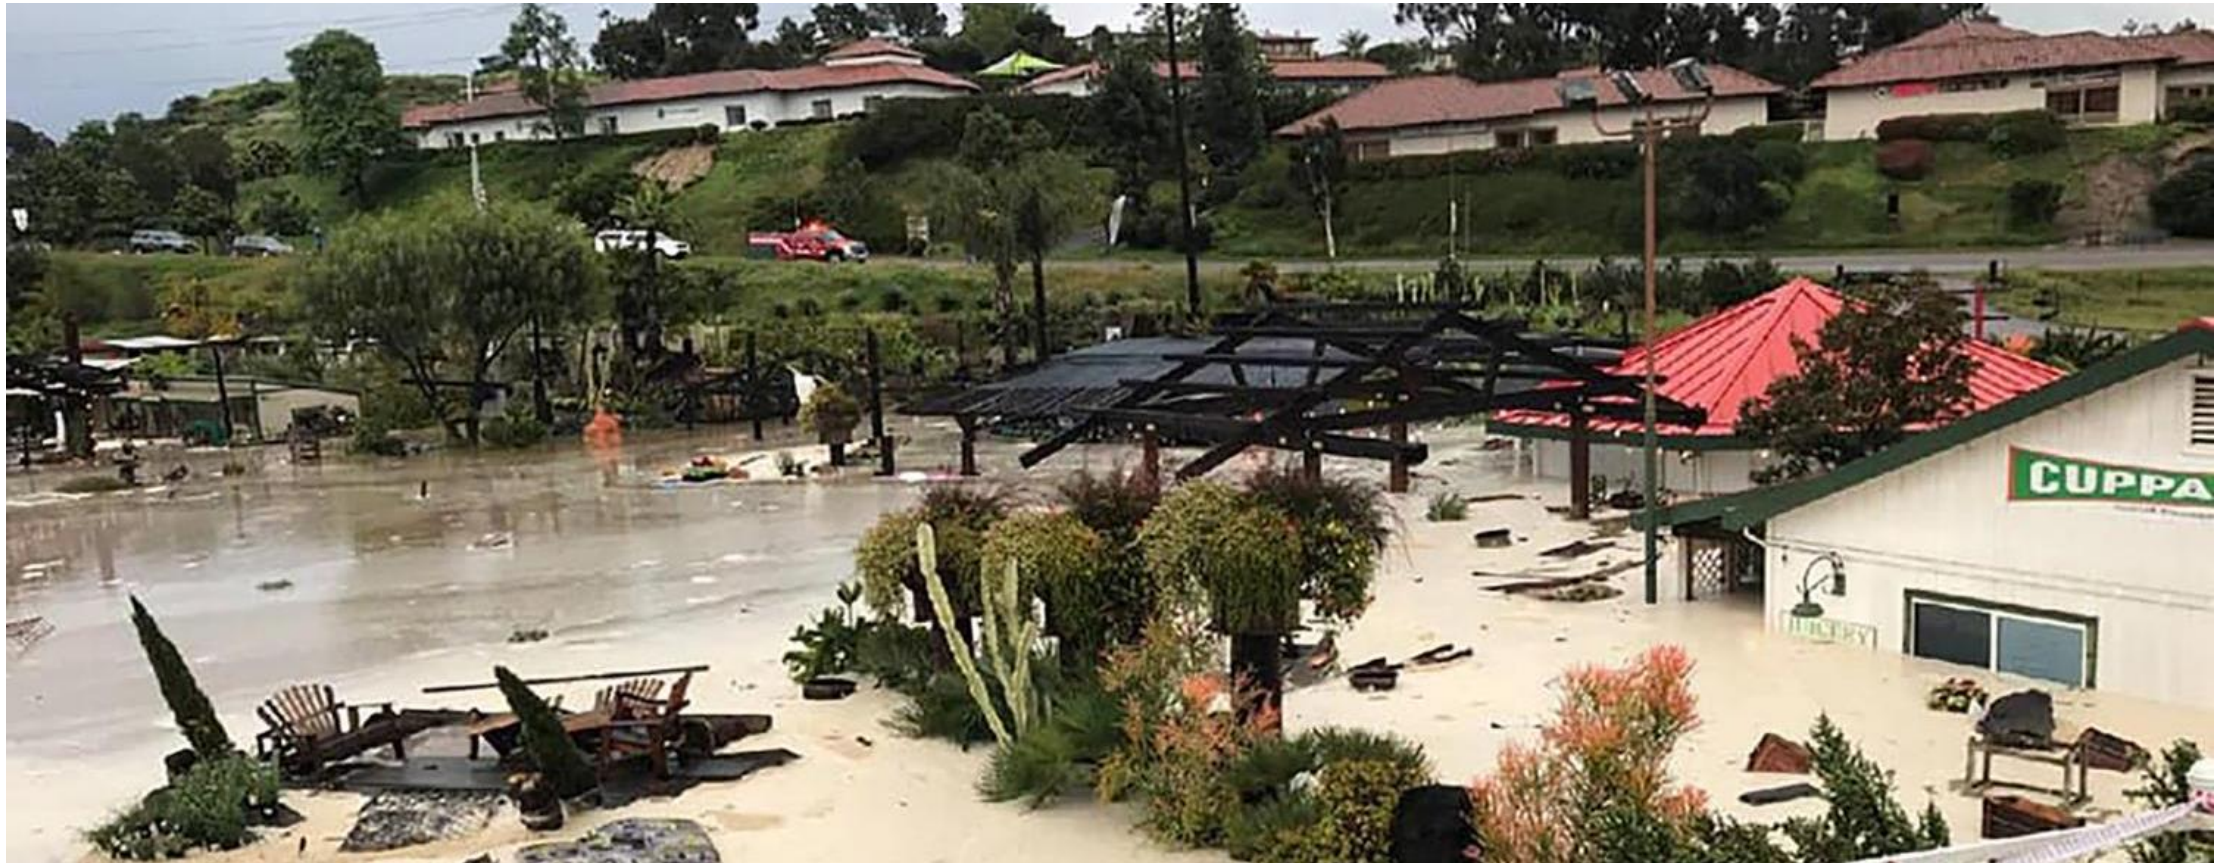
View of Sunshine Gardens facing Encinitas Blvd. Photo taken April 10, 2020  
and retrieved from North Coast Current<sup>4</sup>
