EAGLE EYE HOME INSPECTION

RESIDENTIAL REPORT

[REDACTED]
North Myrtle Beach SC 29582

[REDACTED]
JUNE 23, 2021

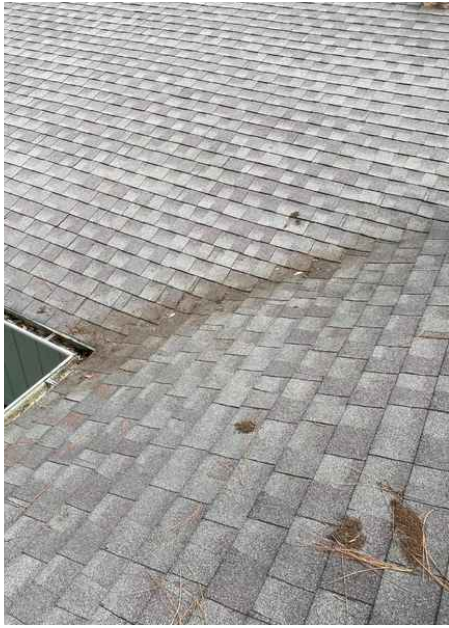
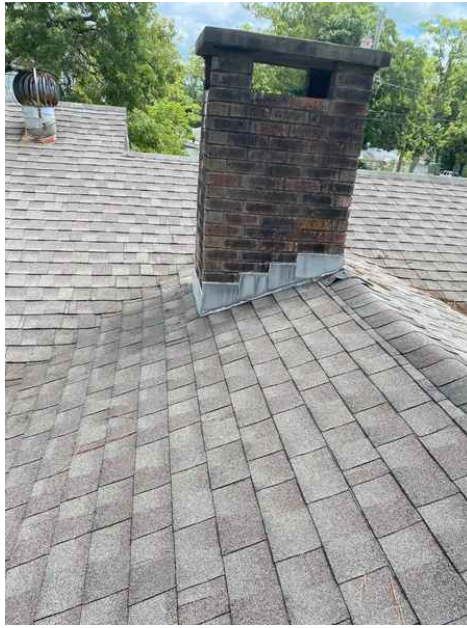
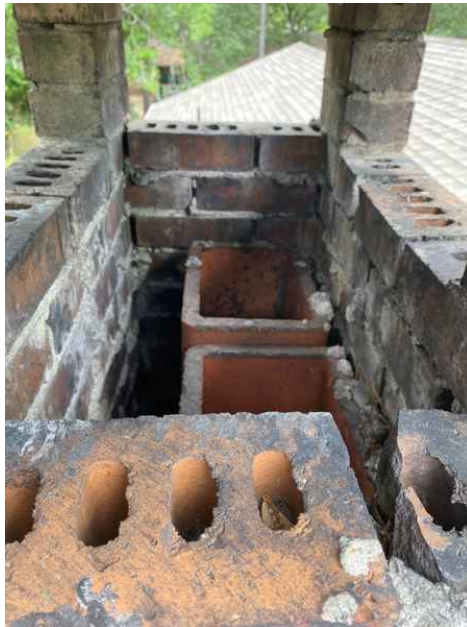
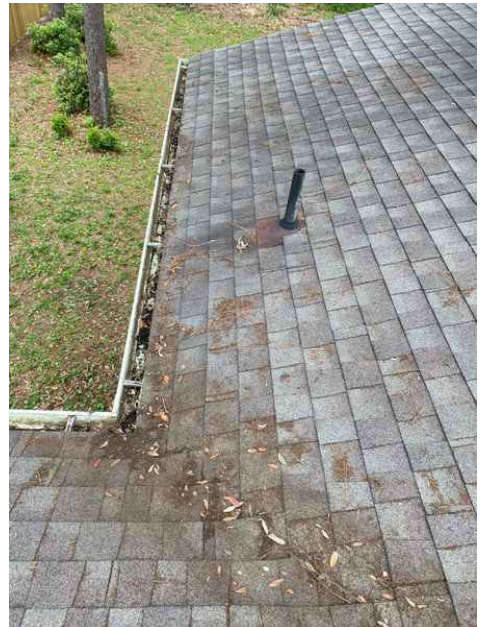
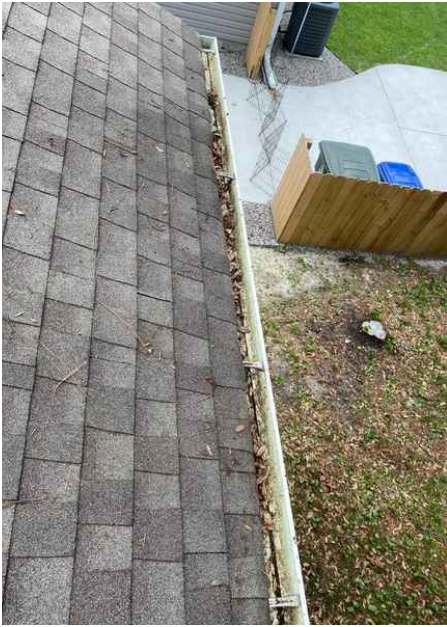
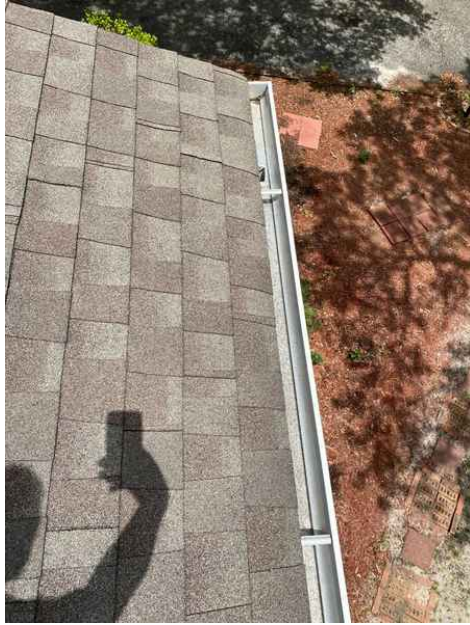
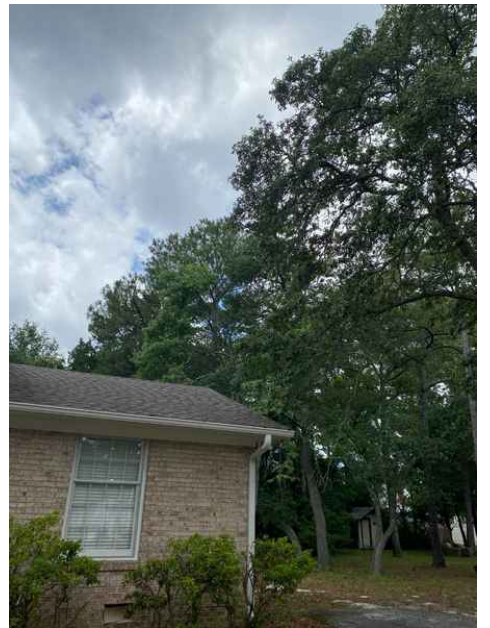
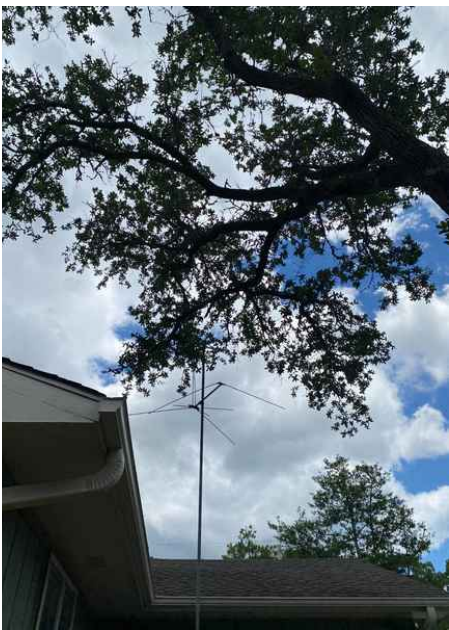
Roof Structure: Pics of Roof Taken at the time of inspection

The overall condition of the roof (at the time of inspection) indicates at the very least, the need for flashing replacement on all roofing penetrations, including the chimney. The shingles show significant granule loss. There are several spots with cracking, with some shingles showing a brittle condition. Budgeting for a new roof (shingles, felt and flashing) would be a good idea. Although this roof appears to be approaching the end of its useful life, flashing replacement and reseal may possibly extend it.

Of more concern is the condition of the chimney, it's masonry and flashing. The brick shows severe deterioration and a loss of mortar inside the chimney above the flue liner, with pitting and a need for pointing being obvious. This is mostly due to moisture intrusion from rain going directly into the chimney. There may also be structural issues with the chimney (at the top), which will require a thorough evaluation by a chimney contractor.

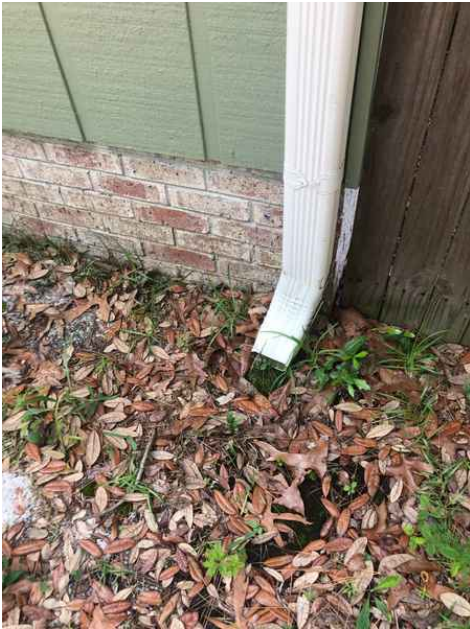
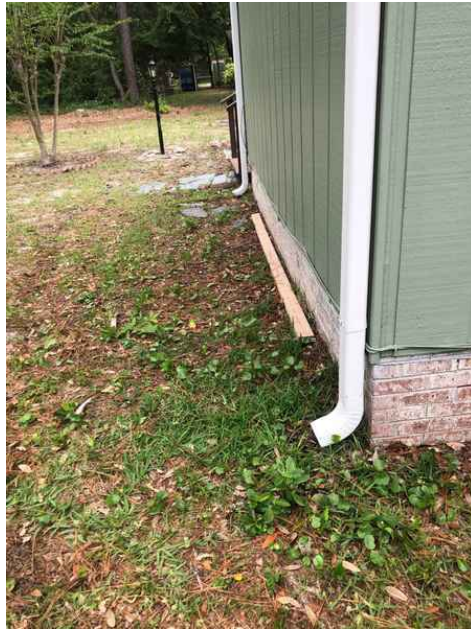
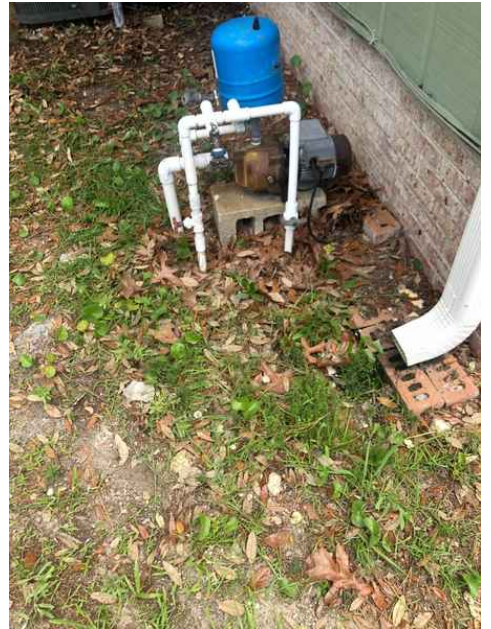
DOWNSPOUTS: DISCHARGE TO FOUNDATION- QC

One or more downspouts discharged roof drainage next to the foundation at the time of inspection. This condition can result in excessively high moisture levels in soil at the foundation and can cause damage related to soil/foundation movement. Excessive moisture levels in soil near the foundation can affect the ability of the soil to support the weight of the structure above and can cause damage related to soil/foundation movement. The Inspector recommends the installation of downspout extensions to discharge roof drainage a minimum of 6 feet from the foundation.

Contact a qualified gutter contractor

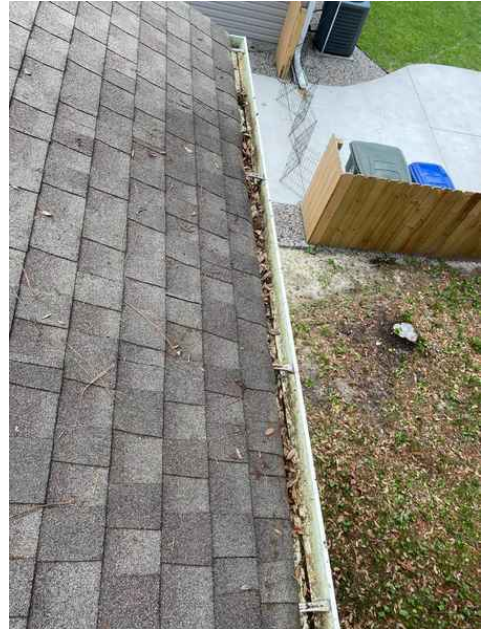
2.6.1 Flashing

CORROSION: MODERATE

Recommendation

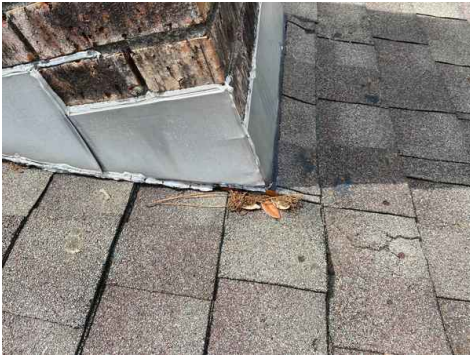
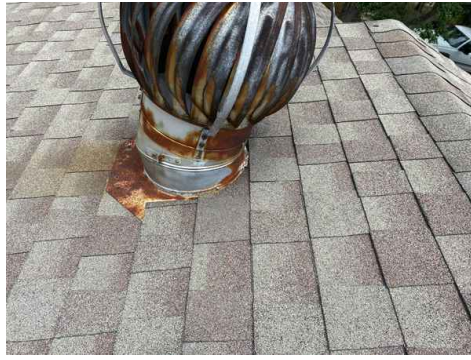
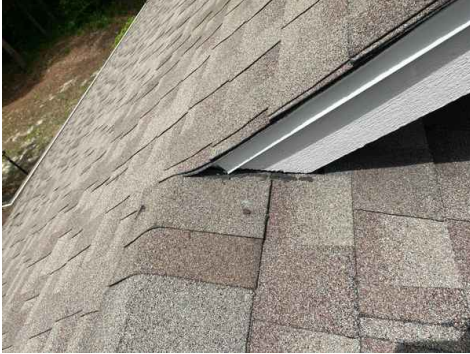
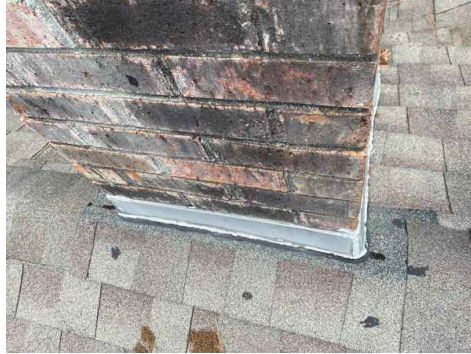
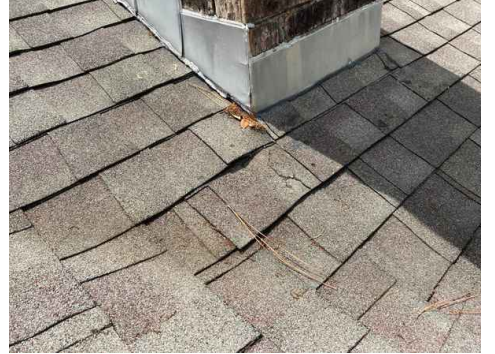
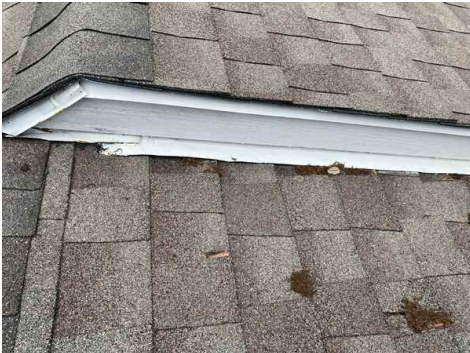
2.6.2 Flashing

NO FLASHING, SEALANT ONLY

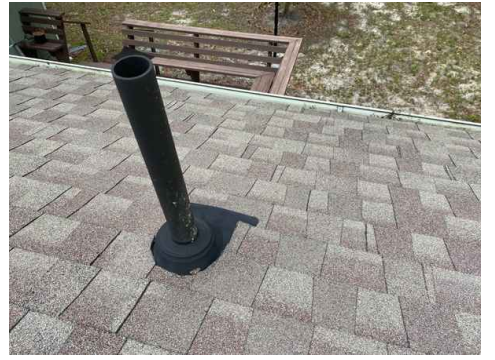
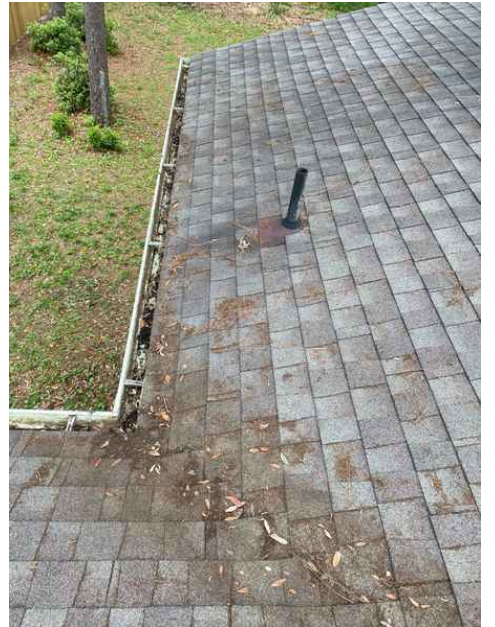
Metal flashing protecting the roof was generally old and exhibited moderate to severe corrosion at the time of the inspection. Flashing should be inspected annually and replaced before it begins to leak. All work should be performed by a qualified roofing contractor. Inspector recommends the roof be thoroughly examined by a roofing professional, with flashing replaced as necessary.

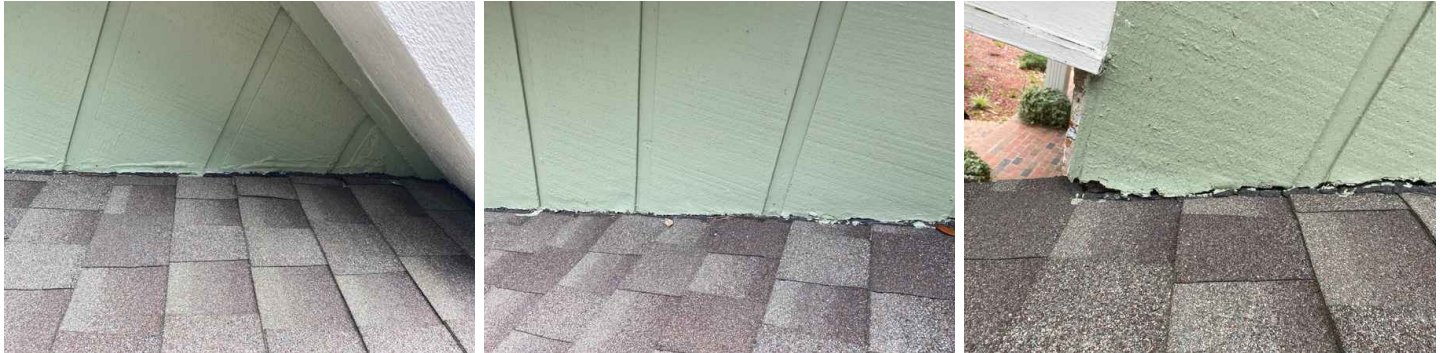
No roof flashing was installed. Roof sealant was used to seal areas that normally would be protected by metal flashing. Unless they are diligently maintained, these areas will allow roof leakage sooner than if they were properly protected by metal flashing. Sealant will need to be examined annually and re-applied as needed. Proper flashing should be installed by a qualified roofing contractor at the first opportunity.

Contact a qualified roofing professional.

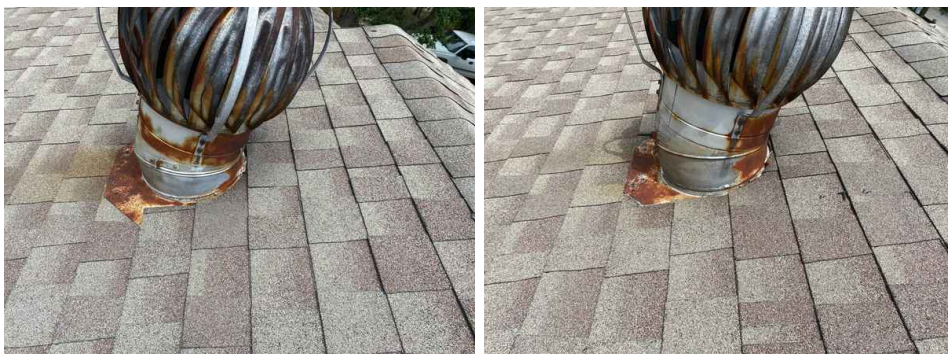
VENT CORROSION: MODERATE

Exhaust vent on the roof exhibited moderate corrosion at the time of inspection. Inspector recommends further evaluation, repair or replacement of all roof penetration vents and related flashing.

Contact a qualified roofing professional.

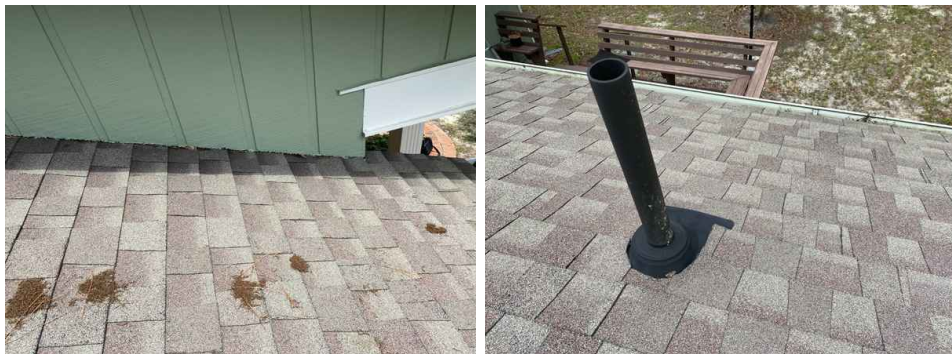
2.8.1 Asphalt Shingles

Asphalt shingles were older and suffered noticeable uniform granule loss across the roof. According to shingle manufacturers and insurance companies, this is not necessarily a defective condition, but a natural result of the aging process. The bond between asphalt and granules deteriorates over time as asphalt loses volatile compounds, dries and shrinks. It does not affect the ability of the shingles to shed water.

Contact a qualified roofing professional.

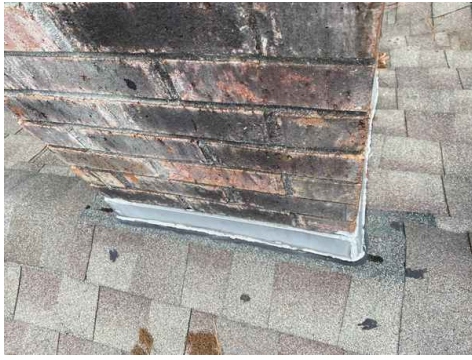
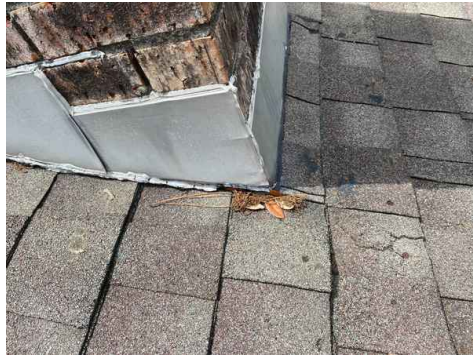
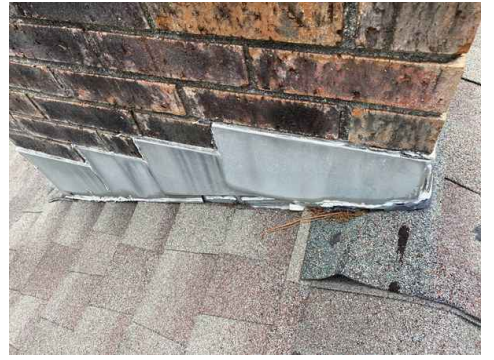
2.9.2 Chimney

CHIMNEY - SIGNIFICANT SIGNS OF MASONRY DETERIORATION

The chimney masonry showed significant deterioration at the time of inspection. There is no rain cap or pest screen on the top of the chimney above the liner, which allows moisture and pests into the chimney and flue. The inspector recommends a thorough evaluation by a chimney contractor to determine the level of deterioration a required repairs.

Contact a qualified professional.

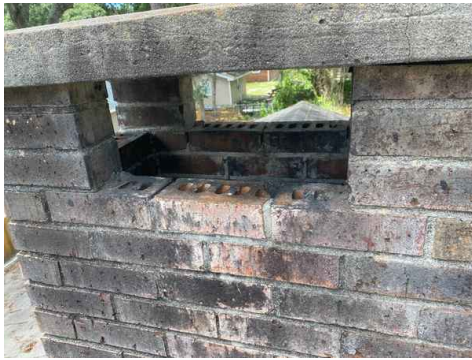
2.10.1 Roof Observations

ROOFING CONDITIONS: CHIMNEY

The chimney top (inside) showed significant signs of deterioration due to moisture intrusion. The inspector recommends further evaluation of the chimney and components by a professional chimney contractor and chimney sweep, BEFORE attempting to use the fireplace.

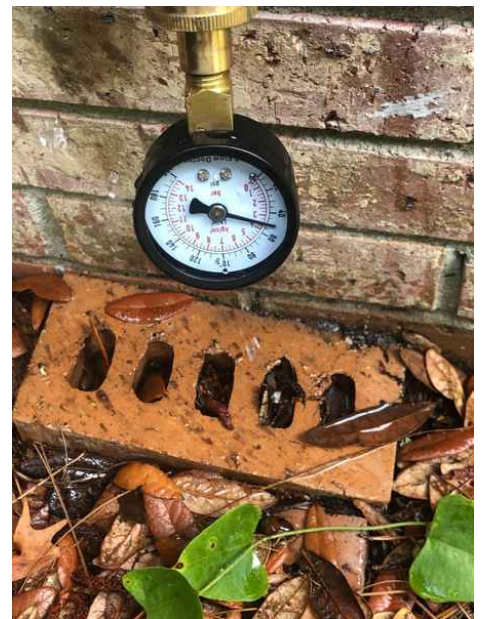
Plumbing: Water Pressure
50-55 psi

Plumbing: Hose Bib showing water pressure

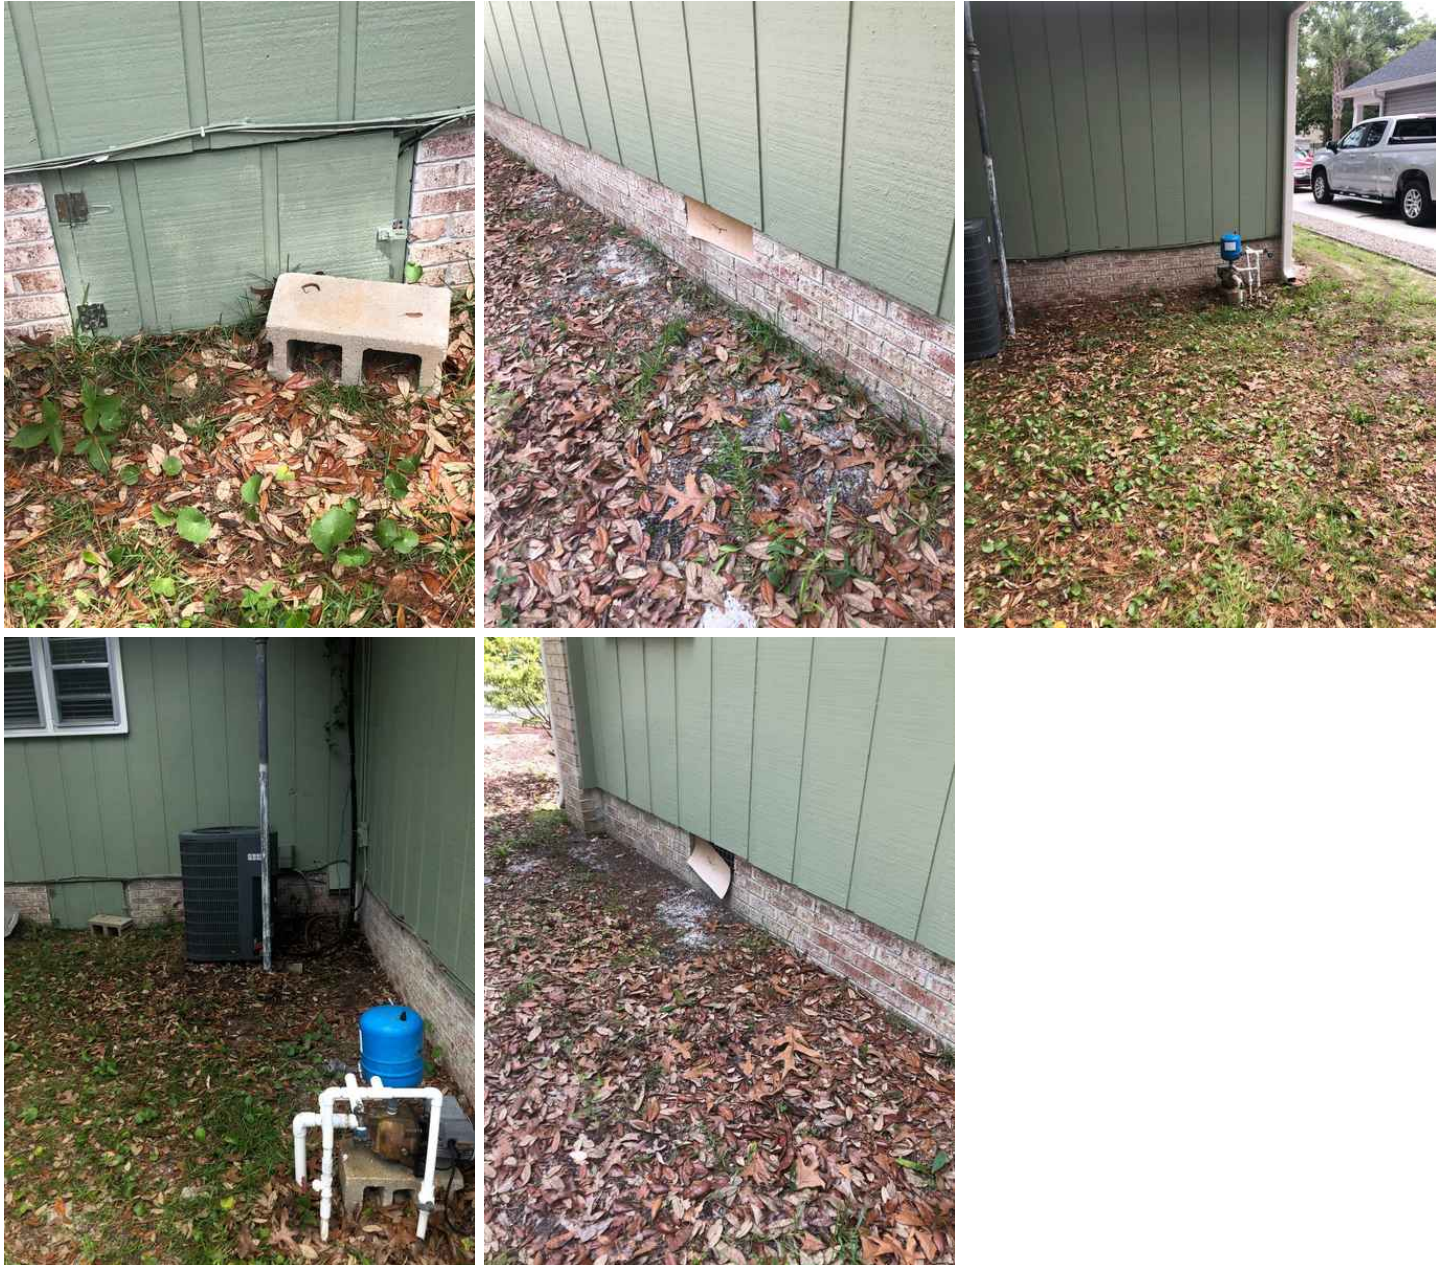
GRADE AT FOUNDATION NEARLY FLAT - MINIMAL DRAINAGE

The overall grade at the home's foundation was nearly flat at the time of inspection. This condition if left uncorrected, will allow moisture to penetrate the foundation and crawlspace, and the possibility of standing water. Grade should taper away from the foundation at least 6" over 10', grading away from the foundation and crawlspace.

Recommend consulting with a landscape contractor to further evaluate and make corrections.

Contact a qualified landscaping contractor

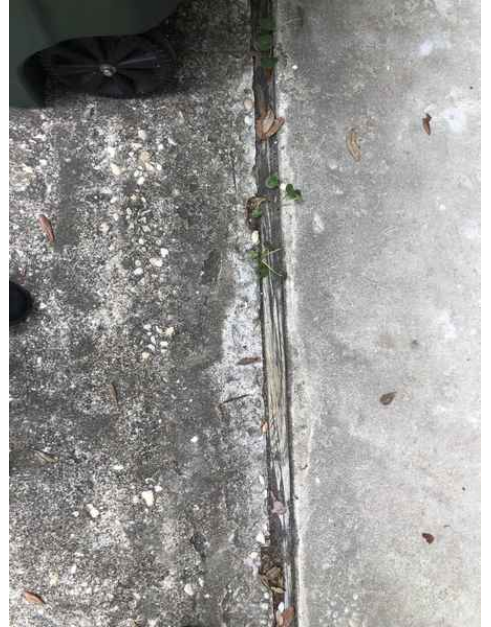
3.2.1 Driveway & Walkway

The driveway was rough, and in places, non-existent, with exposed stones and ruts at the time of inspection. Recommend consulting with a qualified contractor for replacing driveway.

Contact a qualified concrete contractor.

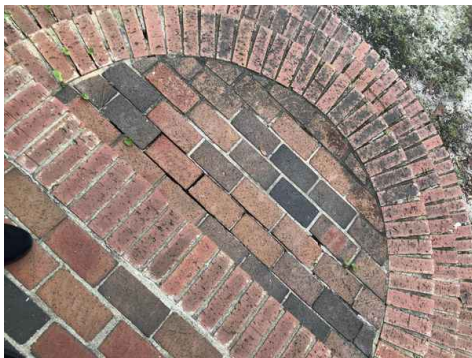
BRICK WALKWAY AND STEPS - MISSING MORTAR / CRACKING / PITTING

Brick work on the walkway, steps and porch had missing mortar, cracking and some pitting at the time of inspection. This condition if left untreated could become a trip hazard. Recommend repair by a licensed brick mason.

Contact a qualified masonry professional.

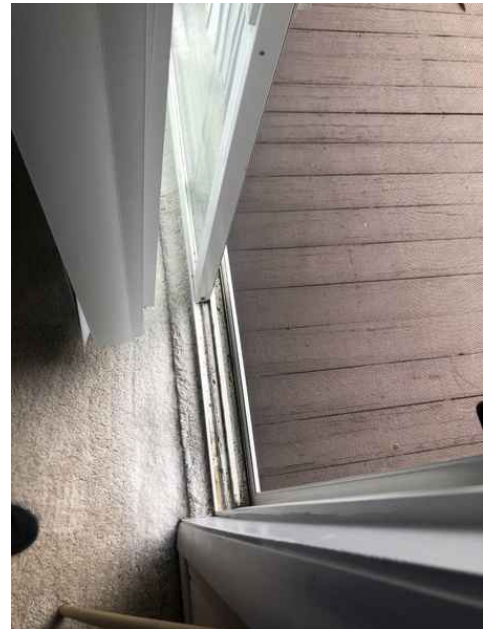
3.3.2 Door/Window Exteriors

SLIDER IN MASTER BEDROOM - IS SLOW TO OPEN

Slider in master bedroom was slow to open at the time of inspection. Inspector recommends further evaluation and repair by a qualified professional.

Contact a qualified professional.

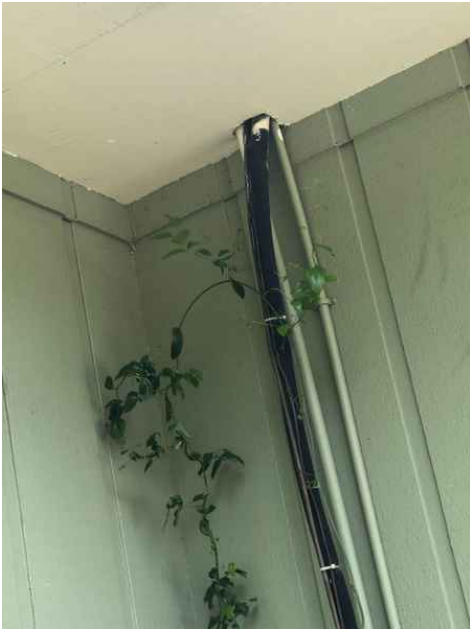
3.4.1 Soffit & Fascia

HVAC WIRING / PLUMBING CONNECTIONS THROUGH SOFFIT - NOT SEALED

The outside HVAC condensing unit wiring and plumbing entered the home through the soffit area, which was not sealed against moisture intrusion or pests at the time of inspection. Recommend contacting a handyman to facilitate the sealing of the area in question.

Contact a qualified handyman.

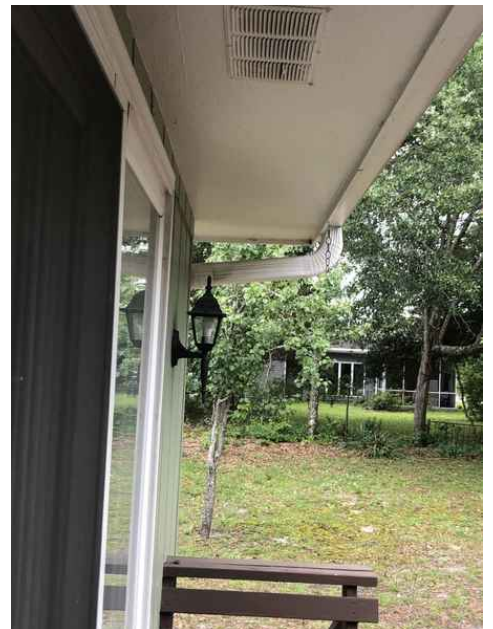
3.4.2 Soffit & Fascia

SOFFIT VENTILATION MINIMAL

Ventilation through the soffits of the home were either non-existent or partially blocked at the time of inspection. The soffit vents need to be unblocked in order to assist in proper ventilation of the attic space. The inspector recommends further evaluation of the attic space ventilation by a qualified professional.

Contact a qualified professional.

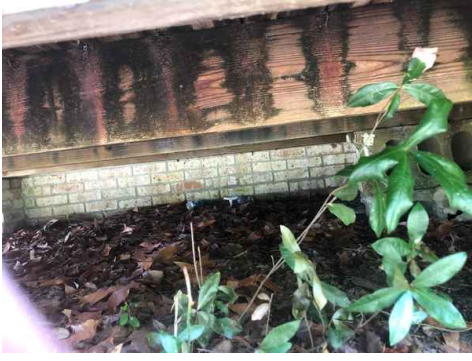
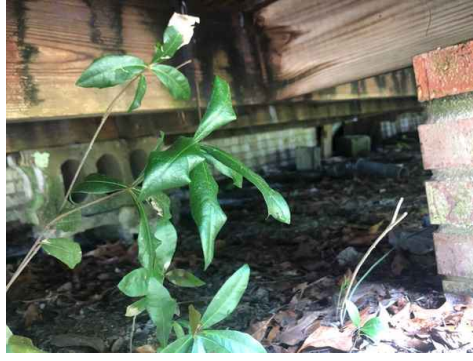
FINISH COATING AND OVERALL DECK - MODERATE DETERIORATION

A finish coating designed to protect the deck exhibited moderate deterioration was non-existent on the deck at the time of inspection. The deck covering was painted and showed signs of cupping and fastener movement.

Failure of any finish coating will allow Ultra Violet (UV) radiation from sunlight, heat, moisture and freezing moisture to reduce the lifespan of bare wood exposed to weather. Maintenance performed on an appropriate schedule can significantly extend the lifespan of wood deck components.

Recommend consulting with a decking contractor for resetting of decking board fasteners and to install an adequate non-painted finish coating designed to protect the deck from UV radiation deterioration.

Contact a qualified deck contractor.

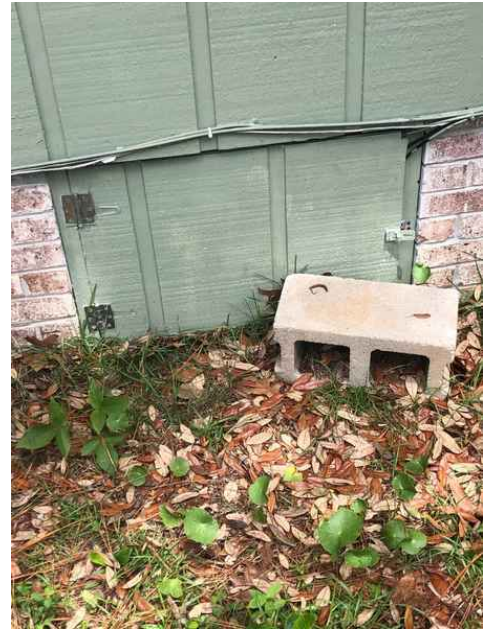
CRAWLSPACE - COMPLETE ACCESS TO ALL PORTIONS

The crawlspace had portions that were inaccessible due to debris and other obstructions.

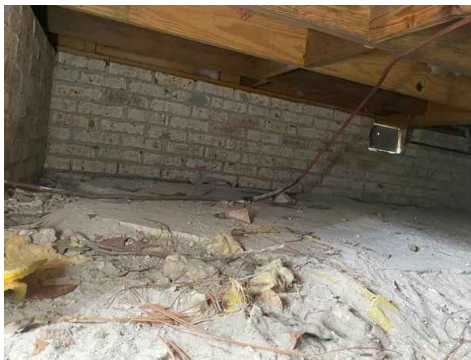
INSULATION: LOOSE, MISSING INSULATION

Contact a qualified professional.

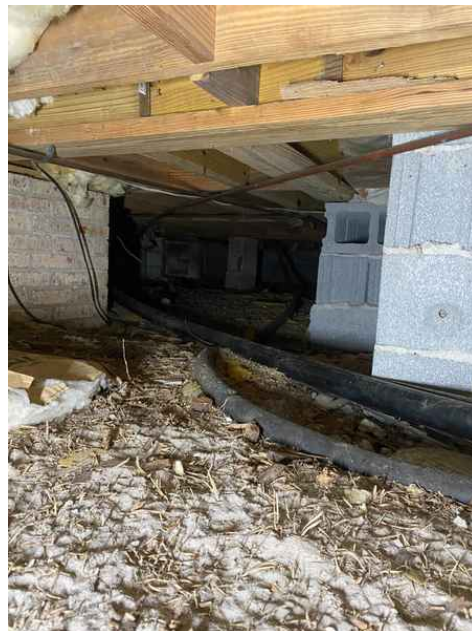
4.1.1 Crawlspace

Thermal insulation was loose or missing in the crawlspace. Insulation should be secured or replaced to help reduce heating costs and increase home comfort.

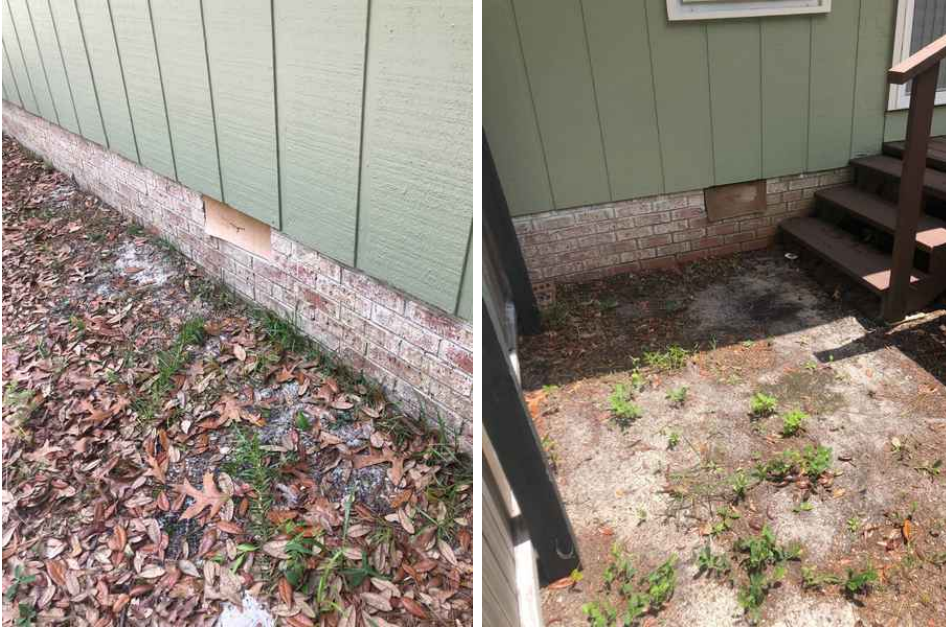
4.1.2 Crawlspace

CRAWLSPACE VENTS BLOCKED

Many of the exterior vents to the crawlspace were blocked at the time of inspection. This condition prevents proper ventilation for the crawlspace. Recommend the vents be further evaluated and corrected as needed, by a qualified professional.

Contact a qualified professional.

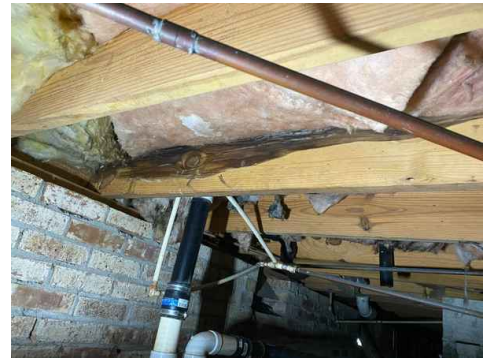
4.1.3 Crawlspace

MOISTURE INTRUSION - SUPPORT BEAM

A flooring joist support beam showed signs of moisture intrusion at the time of inspection. An active plumbing leak from the bathroom fixture above that location appears to be where the water is coming from. Inspector recommends consulting a plumbing professional for repairs.

Contact a qualified plumbing contractor.

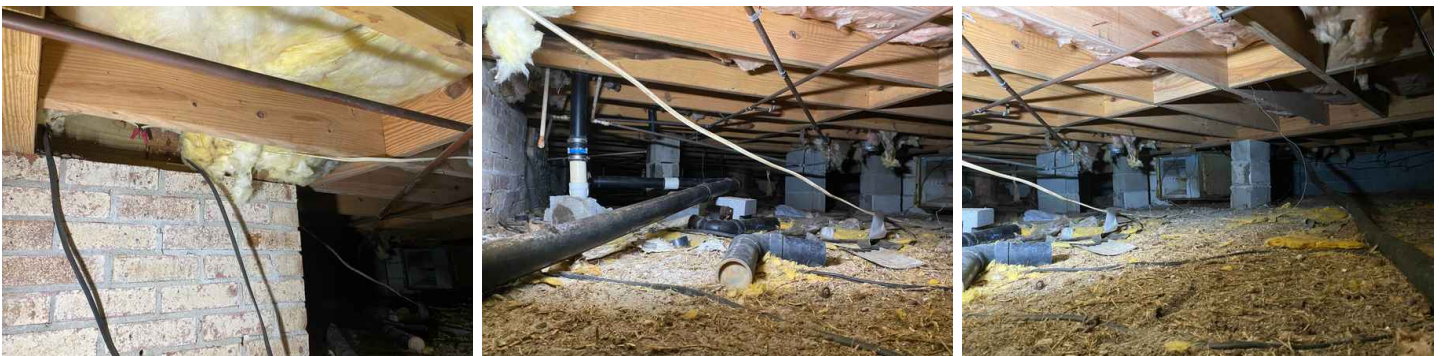
4.1.4 Crawlspace

ELECTRICAL - OPEN SPLICES AND UNSUPPORTED WIRING

There were open splice wires and non-supported wiring within the crawlspace at the time of inspection. This condition can allow moisture to penetrate wiring creating an electrical and fire safety hazard. The inspector recommends consulting with a an electrical contractor for repairs.

Contact a qualified professional.

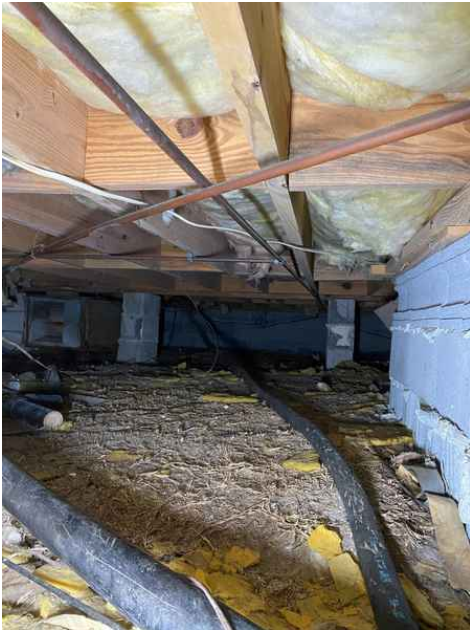
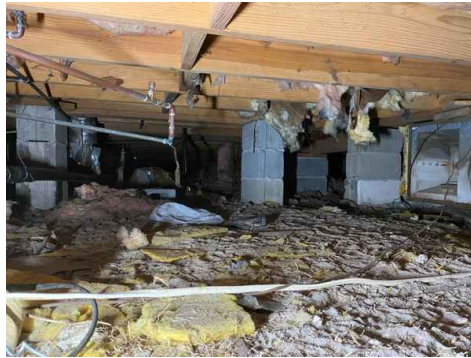
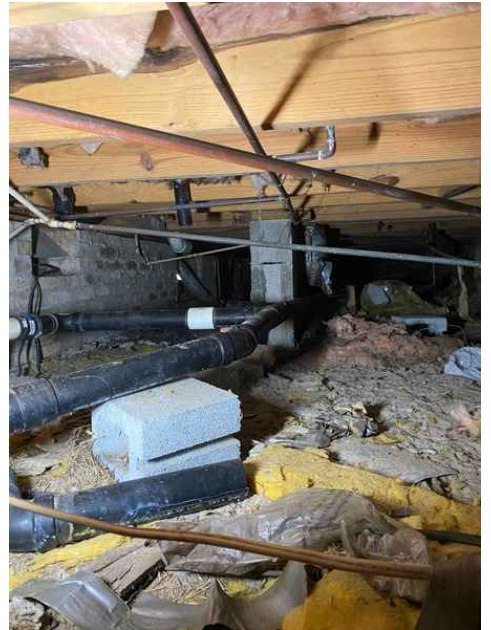
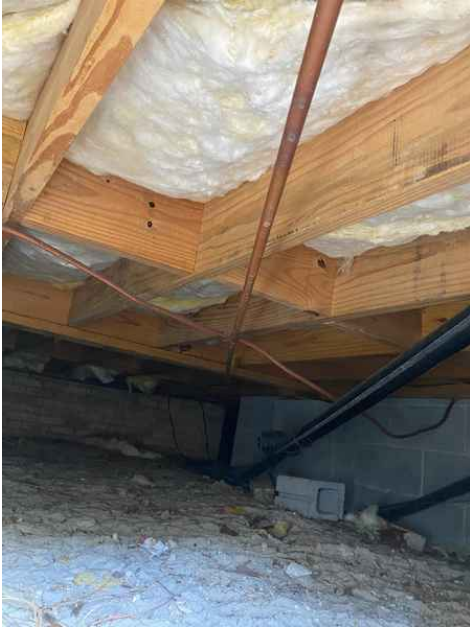
4.1.5 Crawlspace

PLUMBING - WATER LINES UNSUPPORTED

Contact a qualified plumbing contractor.

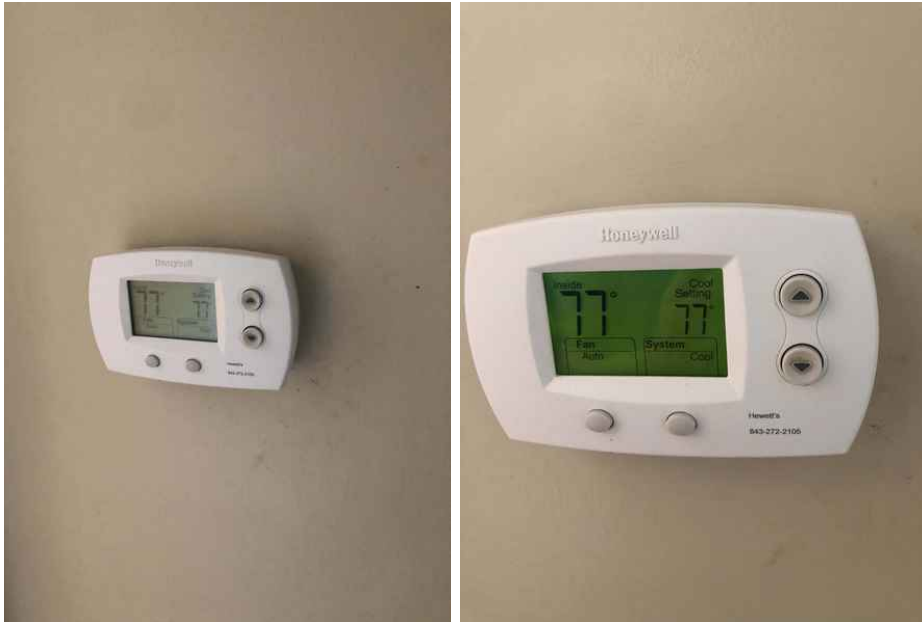
Thermostat: Thermostat Location

The thermostat was located in the main hallway at the time of inspection. The hvac equipment responded to the thermostat and was found to be operating as was designed.

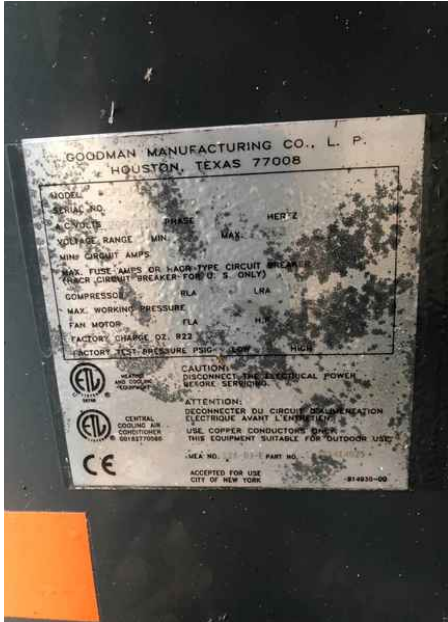
Heat Pump: Heat Pump Info & Data Plate Photo

The photo shows the data plate information for the heat pump. Note that the data plate is pitted, with portions of it being illegible.

The heat pump was located on the left rear exterior of the home.

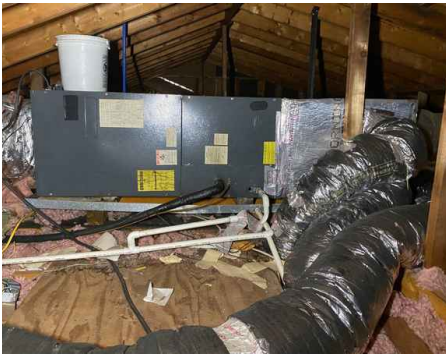
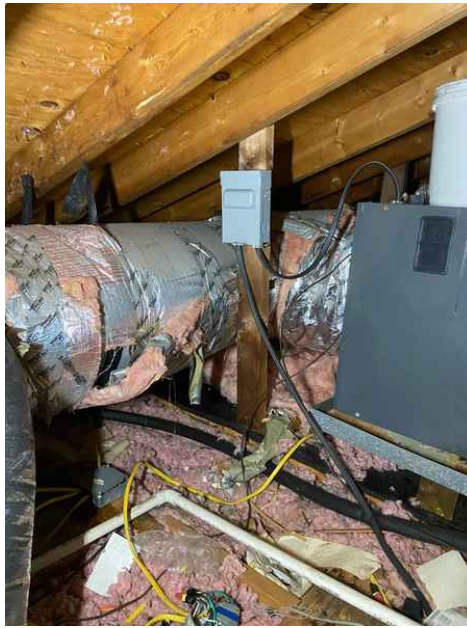
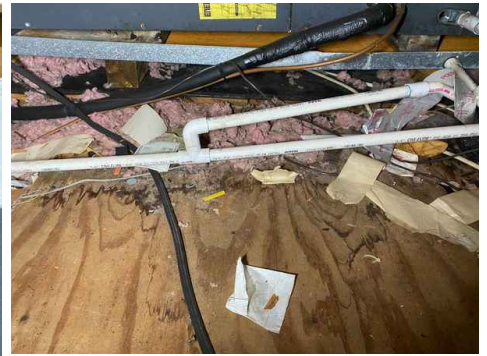
Air Handler (attic): Air Handler (Attic) Pics

The air-handler brand is Goodman. It was manufactured in 2004.

The disconnect for the air handler is shown in the pics below.

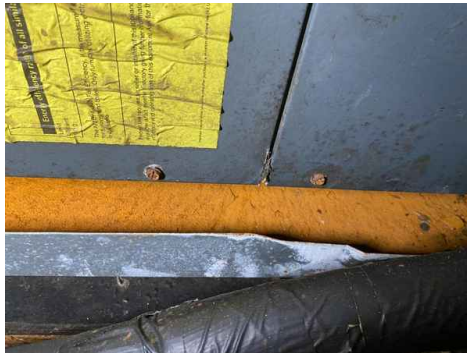
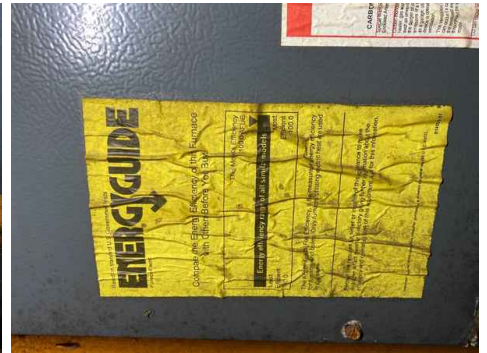
Brand: Goodman - Yewar: 2004

Drain line should be inspected and kept clean of debris and rust, in order to facilitate proper draining of the pan.

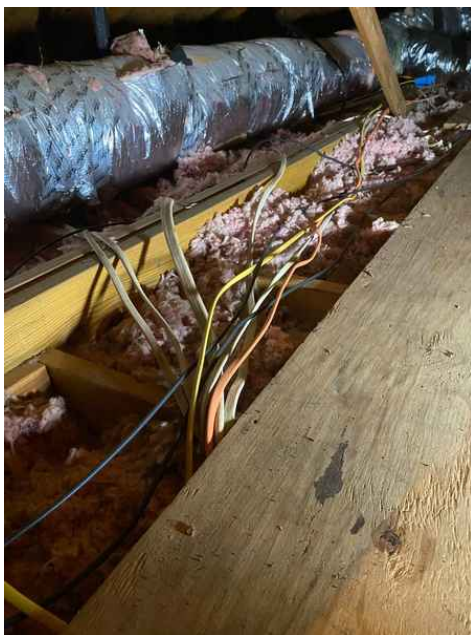
6.3.1 Air Handler (attic)

LOOSE UNSECURED WIRING

Contact a qualified professional.

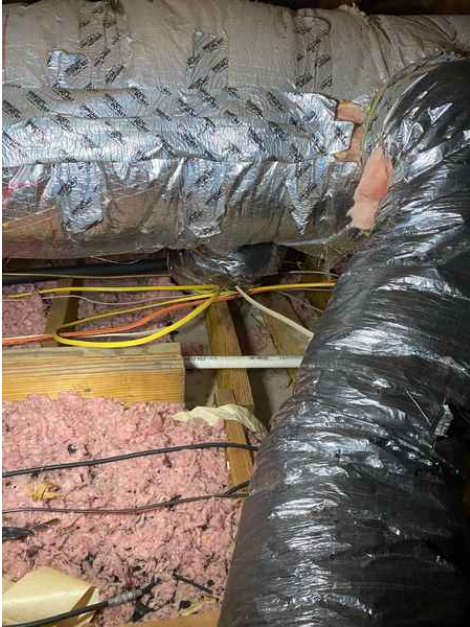
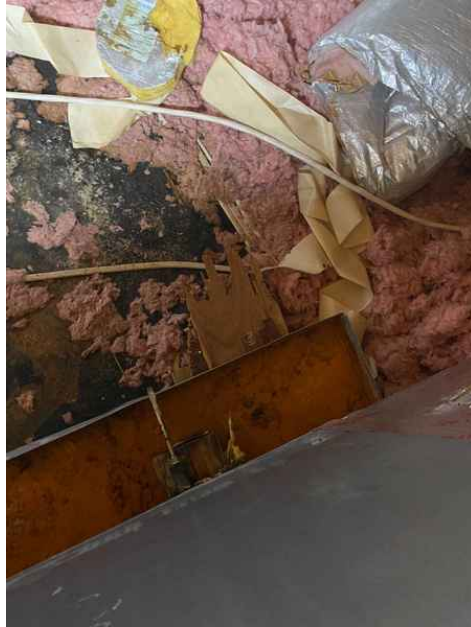
6.3.2 Air Handler (attic)

DRAIN PAN FOR AIR HANDLER - DEBRIS WILL BLOCK DRAIN

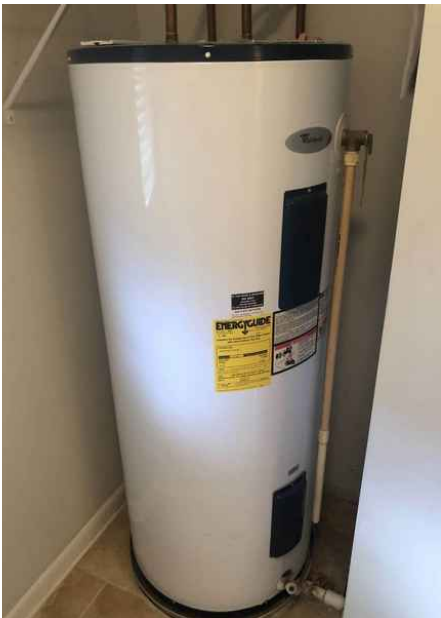
Water Heater: Photo of water heater

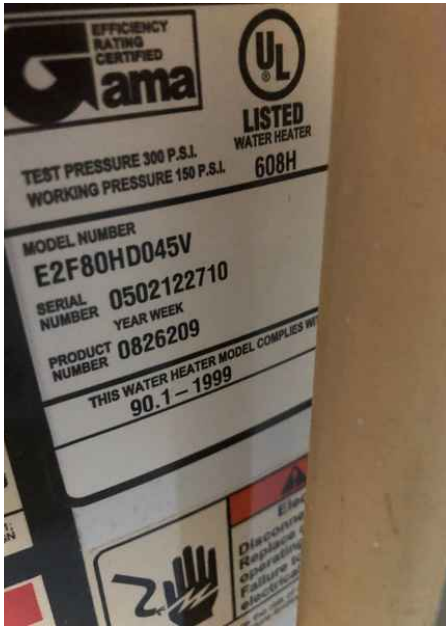
The photo shows the data plate of this water heater.

The Brand is WHIRLPOOL. It was manufactured in 2005.

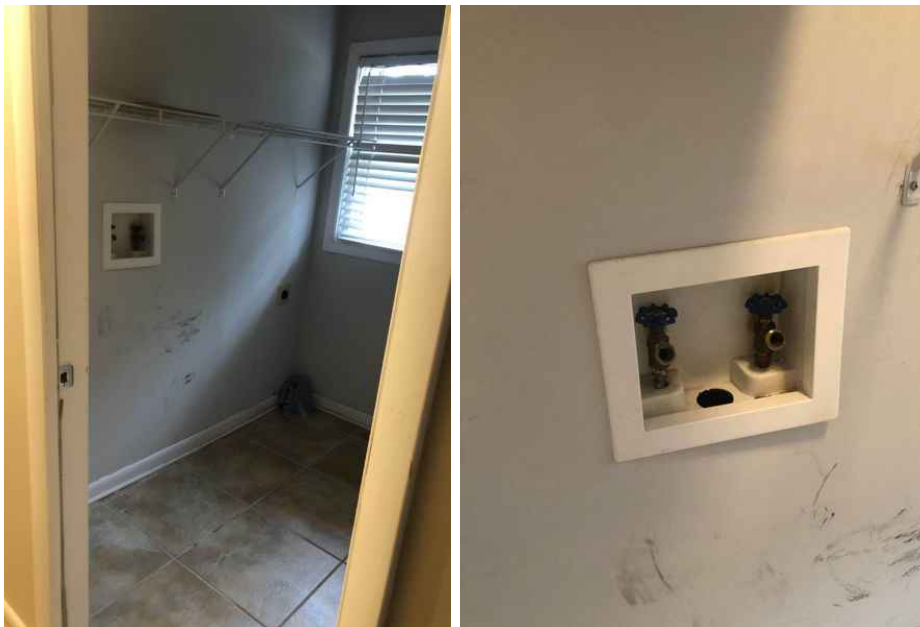
Laundry Room: Laundry Pair Connections

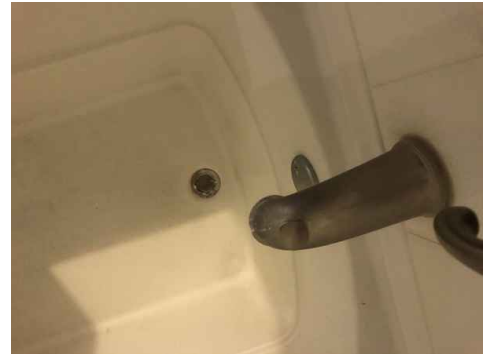
The tub in the bathroom had no inoperable stopper at the time of inspection. Recommend further evaluation and the installation of an operable stopper by a licensed plumber.

Contact a qualified plumbing contractor.

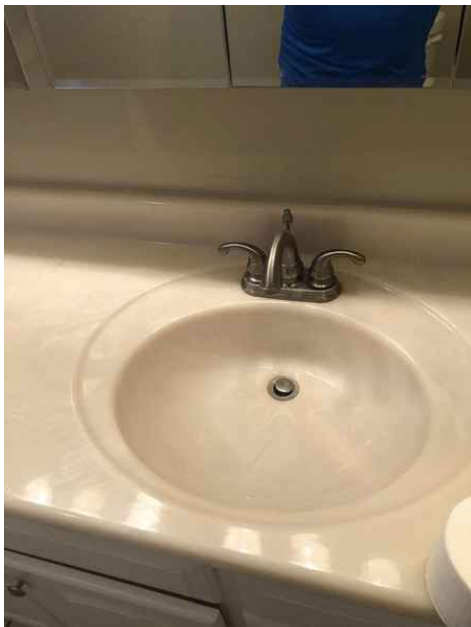
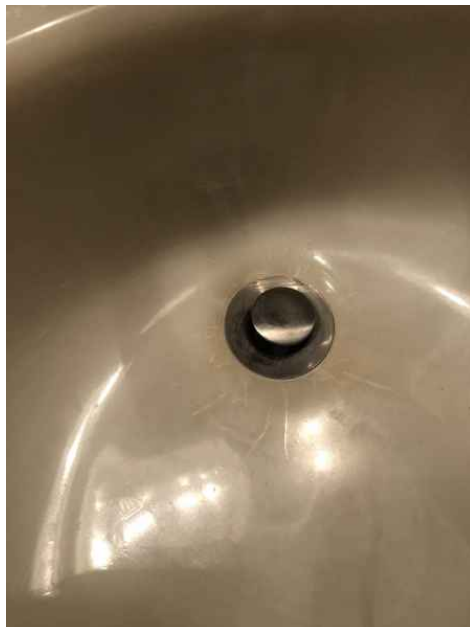
7.1.3 Bathrooms

PLUMBING LINES TO SINK ARE NOT SEALED AT WALL

The plumbing vent and water lines coming to the sink through the wall were not sealed at the time of inspection. This condition allows moisture intrusion and pests to enter the bathroom space and potentially beyond. Recommend these lines be sealed by a licensed contractor or plumber.

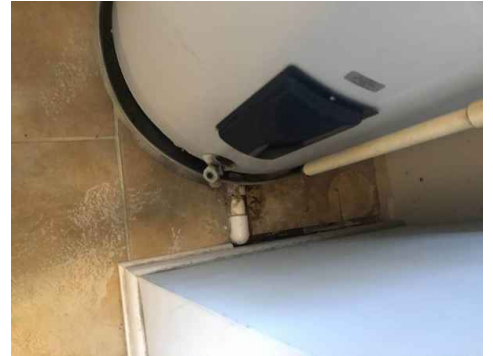
7.3.1 Water Heater

TPR DISCHARGE PIPE: TERMINATION > 6" ABOVE FLOOR- QC

Contact a qualified plumbing contractor.

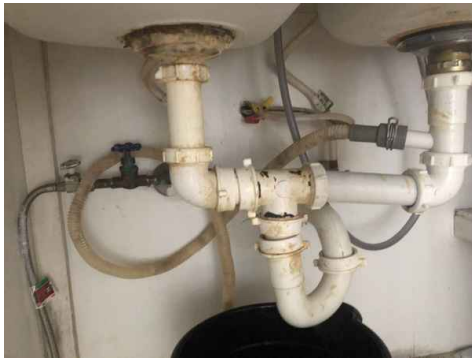
KITCHEN SINK SHOWED SIGNS OF LEAKING INSIDE THE CABINET

Contact a qualified professional.

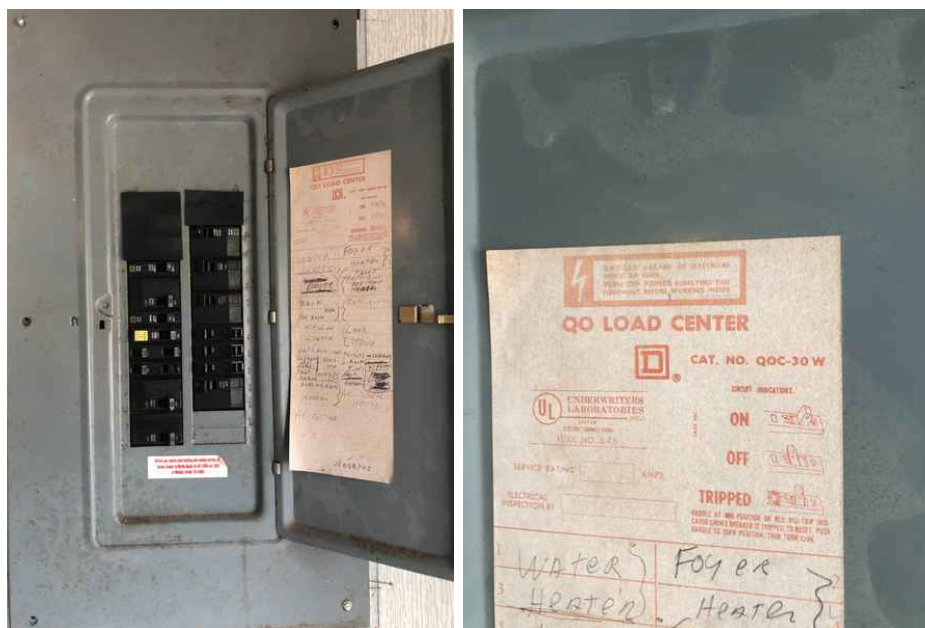
Service Panel: Panel Data Plate

The manufacturer's label for the service panel is shown in the photo.
