EAGLE EYE HOME INSPECTION

RESIDENTIAL REPORT

[REDACTED]
North Myrtle Beach SC 29582

[REDACTED]
JUNE 23, 2021

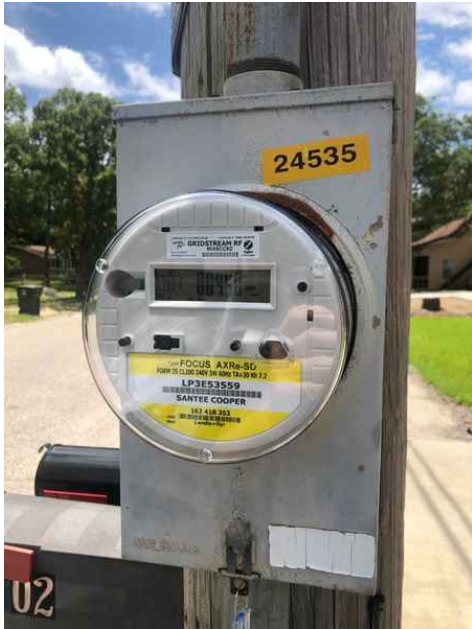
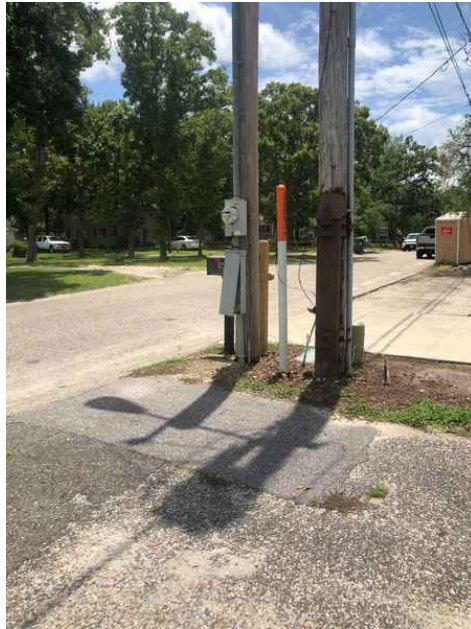
MAIN DISCONNECT PANEL AT METER WILL NOT CLOSE PROPERLY - ALLOWS MOISTURE INTRUSION

The service disconnect for the home was located at the electric meter and panel located on a pole at the edge of the front of the driveway, at the time of inspection. The panel was damaged and would not close properly, allowing for moisture intrusion to occur. This is an electrical safety hazard. Inspector recommends contacting the utility serving the home for further evaluation and repair.

Contact a qualified professional.

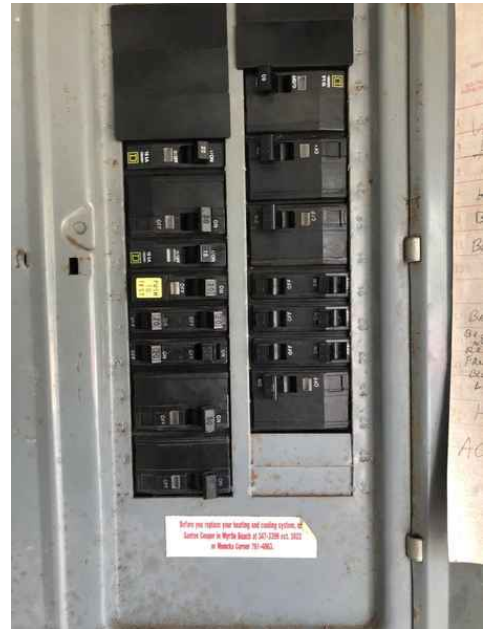
8.5.1 Branch Circuits

AFCI: NONE INSTALLED (BR)- QC

Contact a qualified professional.

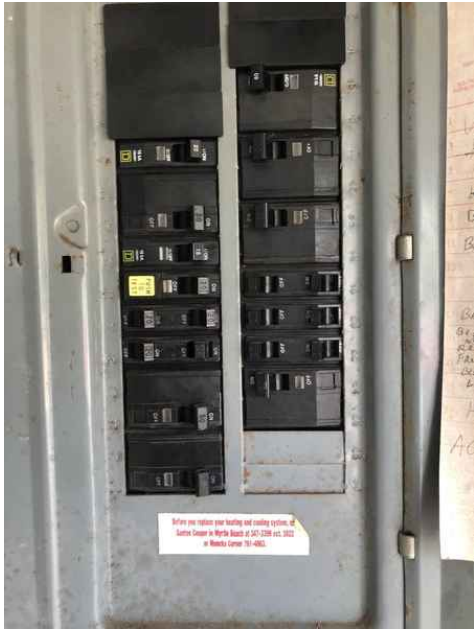
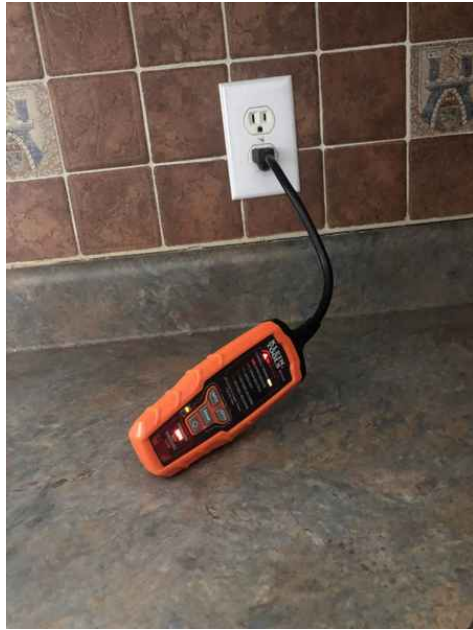
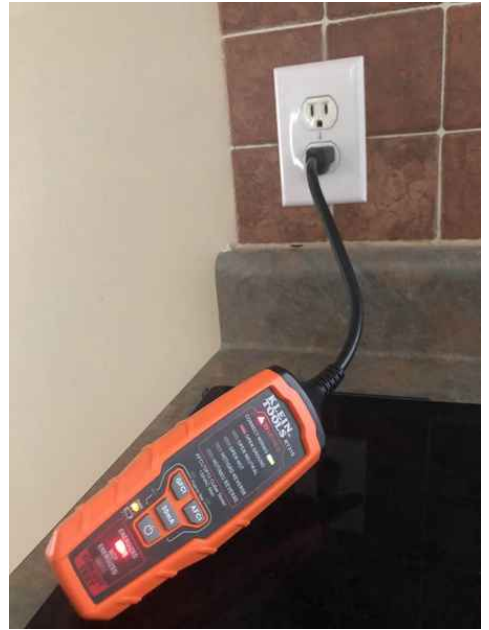
8.5.2 Branch Circuits

GFCI: NONE INSTALLED- QC (SHORT)

Contact a qualified electrical contractor.

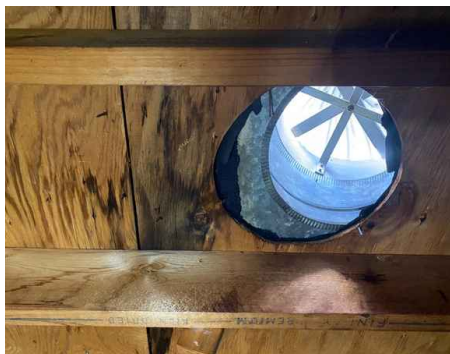
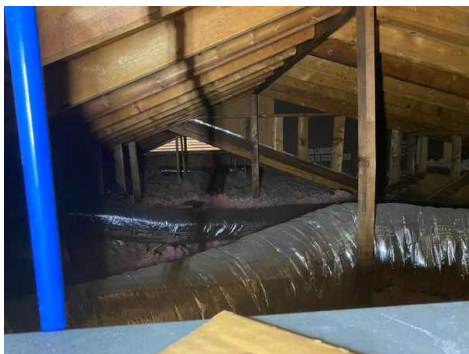
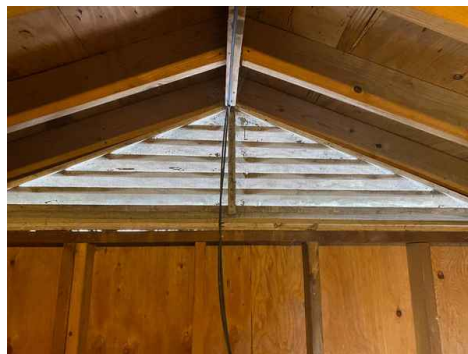
Attic/Roof Structure Ventilation: Gable, Soffit Vent and Roof Vents

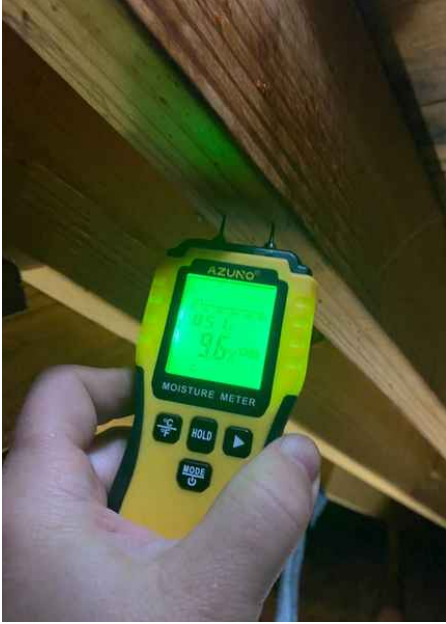
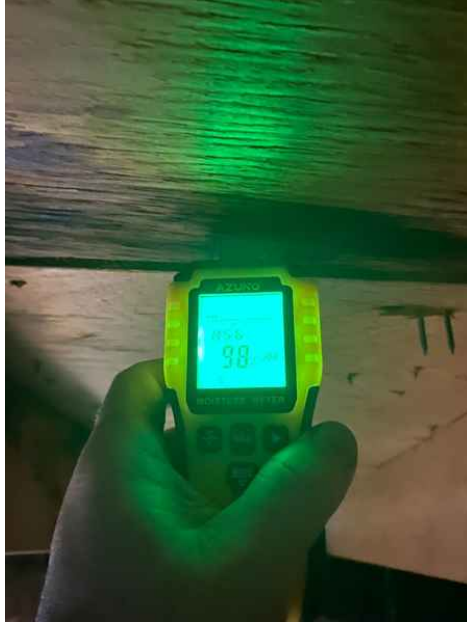
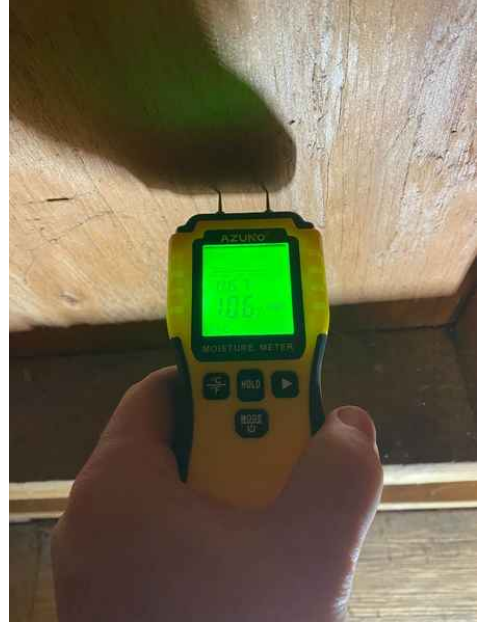
Attic/Roof Structure Ventilation: Roof Sheathing Moisture Readings

All moisture readings for the roof sheathing were normal at the time of inspection.

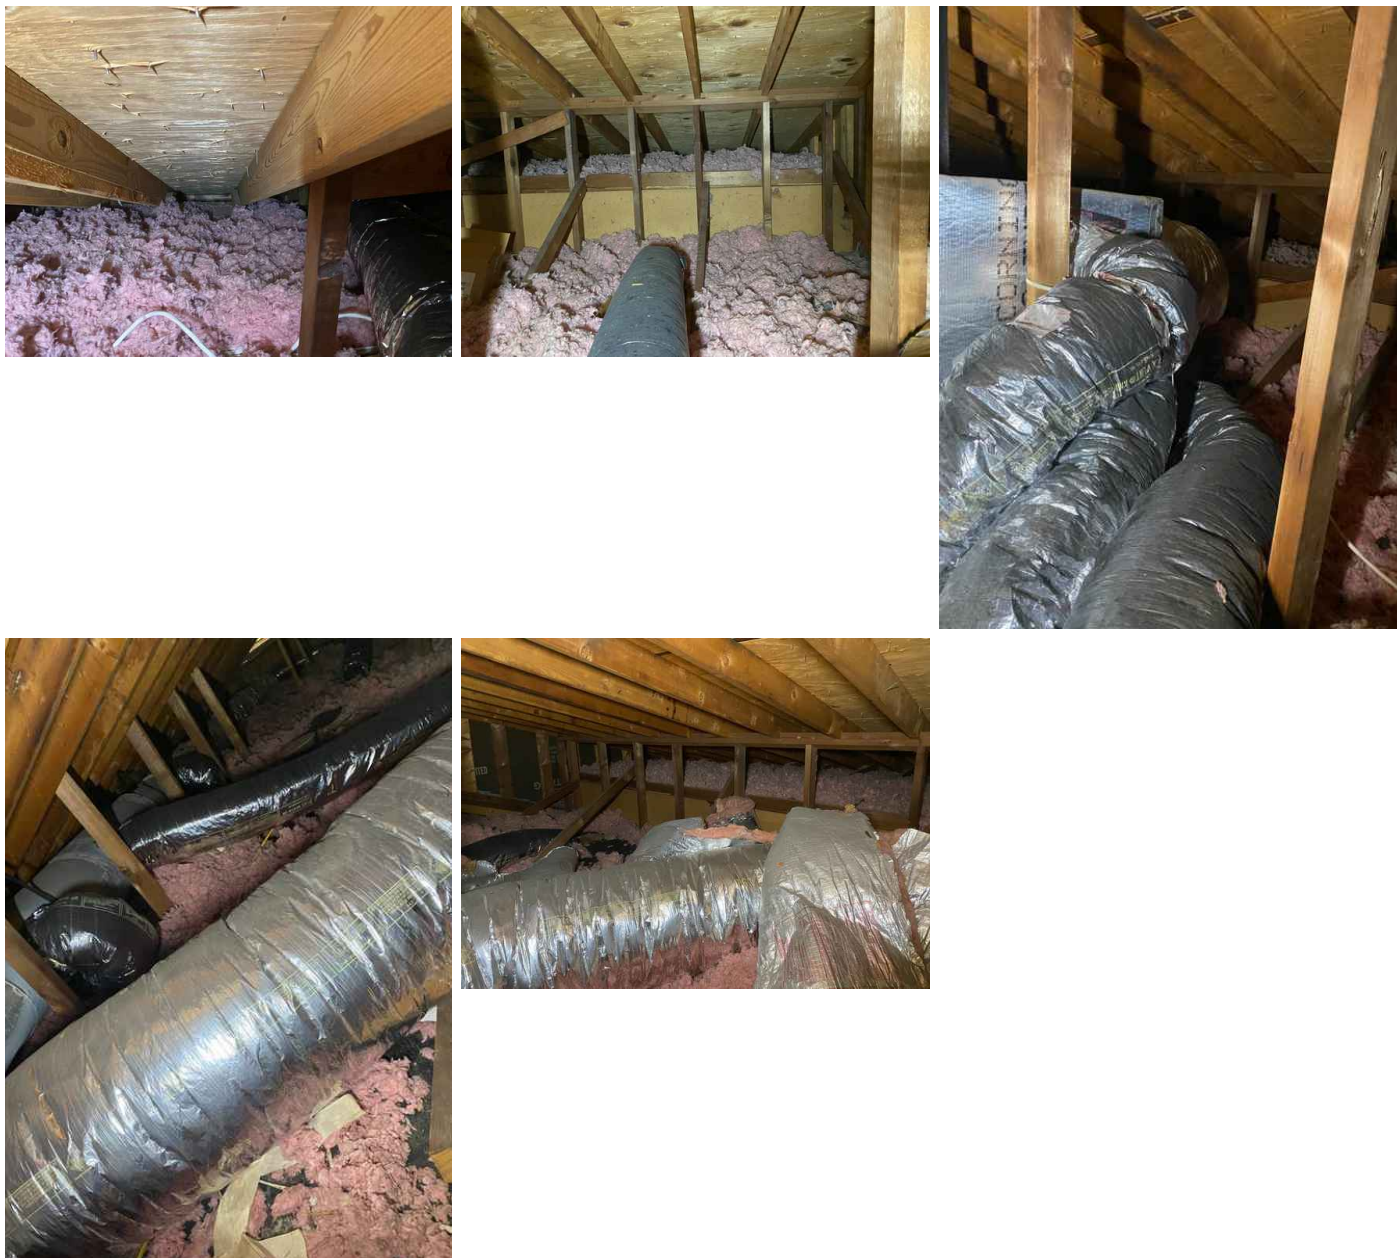
Thermal Insulation: Attic Insulation Pics

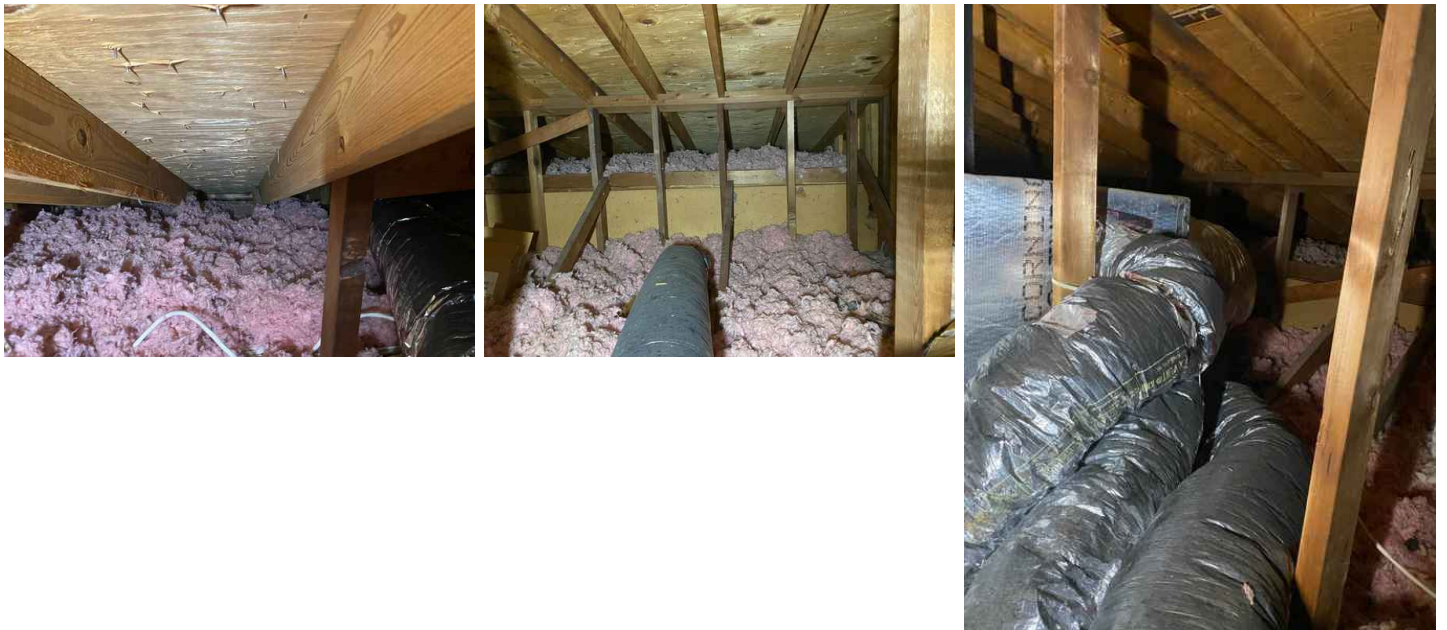
Attic floor insulation depth averaged 6 to 8 inches at the time of inspection. The Inspector recommends installing additional insulation to comply with local energy codes.

Contact a qualified insulation contractor.

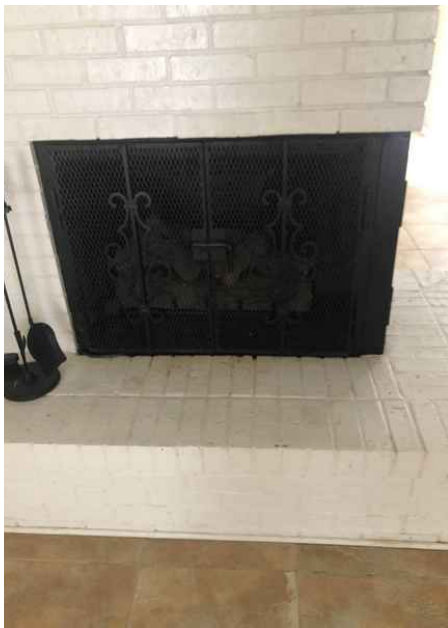
Main Living Area: Chimney and Fireplace Disclaimer

Inspection of the chimney interior, liner, smoke chamber, firebrick, cleanout and damper lies beyond the scope of a home inspection. The inspector recommends consulting with a professional chimney sweep for a thorough inspection of the chimney and related components before using the fireplace.

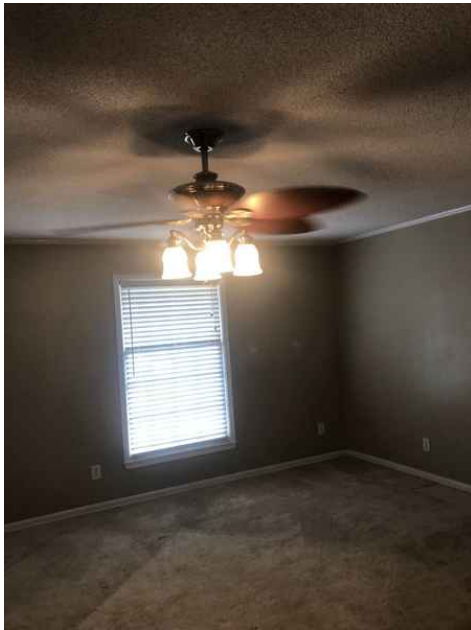
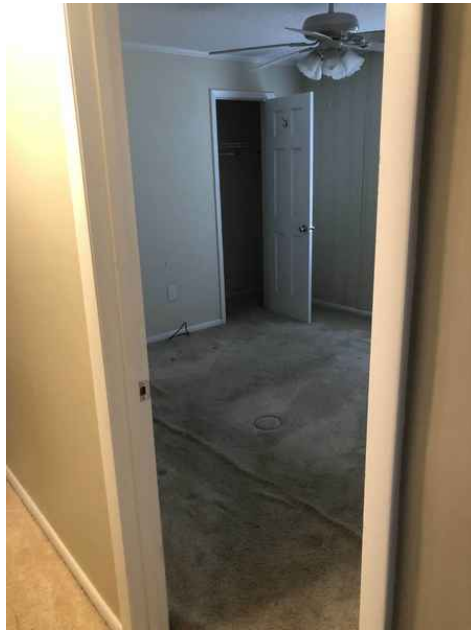
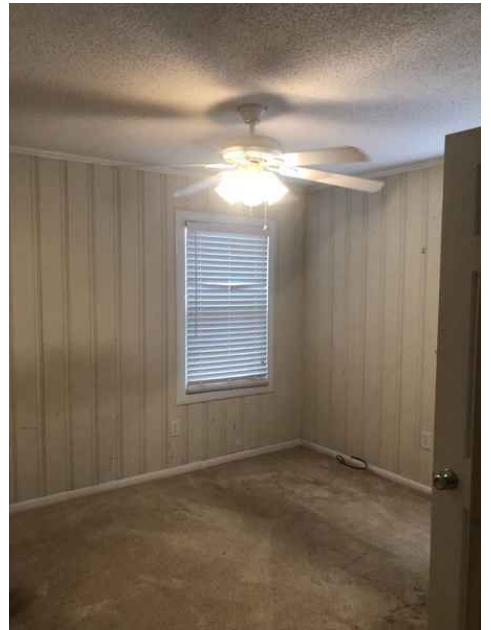
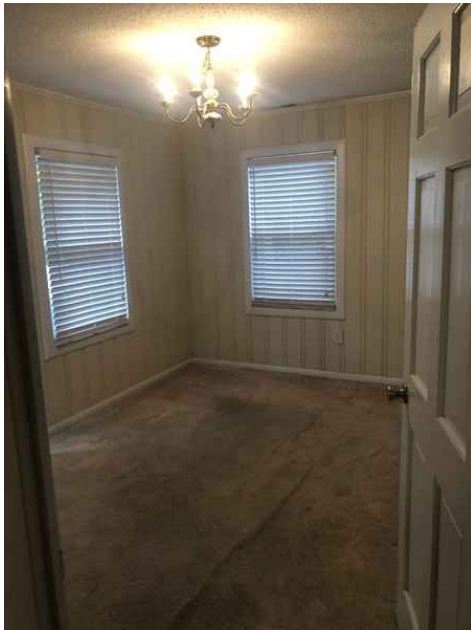
FLOORS: CARPET, STAINS AND DISCOLORATION- QC

Carpet in the bedrooms had areas of staining or discoloration and showed signs of being at the end of their useful life, at the time of inspection.

Contact a qualified flooring contractor

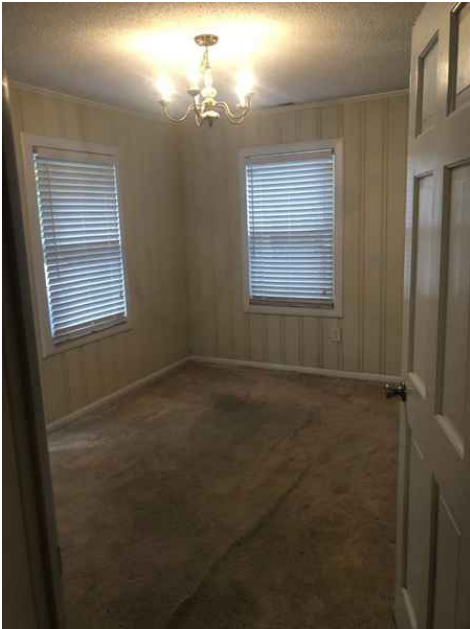
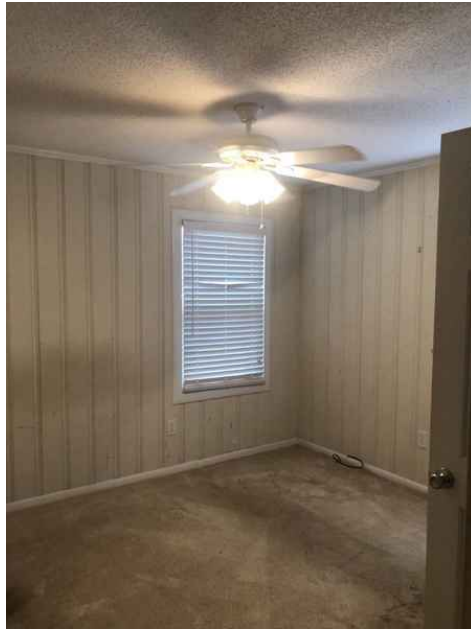
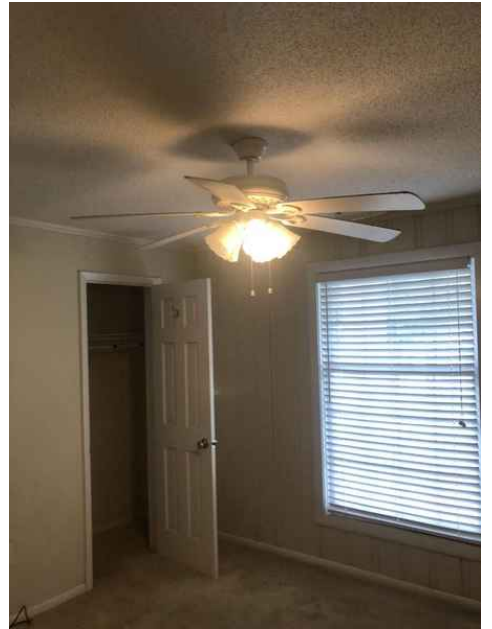
10.2.3 Bedrooms

WINDOWS: DBL HUNG - WOULD NOT OPEN

Contact a qualified window repair/installation contractor.

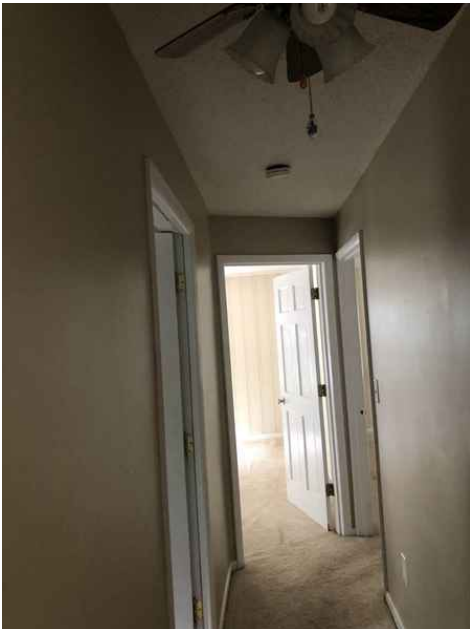
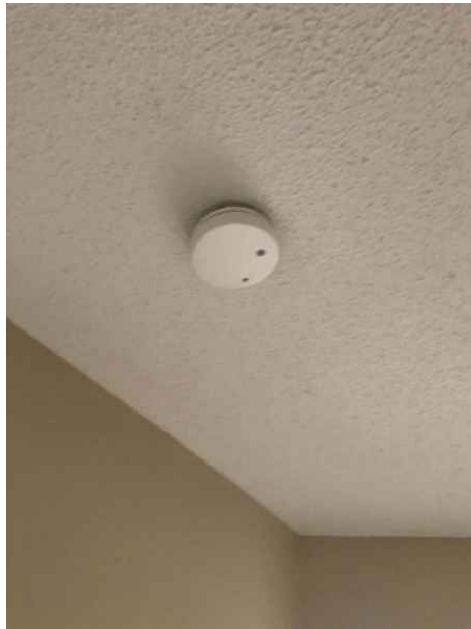
10.3.1 Smoke Detectors

ONE SMOKE DETECTOR FOR ENTIRE FLOOR

Contact a qualified professional.

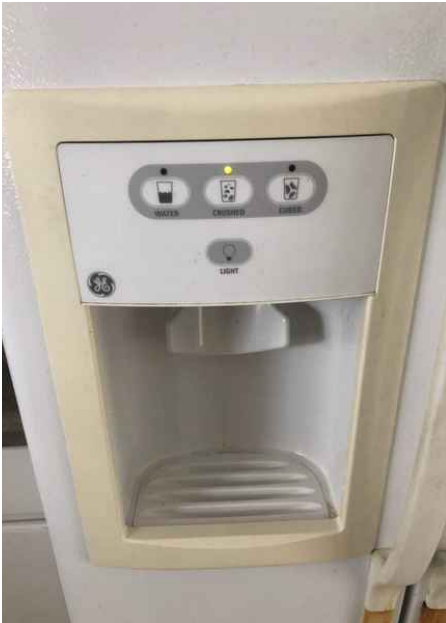
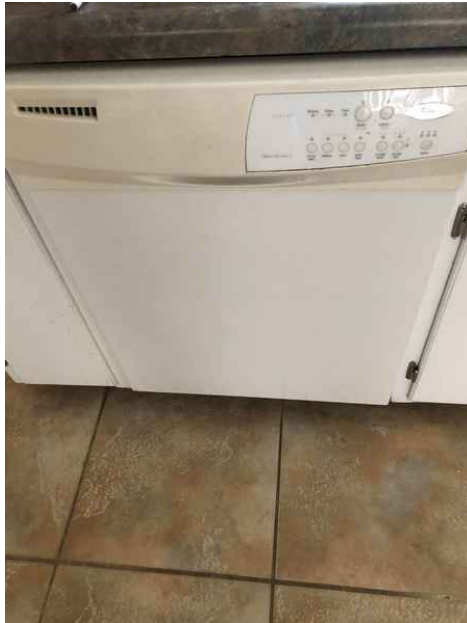
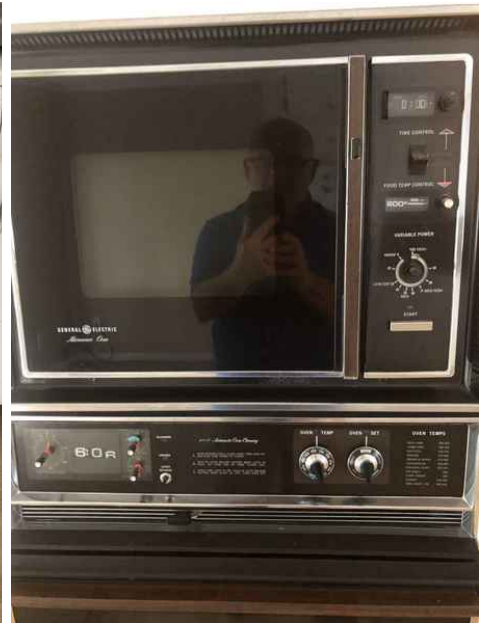
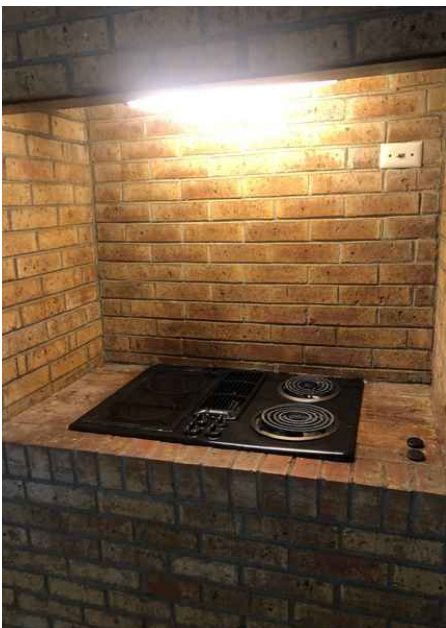
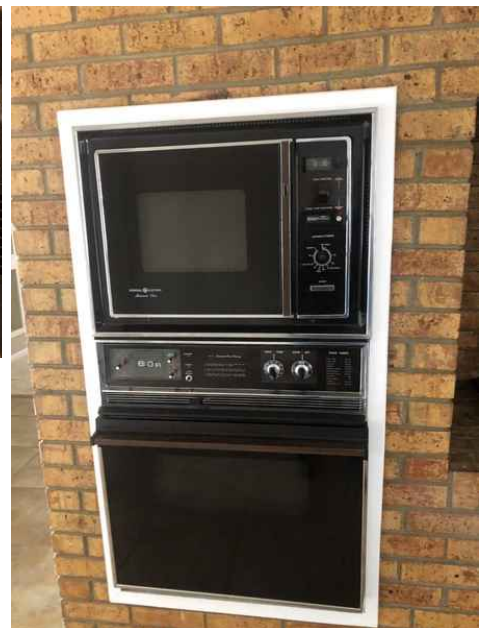
Appliances: Visual Inspection Only

All of the appliances in the kitchen were on at the time of inspection. A visual inspection of the appliances was performed. Inspector has noted that the appliances are nearing or near the end of their life and recommends they be replaced.
