Anthem Council

Level 1 Reserve Study

Report Period - 1/1/2026 to 12/31/2026

Executive Summary - Anthem Council - ID # 11900

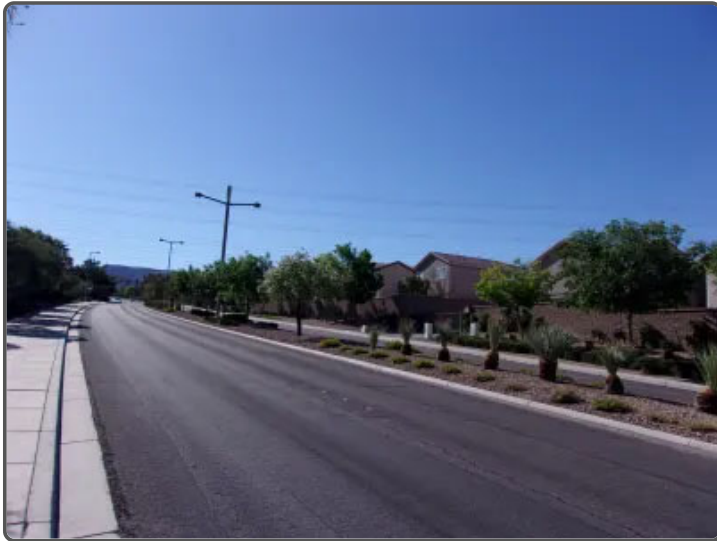
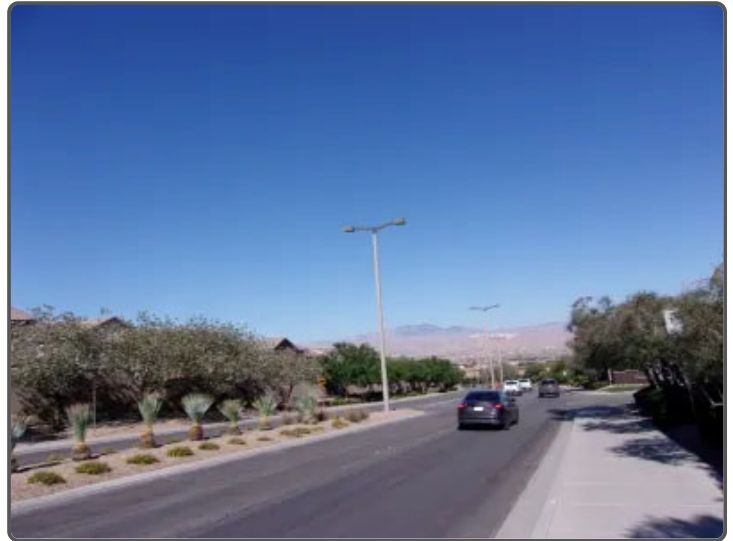
Comp # **403** **Concrete - Repair/Replace**

No expectation to completely replace the concrete surfaces. We recommend making local repairs as necessary as an operating expense and funding to make more significant repairs approximately every 10 years.

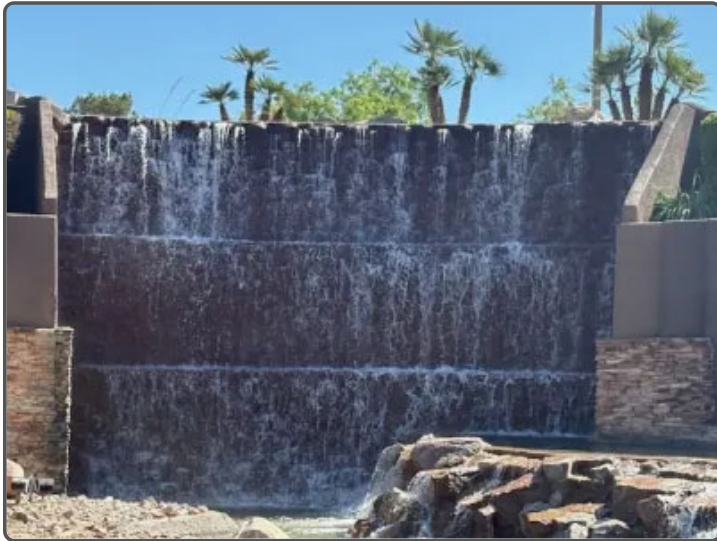
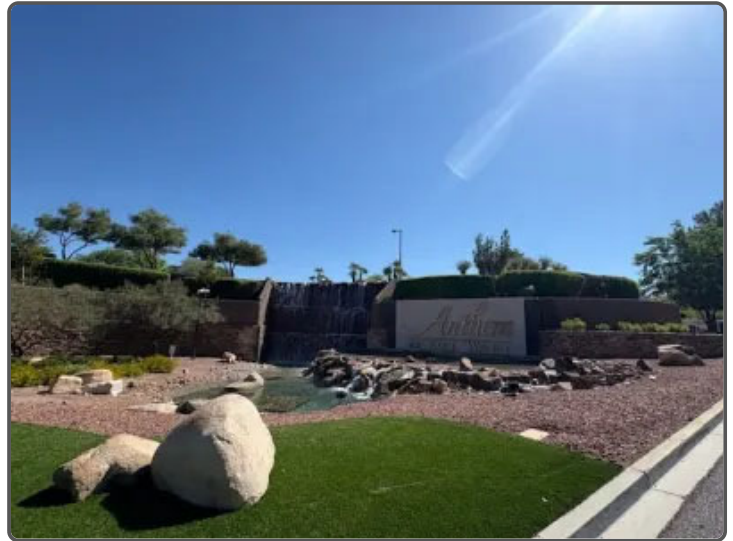
Comp # 801 Monument Signs - Repaint/Refurbish (2025)

We recommend funding to generally refurbish these monument signs approximately every 15 to 20 years to maintain appearance and keep up with current decorative tastes.

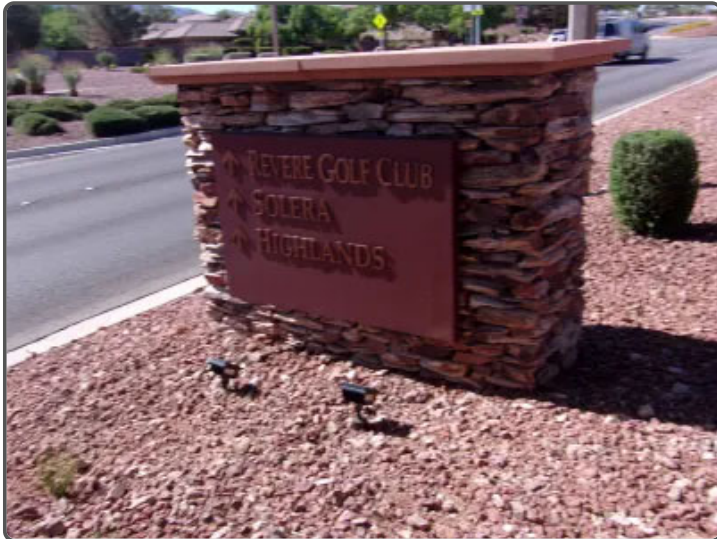
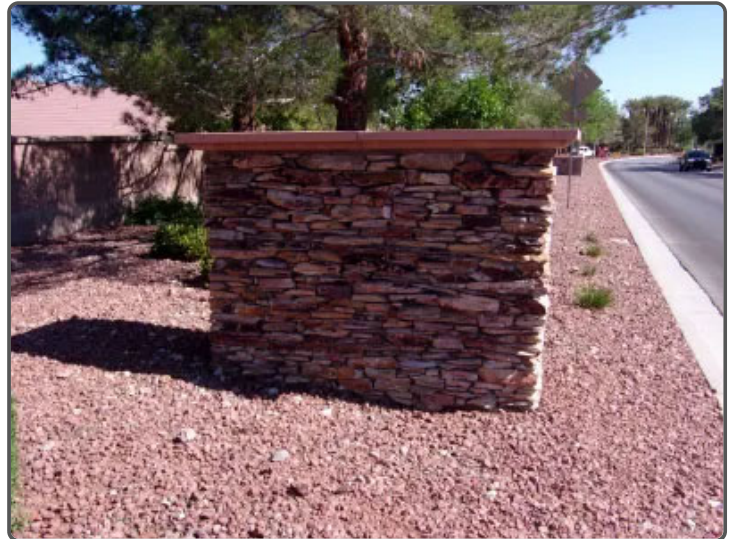
Comp # 805 Direction Signs - Refurbish

We recommend funding to repair and generally refurbish the directional signs approximately every 10 to 12 years to keep up with the appearance throughout the community.

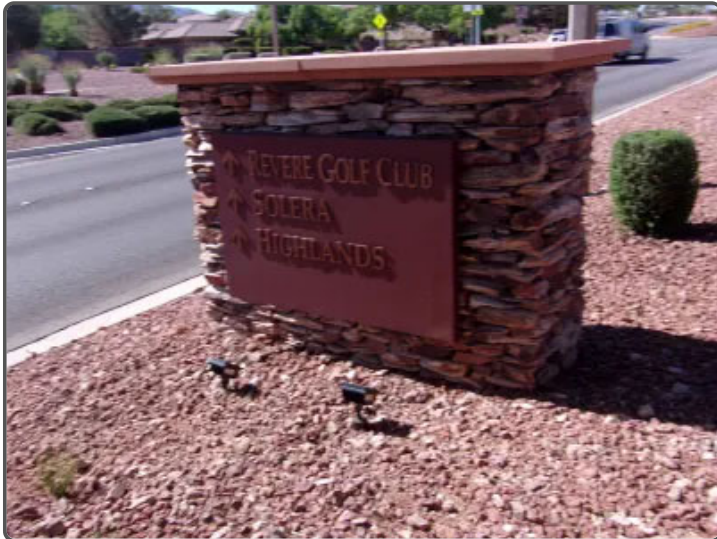
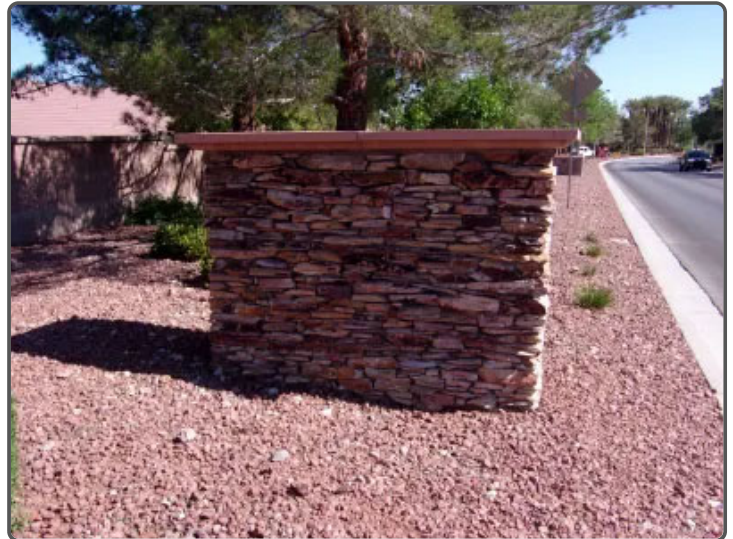
Comp # 806 Direction Signs - Repaint (2025)

We recommend funding to repair and generally refurbish the directional signs approximately every 10 to 12 years to keep up with the appearance throughout the community.

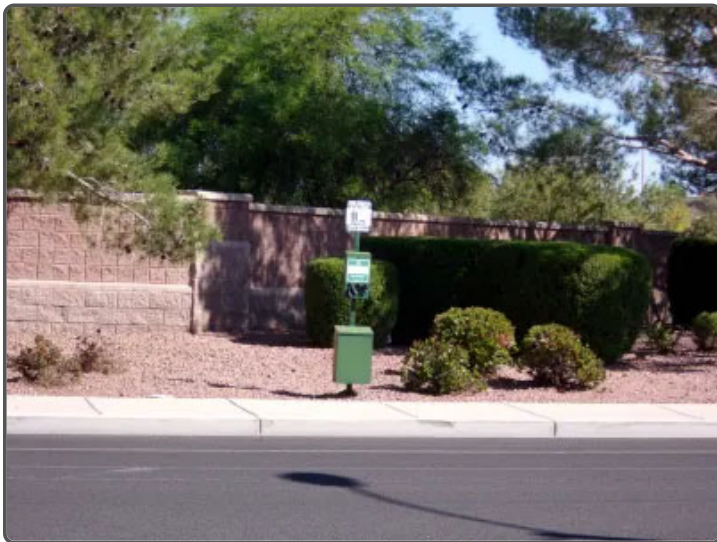
Comp # 890 Pet Waste Station - Replace (Operating Expense)

No problems noted with the pet waste station. Due to the minimal cost to replace this station reserve funding is not appropriate. Expect to replace this station when necessary as an operating expense.

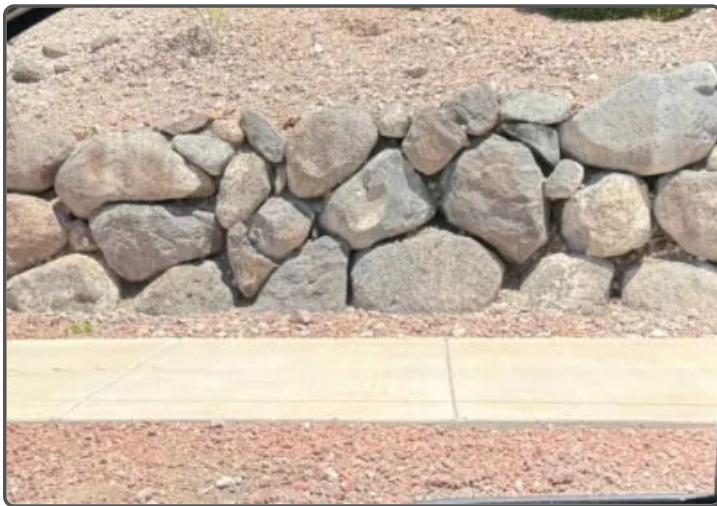
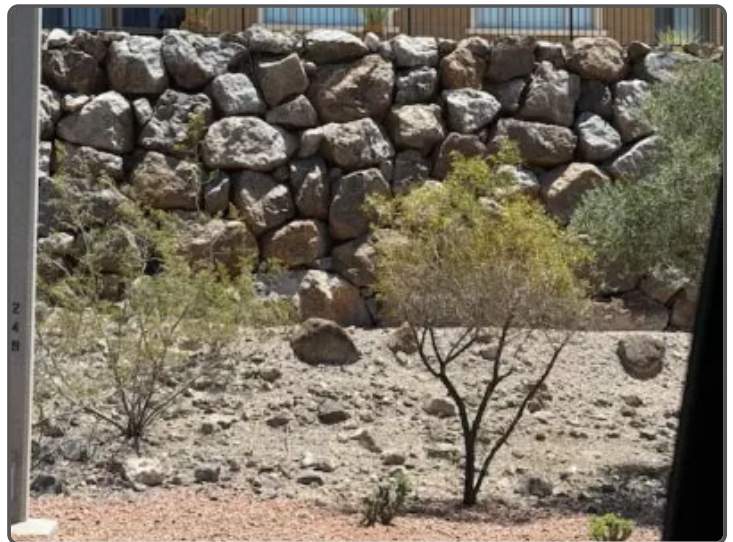
Comp # 1005 **Stone Walls - Repair/Maintain**

No expectation to completely replace block walls. Expect to make local repairs as necessary as an operating expense and funding for an allowance to make more significant repairs approximately every 10 years.

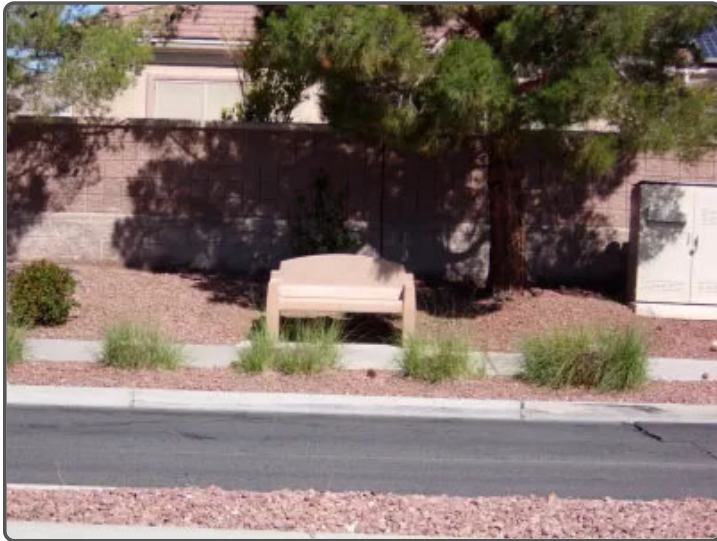
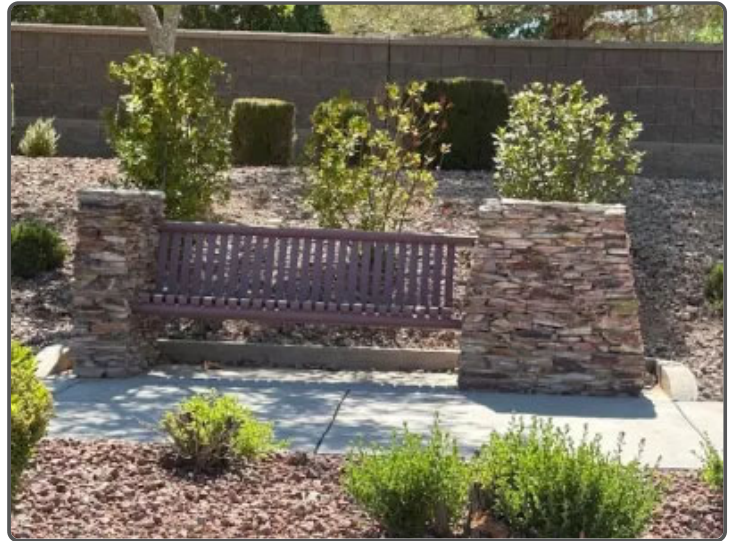
Comp # 1307 **Benches - Replace**

We recommend funding to replace these benches approximately every 20 to 25 years to maintain the appearance of the community.

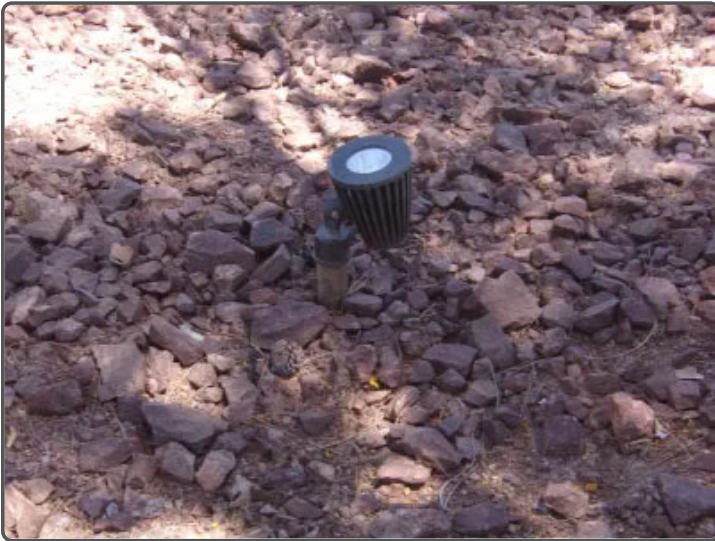
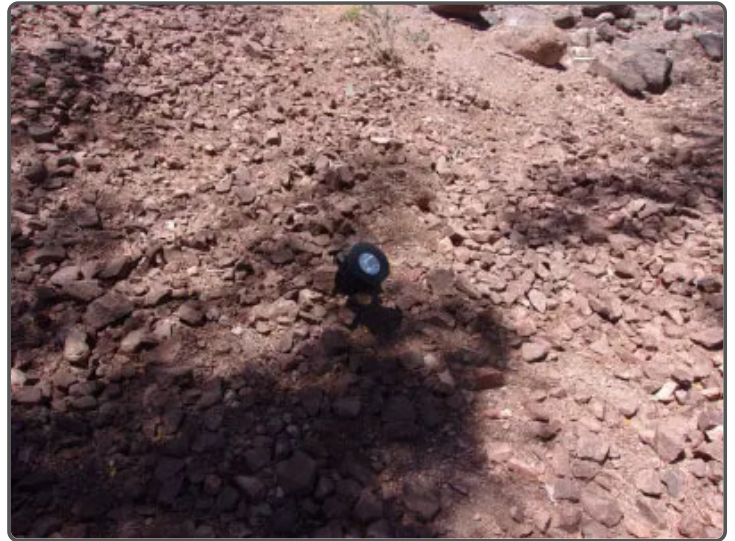
Comp # 1603 Landscaping Tree Lights - Replace

Although these lights may reach an extended life we recommend funding to replace them approximately every 15 to 20 years.

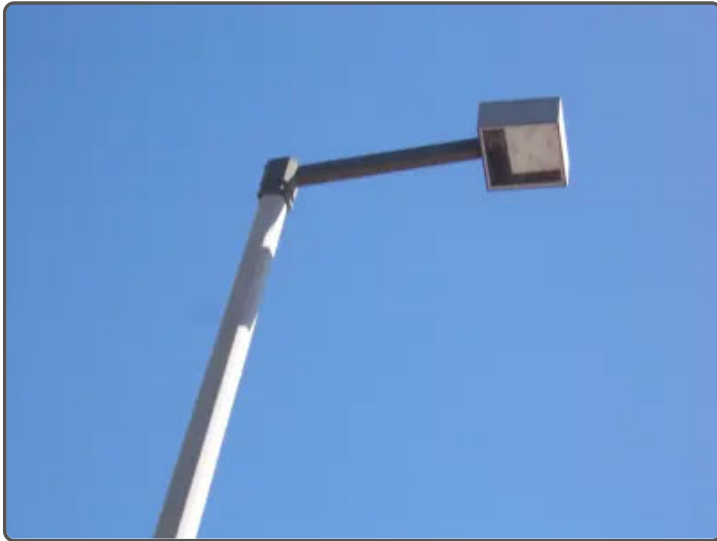
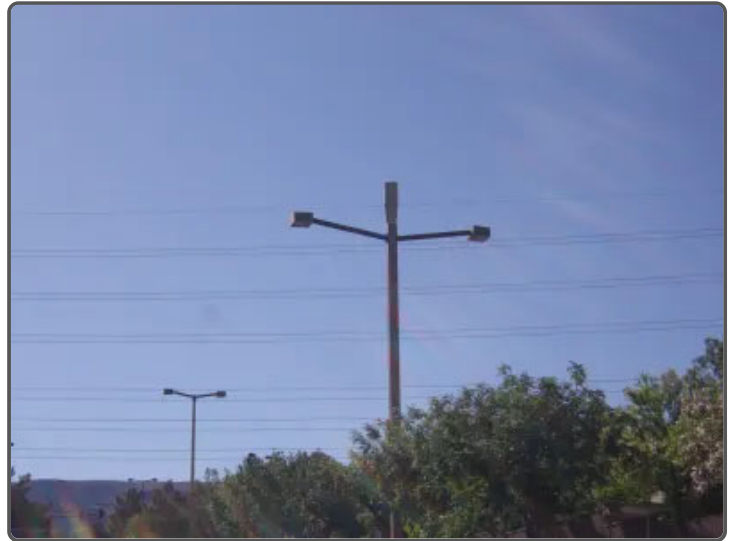
Comp # 1604 **Street Light Poles- Full Replacement**

We are funding to make a full street light pole replacement approximately every 30 years. Remaining useful life provided by client.

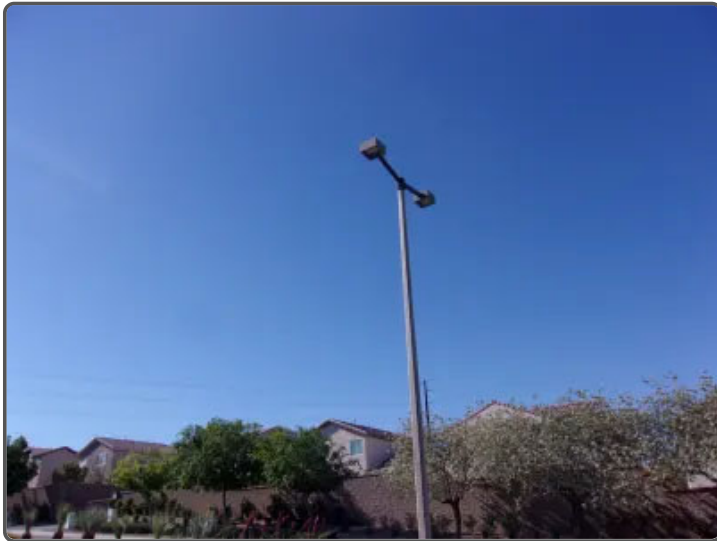
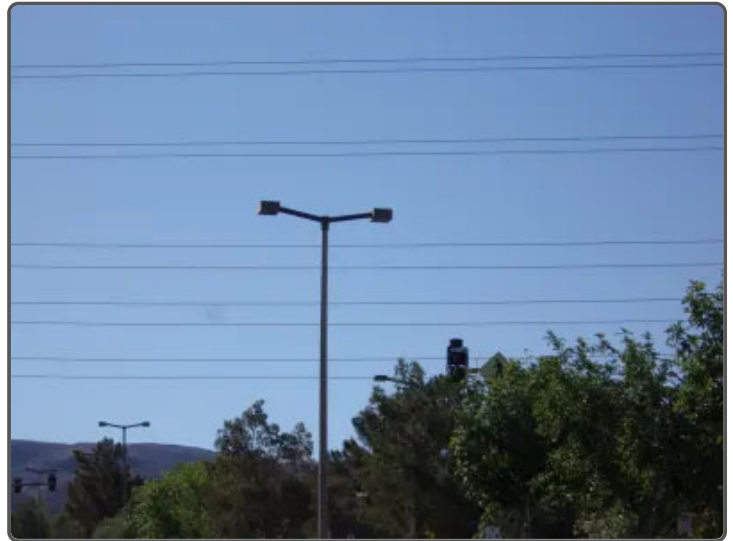
Comp # 1609 Street Light Poles/Fixtures - Partial Replacement

We are generally funding to replace of approximately 10 poles every year.

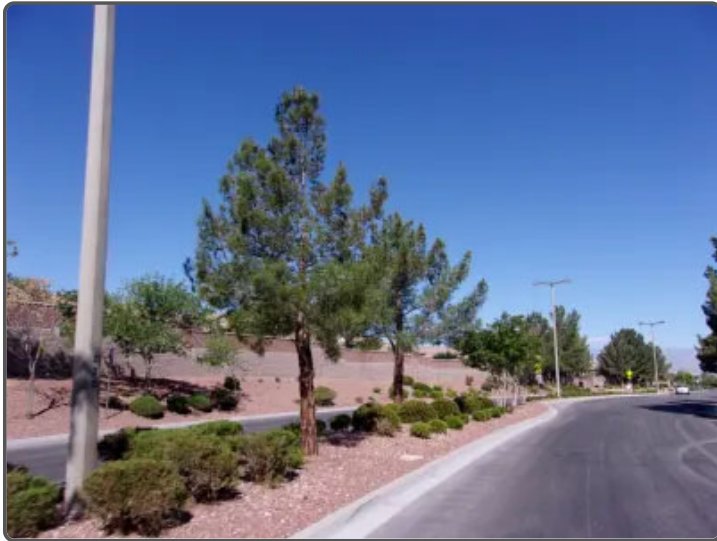
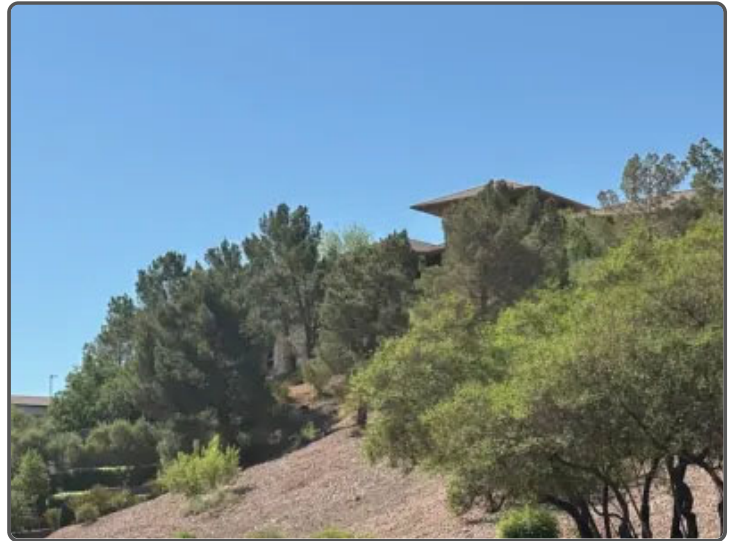
Comp # 1804 **Tree Trimming - Perform (1/3 Annual)**

Trees should be trimmed periodically to maintain appearance and to ensure health of the trees. We are generally funding to trim 1/3 trees annually

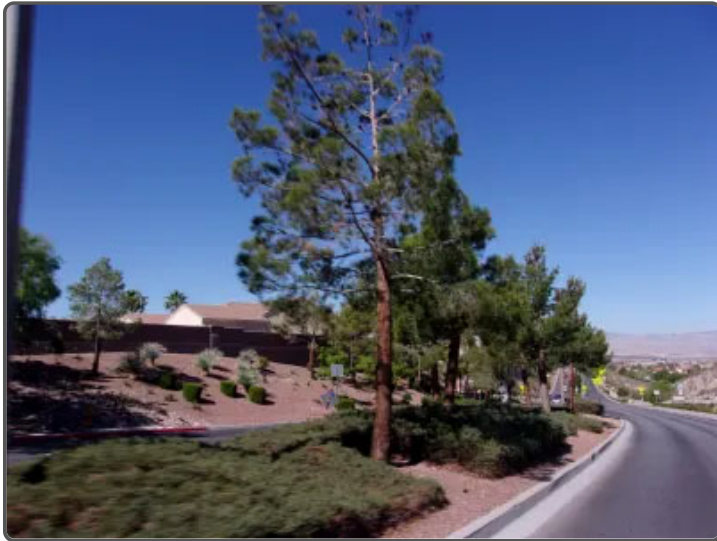
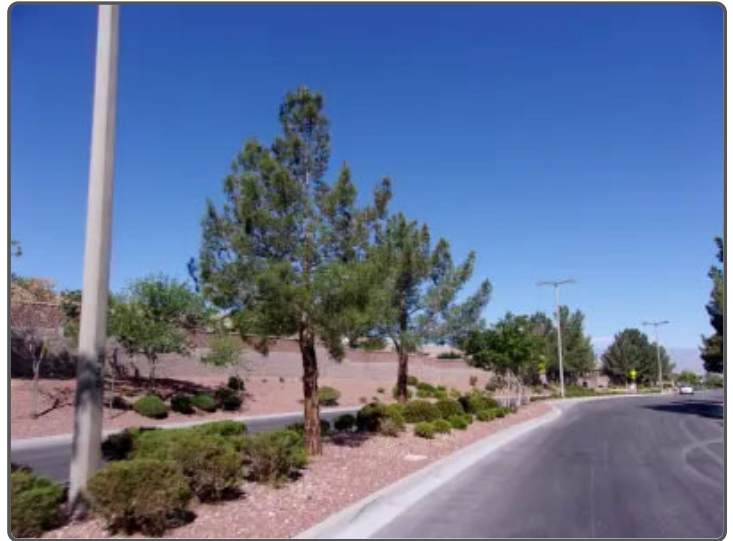
Comp # 1805 Partial Tree - Replacement

Although it is hard to predict when a tree will die, we recommend funding to make replacements as needed approximately every 3 years.

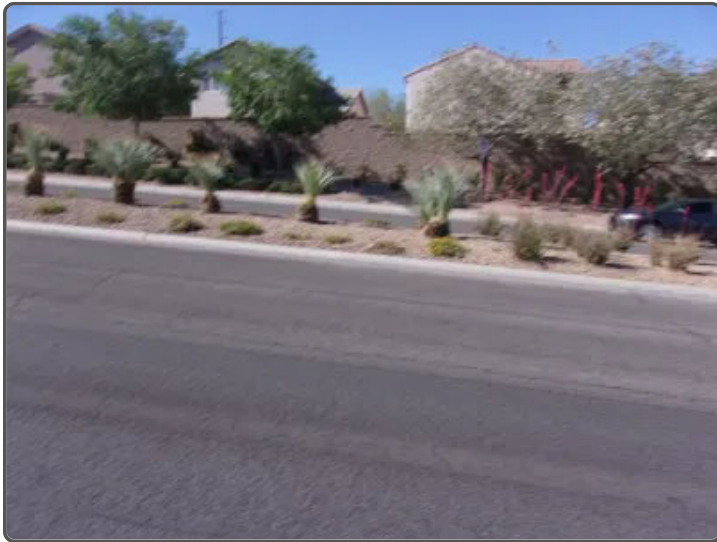
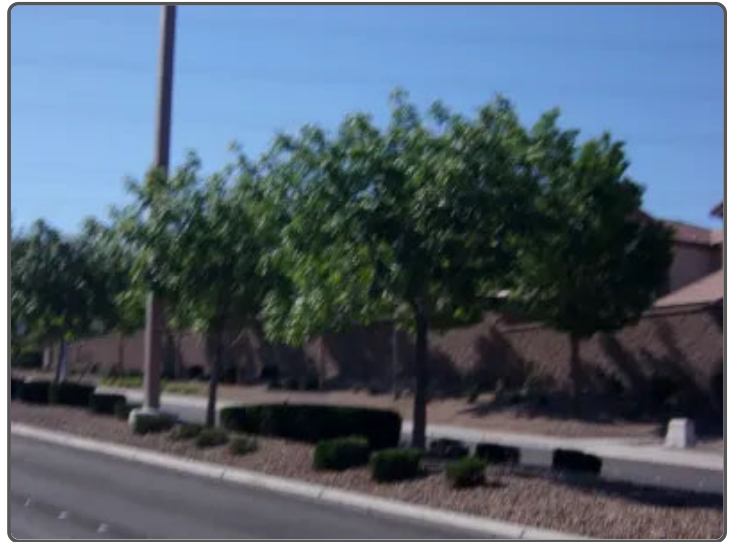
Comp # 1813 Landscaping / Irrigation - Major Renovate (Phase I, Completed 2025)

We are funding an allowance for a major project to the landscaping infrastructure including significant and/or total irrigation replacement approximately every 10 to 15 years. This allowance should be re-evaluated in future Reserve Studies as the community ages and the property develops a history of repairs, landscaping upgrades, etc.

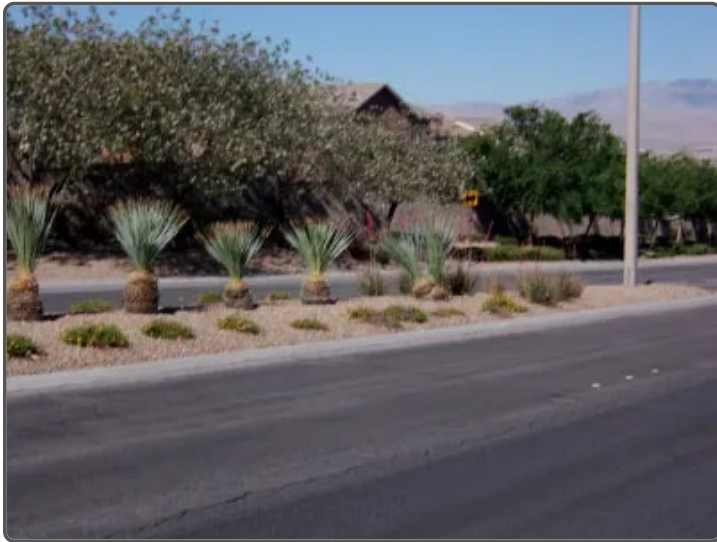
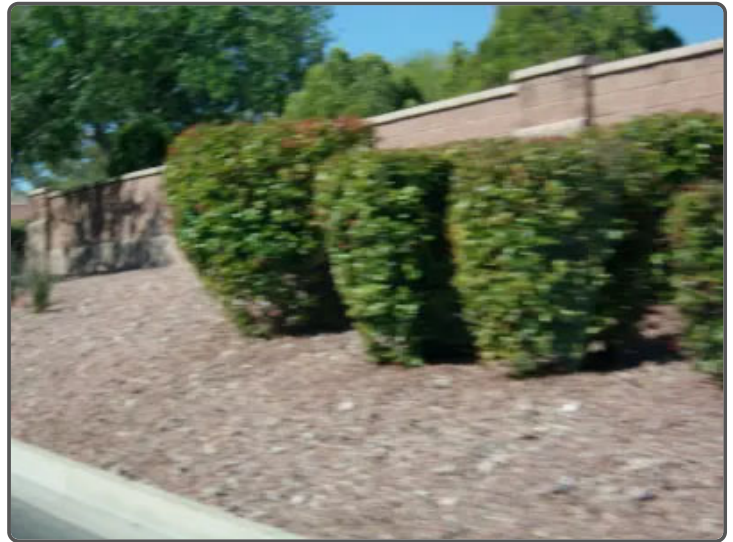
Comp # 1813 Landscaping / Irrigation - Major Renovate (Phase II, 2026)

We are funding an allowance for a major project to the landscaping infrastructure including significant and/or total irrigation replacement approximately every 10 to 15 years. This allowance should be re-evaluated in future Reserve Studies as the community ages and the property develops a history of repairs, landscaping upgrades, etc.

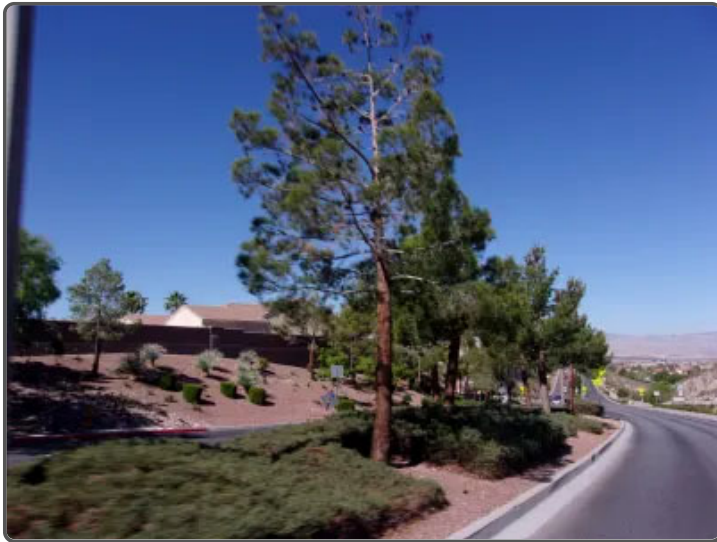
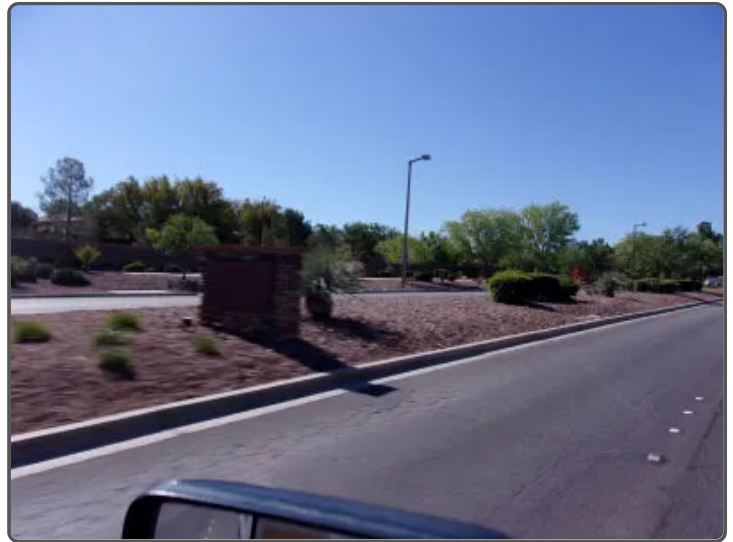
Comp # 1813 Landscaping / Irrigation - Major Renovate (Phase III, 2027)

We are funding an allowance for a major project to the landscaping infrastructure including significant and/or total irrigation replacement approximately every 10 to 15 years. This allowance should be re-evaluated in future Reserve Studies as the community ages and the property develops a history of repairs, landscaping upgrades, etc.

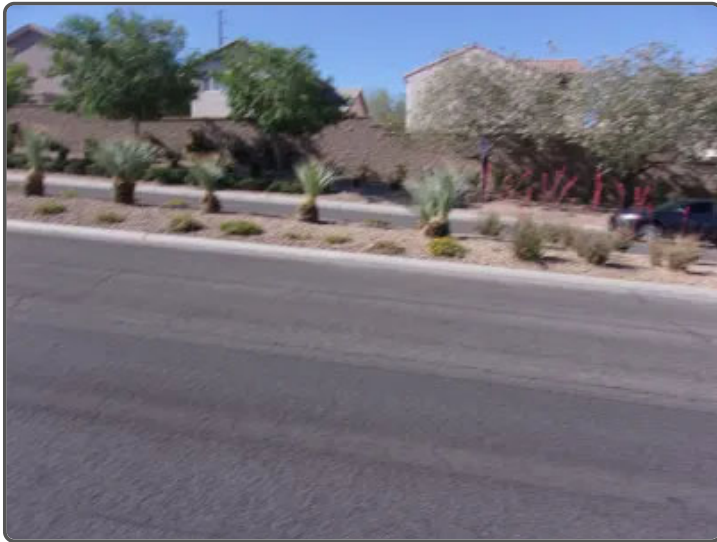
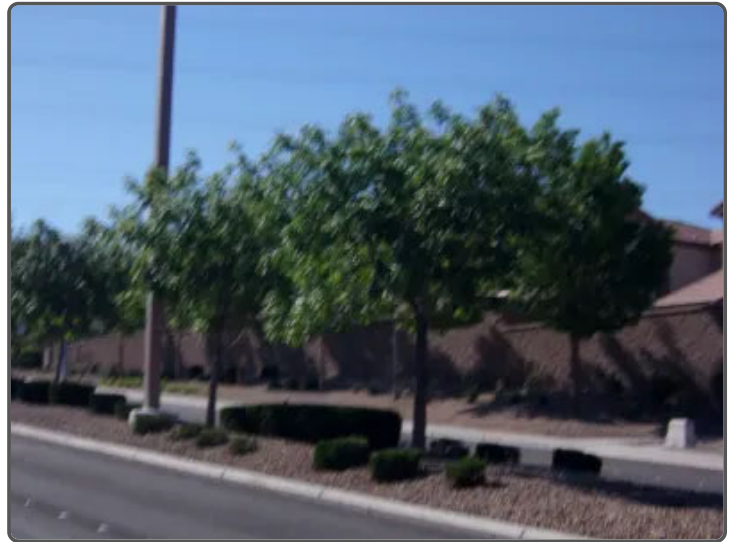
Comp # 1813 Landscaping / Irrigation - Major Renovate (Phase IV, 2028)

We are funding an allowance for a major project to the landscaping infrastructure including significant and/or total irrigation replacement approximately every 10 to 15 years. This allowance should be re-evaluated in future Reserve Studies as the community ages and the property develops a history of repairs, landscaping upgrades, etc.

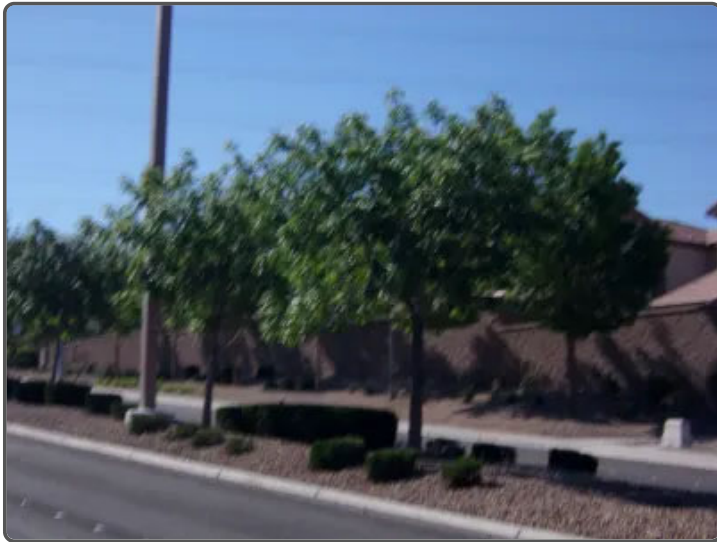
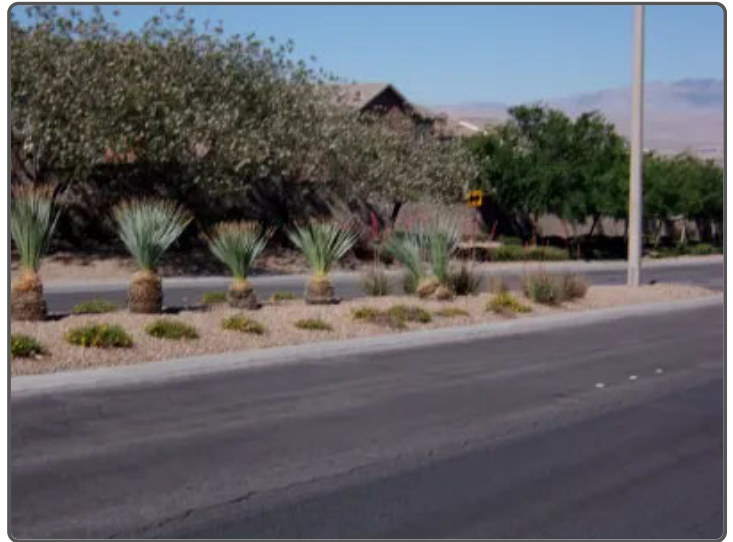
Comp # 1814 **Landscaping / Irrigation - Minor Renovate**

No expectation to completely re-landscape the community. We recommend funding for an allowance to make repairs to the irrigation system, landscape lighting, rock replenishment, and to generally renovate the landscaping approximately every 2 years.

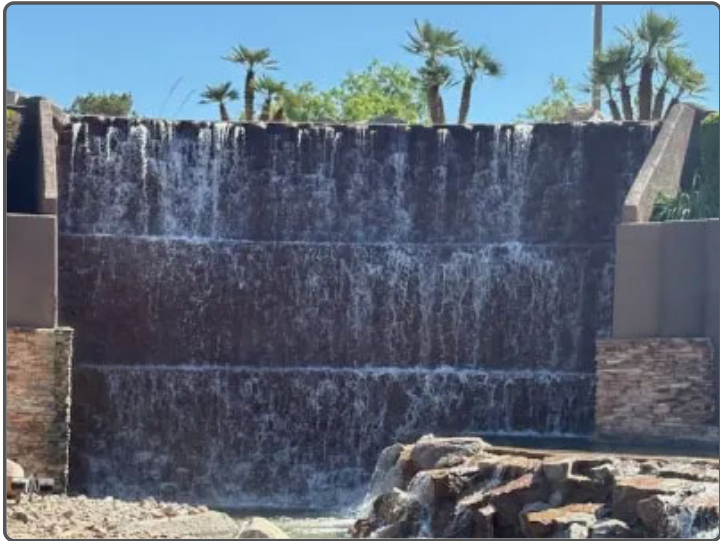
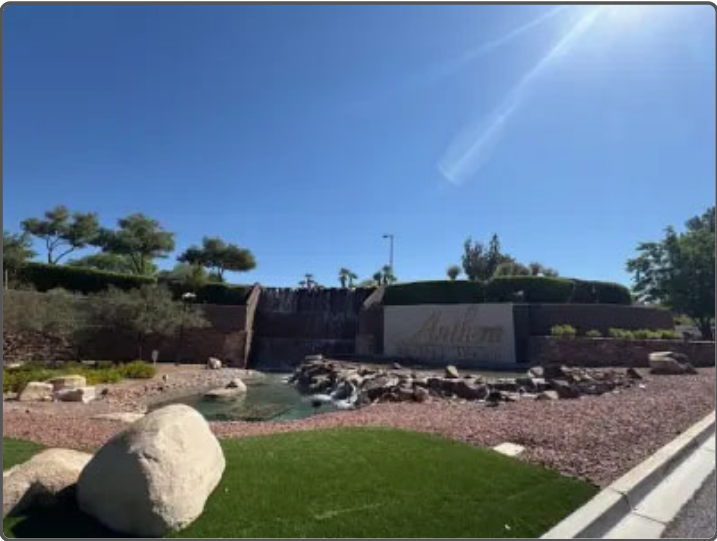
Comp # 2201 Water Features - Major Refurbish

Although these features have a relatively long life, we recommend funding to refurbish and repair them approximately every 20 to 25 years to ensure proper function and appearance.

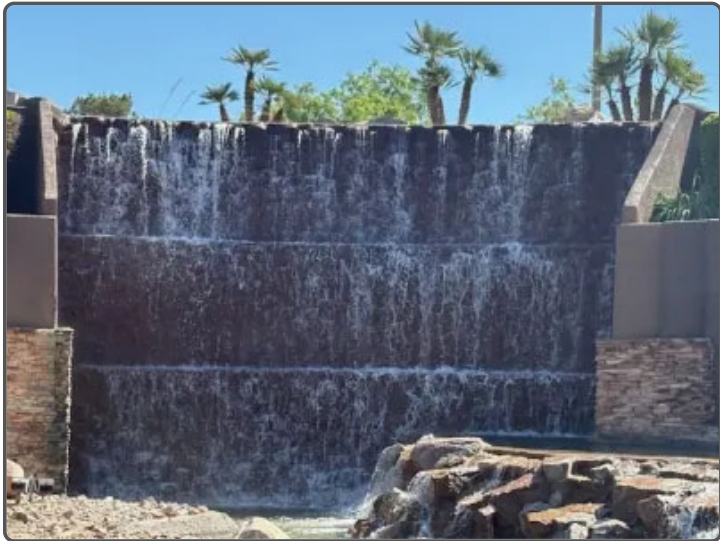
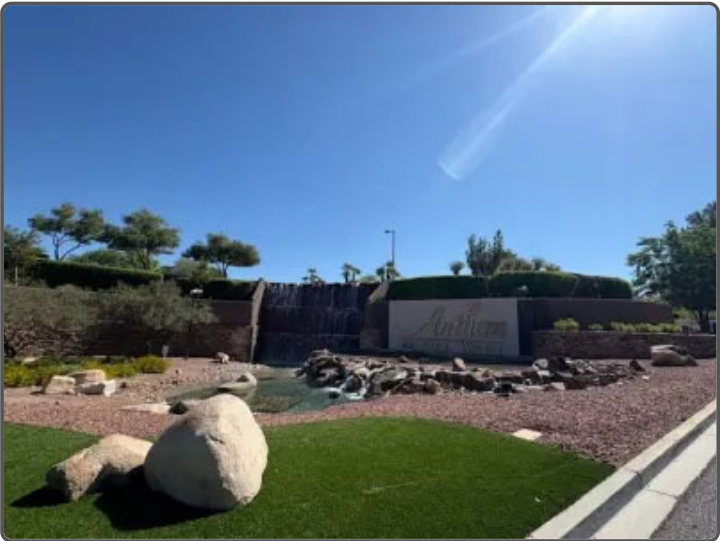
Comp # 2201 Water Features - Minor Refurbish

We are generally funding to make minor repairs and maintenance to the water features approximately every 2 to 4 years.

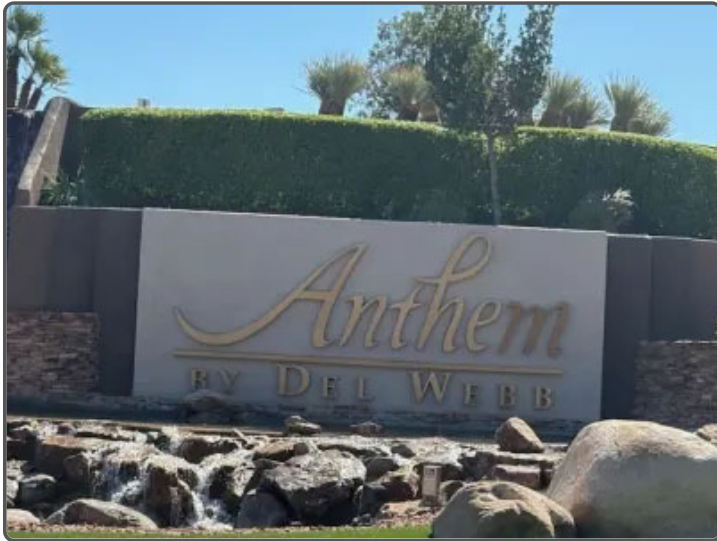
Comp # 2207 Fountain Lights - Replace

No access at time of site visit. We recommend funding to replace these fountain light fixtures approximately every 13 to 15 years to maintain appearance and ensure proper function.
