LOCATION: NOTTINGHAM, PA

PROJECT: DAIRY

COMPLETION DATE: MAY 2021

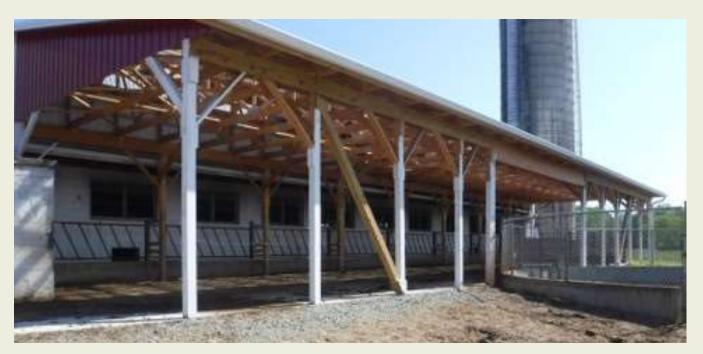
AFTER

- Riparian Forest Buffer and Streambank Fencing Absorb nutrient and sediment runoff, shade stream and cool water temperatures, stabilize streambanks, provides wildlife habitat.
- Off Stream Watering Facilities Keep livestock out of stream for watering purposes.
- Stabilized Access Road Reduce erosion on high traffic areas.
- Silage Leachate Collection Reduce nutrient laden runoff into surface waters.
- **Roofed Barnyard** Eliminate precipitation from coming in contact with manure and generating nutrient runoff.
