ACCURATE PANEL SYSTEMS TEST REPORT

SCOPE OF WORK CAN/ULC S134, STANDARD METHOD OF FIRE TESTS OF EXTERIOR WALL ASSEMBLIES

REPORT NUMBER G104472572-SAT-005 R0

TEST REPORT FOR ACCURATE PANEL SYSTEMS

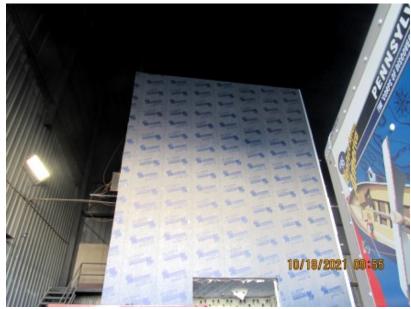
Photo No. 1 Weather barrier installed

The concrete base wall was sheathed with one layer of 1/2 in. thick type X gypsum sheathing. SOPRASEAL[®] STICK VP weather barrier was applied to the surface of the gypsum sheathing by sheets with adhesive backing. 4 in. long, 16GA stainless steel APS clips were then installed to the vapor barrier using Hilti KH-EZ 1/4x1 - 7/8 in. long concrete anchors, using two fasteners per APS clip. A single layer of 4-in. Rockwool mineral wool of 6.2 pcf outer density, and 4.1 pcf inner density, was then installed to make a friction fit between the APS clips. 16GA, 1 in. x 2 in. vertical angle at nominal 16 in. oc was fastened to the APS clips using $\frac{1}{4}$ #14x1 410 stainless steel TEK screws with xylan coating. Using #10-16x1 pan head Tek screws with Ruspert coating, APS Parapet clips were then installed to the vertical angle at 16 in. oc.

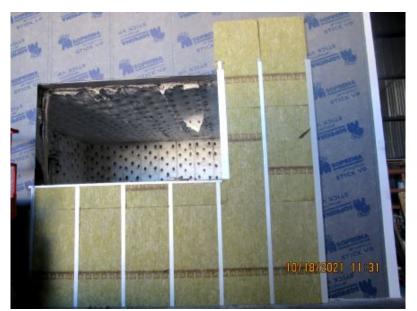
Photo No. 2 Installation of insulation

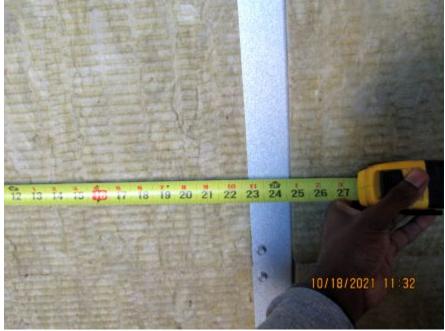
Photo No. 3 Vertical Angle Spacing

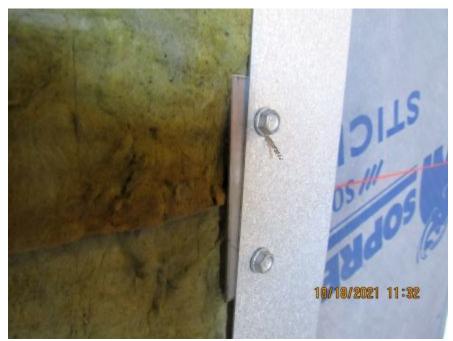
Photo No. 4 Vertical Angle attachment

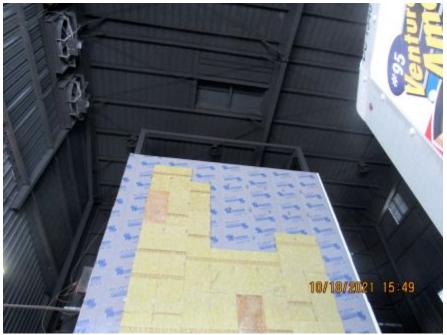
Photo No. 5 Installation of mineral wool

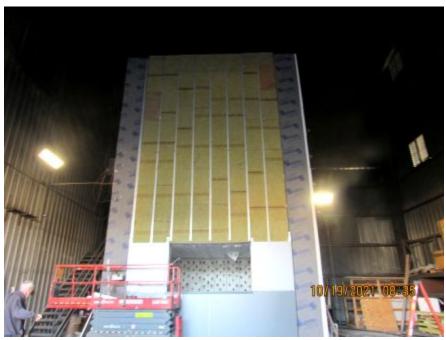
Photo No. 6 Installation of panels

The 4mm Alucoil[®] FR Black ACM panels were installed to the APS parapet clips using APS Framing Extrusions.

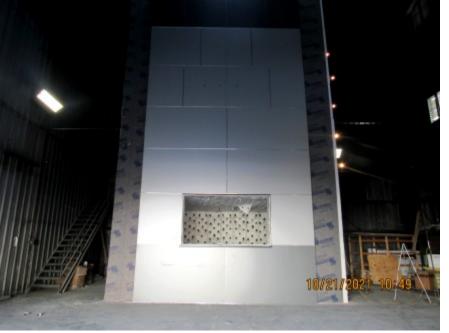
Photo No. 7 Wall installation complete

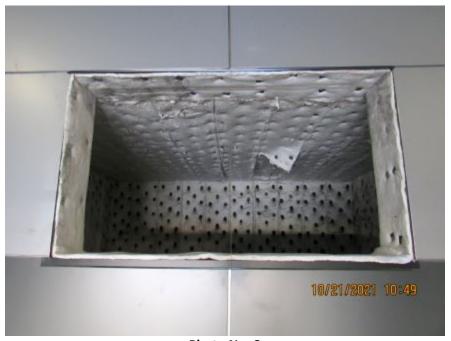
Photo No. 8 Window opening pre-test

The window opening jambs, sill and header were lined with 16GA steel flashing, width of 10 in. with 1 in. thick ceramic fiber blanket.

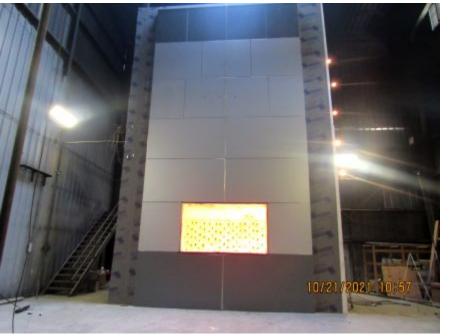
Photo No. 9 Start of test

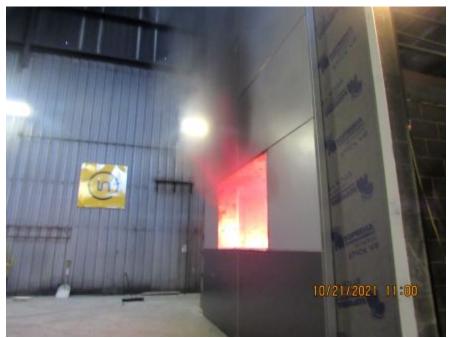
Photo No. 10 Flames exiting window opening

| FIRE-RESISTANCE TEST OBSERVATIONS | | |
|---|--|--|
| 03:20 | Flame tips coming out of window opening | |

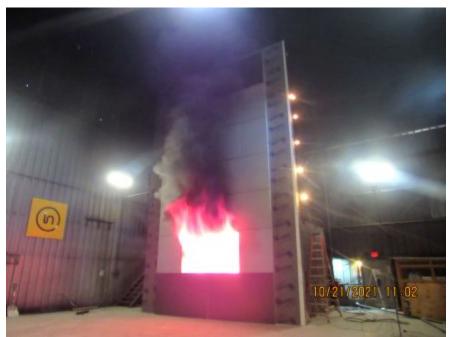
Photo No. 11 Flame height at 2 meters

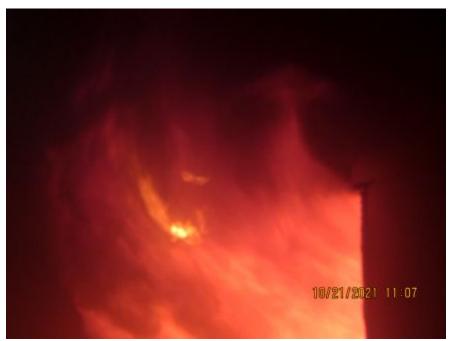
Photo No. 12 Flaming at window header

| FIRE-RESISTANCE TEST OBSERVATIONS | | |
|---|--|--|
| 07:53 | Flaming at header in center | |
| 16:30 | Flaming along length of header | |

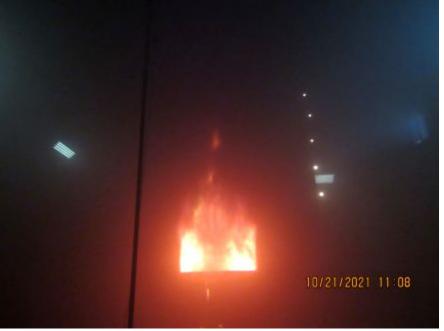
Photo No. 13 Flame up center to 4 meters

Data for the three radiometers installed at the 3.5 m height above the window is listed in the table below. The maximum flame spread observed above the window opening was 4 m. The maximum average heat flux determined as required by the standard was 26.7 kW/m².

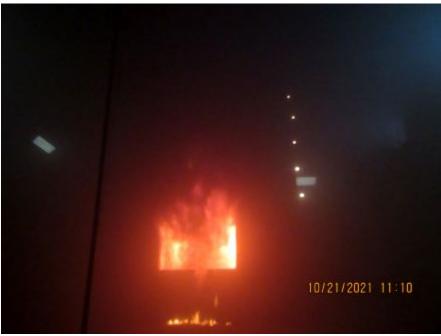
Photo No. 14 Debris falling

| FIRE-RESISTANCE TEST OBSERVATIONS | | |
|---|--|--|
| 12:12 | Debris falling | |

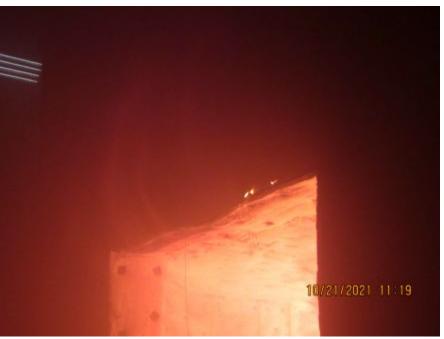
Photo No. 15 Gas decreased

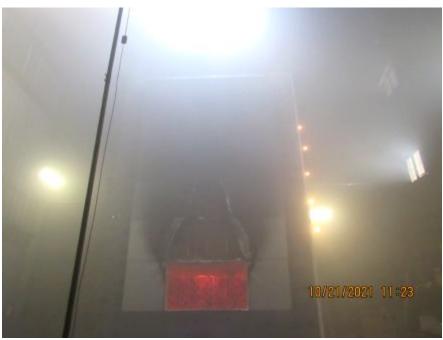
Photo No. 16 Gas off

| FIRE-RESISTANCE TEST OBSERVATIONS | | |
|---|--|--|
| 25:00 | Gas off, no residual flaming seen | |

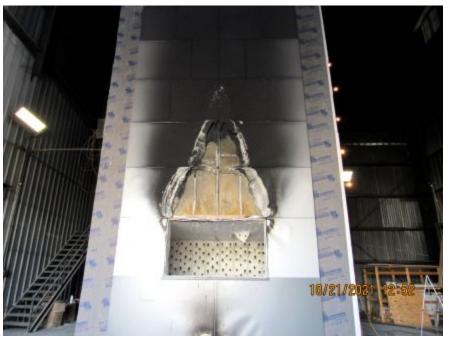
Photo No. 17 Post-test

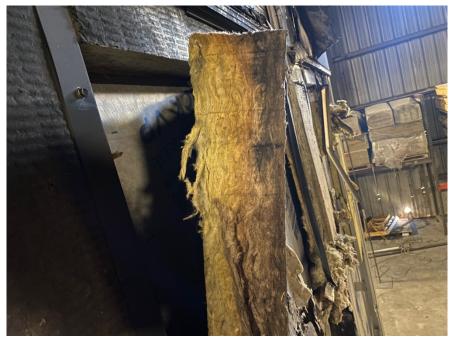
Photo No. 18 Mineral wool char

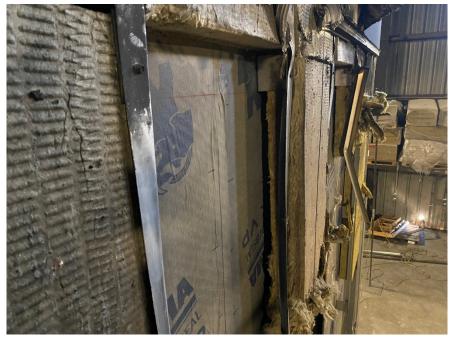
Photo No. 19 WRB post-test

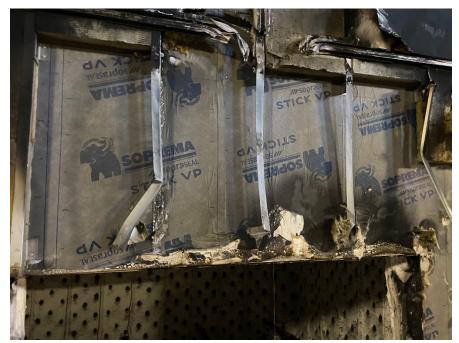
Photo No. 20 WRB above window opening
