## Uniform Mitigation Verification

788 Park Shore Dr Bldg D

Prepared for  
**Hidden Lake Villas Condominium Association**

# Uniform Mitigation Verification Inspection Form

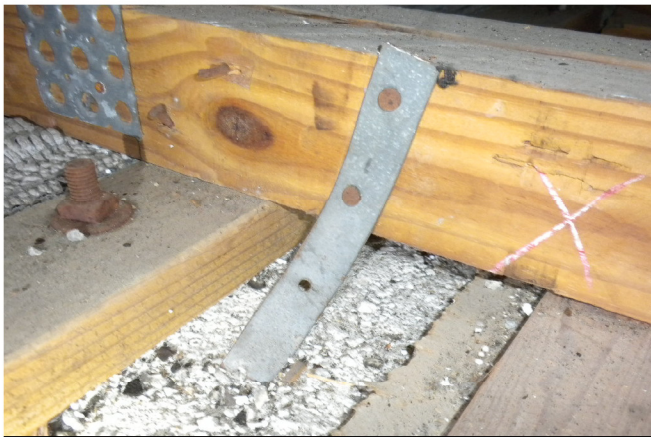
Roof to Wall Attachment

4. **Roof to Wall Attachment:** What is the **WEAKEST** roof to wall connection? (Do not include attachment of hip/valley jacks within 5 feet of the inside or outside corner of the roof in determination of WEAKEST type)

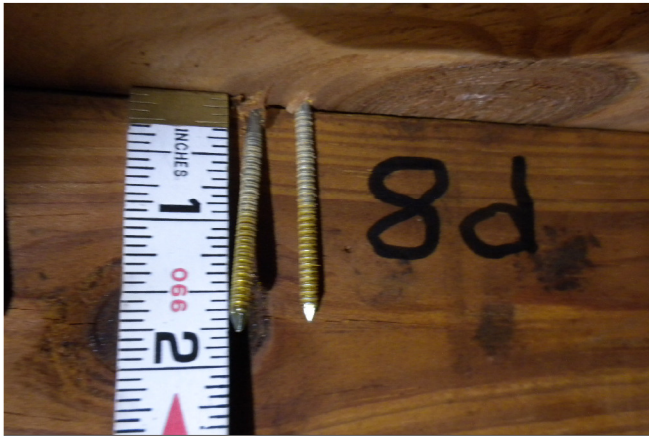
Roof Deck Attachment

3. **Roof Deck Attachment:** What is the weakest form of roof deck attachment?
    - A. Plywood/Oriented strand board (OSB) roof sheathing attached to the roof truss/rafter (spaced a maximum of 24" inches o.c.) by staples or 6d nails spaced at 6" along the edge and 12" in the field. -OR- Batten decking supporting wood shakes or wood shingles. -OR- Any system of screws, nails, adhesives, other deck fastening system or truss/rafter spacing that has an equivalent mean uplift less than that required for Options B or C below.
