# Lake Elsinore and Canyon Lake Watersheds Nutrient TMDL Monitoring 2017-2018 Annual Report - FINAL

**Prepared for:**

Lake Elsinore & San Jacinto Watersheds Project Authority  
11615 Sterling Avenue  
Riverside, California 92503

Wood Environment and Infrastructure Inc.  
(formerly Amec Foster Wheeler)  
9210 Sky Park Court  
Suite 200  
San Diego, CA 92123

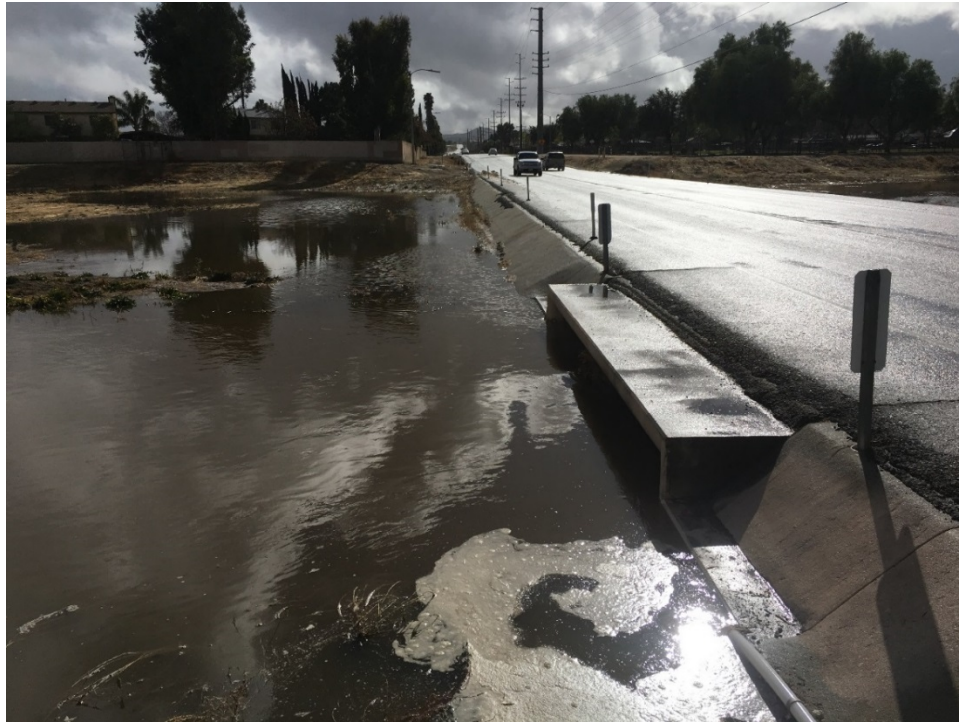
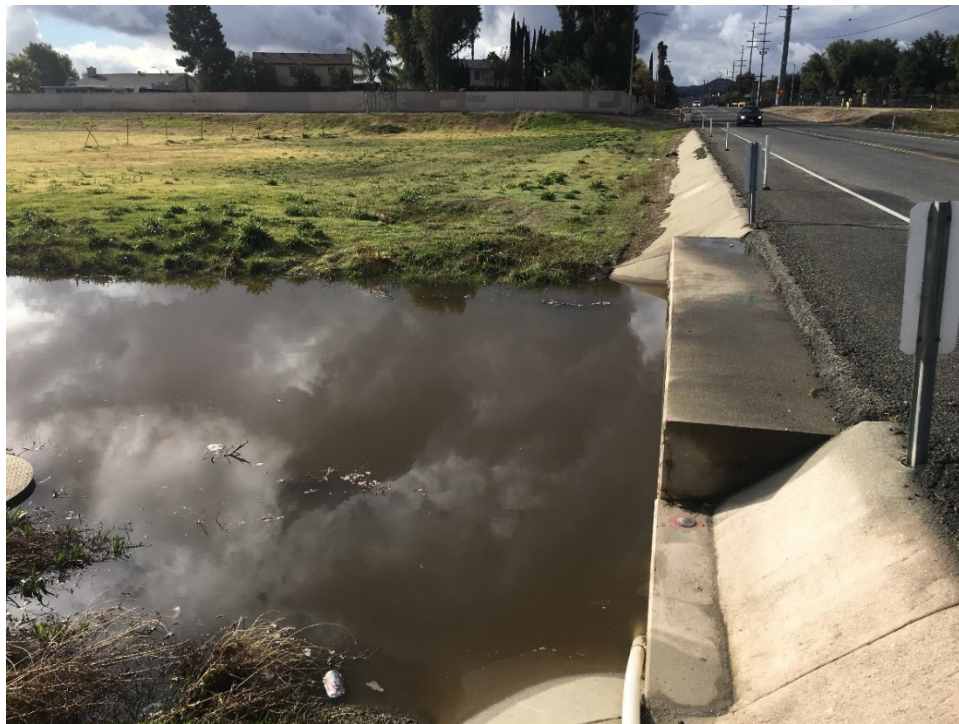
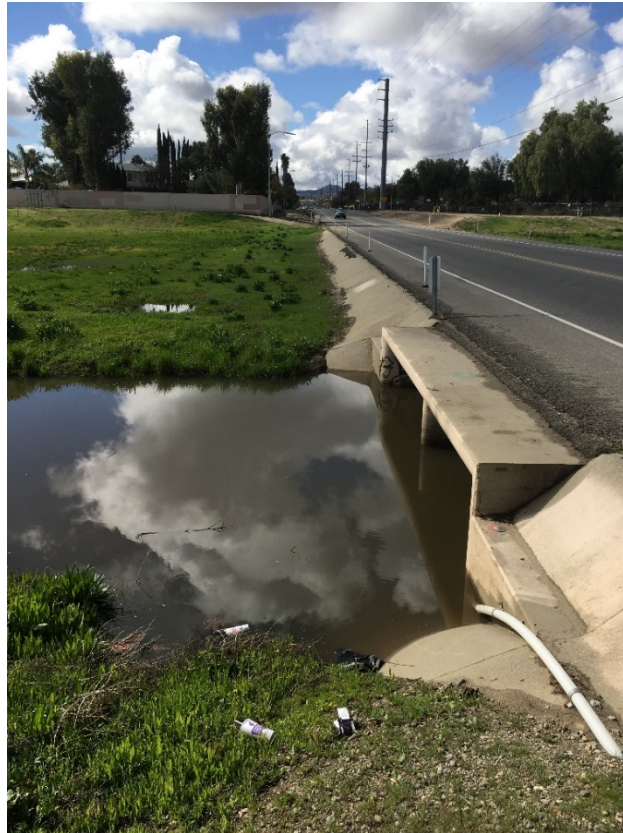
**Figure 2-6. Storm Event at Salt Creek at Murrieta Road (January 9-10, 2018)**

**Figure 2-7. Storm Event at Salt Creek at Murrieta Road (February 27-28, 2018)**

**Figure 2-8. Storm Event at Salt Creek at Murrieta Road (March 22-23, 2018)**

Photos taken during the storm events are provided in Figure 2-6, Figure 2-7, and Figure 2-8.

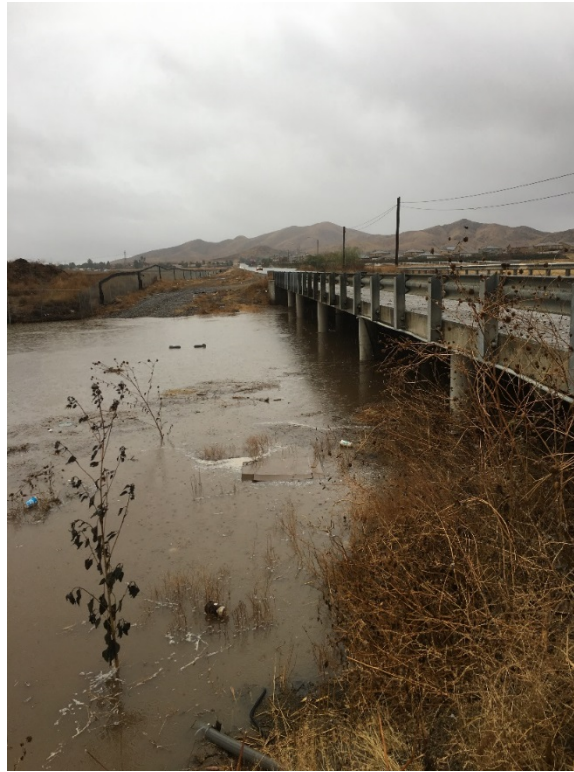
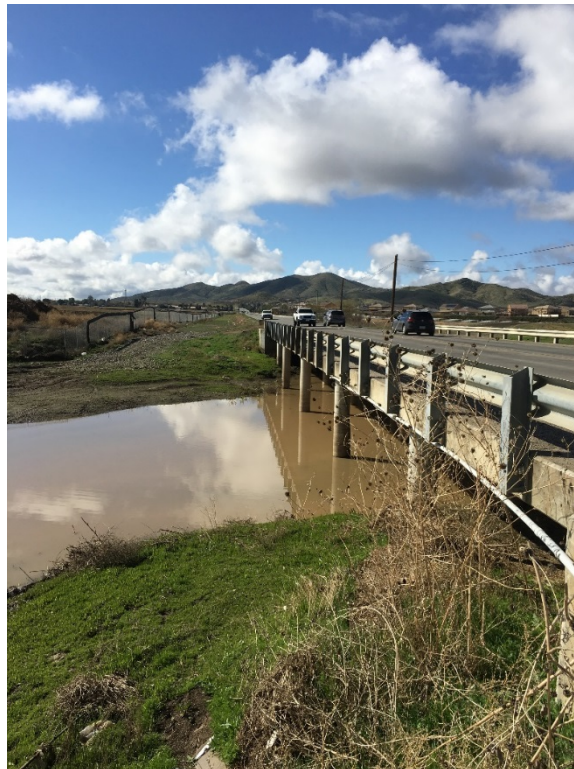
**Figure 2-12. Storm Event at San Jacinto River at Goetz Road (January 9-10, 2018)**

**Figure 2-13. Storm Event at San Jacinto River at Goetz Road (March 22-25, 2018)**

Photos taken during the storm events are provided in Figure 2-12 and Figure 2-13.

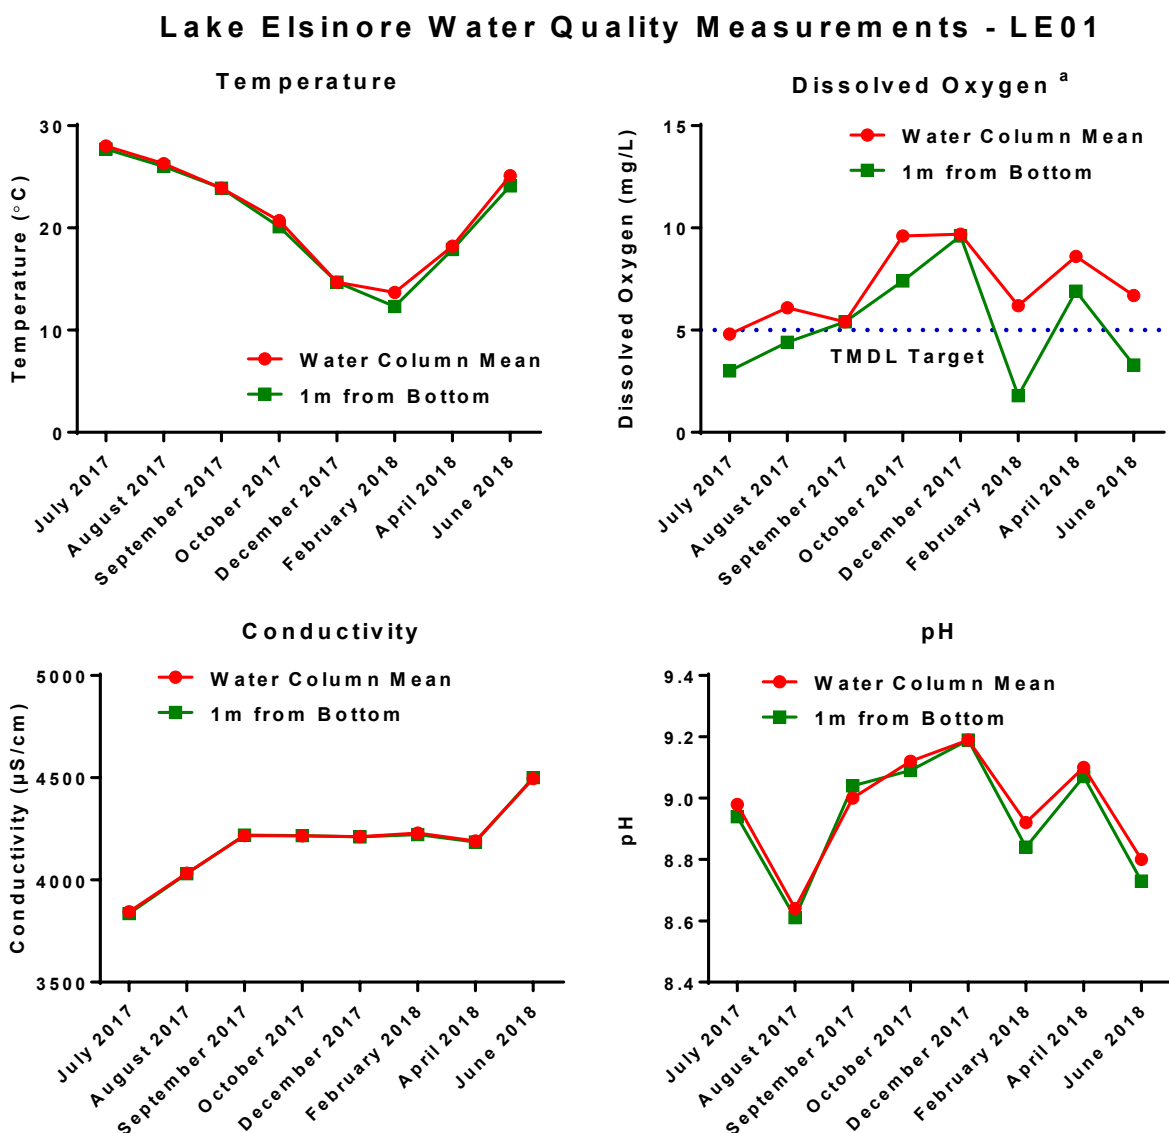
**Figure 3-3. In- Situ Physical Water Quality Parameters - Lake Elsinore - Site LE01**

<sup>a</sup> - TMDL Target for dissolved oxygen is depth average no less than 5 mg/L no later than 2015, no less than 5 mg/L 1 meter above lake bottom no later than 2020

Temperature exhibited a typical pattern with lowest values occurring during the winter events (December and February) and highest values in summer months (July and August). The greatest mean DO concentrations throughout the water column were observed in February at Site LE03, and in December at Sites LE01 and LE02. Conductivity increased from July through September 2017, from approximately 3800 to 4200 microsiemens per centimeter ( $\mu\text{S}/\text{cm}$ ). The conductivity remained relatively stable between September 2017 and April 2018, at approximately 4200  $\mu\text{S}/\text{cm}$ . Conductivity then rose slightly to approximately 4500  $\mu\text{S}/\text{cm}$ , during the June 2018 event. The overall annual average pH in the lake was 8.95. The pH values in August 2017 and June 2018 were approximately 0.4-0.6 units lower than mean values for other events.

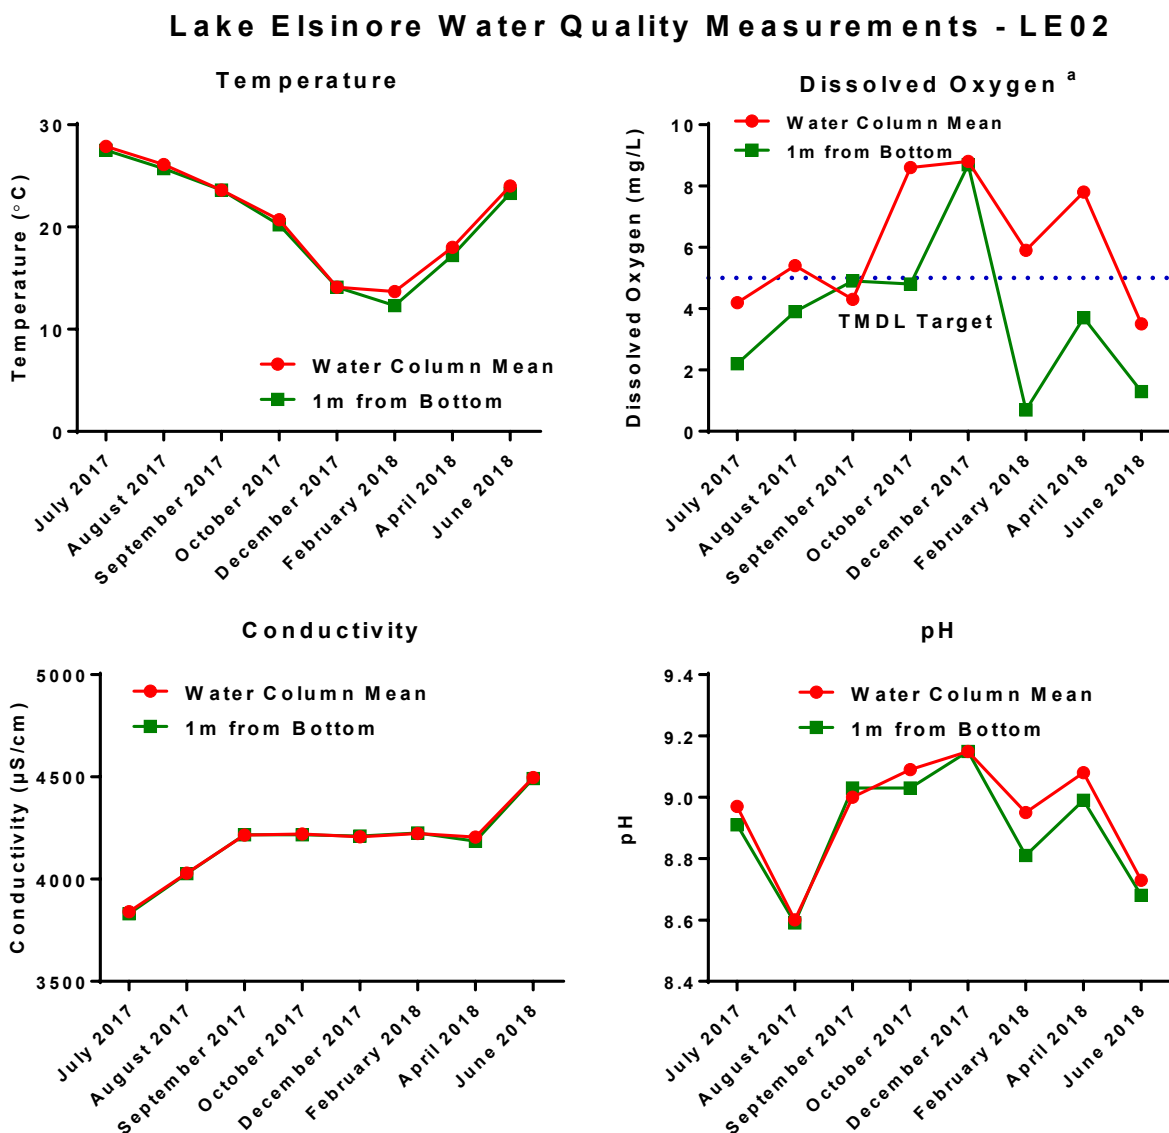
**Figure 3-4. In- Situ Physical Water Quality Parameters - Lake Elsinore Site LE02**

<sup>a</sup>-TMDL Target for dissolved oxygen is depth average no less than 5 mg/L no later than 2015, no less than 5 mg/L 1 meter above lake bottom no later than 2020

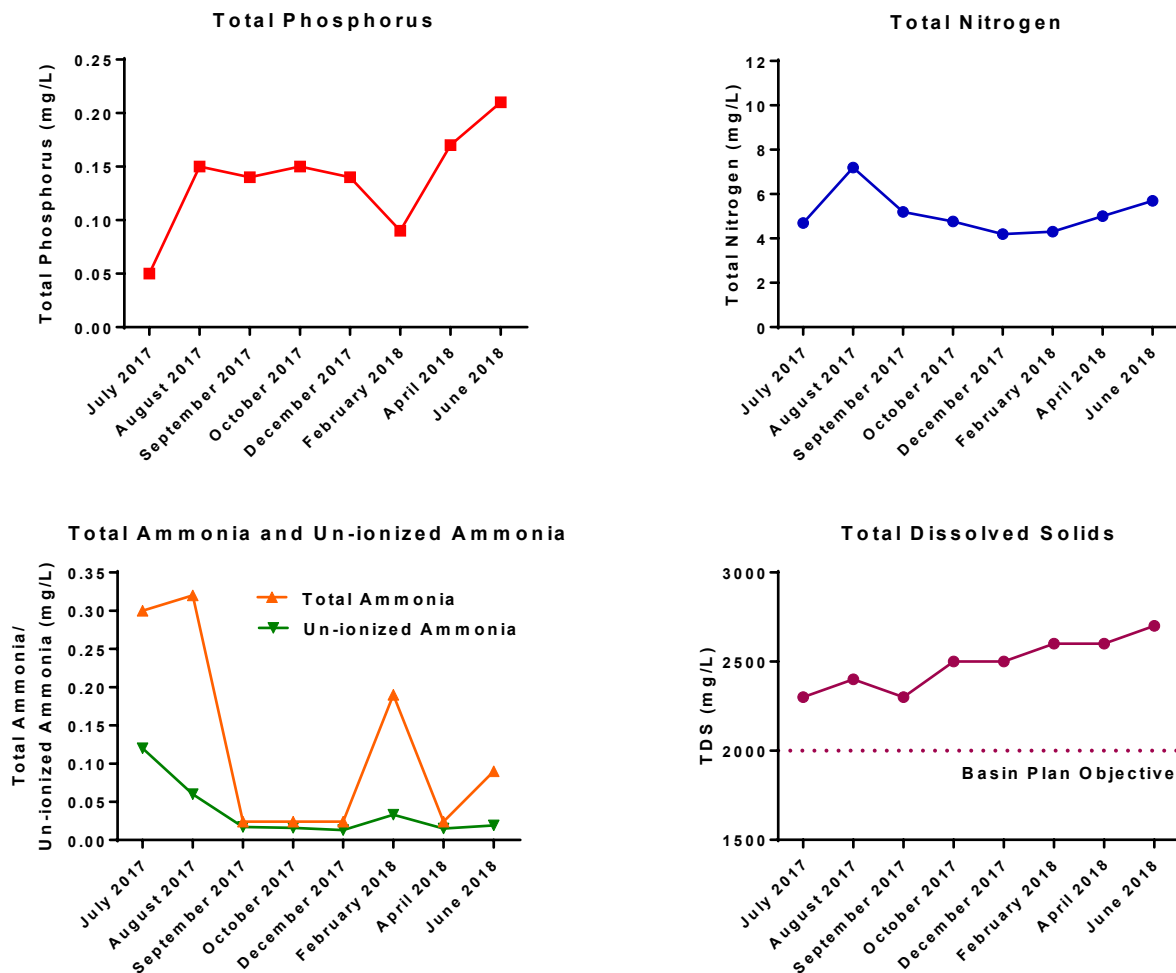
**Figure 3-6. Lake Elsinore Analytical Chemistry – Depth-Integrated Means  
 (July 2017-June 2018)**

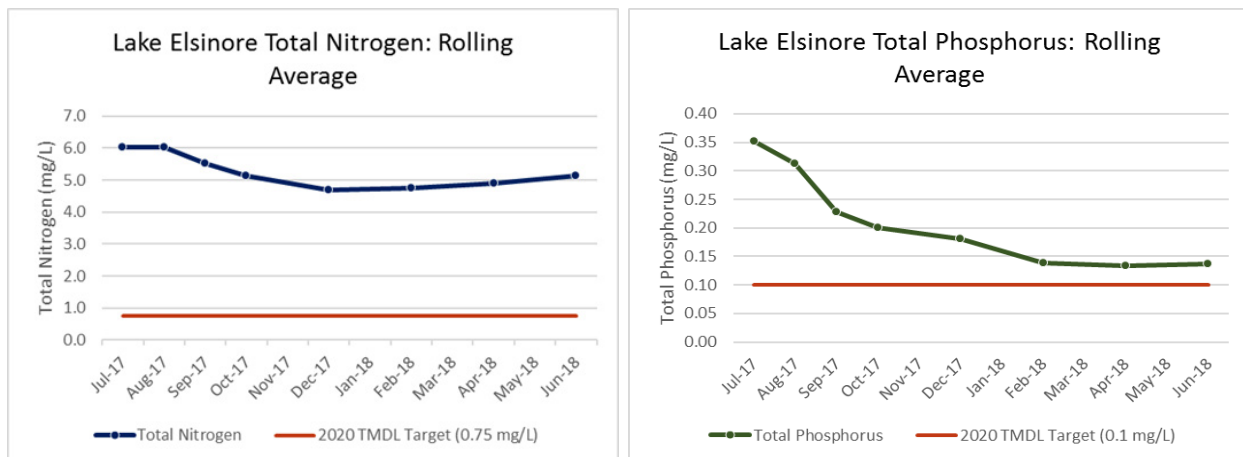
**Figure 3-7. Lake Elsinore Analytical Chemistry – Rolling Averages  
 (August 2016 – June 2018)**

*Values are calculated by averaging the value of each event with the previous seven events (i.e. one year of data) to obtain a rolling average.*

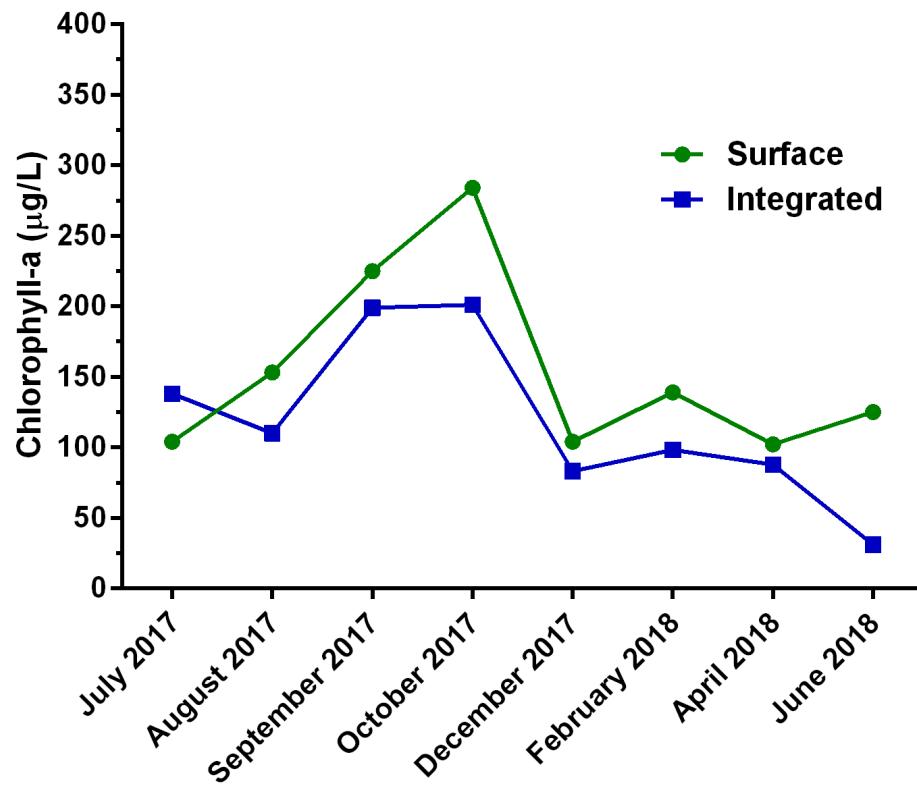
**Figure 3-8. Lake Elsinore Analytical Chemistry – Depth-Integrated and Surface Chlorophyll-a**

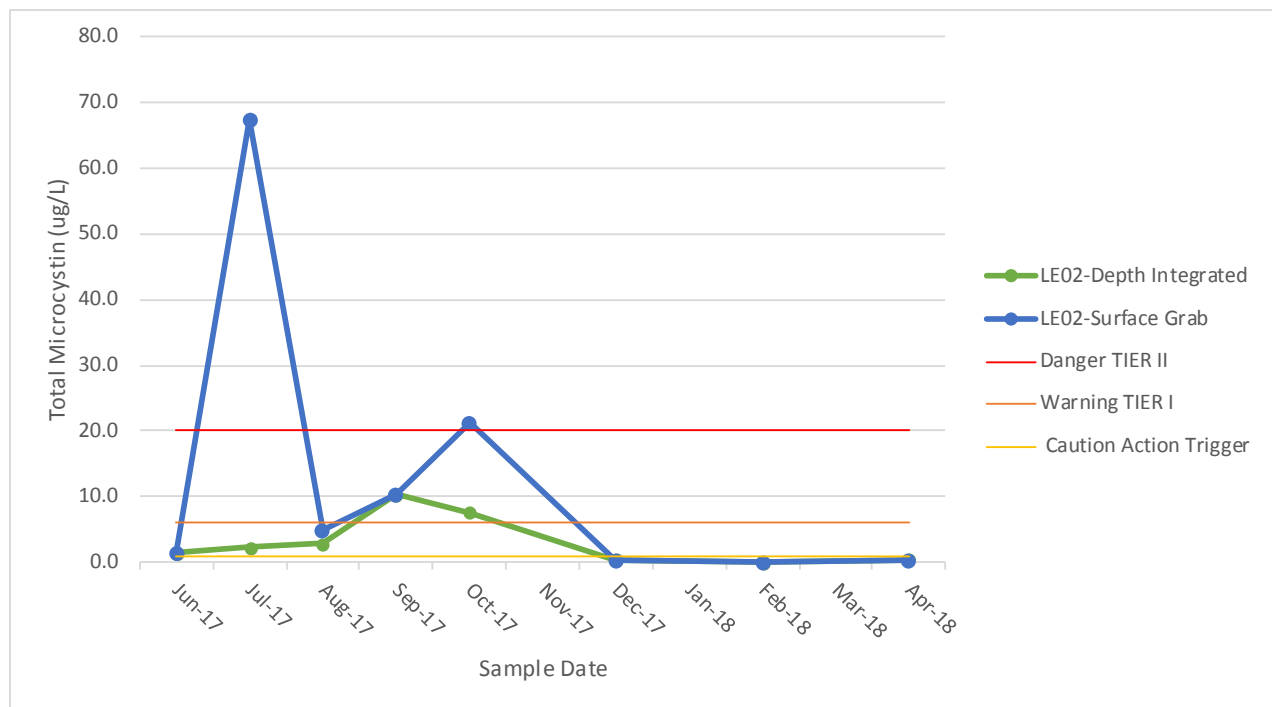
**Figure 3-9. Lake Elsinore Microcystin concentrations June 2017 to April 2018**

*Note: Due to bimonthly monitoring conducted in non-summer months, samples were not collected for November 2017, or January, March, and May 2018. Sample collection ended in April 2018.*

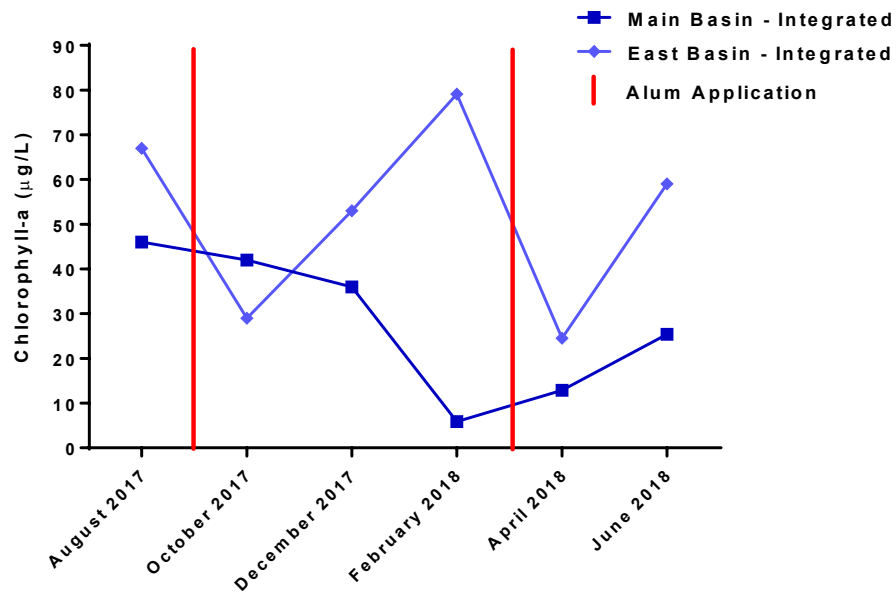
**Figure 3-15. Canyon Lake Analytical Chemistry – Depth-Integrated Chlorophyll-a**  
(Main Basin values represent mean of Sites CL07 & CL08, East Basin values represent mean of Sites CL09 & CL10 samples)
