## RESIDENTIAL INSPECTION REPORT

1234 Main St. Peoria AZ 85383

Buyer Name  
01/27/2022 9:00AM

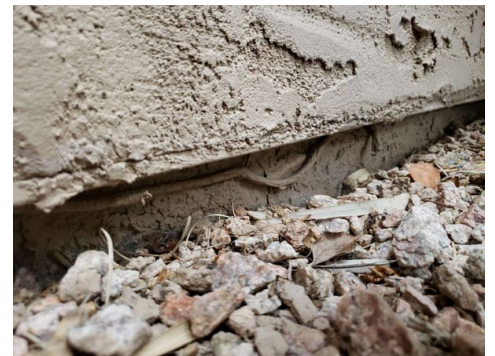
2.1.1 Foundation (including exposed foundation/stem wall and basement)

#### FOUNDATION PAINT

Flaking and/or peeling exterior paint noted at/along the foundation. Recommend having the loose paint scraped and concrete repainted as needed by a qualified painter.

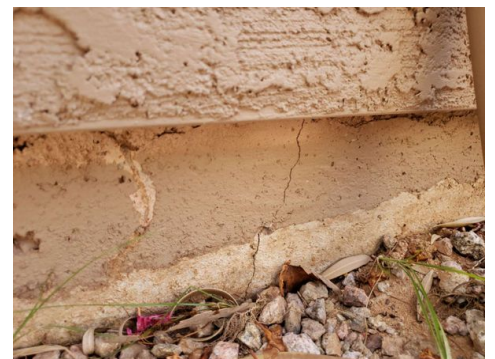
2.1.2 Foundation (including exposed foundation/stem wall and basement)

#### VERTICAL CRACKS W/ SEPARATION LESS THAN 1/8"

Vertical cracks with separation of less than 1/8" observed. Recommend assessment and service/re-sealing by a qualified contractor/foundation contractor to prevent moisture intrusion and further damage.

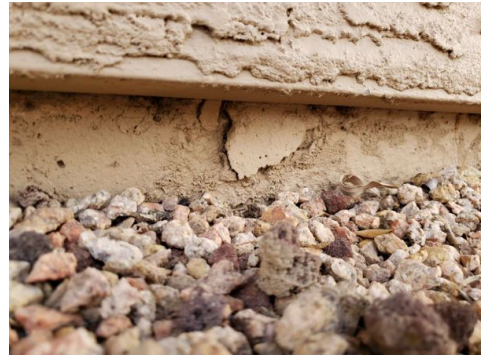
2.1.3 Foundation (including exposed foundation/stem wall and basement)

### **CRACKED/DISPLACED CONCRETE**

Cracked and loose, displaced or missing concrete observed. Recommend assessment and service/repair by a qualified concrete/foundation contractor to prevent further damage.

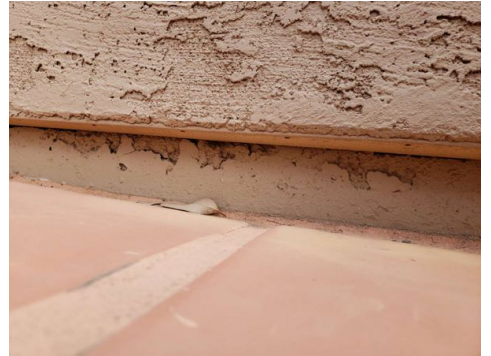
2.1.4 Foundation (including exposed foundation/stem wall and basement)

### **AGGREGATE/MISSING PARGE**

Missing parge coat/visible aggregate observed. Recommend assessment and application of parge/finish coat (if deemed necessary) by a qualified concrete/foundation contractor to help maintain an adequate seal.

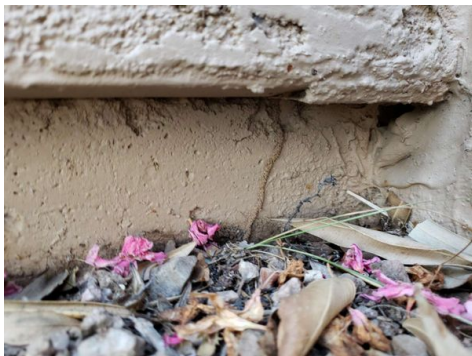
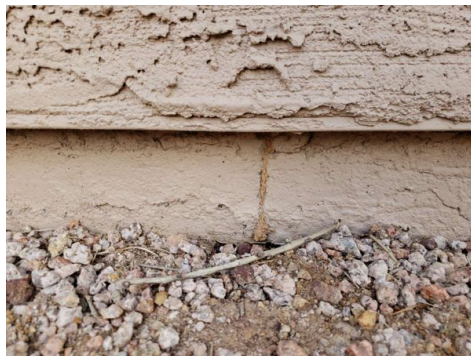
### **WDO EVIDENCE**

Evidence of possible wood destroying organism activity observed. Recommend further inspection by a qualified pest control specialist.

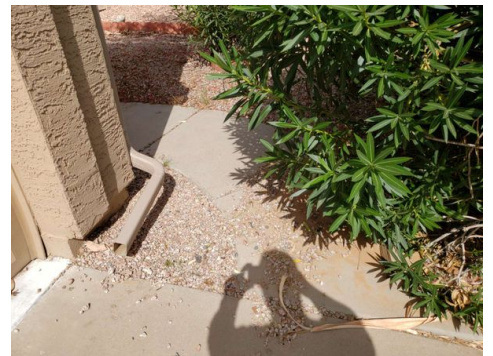
**MISSING WALKWAY DRAIN CHANNEL (LIMITED DRAINAGE)**

Missing walkway drain channel noted. Rain water may be trapped between the walkway(s) and the foundation. Recommend monitoring for water retention. Recommend the installation of a drain channel(s) if necessary by a qualified contractor.

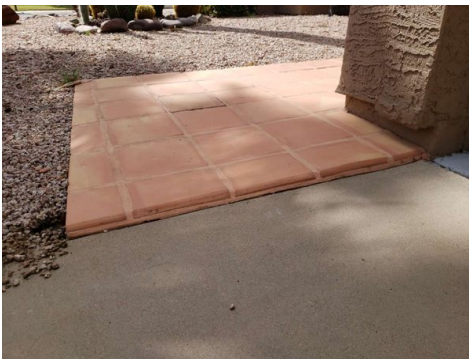
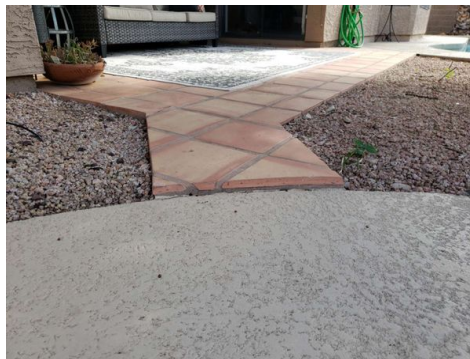
## FRONT AND REAR WALKWAYS

Non standard height step(s) noted could be a trip concern. Recommend caution while walking in these areas or service if needed by a qualified contractor.

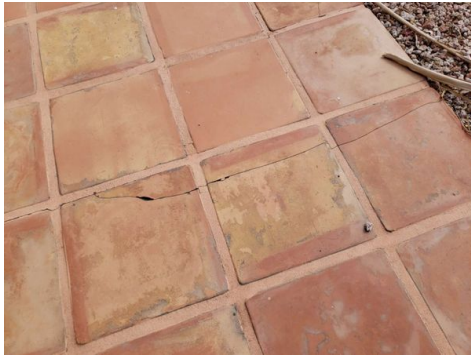
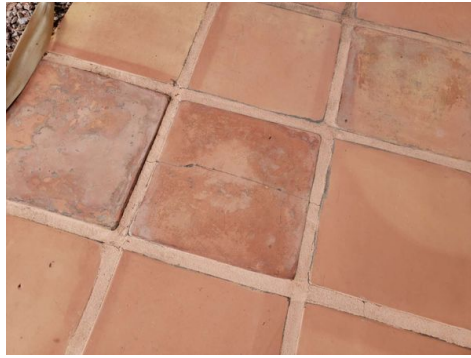
**CRACKED FLOOR TILE**

Cracked floor tile noted at the front walkway. Recommend service if needed by a qualified flooring contractor.

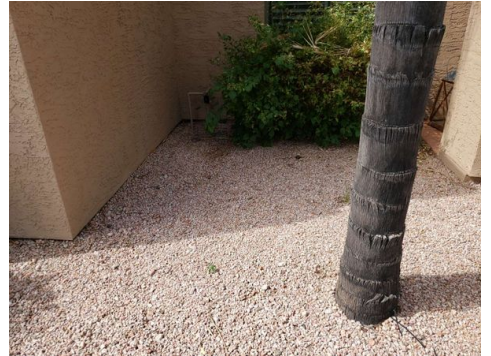
### 3.2.1 Vegetation, Grading/Drainage, and Retaining Walls

Landscaping/mounded soil is sloping towards the structure which may lead to a lack of effective drainage resulting in water pooling around/near the foundation. A slope of approximately 1" per foot away from the foundation for at least 5-6' is recommended. Recommend adjustment/correction by a qualified landscape professional.

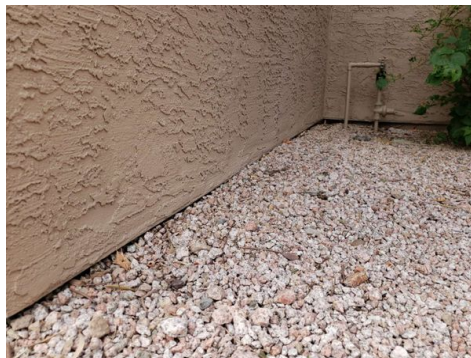
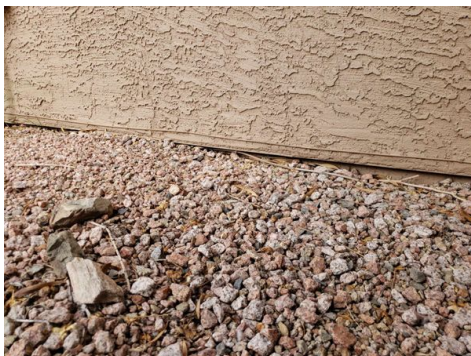
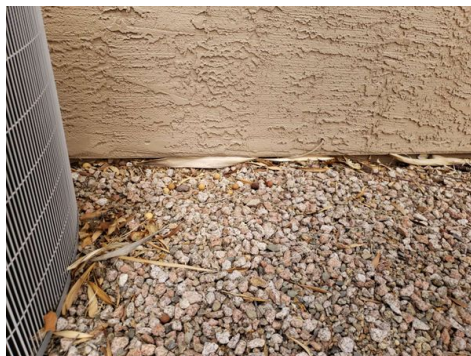
### MULTIPLE AREAS

Excessive/high grade in areas around the structure limits foundation visibility and increases the risk of pest intrusion. Recommend removal/lowering of grade where necessary (leaving an appropriate slope of approximately 1" per foot away from the structure).

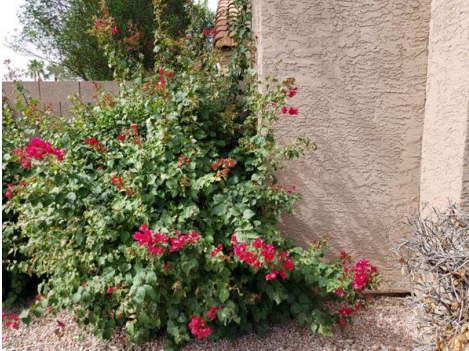
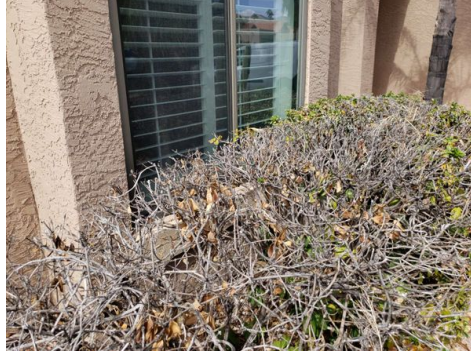
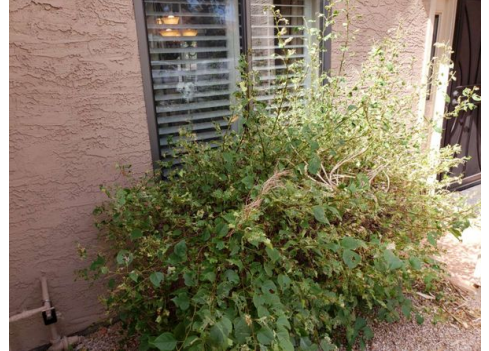
**VEGETATION CONTACTING HOME**

Vegetation is contacting the exterior of the home. This can lead to increased pest activity, moisture intrusion as well as paint/siding damage. Recommend trimming vegetation away from the home or removal as needed by a qualified landscaping professional.

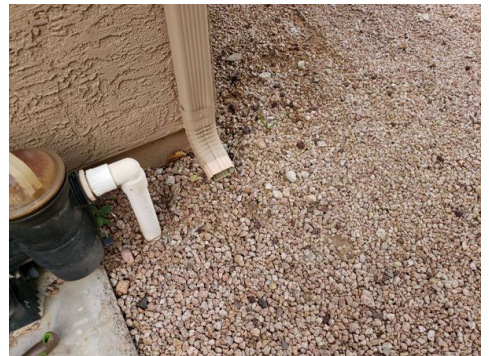
Deficiency/Service or Replace**GUTTER SPLASH BLOCKS MISSING**

Recommend the application of splash blocks at the gutter downspouts as needed to help divert rain water away from the structure.

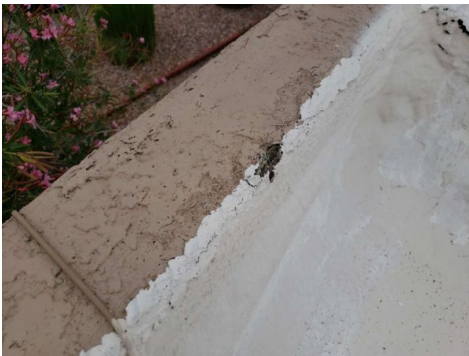
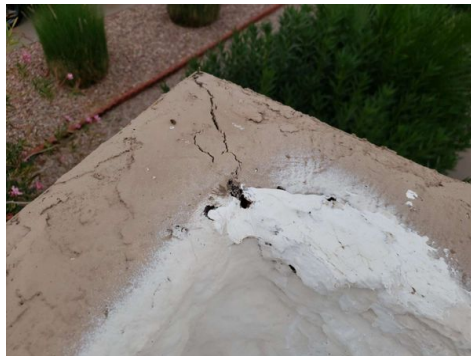
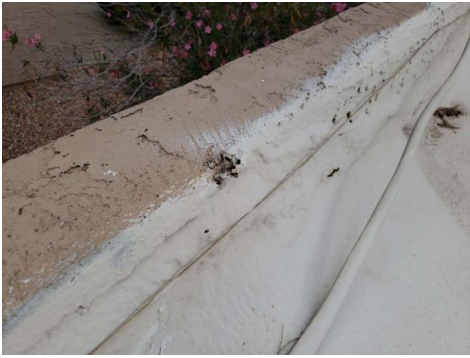
Damaged and/or missing stucco observed. Recommend repair/replacement of stucco in the area by a qualified siding contractor.

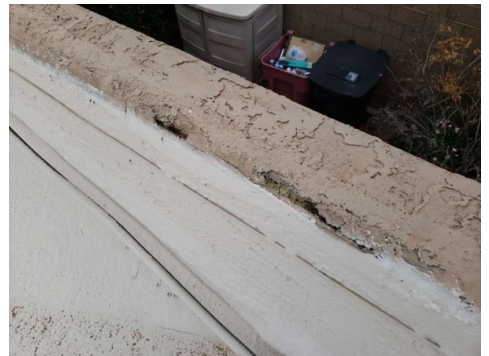
## 3.3.1 Siding and Exterior Paint

**DAMAGED/MISSING STUCCO**

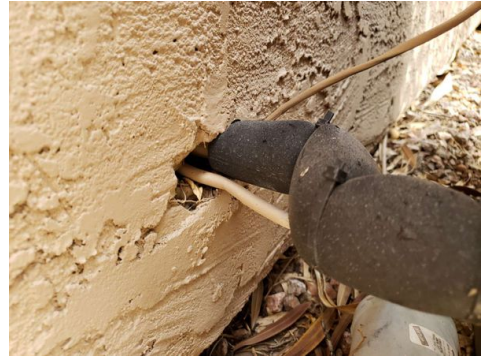
Open/unsealed voids noted where the cooling system lines enter the building. Recommend sealing/filling (w/ expanding foam sealant or stainless steel wool) to prevent pest intrusion into the building.

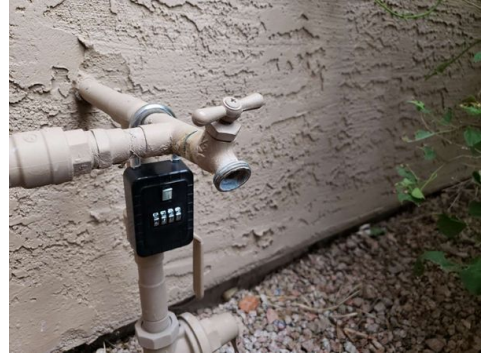
Anti-siphon devices/vacuum breakers are missing. Recommend installing anti-siphon valves/vacuum breakers on each hose bib prior to connecting hoses to prevent outside water from siphoning into the clean/potable water supply.

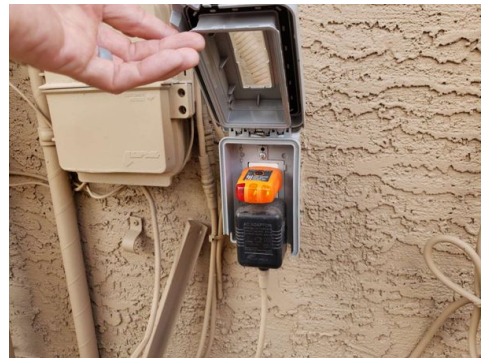
## 3.8.1 Electrical

Exterior receptacle is not GFCI protected. GFCI protection is recommended for all exterior receptacles as a safety precaution even if it was not available or required when the home was built. Recommend the installation of GFCI protection by a qualified electrician.

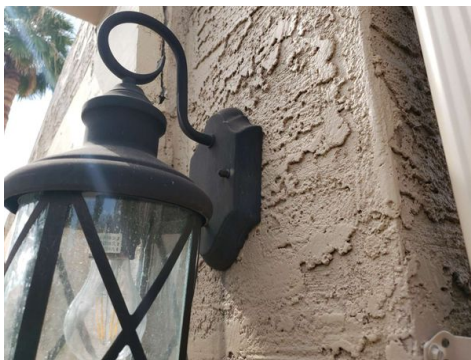
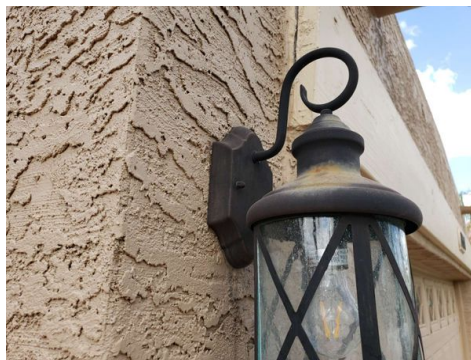
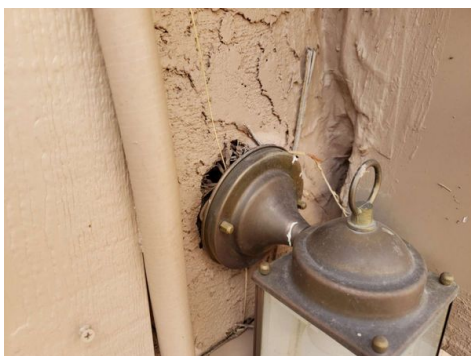
**LOOSE LIGHT FIXTURES**

Exterior light fixture are slightly loose and/or not sealed to the walls (to prevent pest/moisture intrusion). Recommend fully securing and sealing as needed by a qualified professional.

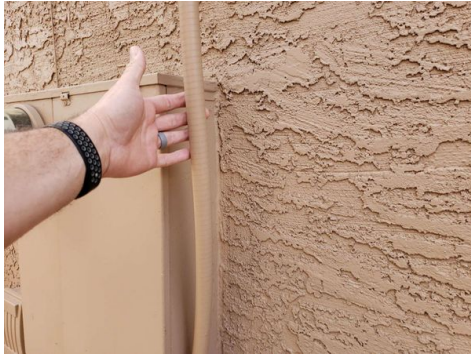
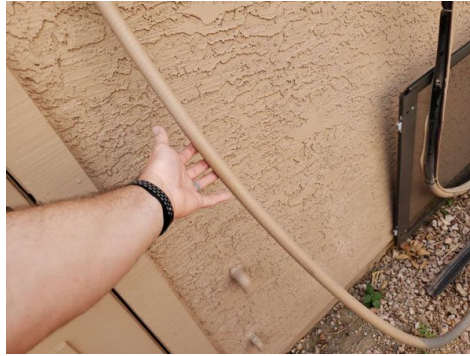
##### **NORTH EXTERIOR**

Electrical conduit is loose/not fully or properly secured. Recommend service/securing by a qualified electrician.

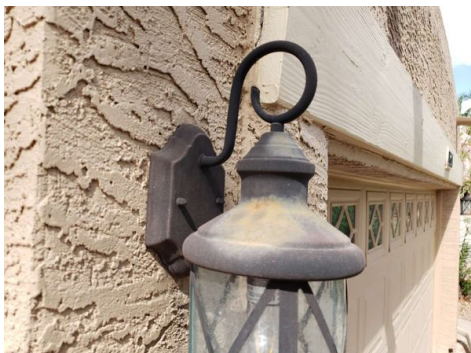
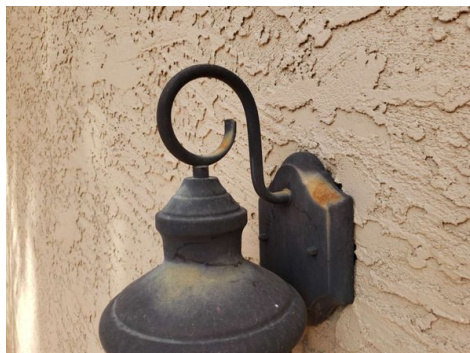
#### **FIXTURE RUST**

Rust noted at exterior light fixtures. Recommend replacement if needed by a qualified electrician.

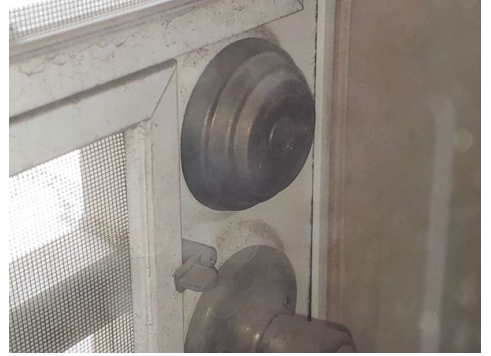
The security door is keyed on both sides presenting a safety concern as occupants without a key may be trapped in case of emergency. Recommend replacement of the lock with one that is not keyed on the interior side by a qualified locksmith or door technician.

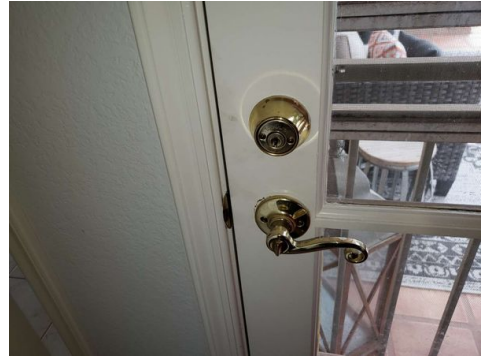
3.10.2 Patio and Other Exterior  
Door(s)

The exterior entry door is keyed on both sides presenting a safety concern as occupants without a key may be trapped in case of emergency. Recommend replacement of the lock with one that is not keyed on the interior side by a qualified locksmith or door technician.  
**Please note the door was locked and not able to be tested.**

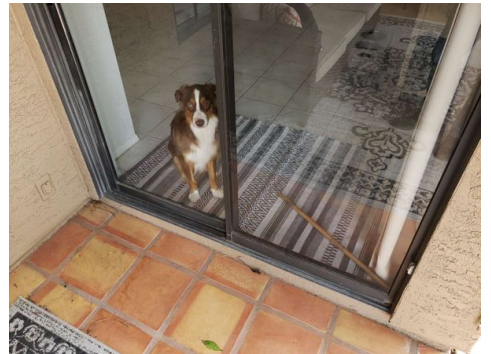
**HARD TO SLIDE (MODERATE)**

The sliding glass door could be considered difficult to open and close. Rolling hardware could be dirty or damaged. Recommend assessment and service if needed by a qualified door technician.

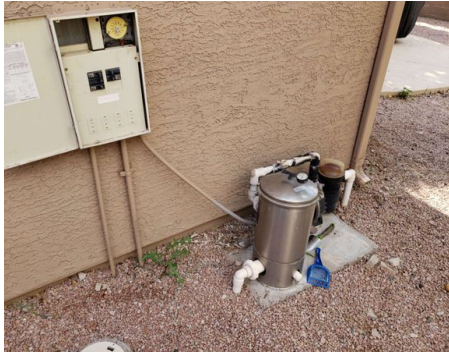
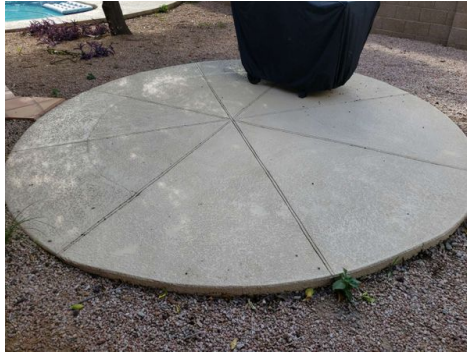
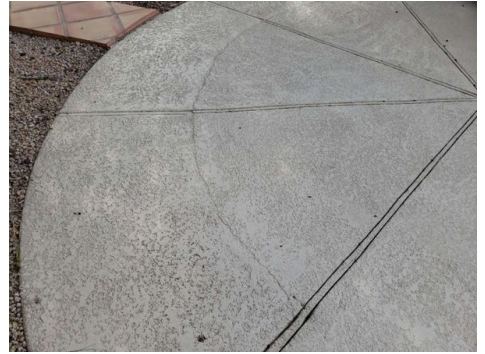
## Equipment not in use

The water circulation equipment at the rear north corner was not functional when the pool was inspected. This equipment appears to be abandoned. There may have once been a hot tub at the nearby circular pad. It is not clear if the electrical panel is still necessary. Recommend evaluation by a qualified pool repair contractor.

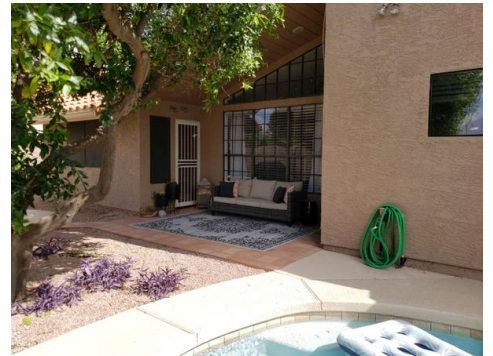
### 4.1.1 Pool Fence/Barrier

There is no pool fence installed and exterior door(s) with direct access to the pool are not self closing. Latch hardware is also lower than 54" off the ground. These conditions limit the pool barrier. Recommend the installation of a pool fence or self closing door hardware with latches at the appropriate height by a qualified contractor to help maintain an effective pool barrier.

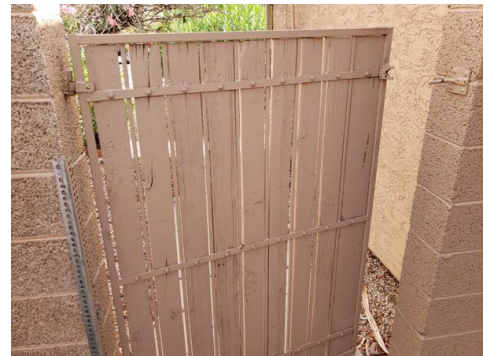
### 4.1.2 Pool Fence/Barrier

#### **SIDE GATE NOT SELF CLOSING**

The side gate is not self closing and latching. Recommend the installation of self closing hardware by a qualified professional to help maintain an effective pool barrier.

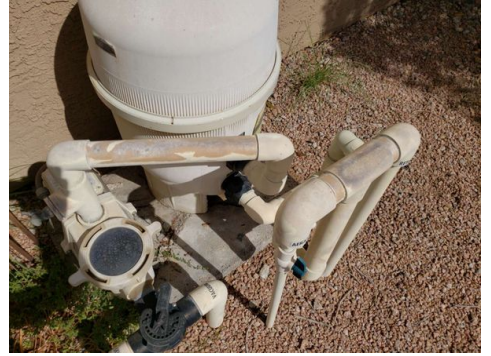
4.9.1 Cleaning/Circulation System  
(including filters and pumps)

The exposed pool piping is not painted or paint has deteriorated. PVC pipe is discolored due to UV exposure. Recommend repainting to prevent further UV exposure.

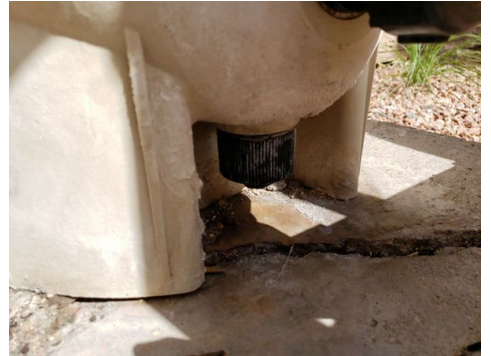
4.9.2 Cleaning/Circulation System  
(including filters and pumps)

Active leaking observed when the pool cleaning system was tested. Recommend service/repair by a qualified pool contractor.

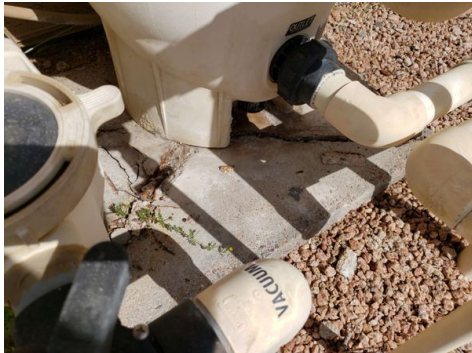
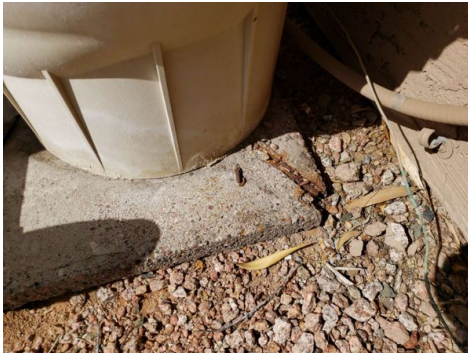
### EQUIPMENT PAD

The equipment pad is damaged with rebar exposed and deteriorating. Recommend replacement as needed by a qualified pool repair contractor.

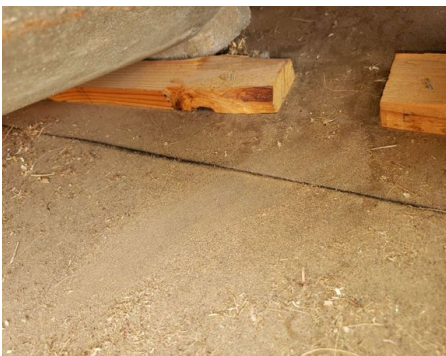
### Pitched Roof Covering(s): Tile underlayment

It appears as though the original tile roof underlayment has been replaced. Underlayment installed appears serviceable.

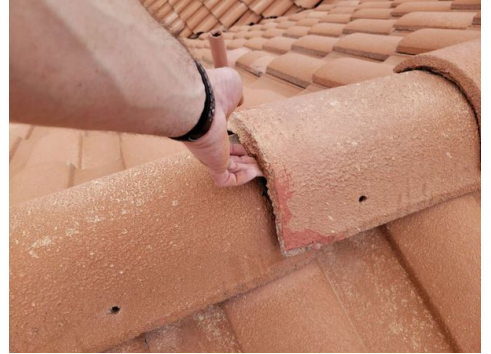
#### LOOSE BARREL TILE

Various hip/ridge barrel tile are loose and may be lifted and/or displaced with high wind. Recommend having tile re-secured by a qualified roofer.

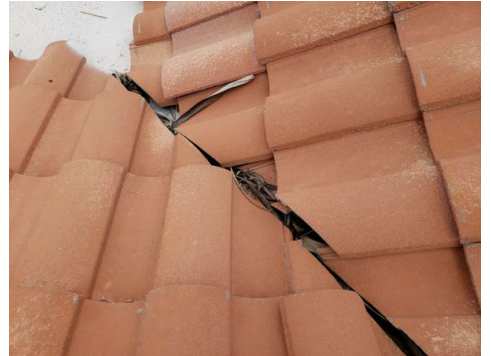
### 5.1.2 Pitched Roof Covering(s)

#### EXCESSIVE DEBRIS

Excessive debris observed on the roof covering and/or in roof valleys can lead to limited drainage/leaking and roof covering damage. Recommend removal of debris and evaluation of roof covering condition below by a qualified roofing contractor.

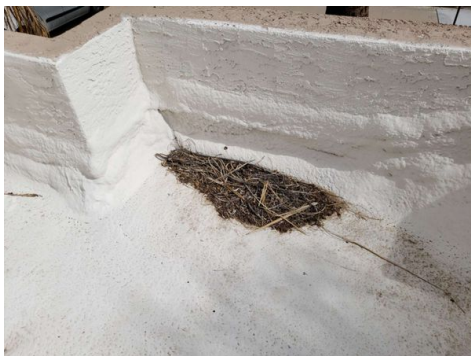
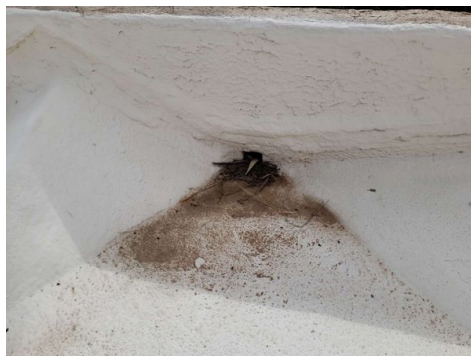
### 5.2.1 Low Slope Roof Covering(s)

#### EXCESSIVE DEBRIS

Excessive debris observed on the roof can lead to limited drainage/leaking and roof covering damage. Recommend removal of debris and evaluation of roof covering condition below by a qualified roofing contractor.

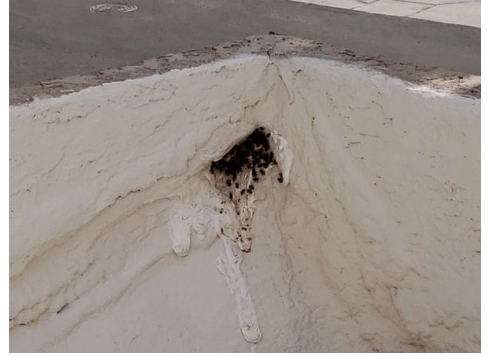
Active beehive/nest noted at the front corner of the flat roof parapet wall. Recommended service by a qualified Pest Control technician.

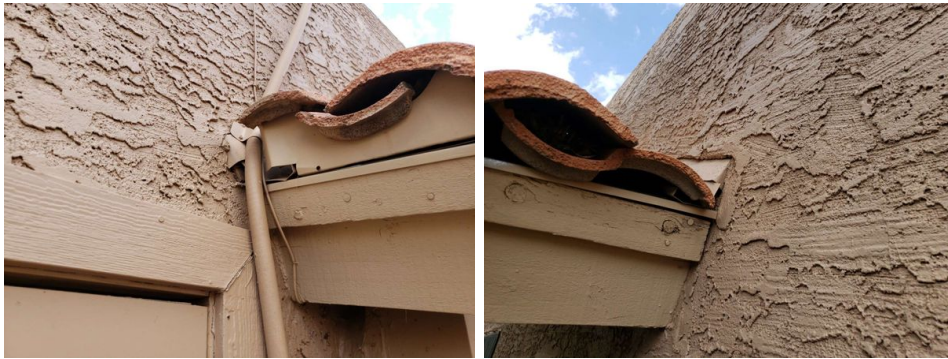
## 5.3.1 Flashings

Missing kick-out flashings noted. Kick-out flashing is helpful in preventing water intrusion and/or siding damage at the intersection of the roof and exterior wall. Recommend kick-out flashing installation by a qualified roofer.

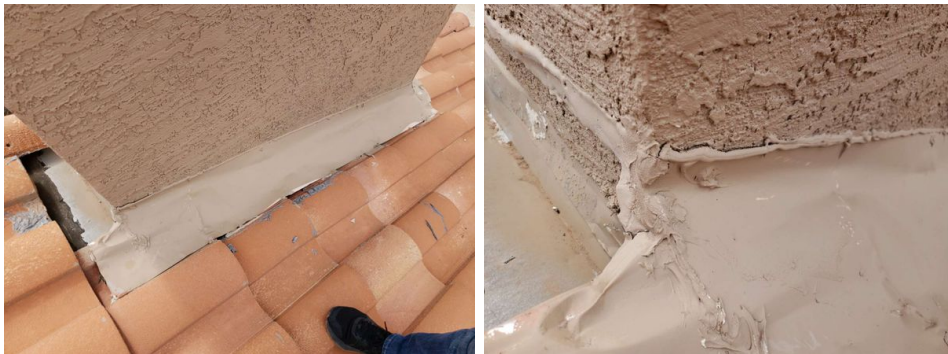
## 5.3.2 Flashings

Method of installation for the chimney transition flashing may not be considered common. Flashing is separating at the attachment to exterior siding. Recommend assessment and service by a qualified roofer.

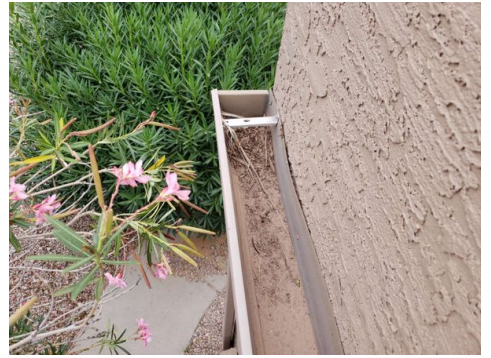
## 5.5.1 Roof Drainage Systems

Recommend removal of dirt/debris in the gutters by a qualified person to maintain adequate drainage.

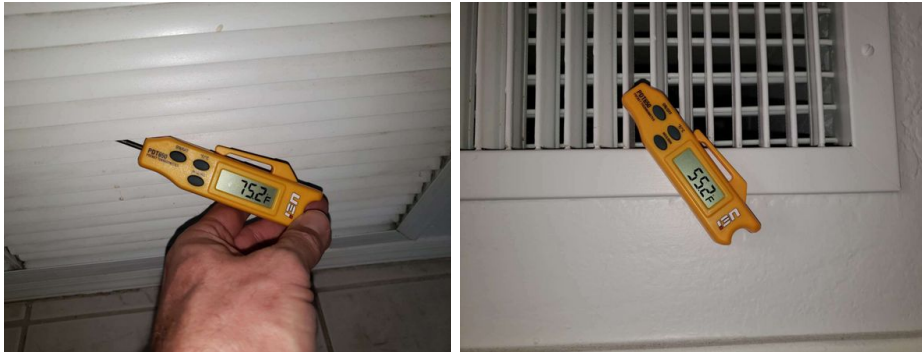
The cooling system produced a temperature differential of (approximately) 15-22 degrees which is considered to be within the acceptable range.

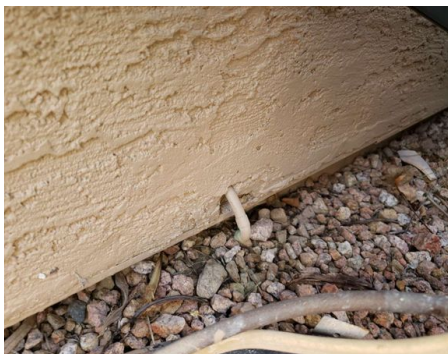
**Cooling System(s): Condensate pump**

There is a condensate pump installed for the air handler. The termination appears to be at the North exterior behind the ductless mini-split condenser however this is not able to be verified as the pump is not able to be manually turned on. Recommend assessment as needed by a qualified HVAC technician.

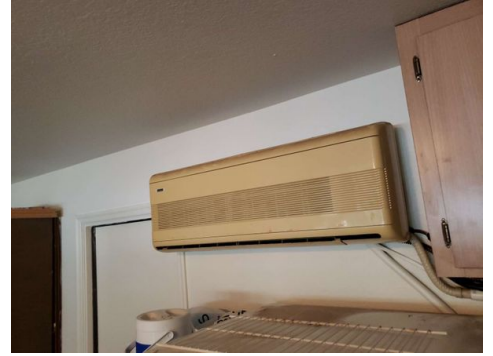
## 6.1.2 Cooling System(s)

The garage ductless system blower unit did not respond to surface mounted controls when tested. Recommend assessment and service if needed by a qualified HVAC technician.

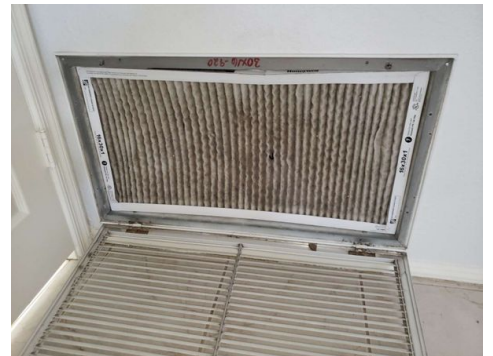
## 6.4.1 Distribution Systems

The air filter appears dirty and in need of replacement. Recommend installing a new air filter and replacing at intervals recommended by the manufacturer.

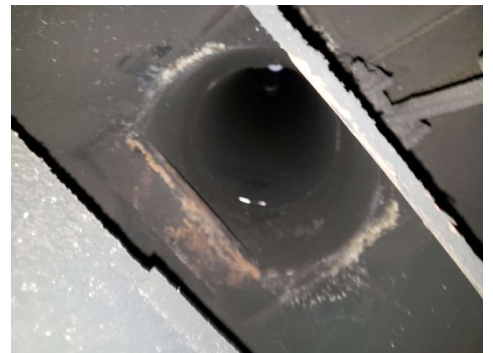
## 6.6.1 Fireplaces and Flues

Creosote observed in the chimney flue. Creosote is combustible and can damage a chimney flue/liner. Recommend having flue cleaned and evaluated by a qualified professional/chimney sweep.

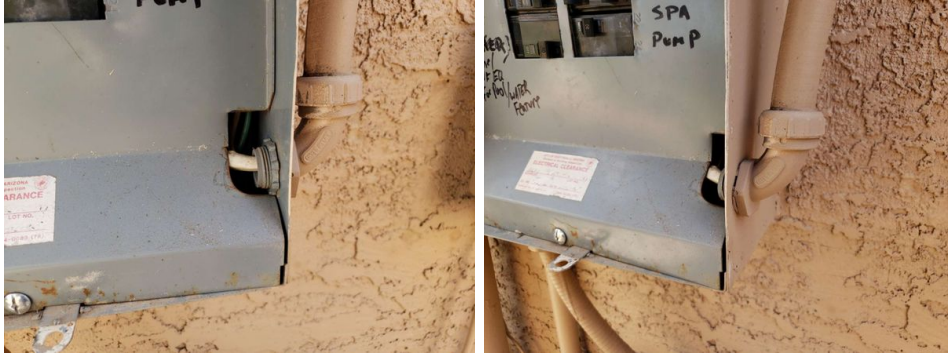
#### **IMPROPER ALTERATION**

The main electric service panel dead front cover has been opened for a 90-degree fitting. This is an improper alteration. Recommend correction by a qualified electrician.

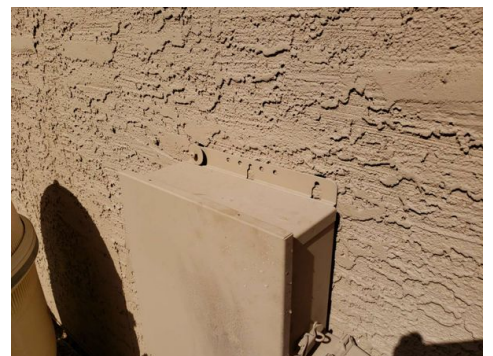
### 7.3.1 Branch Circuit Conductors, Overcurrent Devices and Compatibility

#### **NEUTRAL INSTALLED AS HOT**

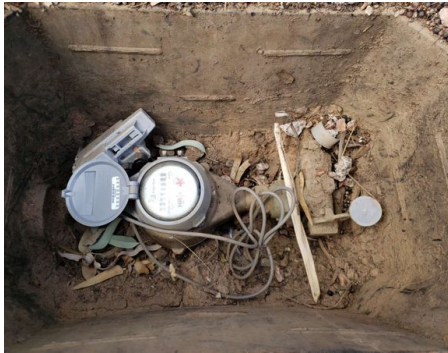
### Plumbing Water Supply & Distribution System (including supports and insulation): Meter observed (water flowing, occupied home)

The utility meter did indicate water flow when observed however the home was occupied during the inspection and one or more fixtures may have been in use. The presence of a leak could not be determined by observing the meter.

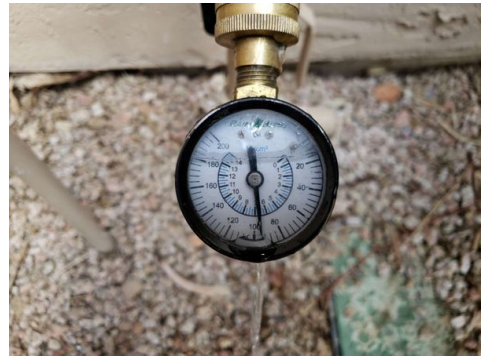
8.1.1 Plumbing Water Supply & Distribution System (including supports and insulation)

A water pressure reducing valve is installed for the home however water pressure exceeded 80 PSI at the time of the inspection. This could indicate the valve is faulty or requires adjustment as a maximum of 80 PSI is recommended. Recommend assessment/service by a qualified plumber.

Deficiency/Service or Replace

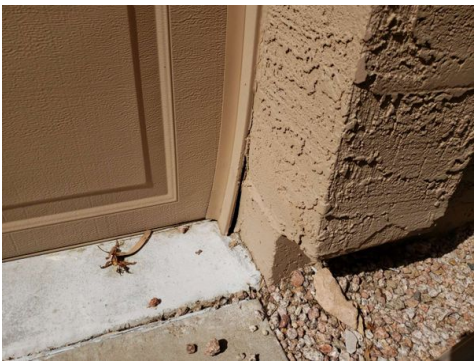
SEPARATED WEATHER-STRIPPING

The garage overhead door opening weather stripping is separated from siding and/or the stem wall. Recommend re-securing and sealing as needed by a qualified professional.

Deficiency/Service or Replace

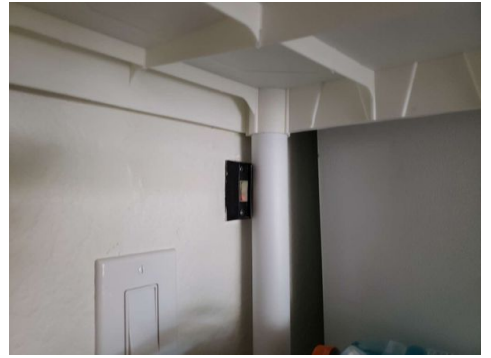
The garage door operator control is installed lower than 5' and could be reached by small children. Recommend raising to 5' (or higher) by a qualified garage door technician.

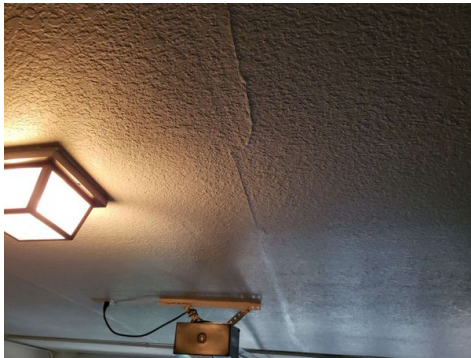
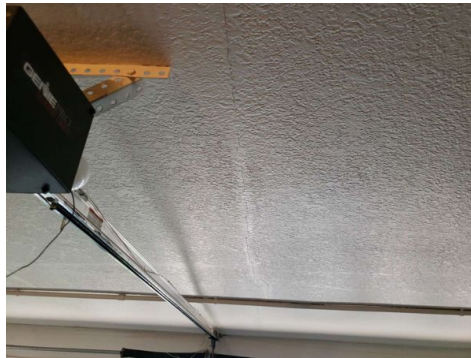
##### **CRACKED DRYWALL (FIREWALL)**

Cracked drywall with no/minimal separation and/or separated drywall tape joints observed may limit the firewall separation for the garage. It is important to maintain an adequate firewall barrier to slow the spread of potential fire/fumes from the garage to the living space of the home. Recommend having openings re-sealed by a qualified professional to maintain adequate firewall separation in the garage.

Safety Concern/Service or Replace

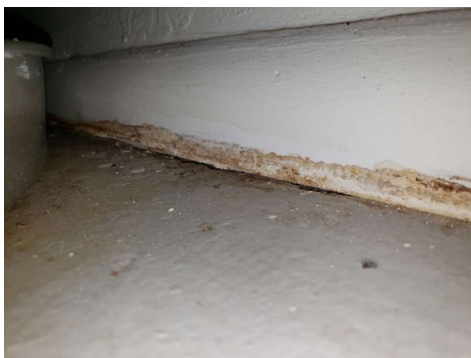
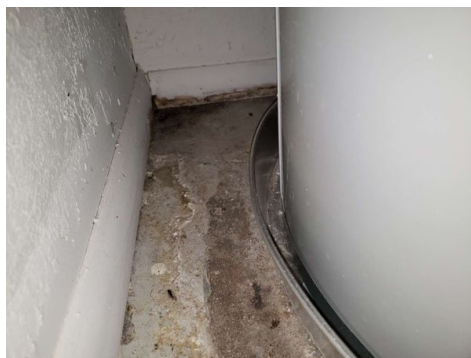
##### NEAR WATER HEATER

Water staining/damage noted. No elevated moisture was detected at the time of the inspection. No indication of leaking nearby. Recommend assessment and service/replacement of damaged material by a qualified contractor.

Deficiency/Service or Replace

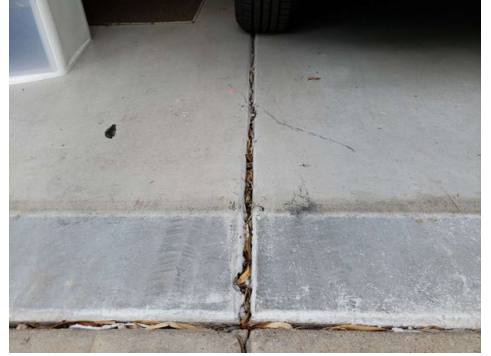
## 9.5.1 Garage Slab/Floor

**CRACKED ALONG CONTROL JOINT**

The garage slab has cracked and separated along the control joint. Recommend resealing as needed by a qualified concrete contractor.

Deficiency/Service or Replace

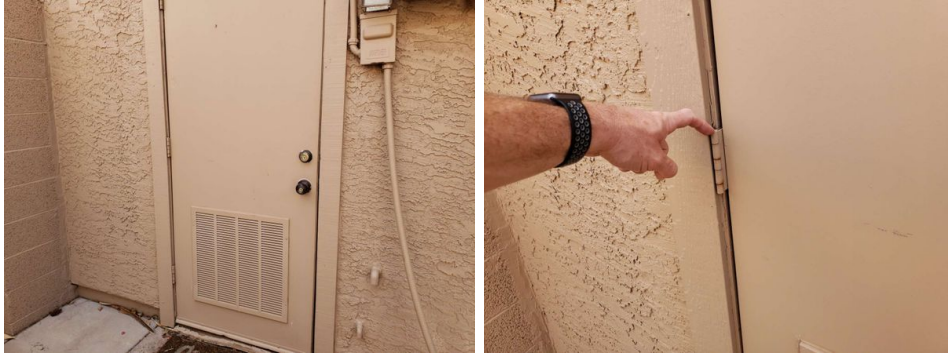
The garage service/exterior door is installed with the hinges on the exterior side and swings outward. Exterior doors are most commonly installed with the hinges in the interior side and swing inward. This could be a safety concern should the door be obstructed/blocked on the exterior side. Removal of the hinge pins on the exterior side may also be possible. Recommend assessment/re-installation if possible or replacement if needed by a qualified door contractor.

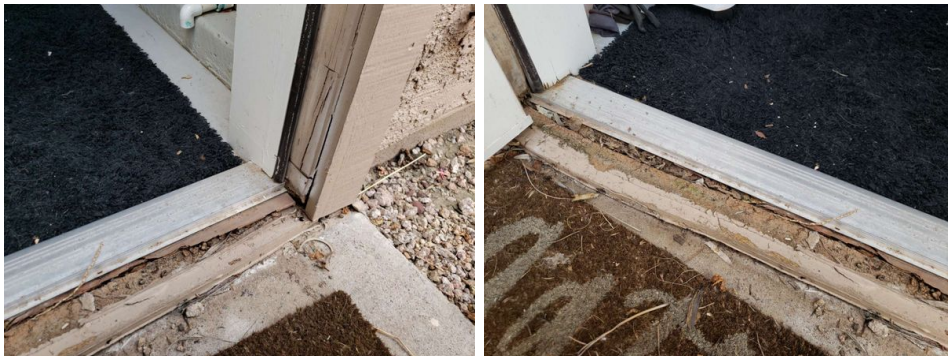
## 9.11.4 Garage Service/Exterior Door

Moisture damage observed at the garage service/exterior door. Recommend service/repair or replacement by a qualified door technician.

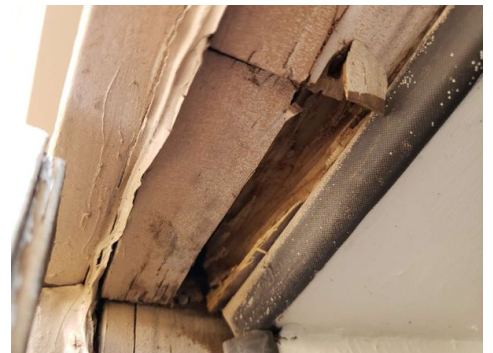
## 9.11.5 Garage Service/Exterior Door

Evidence of possible wood destroying organism activity observed. Recommend further inspection by a qualified pest control specialist.

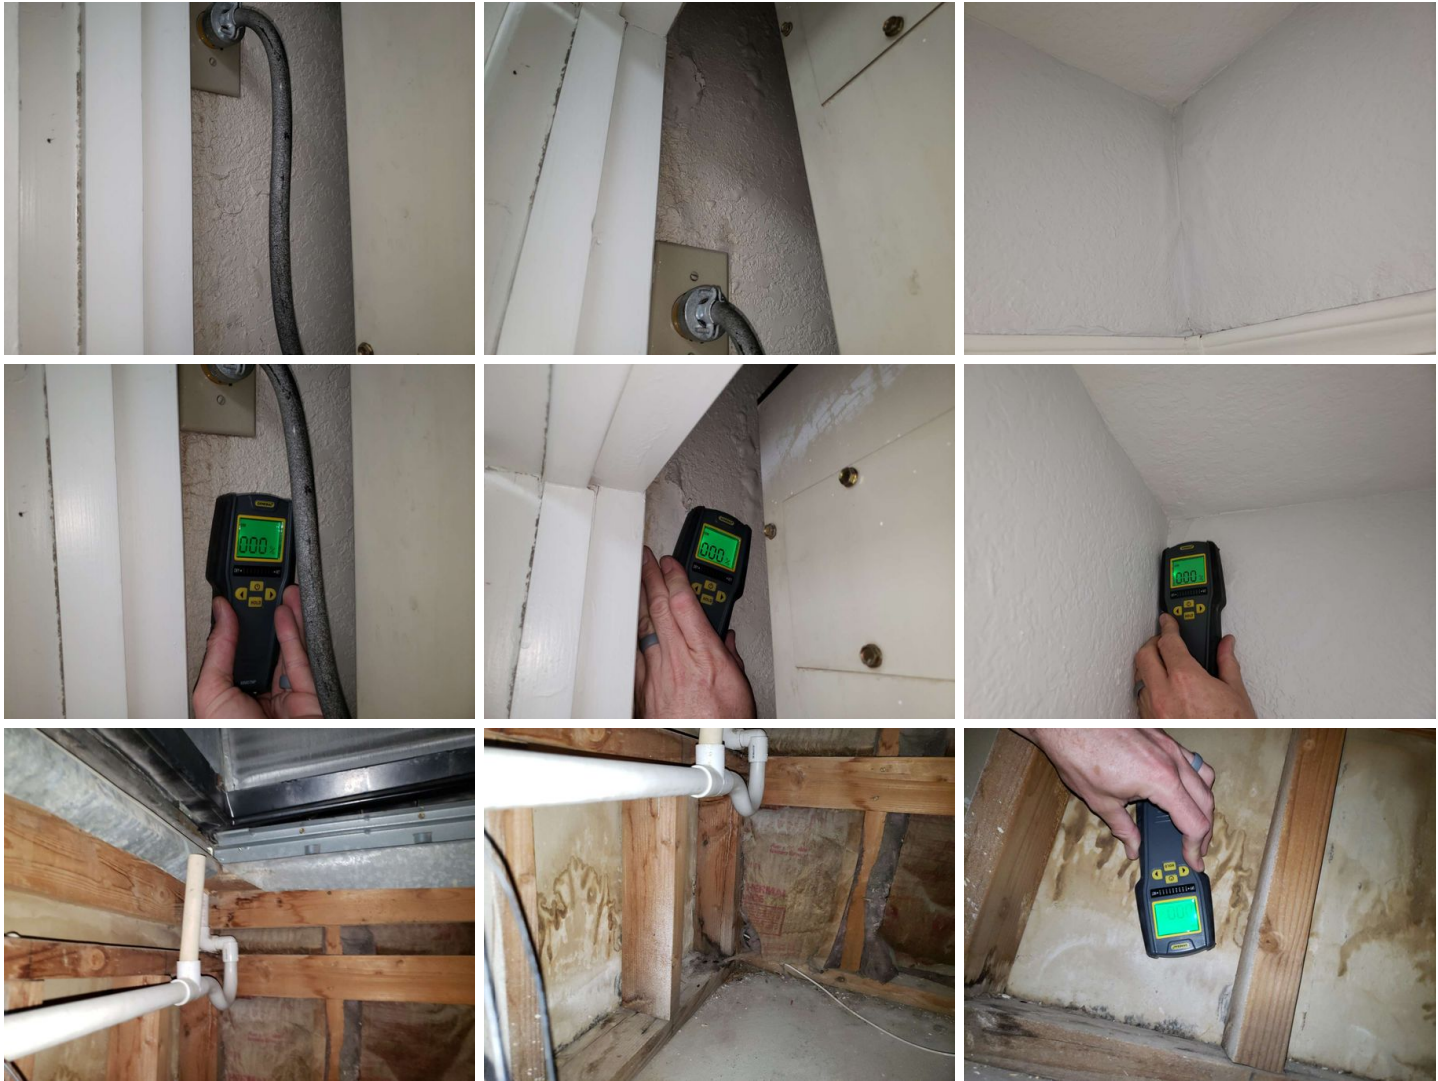
### 10.1.1 Walls/Ceiling

### EVIDENCE OF LEAK (NO ELEVATED MOISTURE DETECTED)

Water staining/damage noted. No elevated moisture was detected at the time of the inspection. Any observed indication(s) of leaking above/nearby will be documented in this report. Recommend assessment and service/replacement of damaged material by a qualified contractor.

Deficiency/Service or Replace

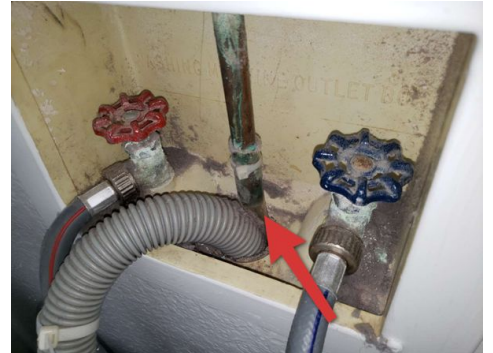
The water softener system regeneration drain/line terminates inside the washer drain with no air gap. This is considered to be a cross connection (direct connection to a contamination source) as sewer gas could be drawn into the clean/potable water supply if the drain dry were to dry out. Recommend correction/establishing an air gap by a qualified plumber.

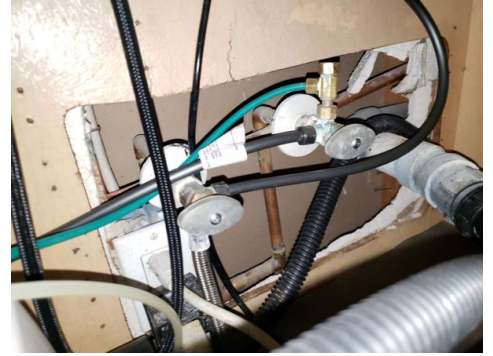
#### **MISSING DRYWALL**

Missing drywall observed. Recommend service/replacement by a qualified drywall professional.

Deficiency/Service or Replace

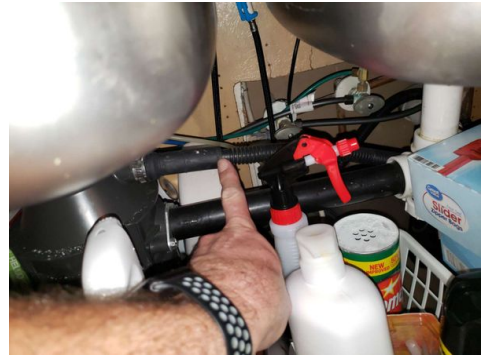
## 11.8.1 Dishwasher

A high loop is required on a dishwasher drain if an air gap is not installed. A high loop will help prevent backflow of water between the sink and the dishwasher. Recommend raising and securing a portion of the dishwasher drain hose as high as possible below the kitchen sink.

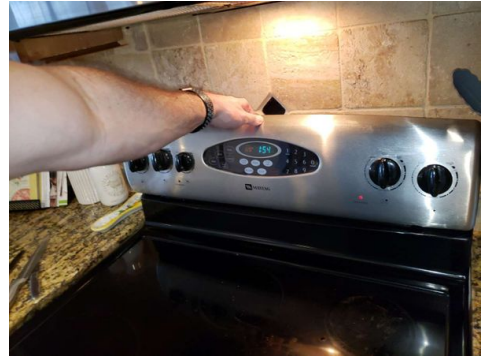
## 11.10.1 Ranges/Ovens/Cooktops

There is no anti-tip bracket installed for the range/oven. An anti-tip bracket will secure the range/oven to the wall or floor and help prevent accidental tipping should excessive force be placed on the open door. Recommend installation of an anti-tip bracket by a qualified appliance technician.

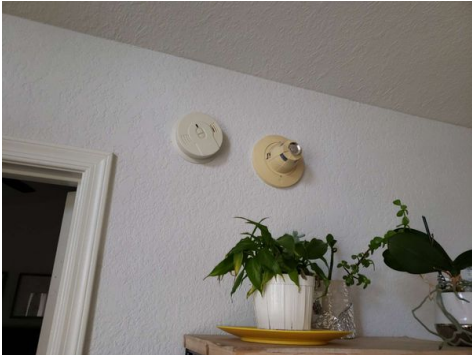
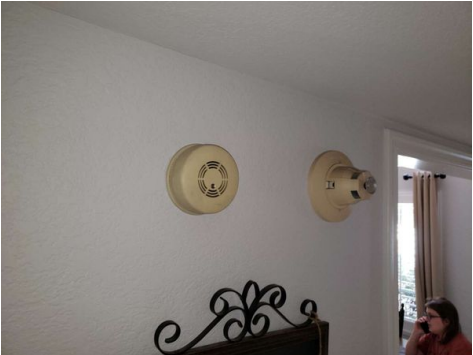
**SMOKE DETECTORS 10+ YEARS**

Smoke detectors appear to be 10 years or older. It is recommended that smoke detectors be replaced at 10 year intervals or sooner. Recommend replacement by a qualified electrician.

Deficiency/Service or Replace

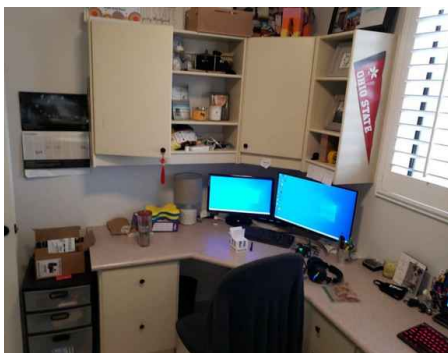
**Walls/Ceiling: Permanent Counter/Cabinets**

Cabinets and counter are permanently installed/secured to walls in one of the guest bedrooms. Removal may be necessary depending on the use of the space. Please note tile flooring *may not* be installed below the area.

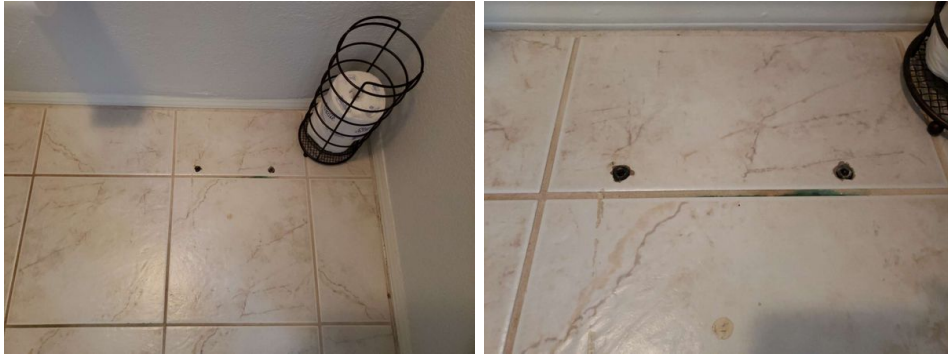
## 14.2.1 Flooring

**HARDWARE**

Hardware is embedded in the tile floor in front of the master toilet. The reason was not able to be confirmed. Recommend assessment and service if needed by a qualified flooring professional.

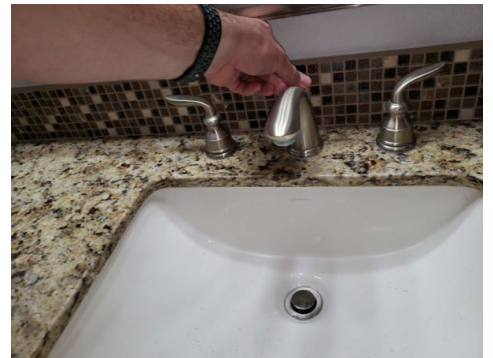
## 14.6.1 Sinks (including supply, drain, functional flow &amp; drainage)

The drain stop did not respond (raise/lower) when tested. Recommend service/repair as needed by a qualified professional/plumber.

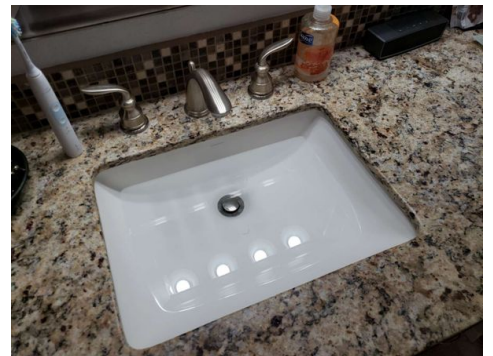
## 14.6.2 Sinks (including supply, drain, functional flow &amp; drainage)

**SLOW TO DRAIN**

Slow drainage noted. The sink filled with the drain open (drain stop open or missing). Recommend service/clearing by a qualified plumber.

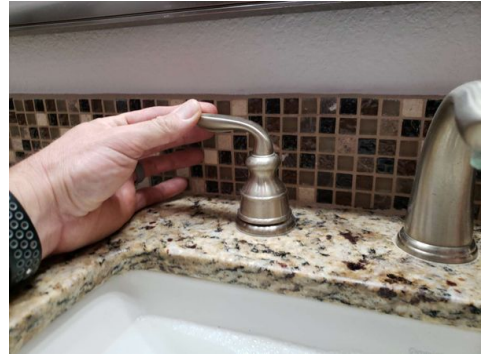
The master bath left faucet hot water handle does not stop in the off and fully hot positions. Recommend repair by a qualified plumber.

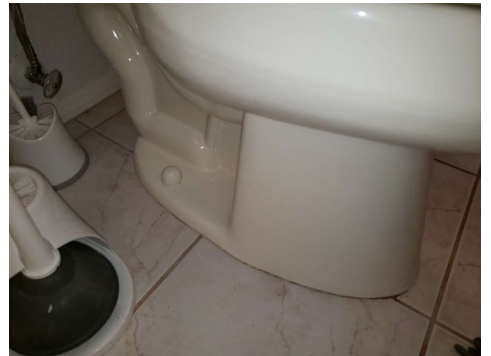
14.8.1 Toilet/Supply and Drain

### LOOSE TOILET (SLIGHTLY)

The toilet is not firmly secured to the floor. Recommend securing by a qualified plumber.
