# Arlington High School Network Closet Retrofit Fall 2021

By Jason DuBose

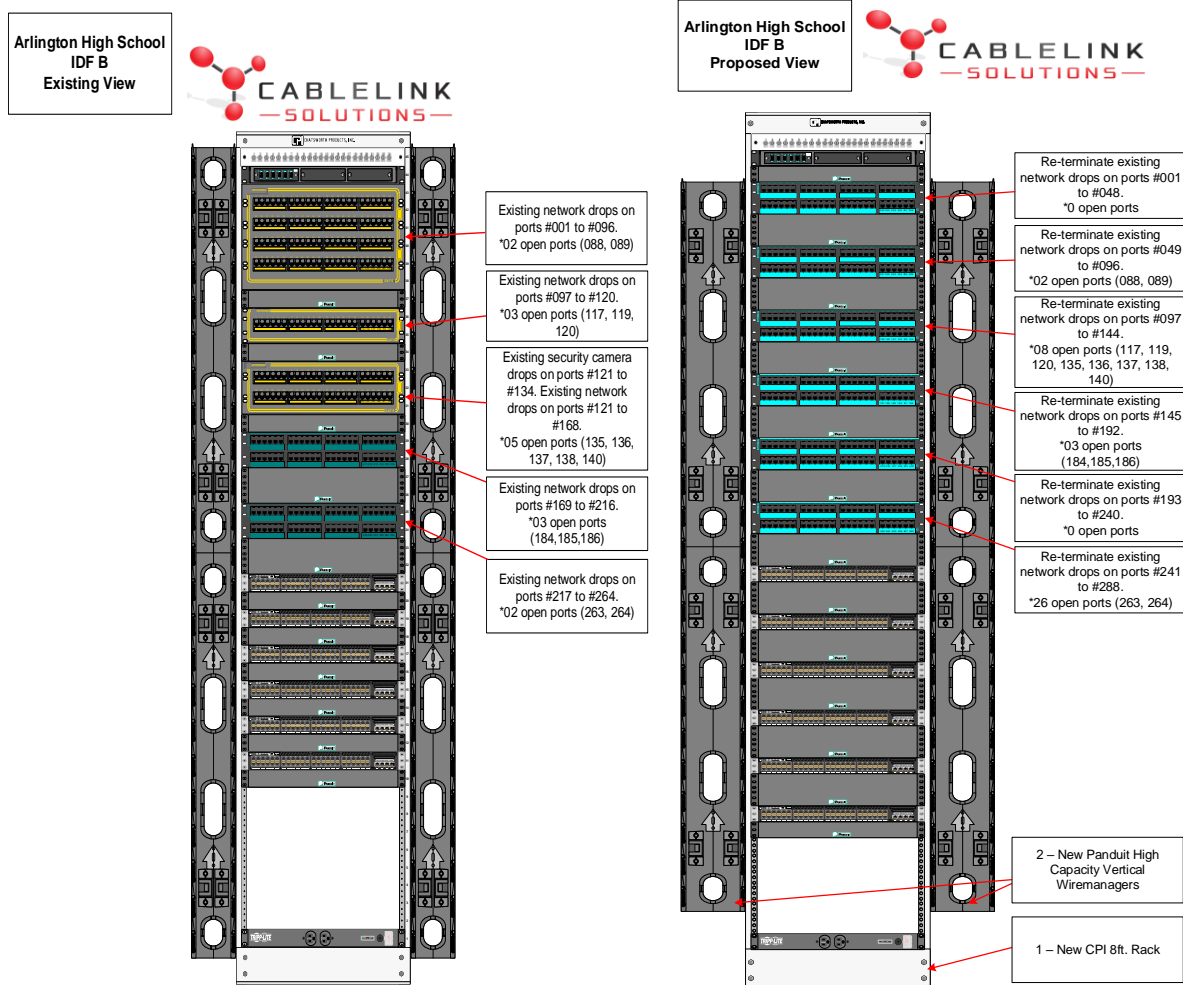
*In the below drawing the one on the left has been created as part of our discovery process of what is existing currently. This one is showing the layout with a traditional 7ft 19" Rack. 4"x4" front and back vertical managers, primarily 1 RU Horizontal wire managers. The drawing on the right shows what it would look like with an 8ft 19" Rack 6" x6" front and back Vertical wire managers and also new Ortronics Cat 6 48 port Patch panels and 2RU Horizontal Wire managers.*

As you can see on the Visio drawing below, Cablelink Solutions can also provide you with detailed rack elevations. These give our Installers an exact layout of how the new rack, cable managers and patch panels should be oriented. No hand drawn rack layouts that can be misinterpreted. A detailed color Visio drawing with specific notes to make sure work is completed correctly.

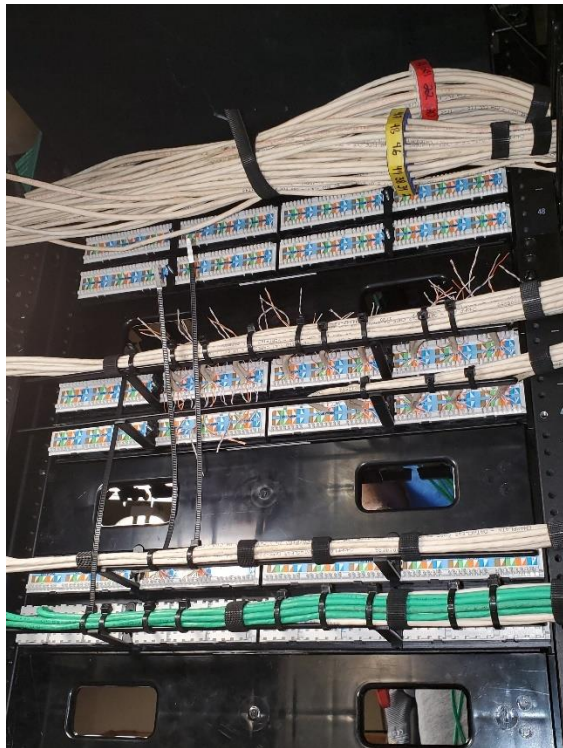
*Note: the plastic zip ties are only temporary and will be replaced with Velcro after the cables have been laced in and terminated. They help with breaking out the cables in pairs for the top and bottom port punch down position.*

As you can see from the picture on the left much of the older white cabling is at the top of the rack where it was the original cabling installed.

Over the years different types of cable, colors, and brands of UTP cable had been terminated on the panel. While we are reworking the racks, we are also taking these several generations of cabling and redressing them to make them look more consistent and uniform. Some of the older Cat 5 cable had a manufacture date of 08/24/1994 stamped on them. Something else to consider is the actual patch panel termination. Years ago, the tolerances for the amount of the cable jacket that was stripped back and the amount of untwist allowed for the individual cable pairs was less critical. So, technicians sometimes stripped back way too much jacket and untwist. We reterminated the cables with the modern rules for length of jacket removal and amount of wire pair untwist accounted for.

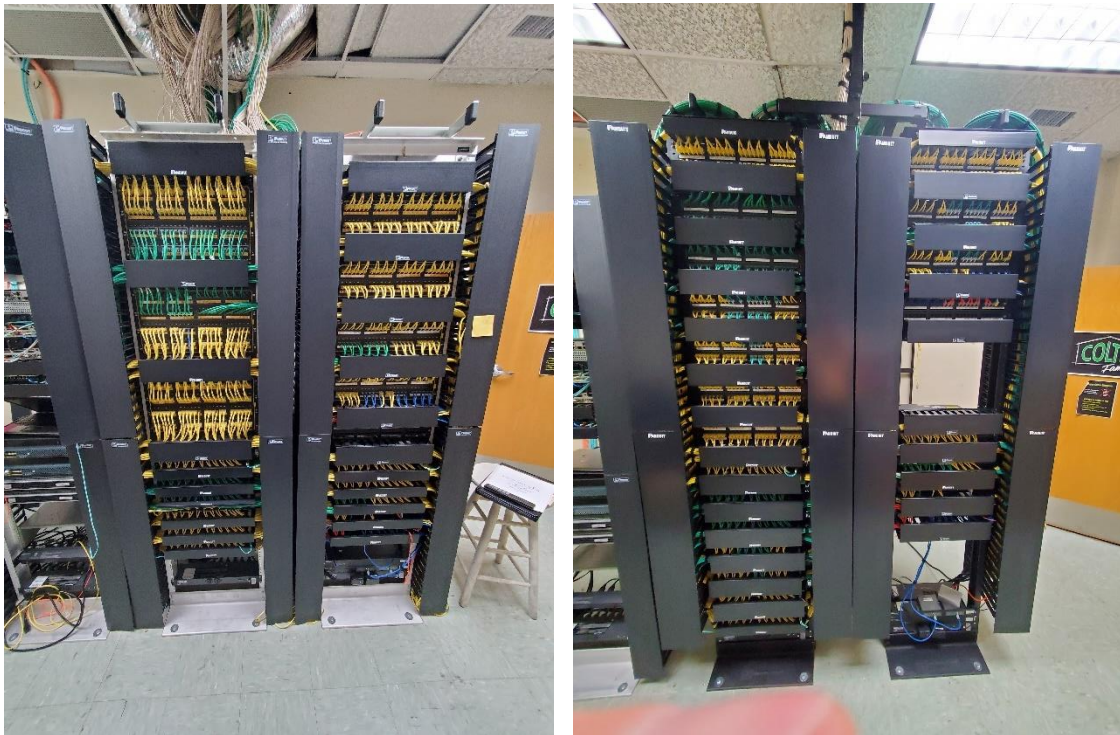
*The picture on the left is the MDF before we started. Many of the white cables shown coming out of the ceiling were cut off in the past and were just hanging because they were once part of an old-style phone system. We were able to reroute them and also re-terminate them on the new panels, so they were available to be used again. Being cut short we used a vertical piece of ladder rack to still have some of the shorter white cables be able to dress down into the rack. We were also able to fix the damaged ceiling grid since we rerouted all the different cables that were before too short or crossing each other.*

This room had the most work performed in it by far. It was the only room of the seven that needed to have two racks replaced. It also needed some work done to help fix the damaged ceiling grid where over time cabling just sort of came out of the large opening with out any consideration to putting back the drop ceiling tiles. Leaving the room to look like the entire ceiling was about to fall on top of all the racks and equipment.

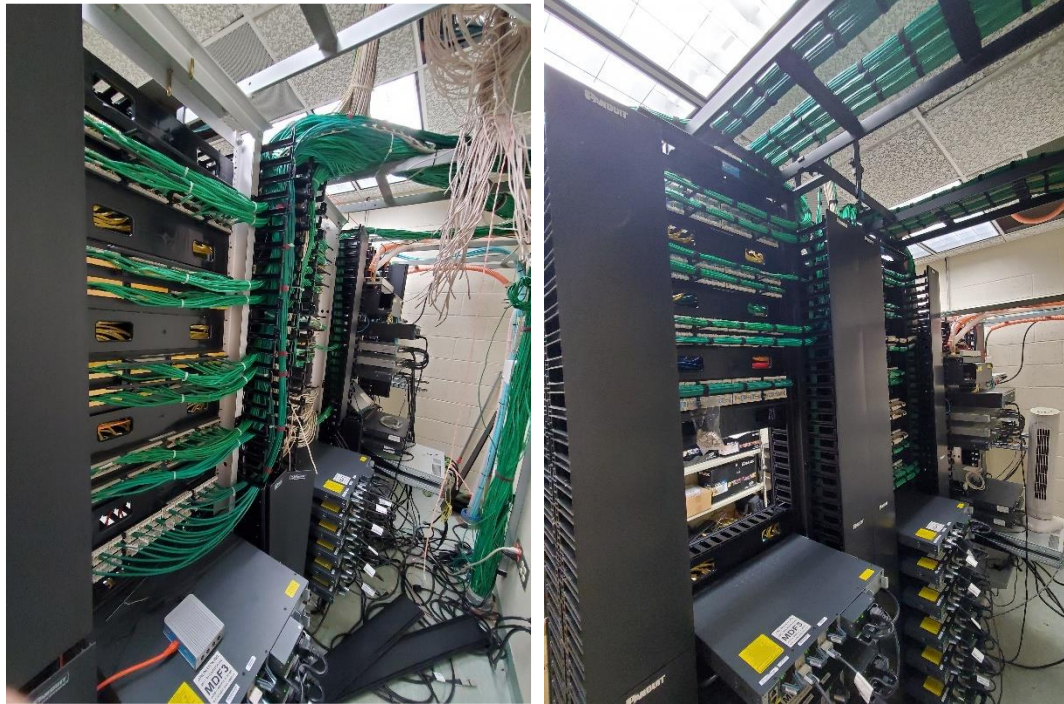
*You can see the before and after pictures of the back side of the two replaced MDF racks in the above photos. A cleaner and more professional looking rack layout. Older cables that were no longer needed were removed; older white cables that were still in use got re-terminated on the new racks. Using the taller 8ft racks some of the cabling that was originally in the left rack was able to move over to the rack on the right side. Freeing up space in the left rack for future growth.*

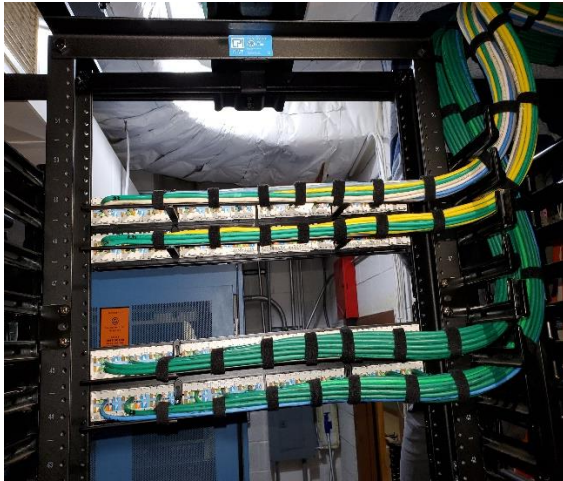
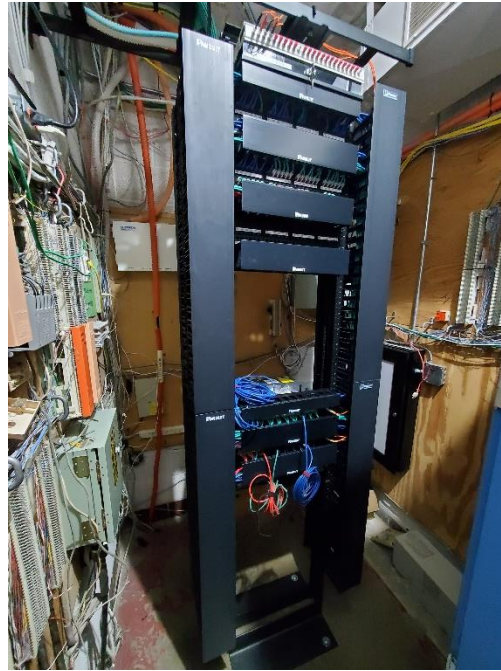
*Once again there are several different colors and generations of cabling being re-terminated into the CAT 6 new patch panels. The new rack also allows the district to stake claim to parts of the closet for the future. In case some of the old Demarc telecom equipment is removed, it will not become a custodial storage closet. Note Blue AT&T(Southwestern Bell) cabinet in background.*

This was probably the tiniest closet we dealt with on the project. This room was the schools original Building entrance point and DEMARC for the old telephone cabling from AT&T (Southwestern Bell). It was also where the OSP fiber enters the building from AT&T. They have a 7 ft enclosed metal equipment cabinet that takes up probably about 25% of the rooms usable space. Even though it's filled with mostly obsolete, unused equipment we decided to work around it. Originally, there was an old 3 ½ foot Swing gate style wall mount rack in there. We replaced it with a new 8ft 2-post 19" Chatsworth rack and used 4" front and back vertical managers due to the tight space. We also had to terminate (9) extremely short older cables on a wall mount patch panel bracket. We were not able to regain any more slack from the old cables. They were installed way back in the mid 1990's and the installers ran them without any slack loop at the Closet side. Also, some of them were ran at a diagonal instead of the current practice of running cable with 90-degree angles in J-hooks. These cables were so old they were running through bridle rings. So, because they could still be in use, we re-terminated these on a wall mounted patch panel. On this round we were just redoing the closet side. The information was given to the district and at a later time they will have us replace the cables still in use with new Cat 6 drops.

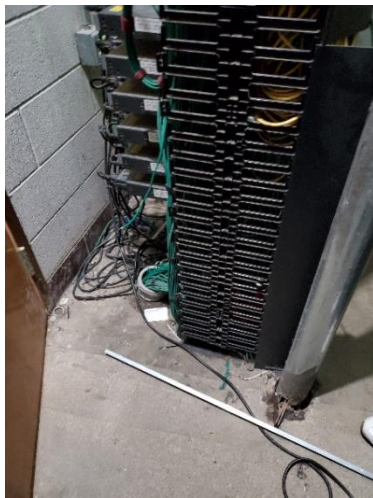
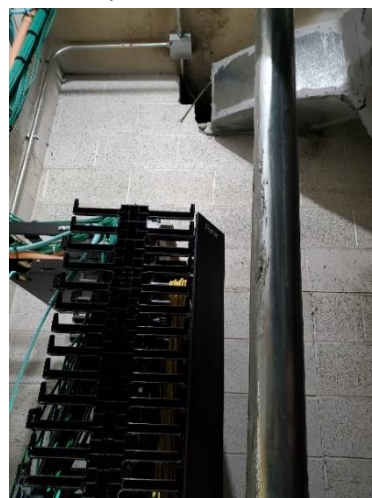
This is the original orientation of the rack in IDF B. As you can see the Cisco switches are almost impossible to access from the back side and in both pictures, you can see the gas pipe in the way covered by its protective casing. Also notice where the wooden door comes close to the rack.

We replaced the existing 7ft 2-post rack with an 8ft 2-post and new 2RU Horizontal wire managers and 6" x 6" vertical managers. Redressed and re-terminated the cabling onto new Cat 6 2RU 48 port patch panels. We had to drill new core holes on the left and right side where the vertical cable managers cover the floor. The natural gas pipe is less in the way than before. The wooden door will have its hinges reversed and it will eventually open outward instead of inward. This delayed us from mounting the left side's 6"x6" cable manager until the door can be rehung. At least now there is a full 1-1/2' of clearance from the back of the Cisco switch to the wall. So that the AISD Cisco Team can have easy access to the back of the switches.

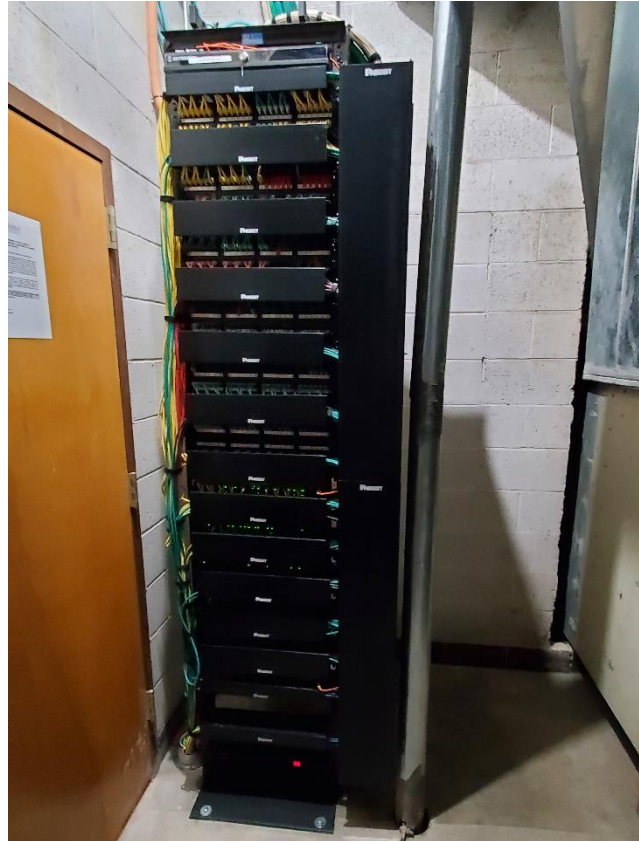
In this closet several 3- and 4-foot yellow patch cords were used. So, when we relocated the patch panels and replaced the 1RU wire management with 2RU managers we needed to change out the short patch cords on the front with longer 7ft green patch cords. Here we used the Ortronics EZ patch Box. Each box contains 50 patch cords on a reel. You simply pull out a patch cord and it's connected to the next one by a disposable clip. You use what you need without having to open plastic bags or undoing twist ties. Very convenient and produces a lot less waste packaging to have to clean up.

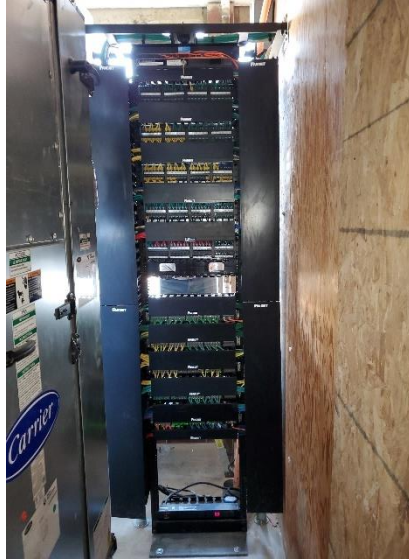
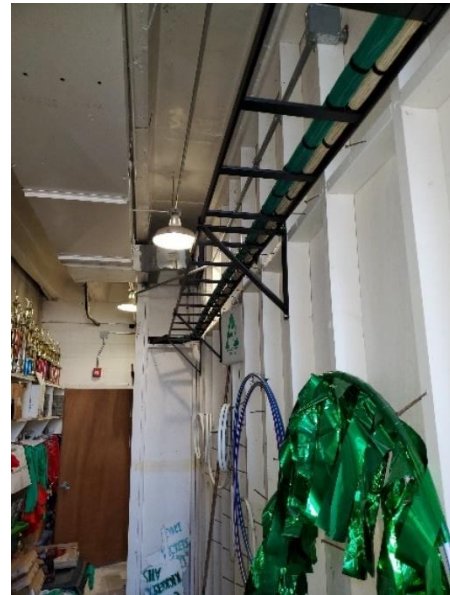
This was another closet that was placed in an Air handler room. We needed to install a new 8ft 2-post 19" rack and new wire management.

We needed to drill an additional floor core and add 2 new 2" wall sleeves. First, we needed to reduce the cable fill ratio in the existing 1 1/2" conduit. We replaced this with a new 2" sleeve then we rerouted the cables that came from the west

section of the IDF to get back some slack we needed to re-terminate the cabling onto the new rack. The original installers went down the original 1 1/2" above ceiling sleeve combining them, well past the direct path they could have taken on the 1<sup>st</sup> floor into the room below the IDF. Instead of adding a 2<sup>nd</sup> sleeve. By rerouting these cables, we regained about 20 ft of extra slack for every cable coming from the west side of the section covered by this IDF. By adding an extra 2" sleeve we also solved the overfilled conduit and created a new more direct path getting both runs to the proper fill ratio.

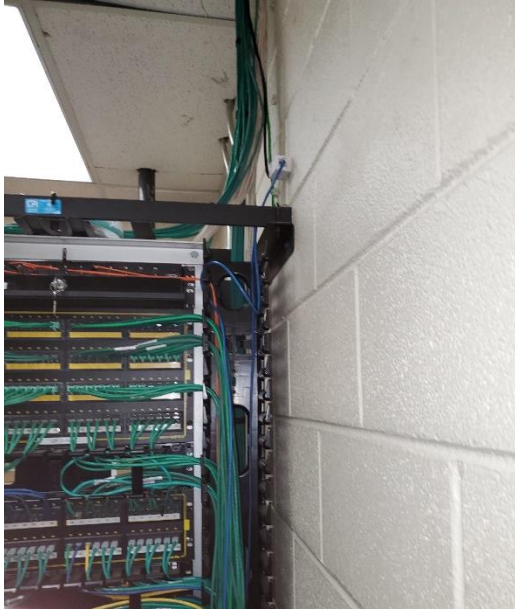
In this closet we needed to re-orient the rack back some to better cover the core hole that was added after the original rack was installed. We also installed new 6" x 6" Panduit verticle cable managers and also 2RU Horizontal cable managers were added. We replaced several of the older Cat 5 oversized patch panels with the newer 2 RU Cat 6 patch panels. We also added an 8ft Rack to replace the 7ft one. We also reouted some of the cabling from the way it was entering into the IDF and into the rack. Several cables crossed over and needed to be pulled out and

replaced into new bundles so that they flowed down into the right side of the rack and became more uniform.

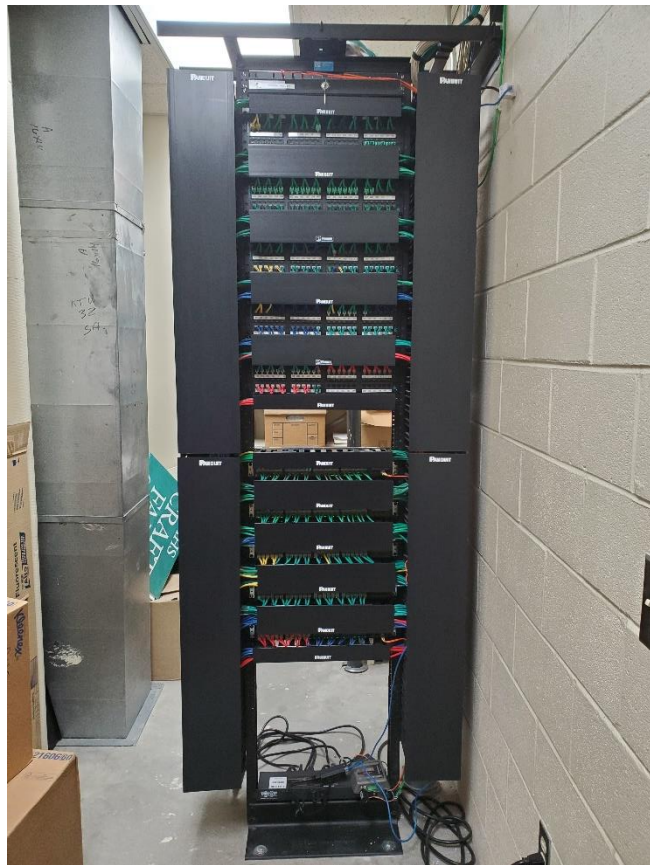
**IDF D with the finished look of the new 8ft Rack and new wire managers**

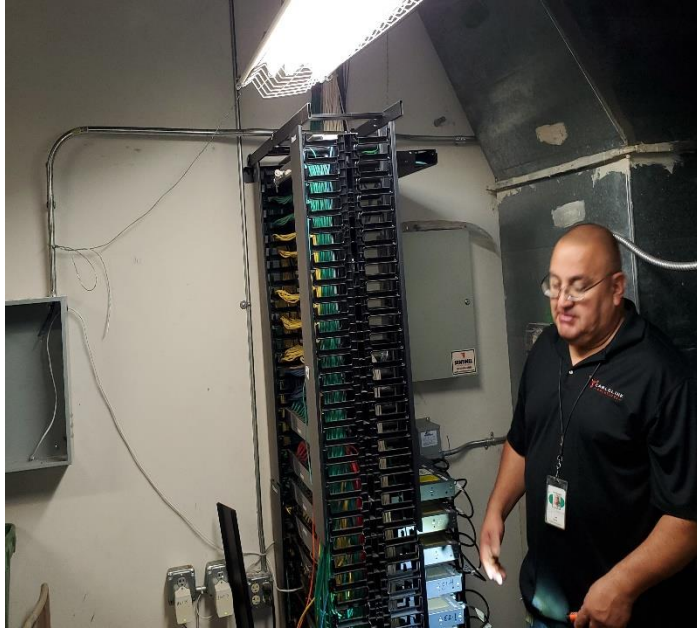
**IDF E**

**Lee Solis owner of Cablelink -Texas going over the plan for the work required for IDF E.**

In IDF E we had to deal with several other trade's cabling and piping that was installed around the network equipment rack as time went by. As you can see in the picture there is an unused metal panel that has a ¾' EMT pipe running through the data cable bundle. Another panel that is still in use for some building controls is behind the rack in the way also. We needed to install 2 new 2" floor cores and one new 2" wall sleeve to be able to re-route the cabling to cleanly enter the new 8ft rack. This also allowed us to achieve a proper fill cable fill ratio once again for the conduits. We also were able to once again to achieve separation in conduit with only data

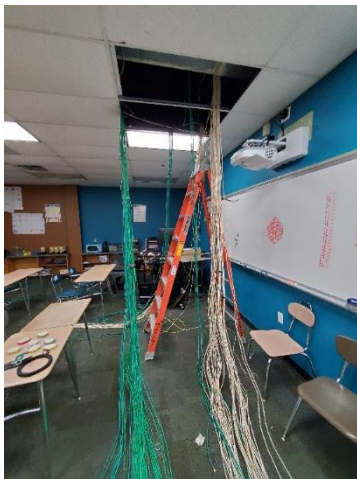
**This picture is also from IDF E. This is the classroom next door to the mechanical room where the cables from the 2nd floor enter the top left side of the rack in IDF E. We replaced the existing 1-1/2" Sleeve with a new 2" sleeve. As you can see, we are pulling back the cabling so it can be re-routed with new J-hook pathways and grouped in more sensible bundles before it enters the new rack through the wall in the right side of the picture.**

cabling in the cores. The cores made it easy for other trades to run their cabling between floors, but it created the problem of mixing cable types that could cause EMF interference for the data cabling. This was also one of the closets that had 50% of older white cabling and newer green jacketed Berk-Tek cabling. We moved the rack out away from that metal building control box. We also needed to get away from that large square airduct that was too close to the newer rack location, and taller 8ft rack. We also moved chains hanging the overhead florescent light. Since we installed the newer 8ft rack, the light was in the way. We added two new 2" floor cores one on each side of the rack to be hidden by the new 6" x 6" managers. So, now the only cable left in that old conduits were other trades building control cables, access control cabling and PA speaker cabling.

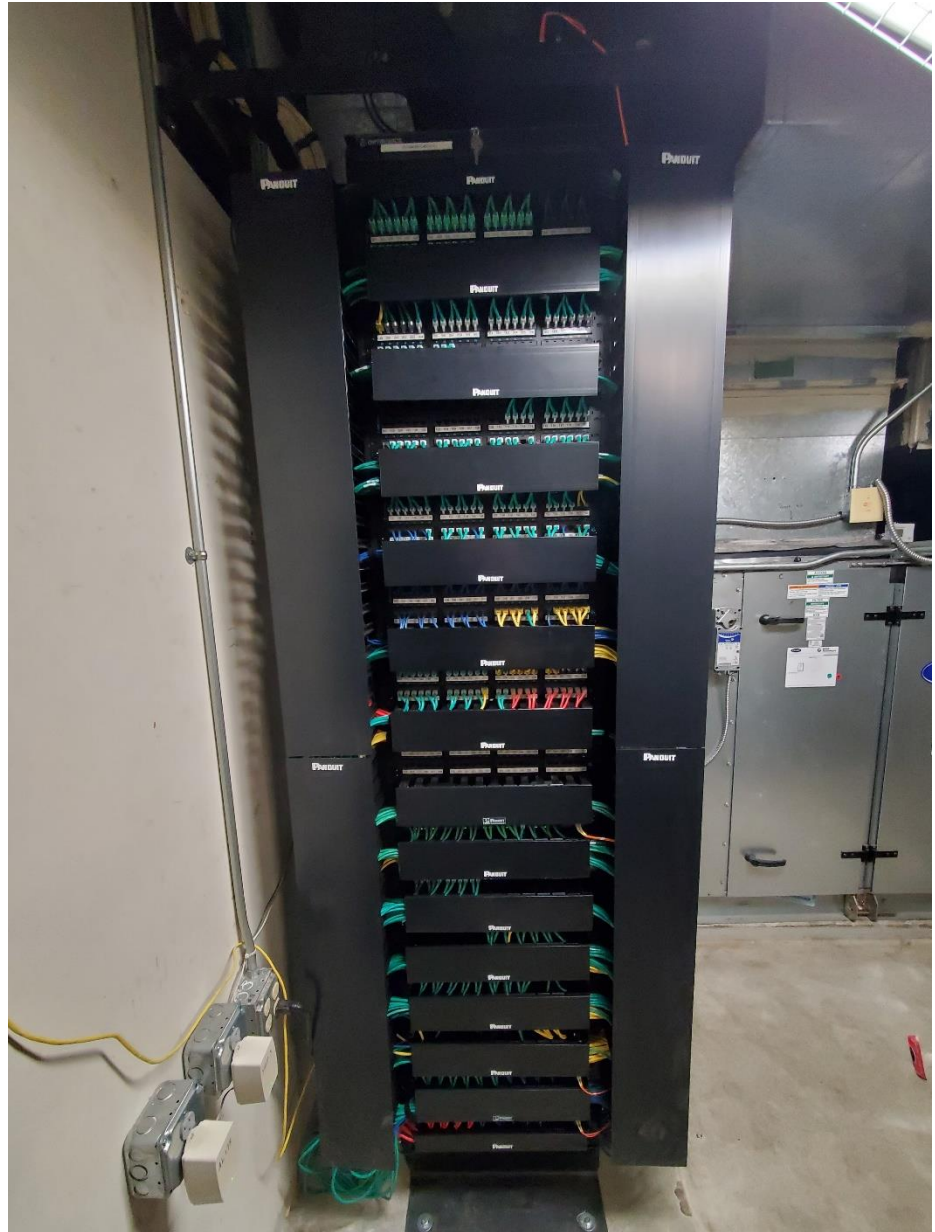
**IDF E. The new 8Ft rack with new 6" x 6" Vertical managers and all 2 RU Horizontal managers. The 3/4" EMT pipe has also been removed that ran along the wall through the cable bundle. The fluorescent hanging light's chain hangers have been moved away from the new rack location.**

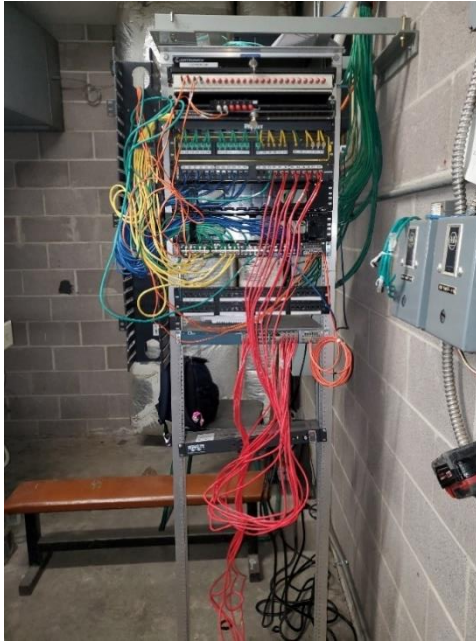
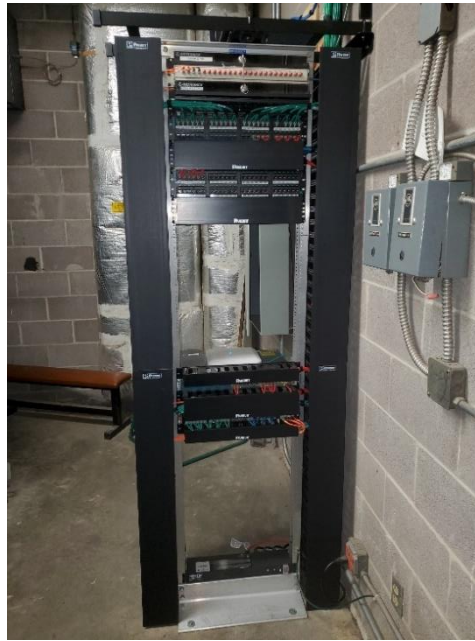
This is a small closet on the West side of the Main GYM area. It had only a single sided piece of latch duct screwed onto the side for vertical wire management. We used the 4"x 4" vertical managers here because there are not that many cables coming to this rack. We changed out the ladder rack to black to match the cable management on top and added a piece coming down the wall to the rack from where the cable bundle runs above the Air handler unit.

This is one of the few closets that we didn't change out the rack and left the old unpainted aluminum 7 ft 2-post rack in place. We did redress the cables in to bundles and reterminated them onto new Cat 6 48- port patch panels. The most visual thing we did was install Vertical and horizontal cable management to clean up the look of the rack. Also took the time to mount the PDU at level. Something the original installers didn't do. I guess they forgot their level that day.
