Reserve Analysis Report

Sunridge at Avon II

1050 W Beaver Creek Blvd
Avon, CO 81620

Level I Study with Site Inspection

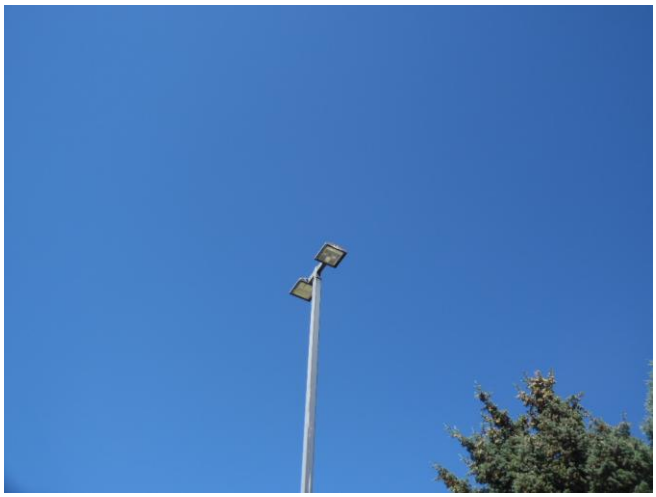
Lighting — Street Lights

Approximate Component Quantity	-	15	Estimated Current Unit Cost	$	1,400.00
Unit of Measure	-	Each	Estimated Total Current Cost	$	21,000
Normal Useful Life (Years)	-	25	Estimated Total Future Cost	$	28,222
Estimated Remaining Useful Life (Years)	-	10	Fully Funded Balance	$	12,600
Estimated Replacement Year	-	2036	Depreciation This Year	$	840
Cost Source	-	1	Monthly Contribution	$	88.02
Depreciation Percent	-	0.42%	Fully Funded Balance Percent		0.70%
Life Remainging Percent	-	40%
