Title 5 Official Inspection Form

15 Pleasant Street Anchorage Condominiums - WEST BUILDING — Assessors Map 14 & Parcel F-4
Property Address

West Roxbury | MA | 02132 | August 28, 2023
City/Town | State | Zip Code | Date of Inspection

Moran Engineering Associates, LLC
Company Name

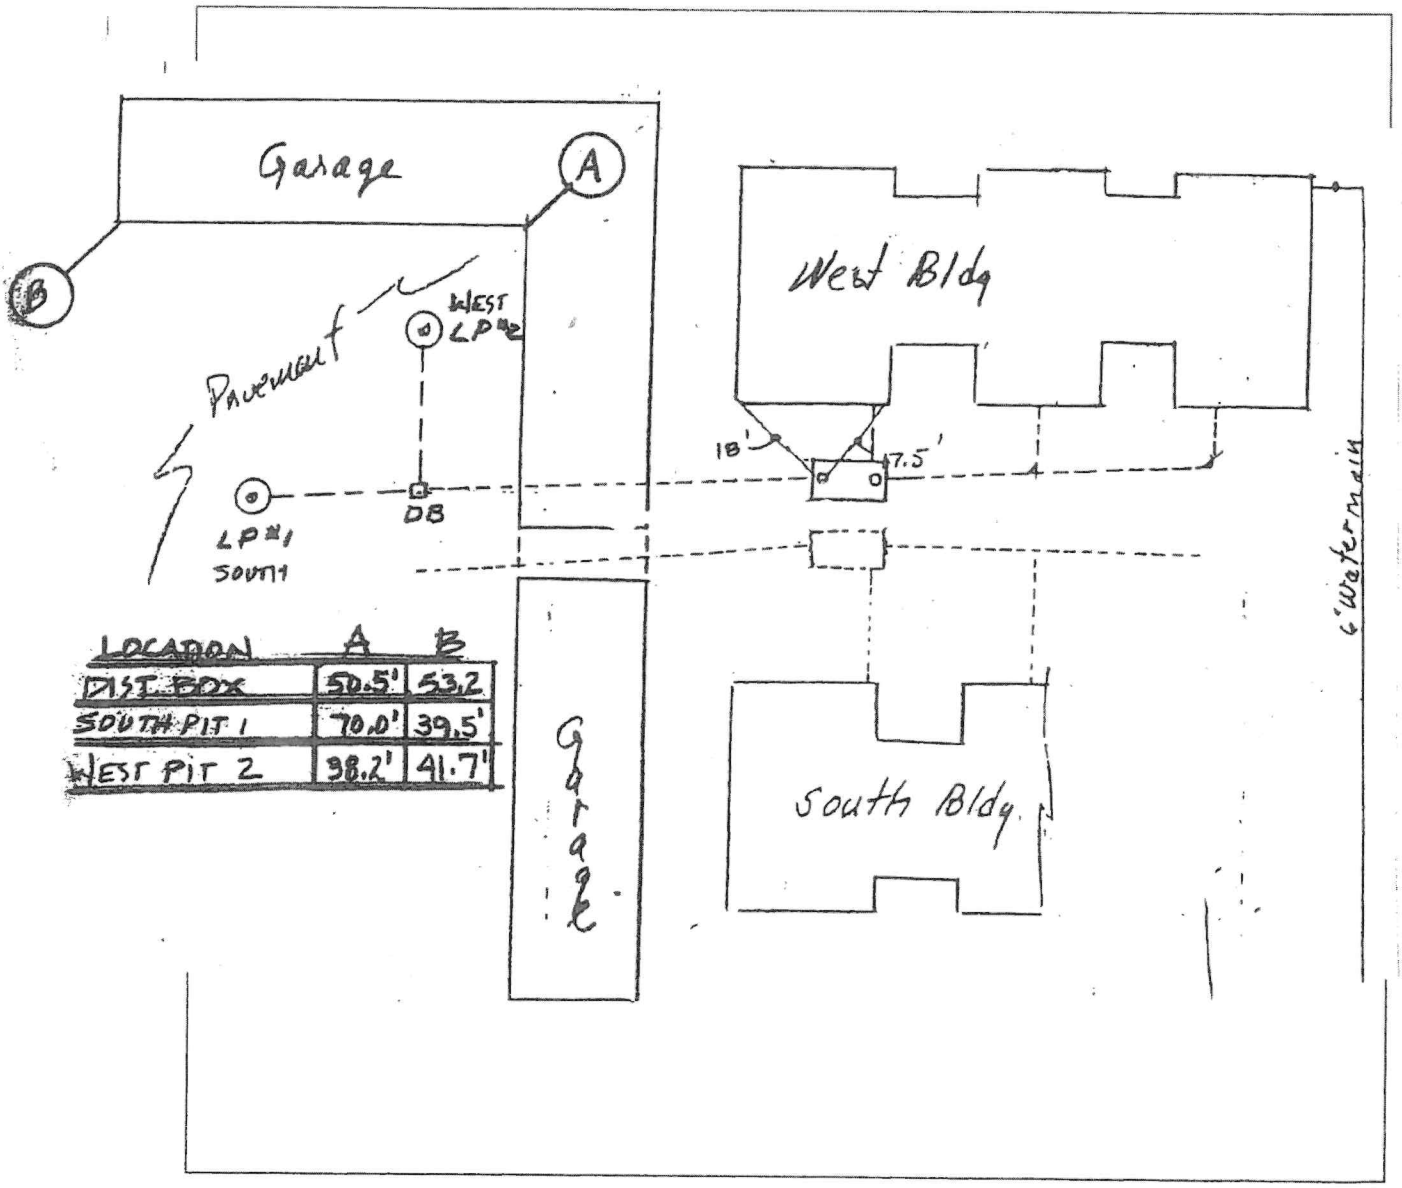
14. **Sketch Of Sewage Disposal System:**
Provide a view of the sewage disposal system, including ties to at least two permanent reference landmarks or benchmarks. Locate all wells within 100 feet. Locate where public water supply enters the building. Check one of the boxes below:

Comments (note condition of soil, signs of hydraulic failure, level of ponding, damp soil, condition of vegetation, etc.):
SAS:
West Leach Pit: 24" steel cover at grade. Liquid: 1.3'. Staining indicators at 4.2' +/- above floor.
South Leach Pit: 24" steel cover at grade. Liquid: 3.5'. Staining indicators at 5' +/- above floor.

There were no observed signs of backup, breakout or hydraulic failure within or above the leaching areas at the time of the field inspection.
