PB92-910402
NTSB/AAR-92/02
(SUPERSEDES NTSB/AAR-90/01)

AIRCRAFT ACCIDENT REPORT

EXPLOSIVE DECOMPRESSION--
LOSS OF CARGO DOOR IN FLIGHT
UNITED AIRLINES FLIGHT 811
BOEING 747-122, N4713U
HONOLULU, HAWAII
FEBRUARY 24, 1989

Adopted: March 18, 1992
Notation 5059C

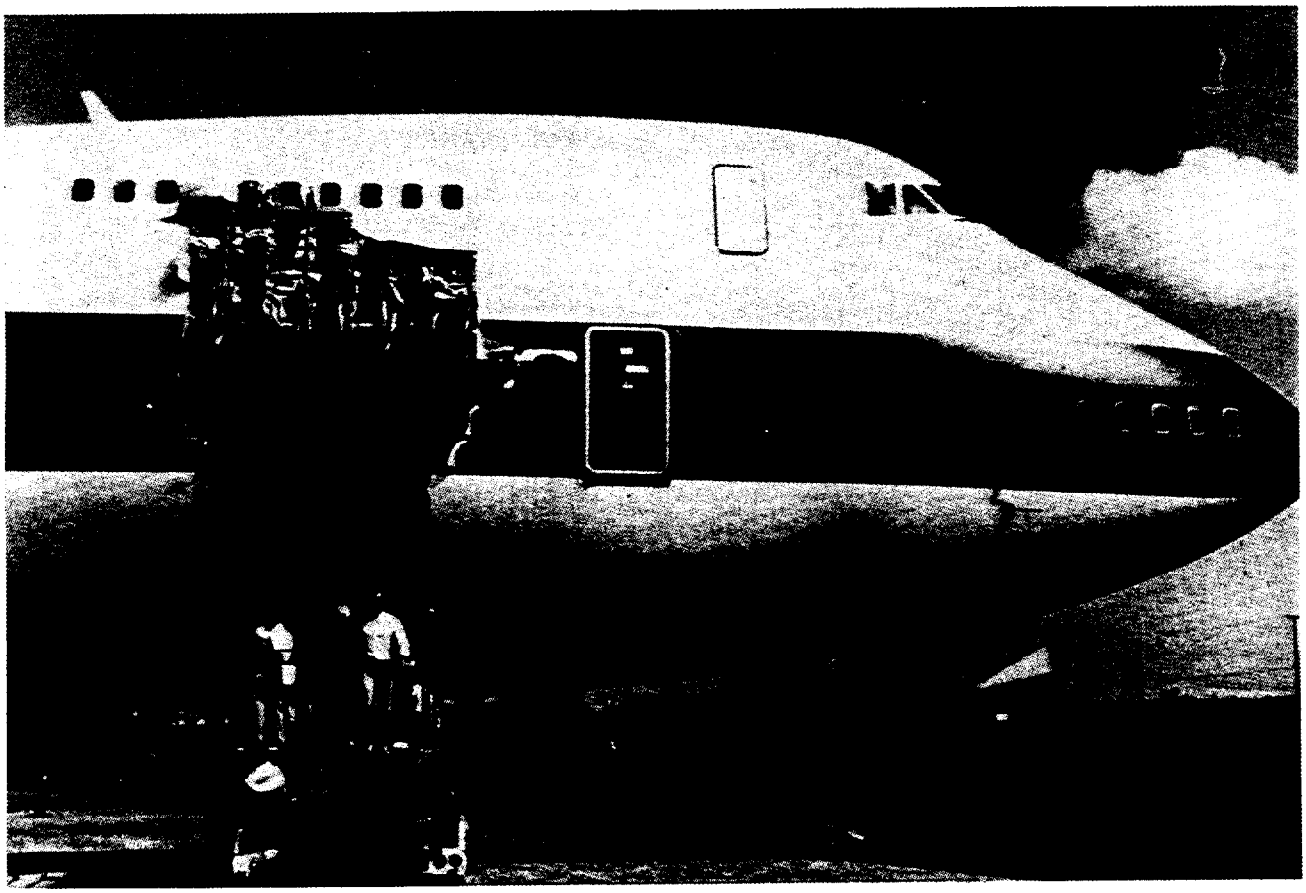
The primary damage to the airplane consisted of a hole on the right side in the area of the forward lower lobe cargo door, approximately 10 by 15 feet large. The cargo door fuselage cutout lower sill and side frames were intact but the door was missing (see figures 1 and 2). An area of fuselage skin measuring about 13 feet lengthwise by 15 feet vertically, and extending from the upper sill of the forward cargo door to the upper deck window belt, had separated from the airplane at a location above the cargo door extending to the upper deck windows. The floor beams adjacent to and inboard of the cargo door area had been fractured and buckled downward.

Figure 1 .--Overall view of forward cargo door area
on the right side of the aircraft.

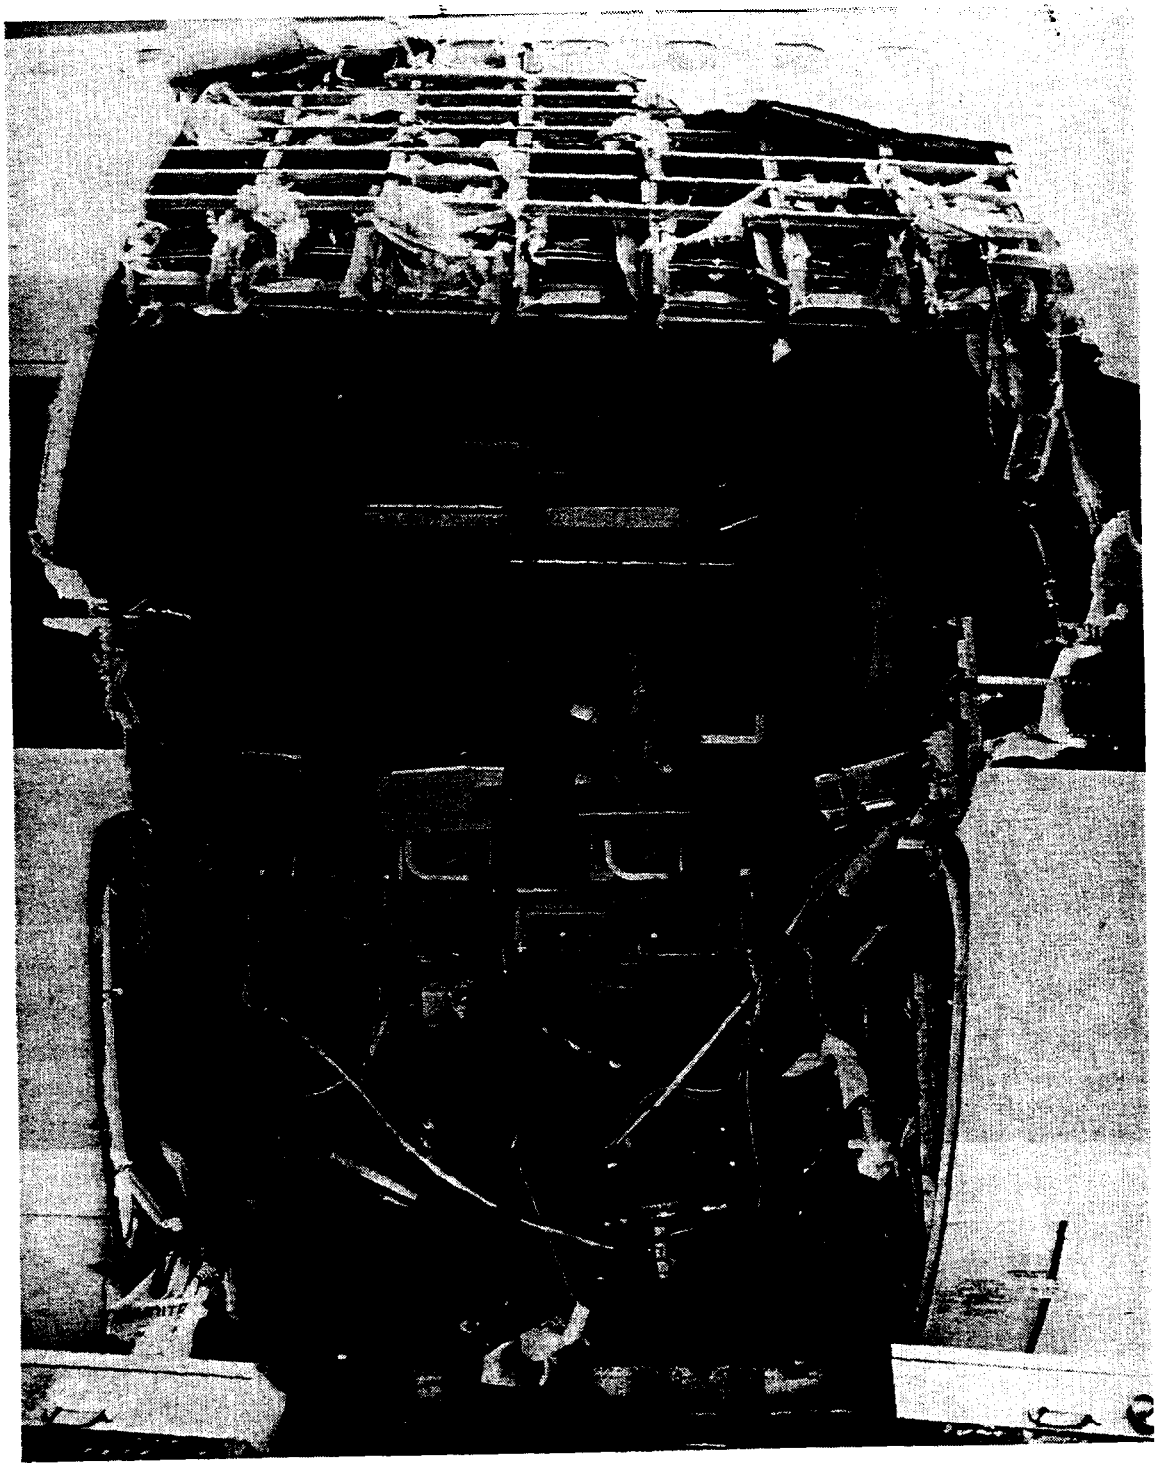
Examination of all structure around the area of primary damage disclosed no evidence of preexisting cracks or corrosion. All fractures were typical of fresh overstress breaks.

Figure 2.--Close-up view of hole and surrounding structure damage.

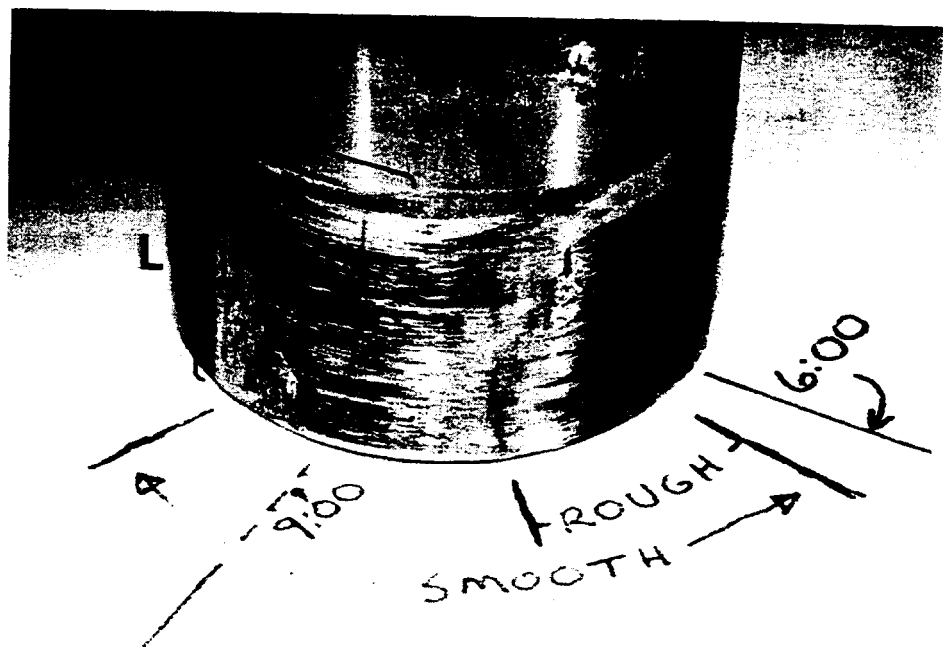
Based on the orientation of the latching mechanisms, the fully unlatched latching cams would first contact the latch pins from about the 1: 15 o'clock position to the 7: 15 position as the door was closed. As the cams are being latched around the pins, they would rotate approximately 80°, making contact with the pins from about the 4:15 position to the 10:15 position (See figure 7).

Figure 7.--Latch pin number 6. Note the rough and smooth areas and the steps indicating the contact area with the latch cam.

Detailed examination of the exposed surface of the pins (the portion of the pins extending from the housings) revealed various types of wear and damage. In general, all of the forward door cargo latch pins had smooth wear over the entire portion of the pin area contacted by the cams during normal closing and opening of the door. The pins also had distinct roughened (smeared) areas between the 6:15 and the 7:30 positions (See figure-8). The roughened areas had evidence of "heat tinting" and transfer of cam material to the surface of the pins. On pins 1 and 8 the roughened areas extended past the pin bottom to the 5:00 position. The 7:30 position approximately corresponds to the area on the pin where the lower surface of the cam would be relative to the pin when the latch cams are in the unlatched or nearly unlatched position.

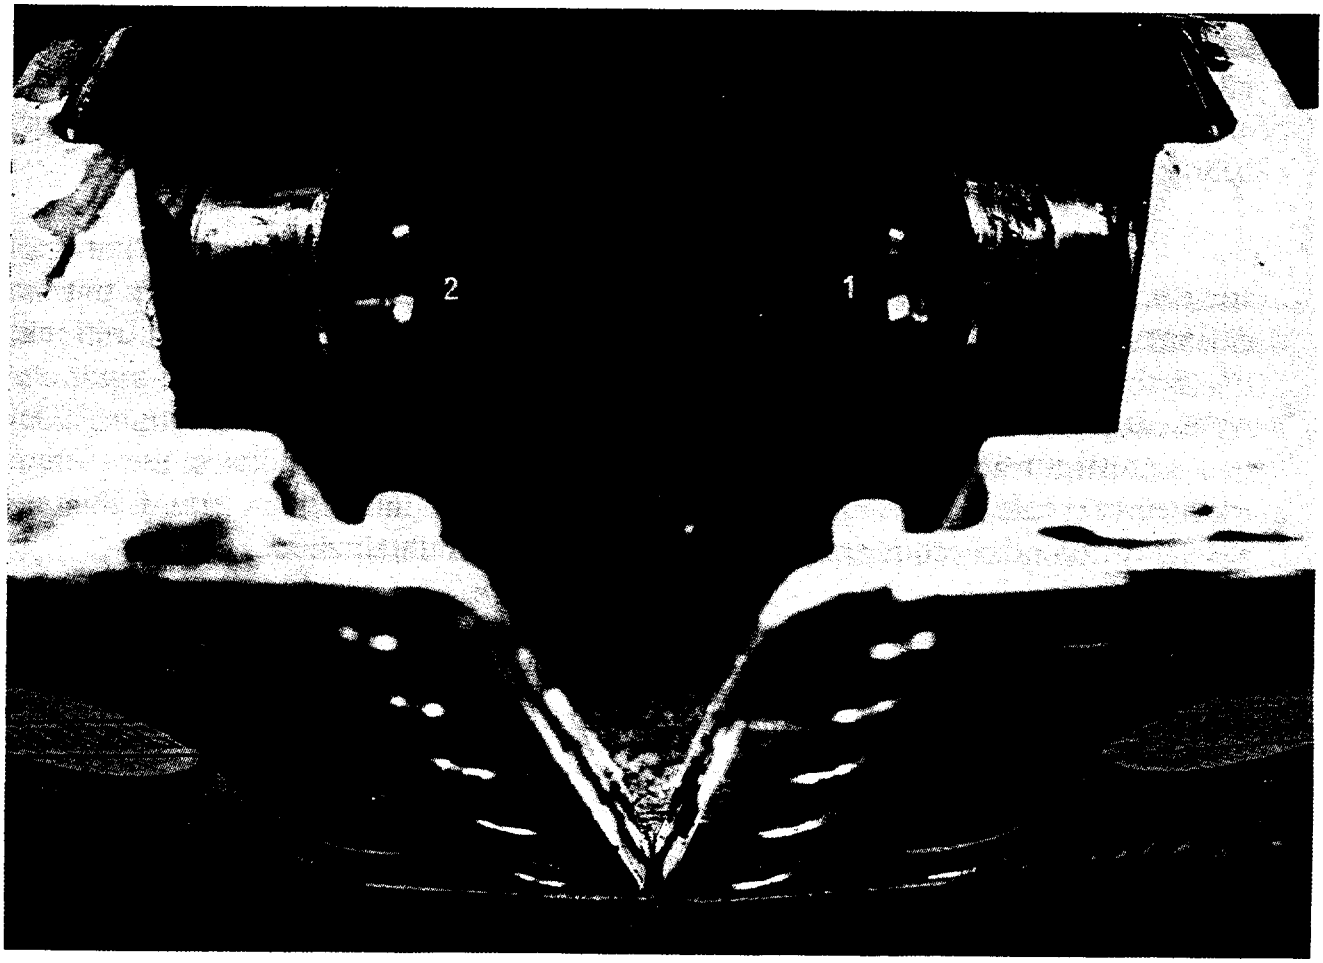
Figure 8.--Lower latch pin and housing assemblies Nos. 1 and 2 looking up and slightly outboard.

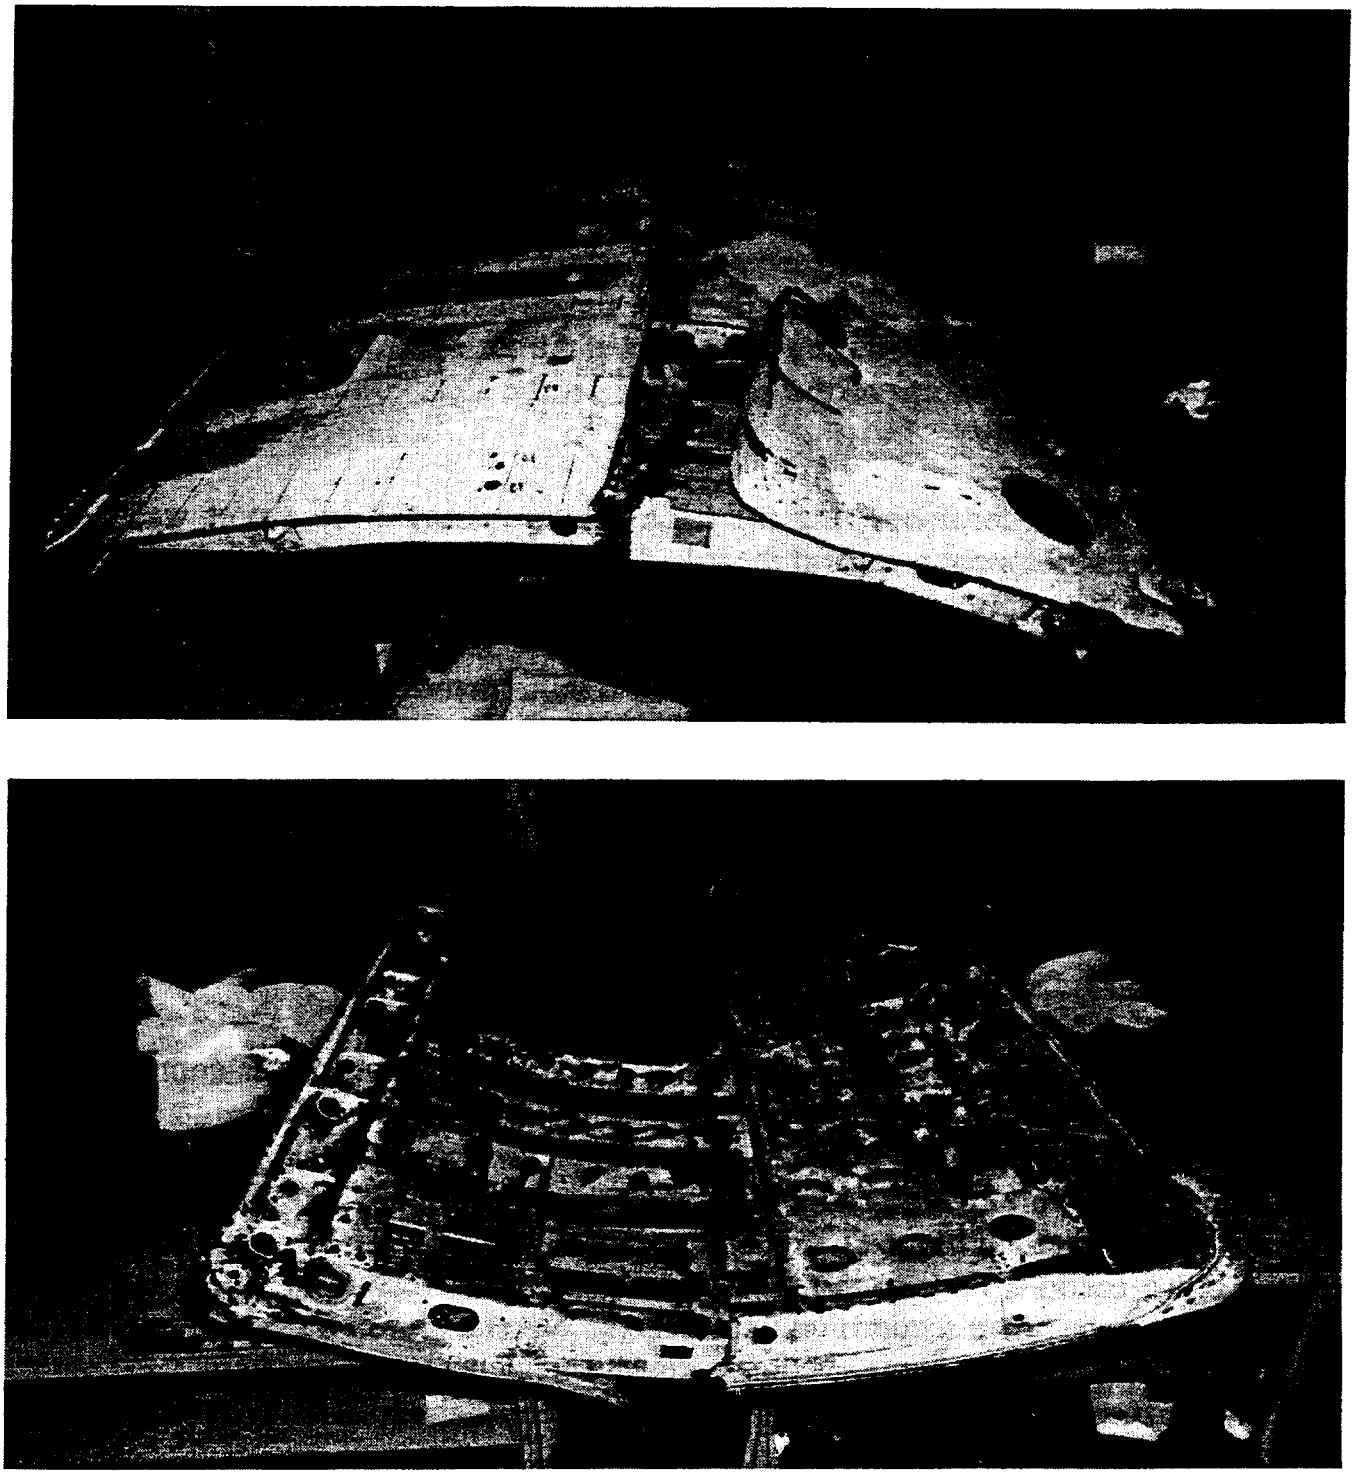
The cargo door had fractured longitudinally near the mid-span lap joint near stringer 34R, just beneath the mid-span torque tubes. Except for an area of missing skin between frames 2 and 3 and a portion of frame webs where the upper latch lock torque tube had tom out, the frames and skin of the upper door

Figures 9 and lO.--Exterior [top photo] and interior bottom photo] views of cargo doors after removal of pull-in hooks, latch cams, lock sectors, and actuators.

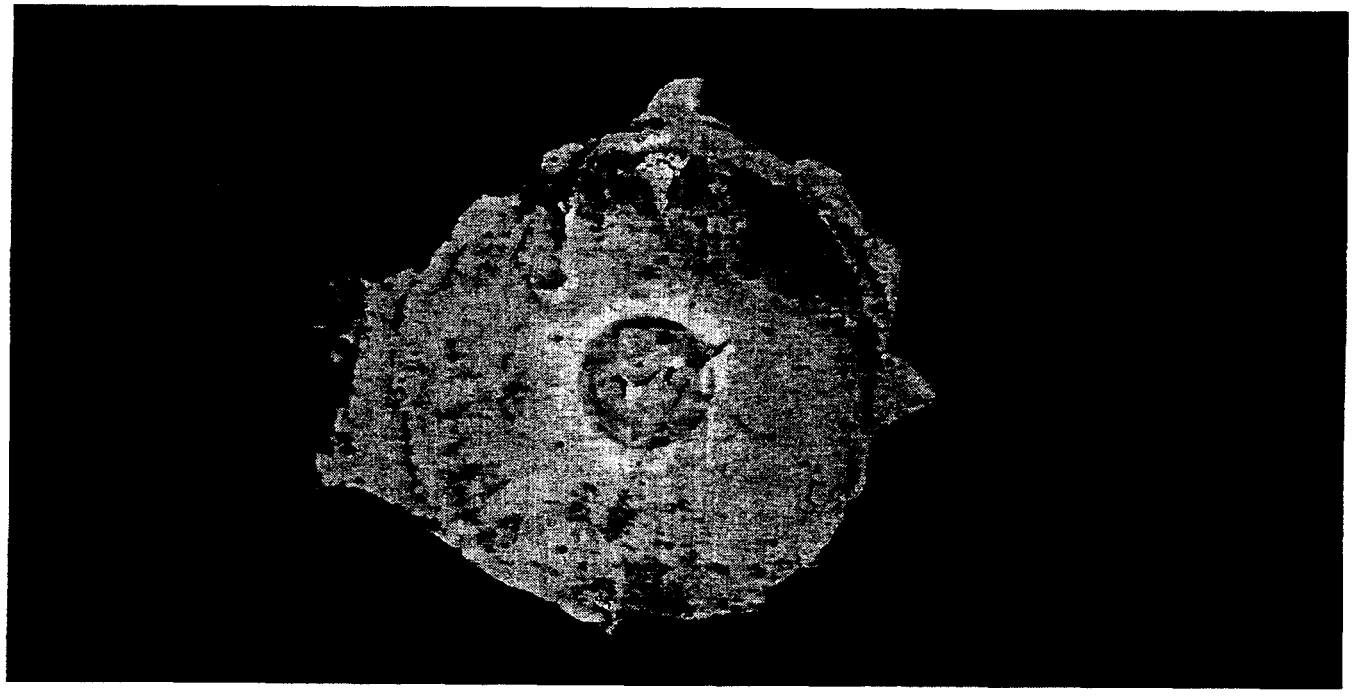
Figure 13.--Underside of decal piece (2X Magnification).

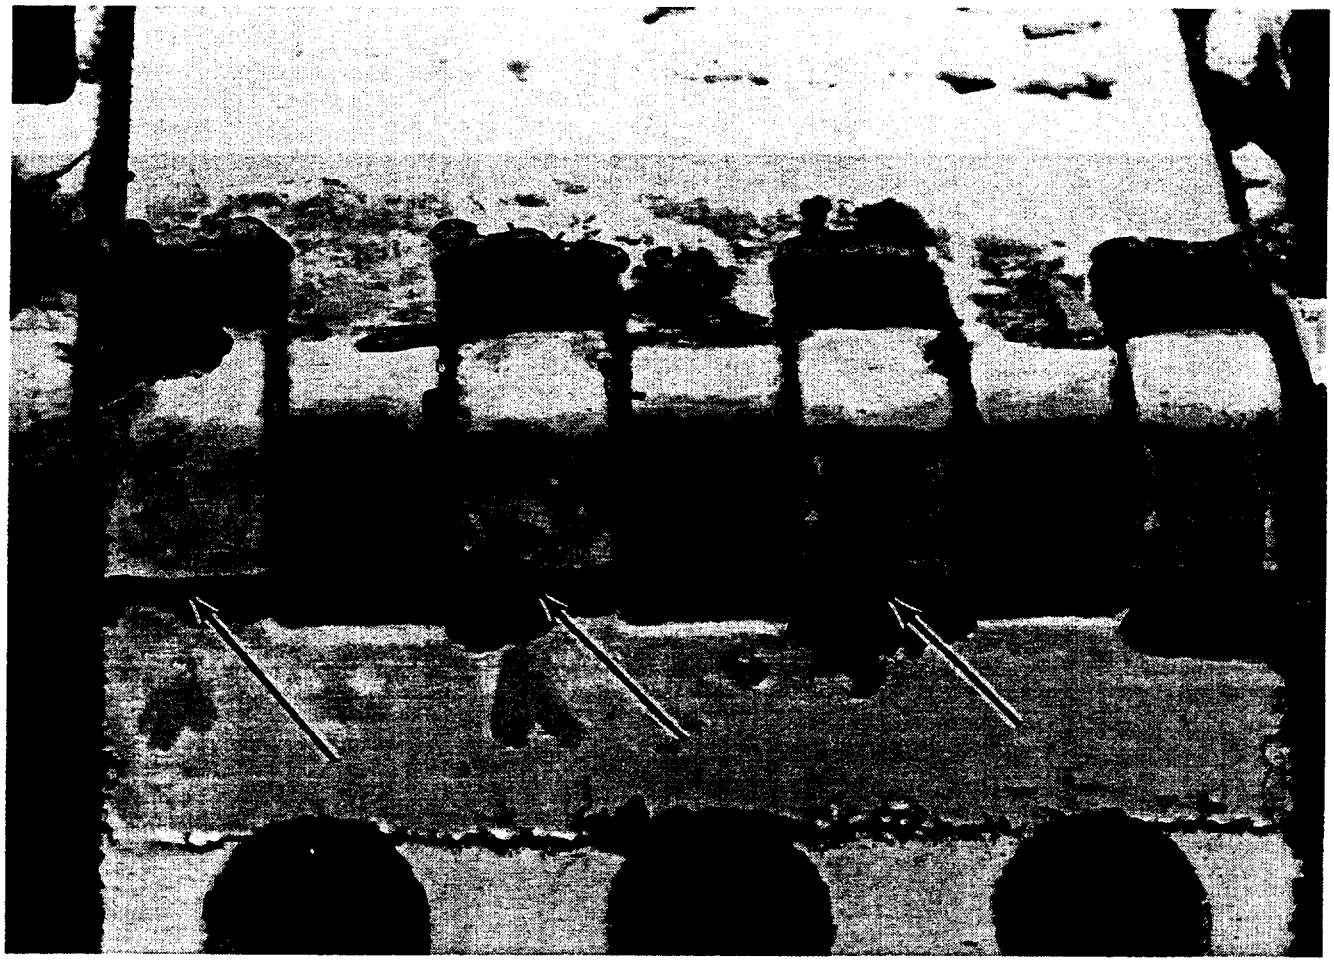
Figure 14.--Close-up view of cargo door hinge section.
Arrows show impressions caused by contact with opposite hinge section.

were slightly bent. The upper flange of the door, to which the door hinges are attached, was not deformed. The forward cargo door can rotate open 143 degrees before the hinge would deform, permitting the door to contact the fuselage above.

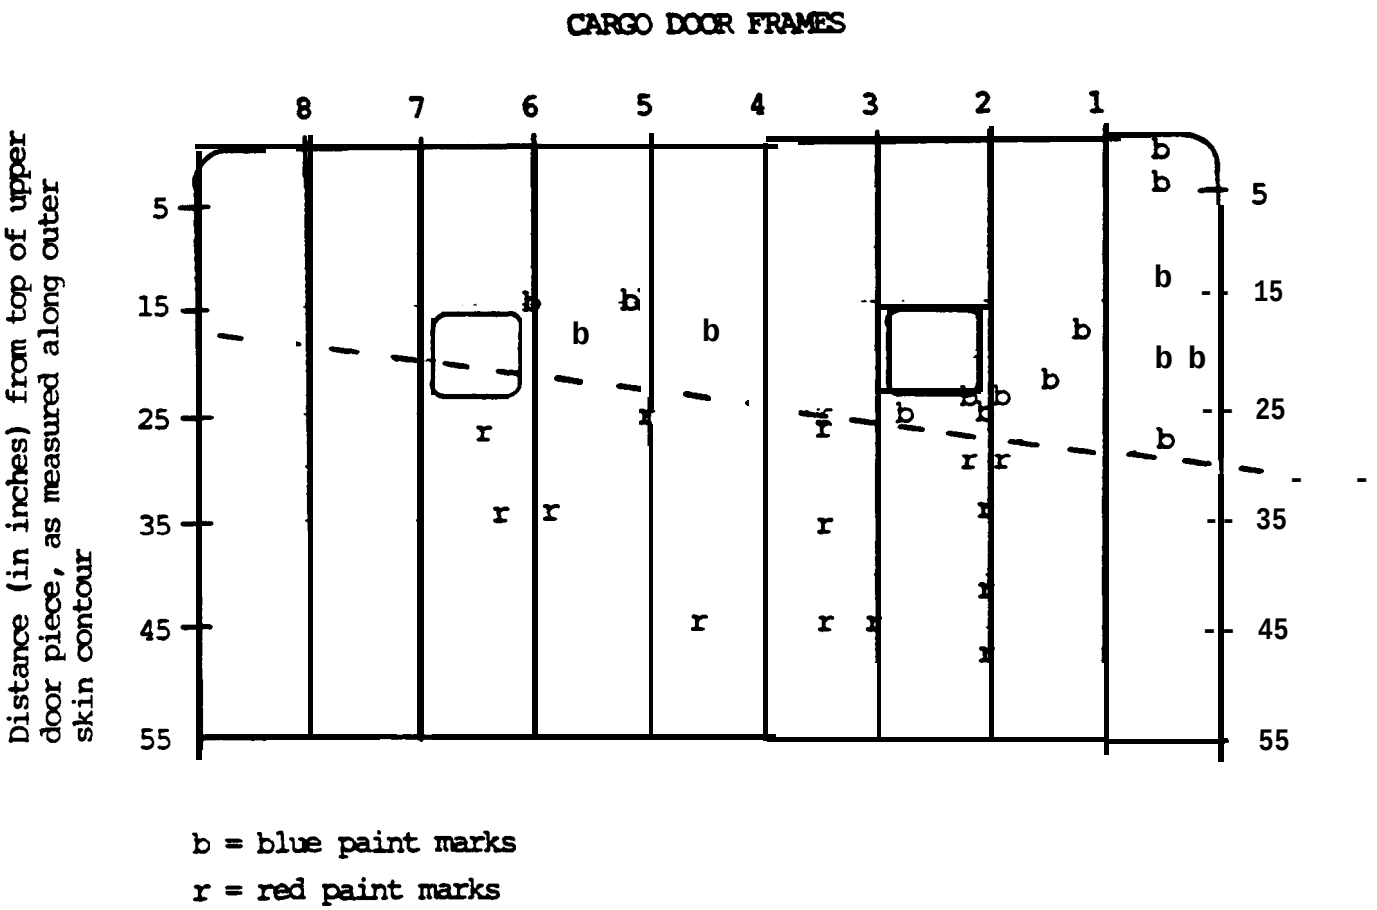
The master latch lock handle housing and trigger were found relatively flush with the door outer skin. The top of the handle was recessed approximately 0.50 inch inward from flush, and the bottom of the handle was protruding approximately 0.40 inch outward from flush (See figure 16). This

Figure 15.--Documented paint marks on outer skin of upper door piece. Dashed line is approximately 8 degrees from horizontal.

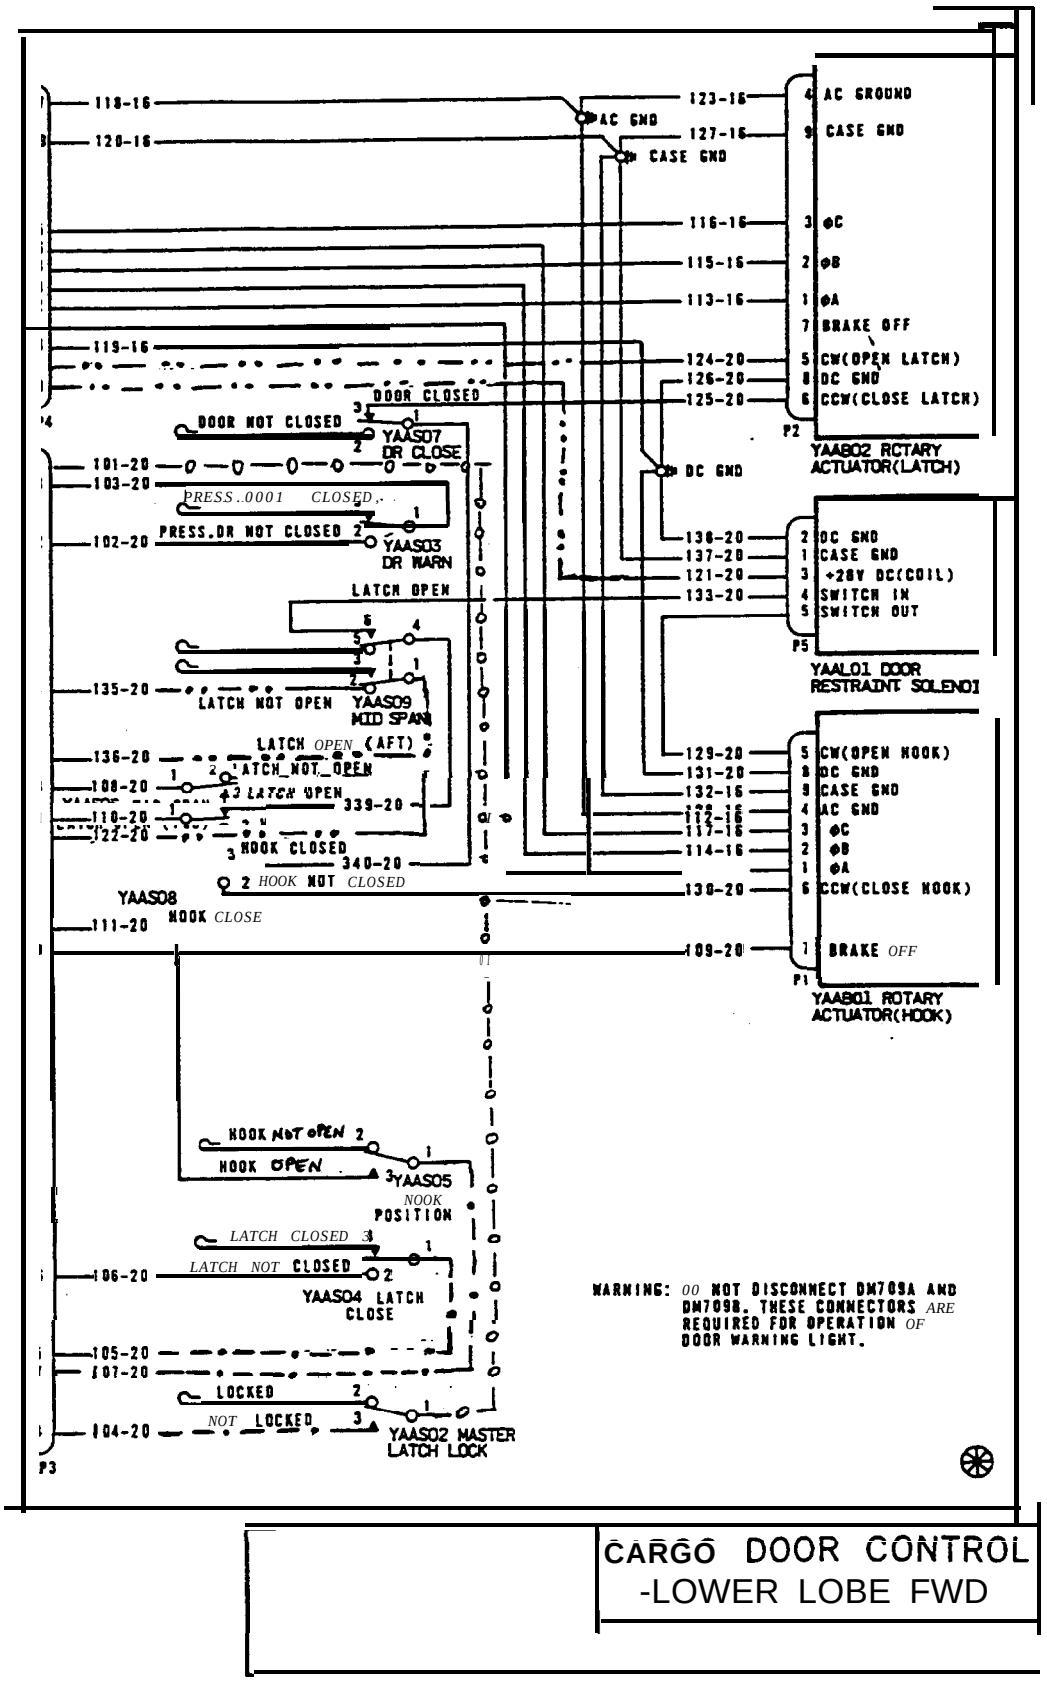
Figure 17.--Diagram of cargo door electrical circuitry.

Conductive contact of (-0-o-o-o) or (--.--.--) coded wire with (-..-..-) coded wire could potentially result in providing a 28VDC circuit path to the latch actuator open circuit. Direct wire-to-wire paths are coded in Figure 17 as defined above. The two-wire short circuit paths are identified as wire pairs consisting of wire 101-20 shorting with any of the following wires; 108-20, 121-20, 122-20, 124-20, 135-20, or 136-20.

If the S2 master latch lock switch fails in the "Not Locked" position, there are additional wire pairs that provide short circuit paths. These are coded in Figure 17 as (--.--.--) to (-..-..-..) wire pairs.
