PROJECT
IntegraRack®

TITLE
IR-EW15 BallastRack™ System Data Sheet
IR-EW150017

Subject: Lateral Load Mechanical Stress Test on IR-EW15 BallastRack (6061 T6 Aluminum) Solar Module Racking System with IR EarthScrews

Subject: Simulated Wind Load, Snow Load, and Horizontal Racking Load Testing on IR-30 Solar Racking System.

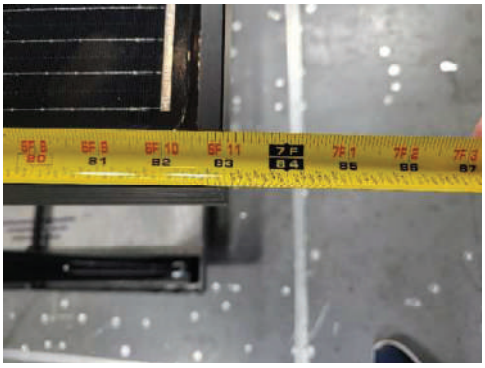
Figure 21: Solar panels total length 83 in.

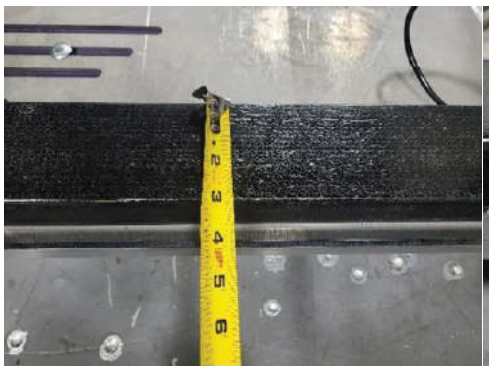
Figure 26: Frame base support width

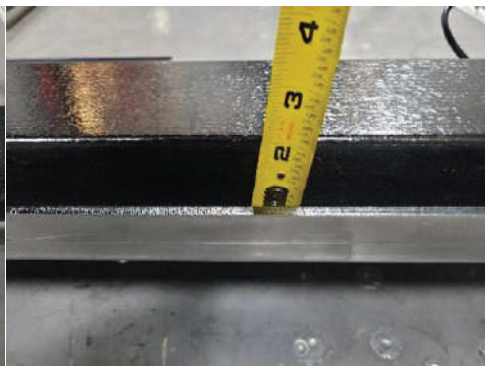
Figure 27: Frame base support height

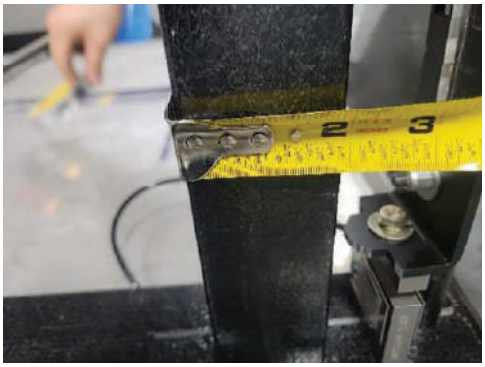
Figure 28: IR Ballast rack leg width 1
