PROJECT IntegraRack				
	TITLE IR-05MBDB Solar Racking System Data Sheet 5 Degree North/South With Wind Spoiler				
APPROVED Paul Budge 09/25/2025	SIZE B	CODE	DWG NO		REV
CHECKED Paul Budge 09/25/2025					
DRAWN Jeffery Glauser 9/25/2025	SCALE	WEIGHT		SHEET 1/3

Subject: Witness of Wind Tunnel Testing on IntegraRack Products at the George E Boeing Aeronautics Department (Kirsten Wind Tunnel) at the University of Washington

PRELIMINARY LABORATORY TEST REPORT

CLIENT	PROJECT/TEST DESCRIPTION	CLIENT ORDER NO.
Diversi-Tech Corporation	Multiballast DB Compression Test	per S.A.

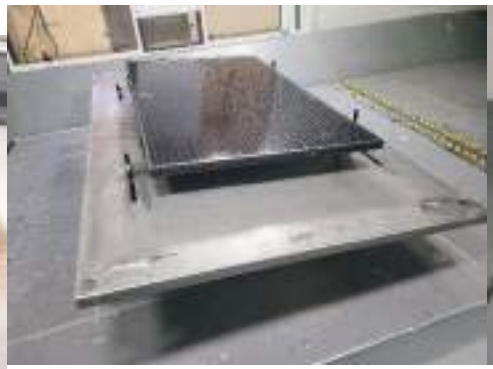
Figure 11: Setup after Run 2, 109 mph winds. No damages or loose hardware noted.

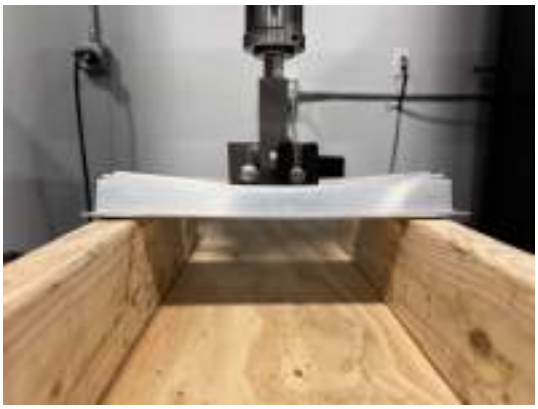
Test No.	Test Specimen	Displacement at Maximum Load (lbf)	Maximum Load (in.)	Observations
1	Multiballast DB base with H-module bracket	0.888	2,653	Test stopped due to permanent deformation to the Multiballast DB base.

Photo 3: 2477 lbf load applied after test manually stopped

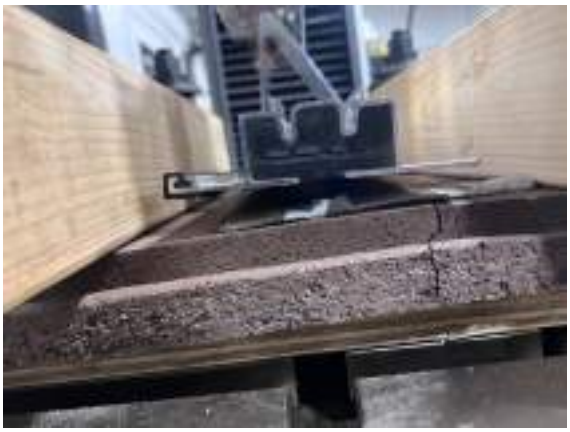
Photo 11: Tension test #2 adhesive failure, aluminum to adhesive

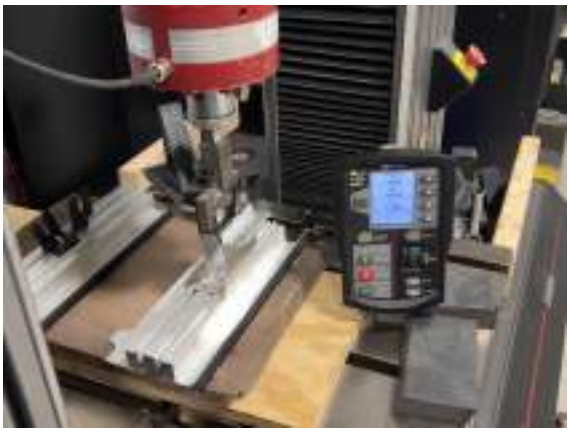
Test No.	Test Specimen	Displacement at Maximum Load (lbf)	Maximum Load (in.)	Observations
1	Multiballast DB bonded to tile shingle #2 with tower bracket (photo 15)	0.272	729	Test automatically stopped due to load drop when the tile cracked @ 729 lbf
2	Multiballast DB bonded to tile shingle #2 with tower bracket (photo 16)	0.530	1,353	Initial minor deformation was noted starting @ ~ 850 lbf, test continued until major deformation was witnessed load drop after hitting a max load of 1,353 lbf

Photo 15: Compression test #1 near max load before tile broke

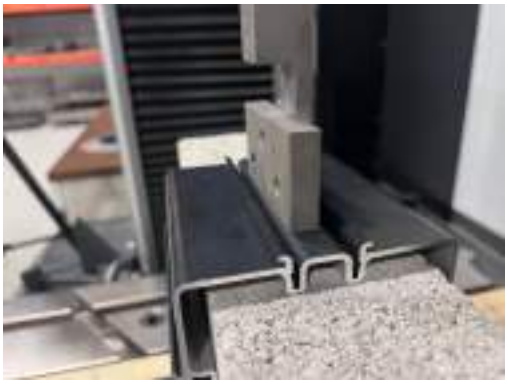
Test No.	Test Specimen	Displacement at Maximum Load (lbf)	Maximum Load (in.)	Observations
1	Multiballast to concrete block with riser mount and H-module bracket (Photo 1)	0.775	535	8°, 13°, 20° Multiballast riser bracket started deforming and test stopped, minor deformation @ ~430 lbf and major deformation @ ~520 lbf
2	Multiballast to concrete block with H-module bracket (Photo 5)	0.185	2,750	Test manually stopped @ 2000 lbf, minor deformation noted in H-module bracket.
3	Multiballast to concrete block (Photo 9)	0.099	2,371	Test manually stopped @ 2000 lbf, no deformation was noted.

Photo 10: Compression test #3 post test

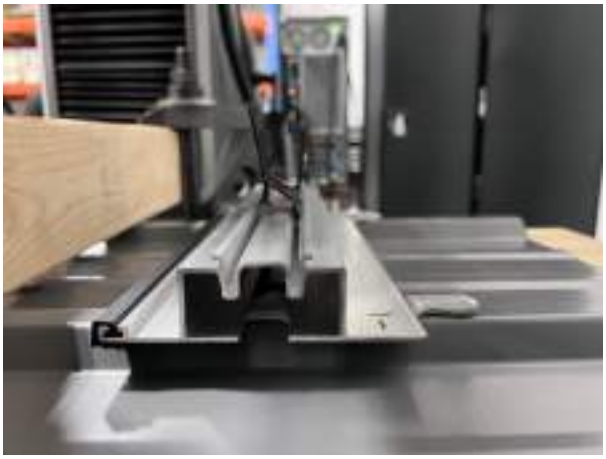
Photo 5: Tension test #1 “H” bracket slipped out

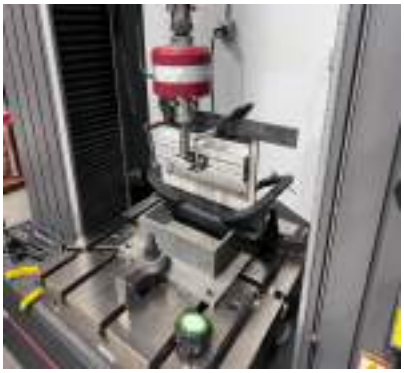
Photo 7: De-bond between the adhesive to cement board interface
