PROJECT
IntegraRack

TITLE
IR-40FSAA / FSAB / FSAC Solar Racking System Data Sheet

LABORATORY TEST REPORT

Subject: Simulated Wind Load, Snow Load, and Horizontal Racking Load Testing on IR-30 Solar Racking System.

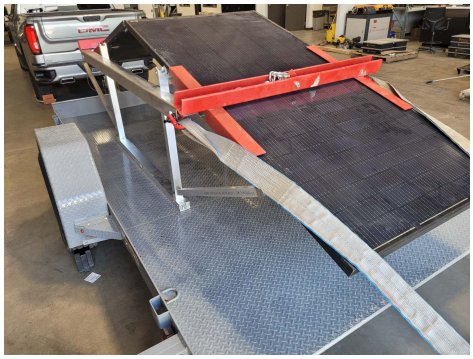
Photo 1: IR-EW15 BallastRack with 2 solar panels installed and load application frames (red)

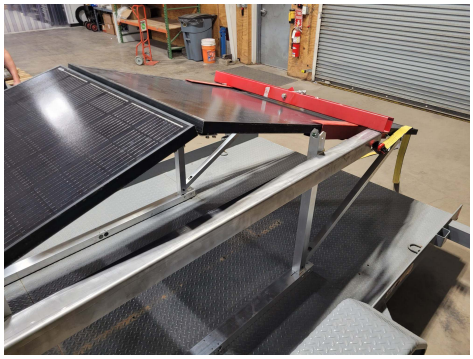
Photo 3: IR-EW15 BallastRack with 2 solar panels installed and load application frames (red)

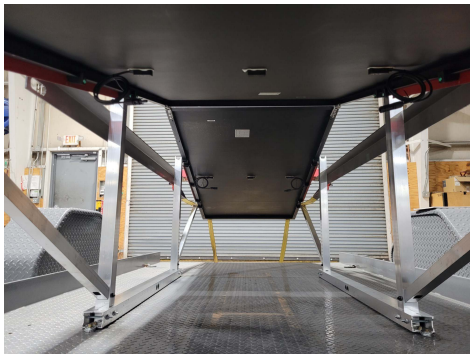
Photo 4: Underside of IR-EW15 BallastRack

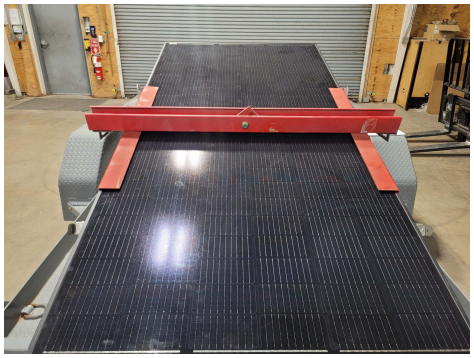
Photo 5: Load point attachment frame on solar panel

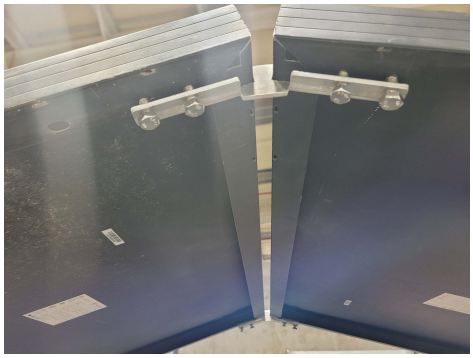
Photo 6: Brackets below solar panel at top point of the IR-EW15 frame

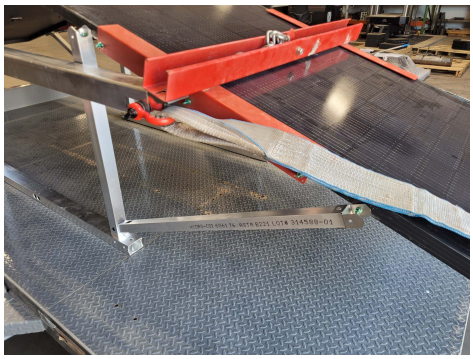
Photo 9: Load attachment points with shackle

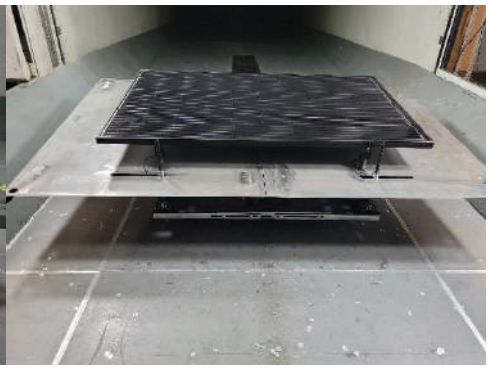
Figure 2: Run 1 through 3 setup with panel

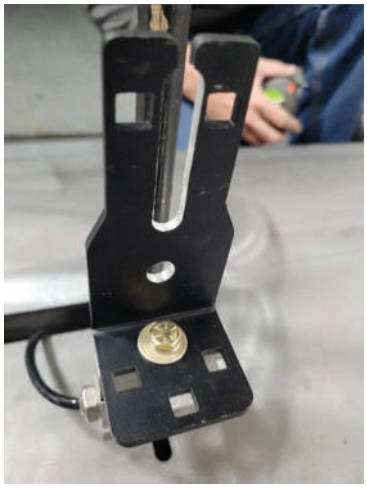
Figure 4: Bracket at back edge LC5-3, LC5-4

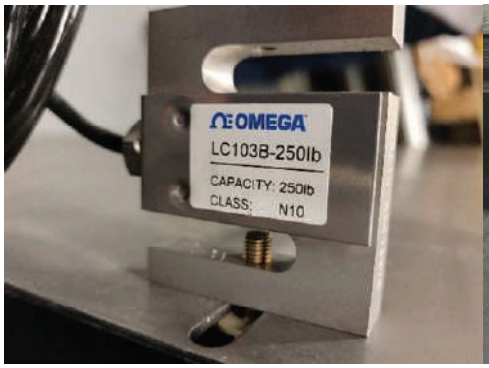
Figure 5: Load Cell Model used for tests

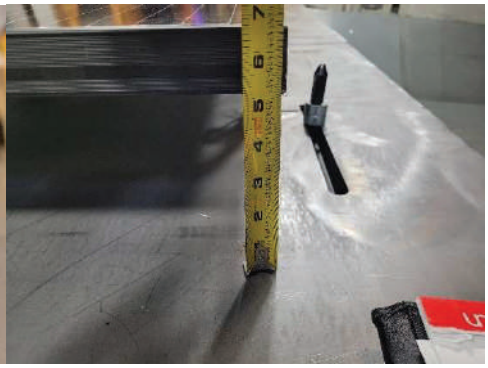
Figure 6: Height from roof to panel, Runs 2 & 3

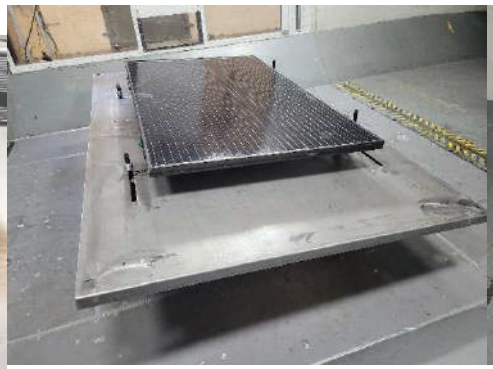
Figure 11: Setup after Run 2, 109 mph winds. No damages or loose hardware noted.

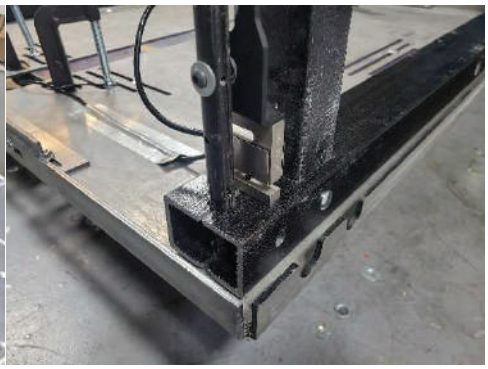
Figure 15: Load cell location at leading edge, LC0-1 & LC0-2

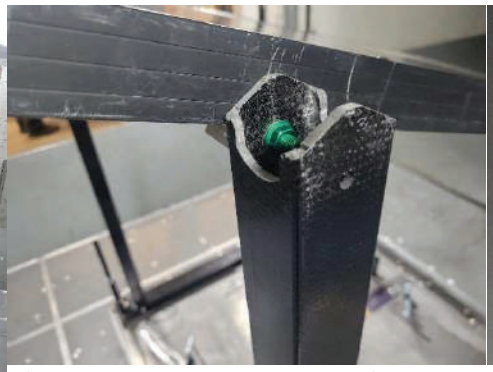
Figure 17: IR Ballast frame connection to solar panel

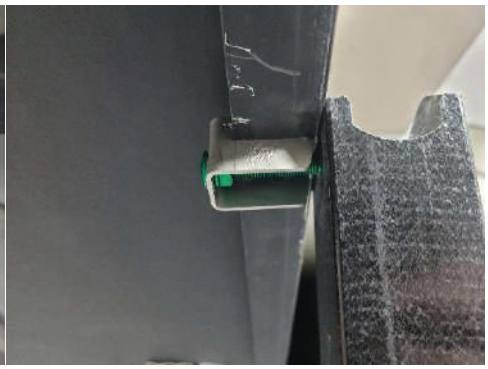
Figure 18: IR Ballast frame connection to solar panel

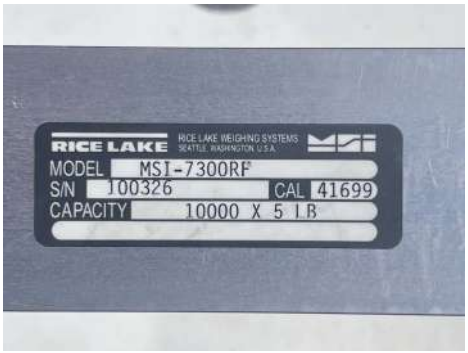
PHOTO 2: Dynamometer ID label

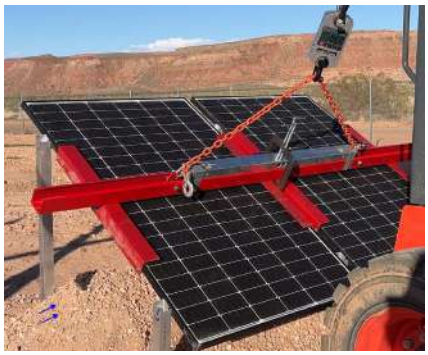
PHOTO 8: Test 2 - Evidence of ballast shift

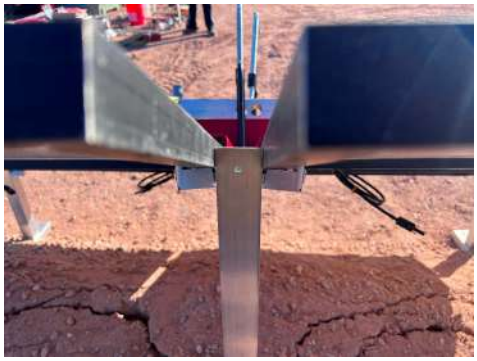
PHOTO 13: IR-F2 Clamp bracket after completion of testing

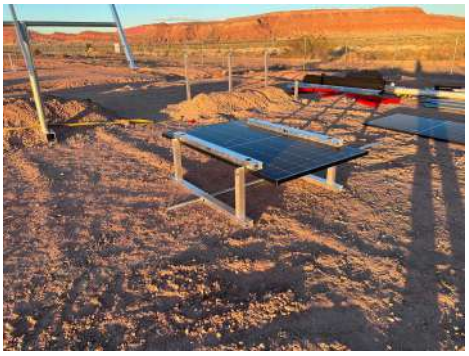
PHOTO 3: IR-30 Solar Racking System setup for test

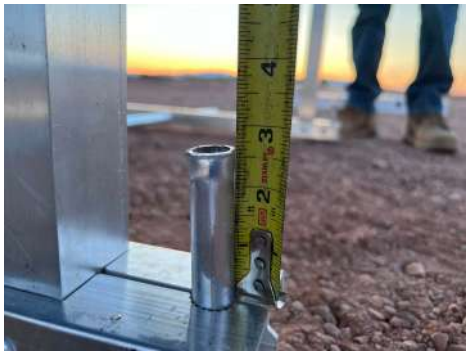
PHOTO 4: 'Stickout' measurement example at Spike #3
