Wind Mitigation

Belfort Q Condominum Association, Inc

9429-9499 N Belfort Circle Building Q

Uniform Mitigation Verification Inspection Form

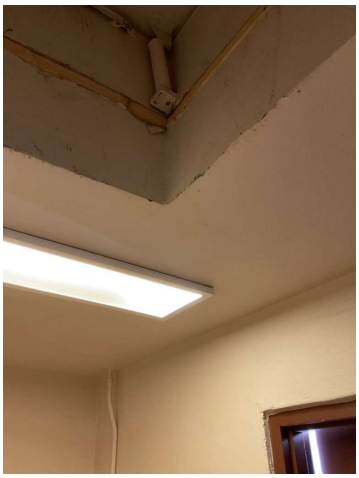
Concrete deck
