Home Inspection Report

Property: 11019 Bridge House Road Windermere Florida 34786

Inspection Date: 11/28/18

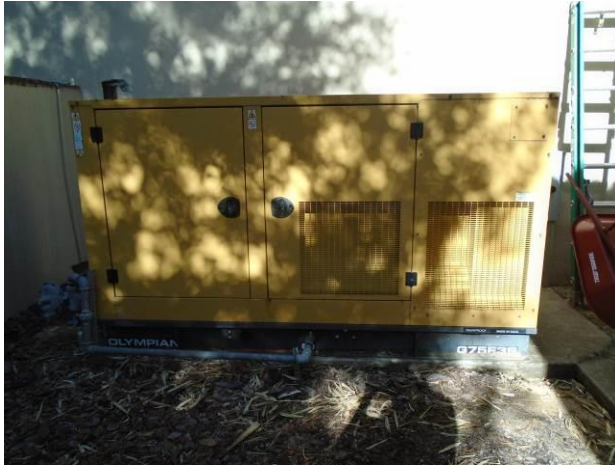
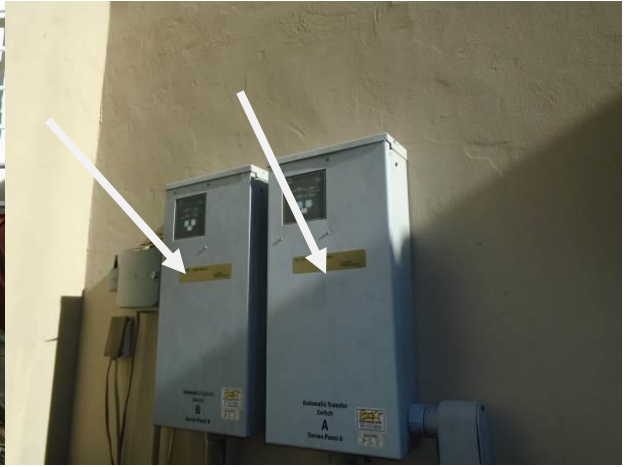
- All of the electrical boxes for the generator do not have dead front panels installed.

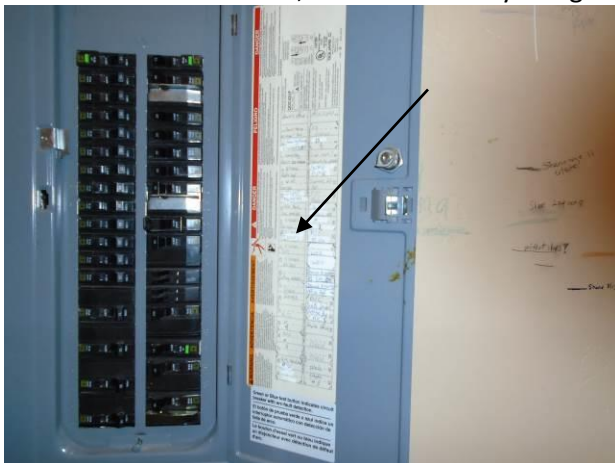
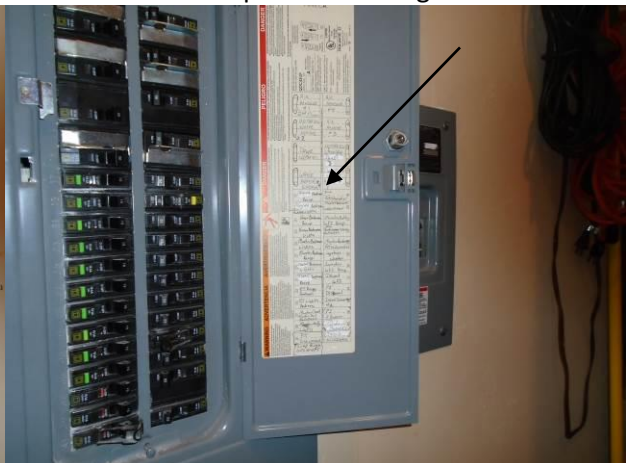
- One or more neutral wires are incorrectly connected under a single screw on the grounding or neutral bus bar at the interior sub panels and should be serviced. Unless the manufacturer states otherwise, bus bars are only designed for one conductor per terminating screw.

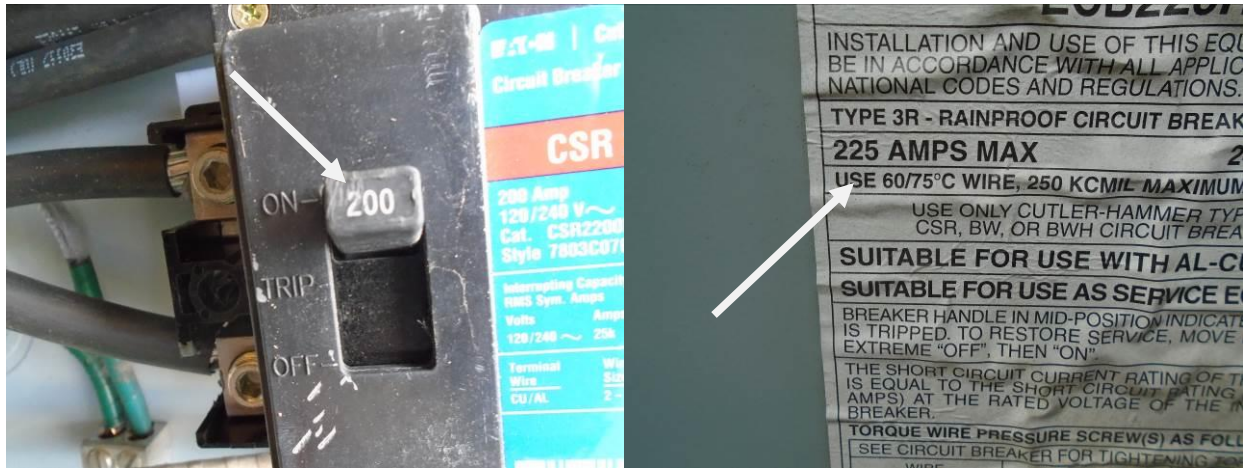
- **Electrical service:** Underground
- **Main breaker size:** Could not determine see page 26.
- **Panel manufacturer:** Eaton/Square D
- **Branch wiring:** Copper 15 and 20 amp breakers

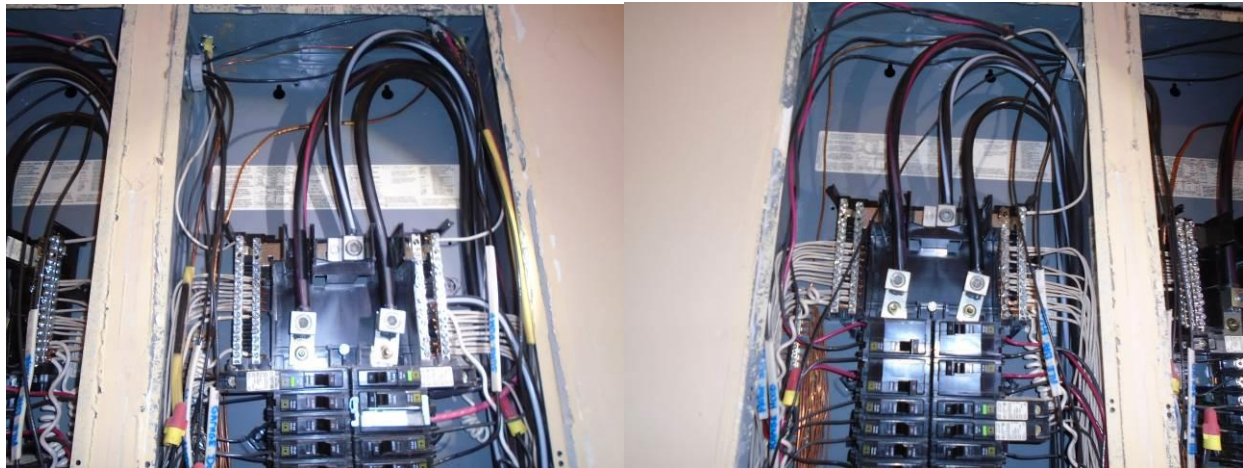
- **Main lines:** Stranded aluminum
- **Single strand aluminum branch wiring present :** No
- **Appears grounded :** Yes
- **Representative numbers of outlets inspected :** Yes
- **Arc fault (AFCI) breakers present in appropriate rooms:** Yes. The home was occupied at the time of inspection. The tripping mechanisms for the arc fault breakers were not operated.
- **Ground fault (GFCI) protection present on all appropriate outlets:** No see page 27.
- **Main electrical shut off:** See page 26.
- **Overall electrical condition:** Due to the number of electrical issues we recommend that a licensed electrician evaluate the entire electrical system in this home.
