Home Inspection Report

2965 Deer Run Trail
Orono, MN 55356

Inspection Solutions

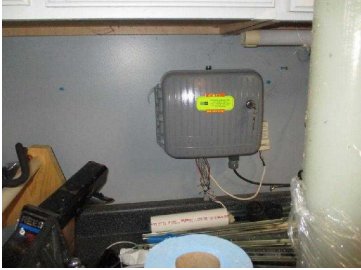
11. Lawn Sprinklers: Front and back yard - Not tested due to season

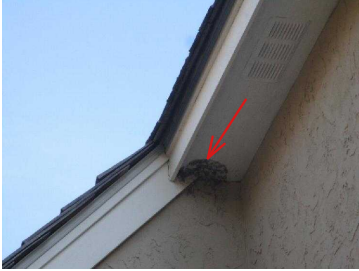
4. Soffits: Wood - Past signs of wasp or bees.

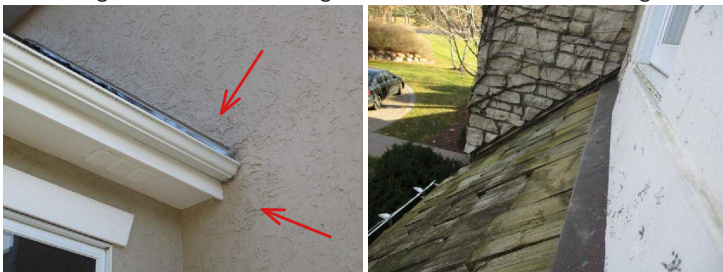
3. Type: Gable
4. Approximate Age: Unknown
5. Flashing: kick out flashings noted. Kick out flashings have been installed at the roof terminations

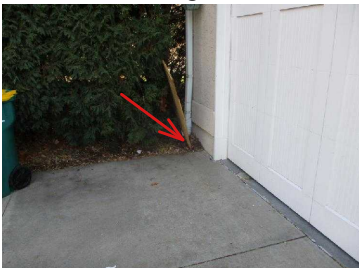
1. Type of Structure: Attached Car Spaces: 4
2. Garage Doors: Insulated aluminum with wood
3. Door Operation: Mechanized
4. Door Opener: Lift Master
5. Exterior Surface: Stucco - Remove the vine growth as well as grade and mulch installed above the stucco cladding.

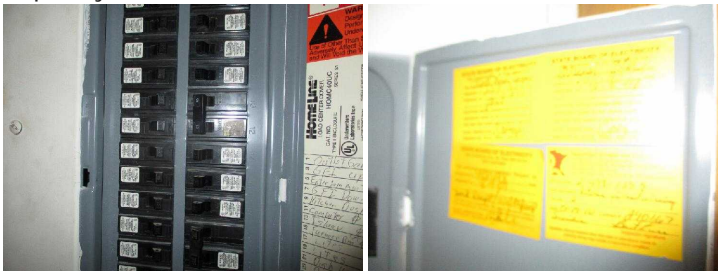
Basement Bedroom #1 Electric Panel

8. Manufacturer: Home Line - City stamp for 1996, 1998 2002 as well as 2010. Box at its main capacity

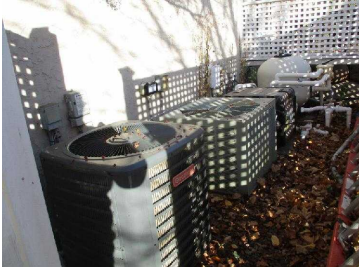
Main #1 AC System

1. A/C System Operation: Not Inspected - The average life expectancy of a A/C unit is 20-25 years. This unit is 29 years old. The unit is at the end of the manufactures stated design life and should be serviced and certified.

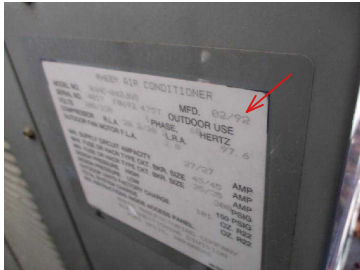
2. Condensate Removal: Plastic tubing
3. Exterior Unit: Pad mounted - Needs cleaning at the exterior.
4. Manufacturer: Goodman
5. Area Served: Partial Approximate Age: 1992

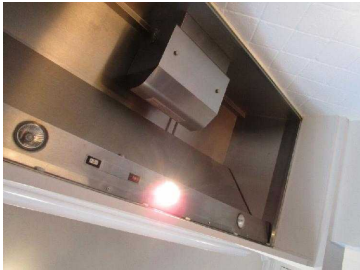
2. Ventilator: Vent A Hood - Only one of the three vent hood lights work.

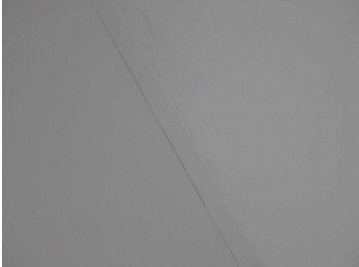
1. Ceiling: Texture paint - Cracked tape joints noted at the ceiling.

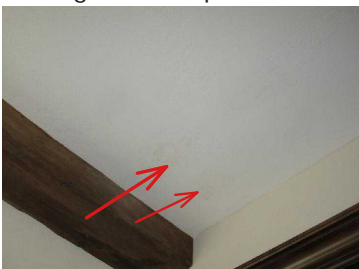
8. Ceiling: Texture paint - Stain/discoloring noted at the ceiling above the wet bar location.

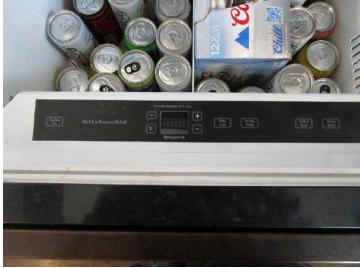
11. Dishwasher: Fisher & Paykel
12. Refrigerator Drawer: KitchenAid - Refrigerator drawer display does not appear to be working. The refrigerator drawer is cooling/function at the time of inspection.

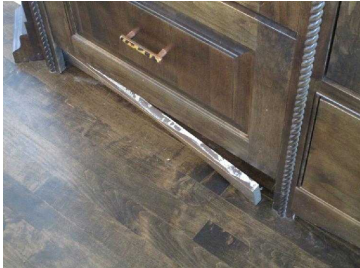
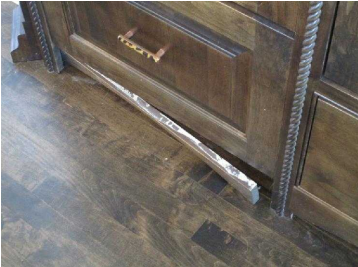
13. Air Gap Present? Yes No
14. Counter/Cabinet: Grainet and wood - Trim below the cabinets is loose.

27. Family Room Living Space Counter/Cabinet: Grainet and wood - Trim below the cabinets is loose.

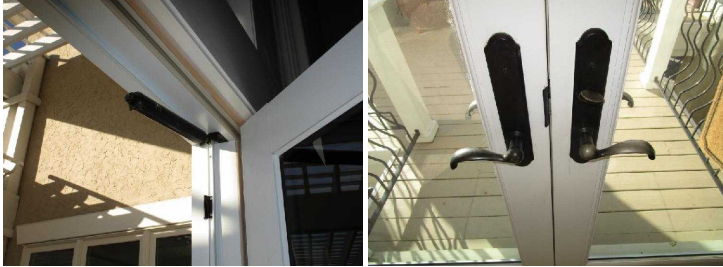
23. Doors: French Patio Doors with Glass - Door dead bolt does not align. Storm doors at the exterior are no longer in place.

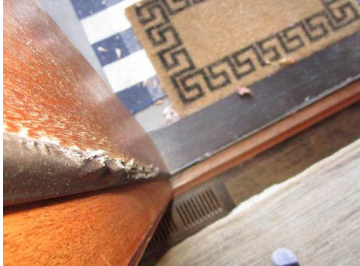
27. Closet: Reach-in
28. Ceiling: Texture paint
29. Walls: Paint
30. Floor: Hardwood
31. Doors: Entry Door - Weather stripping is damaged at the door. Door dead bolt is loose and does not align properly.

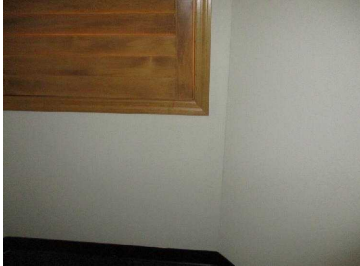
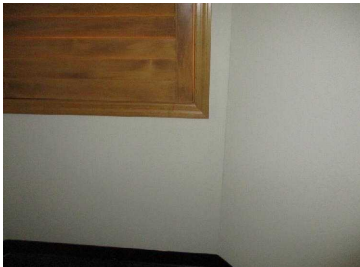
- 82. Walls: Paint - Cracks present

34. Lower Level Gym Living Space Walls: Paint - Cracks present

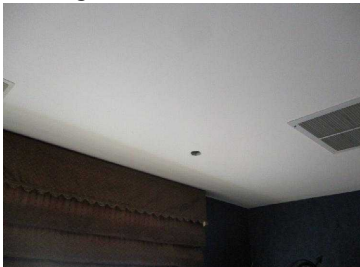
- 89. Ceiling: Paint - Hole noted in the ceiling

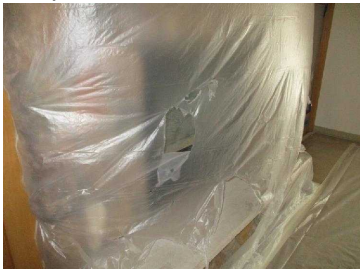
Lower Level Fireplace

1. Fireplace Construction: Prefab - Covered from painting contractor.

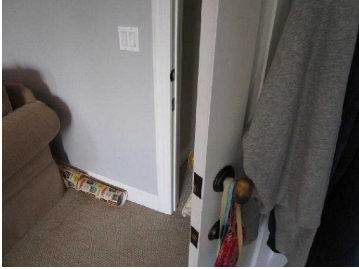
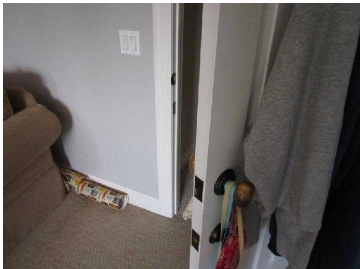
31. Doors: Six Panel - Door does not latch closed, adjust the back set as needed.

- 37. Master Suite Bedroom Floor: Hardwood - Scratches as well as dings in the surface
- 38. Master Suite Bedroom Doors: Six Panel - Door to the bathroom are loose
- 39. 2nd Floor North Bedroom Bedroom Floor: Carpet - Carpet Stained/soiled
- 40. 2nd Floor South Bedroom Doors: Six Panel - Door does not latch closed, adjust the back set as needed.

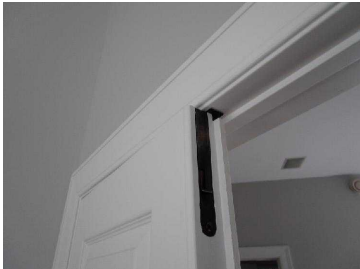
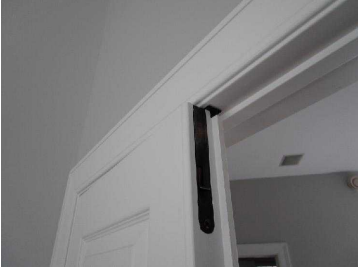
19. Doors: French Doors - Left hand door rubs at the frame and does not close properly.

47. Owners Suite Bathroom Doors: French Doors - Left hand door rubs at the frame and does not close properly.

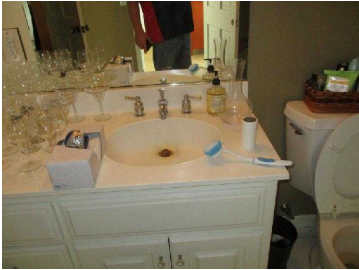
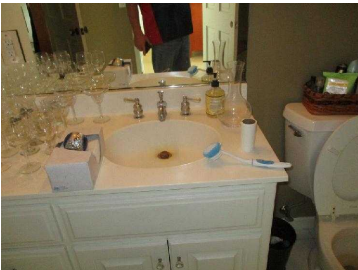
59. Electrical: 110 VAC GFCI
60. Counter/Cabinet: Composite and wood
61. Sink/Basin: Molded single bowl
62. Faucets/Traps: Metal - Peeling finish

49. 2nd Floor South Bathroom Closet: Walk-in - Full of debris
50. 2nd Floor South Bathroom Walls: Paint - Past staining noted
51. 2nd Floor South Bathroom Doors: Six Panel - Rubs at the pocket
52. 2nd Floor South Bathroom Ventilation: Air to Air - No mechanical ventilation present.
53. Lower Level Bathroom Bathroom Ceiling: Paint - Under painting contractor at the time of inspection
54. Lower Level Southeast Bathroom Faucets/Traps: Metal - Peeling finish

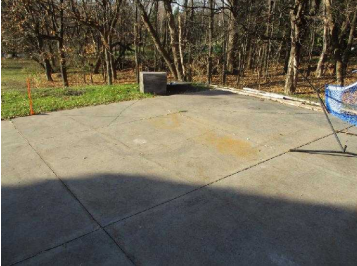
1. Driveway: Asphalt and Concrete - Re seal the asphalt as well as cracks in the concrete

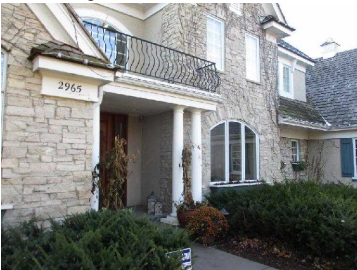
5. Balcony: Painted wood - Older board in place with peeling paint

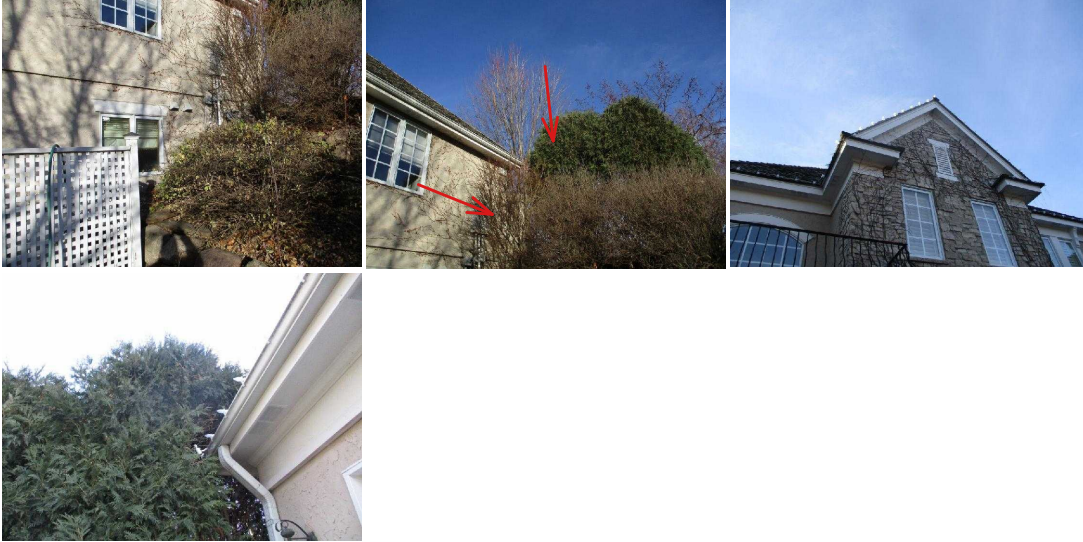
6. Vegetation: Trees grass and shrubs - Tree limbs over hang the roof and should be cut back

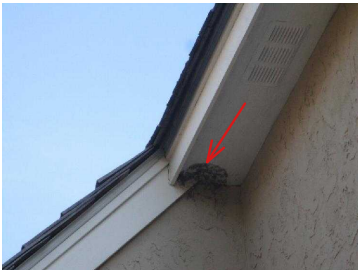
8. Soffits: Wood - Past signs of wasp or bees.

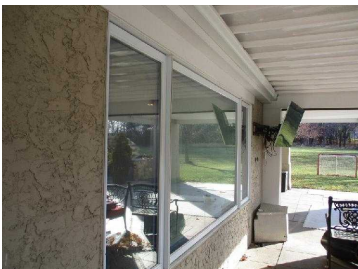
9. Basement Windows: Casement - Covered at the time of inspection from painting contractor.

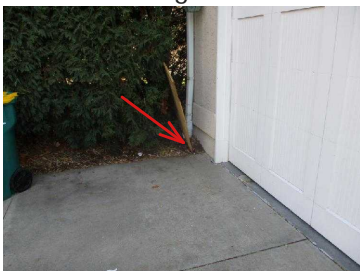
15. Front Garage Exterior Surface: Stucco - Remove the vine growth as well as grade and mulch installed above the stucco cladding.

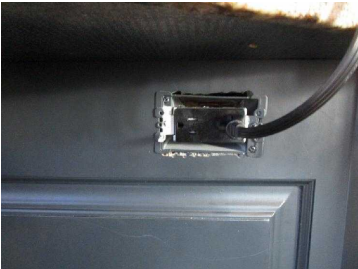
22. Main Kitchen Electrical: 110 VAC GFCI Protected and Lighting Circuits - Missing outlet and switch cover plates. One light over the sink does not work.

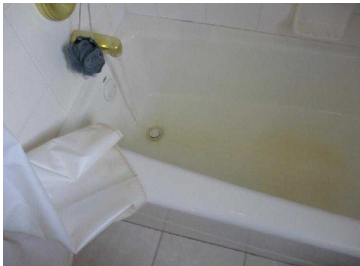
- 46. 2nd Floor North Bedroom Bathroom Tub/Surround: Fiberglass tub and tile surround - Needs cleaning

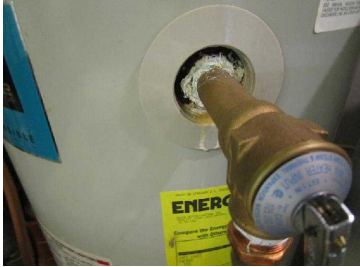
57. Utility Room, West Water Heater TPRV and Drain Tube: Copper - Corrosion noted at the TPR valve where it meets the water tank/heater.

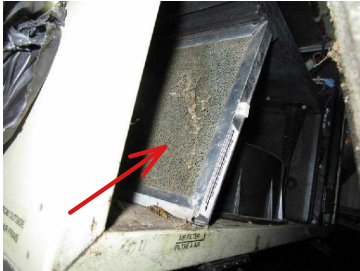
58. Utility Room, West Heating System Heating System Operation: Functional at the time of inspection - The average life expectancy of a boiler is 25-30 years. This unit is approximately 26 years old. Boiler was last serviced in 2020.
59. Utility Room, East Heating System Devices: Air to Air exchanger - Clean the two reusable filters every three months and the core on a yearly basis. Filters are in need of cleaning.
60. Utility Room, East Heating System Devices: Air to Air exchanger - Clean the two reusable filters every three months and the core on a yearly basis. Filters are in need of cleaning.

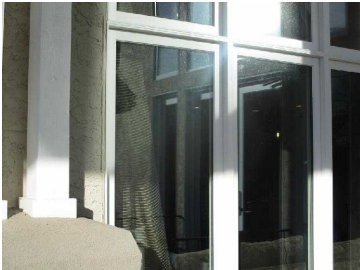
2. Trim: Wood - Peeling paint noted at isolated locations. Deteriorating trim noted at the lower door frames.
3. Patio Door: Sliding - Deteriorated trim noted at various exterior frames
4. Windows: Casement - Window seal broken or damaged. See interior notes.

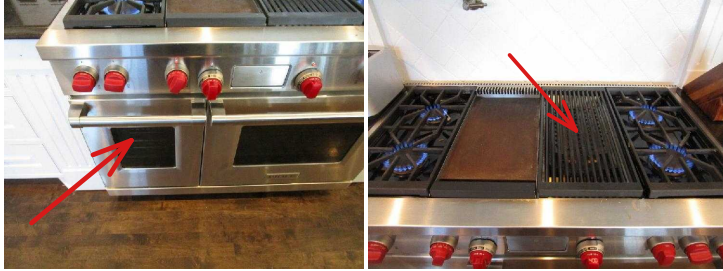
7. Main Kitchen Cooking Appliances: Wolf - Small oven was not working at the time of inspection. The cook top grill does not work properly. Repairs needed.

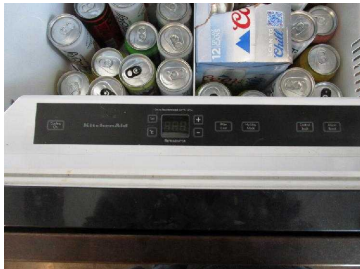
8. Family Room Living Space Refrigerator Drawer: KitchenAid - Refrigerator drawer display does not appear to be working. The refrigerator drawer is cooling/function at the time of inspection.

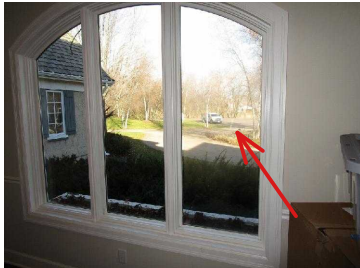
9. Dining Room Living Space Windows: Fixed - Broken thermo seal at the right hand fixed window unit, resulting is moisture/fogging between the window glazing.

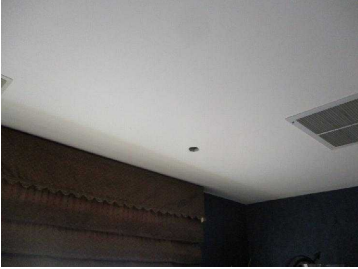
11. Lower Level Office Living Space Ceiling: Paint - Hole noted in the ceiling

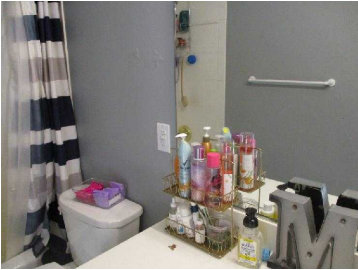
12. 2nd Floor North Bedroom Bathroom Electrical: 110 VAC - **Faulty GFCI outlet-replace**

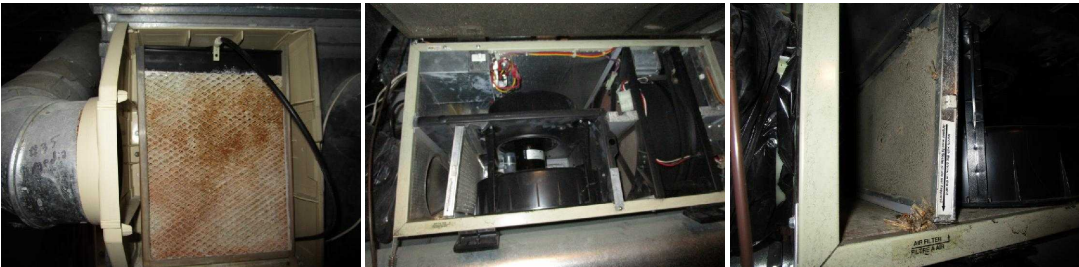
18. Utility Room, West Heating System Heating System Operation: Not Functional at the time of inspection, Recommend Service - **The Weil-McLain boiler was not functioning at the time of inspection. Repairs are needed.**
19. Utility Room, East Heating System Humidifier: April-Aire - **Not functioning at the time of inspection. Replace water pad filter.**

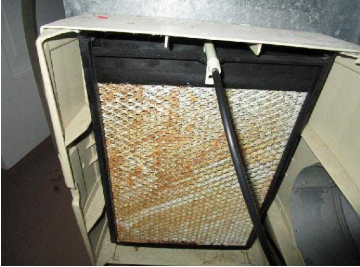
20. Utility Room, East Heating System Humidifier: April-Aire - **Not functioning at the time of inspection. Replace water pad filter.**
