INSPECTION REPORT

For the Property at:
1000 FARM RD
FORNEY, TX 75126

Prepared for: JANE DO
Inspection Date: Thursday, February 8, 2024
Prepared by: Jeffrey Knight, 25885

Knight Home Inspection
10121 Bantry Lane
Forney, TX 75126
214-566-5243

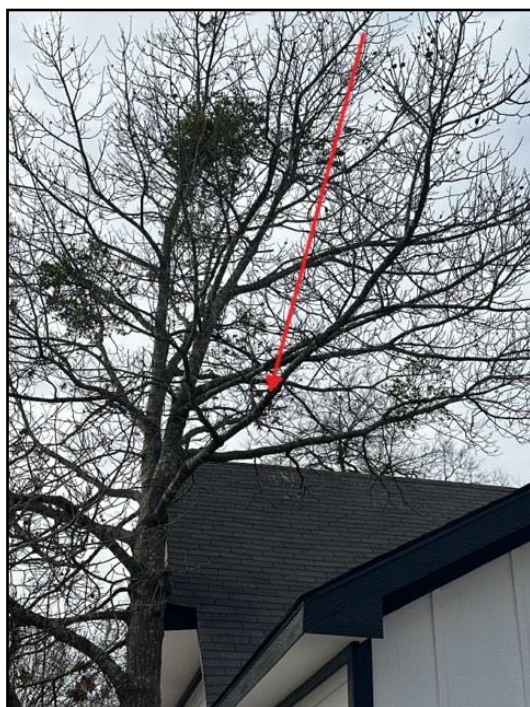
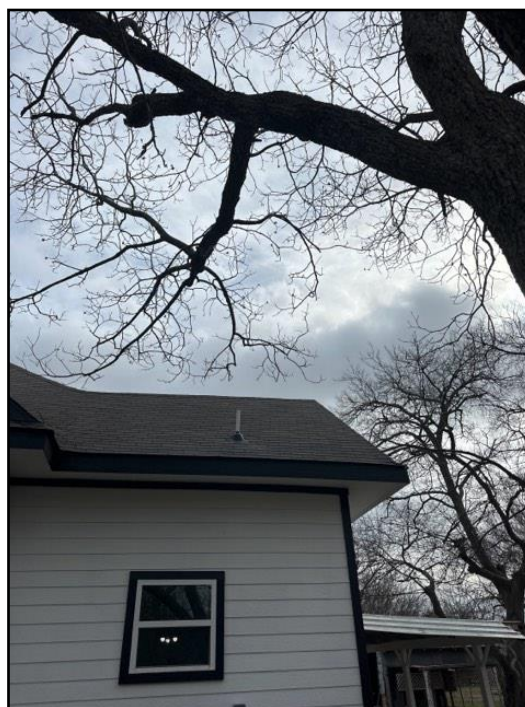
2. Condition: • Tree branches touching roof

12. Tree branches touching roof

13. Tree branches touching roof

Recommend a professional licensed tree arborist make repairs

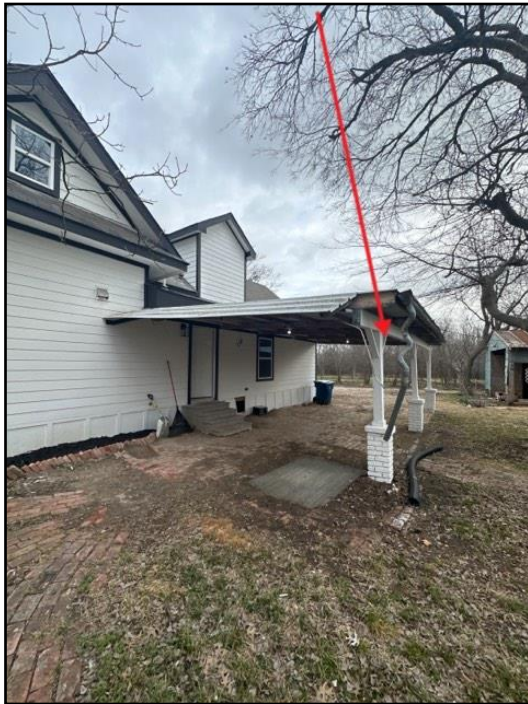
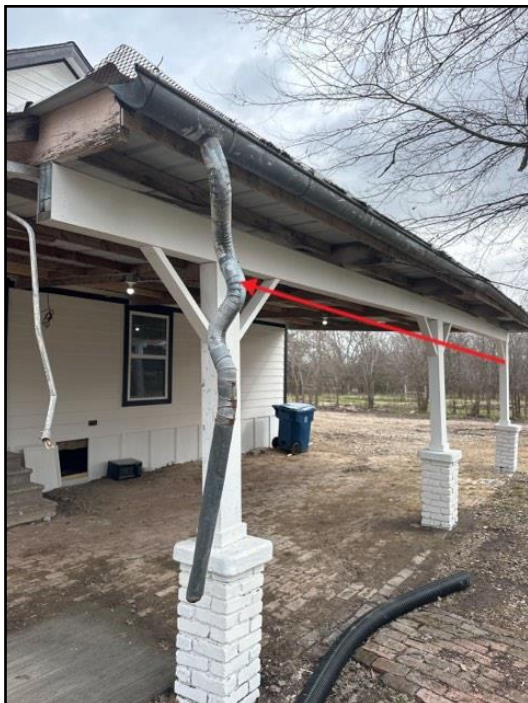
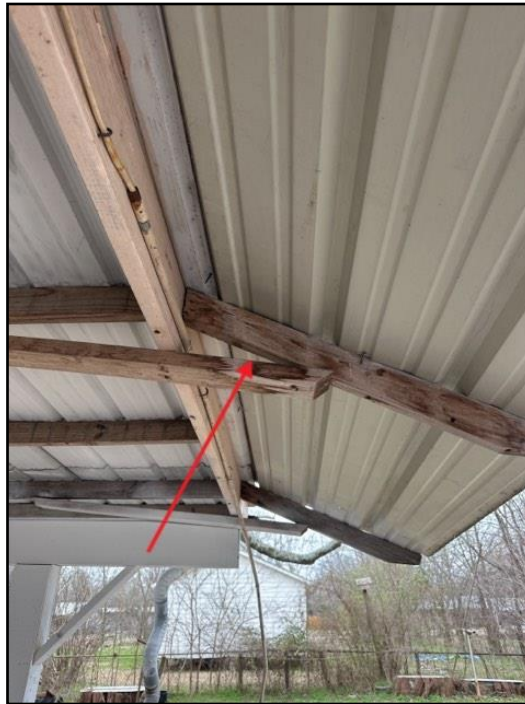
7. Condition: • Poorly built

Rear porch cover is not safely built and the post are leaning and not structurally sound. Additionally, the gutters are damaged and the electrical is unsafe. recommend a professional licensed contractor further evaluate make repairs

19. Poorly built

21. Poorly built

23. Poorly built

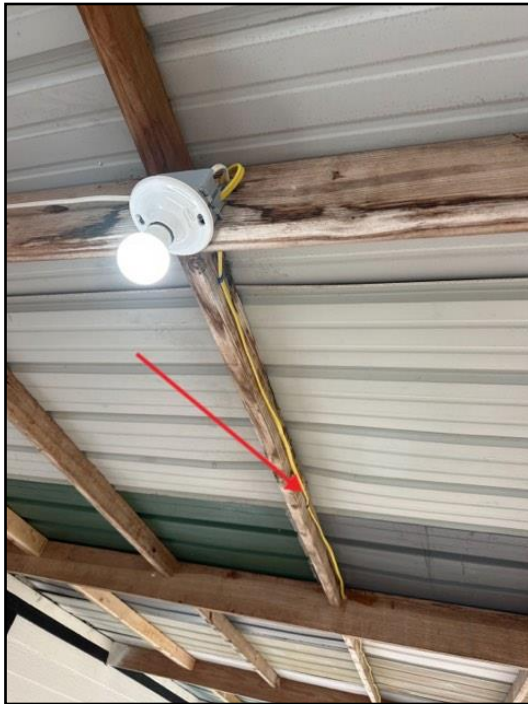
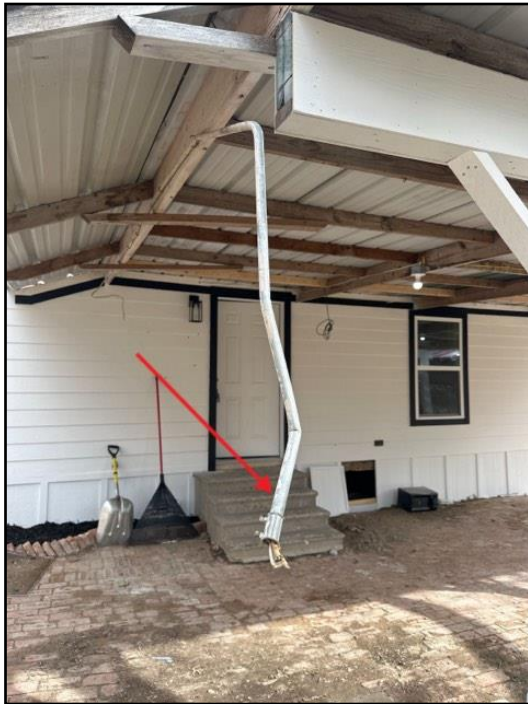
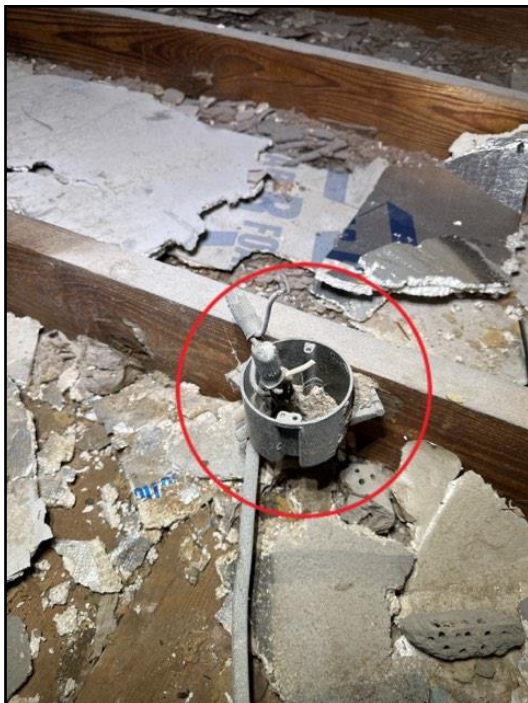
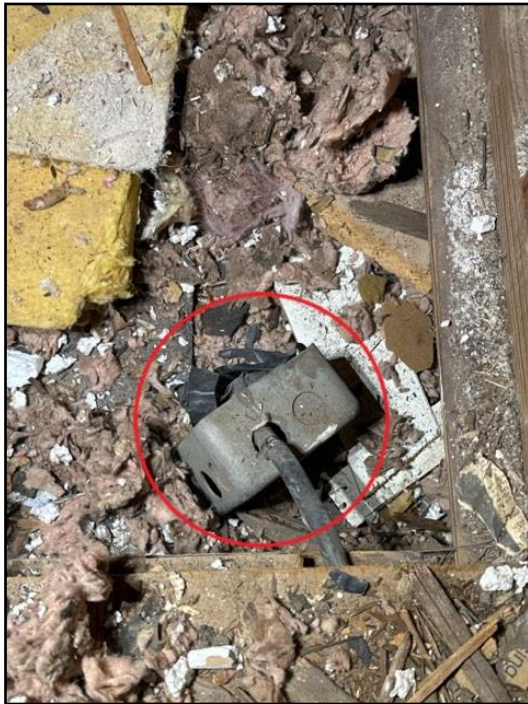
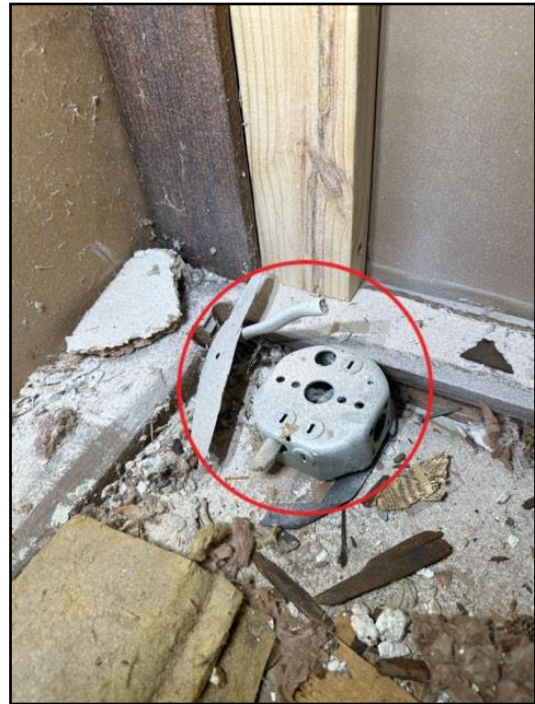
19. Condition: • [Exposed on walls or ceilings](#)

Exposed electrical Romax wiring recommend a professional, licensed electrician make repairs

Location: Exterior rear/attic Westside/attic south access/attic various locations

42. Exposed on walls or ceilings

44. Exposed on walls or ceilings

46. Exposed on walls or ceilings

48. Exposed on walls or ceilings

49. Exposed on walls or ceilings

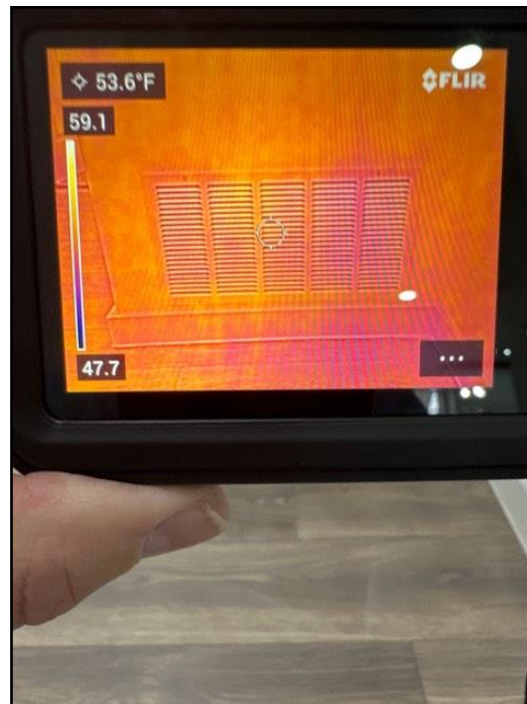
65.

Temperature difference across cooling coil: • 12° • This suggests performance issues. Service may be needed.

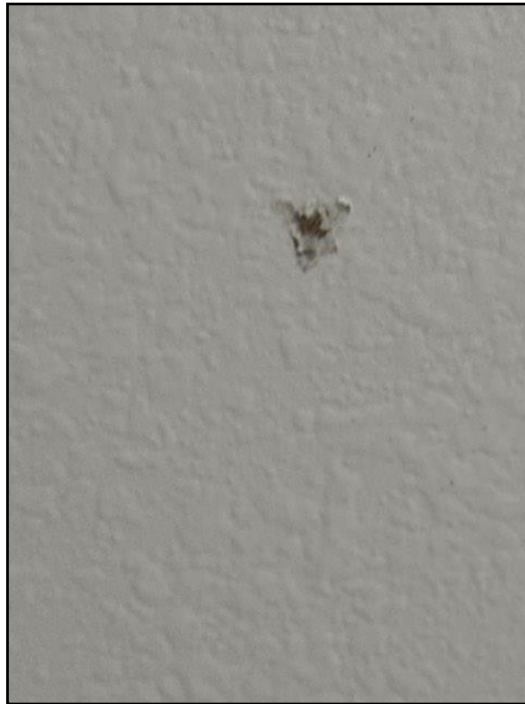
83. *Typical minor flaws*

35. Condition: • Typical minor flaws

Some typical minor flaws located throughout the home, overall the interior looks clean and has a nice new paint job recommend touchup repairs

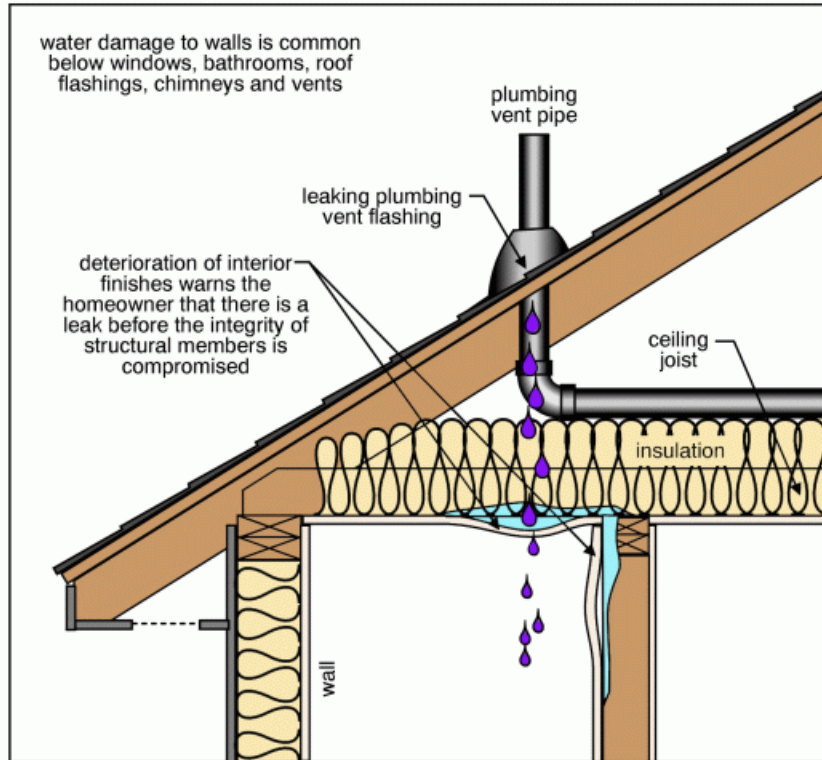
84. Damage

36. Condition: • Damage

Implication(s): Damage or physical injury due to falling materials

Recommend a professional licensed contractor make repairs

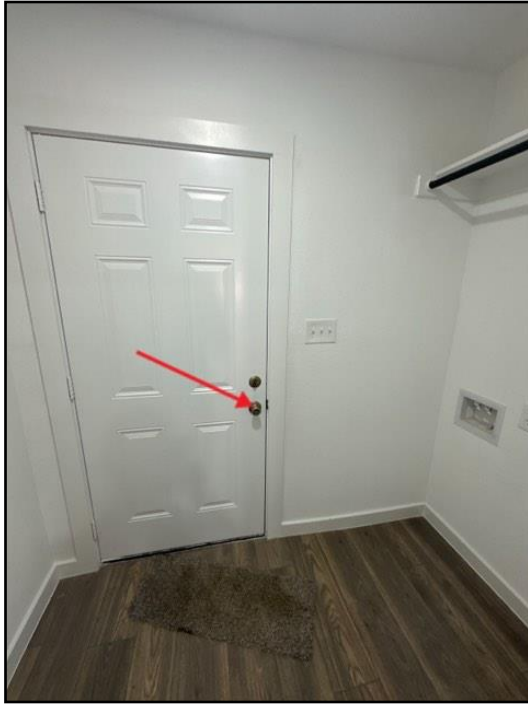
86. Inoperable

39. **Condition:** • [Inoperable](#)

Doorhandle does not latch recommend repair

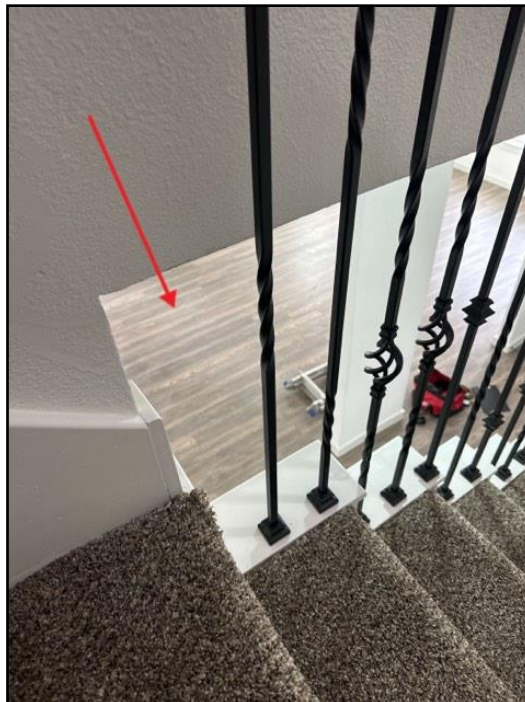
89. Too far apart

41. Condition: • [Too far apart](#)

Stair spindles too far apart at the top of the stairs, this can present a hazard for small children falling or getting their head stuck in between them, recommend a professional licensed contractor make repairs

Implication(s): Fall hazard

Location: Top of stairs
