# HomInspect - home inspection services

## \*\*\* Residential Inspection Report \*\*\*

December 23, 2019

1122 15th St  
Your Town, USA

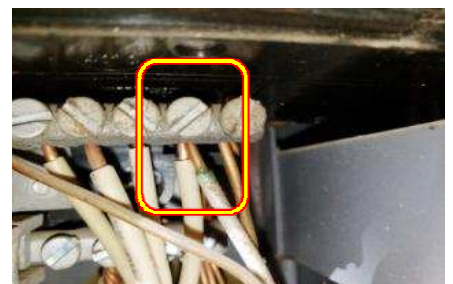
- The masthead insulator grommet was damaged/missing where the main overhead service entrance conductors (SEC) enter masthead. Recommend further evaluation by a qualified electrical contractor and corrective repair as necessary.
- There were neutral (white) wires doubled or bundled together under the same lug (screw), this condition could cause loose connections and overheating. Neutrals should always have a single connection (Unless the manufacturer states otherwise, bus bars are only designed for one current carrying conductor per terminating lug). Recommend further evaluation by a qualified electrical contractor and corrective repair in accordance with accepted practice is recommended.

Neutral (white) wires were doubled or bundled together

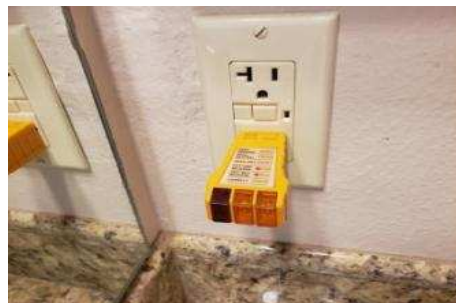
- There were outlets in garage next to the work bench that tested with reverse polarity. This happens when the hot live wire (black or red wire) and neutral wires (white wire) get flipped around at an outlet or switch. Reversed polarity creates a potential shock hazard. Recommend further evaluation and corrective repair in accordance with accepted practice.
- GFCI electrical outlet in the master bath did not respond correctly when tested and should be repaired or replaced as necessary for safe and proper function. A GFCI outlet also known as "Ground fault circuit interrupter device" is to add additional protection against electrical shock or electrocution. It's designed to detect very low levels of electrical current leaks (ground faults), and acts quickly to shut off power, preventing serious shock.

GFCI outlet not responding correctly

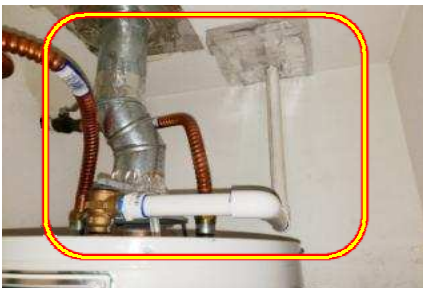
- The water heater TPR (temperature pressure relief valve) discharge pipe has a positive slope or runs uphill. This condition can cause water to be trapped in the discharge pipe and could cause the TPR valve to fail. This TPR valve is a very important safety device. Also noted the TPR piping material (PVC) used was improper. Recommend corrective repair as necessary to properly configure the discharge pipe that meets current standards.
- It is recommended in accordance with current standards to install a drain pan below the water heater to protect against potential water leakage and damage concerns.

TPR pipe improper/runs uphill

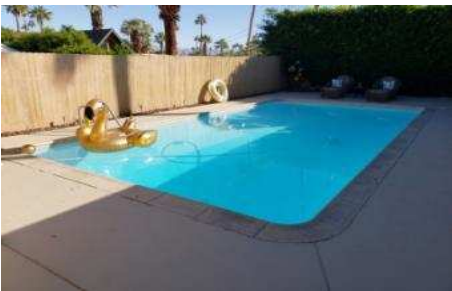
**Further Comments:** No concerns observed

View of decking

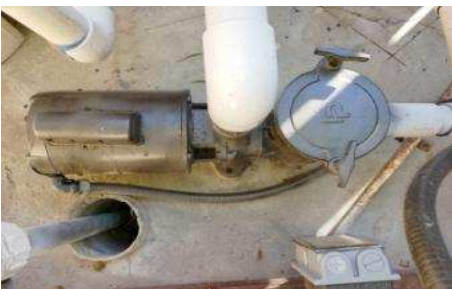
**Further Comments:** No concerns observed

Pump was functional
