Home Inspection Report

Alabama Home InspeXions, LLC

12:16 September 29, 2020

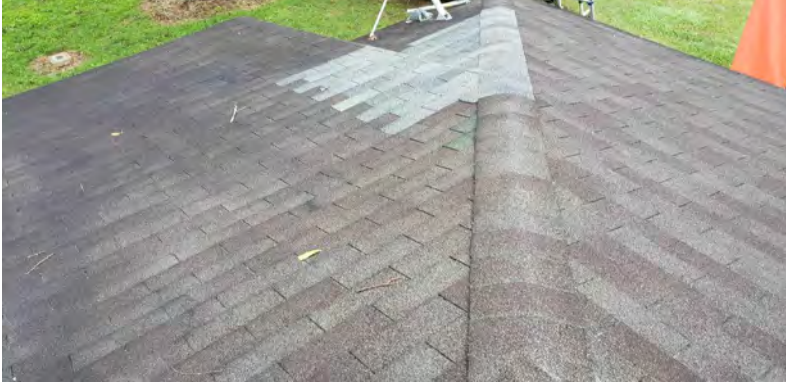
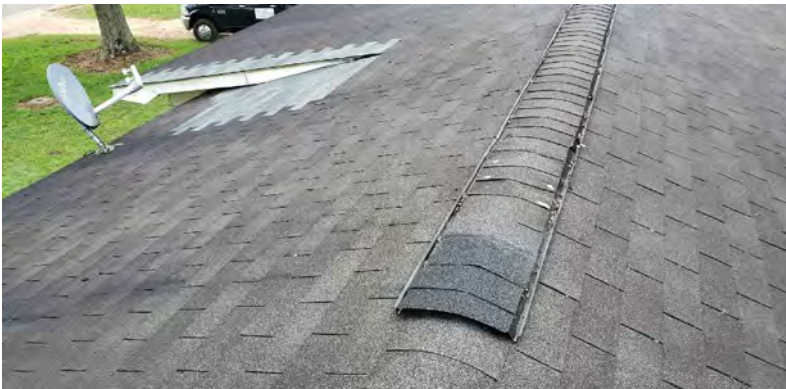
Material: Asphalt shingle - It appears that recent roof maintenance has been completed and appears satisfactory. Recommend requesting a copy of the repair invoice for future reference and possible warranty information.

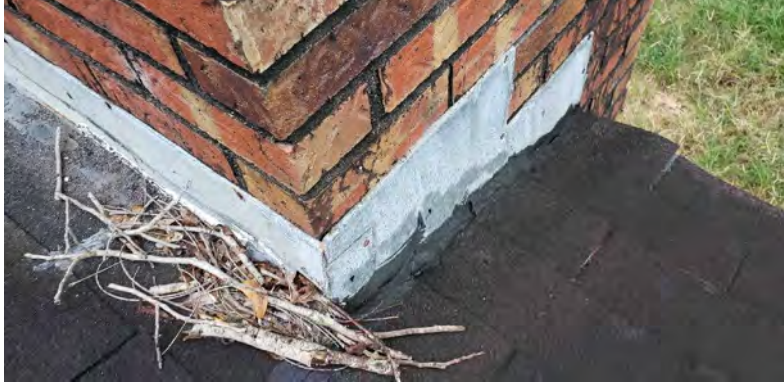
Satisfactory, Marginal Chimney Flashing: Metal - [Dry rot and loose sealant. Recommend sealing flashing. No active leak detected.](#)

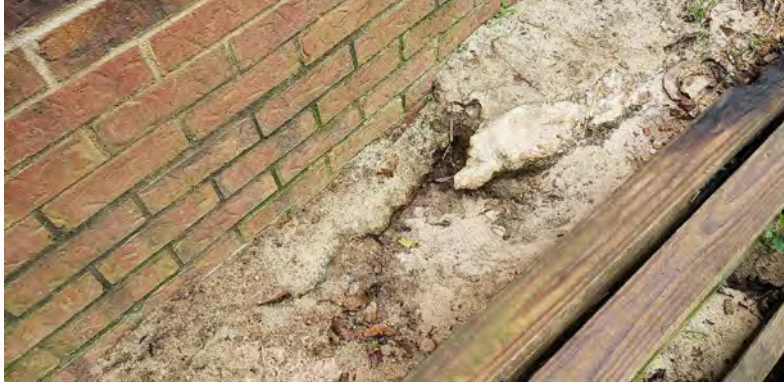
Satisfactory, Marginal Grading: Flat, Minor slope - Grading has negative slope and water is pooling against the foundation. We recommend evaluation by a licensed contractor to determine your best course of action.

Many dig holes from pets. Recommend filling the holes and planting grass.

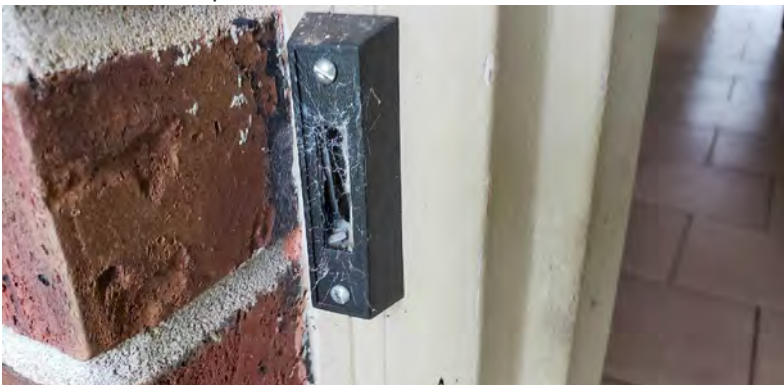
Not Inspected Door Bell: Non Operational

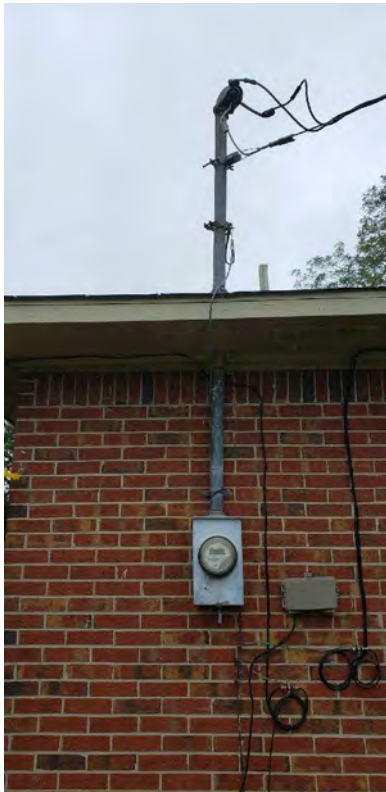
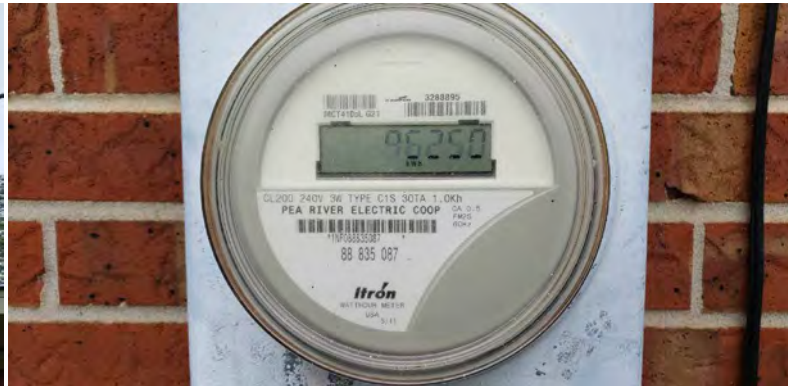
Service Amps/Volts 200 Amp Meter / 240 Volts

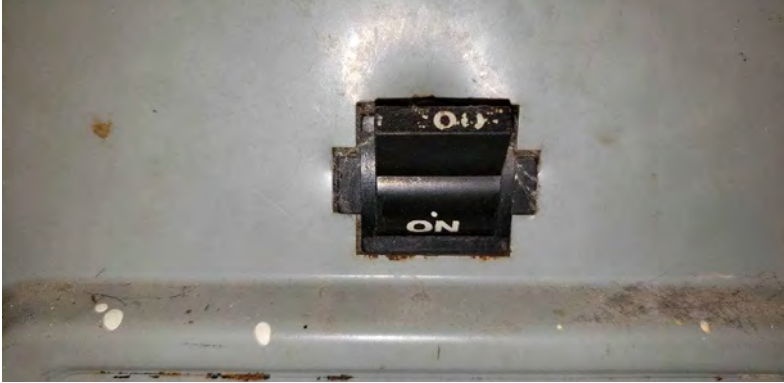
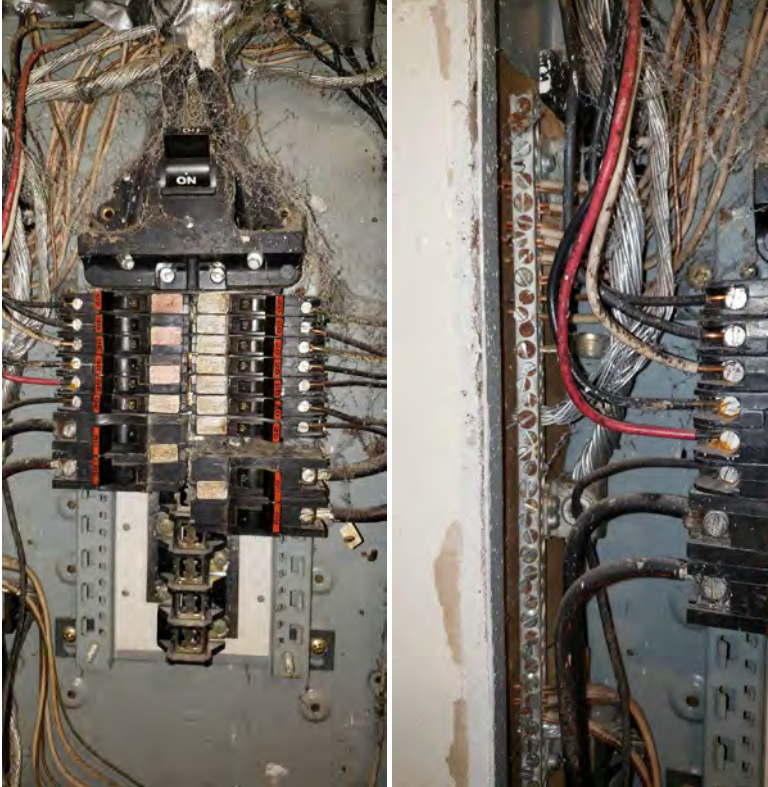
Satisfactory, Major Concerns Manufacturer: Federal Pacific - Federal Pacific panel breakers have had a history of not tripping when circuit overloading exists. Recommend the electrical panel and circuit breakers be evaluated by a licensed electrical contractor and any recommendations be followed.

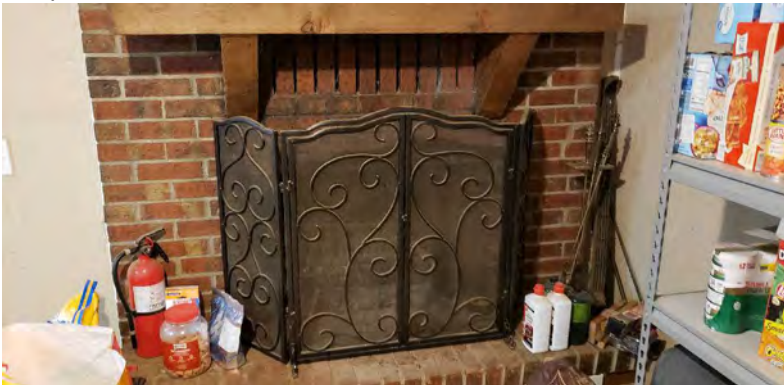
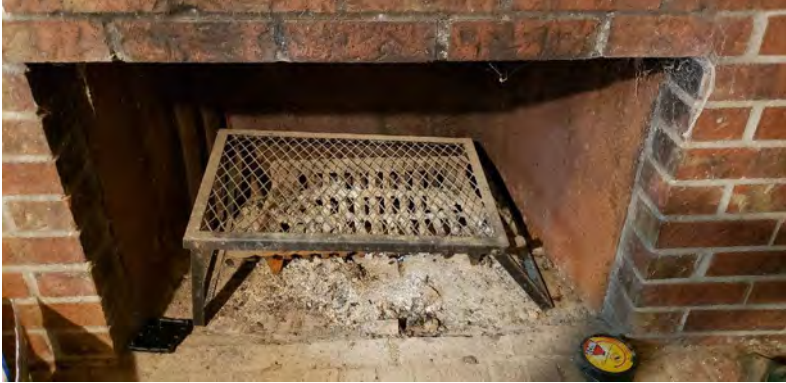
Breakfast area Fireplace

Satisfactory Fireplace Construction: Brick, Prefab

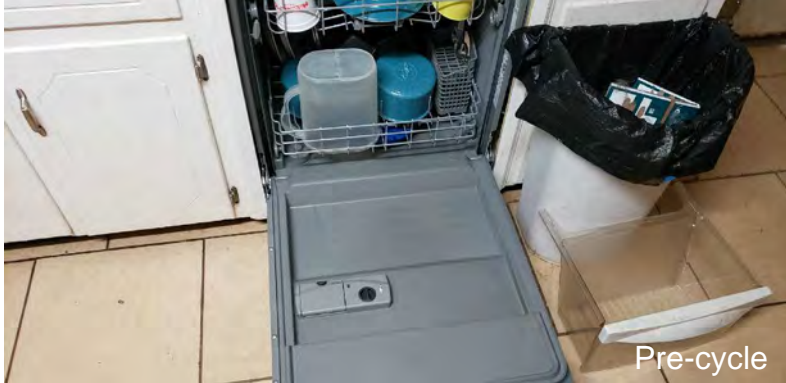
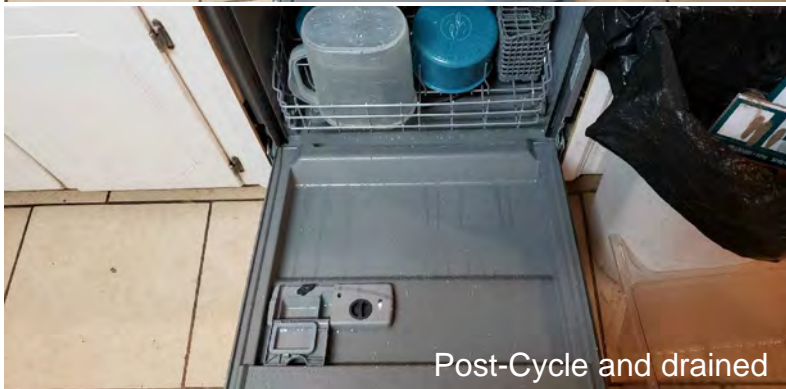
Dishwasher: Frigidaire

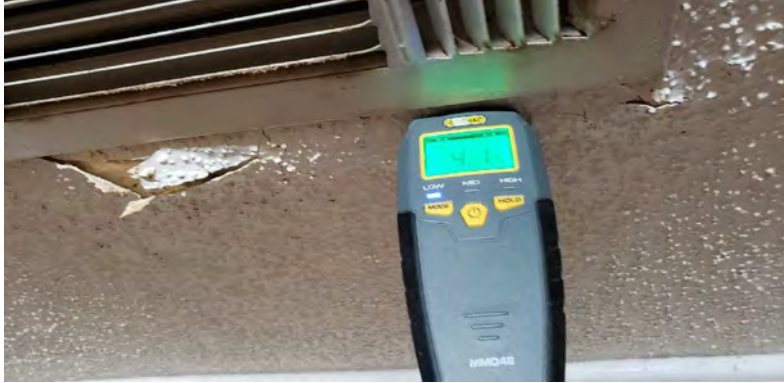
Satisfactory, Marginal Ceiling: Drywall - [Loose or peeling paint](#). [Recommend painting](#).

[Evidence of past water staining. Moisture testing was conducted in multiple locations and no active leak was detected at the time of the inspection.](#)

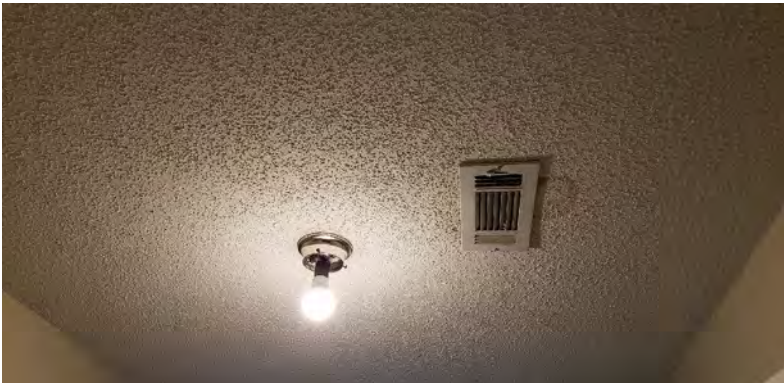
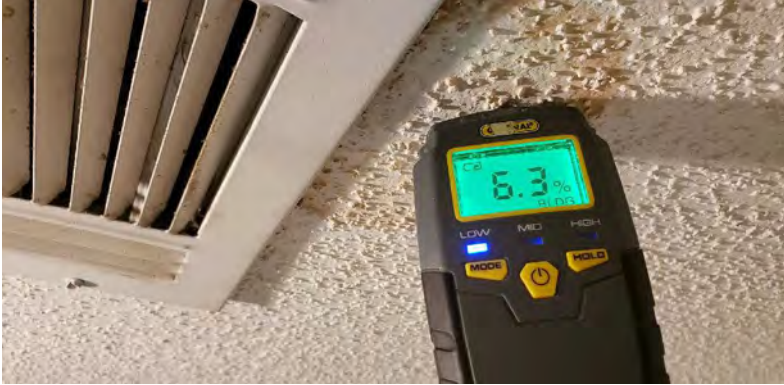
Main Floor Laundry Room/Area

Satisfactory Ceiling: Drywall - Evidence of past water staining. Moisture testing was conducted in multiple locations and no active leak was detected at the time of the inspection.

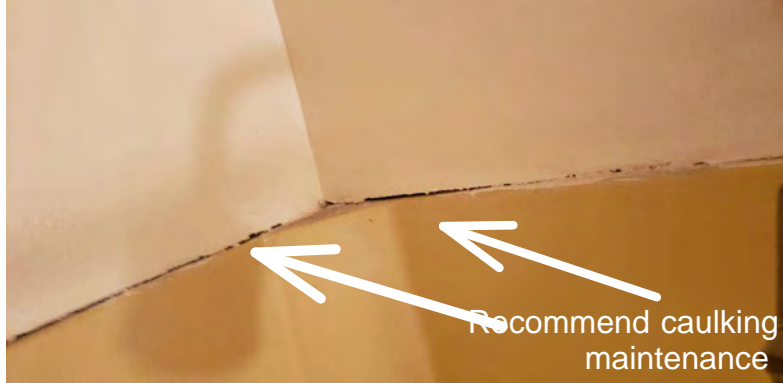
Satisfactory, Marginal Tub/Shower Combo Fiberglass/Acrylic Tub and Surround - [Recommend caulking maintenance.](#)

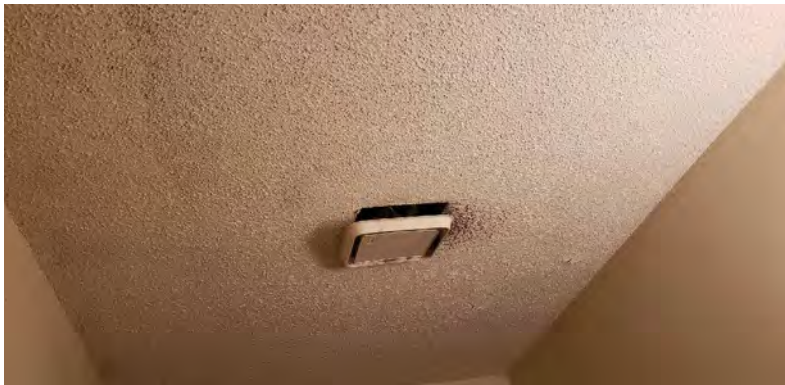
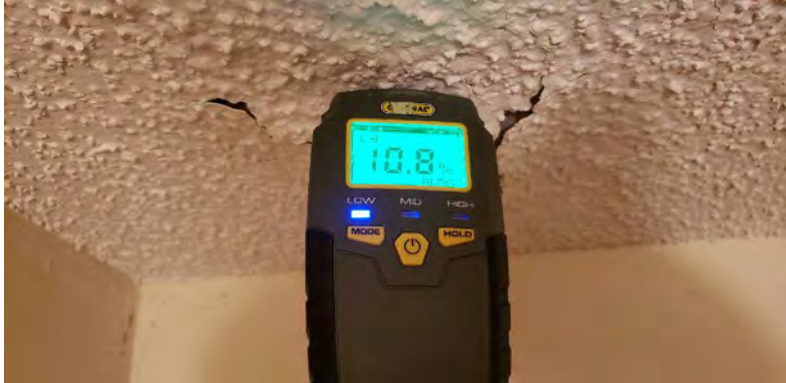
Ceiling: Drywall - Evidence of past water staining. Moisture testing was conducted in multiple locations and no active leak was detected at the time of the inspection.

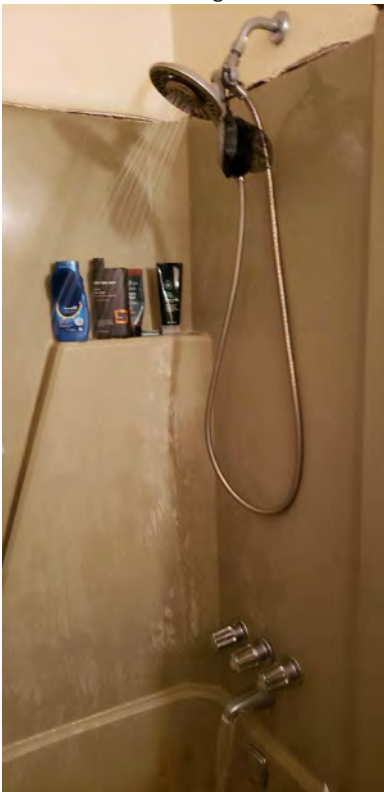
Satisfactory, Marginal Tub Plumbing Dual Handled Faucet - [Slow draining. Recommend cleaning the drain and retesting.](#)

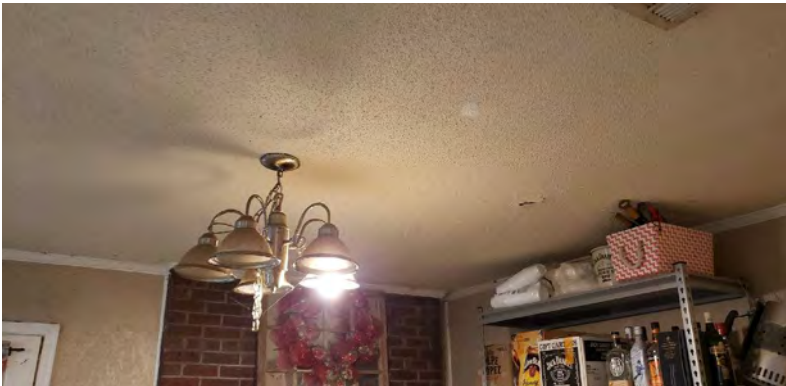
Breakfast Area Living Space

Satisfactory Ceiling: Drywall - Evidence of past water staining. Moisture testing was conducted in multiple locations and no active leak was detected at the time of the inspection.

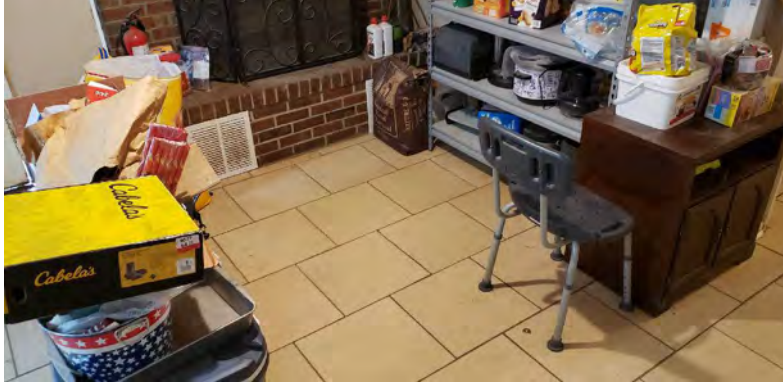
Satisfactory, Marginal Floor: Tile - [Chipped tiles](#). [Recommend repair](#)

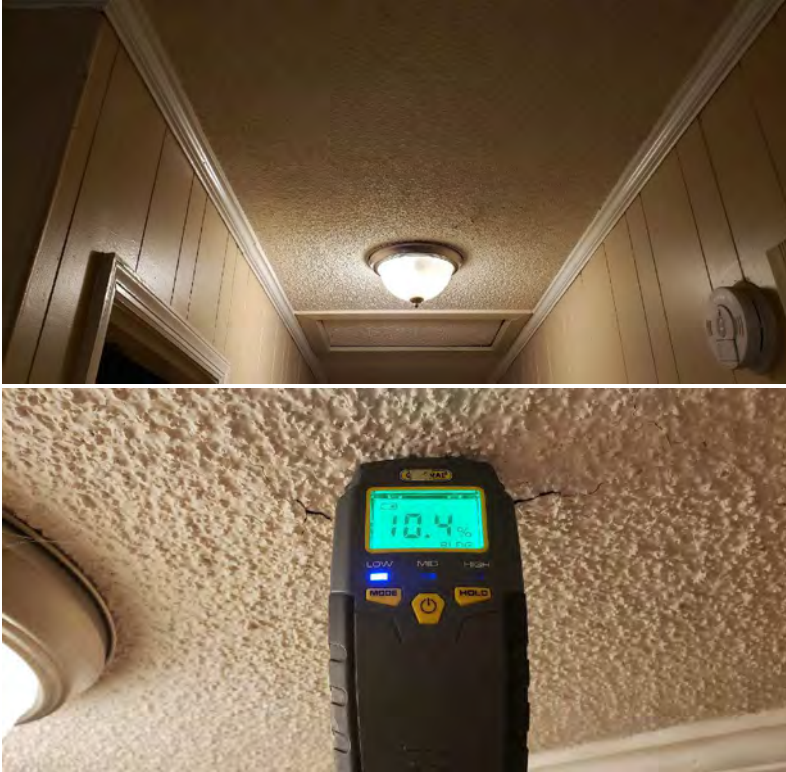
Ceiling: Drywall - Evidence of past water staining. Moisture testing was conducted in multiple locations and no active leak was detected at the time of the inspection.

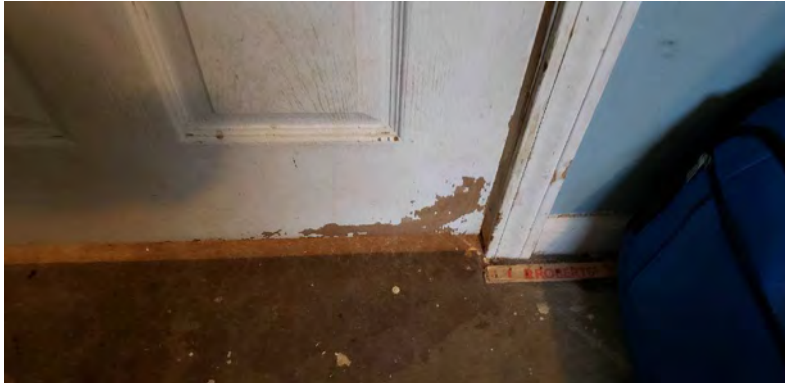
Satisfactory Doors: Hollow core swing door. **Peeling paint.**

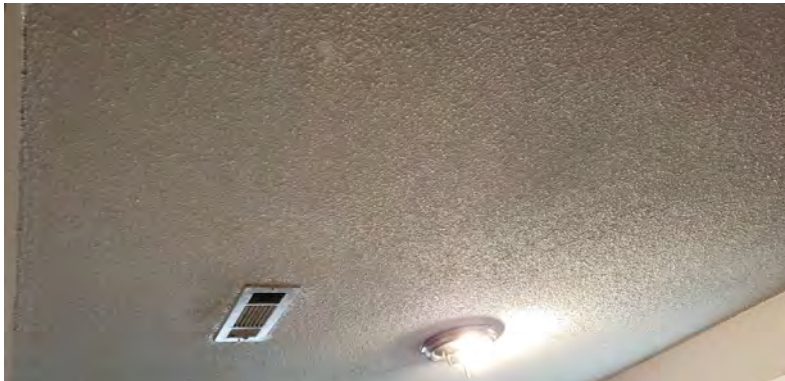
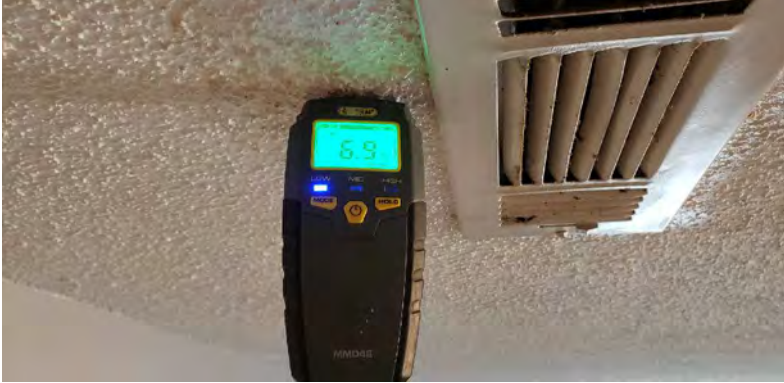
Satisfactory Ceiling: Drywall - Evidence of past water staining. Moisture testing was conducted in multiple locations and no active leak was detected at the time of the inspection.

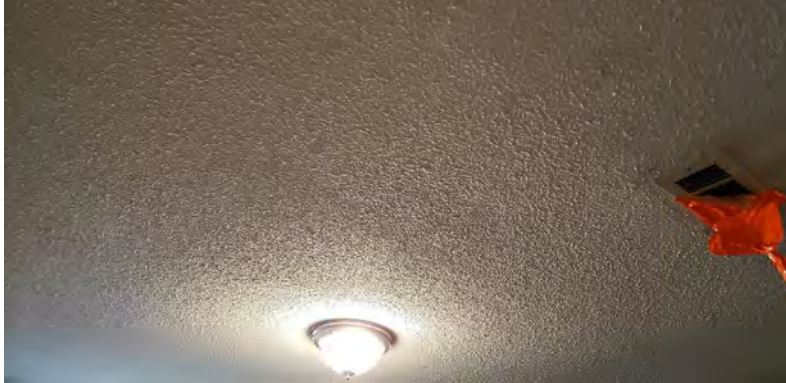
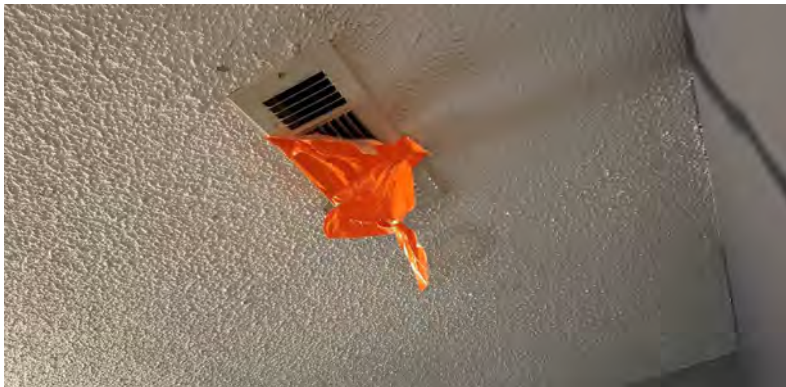
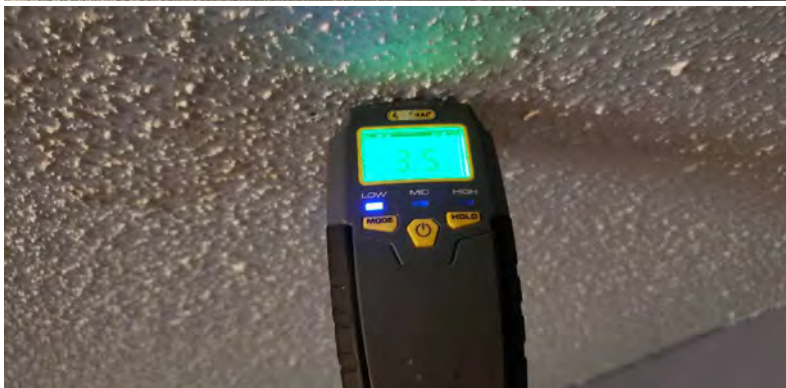
Satisfactory Ceiling: Drywall - Evidence of past water staining. Moisture testing was conducted in multiple locations and no active leak was detected at the time of the inspection.
