Review Committee Report on the
Fatal Accident Involving *Imedi*
During the 2018 Chicago Yacht Club Race to Mackinac
on July 21, 2018
Published: February 25, 2019

Committee Members: Christopher Thomas, chair, Nick Berberian, Sally Lindsay
Honey, Jay Kehoe, Matt Knighton, Shawn O’Neill, Sarah Renz, and Ronald White

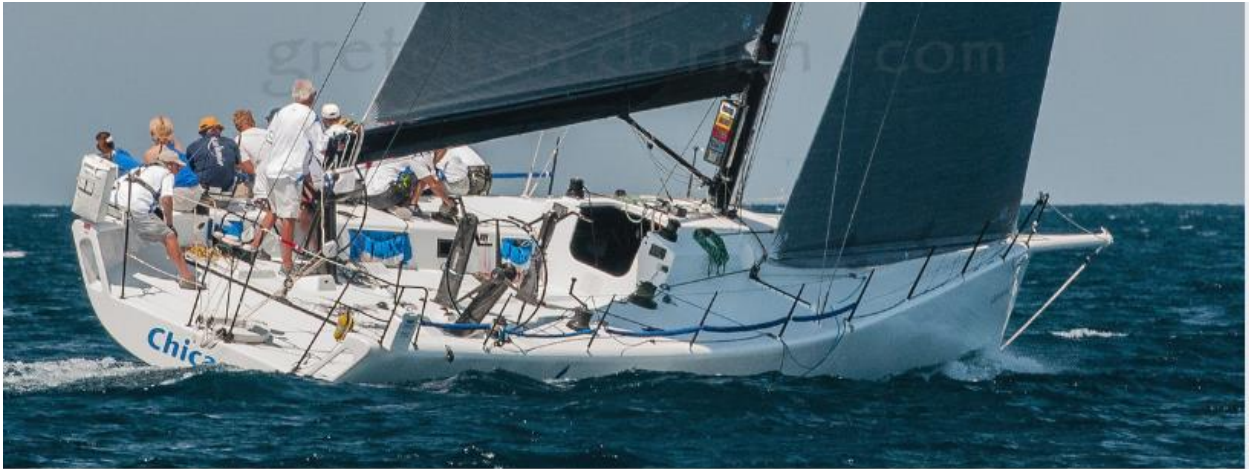
The TP 52 has a large open cockpit, with the vang control located far aft and remote from likely handholds and jacklines.
